Structural strengthening of a historical building in Rio Branco city – Acre

D. C. S. Amorim¹, D. R. C. Oliveira¹

¹ Civil Engineering Post-graduation Program, Federal University of Para, Brasil.

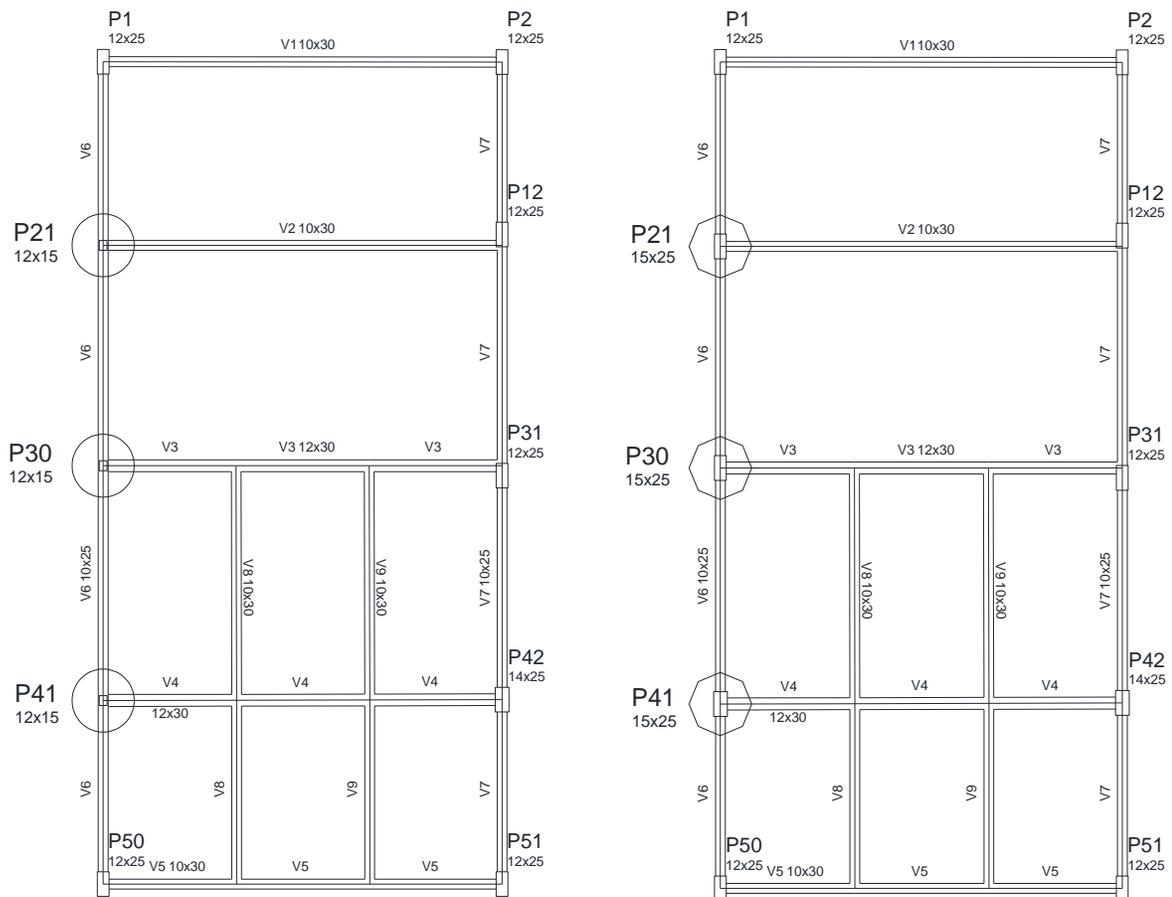
Figure 2. Location and dimensions of columns P21, P30 and P41 before and after structural strengthening (right).

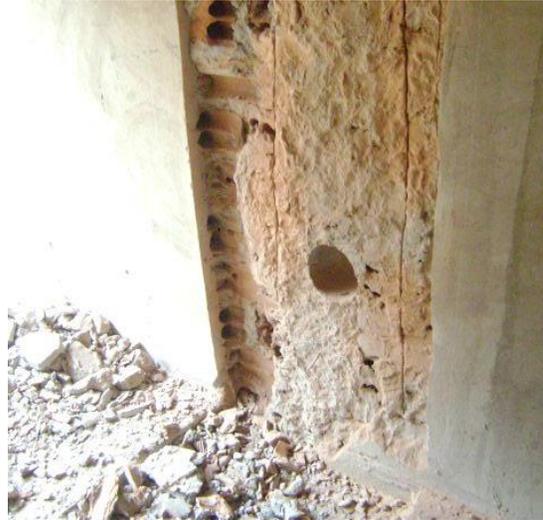
To check the existing structural safety, inspection visits and monitoring of the construction site during the execution of the revitalization work were carried out, where the procedures, techniques and equipment used in operations were identified and the photographic record being held at all stages of the executive process in 2009 and 2010. Before performing any procedure on the structure, the technical team highlighted the importance of axial compression tests on concrete testimonies to enable identification of any eventual problems related to concrete strength, since the old concrete was originally made with ceramic pieces of bricks and roof tiles. The test results indicated that, in general, the structural concrete has low compressive strength and contained coarse aggregate larger than 50 mm, which contributed to the formation of voids inside of some columns. It notes that the use of coarse aggregates derived from reducing of ceramic elements such as bricks and tiles is still a common practice in the city of Rio Branco, where there is shortage of gravel and rolled pebble. Figure 4 shows the location of extraction of the concrete testimonies in a column and Table 1 shows the results for concrete compressive strength of concrete testimonies from columns P21, P30 and P41, which further analysis indicated the need for structural strengthening in the basement level columns.

Figure 4. Testimonies' extraction hole in a column.

Table 1. Concrete's compressive strength.

Pilar	Testemunhos (MPa)	Projeto de reforço (MPa)
P21	13.7	25.0
P30	20.1	
P41	14.7	
Average	16.2

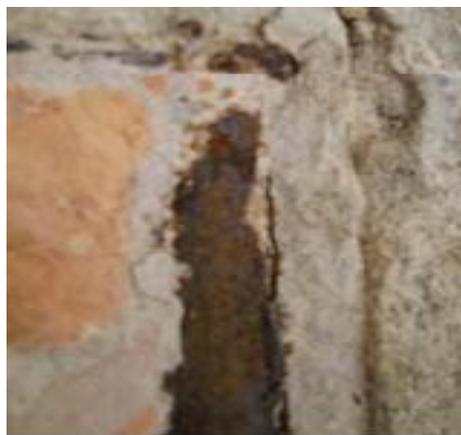
Besides the low compressive strength, it was also found that the reinforcements of some columns had advanced corrosion and severe weight loss, compromising bearing capacity to service loadings and even to permanent ones, once some bars were completely sectioned by corrosion. Figure 5 shows the appearance of the corroded reinforcement bars of the columns. It was concluded that the damage was characteristic of deterioration processes with systemic nature, i.e. related to the quality of the concrete used in the manufacturing of the structural system and

especially the thickness of reinforcements coatings that showed values between 10 mm and 15 mm, considered inadequate to provide the required service life of a structure made of concrete containing such porous aggregates.

Figure 5. Columns' longitudinal reinforcement eroded (corrosion).

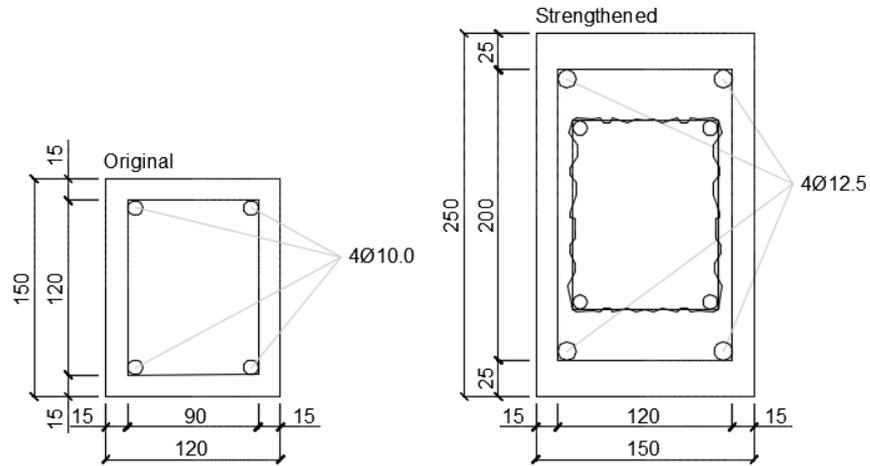
Figure 6. Columns' cross section before and after the structural strengthening.

2.3.2 Reinforcements. The longitudinal and transverse reinforcement (stirrups) before and after the structural strengthening of the columns were composed of steel bars with diameters, numbers and spacing presented in Table 2. The concrete cover for the columns was 25 mm and 15 mm at the short and long sides' dimensions, respectively. Figure 6 shows details of the cross sections of the columns before and after the structural strengthening with reinforced concrete jacketing, and Figure 7 shows details of the transverse and longitudinal bars. The columns P21, P30 and P41 were only strengthened in the basement floor length because these columns presented safety factors below the recommended by the Brazilian standard for reinforced concrete structures design for the future loadings. Figure 8 shows the placement of the reinforcements, where it is possible to see that, despite efforts to preserve as much original architecture, the smaller final dimensions of the columns, plus the 20 mm thick coating mortar layer, would be greater than the wall thickness.

Table 2. Columns' cross section dimensions and reinforcements.

Column	Columns dimensions		Steel		
	Cross section (mm)		Reinforcement (mm)		Design yield stress (MPa)
	Original	Strengthening	Original: Longitudinal / Stirrups	Strengthening: Longitudinal / Stirrups	
P21	120 x 150	150 x 250	4Ø10.0 / Ø5.0e150	4Ø12.5 / Ø5.0e150	435
P30					
P41

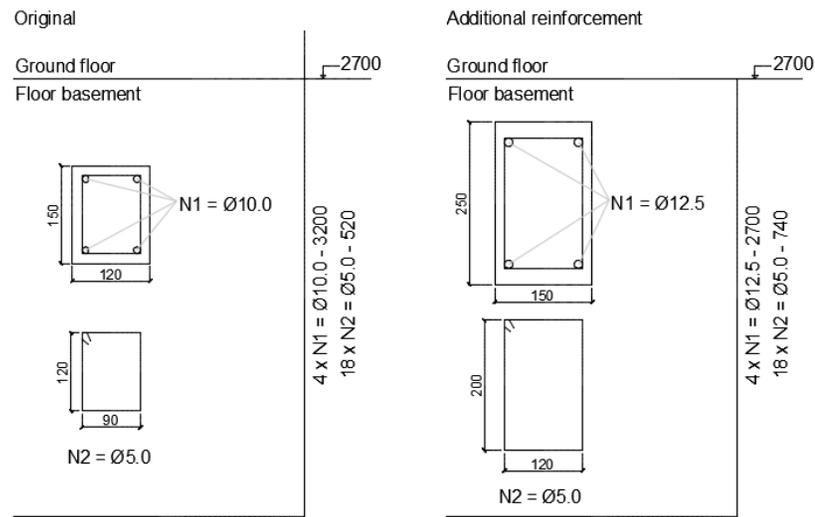
Figure 7. Original and additional reinforcement.

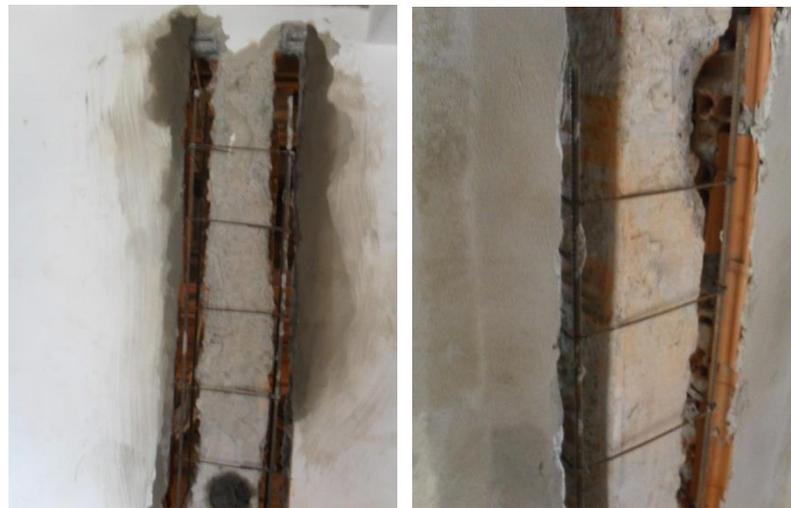
Figure 8. Longitudinal reinforcement and stirrups of the structural strengthening.

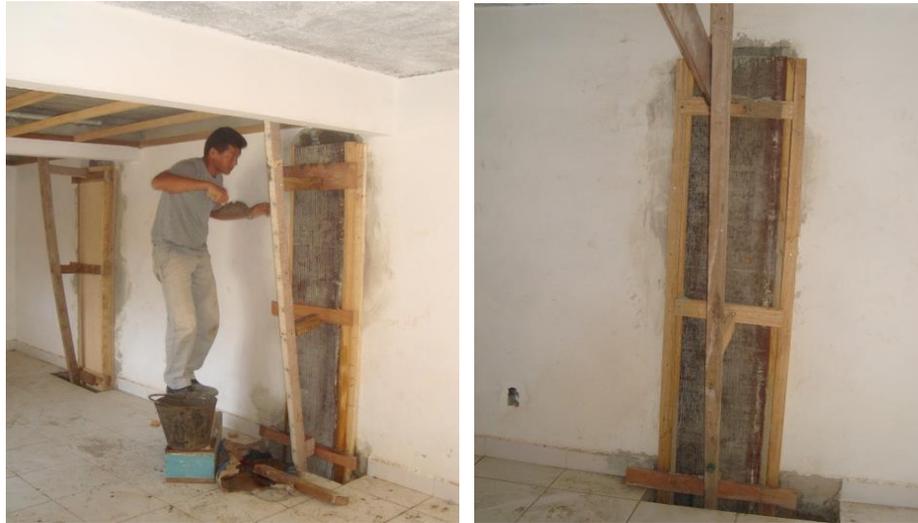
Figure 9. Concrete casting of the structural strengthening.

2.3.3 Concrete casting. So that there was greater adherence between the old and new concrete its surfaces of the columns were wet before the concrete casting. The concrete was carefully released (Figure 9) and the density was achieved with immersion vibrator with a head diameter of 20 mm, first in 50% of the volume of concrete cast in each column and then the remaining volume. After removal of the wooden mold the columns received a mortar coating layer to allow the finishing, or painting. Figure 10 shows the final appearance of the columns with smaller dimensions exceeding in 35 mm the wall thickness.

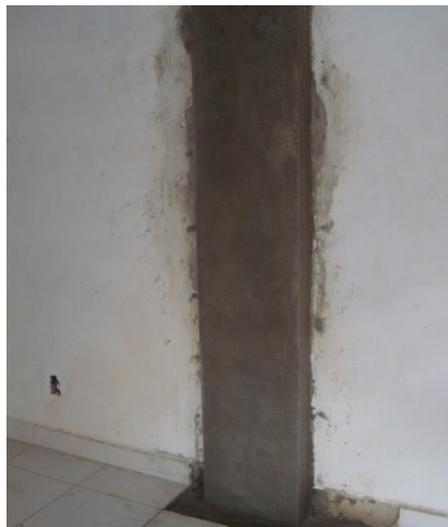
Figure 10. Final aspect of the strengthened columns.

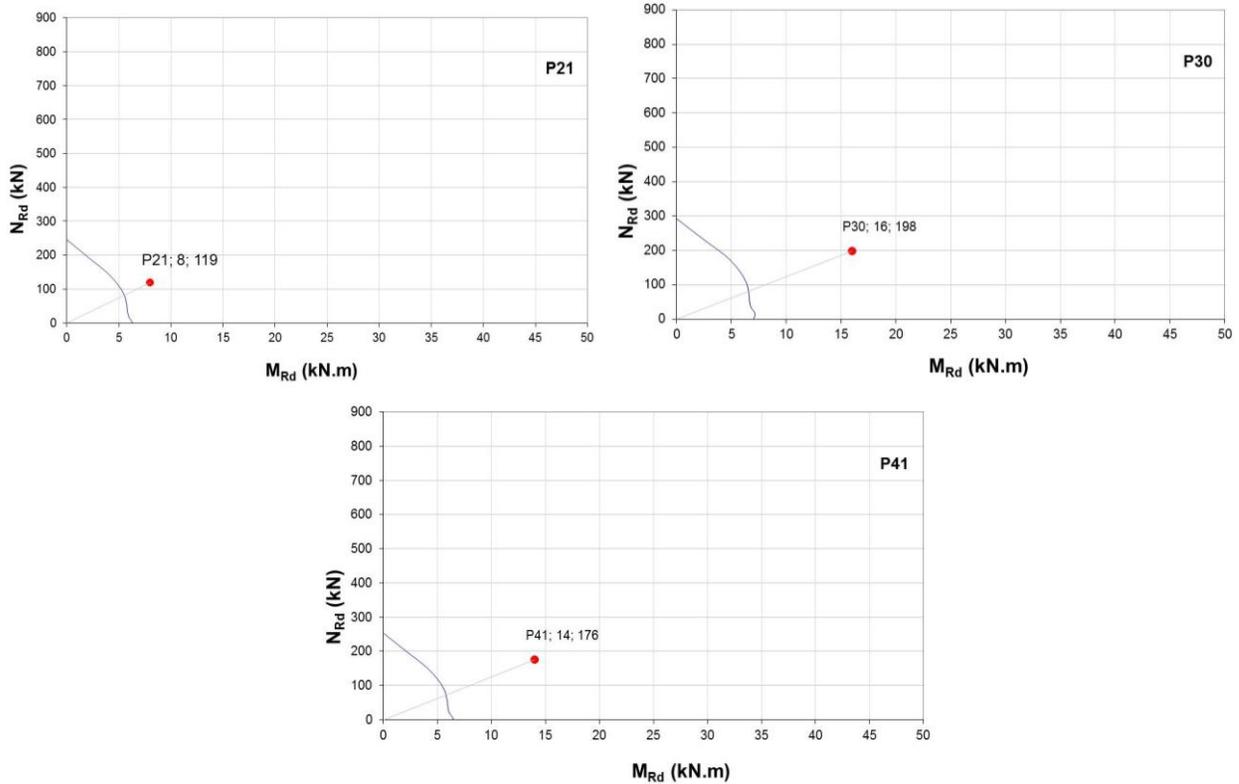
Normal acting force (N_{Sk}) was obtained from Altoqi Eberick 2002 software and the results found with the preliminary analysis for the safety factors of the columns P21, P30 and P41 before strengthening not meet the normative safety requirements, as shown in Table 4. Figure 11 shows the interaction envelopes of resistant forces of these columns, i.e. the consideration of acting and resistant characteristic bending moments without any coefficient of increase or decrease in these actions. In this case, it is observed that the bending moments are more important and destabilize the columns (Marí & Helleland, 2005), which did not occur because the current actions were lower than those considered in the structural design up to now. It is also possible to conclude with more refined analysis that the progress of corrosion on the flexural reinforcement could significantly reduce the resistant capacity of the columns to flexure and even if the maximum designed loads did not occur, small additions could cause the loss of stability of these columns (Tang & Yang 2011), evidencing the need to strength these structural elements.

Table 4. Columns' safety coefficient before and after the structural strengthening

Column	f_{ck} (MPa)	f_{cd} (MPa)	f_{yd} (MPa)	A_c (mm ²)	A_s (mm ²)	γ_u	γ_n	N_{Sk} (kN)	$N_{Sd,Eq}$ (kN)	N_{Rd} (kN)	γ_f
P21	13.7	9.9	435	18000	482	1.5	1.35	119	240	155	0.65
P30	20.1	14.4						198	400	215	0.54
P41	14.7	10.5						176	356	164	0,46

Figure 11. Envelopes for columns P21, P30 e P41 before the structural strengthening.

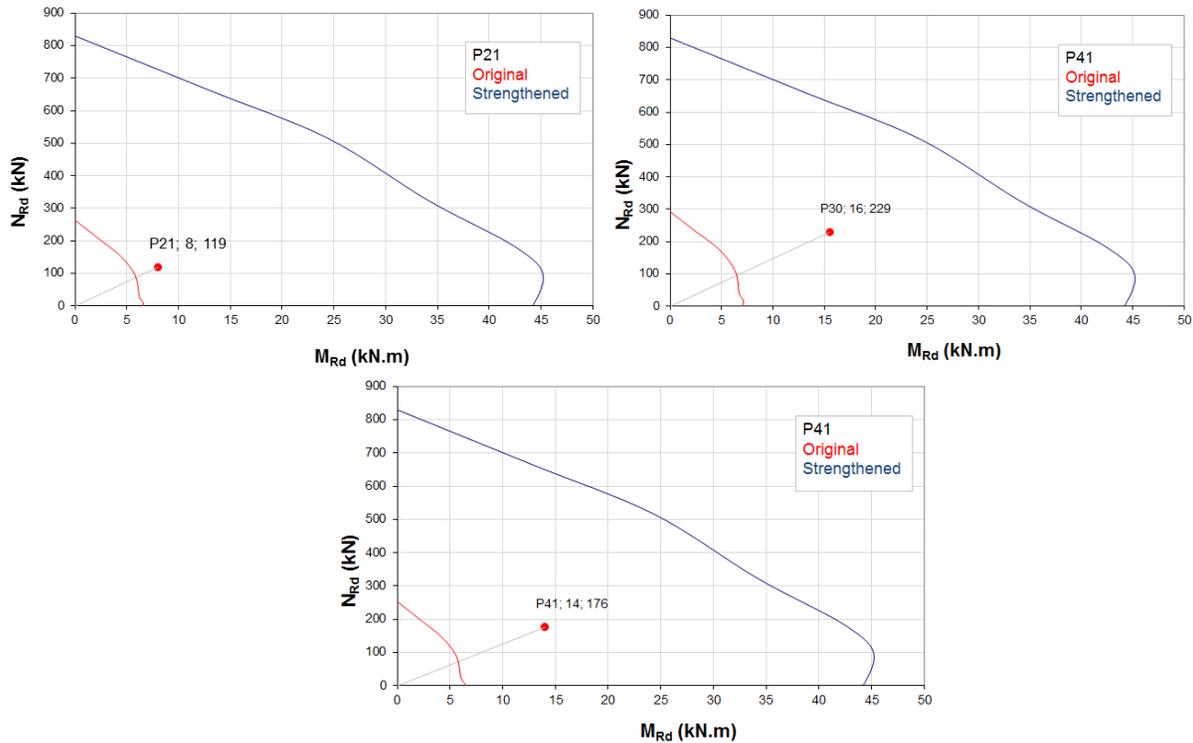
Columns' design safety factors for P21, P30 and P41 strengthened columns was based on the prescriptions of NBR 6118 (ABNT, 2014) following the same criteria used for the original columns without strengthening. The results are presented through the interaction envelopes of Figure 12. The safety factors of each column were determined by the ratio between the length of the straight line from the origin to the outer envelope, passing through the acting loads point, and the distance from this point to the origin, and results are presented in Table 5.

Figure 12. Envelopes' for strengthened columns P21, P30 and P41.

Table 5. Final safety factors

Column	Safety factor
P21	3.5
P30	1.8
P42	2.1
