## Characterization of failures and estimation of the qualitative seismic vulnerability of two reinforced concrete school buildings located in Falcón State.

The objective of this study was to characterize the structural failures and estimate the qualitative seismic vulnerability of two reinforced concrete school buildings located in Falcón State, Venezuela. The methodology employed included a visual inspection with photographic documentation of failures, environmental classification according to the NTF 4015:2012 standard, and determination of qualitative seismic vulnerability using the FUNVISIS method (Code FUN-002, 2014). The results showed that both schools are exposed to a chloride-corrosive environment (M4). The originality of this study lies in the application of the FUNVISIS method to school buildings in a marine environment. The seismic risk analysis revealed that one school exhibits high vulnerability (P5), while the second showed medium-low vulnerability (P8).

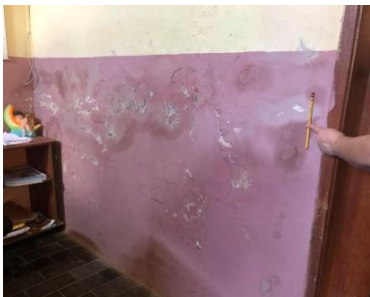
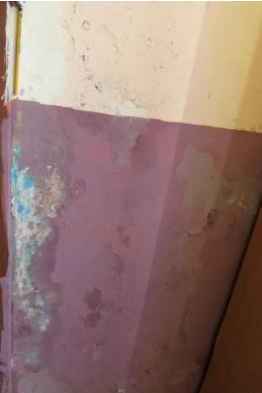
Figure 4. Failure Symptomatology Form. Module 1. 1/3  
Source: Prepared by the authors (Pérez et al., 2022).

| <div style="display: flex; justify-content: space-between; align-items: center;"> <div> <b>FAILURE SYMPTOMATOLOGY FORM</b> </div> </div> | |
|---|---|
| <div style="display: flex; justify-content: space-around;"> <div style="text-align: center;"> <p><b>1</b></p> </div> <div style="text-align: center;"> <p><b>2</b></p> </div> </div> | <p>Moisture, efflorescence, and bulging of the render are observed in the lower third of all enclosure walls in this direction. Detachment of the main coating (paint) is also observed.</p> |
| | <p>It is presumed that the moisture present is due to capillary effects caused by the rise of water contained in the foundations toward the structure through the pores of the slab concrete, the blocks, and the render itself, releasing salts and leaving white stains.</p> <p>In addition, in the specific case of the enclosure wall located between axes H-I and 4-6 (photo 1), there is a possible leak caused by the sanitary installations of the adjacent bathroom.</p> |

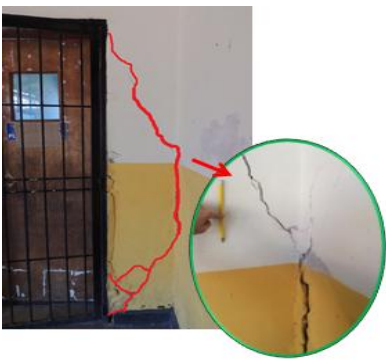
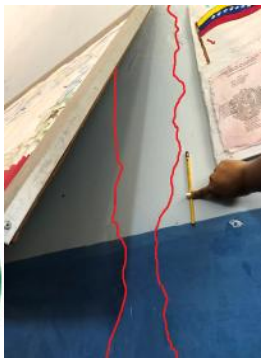
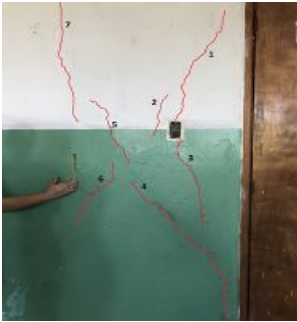
Figure 5. Failure Symptomatology Form. Module 1. 2/3  
Source: Prepared by the authors (Pérez et al., 2022).

| <div style="display: flex; justify-content: space-between; align-items: center;"> <div>FAILURE SYMPTOMATOLOGY FORM</div> </div> | |
|---|---|
| <p>1</p> <p>2</p> <p>3</p> | <p>Concrete bulging is observed, in addition to:</p> <ol style="list-style-type: none"> <li>1. Crack in the external enclosure wall of classroom 1, marked in red, located on axis H between axes 3-4. The crack starts at the upper left corner of the door frame, with a length of 1.24 m and a thickness of 0.05-0.70-0.80mm down to the yellow coating. It continues to the lower edge of the door frame with a length of 1.31m and a thickness &gt; 2mm.</li> <li>2. Cracks in the enclosure wall on axis H between axes 1-4, marked in red, on both the classroom 1 side and the classroom 2 side. In classroom 2, two cracks are visible: one located in the central third of the enclosure wall, 0.70 m long and more than 2mm thick. The second begins at the top of the enclosure wall with a length of 2.52 m and thicknesses of 0.10-0.08-0.60-0.50-0.30-1.50mm.</li> <li>3. Various cracks and fissures, marked in red, on the internal enclosure wall of classroom 1, located on axis H between axes 3-4.</li> </ol> |
| | It is presumed that the "X"-shaped cracks originated from the seismic movements that occurred in 2009. |

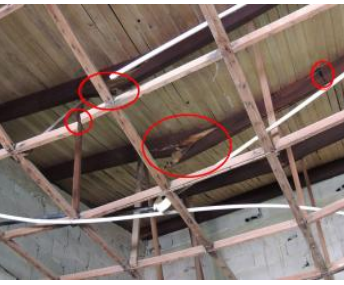
Figure 6. Failure Symptomatology Form. Module 1. 3/3  
Source: Prepared by the authors (Pérez et al., 2022).

| <div style="display: flex; justify-content: space-between; align-items: center;"> <div> <b>FAILURE SYMPTOMATOLOGY FORM</b> </div> </div> | |
|---|---|
| <div style="display: flex; justify-content: space-around;"> <div style="text-align: center;"> <b>1</b><br/> </div> <div style="text-align: center;"> <b>2</b><br/> </div> </div> <div style="display: flex; justify-content: space-around; margin-top: 20px;"> <div style="text-align: center;"> <b>3</b><br/> </div> <div style="text-align: center;"> <b>4</b><br/> </div> </div> | <p>The following is observed on all the tongue-and-groove roofs of the classrooms in Module 1:</p> <ul style="list-style-type: none"> <li>-Moisture stains across the entire roof covering</li> <li>-Detachment of the wooden roof purlins</li> <li>-Rust stains on the metal roof purlins</li> <li>-Loose electrical cables, without protection or covering</li> </ul> <p>On the roof of classroom 7 (photo 4), breaks are observed in the wooden roof purlins. The ceiling support structure also shows detachment, and rust stains are visible.</p> |
| | <p>It is presumed that the moisture stains and the detachment of the tongue-and-groove boards are due to rainwater pooling on the roof covering, probably caused by deterioration of the waterproofing material from lack of maintenance.</p> <ul style="list-style-type: none"> <li>-The roof purlins of classroom 7 may be broken due to having been subjected to overloads at certain points.</li> </ul> |

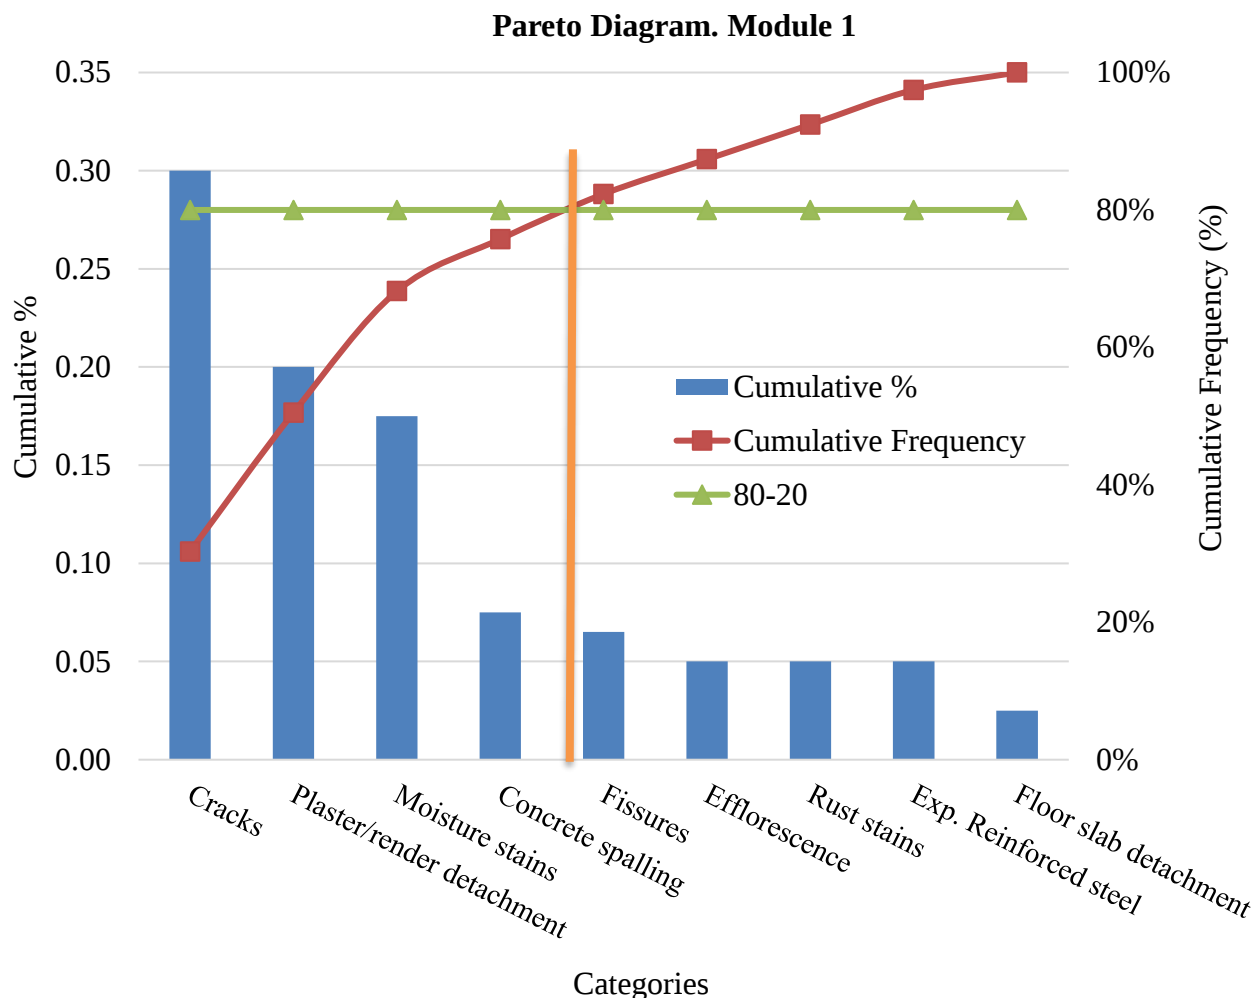
Figure 7. Pareto Diagram of the José Ramón Yépez school, Module 1.

The diagram shows that 80% of the failures correspond to cracks, plaster/render detachment, moisture stains, and concrete spalling. Cracks in structural elements are mainly associated with corrosion caused by chloride ion attack; this assumption is supported by the marine environmental classification and by the characteristic orientation of the cracking along the direction of the reinforcing steel. This mechanism begins with surface bulging caused by rust products; upon chloride attack, the passive layer is broken and the steel corrodes, initially producing a fissure, then a crack, followed by expansion of the concrete and complete exposure of the bar at the surface. The significance of the extent of cracking in relation to durability depends largely on whether the cracks follow the same direction as the reinforcing bar, particularly from a corrosion standpoint, since they can also reduce bond strength and shear resistance (Beeby A., 1993); other cracks appeared following the replacement of doors, grilles, and windows in 2007, or as a result of bending stresses in elements lacking nearby supporting columns. Moisture stains on enclosure walls are

attributed to the absence of stormwater drainage systems and to damage in the piping. Plaster/render detachment, in turn, is linked to persistent dampness in the walls and to the development of corrosion processes in the reinforcing steel. It is worth noting that in two areas of the school, overlapping roof coverings were observed; although this condition can initially be classified as a construction defect, it generates more serious problems over time and increases the module's seismic vulnerability.

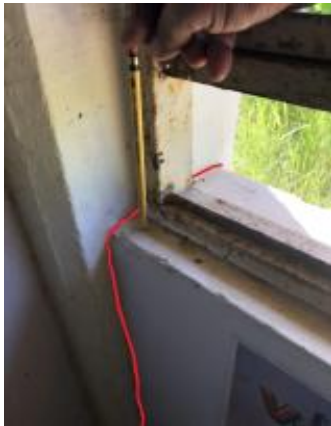
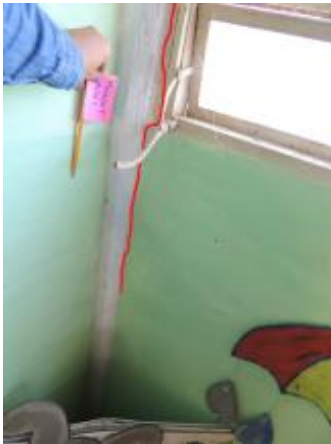
Figure 10. Failure Symptomatology Form. Module 4. 1/3

| <div style="display: flex; justify-content: space-between; align-items: center;"> <div style="text-align: center;"> <h2>FAILURE SYMPTOMATOLOGY FORM</h2> </div> </div> | |
|---|---|
| <div style="text-align: center;">1</div> <div style="text-align: center;">2</div> | <p>1. A vertical crack is observed on axis 3, between axes C-D, in classroom 2, module 4. The crack has widths of 0.70 mm at the top, 0.30 mm in the middle and lower sections. The length is 0.74 m.</p> <p>2. A vertical crack is observed on axis 3, between axes G-H, in classroom 3, module 4. The crack has widths of 0.50 mm at the top, 0.10 mm in the middle and lower sections. The length is 0.98 m.</p> |
| | <p>It is likely that the fissure originated from structural movements, short-column effects, or the density differential between the block and column elements.</p> |

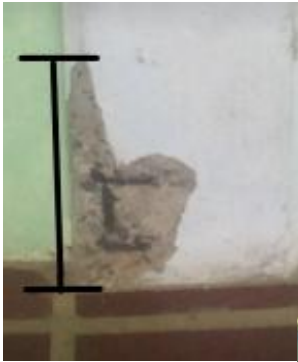
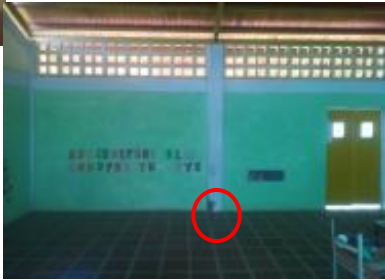
Figure 11. Failure Symptomatology Form. Module 4. 2/3.

| <b>FAILURE SYMPTOMATOLOGY FORM</b> | |
|---|---|
| | <p>Concrete spalling and exposed reinforcing steel are observed in the column located on Axis 1-H in classroom 1, module 4. The classroom was not accessible; photos taken from the window. The approximate area of exposed steel is <math>0.40\text{m} \times 0.15\text{m} = 0.06\text{m}^2</math></p> |
| | <p>It is presumed that the corrosion is due to the thin concrete cover thickness on the columns, combined with the aggressive environment to which the building is exposed.</p> |

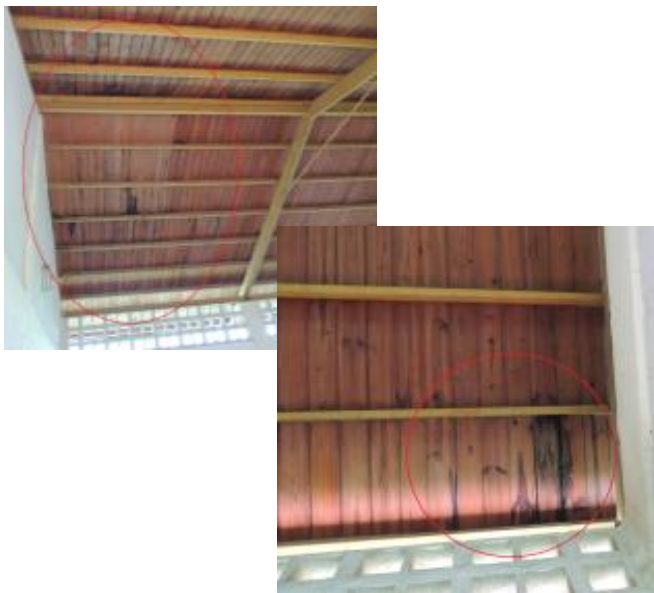
Figure 12. Failure Symptomatology Form. Module 4. 3/3.

| <div style="display: flex; justify-content: space-between; align-items: center;"> <h2 style="margin: 0;">FAILURE SYMPTOMATOLOGY FORM</h2> </div> | |
|---|---|
| | <p><b>1.</b> Moisture staining is observed on the interior of the tongue-and-groove roof of classroom 3, module 4, located on axes 1-2 between axes C-D.</p> <p><b>2.</b> A black moisture stain is observed on the interior of the tongue-and-groove roof of classroom 2, module 4, located between axes F-G and 2-3.</p> |
| | <h3 style="text-align: center;">Hypothesis</h3> <p>It is presumed that the moisture stains on the tongue-and-groove boards are due to the lack of a drip edge on the roof border to protect it from leaks. It is also possible that the waterproofing material was not extended far enough to cover the roof edge, causing water to seep between the waterproofing and the wood.</p> |

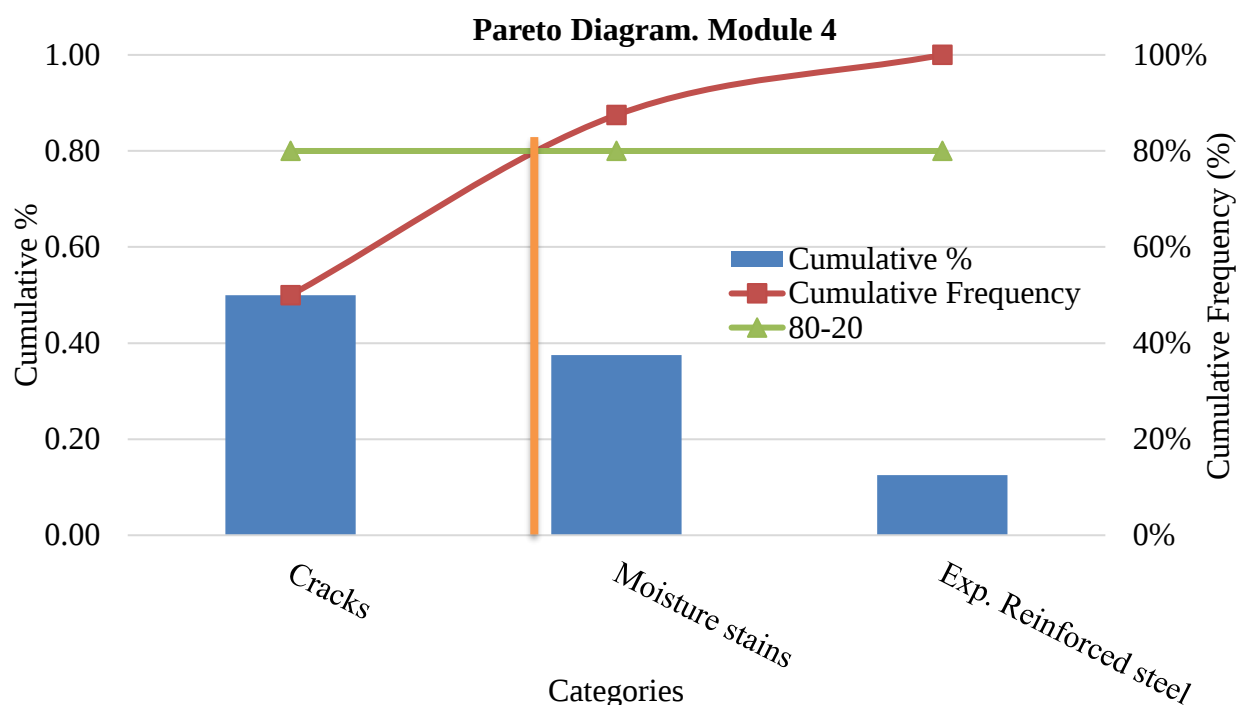
Figure 13. Failure Diagram of the Armando Schwarck Anglade Primary School, Module 4.  
Source: Prepared by the authors (Pérez et al., 2022).

The Pareto diagram in Figure 13 shows that 80% of the failures correspond to: cracks and moisture stains, leaks caused by deficient roof waterproofing, moisture stains originating from potable water piping, absence of rainwater collection channels leading to water pooling and allowing the walls to become damp, oxidation on window and door frames caused by the ingress of chloride ions into the surrounding environment given that this building is exposed to an aggressive environment, and finally, concrete spalling generated by corrosion occurring in structural elements. This type of failure in the building, resulting from interaction with the environment, could be avoided through concrete mix designs with low water/cement ratios, sufficient cement content, and the use of admixtures, as well as careful placement and curing of the cast elements (Sanjuan M., Castro P., 2001).
