Evaluation of pathological manifestations in buildings in terms of geographical orientation

W. Mazer¹, L. M. R. Silva², E. Lucas³, F. C. M. Santos⁴.

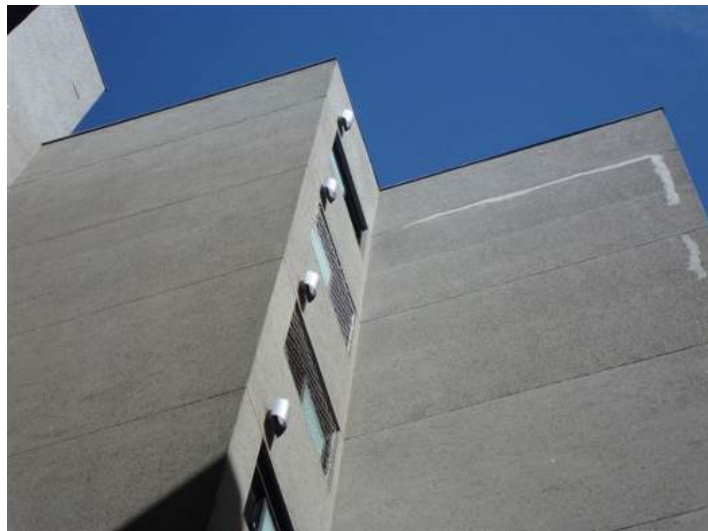
In Table 1 we can appreciate that in all buildings that presented pathological manifestations on their facades, the incidence of fissures was also present; it was seen that the largest portion of the fissures, as indicated in Table 2, happen on the facades that face North, which, in Curitiba, receives the most solar incidence, and which can suffer a variation in temperature of up to 10°C in the same day, as indicated in Figure 7. Some examples of these incidences are shown in Figure 6. Most of the time, splintering also occurs in the same facades as the variation in temperature, in addition to failures in the execution of the building, also have an influence on this type of damage.

a) Thermal variation fissures.

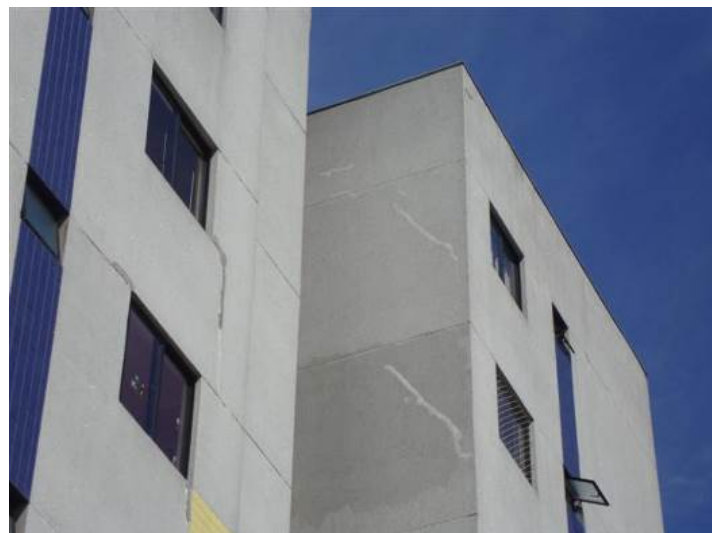
b) Structure movement fissures.
Figure 6. Fissures on the facade.
