## Potential of thermographic analysis to evaluate pathological manifestations in façade cladding systems

O. T. Takeda<sup>1</sup>, W. Mazer\*<sup>1</sup>

DOI: <http://dx.doi.org/10.21041/ra.v8i1.181>

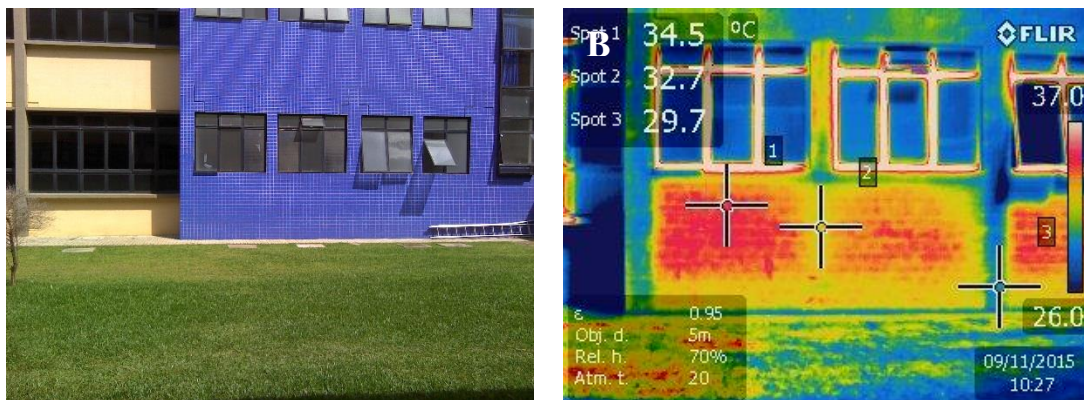
Figure 1. A) Block C façade constituting the study area  
B) Thermogram of study area 1.

Points with damaged grout joints between the ceramic tiles around the window framing region were identified in the visual exam of study area 1 presented in Figure 1A.

Additionally, the percussion test detected hollow sounds in wall parts and window framing regions. Figure 1B shows a thermogram where it is possible to identify thermal anomalies in part of the façade executed with ceramic tiles during the positive heat flow in region with direct exposure to solar irradiation during the morning period.

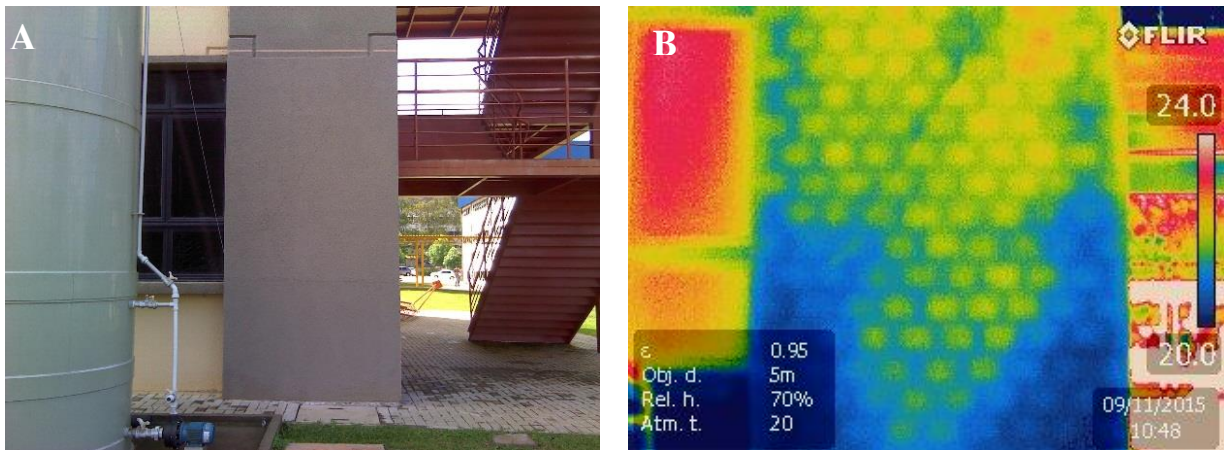
The visual inspection performed in study area 2, presented in Figure A, verified the existence of fissures in the cladding. Additionally, the percussion test detected hollow sounds along the entire fissure region and below the fissure.

Figure 2. A) Part of Block C façade consisted of light gray acrylic texture over mortar plaster. B) Thermogram of study area 2.

In the thermogram presented in Figure 2B it is possible to identify a thermal anomaly in part of the façade during a positive heat flow period in region with no direct exposure to solar irradiation during the morning period. The characteristic anomaly from the presence of moisture identified by the thermogram, together with the presence of a fissure in the cladding and the coating detachment, infers the presence of moisture in the inferior region, between the mortar plaster and the concrete brick masonry.

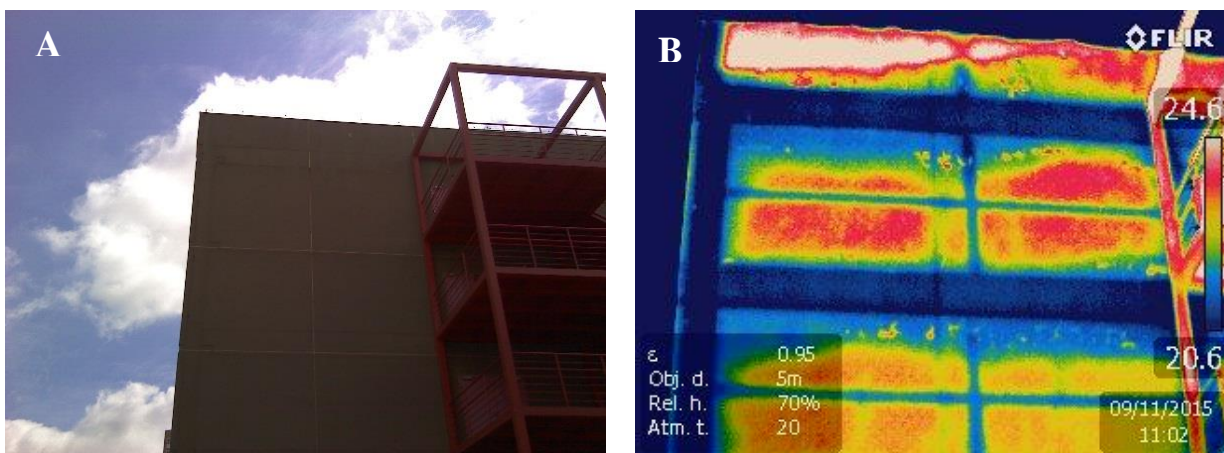
In study area 3, shown in Figure 3A, it is possible to observe block B lateral façade executed with light gray acrylic texture over mortar plaster applied in a concrete brick masonry during the positive heat flow period in a region with no direct exposure to solar irradiation during the morning period.

Figure 3. A) Block B lateral façade. B) Thermogram of study area 3.

In the thermogram presented in Figure 3B it is possible to observe a thermal anomaly in the interface region between the concrete brick masonry and the structural beam above, which is a characteristic of moisture presence. Likewise, it is possible to identify the structural elements, concrete tie beams that hold the concrete brick masonry walls and the more elevated temperature in the roof parapet wall region exposed to solar irradiation.

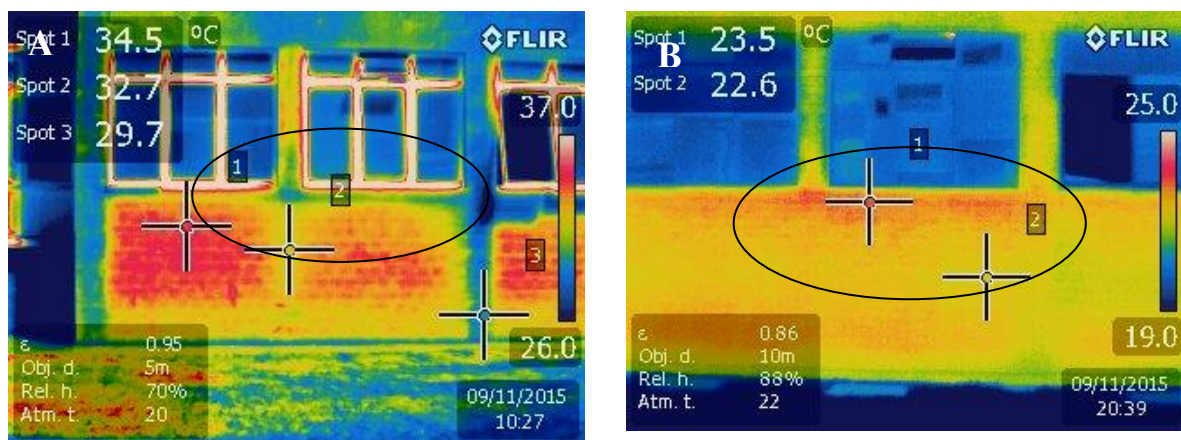
Figure 5. A) Exploratory study thermogram.  
B) Confirmatory study thermogram.

In the confirmatory study of study area 1, presented in Figure 5B, it is possible to identify a thermal anomaly that may be associated to a possible detachment with presence of moisture below the ceramic cladding in the window framing region, since the presence of moisture in the region has the characteristic of maintaining higher temperatures in the thermograms during the negative heat flow period in comparison to the unaffected region. This hypothesis is reinforced by the identification of points with damaged grout between the ceramic tiles in the window region. It is also possible to observe in the exploratory study thermogram, shown in Figure 5A, that during the positive heat flow period the temperatures in the window framing regions are smaller due to water evaporation.

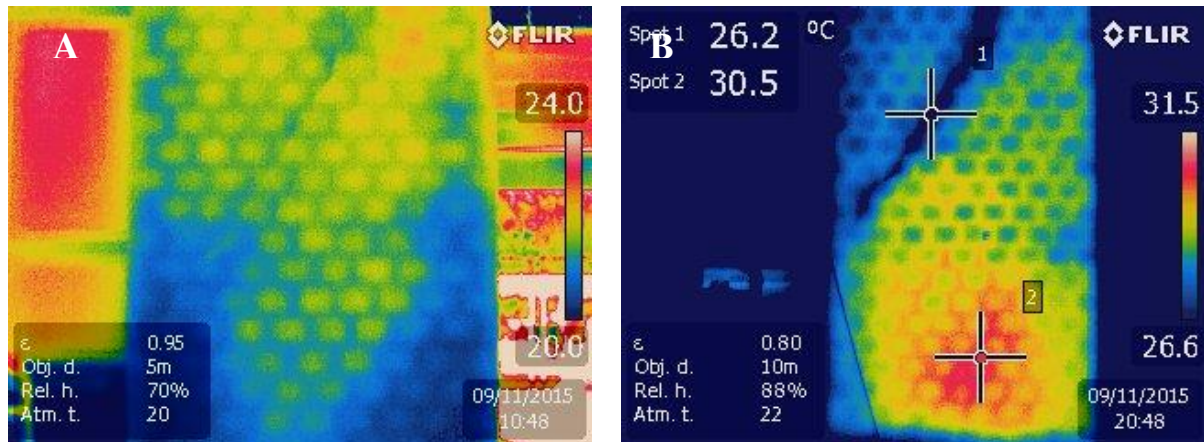
A fissure was observed in the cladding of study area 2, as presented by the thermograms shown in Figure 6.

Figure 6. A) Exploratory study thermogram.  
B) Confirmatory study thermogram.

In the exploratory study thermogram, shown in Figure 6A, it is possible to observe the existence of a thermal gradient in the lower part of the façade and a diagonal line, with temperatures lower than the central part of the façade. In the confirmatory study thermogram, illustrated in Figure 6B, it is possible to verify the existence of the diagonal fissure, marked by point 1, and the region with mortar plaster detachment together with moisture presence marked by point 2, with a higher temperature due to the ability water has of retaining heat during negative heat flow periods when compared to that of cladding materials.

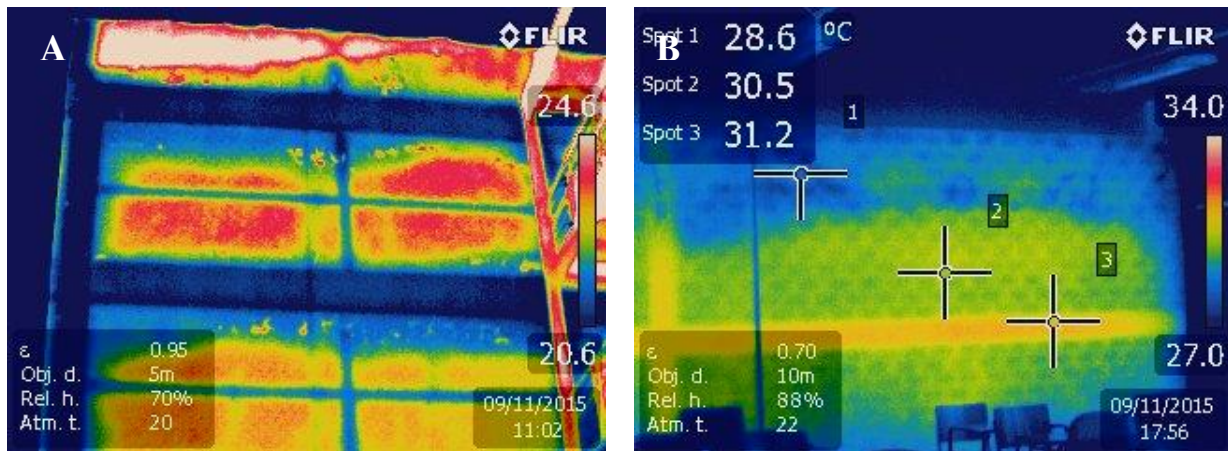
Figure 7. A) Exploratory study thermogram.  
B) Confirmatory study thermogram.

In the exploratory study shown in Figure 7A, it is possible to observe the existing temperature variation, indicating lower temperatures in regions close to beams. In Figure 5B, obtained from the last floor interior, it is possible to observe a thermal anomaly in the region of the interface region between the concrete brick masonry and the structural beam above. The presence of moisture was evident in the interior of the building due to mold presence on walls in the humid region identified by the thermogram.

In addition, a visual inspection was carried out in the external region, due to the possibility of access by the fire scape ladder, from where it was verified the presence of a fissure in the entire extension of the interface region between the concrete brick masonry and the structural beam above in the affected region, thus allowing water infiltration into the building.
