## Adaptation of a damage map to historical buildings with pathological problems: Case study at the Church of Carmo in Olinda, Pernambuco

In view of the above, this article is the result of a Master's research project in progress and presents the processes of drawing a damage map based on the methodologies adopted by IPHAN, seeking to implement them in a real case study on the façades of the Carmo Church in the municipality of Olinda, PE.

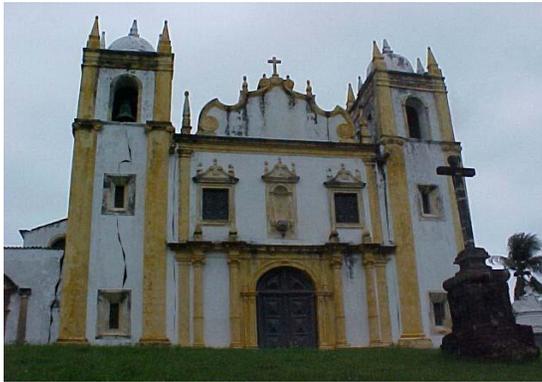
Figure 3. Structural damage to the Carmo Church in the year 2000. Source: Public Collection of Olinda.

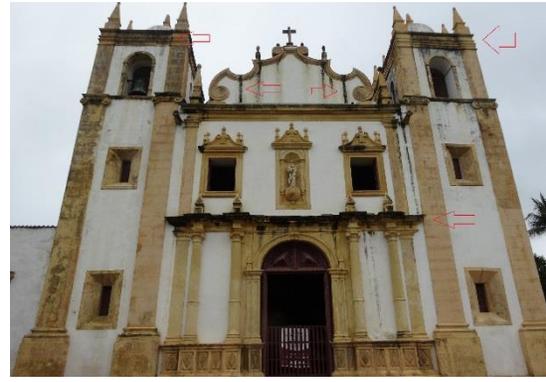
the Church was returned to the population. However, only 4 years following the restoration work, some anomalies in the façades can be observed.

Figure 4. Current damages to the Carmo Church. Source: Authors.

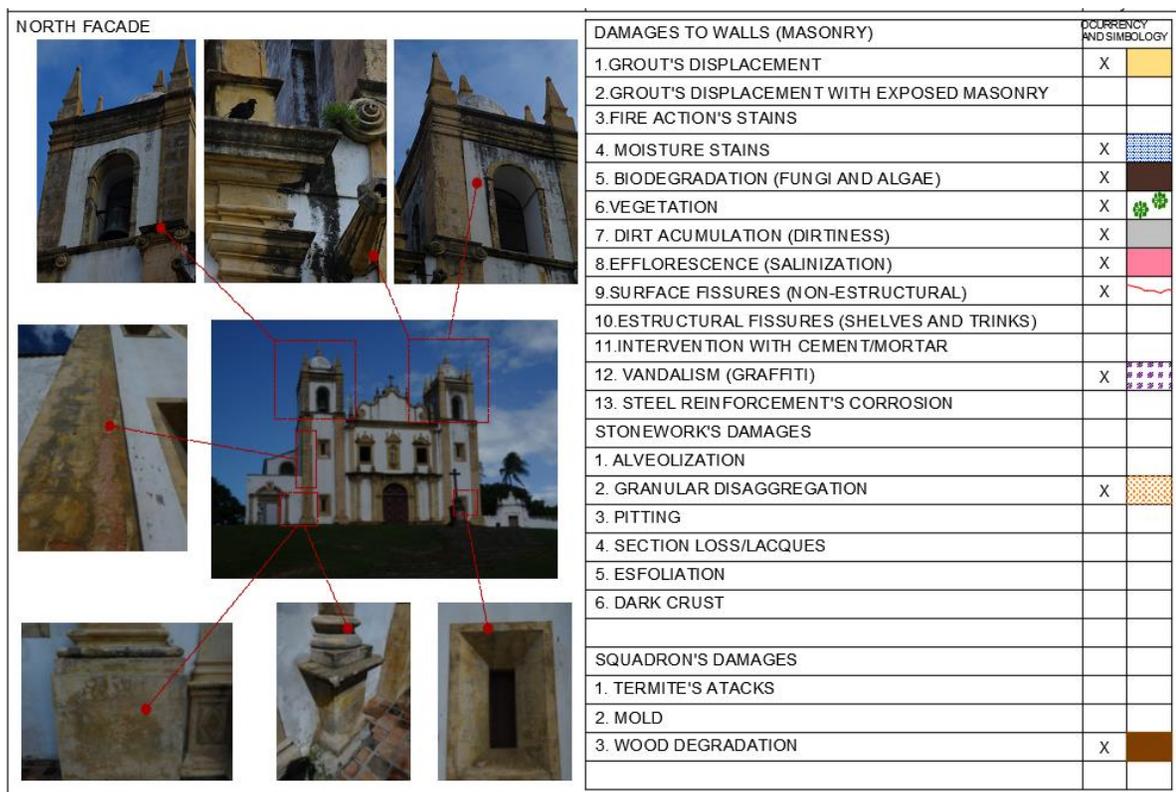
Figure 6. Damage identification form for the north façade of the Carmo Church. Source: Authors.

The investigations carried out affirm that the most commonly observed pathological problems in the façades of the Carmo Church were: dirt, vegetation, cracks, and humidity, with recurrences of black crust also being found in the east, west, and north façades. During the inspections, pieces of reinforced concrete with highly corroded steel reinforcement were also found, as well as a rotted wooden door in the north facade. In the following figures, the identification cards for the principal pathological manifestations are presented succinctly.

The DIF is organized to present, in addition to the list of damages found, some relevant photographs of the anomalies and the date on which the surveys were carried out, in order to establish a relationship between the state of degradation of the building and the time when it was inspected, as shown in Figure 6. The period in which the building was surveyed is important, in light of the possibility of the evolution of damage, as pathological manifestations tend to develop when the environment in which the building is located is conducive.

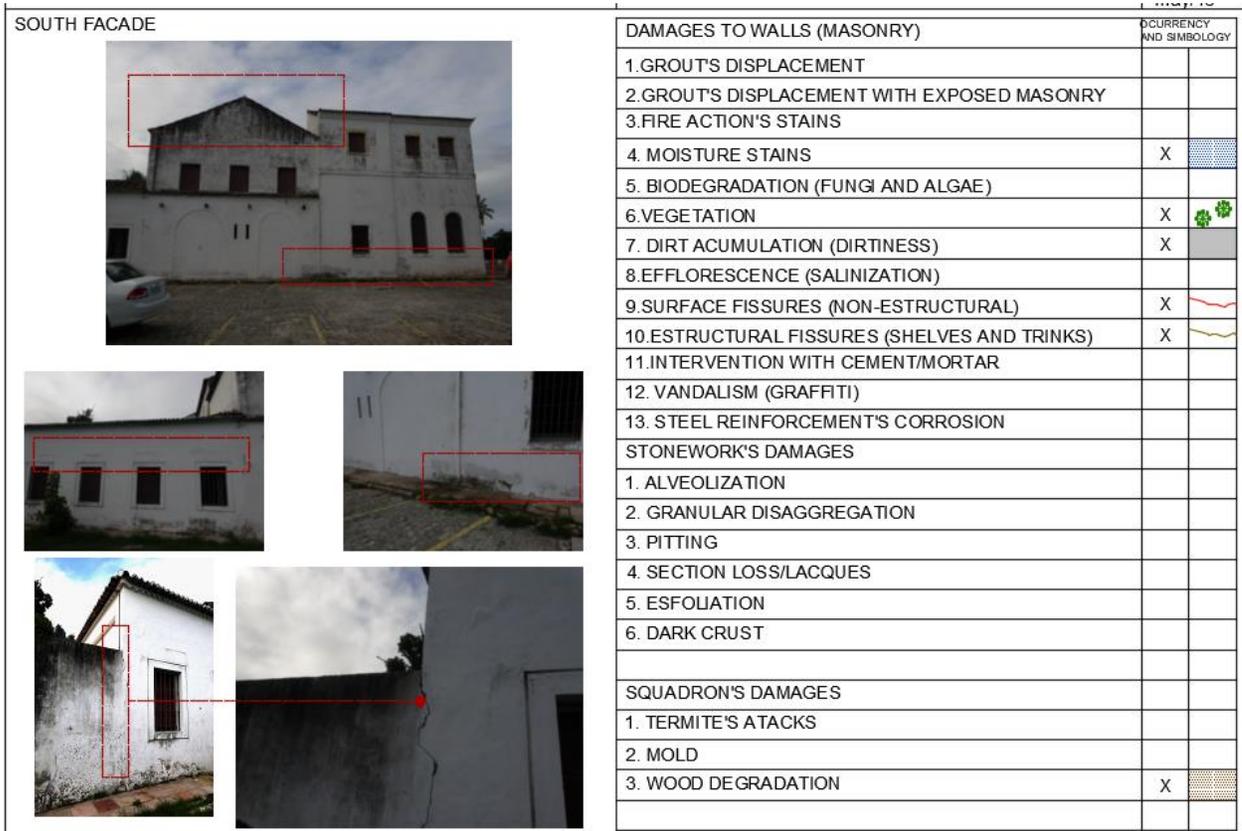
Figure 8. Damage identification form for the south façade of the Carmo Church. Source: Authors.

On the southern façade, damp spots with accumulations of dirt were also observed, including ascending moisture stains along the entire length of the façade (see Figure 8).

Some alterations to the initial design of the building were also verified, including former doorways that have been sealed and windows that have been reduced in size. No information was found about these interventions, making it difficult to identify the material that was used to seal these elements.

It is believed that the material used was probably something with high porosity and high permeability, since moisture spots can be observed in the areas where these changes were made.

Another point identified was the appearance of a vertical crack with a gap ranging from 0.5 to 2 mm near the deposit wall (south façade). Because the Carmo Church has a history of structural problems resulting from settling, having undergone foundation reinforcement in 2001, treatment of this problem will require monitoring of the fissure in order to identify its origin.

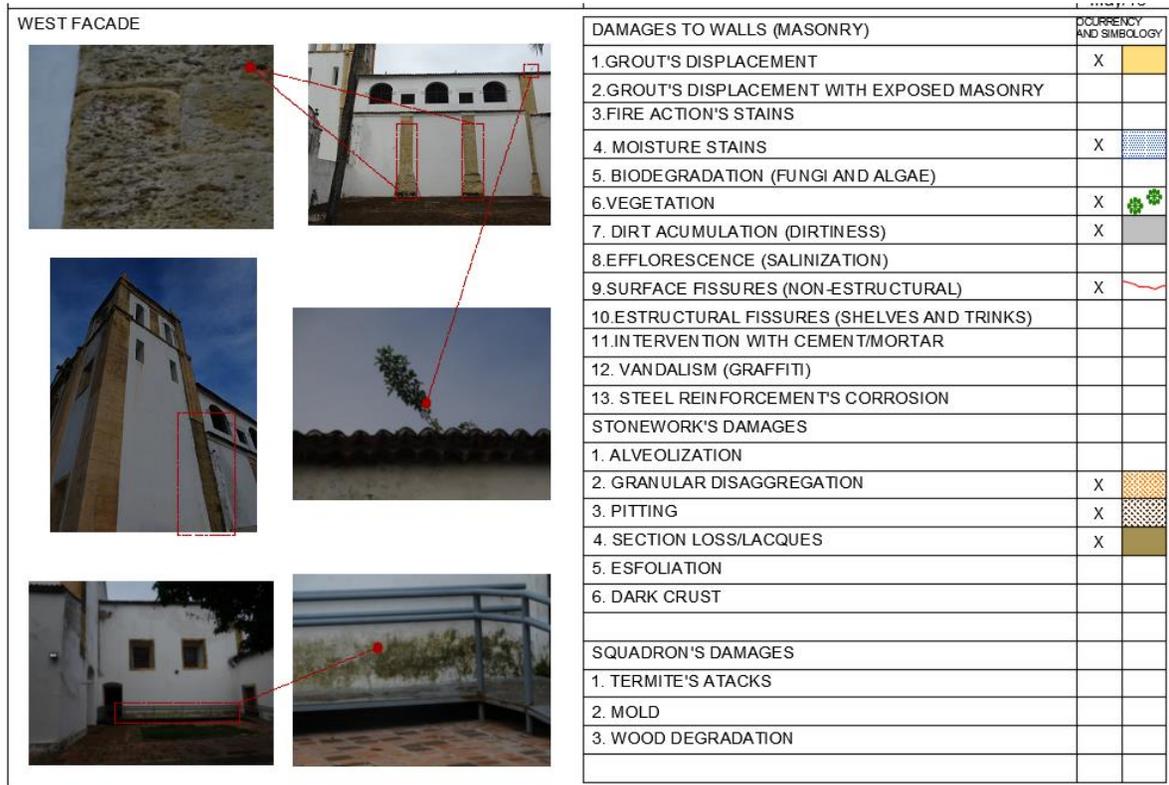
Figure 9. Damage identification form for the west façade of the Carmo Church. Source: Authors.

Figure 9 shows the damage identification form for the west façade. The anomalies found were similar to the other façades; however, this façade had more damage to its masonry structures, which presented granular disintegration, pitting, and section losses (gaps).

The DIF for the west façade (Figure 9) also showed that the water penetration process capillarity action in the soil was intensified by the construction of a metallic ramp that causes water to splash onto the façade when it rains. This explains the development of mold and slime at this location.

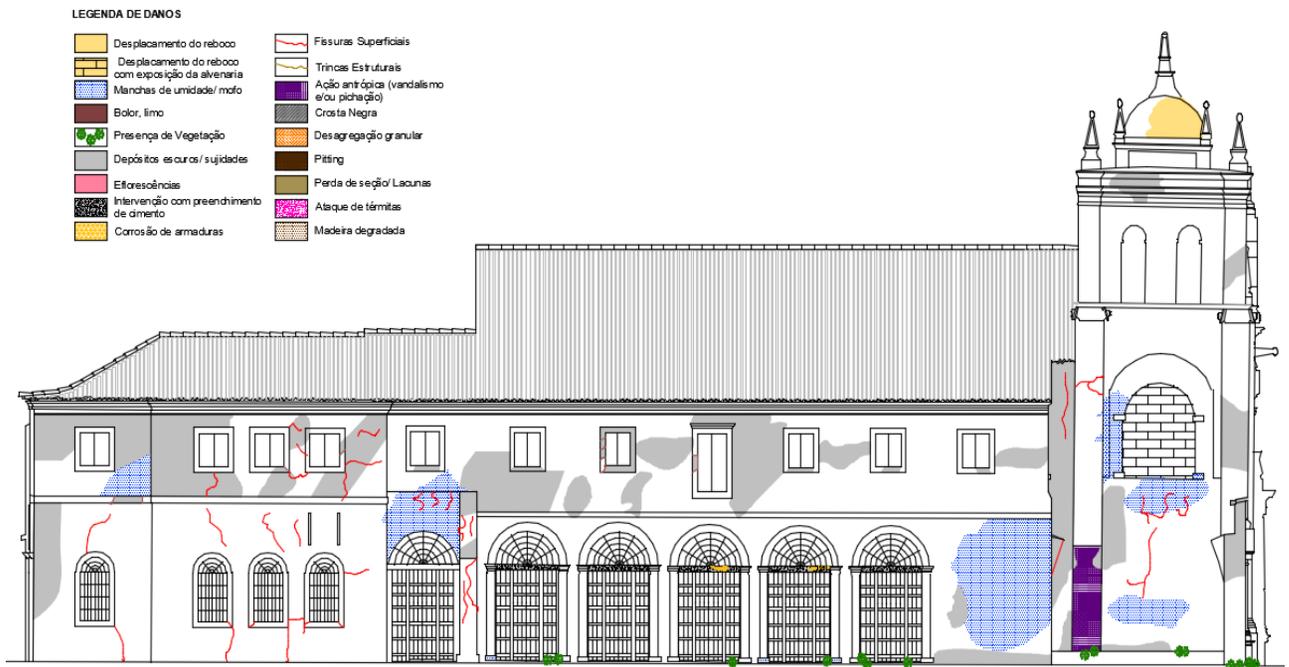
Figure 12. Damage Map of the East Façade of the Carmo Church. Source: Authors.

The use of reinforced concrete, demonstrated by the presence of reinforcement corrosion, indicates an intervention in the structure with the use of construction technologies that did not exist at the time of the original construction of the church. Therefore, the treatment of this pathological manifestation should be done as soon as possible, and in a way that does not interfere with safety, while preserving the architectural features of the façade.

It is important to note that the east façade of the building has a higher incidence of saline mist. The Carmo Church is located in a coastal area, so structures made with reinforced concrete are subject to the degenerative action of chlorides and the cycles of wetting and drying produced by the rains.

In this sense, the correction of the corroded points found during the east façade inspection must be performed as quickly as possible, in order to avoid the loss of steel sections, the breaking of steps, or the displacement of larger areas.
