Analysis of pathological manifestations of concrete in urban overpasses

The paper presents the case study of pathological manifestations in concrete structures, located in the Northern Road Hub of Brasília, using the GDE / UnB methodology, which qualifies and quantifies the degradation of structural damages. The general state of the structure was characterized in order to serve as a subsidy for decision making regarding routine interventions, in order to extend the useful life of the structure. The methodological routine consists of conducting field inspections, catalog of structural pathologies with photographic survey, characterization of pathologies and classification according to the weighting factors and damage intensity factors of the structure according to the GDE / UnB methodology for special works of art, calculation and overall classification of the structure damage.

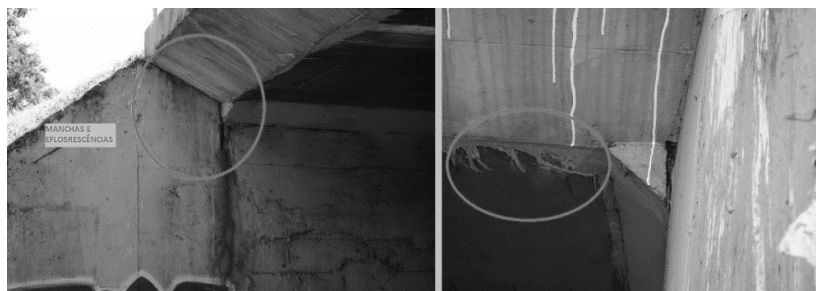
Stains were identified in the structural elements of reinforced concrete in the soil as presented in Figure 4. They can be caused mainly by the infiltration of rainwater from the soil adjacent to the structure, and by infiltration of water from the flexible pavement of the bearing track to the slab. This situation could be mitigated if there was a drip tray on the side of the support floor of the bodyguard that is on the slab. Another measure that should be adopted is the waterproofing of the concrete layer on the slab before the layer of H.M.A. of the pavement. These poor waterproofing phenomena were also seen in the curtains.

Figura 4. Manchas na estrutura da Laje

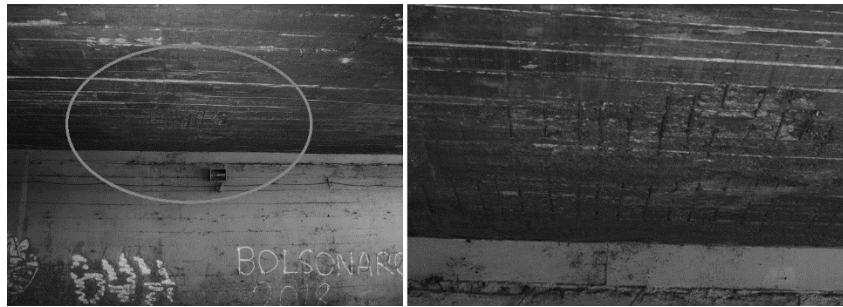
By the analysis of Figure 5, it was observed, in the slab region, large areas with insufficient concrete cover to protect the steel reinforcement. As a result of this insufficient cover, there is a high level of deterioration on the rebars. Because it was exposed to moisture, a reduction of steel section was observed. Thus, the durability of the reinforcement was significantly affected.

Figura 5. Cobrimento insuficiente e deterioração da Armadura

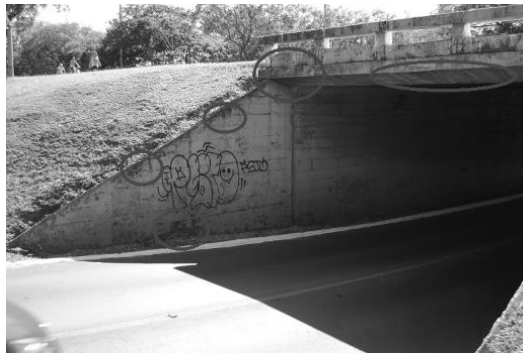
The overpass 02 is located at the Eixão between the superquadras 103/104 and 203/204 North. It presented a great number of stains in several parts of the structure; most of them in the part that is exposed to rain without a concrete cover as seen in Figure 6.

Figure 6. Stains scattered on the structure

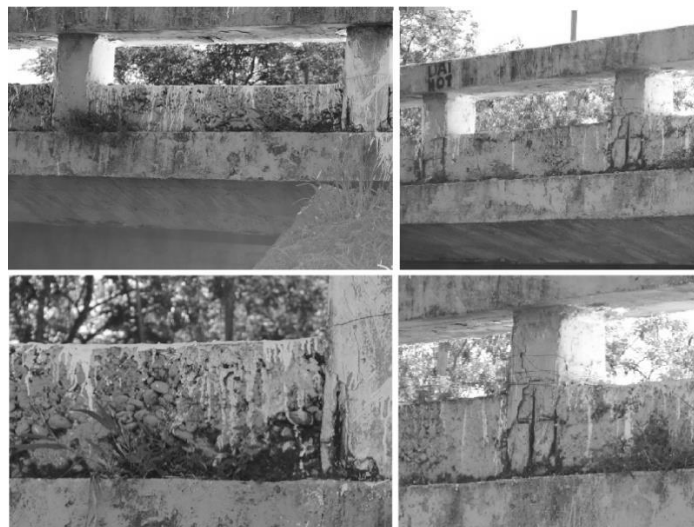
Different types of damage to the bodyguard such as failure on the concreting, displacement of the concrete covering on the columns that resulted in the exposure of the rebars to the rains, and corrosive agents in the reinforcement can be observed in Figure 7.

Figure 7. Failure in concreting, displacement of concrete, and pathological manifestations on the rebars (Bodyguard)

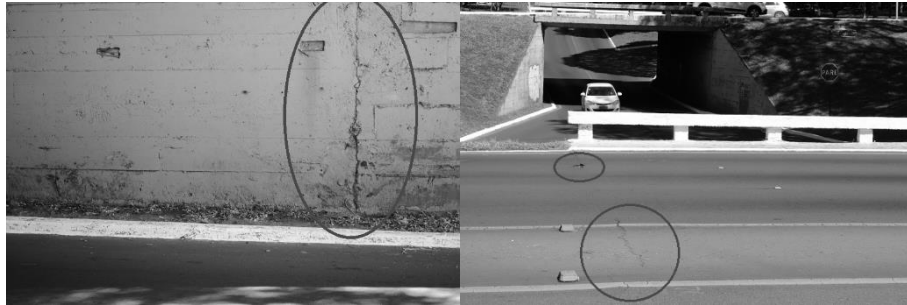
In Figure 8, it is possible to visualize a vertical crack and wooden formwork left in the region of the curtain. In addition, the condition of the flexible pavement was analyzed. On the slab of the overpass, by the figure, it is noticeable the presence of a small hole and a crack perpendicular to the flow. Analyzing the crack, there is evidence that it has caused by the wear of the expansion joint material of the deck.

Figure 8. Crack in the curtain and pathological incidences in the bearing track.

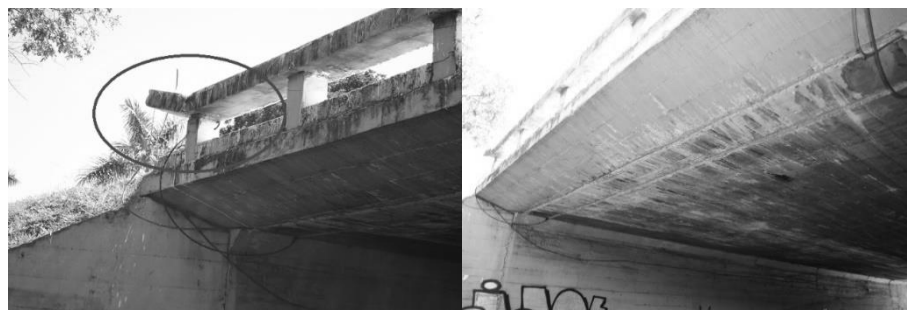
Figure 9 shows two types of frequent damage caused by the impact of vehicles on this type of overpasses. They are both related to the impact of a vehicle on the bodyguard and the dragging of the truck body that travels in the track with a higher height to the height of the overpass. Those impacts cause damage to the concrete covering of the slab and, in some occasions, to the own reinforcement of the structure.

Figure 9. Damage to the bodyguard structure and overview - Damage to the slab due to vehicle tallest than the height of the overpass.

- In Overpass 03, the element that presented the highest degree of deterioration was the bodyguard with a value of 84.53, which is considered a poor level. Therefore, it is recommended to define a period for rigorous specialized inspection and to plan a short-term intervention at a maximum of 6 months.
