Diagnostic of damage in a building of the early twentieth century in Havana. Case study

A. H. Oroza^{1*}

, R. G. Hernández¹

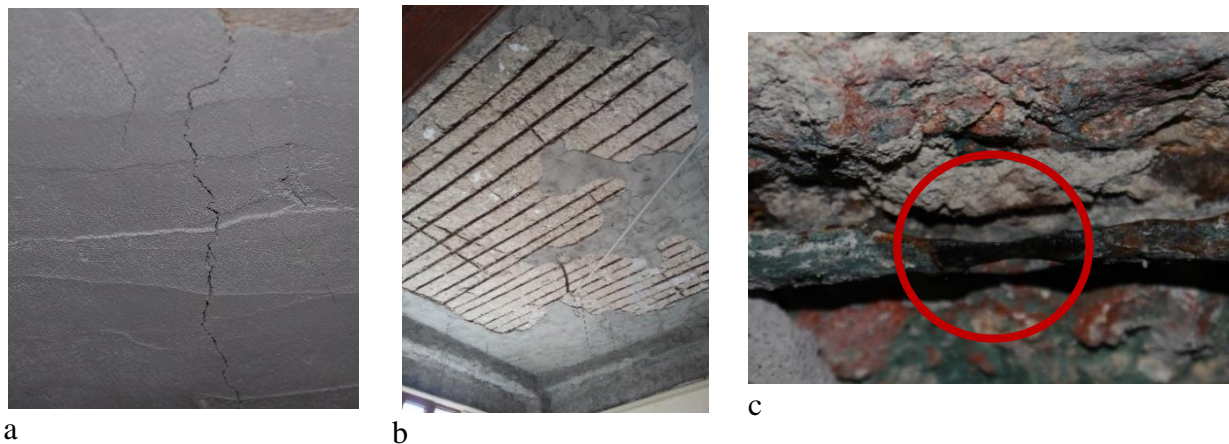
Slabs with loss of concrete coating, exposed steels and longitudinal cracks in the direction of reinforcement bars were identified (Figure 2a). The roof slab of the seventh level, in addition to

On the ceiling of all the apartments it was observed that the slabs had been previously repaired. The material used for the restoration was a cement-based structural mortar. During the inspection it was possible to verify that in these previous repairs, the original slab thickness was never recovered. Also, no anticorrosive treatment was applied to the reinforcing steel bars and as a consequence, most of the applied restoration mortar already showed cracks, slapping and loosening in various areas (Figure 2b)

The most affected spaces were those destined for cooking and bathing due to the steam generated by to the use of hot water. The reinforcement steels in the slabs of these areas had severe atmospheric corrosion effects. Some of the existing bars were found fractured or with a very advanced localized section loss (Figure 2c), jeopardizing the structural stability of the element due to possible flexural failure. The measured carbonation depth ranged between 5-6 cm, with a calculated K_{CO_2} of 5.2 mm/year. The coating thicknesses (ec) were within 1-2 cm.

Figure 2. Damages identified in the roof slabs. a) Longitudinal cracks in the direction of the steel bars resulting from corrosion. b) Loss of repair mortar on the ceiling slabs in large areas of the living room. c) Localized corrosion at reinforcement bar

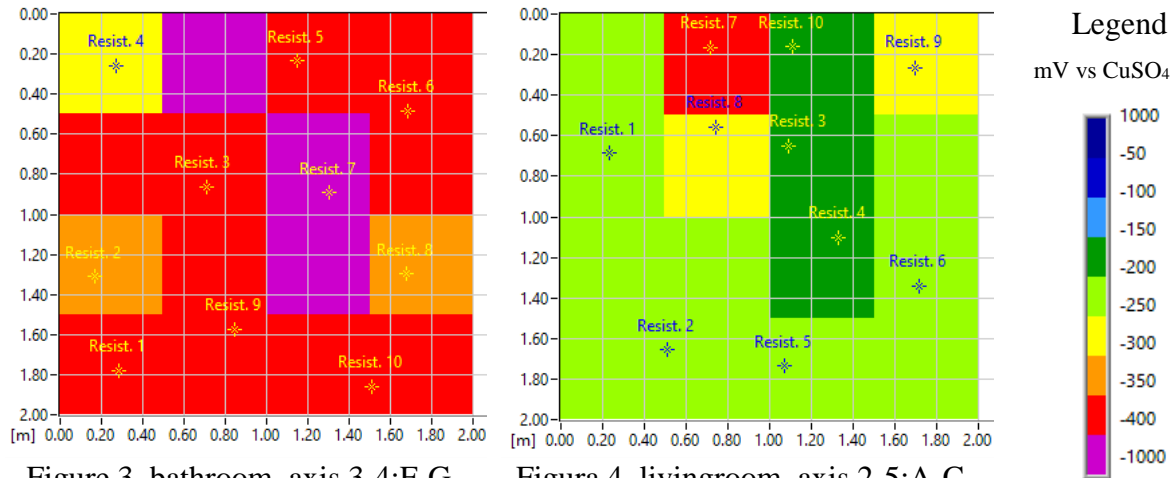
The results between both techniques demonstrate that there is a correspondence between the values of E_{corr} and ρ . In areas with hot water use, the diffusion of oxygen is increased, as well as its availability at the level of reinforcements. In reinforced concrete elements where there is no primary protection due to the advance of carbonation and the presence of chloride salts, the established corrosion rate (i_{corr}) becomes the main parameter that determines the reason for deterioration of the structure. In the drier areas, more positive E_{corr} values are recorded with resistivity levels greater than 80 K Ω -cm.

Figure 3. bathroom, axis 3-4:F-G

Figura 4. livingroom, axis 2-5:A-C

Figure 3 and figure 4. Mapping of Ecorr on the reinforced concrete slabs of the third level

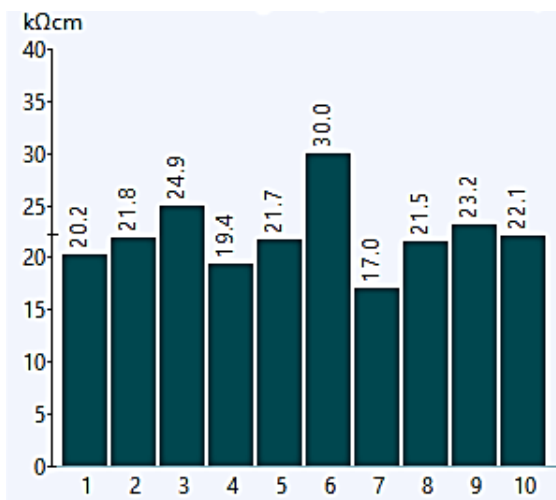
Figure 5. bathroom, axis 3-4:F-G

Figure 5 and figure 6. Results of the apparent resistivity on the reinforced concrete slabs of the third level

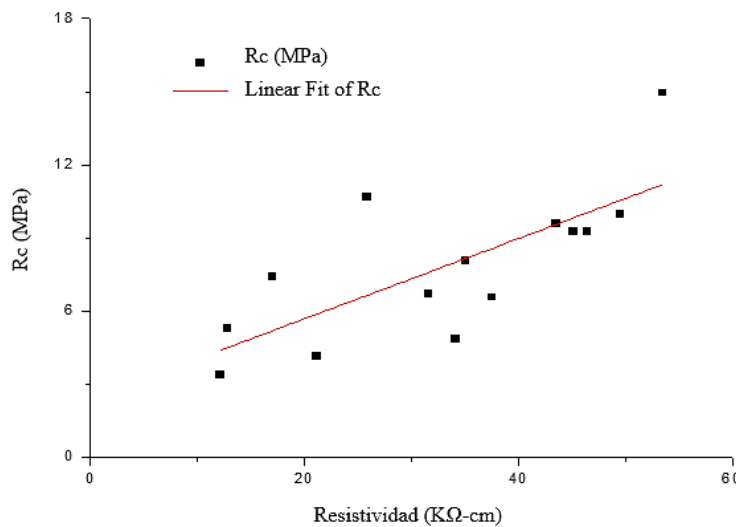
Other authors (Ramezaniapour et al., 2011) demonstrated that for the same cement mix design, there is a linear relationship between compressive strength and ρ due to the chemical similarity of the pore solution. To assess the correspondence between the concrete permeability of reinforced concrete slabs and the ρ measured directly on the slabs, both results were correlated based on the strengths of the extracted probes. Figure 7 shows the graph obtained regarding the correlation between the R_c and ρ for the mid-level slabs of the studied property.

Figure 7. Relationship obtained between R_c and ρ of the slabs

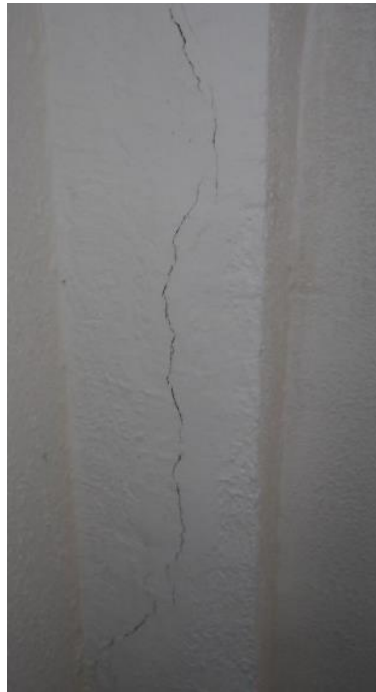
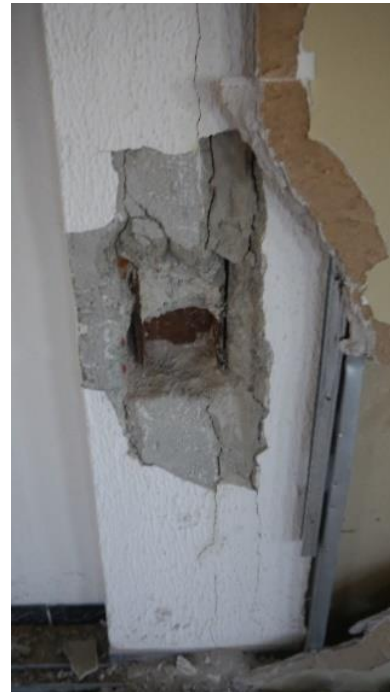
The visual inspection was carried out in the columns located in the last, penultimate and intermediate corridor. For the construction of the columns, I-sections and Ø16 steel bars were used interchangeably. It was identified that the vast majority of these had been previously intervened and still have a state of deterioration marked mainly by longitudinal cracks (Figures 8 and 9), as a consequence of the corrosion of the reinforcements. In general, both the I-sections and the bars that make up the columns showed a high level of corrosion with loss of section.

Figure 8 and figure 9. Current deterioration state of columns.

In the particular case of the second level, a high degree of corrosion with loss of section in the different reinforcements of the columns was widely observed. All the elements studied are made up of type I profiles. The coves were made in the columns indicated in Figure 10. Next, in table 5 the numbers of the coves made, and the measured wing thicknesses are presented.
