An approach to the convent of Santa Clara de Asís in Havana. Study of its conservation status and intervention proposals

ABSTRACT

Santa Clara de Asis Convent High Choir timber truss has been victim of humidity and attack of abiotic and biotic agents which have caused its gradual degradation. For the identification of pathological processes associated with these agents and because of its patrimonial character, a diagnosis study based on an organoleptic inspection and superficial tests was carried out with the available instruments, which allowed identifying the causes. By modeling the structure with SAP 2000 program, we obtained the results that were used to calculate the solutions proposed for the identified pathologies, mainly for the loss of connection between the wall plate and the tie rod beam.

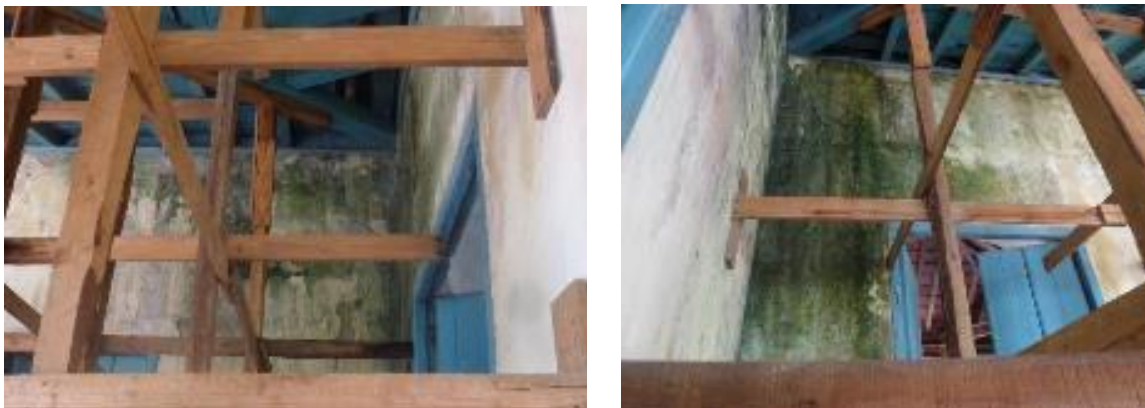
A high environmental humidity can be perceived in the place. On the other hand, the building has been exposed to an excess of water for long periods of time, as there are a lot of seepages coming from the roof, which are evident for the green patinas and rain wash patches on the walls, see “Figures 7-10”. These seepages can cause severe damages in the wood, accelerating the process of rotteness, as well as on the mud walls; these types of constructions tend to retain much humidity.

Figures 7 and 8. Patinas on gallery wall to axis 2 of the Choir.

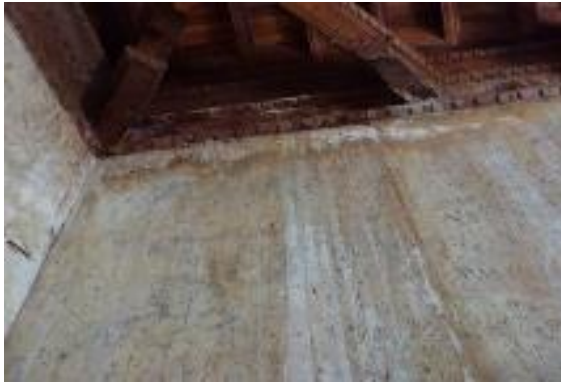
Figure 9. Wall with rain wash in axis A

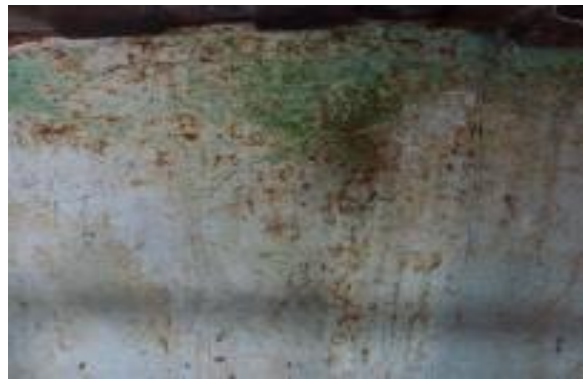
Figure 10. Top wall green patinas in axis 2.

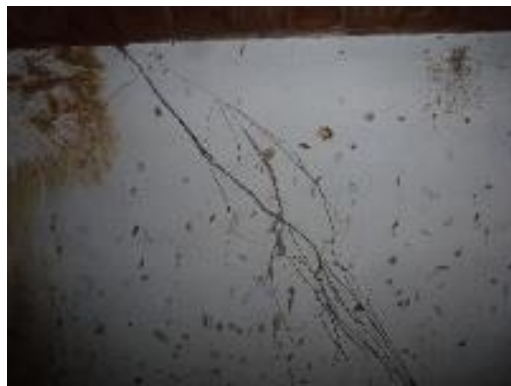
Because of the proliferation of feeder plants on the roof, there are visible developed systems of roots which penetrate the mud walls, see “Figure 11”, and can cause fissures in the wall.

Figure 11. Roots in axis A from the feeder plants on the roof.

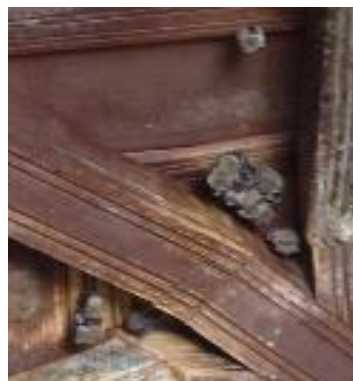
The groups of bats in the roof of the building (see “Figure 12”) have contributed with their excrements and remains of food to the dirtiness of the walls and the deterioration of the building in general, see “Figure 13”. Although in some situations, these chiropterans are beneficial to man, like in the maintenance and regeneration of forests in the dispersion of seeds. However, they can become a plague when they install in places that do not constitute their normal habitat.

Figure 12. Presence of bats.

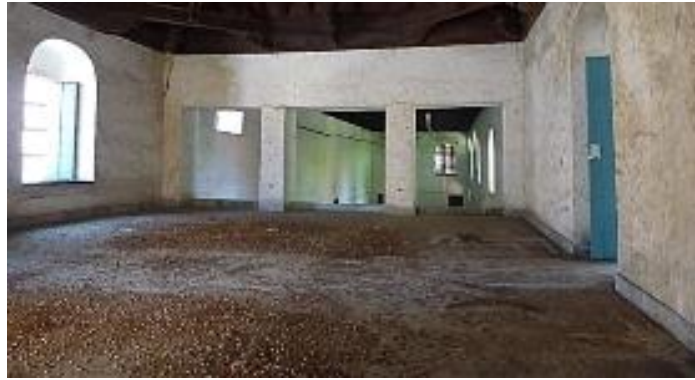
The bats' stools contain acids, which cause problems of an esthetics nature in the walls due to the accumulation of black excrements. They can also affect people's health, by creating a propitious environment for the development of an ecological succession of microorganisms, starting with the growing of bacteria, fungi and finally the proliferation of xylophagous insects.

Figure 13. Dirtiness on the walls and in the building because of bat excrement and food remains.

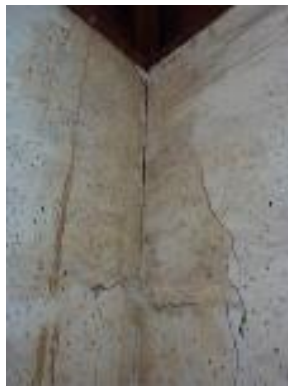
Fissures and vertical cracks, which range between 1-2 cm thick and 3-4 cm deep, mainly in the joints of the walls, see “Figure 14”. These cracks can be the result of an inclination, caused by the thrust of the timber truss, since there are also horizontal cracks in the lower part of the wall, see “Figure 15”.

Figure 14. Crack 1-2 cm thick at the intersection of axes A-1.

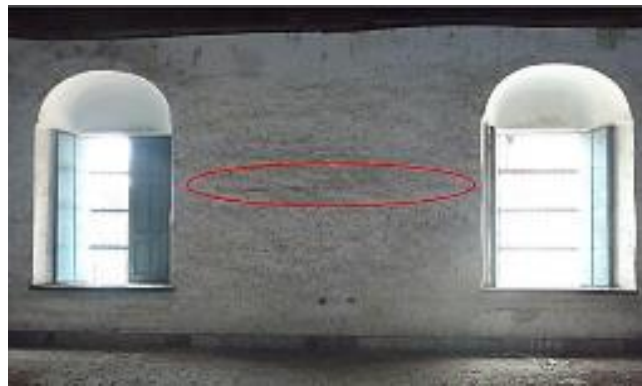
Figure 15. Horizontal cracks in the lower part of the wall (axis 1).

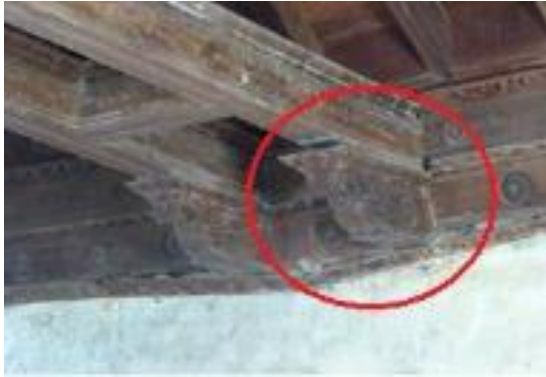
The joint between the tie rod beam and the wall plate is the most critical point, since its malfunction brings about problems to the roof and the inflow of water (Garófalo, 2000; Rodríguez, 2003). At the same time, the thrust on the wall are created by the detached tie rod beam, causing horizontal cracks which come up at a certain height, more visible on the internal face, accompanied by a displacement outward of the highest course. “Figures 16-19” show the drop of the corbels on which

the tie rod beams and angle braces are supported. The cause of this deterioration can be associated with the presence of humidity which is caused by the putrefaction of the supporting elements in the interior of the wall, that is why the elements stopped working like they used to do it and started to give way. In the case of the corbels on which the tie rod beams lean, they are associated to the force exerted by the tie rod beams.

Figure 16. Dropping of corbel under tie rod beam 2 (T2), on axis 2.

5.3 Replacement of wall plate by a one made of wooden.

The wall plate is replaced by a mud sill with the same scantling as the original one with these dimensions (30x35cm); in order to execute the joints in the corners, they will be carried out with a rabbet joint and according to the length of the piece; this will be done every 5 m by means of a key joint. The wood to be used is the Manilkara valenzuelana (a hard-reddish wood, which grows in the island of Cuba) which is a harder wood than the cedar.

5.4 Replacement of tie rod beams with steel tensors.

It consists in placing the steel tensors which will take the stress of the original tie rod beams and will go through the wall plate that is fixed with two nuts and a metal sheet to avoid the crushing of the wood. Thus, using the axial stress obtained from the modeling of the elements with the SAP 2000 program.

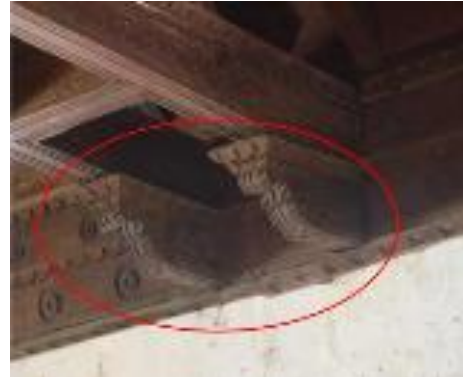
Figure 17. Dropping of corbels under tie rod beams 1 and 2 (T1 and T2), on axis 1.

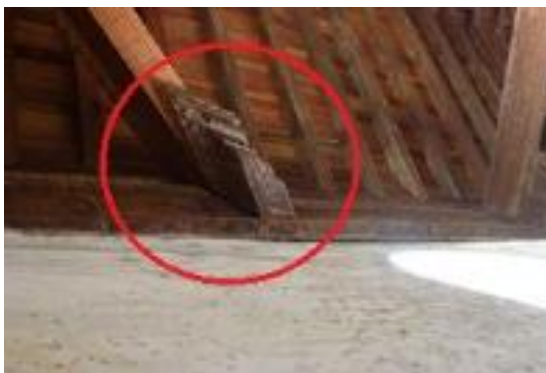
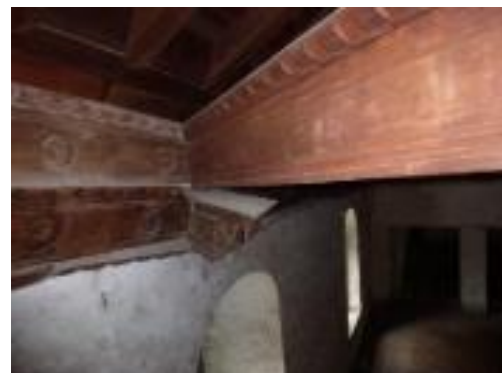
Figures 18 and 19. Dropping of skewed corbels (Sc7 and Sc8) under angle brace 4 (Ab4).

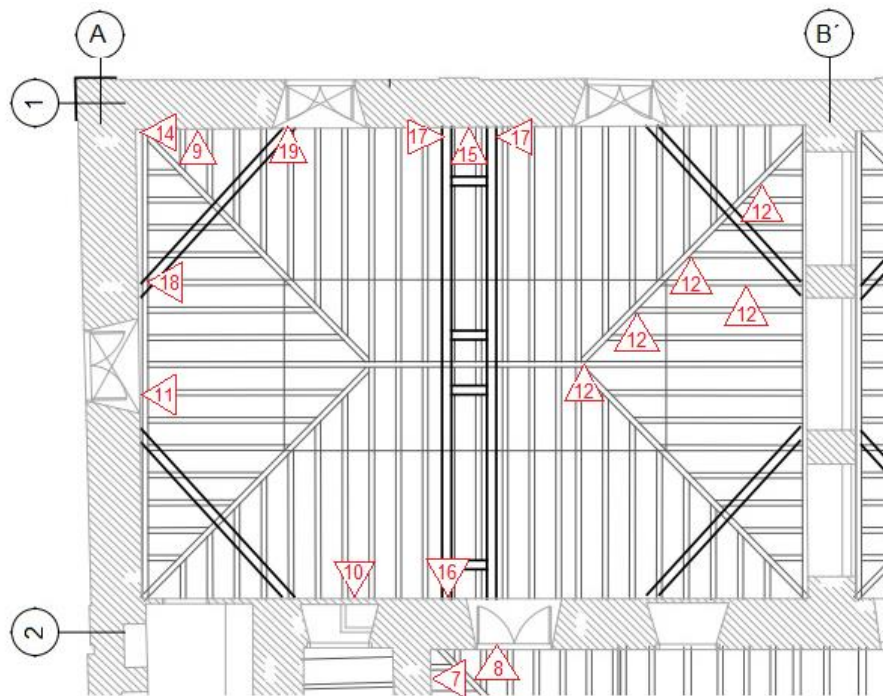
“Figure 25” summarizes the damages detected in the High Choir, placing them in an architectural plan.

Figure 25. High Choir architectural plan showing the location and association of damages Figures 7-12 and 14-19.

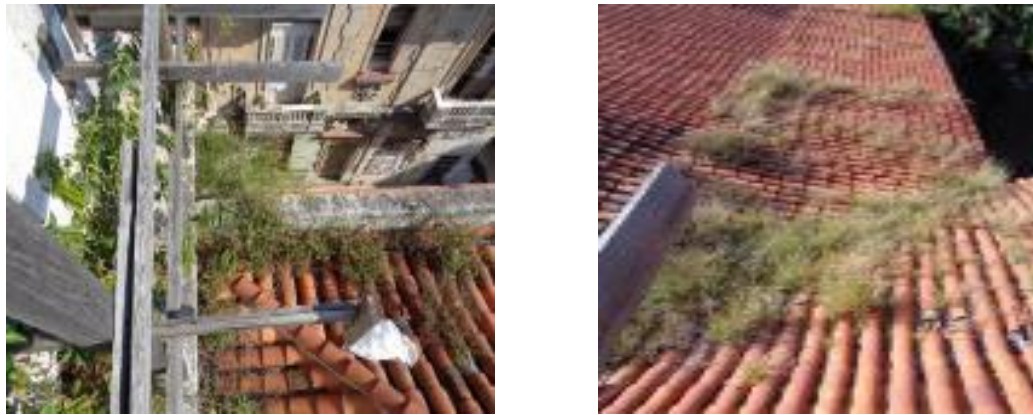
Photographs of parasite plants growing in the roof were taken; see “Figures 26 and 27”. The identification of superior plants was carried out by comparing them with specimens present in the herbarium of the Biology laboratory at the Havana Historian Office Diagnosis Group. There, the botanical family, the scientific and vernacular name (Group of authors, 1999); (Roig, 2014) and the biological aspect (Pérez and Rodríguez, 2007); (Pérez, 2010) were obtained.

Figure 26 and Figure 27. Invading plants on roof of the High Choir.

The plants identified are of herbaceous and arborous aspects, the latter has roots which can penetrate the walls and produce cracks which continue developing, widening and creating new internal tensions in the walls (Pérez, 2010).
