## Application of GUT Matrix in the assessment of pathological manifestations in heritage constructions

The present paper presents the application of GUT (Gravity, Urgency, Tendency) Matrix methodology as a tool in the assessment of pathological manifestations in buildings. Three heritage constructions of the historic center of Sobral, Ceará, Brazil were studied through *in situ* inspections, photographic records and elaboration of the damage map. The GUT Matrix was used as a tool to rank, in each building, priority levels for each damage in order to define their order of treatment. Thus, it was possible to conclude that the applied method can be used as a useful tool to manage the maintenance of buildings through prioritization of the most significant problems and, to contribute directly to the preservation and safety of the built historical heritage.

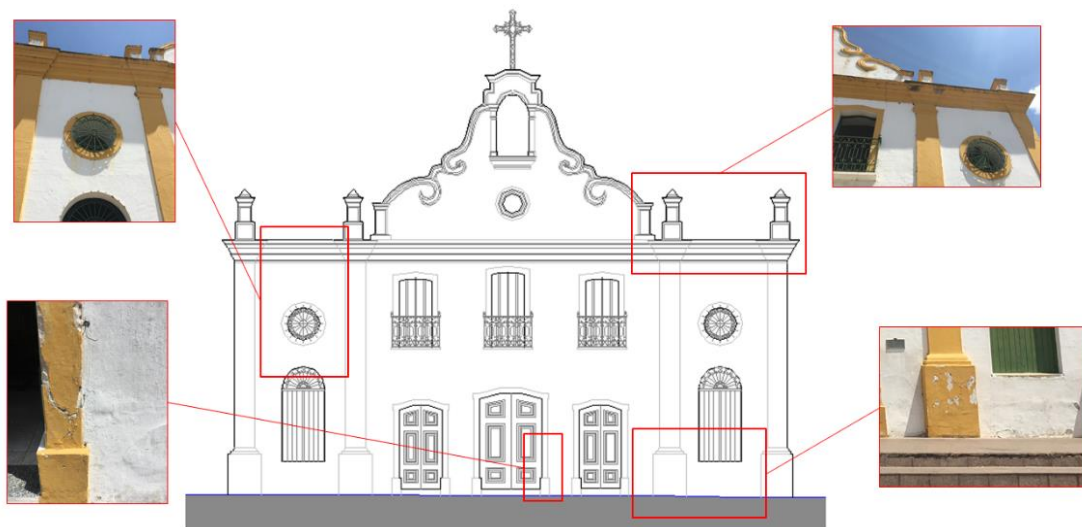
identification of the damage of the structures. Moreover, combining the visual inspection with other control tools, as presented in this work through the GUT Matrix, enriches the results and contributes to their reliability. The inspection of this first church was carried out from the outside to the inside, where firstly the four facades and later the interior were inspected. During inspection the following pathological manifestations were identified: fissures and cracks, disintegration of lining elements, detachment of coating, humidity stains, atmospheric stains, mold/mildew. The main facade presented the biggest number of damages and it is represented by the damage map shown in Figure 4, where detachments are observed in the lower parts of the structure, in the openings and in the central door column some cracks are also visualized, and atmospheric stains can be seen on the top of the church.

The main reason for cracking may be associated with the vibrations existing in the place, because it is located in a central region of the Sobral city and there is a large flow of people and vehicles nearby, that can induce vibrations causing changes in the structure dynamic behavior, which often lead to fissures.

Figure 4. Damage map of the main facade of Nossa Senhora do Rosário Church.

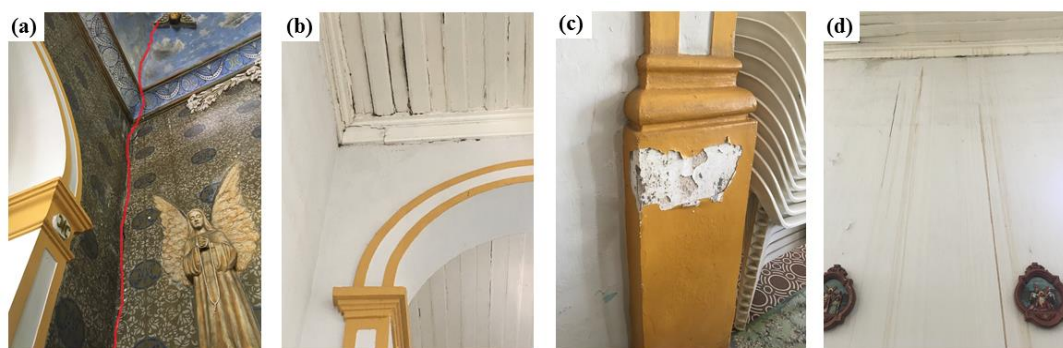
Figure 5. Internal pathological manifestations of the Nossa Senhora do Rosário Church: (a) crack, (b) disintegration of lining elements, (c) detachment and (d) humidity stains.

In the internal part of the church the main, the following pathological manifestations were observed: crack, disintegration of lining elements, detachments and humidity stains, as illustrated by the Figure 5. The most serious situation was the crack located near the altar (Figure 5 (a)), because its presence may be associated with the movements adjacent to the building and new constructions in the vicinity of the sanctuary. These movements occasionally cause sinking of the soil and cracks and fissures in

For the Gravity in the application of the GUT methodology a score 8 was attributed to the crack located near the altar due its large opening. For the Urgency, a score 8 was also inserted due large area of commitment of this damage that requires urgent intervention. Regarding Tendency, a score 6 is attributed knowing that the problem is in a situation of average progression.

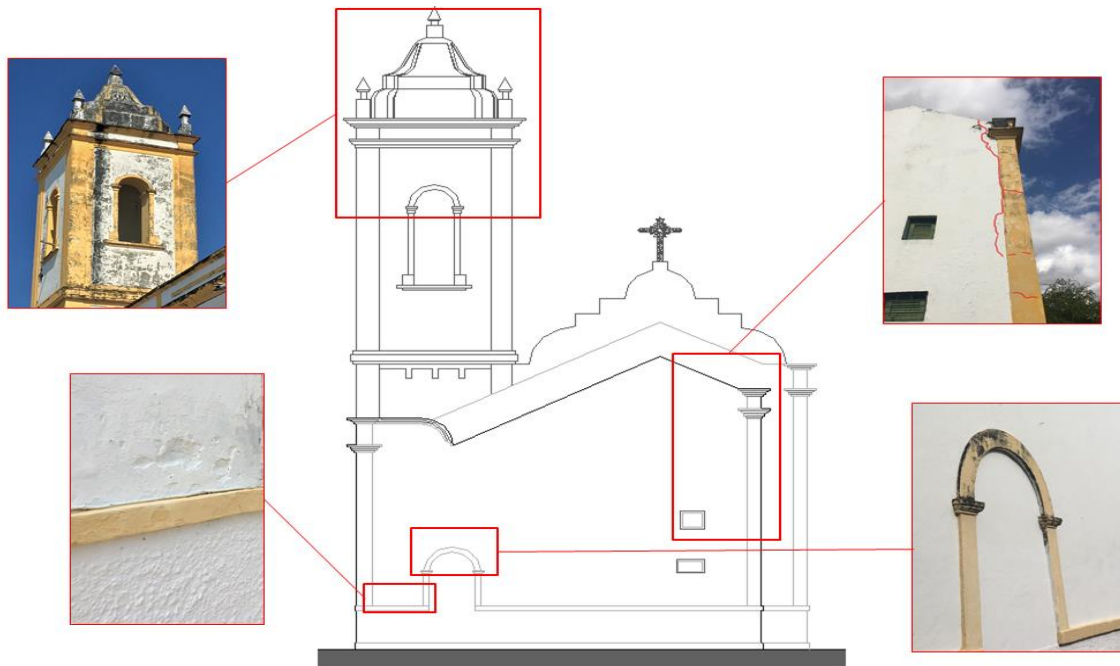
Figure 7. Damage map of the Nossa Senhora das Dores Church.

Figure 7 shows the incidence of a large amount of atmospheric stains in the lateral tower and also in the upper parts of the church. This type of damage was also evident in all other facades. A large crack in the right part of this figure, that starts from the mid height of the wall to the top, was observed. This anomaly is closely linked to a possible sinking of the soil, considering that the structure is located near of the Acaraú River and that over time was impacted by numerous new constructions in the vicinity. Besides this region, in the circular openings of the other facades, this type of damage is also evidenced. There are also detachments of coating in the lower part of this facade, which are also found in the other facades.

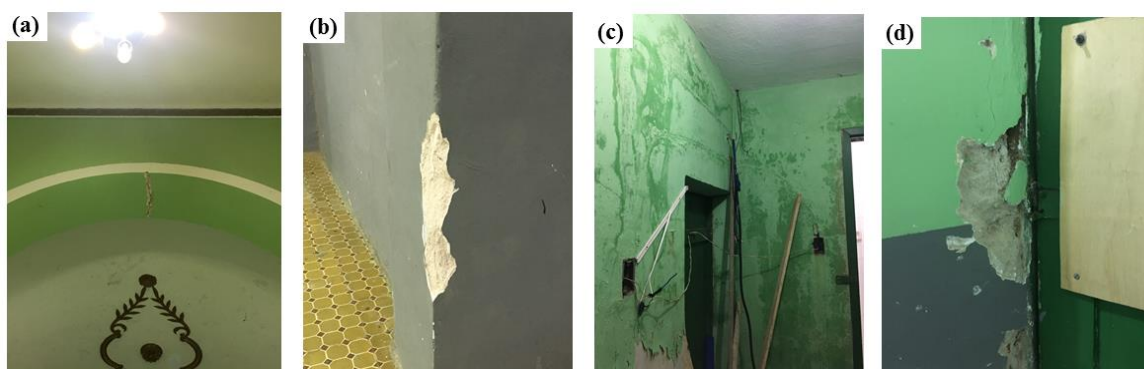
The main pathological manifestations observed in the internal part of the structure were: fissures and cracks, detachment of coating, humidity stains and detachment of coating with exposure of parts of the frame, which are illustrated in Figure 8. In Figure 8 (a), there is the most severe pathological manifestation for this building: a crack located in the central arch of the main nave. This anomaly is in a very aggravated situation, being its occurrence related to the incidence of soil movement of the foundation and to a possible overload in the arch, since many interventions with an increase of load were executed over time, as for example, the exchange of a lining that was previously made of PVC by a slab of reinforced concrete. Thus, to Gravity, a score 10 was attributed, that is, the maximum score of the method here used, which causes a high impairment of the performance of the building. Regarding Urgency, a score 10 was also inserted, due to the large area of commitment of this manifestation, requiring urgent intervention. And for Tendency it was also chosen a score 10, corresponding to the large possibility of evolution of the situation.

Figure 8. Internal pathological manifestations of the Nossa Senhora das Dores Church: (a) crack in the central arch, (b) detachment of coating, (c) humidity stains and (d) detachment of coating with exposure of the frame parts.

The data obtained from the application of the GUT Matrix in this building were organized in the priority graph shown in Figure 9, where it is verified that the pathological manifestation of highest priority is the crack in the central arch of the main nave, with a total of 1000 scores, which classifies it as a total damage, that is, of extreme gravity, urgency of solution and fast tendency of evolution. In addition, the difference between this damage and the two other (infiltration and disintegration of lining elements, both with 216 scores each) is very high, that corresponds to 784 scores, which show the severity of this crack.

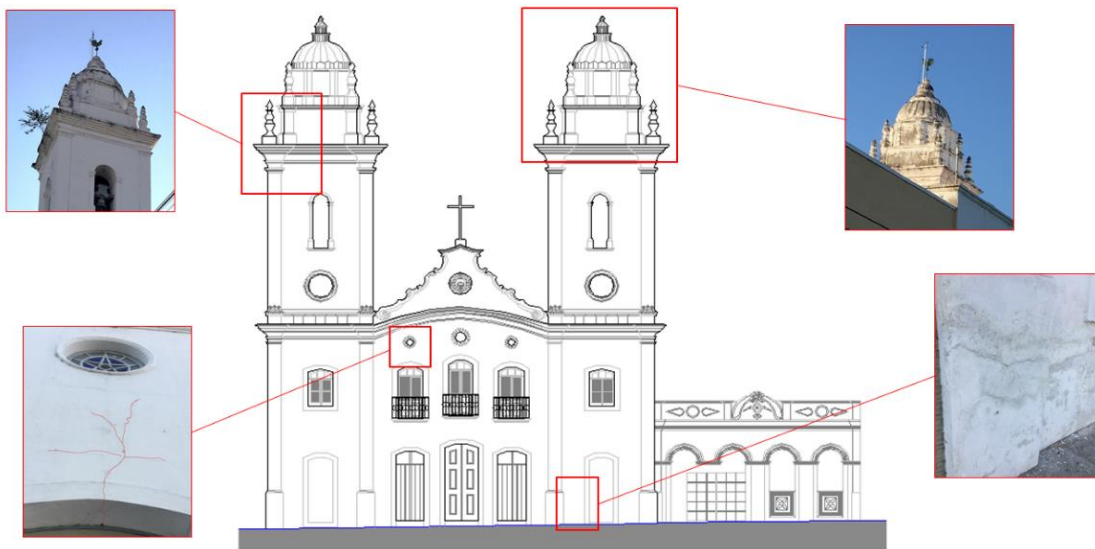
The right lateral facade (connected to the lateral courtyard) and the back facade of the Menino Deus Church were not analyzed because these two facades are linked to the adjacent buildings. However, the other facades as well the internal area were thoroughly inspected, and the main facade presented the most severe damages, which can be observed in Figure 10, where the most evident were: atmospheric stains, located in many regions of the structure mainly on top of the two towers; fissures in the vicinity of circular openings of all doors and windows and in the lower part the columns of a tower, which is accompanied by detachment of coating; and rooting of shrubs, located at the top of the left lateral tower.

Figure 10. Pathological manifestations of the Menino Deus Church.

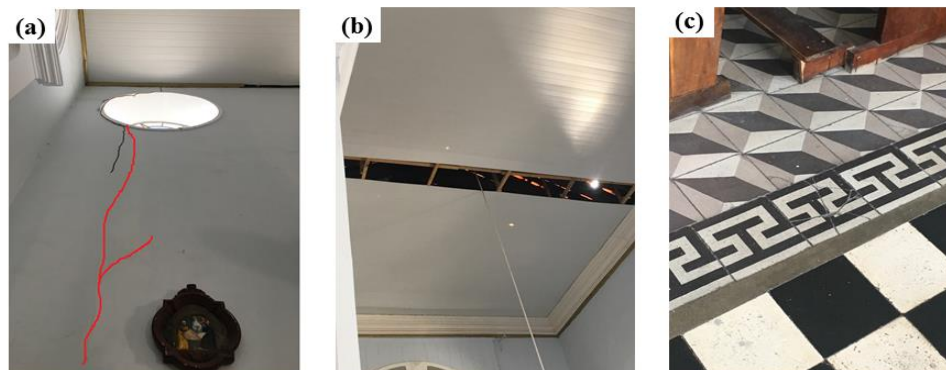
In the internal part of the church the main damages observed were fissures and cracks, disintegration of lining elements and disintegration of floor elements, as shown in Figure 11. Disintegration of lining elements was observed in many parts of the roof, as well as fissures.

Figure 11. Pathological manifestations in the internal part of the Menino Deus Church: (a) Fissures, (b) disintegration of lining elements and (c) disaggregation of floor elements.
