Inspection and evaluation of roofing systems: a case study

The roof system of one of the buildings of the University of Brasília - DF is characterized and evaluated. The main existing anomalies in the roof systems are analyzed and the intervention priority is systematized, in order to correlate them with the corrective measures. The limiting factors for the inspection of the structures were accessibility as well as the lack of intervention projects. The results obtained reported that the main anomalies found in the systems are related to the lack of maintenance. The study also brings, as a contribution, indications and technical recommendations for the resolution of situations.

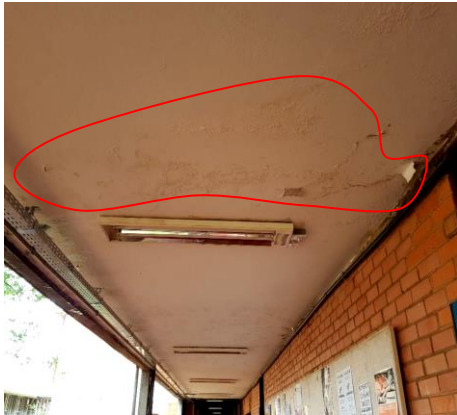
In the internal visit held on 10/30/2018 in the morning, after a rainy season, leaks were observed in the ceiling of the classroom corridor (area 1, 2 and 3), even after rain had ceased, as shown in Figure 3 and Figure 4. The gutters are multiple and are spread over a wide area of the ceiling.

Figure 3. Gutters in the ceiling of the hallway with mold, humidity stains, and peeling of the coating.

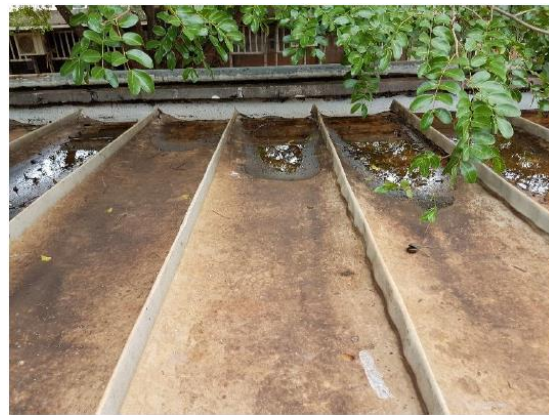
Figure 4. Deformed roof with water accumulation and debris.

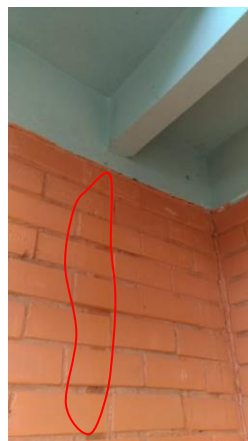
Another major problem related by complaints in Building C is the infiltrations in the CT 25/15 (area 4) classroom of the Department of Civil and Environmental Engineering. The images provided were taken on the morning of 10/29/2018 after a rainy night. Through Figure 5 and Figure 6, it is observed that the infiltrations have water flow originating from the beam-masonry transition inside the room, and at the end of the survey zone, near the focus zone 4, there is a structural joint without signs of sealant to prevent water passage.

Figure 5. Water dripping on the beam-masonry interface

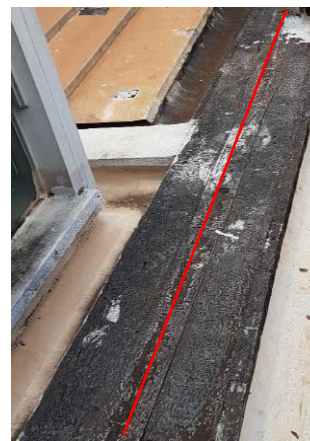
Figure 6. Structural joint without sealant

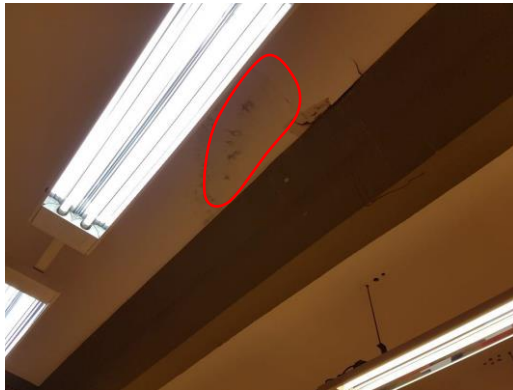
reported infiltrations. In the auditorium ceiling, it is possible to see marks of freshly dried gutters near a beam, including the puddles on the floor. Figure 7 and Figure 8 below illustrate such spots that indicate the water path and the formation of puddles.

Figure 7. Spotlight humidity on ceiling

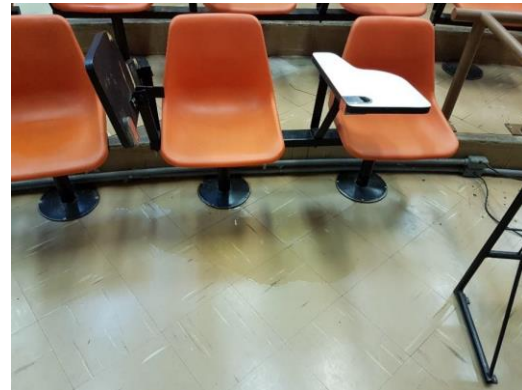
Figure 8. Water puddles formed by dripping

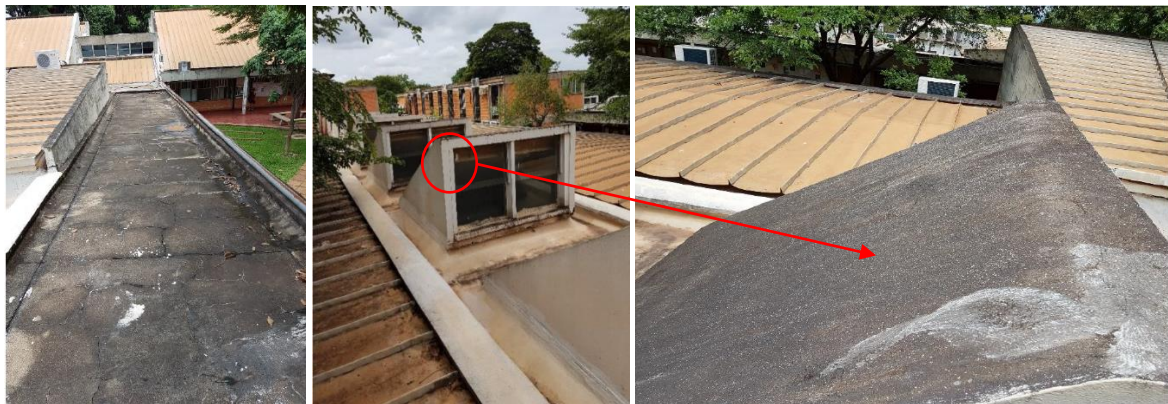
The sheds and the covering of the auditorium entrance hall have no roof: they are made of solid waterproofed slabs, figure 9, figure 10 and figure 11. The sheds present in the roof are from a structural point of view. The performance of the roofing system elements is in good condition, with only fouled surface dirt.

In the support structure, there are no signs that indicate waterproofing after the removal of the roof. Shrinkage cracks were found mostly throughout the slab and, in some places, there are small concrete disintegration. The joints along the length of the slab, as well as between the slabs and rails, are very degraded, with no sign of filler elements and sealant, with water accumulation.

Figure 9, Figure 10 and Figure 11. Support structure without roof/skylight.
