## Fire and collapse of the Wilton Paes de Almeida building in São Paulo, Brazil. Lessons learned

P. Helene<sup>1\*</sup>

DOI: <http://dx.doi.org/10.21041/ra.v10i1.419>

The objective of this work was to make a diagnosis that explains the mechanism of collapse, in just 80 minutes, of the Wilton Paes de Almeida building, which was surprising for the engineering of structural concrete. Previous fires, such as that of the Andraus Building, the Joelma and the Great Avenue, withstood more than 4 hours of fire without collapsing and are currently in use. To understand this unusual collapse, an experimental investigation of the characteristics and properties of the concrete and the reinforcement used in that structure was carried out, based on a "hypothetical structural project" that considered the actual characteristics of the materials used. Based on the diagnosis, recommendations were established so that cases like this do not recur.

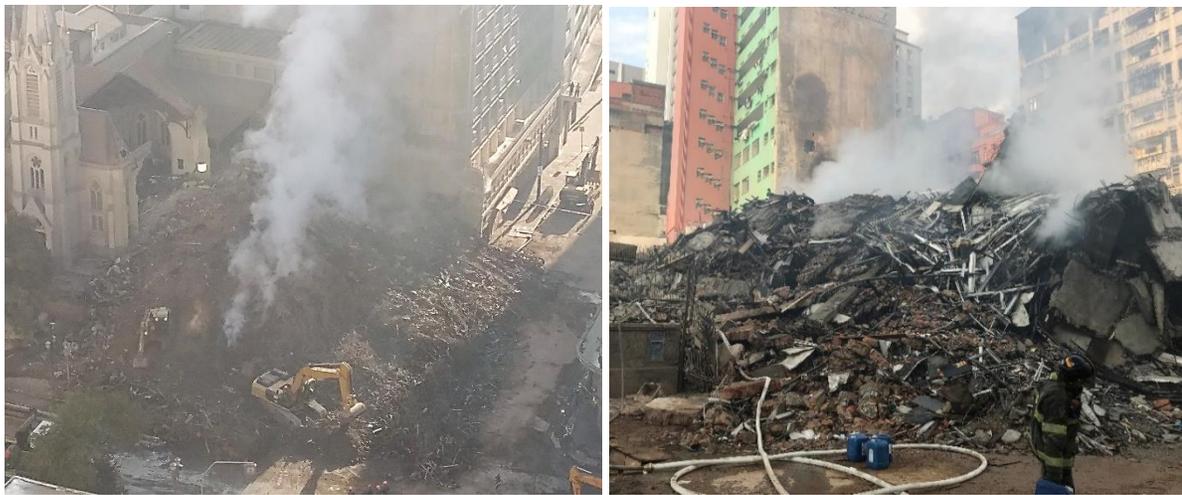
In a short time, due to the building's constructive characteristics, fire spread quickly through the other floors, both upwards (as expected) and downwards (unexpected), taking over the entire structure, from the ground floor to the roof. At about 2:50 AM, the entire building, still in flames, collapsed on itself (Figure 2), causing the death of seven people and many damages on the neighbor buildings as well as huge disruption to families and the traffic and free movement of people from the region.

Figure 2. Wilton Paes de Almeida after its collapse (source: Paulo Helene's personal collection).

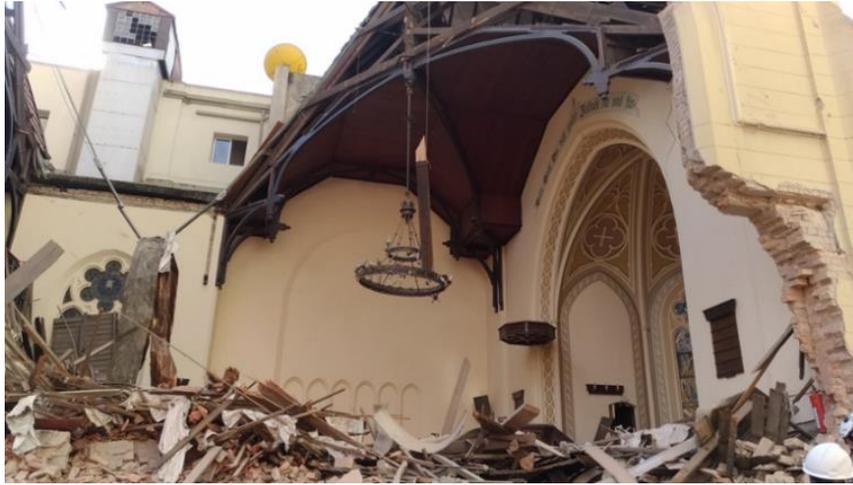
With the collapse occurred in the Largo do Paissandu Square (Center Region of São Paulo), it is evident that the lack of maintenance and neglect with the patrimony can cause many losses and risks to the society. There were 07 people who lost their lives, about 92 families who lost the roof to the housed; 220 million of Brazilians who have lost a public property belonging to the Government estimated at more than US\$ 7 million, and countless of other inconvenience to people who live and work in properties around the building that collapsed (Figure 3).

Figure 3. Damage to the Lutheran Church, next to Ed. Wilton Paes de Almeida (source: Paulo Helene's personal collection)

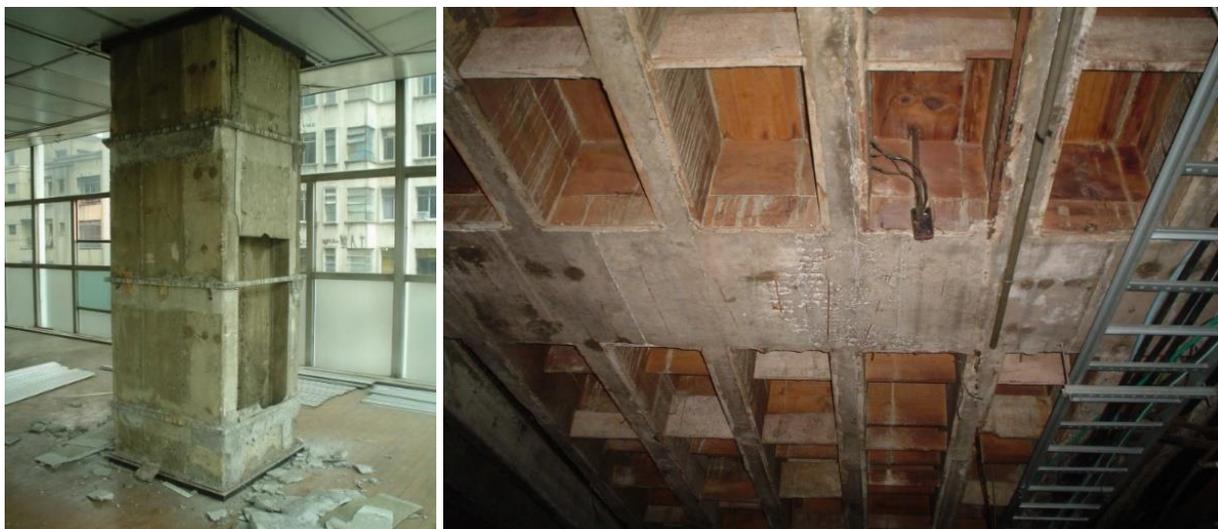
Many adaptations of projects and proposals made during the years of building operation that was headquarters of Federal Police, the Savings Bank and other companies were found in the archives of SPU (Union Heritage Department) together with these sheets. Engineer Leandro Coelho from SPU provided photos of his personal collection taken over the years, where it was possible to confirm, with some degree of precision, the structural typology used in the Wilton Paes de Almeida building (Figure 6).

Figure 6. Columns without metal coating, where it is observed the "H" which is actually a shaft of the air conditioner and I grate beam track with AJE still forms wood.  
(source: personal collection of Leandro Coelho)

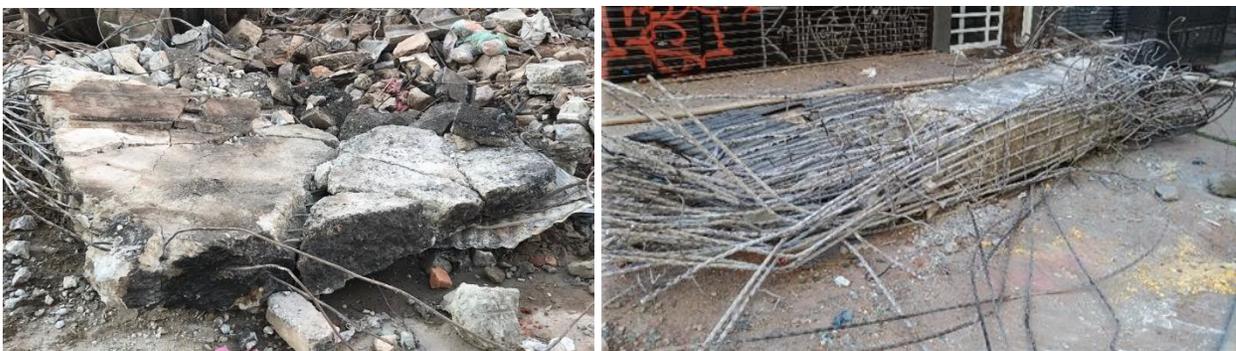
Two major parts of collapsed superstructure were selected for collecting samples of the building to performing characterization tests, one slab portion and one column portion (Figure 10).

Figure 10. Excerpts cantilever slab and column collected from the debris for testing (source: Paulo Helene's personal collection)

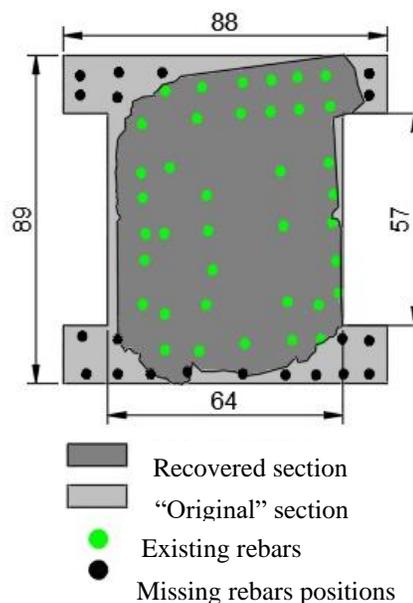
Figure 11. Reconstitution of the cross section of the recovered rubble column.

With the assessment of the cross section, arrangement of reinforcement rebars and their respective average diameters, it was possible to estimate the longitudinal reinforcement rate at approximately 3% of the gross area of the column, which is conventional for multi-story buildings.

The reinforcement cover, an important verification of the durability and fire resistance criteria, range from 1 cm to 5 cm in the collected sample, which, once again, showed a lack of control and construction care, typical and common at the date of execution of this building.

From the point of view of fire resistance, the cover (C1) that is used for the calculation of the resistance to the thermal gradient, extends from the external face of the columns to the center of the rebar reinforcement, which in this case ranged from 2.5 cm to 6.5 cm.

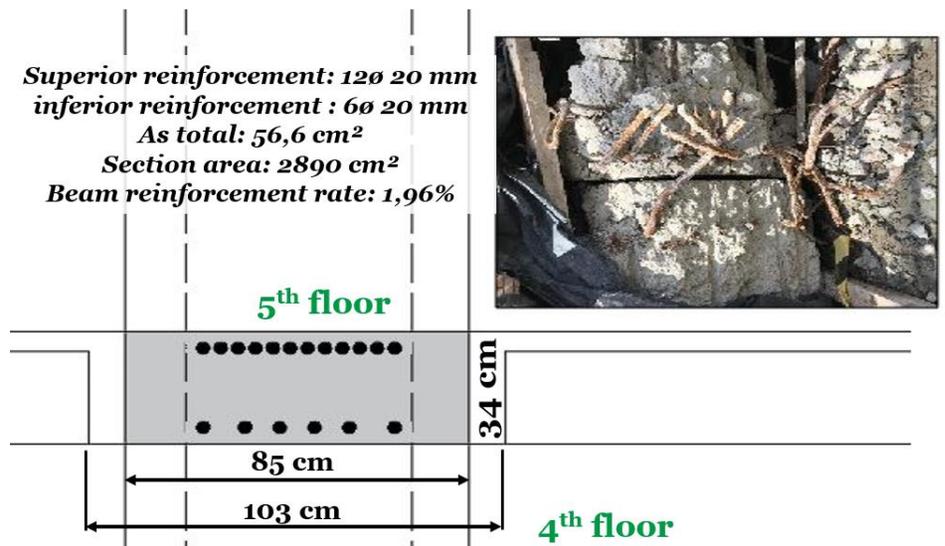
Still in the collected column section, it was found a column-slab intersection, and its evident reinforcement. Therefore, it was possible to determine the arrangement of the reinforcement of the strip-beam (Figure 12).

Figure 12. Configuration of the strip-beam reinforcement.

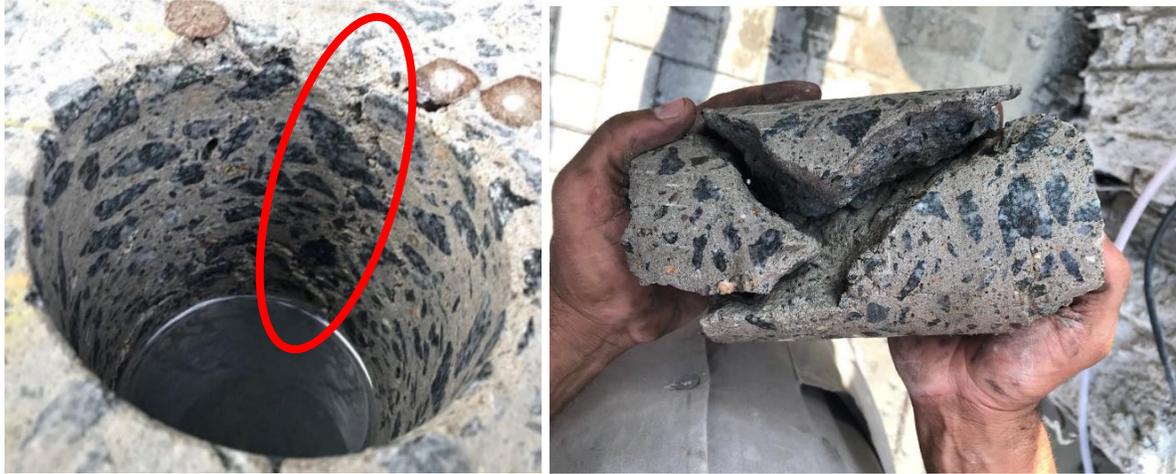
A total of 16 cores were performed, of which only six (06) could be used for mechanical strength, due to the large number of internal cracks, as shown in figure 13. These cracks were possibly caused by poor concrete pouring at the age of the building's construction and, most likely, by the dynamic stresses of the superstructure falling during the building's collapse as well.

Figure 13. Visible cracks during extraction and decomposed core.  
(Source: Paulo Helene's personal collection)

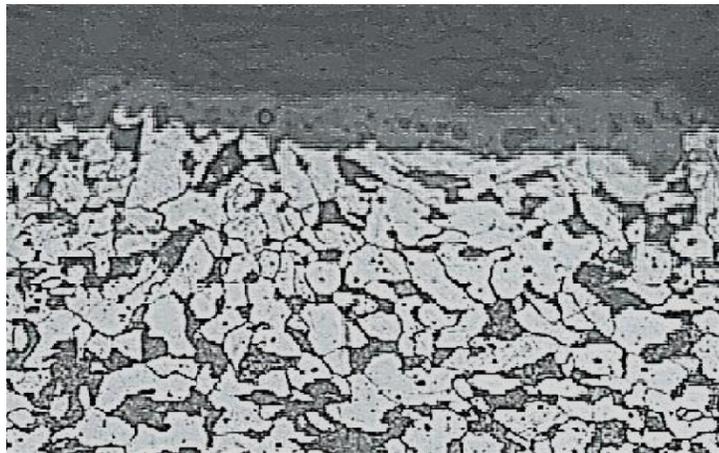
Metallographic analyzes performed at different magnifications showed that the samples of 22, 20, and 16 mm gauge longitudinal notched bars correspond to the CA 60 steel and the 10 mm gauge smooth crossbars and the 8 gauge flat complementary bars. mm correspond to AC 37 steel. An example of metallographic analysis can be seen in Figure 15.

Figure 15. 22 mm diameter, 200x magnified steel bar sample surface  
(Source: ArcelorMittal Laboratory)
