## Fires in concrete structures - Significant case studies in São Paulo

A. F. Berto\*

<sup>1</sup> IPT - Instituto de Pesquisas Tecnológicas, Brasil.

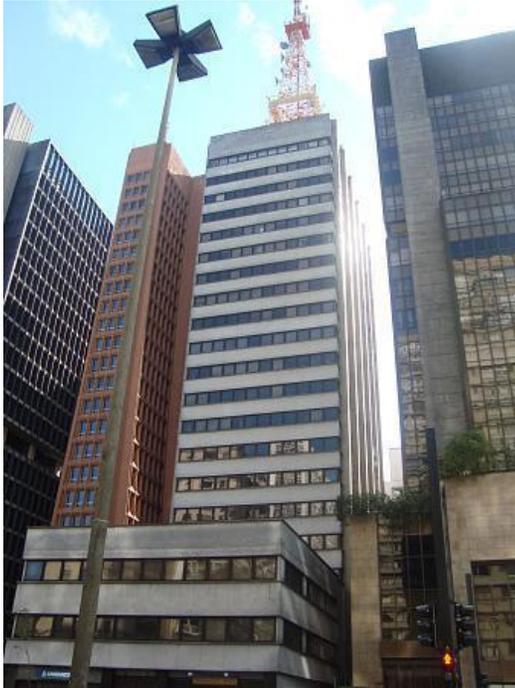
The case of the Grande Avenida building fire occurred in São Paulo in 1981, illustrated in Figures 1, 2 and 3, which developed severely on two consecutive floors of its front podium, evidenced that the thermal expansion stresses of the concrete structural elements that composed the beams and slabs of these pavements, found in the tower the stiffness necessary to direct the thermal expansion stresses to the large section columns in the front podium portion, causing them to collapse.

Figure 1. Grande Avenida Building, highlighting front podium associated with 22-story tower

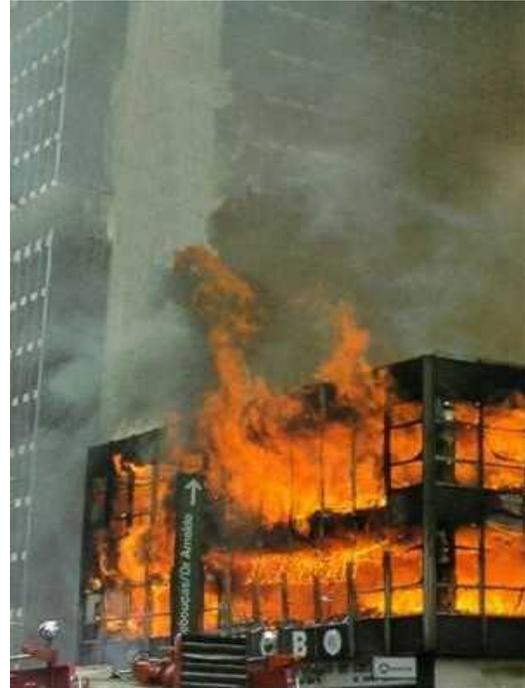
Figure 2. Podium of the Grande Avenida building, submitted to fire on 02/14/1981

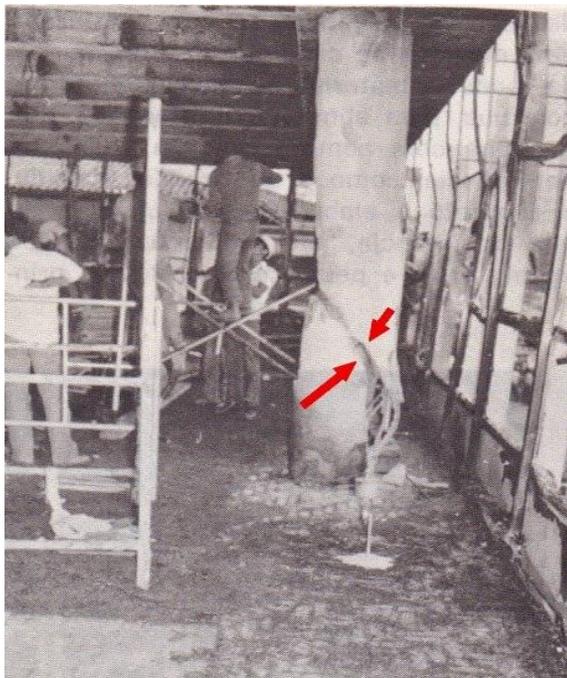
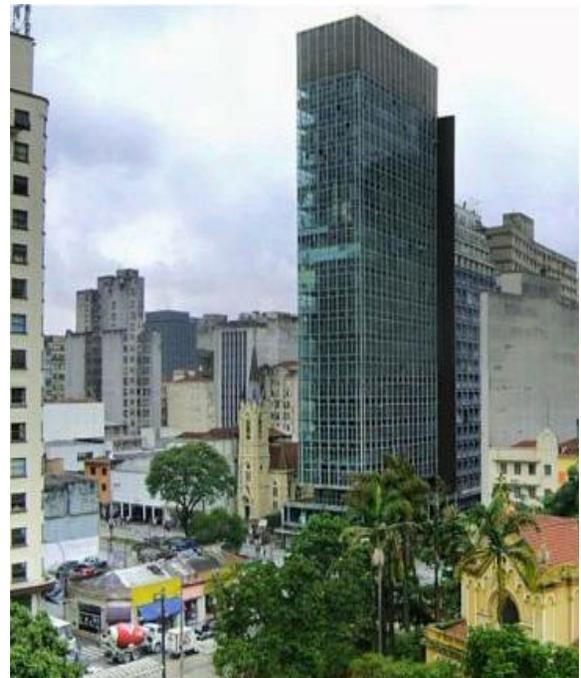
Figure 3. Column break located on the podium of the Grande Avenida building due to slab expansion stresses

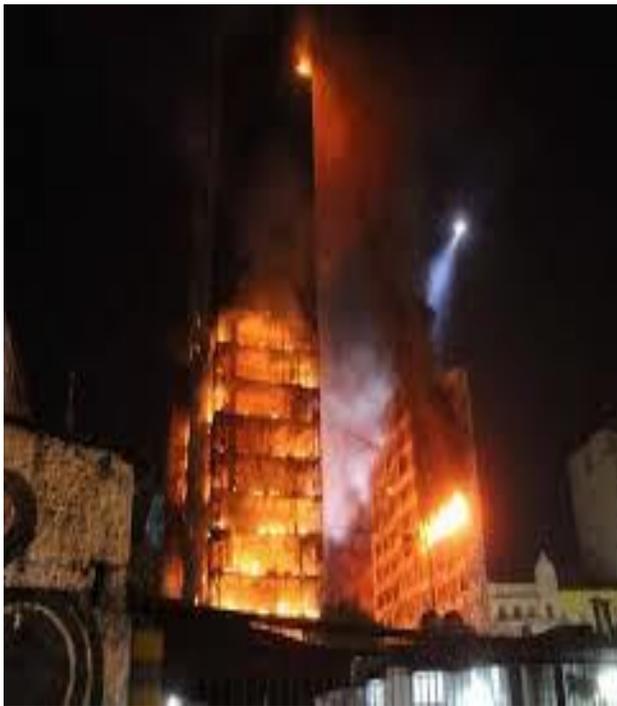
The Wilton Paes de Almeida building fire case, which occurred in São Paulo in 2018, illustrated in Figures 4, 5 and 6, which concomitantly dominated a dozen floors, evidenced the coincidence of two harmful factors that caused the total collapse of its concrete structure just 80 minutes after the fire start: the thermal expansion stresses of the concrete structural elements that made up the beams and slabs of the floors affected by the fire, found on the face composed of a structural wall (twinned with a large building block) the stiffness necessary to direct the thermal expansion stress to the pillars that made up the building structure, especially for those associated with the central circulation core; The asymmetric set distribution of columns determined the predominant direction of this effort towards the columns integrated with the central circulation core (Helene, 2018). This situation caused the columns collapse and, consequently, caused the entire structure collapse. This situation was further aggravated by the reckless structural design of the concrete structure as a whole, which currently would not meet the Brazilian standard for sizing concrete structures.

Figure 5. Wilton Paes de Almeida building subjected to fire on 05/01/2018

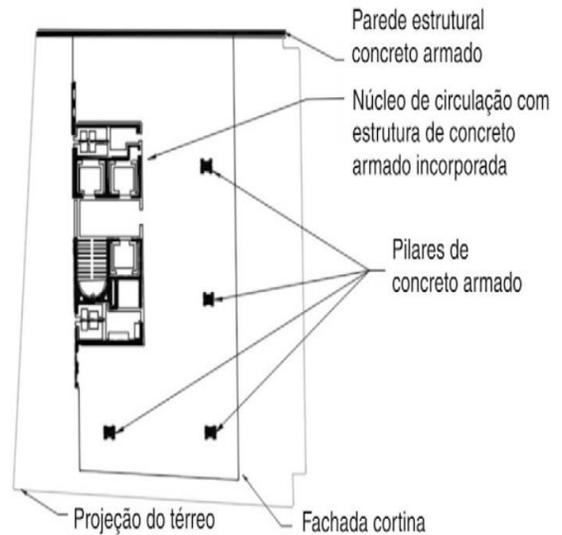
Figure 6. Schematic Floor plan of the building Wilton Paes de Almeida

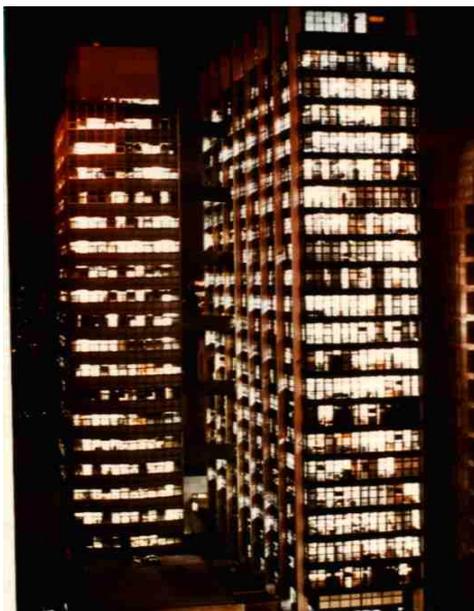
Figure 7. Sede I and Sede II Buildings of Companhia Energética de São Paulo - CESP

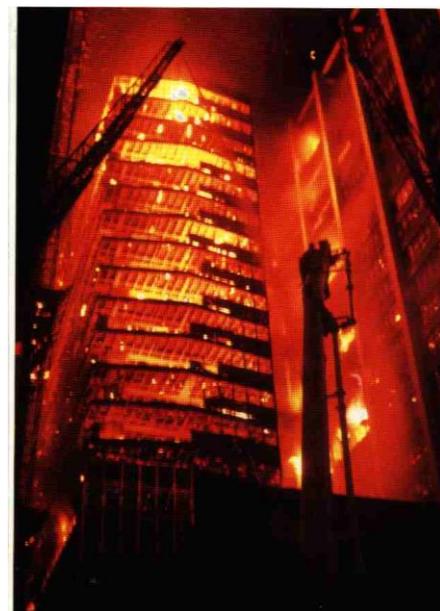
Figure 8. CESP Sede I and Sede II buildings submitted to fire on 05/21/1987

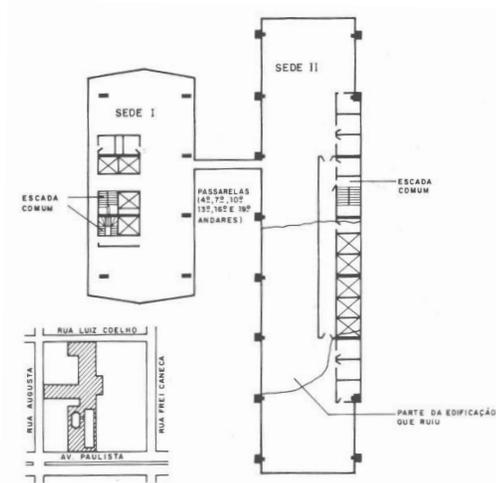
Figure 9. Schematic plan of the type pavement of CESP Sede I and Sede II buildings showing the sector that collapsed

Part of the situations relating to the two buildings structures reported here are shown in Figures 9, 10, 13, 14, 15, 16 and 17. It is clear that on Sede II building, the efforts to expand the beams sheared

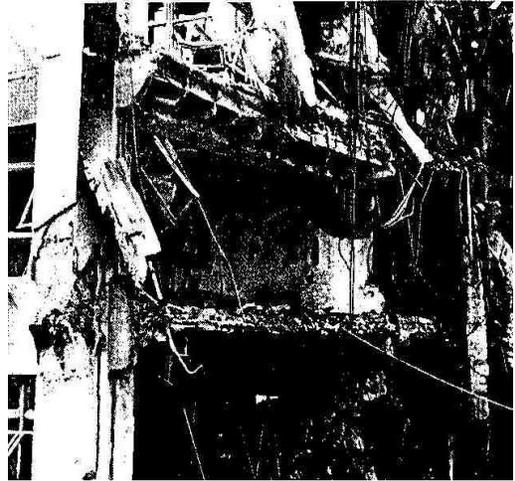
Figure 10. Collapse detail of the concrete structure of CESP Sede II building

The building central region collapse was due to the fire that was developing at its mid-height, resulting from the expansion stresses introduced by two consecutive T-beams in the vertical elements of their respective frames. These two consecutive frames had significantly more stiffened vertical elements on one side of the building, as their cross sections were larger and formed the columns that made up the elevator shaft. The less stiff parts of the two gantries received greater efforts due to these dilations, ruled by the geometric relationship of the column sections on both frames sides, and suffered severe shear, breaking up.

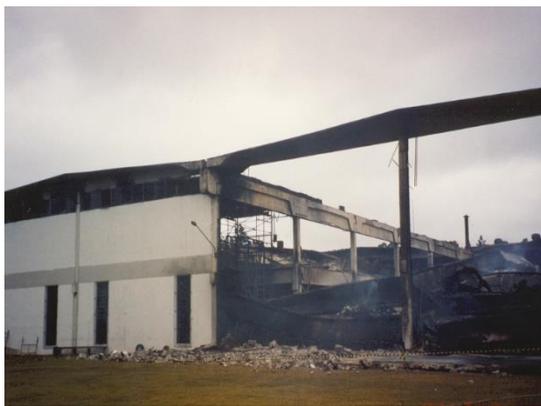
The fire case illustrated in Figures 11 and 12 in 1995 in the São Paulo city metropolitan region

shows the collapse of a large precast concrete structure where the expansion efforts of the concrete structural elements displaced the supports. The absence of solidarity between the horizontal and vertical elements led to the structure collapse.

Figure 11. Collapse of building with precast structure subjected to fire

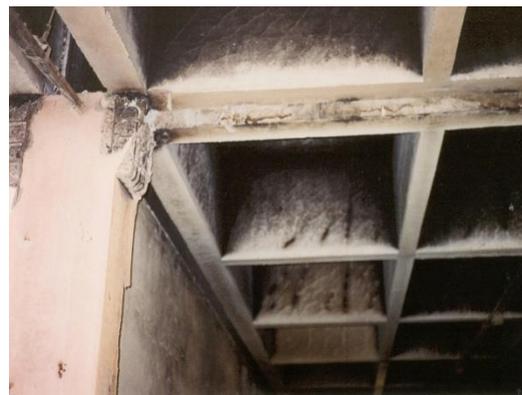
Figure 12. Support displacement of pre-molded fire structure

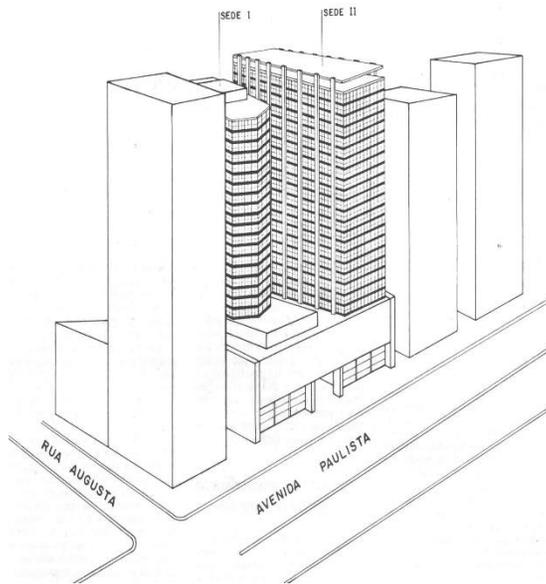
Figure 13. Block affected by fire: Podium and Sede I and II buildings I

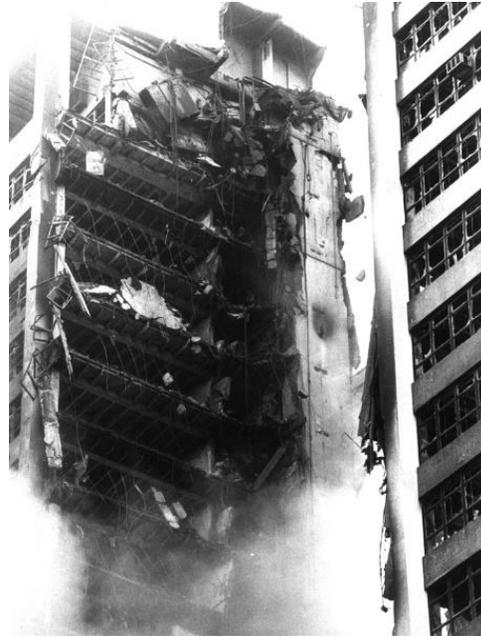
Figure 14. Detail of the Sede II building concrete structure collapse, showing the two remaining parts of the tower.

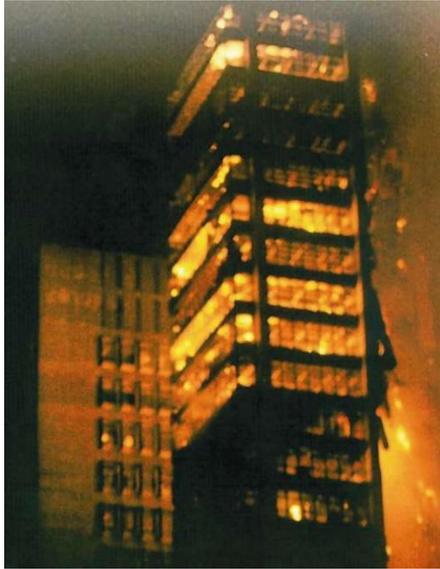
Although only a structure part of the Sede II building collapsed, splitting it in two, what was left of its structure and also the Sede I structure, suffered serious damage, so that after the fire, there was an imminent risk of collapse of both buildings. Such a situation justified the urgent need for two buildings demolition.

Figura 16. Building Sede II Remaining front

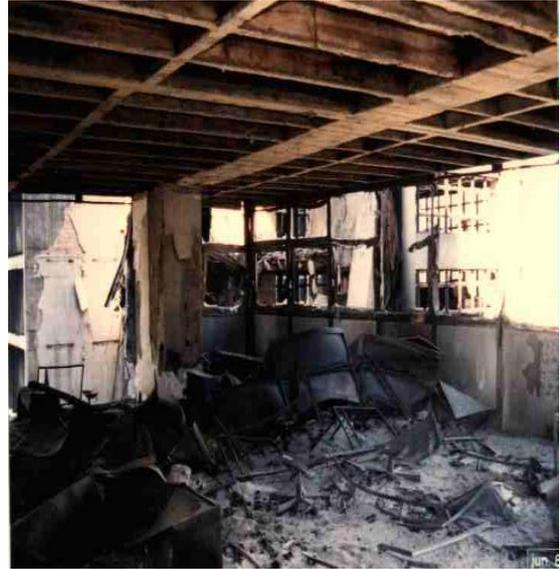
It was found in the Sede I building that the horizontal structural elements (beams and slabs) presented two problems capable of seriously compromising the stability of the structure in a fire situation. One of them was related to coatings of armor, generally very reduced, being next to the concrete surface in some regions. The other related to the reduced cross sections of the ribbed slab beams, which were insufficient to ensure fire resistance of more than 1 h. As a result, a significant part of the horizontal structural elements suffered great deformation.

Figura 17. Fire damaged Sede I building structure
