## Conservation of cultural heritage buildings: Methodology and application to case studies

P. B. Lourenço<sup>1</sup>

### ABSTRACT

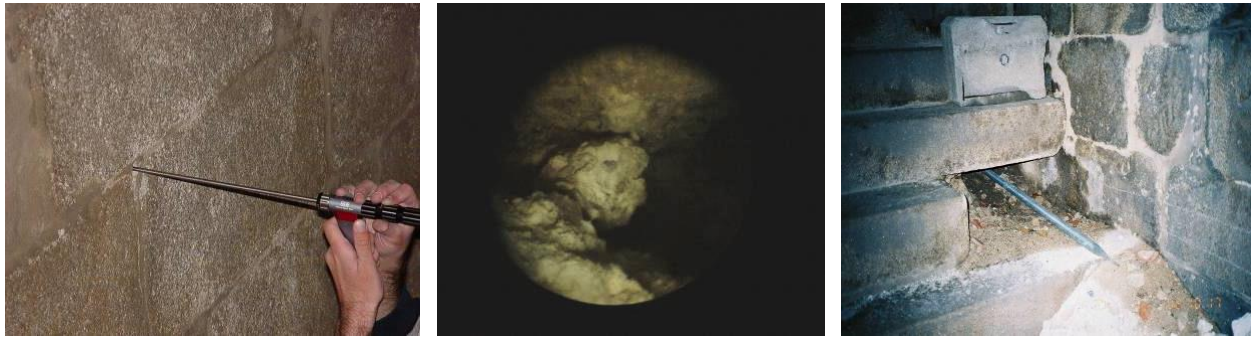
mid-level with stone slabs and architraves apparently supported in columns and stone struts. The South tower possesses an internal core with a staircase shaped helicoidally. The constitution of the masonry walls from the towers was characterized using visual inspection, removing stones of the outer leave in the interior of the tower and by using a boroscopic camera inserted in cracks or in holes drilled in joints, see Figure 4. From the inspection, it was possible to conclude that the three-leaf walls have external leaves of granite ashlar with a thickness ranging from 0.30 to 0.70 m, while the middle leave is made from loose smaller stones and silty soil. The combination of heavy rain in Porto, strong winds in the top of the hill where the Cathedral is located, and the open joints in the external masonry face, results in a wet infill even in the summer and the continuous washing out of the infill.

Figure 4. Visual inspection with boroscopic camera and inspection openings.

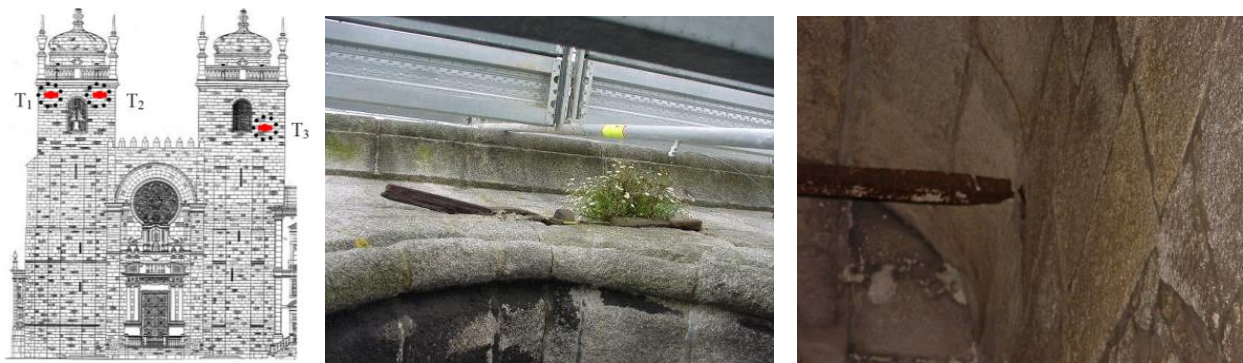
The towers exhibit distributed cracking and significant out-of-plane movements. The existing damage resulted in the past addition of three iron ties (date unknown), see Figure 5. Tie T<sub>1</sub> presents a severely deformed anchorage and tie T<sub>3</sub> is corroded and broken. The separation between the East and West façades of the South tower continued after tie T<sub>3</sub> was broken. The masonry walls in the vicinity of the anchorages are also deformed, as expected due to the application of a large point load. The South tower is more damaged than the North tower, with severe cracks and out-of-plumb walls. Separation between the internal and external leaves of the walls is confirmed by the longitudinal cracking observed in most of the openings, with a maximum width of some centimeters.

Figure 5. Ancient tower ties, with deformed anchorage (T<sub>1</sub>) and broken tie (T<sub>3</sub>).

The solution adopted for strengthening consists mostly of a steel ring in both towers, aiming at confining the structure along the two orthogonal directions, in the sole location possible, see Figure 6a,b. The rings are made with welded stainless steel plates (class AISI 316L), connected to the towers using long, inclined stainless steel anchorages inside of a cloth duct to prevent generalized injection, see Figure 6c-e. The length of the steel profiles is defined so that the elements can be transported to the location through the existing doors and can be easily assembled in situ, without any further welding. In the North tower, the ring also aims at providing a support for the stone pavement for the bells, as stone columns are much deteriorated and had no structural function and the stone struts have very deficient conception. The steel ring is made of channel profiles (240 × 120 mm and 200 × 100 mm height). In the South tower, a set of two ties was provided to the ring, because it was possible for aesthetic reasons and they are a testimony of the ancient broken tie. The ring must cross the staircase at a selected location because the complex internal structure of the tower does not allow otherwise. Due to the lack of internal stiffening elements, a much stiffer steel frame is needed and the steel ring is made of H profiles (180 × 180 mm). Due to the bulging outwards of the East and South façades, and the severe cracks in the corners, several short ties have been added to the structure to stitch the East and

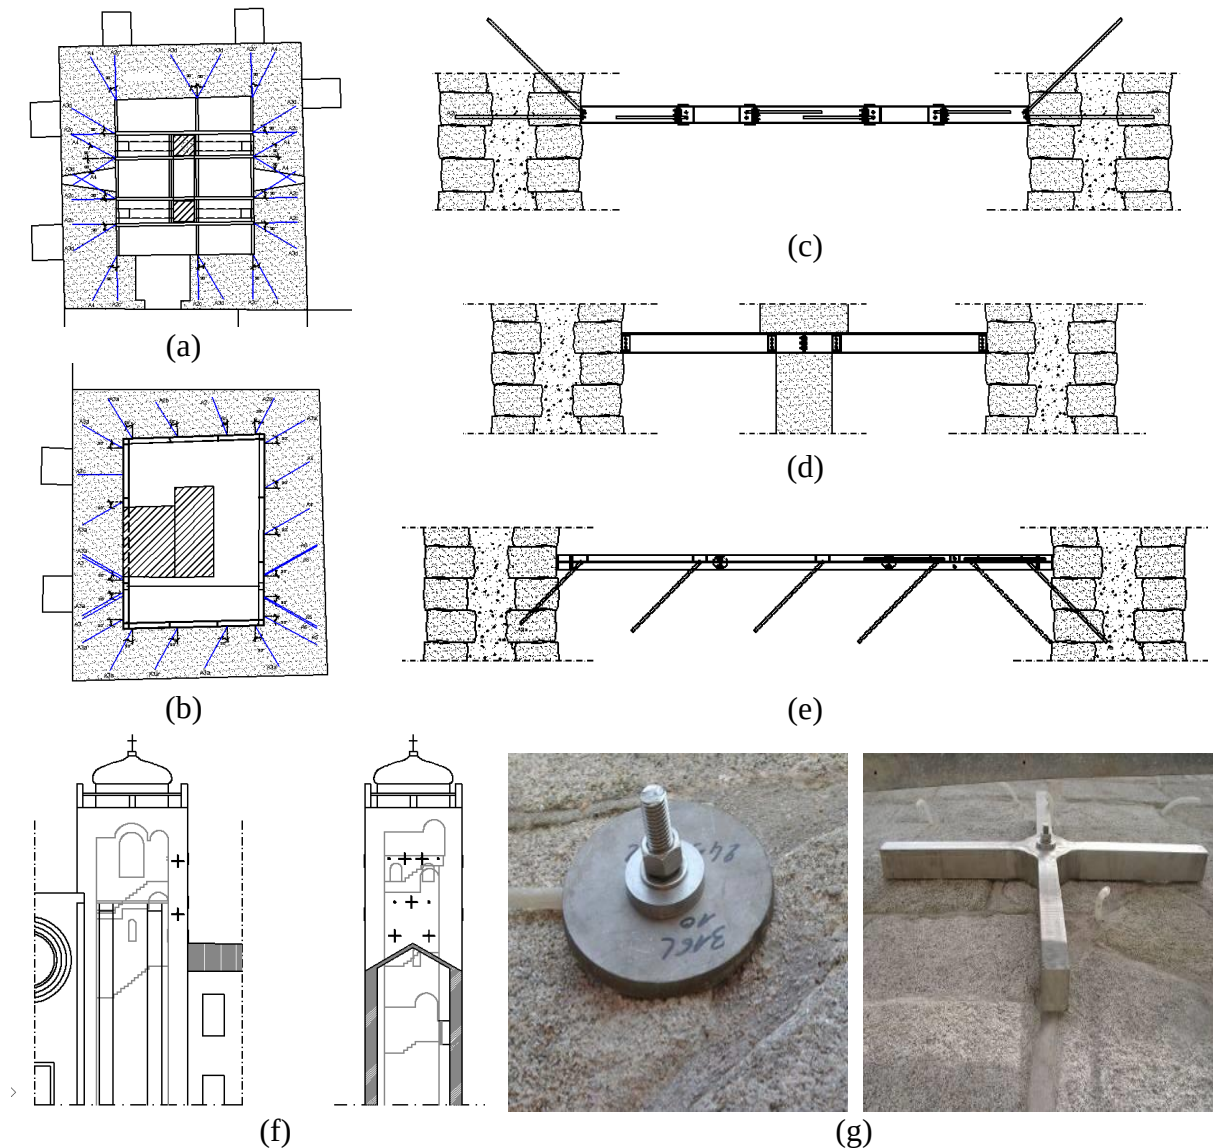
Figure 6. Aspect of the strengthening of the towers: (a) Ring for the north tower; (b) Ring for the south tower; (c) North-south section for north tower; (d) West-east section for north tower; (e) Typical section for south tower; (f) Additional ties in the west and south façades of the south tower; (g) Details of the anchorage plates.

South façades, and two long ties through the core of the South façade have been added to connect the West and East façades, see Figure 6f. Figure 6g presents details of the two types of anchorage plates adopted (circular plates and specially designed crosses).

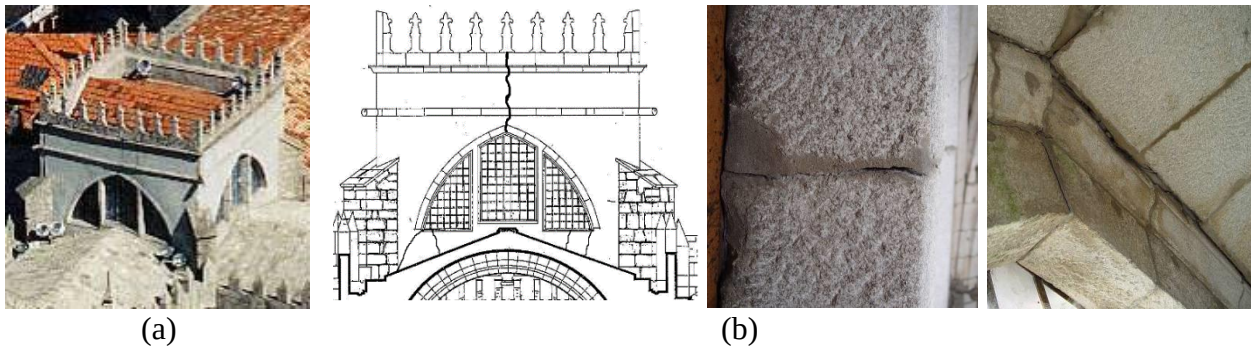
The skylight is located above the transept and presents different cracks, which occurred after the works carried out in the first half of the 20<sup>th</sup> century. In addition, infill material from the vault had recently fallen in the transept. The skylight is made of four walls supported in large arched windows opened in the 18<sup>th</sup> century, with the exception of the East façade with exhibits no opening, see Figure 7a. It has a square plan with 7.5 m side, walls with 6.5 height and 0.65 m thickness. The thickness is reduced to 0.4 m above the vaults and, again, to 0.2 m in the battlements. Buttresses can be found in each corner and a ribbed stone vault makes the ceiling, further topped by a timber double slope roof. The masonry in the walls is of very low quality, made of rubble stone and weak lime mortar. The openings form pointed arches, supported at the thirds of the span with T-shaped columns. The vault is made with stone slabs with a thickness between 0.14 and 0.54 m. Rubble loose infill was removed on top of the vault (about 10 m<sup>3</sup>).

The three walls with windows are cracked at the arch key, with maximum crack widths of 10, 1 and <0.5 mm, in the façades West, North and South, respectively. These walls are also bulging outwards. Figure 7b shows the main crack in the West façade, which crosses the entire section of the wall. Smaller cracks can be also observed closer to the buttresses, under the opening, together with horizontal cracks in the window columns due to bending. The most severe crack in the interior has a width of 25 mm and shows that the vault is separated from the wall in the West

façade. Due to this crack, the stone slabs of the vault are no longer supported in the side rib and a settlement of about 20 mm can be observed at the key of the vault.

The observation of the damage in the skylight, together with the local relief, the severe separation between the East façade and the chancel, the old documents indicating consolidation and enlargement of foundations and the bulging of the walls of the nave indicate that soil settlements and weak foundations can be the main cause of damage. A finite element model of the skylight was used to understand and justify the existing damage. The actions considered include the self-weight of the structure, the weight of the infill, the seismic action and differential temperature. The results for the combination of self-weight plus rubble infill provided a maximum tensile stress found lower than  $0.1 \text{ N/mm}^2$  and located in the window-sills and ribs. The skylight should

Figure 7. Skylight: (a) Aerial view; (b) Cracks in façades, windows, columns and vaults.

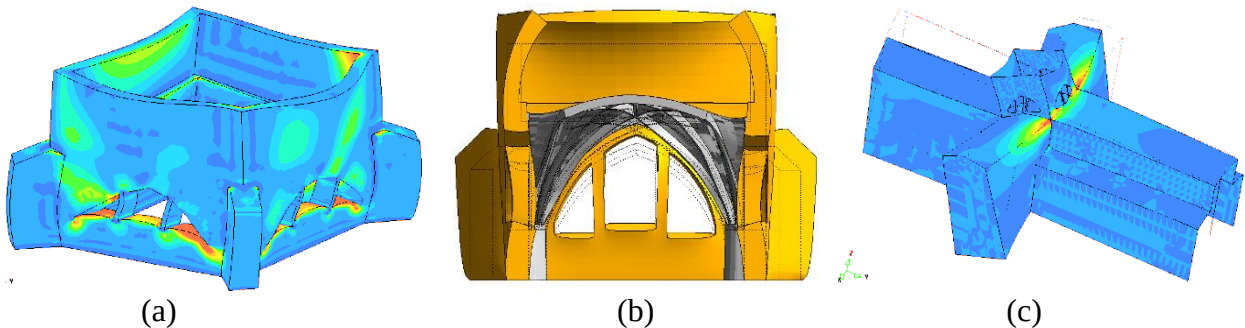
have minor or no damage under self-weight and infill. Seismic loading and temperature were then added to the structure, aiming at explaining the damage, see Figure 8a,b. Even if the deformation for seismic loading has some resemblance with the observed movements in the structure, the stresses found are too low to provoke any damage. The deformed mesh associated with the differential temperature indicates that the walls move to the exterior and suffer significant bending, with significant curvatures in the columns. Still moderate stresses are found and the deformation is not in agreement with the observed movements, meaning that the temperature effect is relevant but should not be the main cause of the damage. A full model of the church was then prepared to analyze the influence between the skylight, the adjacent structure and the soil, see Figure 8c. Very high tensile stresses are found in the skylight and the deformation is similar to the one observed in the structure, confirming that this is the major cause of damage. The remedial measures are given in Lourenço et al. (2004).

Figure 8. FEM analysis: (a) Live loads; (b) Temperature variation; (c) Dead load for full model.

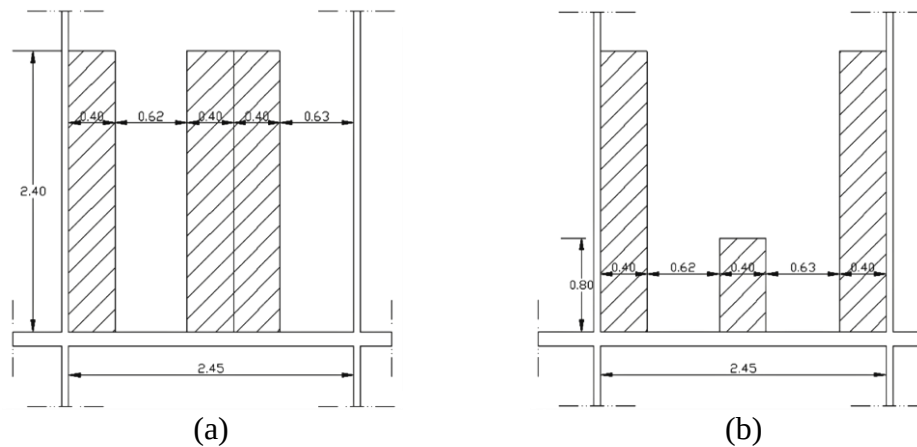
The reinforcement that is present in the slabs is adequate for the previous loads but it is clearly insufficient for the new loads. The proposal of the architect responsible for the works was to adopt three archive shelves with a height of 2.40 m and a base of 0.40 m, see Figure 10, which implies a reinforcement amount twice the existing. The original proposal is possible with a new supporting structure of steel profiles HEB 100, placed transversally in the rooms, and supported by steel angles placed close to the walls. On top of this structure, an OSB new floor would be placed, with a total cost for the solution of about  $100 \text{ USD/m}^2$ . The proposed alternative was to use two taller shelves close to the walls and a shorter shelf in the center, in order to reduce the bending moment, allowing even to provide more room for stocking.

Figure 10. Proposal for book archive: (a) Original; (b) New.

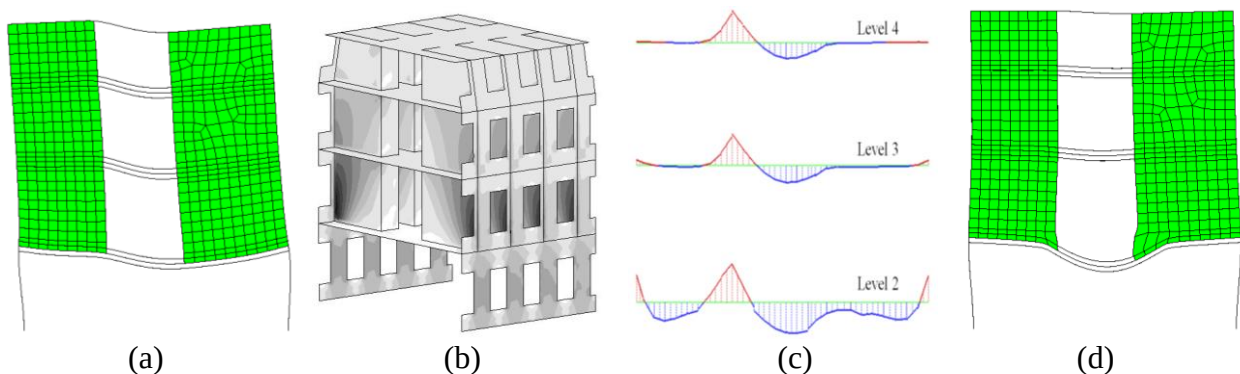
A finite element model was used for the global stability of the structure. The results allow confirming the large stiffness of the internal walls and the asymmetry of the response, see Figure 11a. The analysis of the principal compressive stresses shows that the load is transferred to the external walls, with a behavior similar to a deep beam and using the main beam of level 2 as a “tie” subjected to large flexure, see Figure 11b. The bending moment of the main beams obtained using a linear elastic approach and the failure of the structure using non-linear analysis is shown in Figures 11c,d. The asymmetric deformation and the large stiffness of the walls led to large bending moments producing tensile stress in the upper fibers (60 kN.m in the beam of level 2, in the connection with the left transverse wall). Therefore, the global stability is ensured by the flexural capacity of the nodes in the connection between beams and walls, in a zone where the amount of upper reinforcement is rather low. Figure 11d shows the attempt of the structure to follow a strong redistribution, with a fast progression of a horizontal crack between the walls and the beam in level 2. As the lower reinforcement in the beams is insufficient to carry out the load corresponding to the new use, the structure must be strengthened.

Figure 11. Results for the structural analysis: (a) Deformed mesh; (b) Compressive principal stresses; (c) Bending moments in main beams; (d) Failure from non-linear analysis.

Two possibilities of strengthening were analyzed: (a) a steel beam grid and new columns supporting level 2; (b) a suspension structure for the main beams. Given the aesthetic implications, the usage limitation and the cost, the latter solution was adopted, see Figure 12. Truss steel structures have been added between level 4 and the roof, in between the existing
