Conservation of cultural heritage buildings: Methodology and application to case studies

P. B. Lourenço ¹

¹University of Minho, ISE, Department of Civil Engineering, Portugal, Web: <http://www.civil.uminho.pt/masonry>, <http://www.isise.net>.

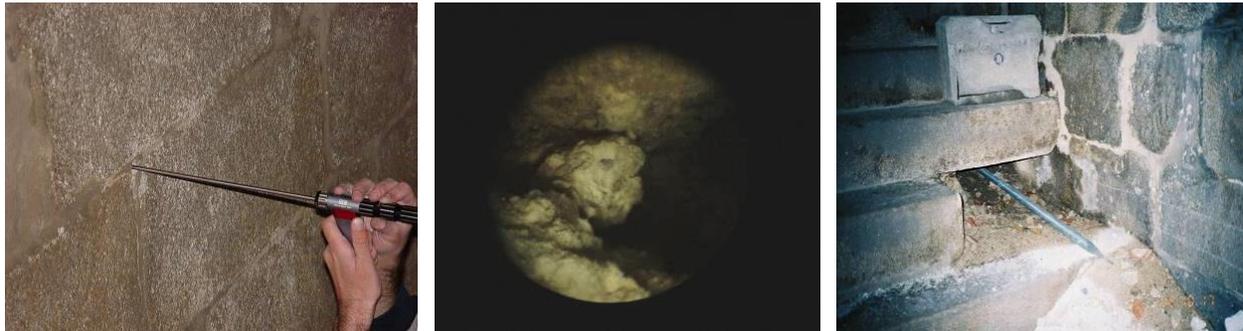
mid-level with stone slabs and architraves apparently supported in columns and stone struts. The South tower possesses an internal core with a staircase shaped helicoidally. The constitution of the masonry walls from the towers was characterized using visual inspection, removing stones of the outer leaf in the interior of the tower and by using a boroscopic camera inserted in cracks or in holes drilled in joints, see Figure 4. From the inspection, it was possible to conclude that the three-leaf walls have external leaves of granite ashlar with a thickness ranging from 0.30 to 0.70 m, while the middle leaf is made from loose smaller stones and silty soil. The combination of heavy rain in Porto, strong winds in the top of the hill where the Cathedral is located, and the open joints in the external masonry face, results in a wet infill even in the summer and the continuous washing out of the infill.

Figure 4. Visual inspection with boroscopic camera and inspection openings.

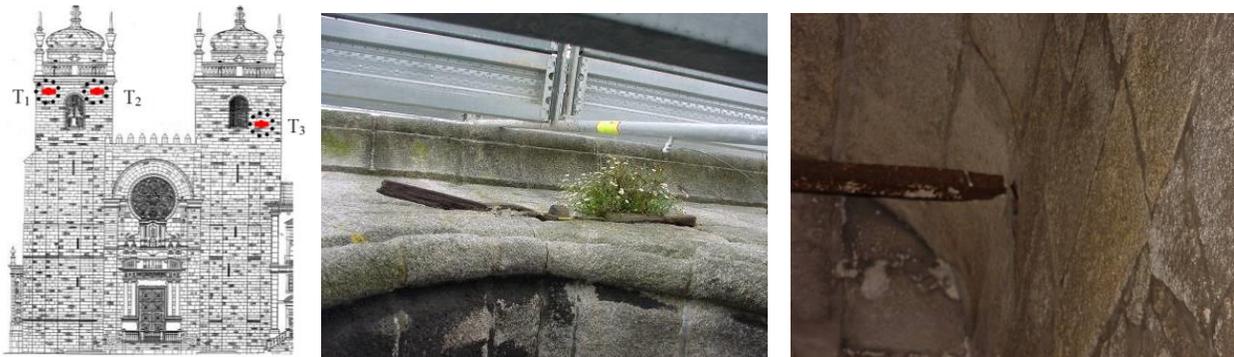
The towers exhibit distributed cracking and significant out-of-plane movements. The existing damage resulted in the past addition of three iron ties (date unknown), see Figure 5. Tie T₁ presents a severely deformed anchorage and tie T₃ is corroded and broken. The separation between the East and West façades of the South tower continued after tie T₃ was broken. The masonry walls in the vicinity of the anchorages are also deformed, as expected due to the application of a large point load. The South tower is more damaged than the North tower, with severe cracks and out-of-plumb walls. Separation between the internal and external leaves of the walls is confirmed by the longitudinal cracking observed in most of the openings, with a maximum width of some centimeters.

Figure 5. Ancient tower ties, with deformed anchorage (T₁) and broken tie (T₃).

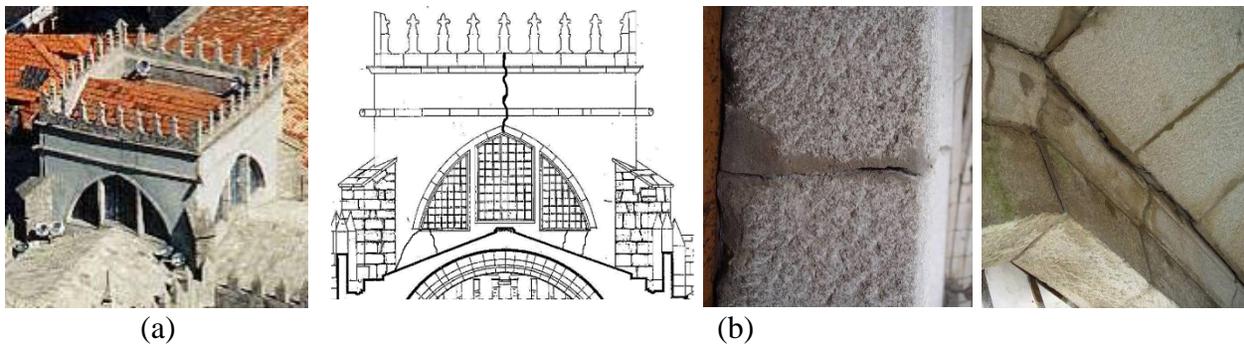
The skylight is located above the transept and presents different cracks, which occurred after the works carried out in the first half of the 20th century. In addition, infill material from the vault had recently fallen in the transept. The skylight is made of four walls supported in large arched windows opened in the 18th century, with the exception of the East façade with exhibits no opening, see Figure 7a. It has a square plan with 7.5 m side, walls with 6.5 height and 0.65 m thickness. The thickness is reduced to 0.4 m above the vaults and, again, to 0.2 m in the battlements. Buttresses can be found in each corner and a ribbed stone vault makes the ceiling, further topped by a timber double slope roof. The masonry in the walls is of very low quality, made of rubble stone and weak lime mortar. The openings form pointed arches, supported at the thirds of the span with T-shaped columns. The vault is made with stone slabs with a thickness between 0.14 and 0.54 m. Rubble loose infill was removed on top of the vault (about 10 m³).

The three walls with windows are cracked at the arch key, with maximum crack widths of 10, 1 and <0.5 mm, in the façades West, North and South, respectively. These walls are also bulging outwards. Figure 7b shows the main crack in the West façade, which crosses the entire section of the wall. Smaller cracks can be also observed closer to the buttresses, under the opening, together with horizontal cracks in the window columns due to bending. The most severe crack in the interior has a width of 25 mm and shows that the vault is separated from the wall in the West

façade. Due to this crack, the stone slabs of the vault are no longer supported in the side rib and a settlement of about 20 mm can be observed at the key of the vault.

The observation of the damage in the skylight, together with the local relief, the severe separation between the East façade and the chancel, the old documents indicating consolidation and enlargement of foundations and the bulging of the walls of the nave indicate that soil settlements and weak foundations can be the main cause of damage. A finite element model of the skylight was used to understand and justify the existing damage. The actions considered include the self-weight of the structure, the weight of the infill, the seismic action and differential temperature. The results for the combination of self-weight plus rubble infill provided a maximum tensile stress found lower than 0.1 N/mm^2 and located in the window-sills and ribs. The skylight should

Figure 7. Skylight: (a) Aerial view; (b) Cracks in façades, windows, columns and vaults.

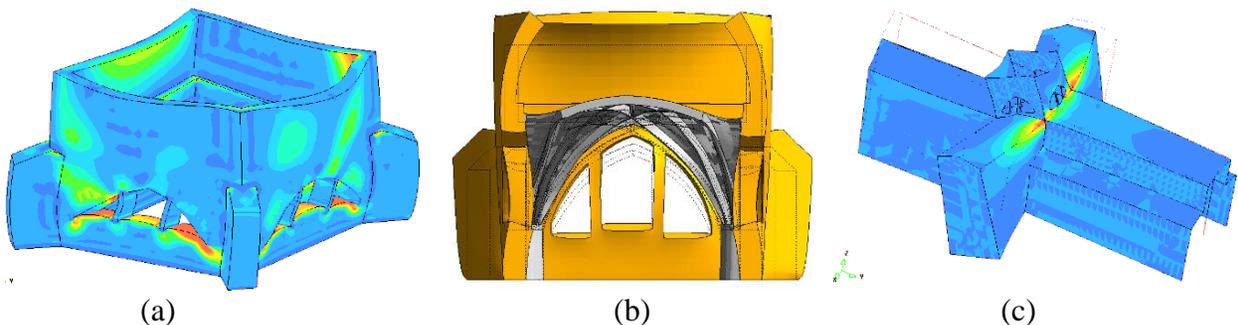
have minor or no damage under self-weight and infill. Seismic loading and temperature were then added to the structure, aiming at explaining the damage, see Figure 8a,b. Even if the deformation for seismic loading has some resemblance with the observed movements in the structure, the stresses found are too low to provoke any damage. The deformed mesh associated with the differential temperature indicates that the walls move to the exterior and suffer significant bending, with significant curvatures in the columns. Still moderate stresses are found and the deformation is not in agreement with the observed movements, meaning that the temperature effect is relevant but should not be the main cause of the damage. A full model of the church was then prepared to analyze the influence between the skylight, the adjacent structure and the soil, see Figure 8c. Very high tensile stresses are found in the skylight and the deformation is similar to the one observed in the structure, confirming that this is the major cause of damage. The remedial measures are given in Lourenço et al. (2004).

Figure 8. FEM analysis: (a) Live loads; (b) Temperature variation; (c) Dead load for full model.

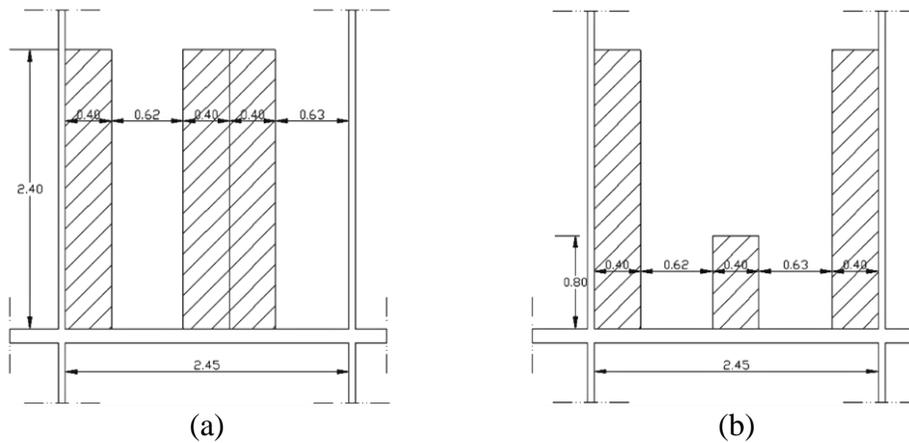
The reinforcement that is present in the slabs is adequate for the previous loads but it is clearly insufficient for the new loads. The proposal of the architect responsible for the works was to adopt three archive shelves with a height of 2.40 m and a base of 0.40 m, see Figure 10, which implies a reinforcement amount twice the existing. The original proposal is possible with a new supporting structure of steel profiles HEB 100, placed transversally in the rooms, and supported by steel angles placed close to the walls. On top of this structure, an OSB new floor would be placed, with a total cost for the solution of about 100 USD/m^2 . The proposed alternative was to use two taller shelves close to the walls and a shorter shelf in the center, in order to reduce the bending moment, allowing even to provide more room for stocking.

Figure 10. Proposal for book archive: (a) Original; (b) New.

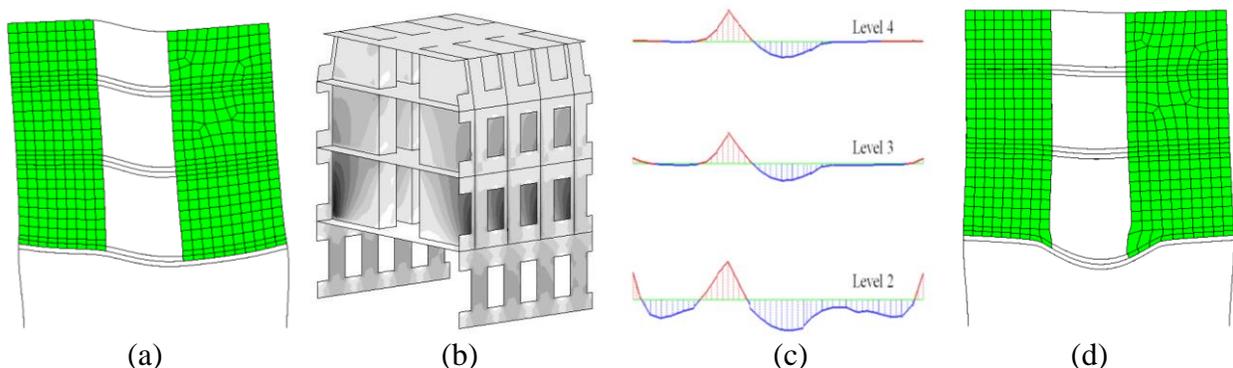
A finite element model was used for the global stability of the structure. The results allow confirming the large stiffness of the internal walls and the asymmetry of the response, see Figure 11a. The analysis of the principal compressive stresses shows that the load is transferred to the external walls, with a behavior similar to a deep beam and using the main beam of level 2 as a “tie” subjected to large flexure, see Figure 11b. The bending moment of the main beams obtained using a linear elastic approach and the failure of the structure using non-linear analysis is shown in Figures 11c,d. The asymmetric deformation and the large stiffness of the walls led to large bending moments producing tensile stress in the upper fibers (60 kN.m in the beam of level 2, in the connection with the left transverse wall). Therefore, the global stability is ensured by the flexural capacity of the nodes in the connection between beams and walls, in a zone where the amount of upper reinforcement is rather low. Figure 11d shows the attempt of the structure to follow a strong redistribution, with a fast progression of a horizontal crack between the walls and the beam in level 2. As the lower reinforcement in the beams is insufficient to carry out the load corresponding to the new use, the structure must be strengthened.

Figure 11. Results for the structural analysis: (a) Deformed mesh; (b) Compressive principal stresses; (c) Bending moments in main beams; (d) Failure from non-linear analysis.
