## Recovery procedures for foundation elements with alkali/aggregate reaction problems. Documental research

DOI: <https://doi.org/10.21041/ra.v11i2.490>

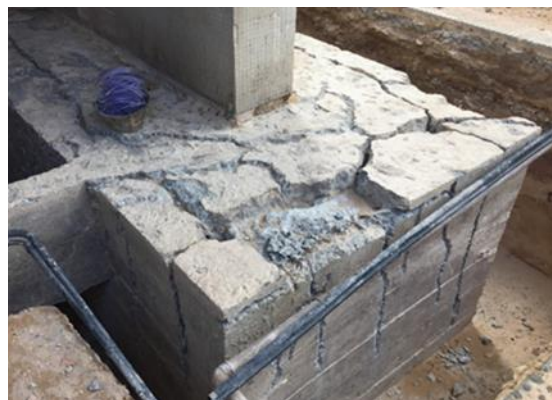
The locations where cracks were found were very similar among the buildings. The cracks were found mostly through routine inspections or because of their effects on the floors. The foundation elements were cracked on the top and on the sides. A preliminary mapping of the structural elements was carried out, where the positioning of the cracks, their direction, their thickness, and where they were most concentrated was verified.

Figure 8. Cracks on a block with AAR.

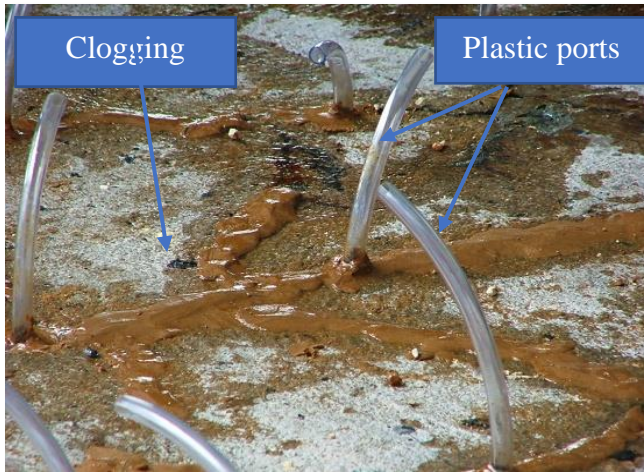
Figure 10. Plastic ports.

In the injection process, plastic and metallic ports were used, as shown in Figures 10 and 11. The metallic ports are part of the new advances in the injection process, to which an injection can be applied under higher pressure, and consequently the penetration of the material to areas of greater depths can occur in a shorter span of time. However, from the data collected in this study, filling was done to close external cracks and ensure the injection, and the most used materials were plastic ports, which are simpler and easier to find on the market.

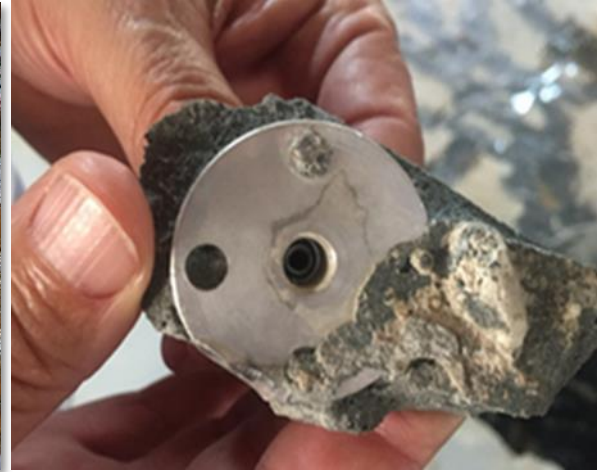
Figure 11. Metallic ports.

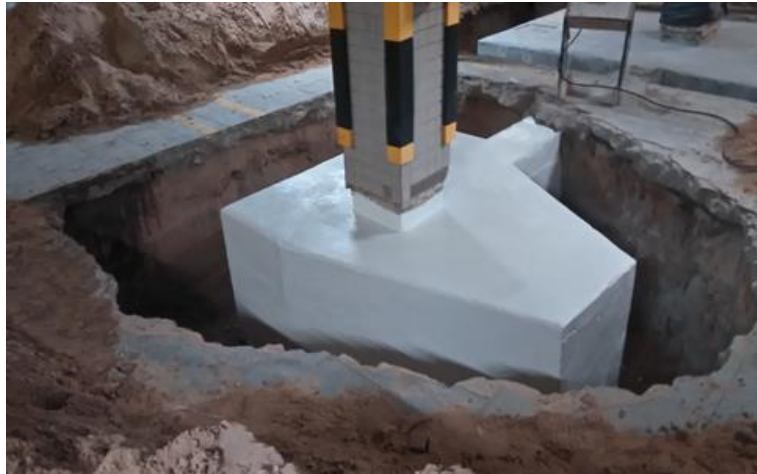
Figure 13. Waterproofed block.

To avoid possible pathological problems caused by moisture, it is imperative to use a waterproofing system that is compatible with the geometry of the pieces and the characteristics of the structure, such as the level of the water table. It was verified in this study that all the recovered foundations used waterproofing on the tops and sides of the elements, as shown in Figure 13.

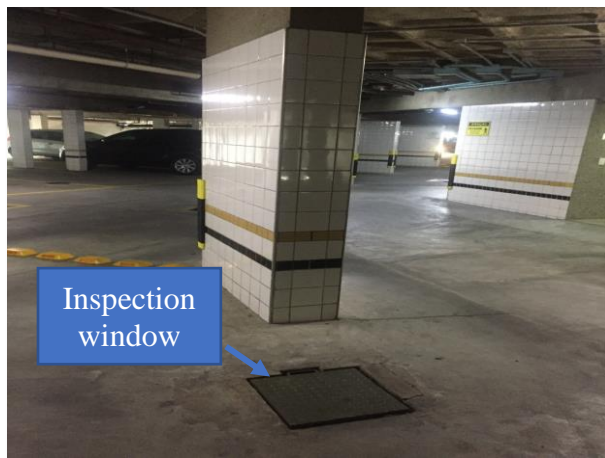
Figure 14. Inspection window.

As a result, it was found that, of the 50 foundations surveyed, only two left the inspection windows. The windows are small openings left in the foundation elements that make it possible to monitor the recoveries from the floors above, as shown in Figure 14. Internally, small pieces of glass are placed, shown in Figure 15, where cracks had previously been identified, so that they can be periodically monitored after their recovery. If any new movement of the foundation block occurs, the tendency will be for this glass to break, indicating a possible continuing of the ASR, or of some other pathological manifestation.

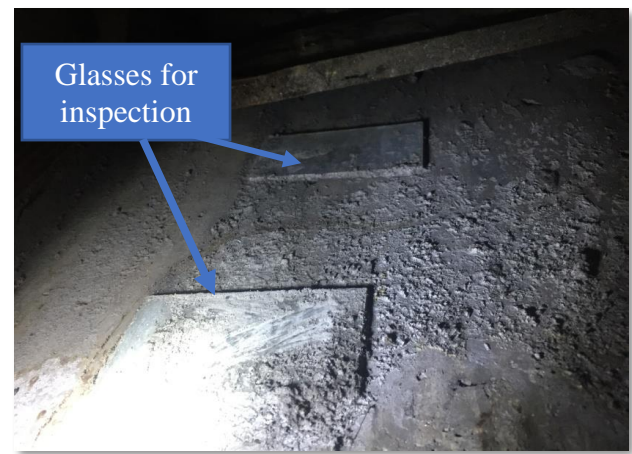
Figure 15. Interior of inspection window.
