Documentation of the pathological manifestations of the Portico of the Cultural Baptism of Goiânia - *Art Déco* historical monument

T. L. Pio Santos^{1*}

, P. F. Silva Júnior¹

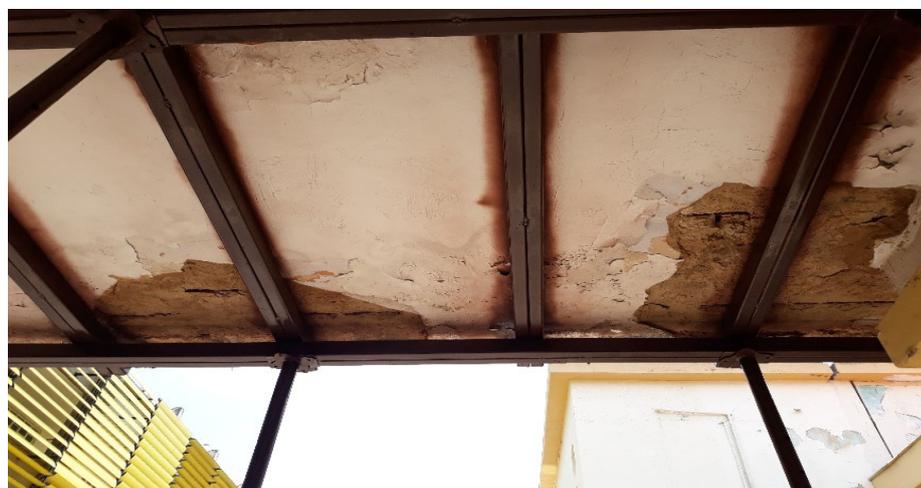
Figure 10. Detachment of concrete at the bottom of the slab

From the visual inspection, it was possible to see that the slab at its bottom presents detachment of the concrete in some places (Figure 10) as a result of the corrosion of the reinforcement.

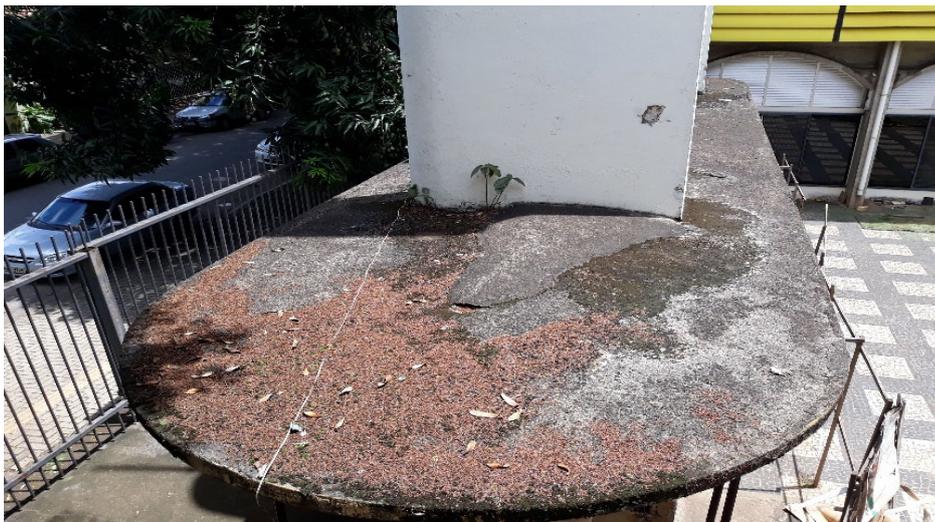
Figure 11. Mold and dirt on the slab

As shown in Figure 11, a considerable presence of mold and dirt was observed on the slab. Mold proliferates in humid, hot and dimly lit environments. This environment may have happened due to the presence of trees near the structure. It was also observed the presence of dirt or black crust, which were caused by the accumulation of dust, soot and pollution particles, originated from the burning of fossil fuels in the combustion engines of vehicles, brought by rainwater or by the action of the wind.

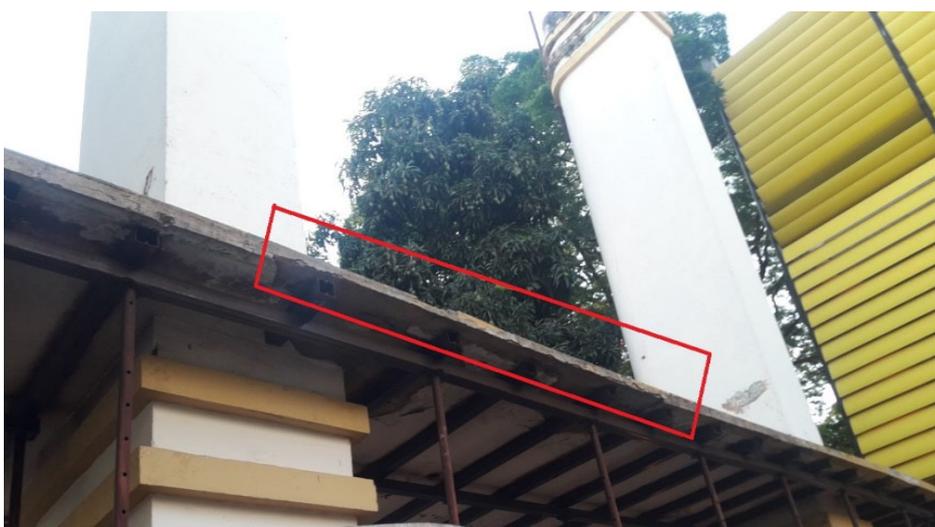
Figure 12. Detachment of the edge of the slab

Part of the edge of the slab was detached and this was due to the carbonation and corrosion process of the reinforcements that took place in its reinforced region. As the carbonation process evolved over time, the cracking of the structure caused its movement, culminating in the detachment of the mortar at its ends (Figure 12).

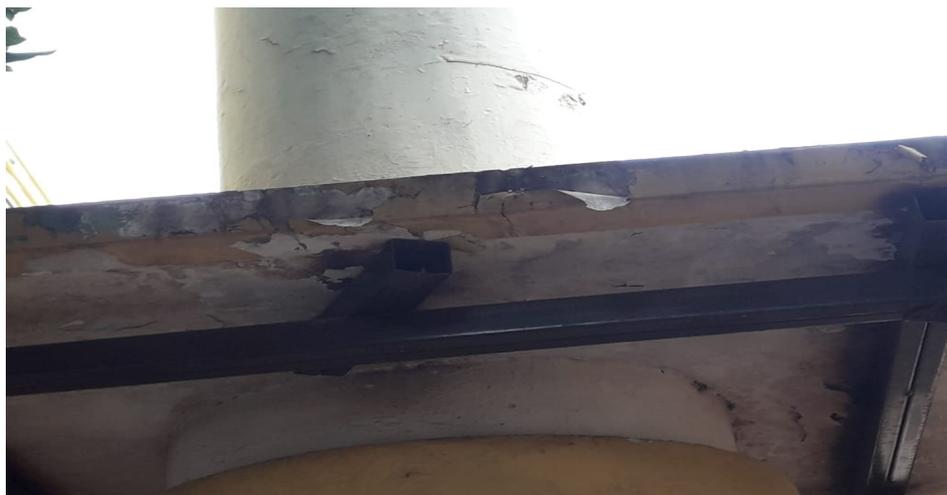
Figure 13. Detachment of the slab paint.

The painting on the slab was quite damaged, showing regions with detachment probably due to the application of paint over an existing layer (another layer of paint of a color different from the visible color that was applied previously was observed), impairing the adhesion between. In the process of lack of adherence, the incidence of rain and humidity are aggravating (Figure 13).

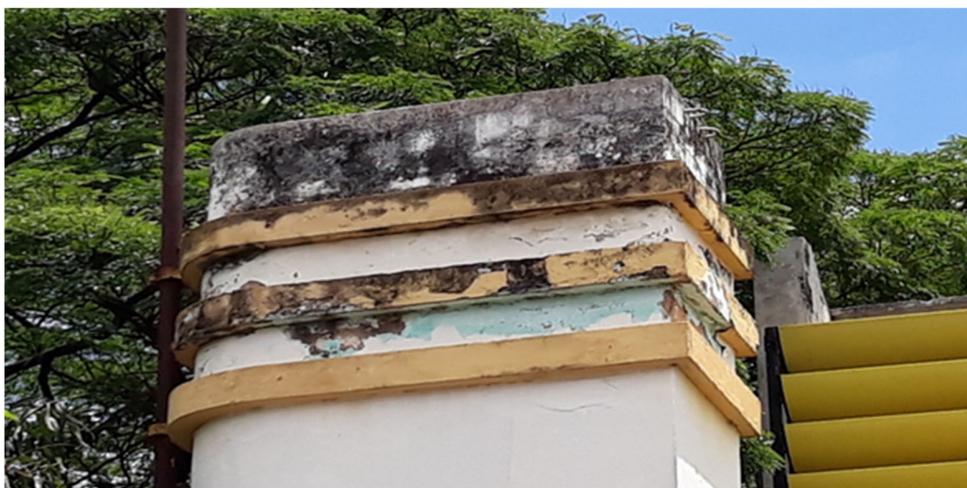
Figure 14. Dirt and detachment of the paint on top of the pillar

Another manifestation noticed in the pillars was the presence of dirt, as shown in Figure 14. This factor is mainly due to the lack of waterproofing and drainage mechanisms at the top of the pillar, which accumulated soot and dust brought by the wind. As noticed on the slab, there was also the detachment of the painting on the pillars and the visible color is also another previously applied coat of paint (a green one), compromising adherence.

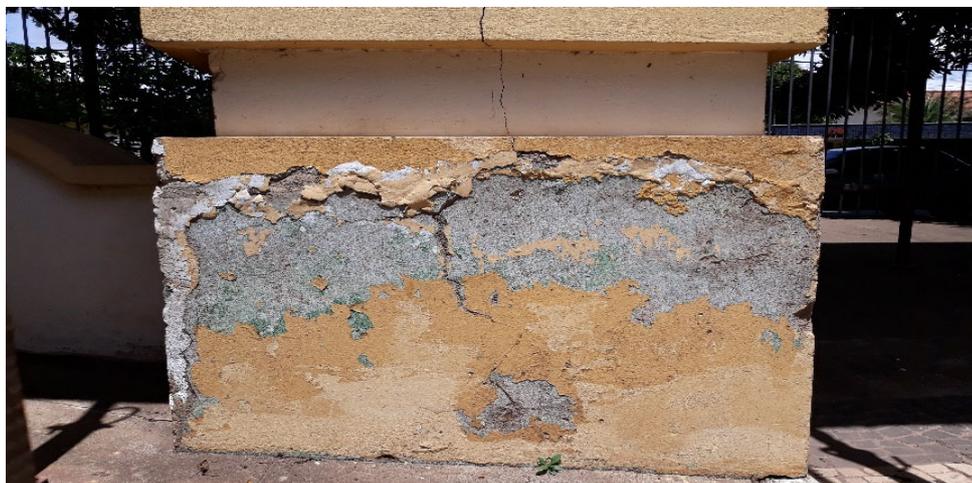
Figure 15: Incidence of cracks and paint discoloration

The discoloration of the paint was verified and could have been caused mainly by its natural aging. Other factors such as the use of yellow colored paint, which is more susceptible to ultraviolet rays, since the pillar suffers a high incidence of sunlight, may also have aggravated the discoloration process. Cracks were noticed at the base of the pillars, possibly caused by the shrinkage of cementitious materials caused by the loss of water by evaporation in a fresh or hardened state and by the variation in temperature due to the high incidence of sunlight (Figure 15). Bubbles were

noticed in the painting of the pillars caused by the presence of humidity (which may have been absorbed by the cracks in the plaster and the hydrostatic pressure caused when its evaporation through the pores of the mortar happened, breaking and pushing the paint film), lack of adhesion and possible application failures such as running a thick layer under extreme heat conditions on a dirty and unprepared surface.

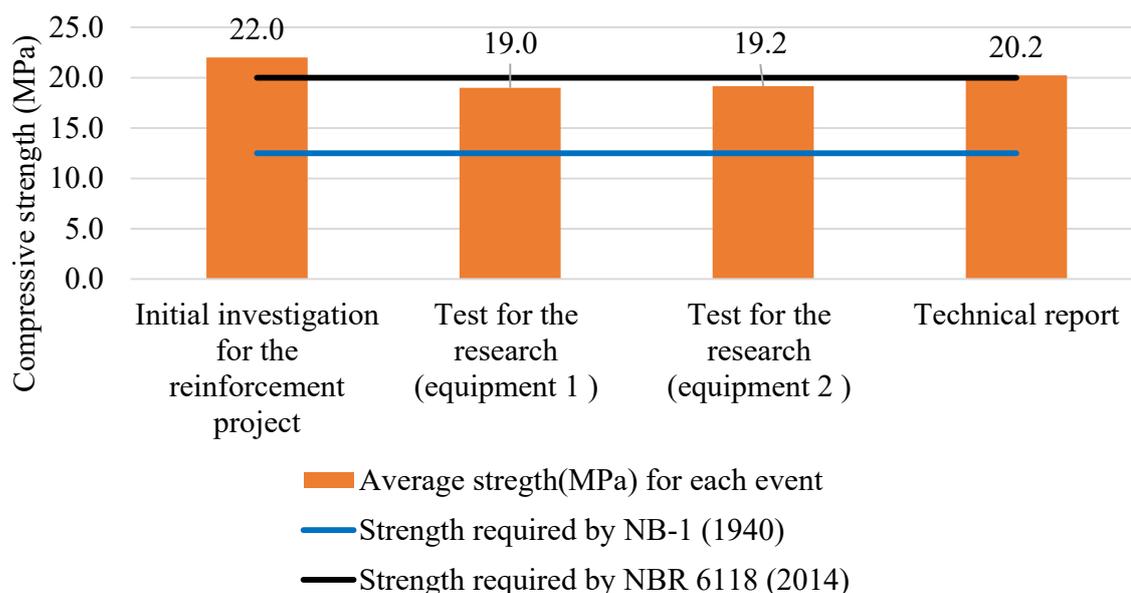
Figure 17. Comparative graph of strength obtained with normative requirements

Figure 17 shows the graph with the compressive strength values obtained from the sclerometer test performed on the structure during the anamnesis process and those carried out in this research. The values shown are an average of the compressive strengths of areas tested by test event. It can be seen from the graph that the results found converge to an average value of estimated strength of 20 MPa, despite the tests having been carried out on different dates and by different operators.

About the normative standards for the minimum strength of concrete structures, since there is no information about the structural design of the frame, knowing that the NB-1 standard- Calculation and Execution of Reinforced Concrete (ABNT, 1940)- which was used at the time when the structure was built recommends a minimum strength for concrete structures of 125 kgf/cm², that is, 12.5 MPa. The current standard NBR 6118 – Design of concrete structures – Procedure (ABNT, 2014) provides a minimum strength of 20 MPa for concrete structures. Thus, the graph in Figure 17 also presents a comparison between the estimated results of compressive strength of concrete, obtained in different sclerometer tests, with the minimum values of characteristic strength of concrete under compression (f_{ck}) recommended by the standard of concrete structure that was used at the time of the construction of the Portico and today.

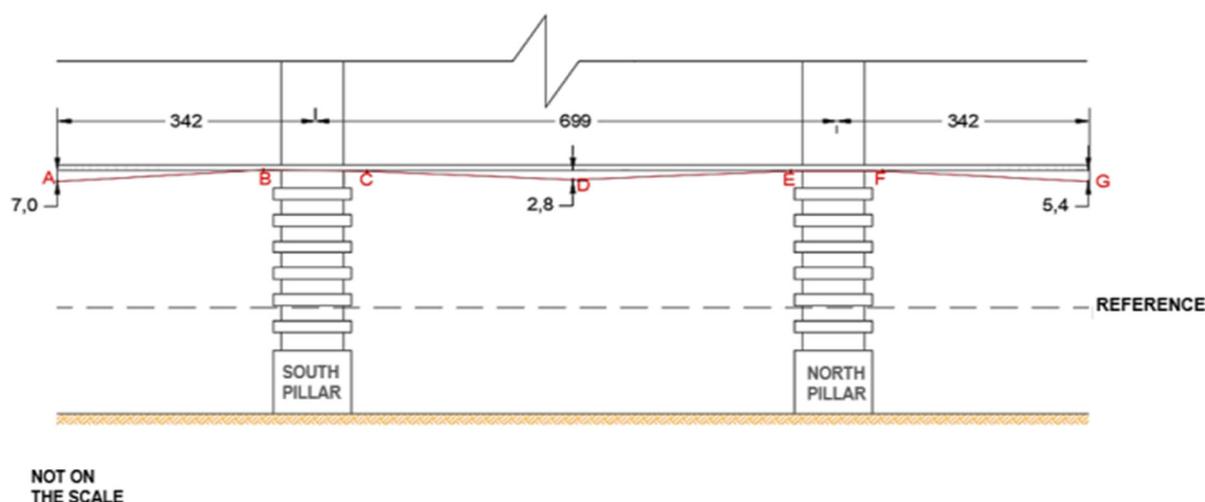
Figure 18. Representation of the biggest slab deflections verified

It is then observed that both overhanging regions whose maximum slab deflections are 7.0 cm at point “A” and 5.4 cm at point “B” are much higher than allowed by the NBR 6118 (ABNT, 2014). For the central region, the slab deflection found at point “D” has a value of 2.80 cm, which is equivalent to that allowed by the standard requirement.

Due to the lack of preventive and corrective maintenance over time, the structure suffered excessive deformations so that the values of the slab deflections verified in the overhang regions demonstrate that it is outside its service limits.

It is worth saying that because it is an old structure, over 70 years old, the creep of the concrete may have been one of the reasons that contributed to the total deformation of the slab. However, this was not considered in the present survey.
