Practical use of the safety factor in the column repair strategy of a concrete building with historical value

In this paper the practical use of the safety factor (FS) in the column repair strategy of a reinforced concrete building with historical value (almost 70 years) is presented. 80% of a building located in the historic center of the city of Campeche, Mexico, declared a World Heritage Site by UNESCO, was repaired. Strategies were used for a better use of material resources, equipment, and labor in the repair of walls, columns, slabs, and beams. One of the strategies was to use the theoretical FS to calculate the repair depth without structural consequences but fulfilling the purpose of controlling the carbonation of the concrete and maintaining the desired prediction of service life.

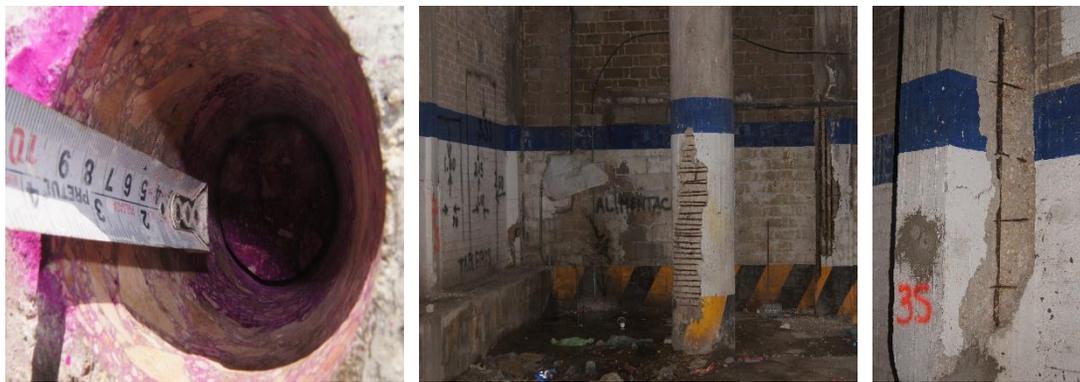
Figure. 3. Carbonation and detachment of concrete.

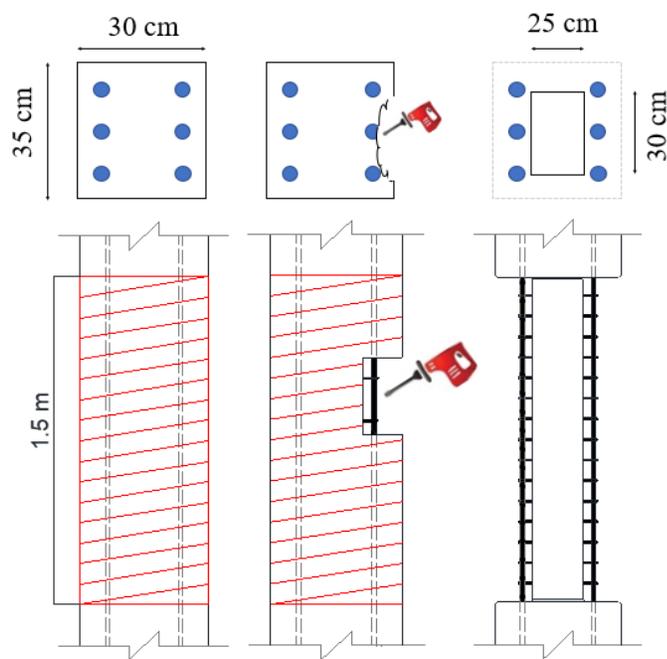
be deduced that the column can support an axial load of 210,000 kg. Now, if the concrete in poor condition is scarified, and it is repaired beyond the reinforcement, remembering that the uniform deep repair is the one that occurs beyond 3 cm or behind the reinforcement, the new cross section of the element is 25x30 cm. If this new cross section is used and the compressive strength obtained previously with the extracted cylinders, it can be determined that the structure, even with the reduction in the concrete section, can support 150,000 kg. If it is considered that, at least, the element was designed with an SF of 1.5, then the structure was initially designed to carry a load of 140,000 kg safely. Therefore, even after scarifying, the item to be repaired can still withstand the loads exerted as it can resist up to 150,000 kg. This could not be entirely true since it is not an analysis that considers all the possible effects that may exist at the time of making the repairs. However, it is a good strategy to be carried out in the field since it allows a quick appreciation of how far one can intervene without structurally affecting the element and to be able to continue with the repair work once the diagnosis has been made.

Figure 5. Criterion for delimitation and scarification of repairs
