Diagnosis and solutions proposal to the damages present in the ceiling of the Convent of Santa Clara de Asís

The Convent of Santa Clara de Asís was inaugurated in Havana in 1644, becoming the first religious convent founded in Cuba. In 2018, the Office of the Historian of Havana (OHCH) began a restoration and recovery project that has involved professionals and students from different branches of technical careers, and professionals linked to the field of construction and conservation of built heritage. The results that have been obtained from these investigations allowed the establishment of priorities and methodologies for its gradual intervention and recovery (Guevara et al., 2019).

The objective of this work is to evaluate the state of conservation in the structure of the wooden ceiling of the circulation gallery located on the upper floor of the first cloister, for which a series of NDTs were combined that allowed identifying the pathologies present and determining the magnitude of the injuries in the beams and wood stud that make it up. This implies a proposed solution that is discussed at the end of the work.

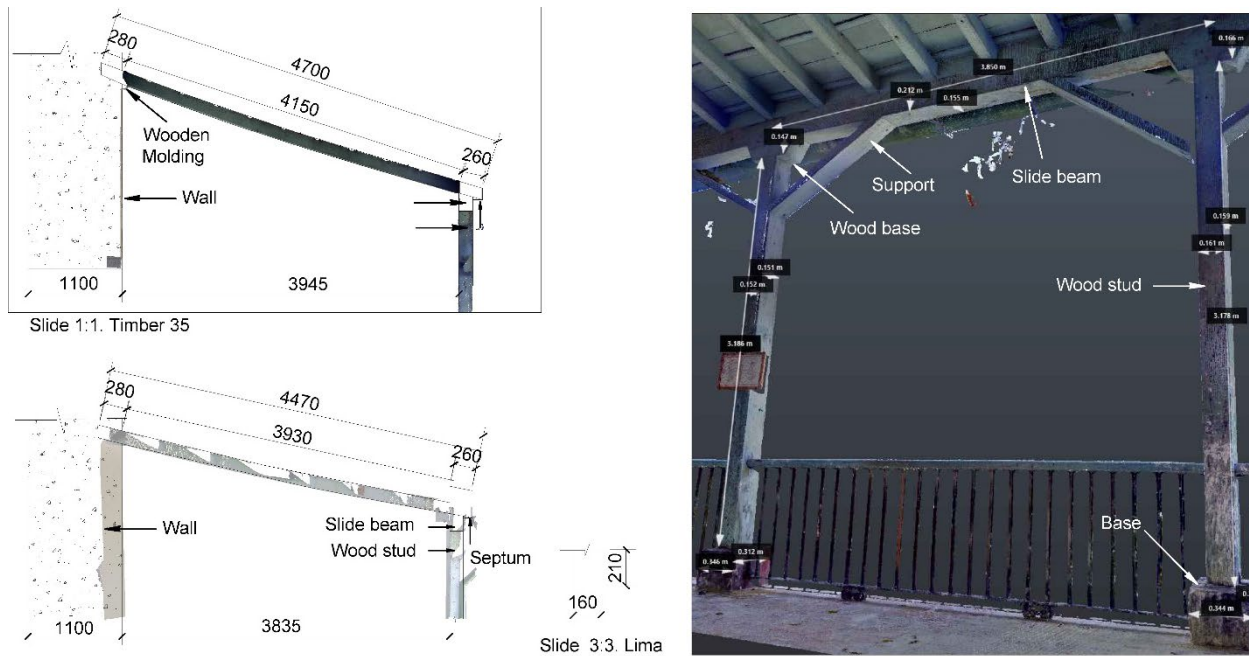
Figure 3. Dimensioning and deformation (in mm) of the wooden elements from the 3D models

The high precision of the data obtained by the laser scanner from the union of the point clouds and the obtaining of the 3D model, allows the measurements of the slab elements to be carried out without the need to intervene on them. To work with representative sections and the wood studs, regions were established and the views were adjusted to obtain measurable images. In the case of the wooden ceiling, a section between beams 35 to 49 was extracted, while for the support elements, a section from studs 5 and 6 was selected. The results are shown in figure 3. Summary of the sizing is indicated in table 2.

For the structural analysis of the slab beams, orthoimages were extracted using the Reconstructor software, and cuts were made using the Autodesk Recap software from beam number 17 to 98. All the beams that make up the slab present deformations to a greater or lesser extent, and some show flexural failures due to a decrease in their bearing capacity. The Cuban standard (NC 53-179:88, 1988), establishes that the maximum admissible deflection is $1/240$ of length for full load. This indicates that the admissible deflection for the wood beams is approximately 1.5 cm, but the values obtained on site are 2 cm to 4 cm higher than those acceptable by calculation. The standard establishes that the deflection of the beams will increase for load periods of more than 10 years by 50% for dry wood, and 100% for wet wood. Considering this, the allowable deflection would increase by 2.25 cm and 3.0 cm, respectively, for which there are still differences between allowable and actual values (Figure 4). It is important to note that not all the maximum deformations found are located in the center of the span, for the reason that there are areas where the element is more deteriorated than others; that is why the beams deform and fail in the most vulnerable area. It was identified that not all the beams are of the same wood species, which is why their hardness and resistance to bending also vary. In the right feet 1 and 7, the deterioration in the joints has caused the displacement of the same and of all the elements that adjoin it. These vertical movements that the right feet have suffered vary between 3.5 cm - 20 cm approximately, and the separation in the scarf joint between the beams that make up the sliding beam ranges between 1 cm to 2 cm, which represents considerable displacements.

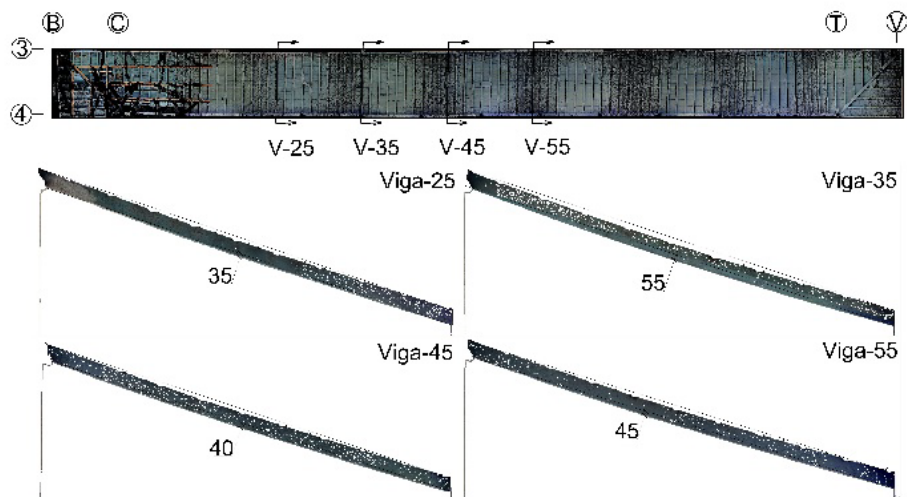
Figure 4. Deformations (in mm) of some wood beams

To evaluate the deformation of the beams and the density they present, the identification of the timber species was carried out, from the taking of samples directly from the beams and uprights. The wood species were identified in a biological laboratory and the densities obtained with a penetrometer were compared with the reference values reported by the National Institute of Agro-Forest Research (INAF).

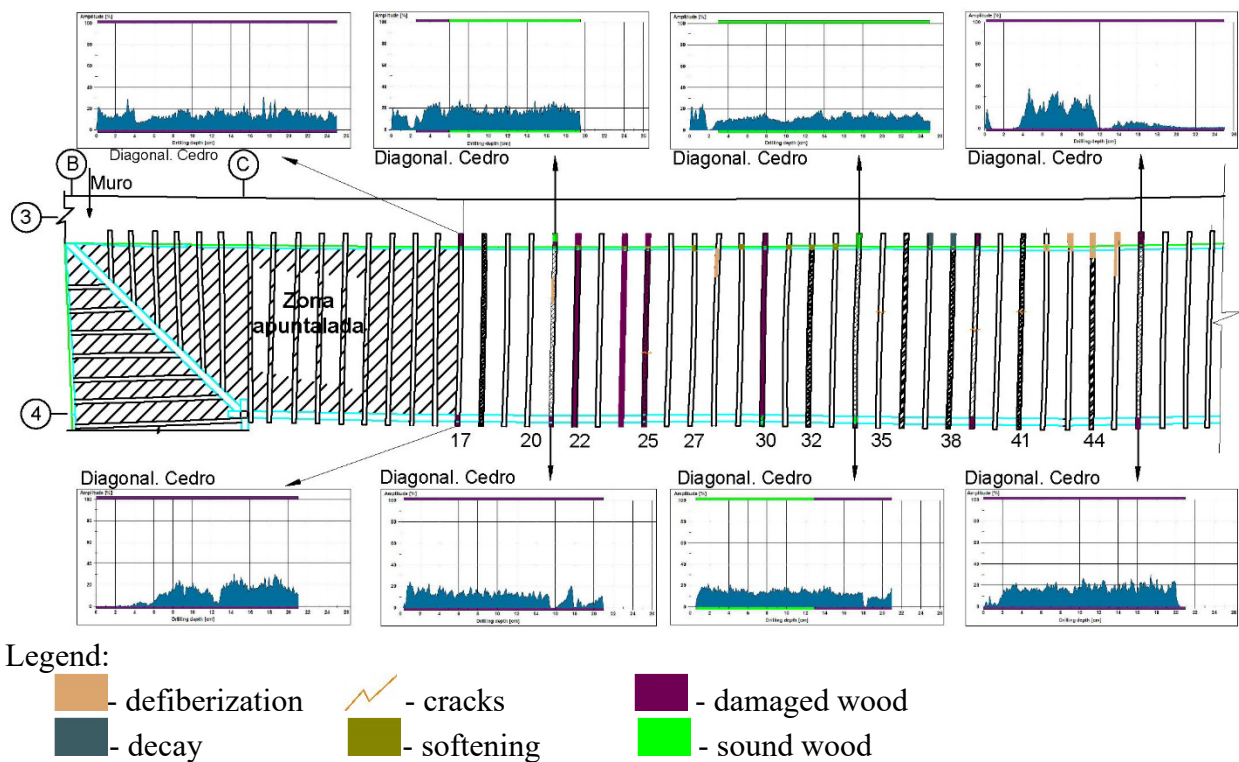
The analysis carried out with the resistograph allowed us to identify that of the 98 beams that make up the roof, 64 of them present different pathological manifestations associated with decay due to exposure to wetting and drying cycles. The resistography began in the area of the junction because it is the most vulnerable area, and depending on the damage detected, measurements were also made in the center of the span or near the supports (Figures 6 and 7).

Figure 6. Results of resistography tests and damages in wooden elements between beams 1-49

In the floor beams, it was determined that 17 of them need to be replaced as a result of their advanced deterioration. Additionally, another 45 beams must be structurally reinforced in different areas, depending on the pathologies developed in each one. Of the remaining 34 beams for which no significant injuries were identified, it will be necessary to disassemble and strip 2 of them due to superficial damages, in order to subsequently recalculate the load for the new beam section (Figures 10 and 11). All the wood studs showed deterioration that required structural reinforcement actions, as well as in the sliding beams, where it will be necessary to replace two sections and reinforce another 3 sections (Figures 12 and 13). The significant decrease in the density of the wood is the result of exposure to wetting and drying cycles, mainly in the rainy months, with the consequent proliferation of fungi and termite infestation. The deformations present in the beams are not only the result of the increase in weight due to excess water and the growth of higher plants, but also due to the loss of their timber properties, which increases the risk of structural failure.

Figure 10. Proposal for a solution to the ceiling between beams 1-49

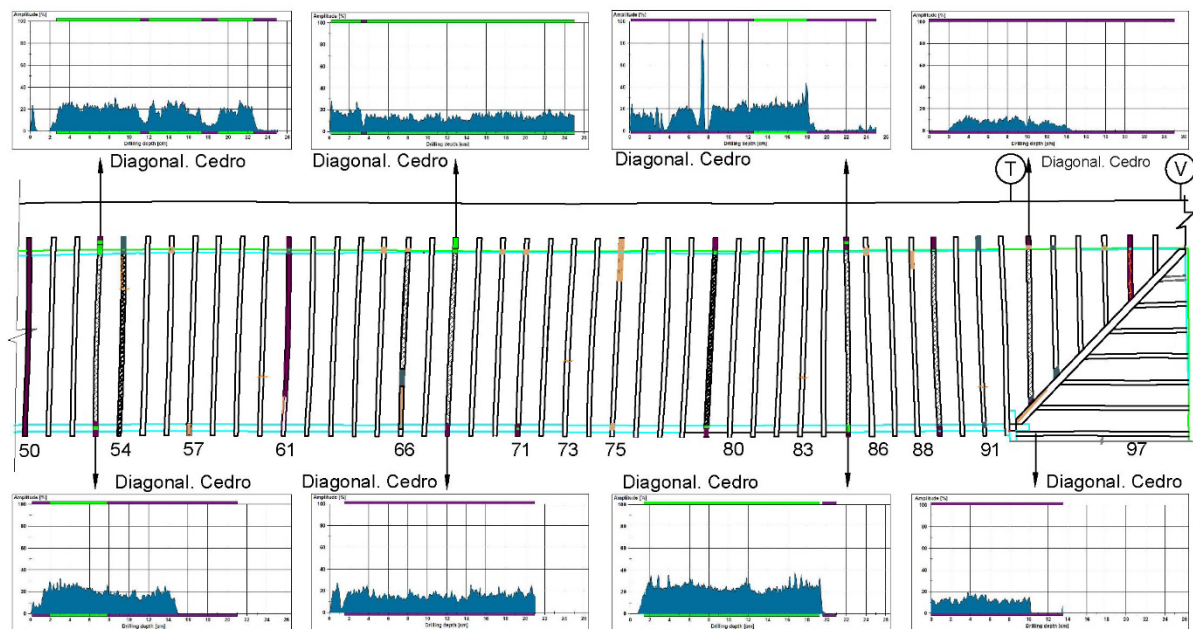
Figure 7. Results of resistography tests and damages in wooden elements between beams 50-98

Figure 11. Proposal for a solution to the ceiling between beams 50-98

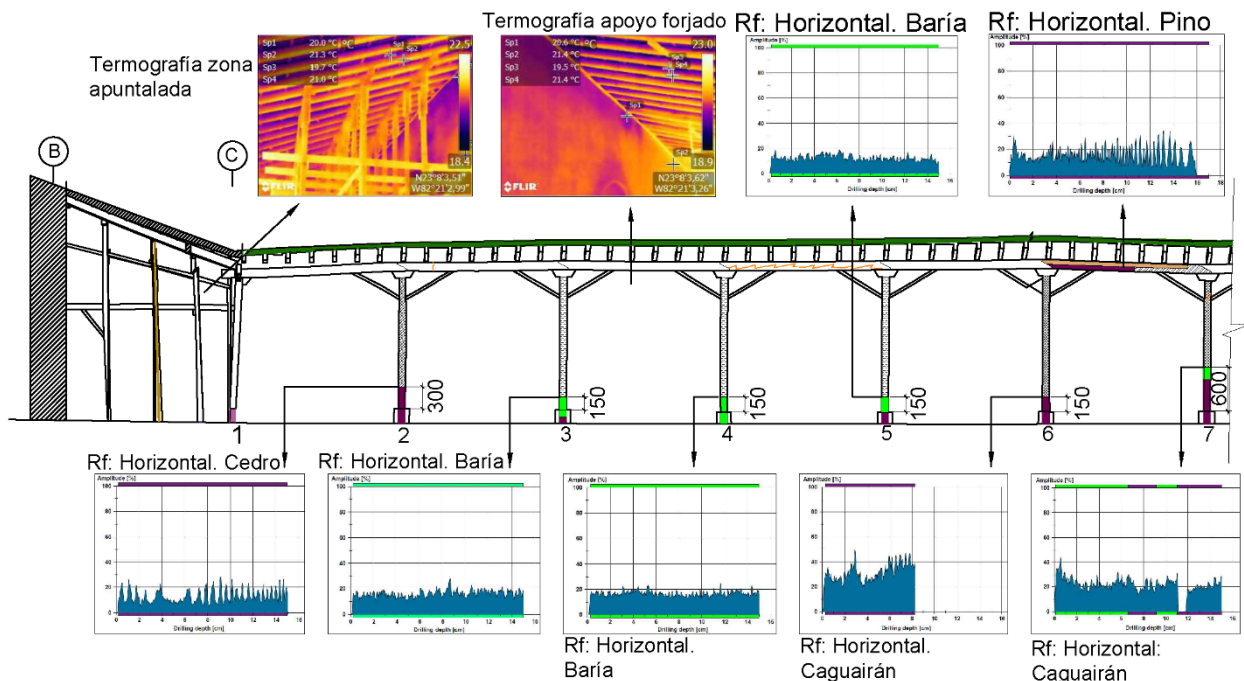
The moisture content measured in the floor beams is between 9%-19%, in the wood studs between 11%-17% and the sliding beam between 11%-12%. The thermographic images obtained reflected how the support wall presents areas of high humidity, which favors the absorption of water in the wood as it is a hygroscopic material.

In the case of the wood studs, the resistography showed low penetration resistance values for all of them, and anomalies similar to those detected in the wooden beams. The extension of the lesions is between 150 mm and 750 mm from the concrete base upwards, and in more than 50% of the wood studs, it is located in the first 150 mm of height.

Figure 8. Results of tests on elements of the slab between wood studs 1-7, where the thermography reflects the humidity present in the wall of axis 3 in the support area of the beams, and the resistography in the wood stud and sliding beam of the axis 4

Figure 12. Proposal for a solution to the wood stud 1-7 and section of the sliding beam

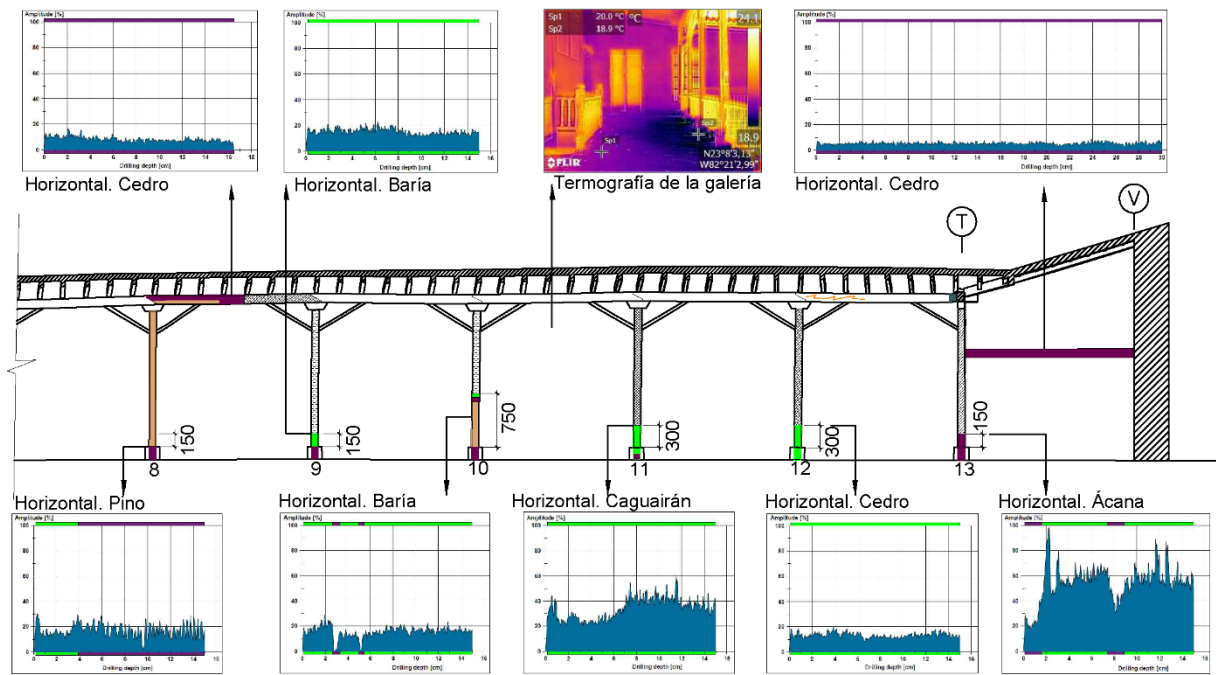
resistography was carried out from the interior side (gallery) to the exterior (patio), with the purpose of identifying the progress in the deterioration based on the width of the beam. In the section between the wood studs 8 and 9, the resistography shows areas with defibration due to the attack of termites. These xylophagous organisms feed on the wood and leave tunnels inside it, consequently, the resistographic curve suddenly changes as a result of the lack of resistance during their advance (Figures 8 and 9). When carrying out the penetrometer tests and the corresponding adjustment calculations, it was evaluated that the wooden elements have a hardness lower than the tabulated values for Cuban woods. These results are in correspondence with the low resistances obtained in the resistography tests. Table 3 presents a sample of some of the elements studied.

Figure 9. Results of tests on elements of the slab between wood stud 8-13, showing the thermography of the gallery with a high level of humidity in the supports of the wood stud, and the resistography in the wood stud and slide beam at axis 4.

Figure 13. Proposal for a solution to the wood stud 8-13 and section of the sliding beam
