Evaluation of the pathological manifestations of the Rio Negro Building in Anápolis-Goiás

This paper shows the application of the methodologies GDE (Degree of Structure Deterioration) and GUT (Severity, Urgency, and Tendency) quantifying the pathological manifestations and determining the points of greatest need for maintenance. Thus, a quantitative perspective was used with the application of the previously mentioned methodologies and after building inspections and visual analysis with a photographic record, notes and mappings the methodologies were applied and it was obtained that most of the pathological manifestations that occur in the structure of the building have humidity as origin, resulting in efflorescence, spots or infiltration. Thus, this work defined the points that need priority, directing measures that can later be taken. The methodologies proved to be efficient and important for decision-making.

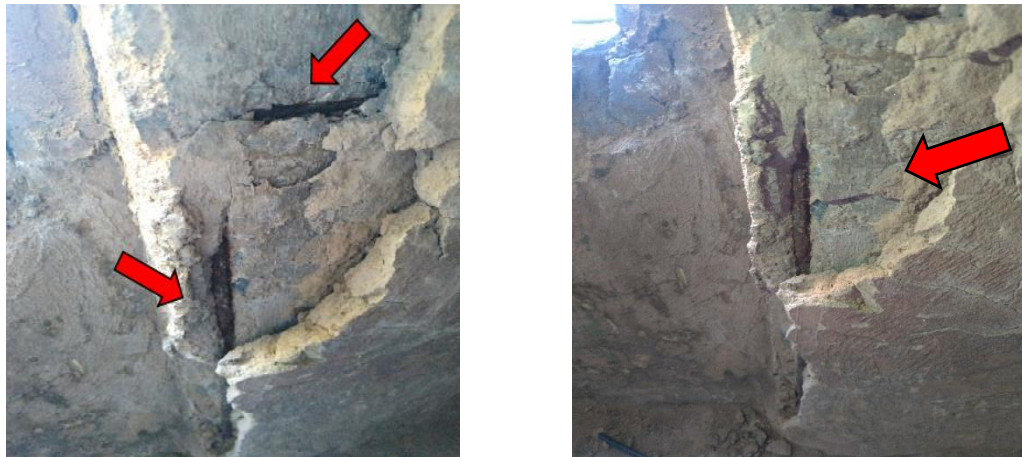
In the column family, only one element, P01, was identified, and it was possible to notice a great exposure of the reinforcements in the process of corrosion, identifying stains along the reinforcements and detachment of the concrete due to the expansion of the reinforcement, as can be seen in Figure 1.

Figure 1. Detachment of concrete and corrosion of reinforcement in element P01

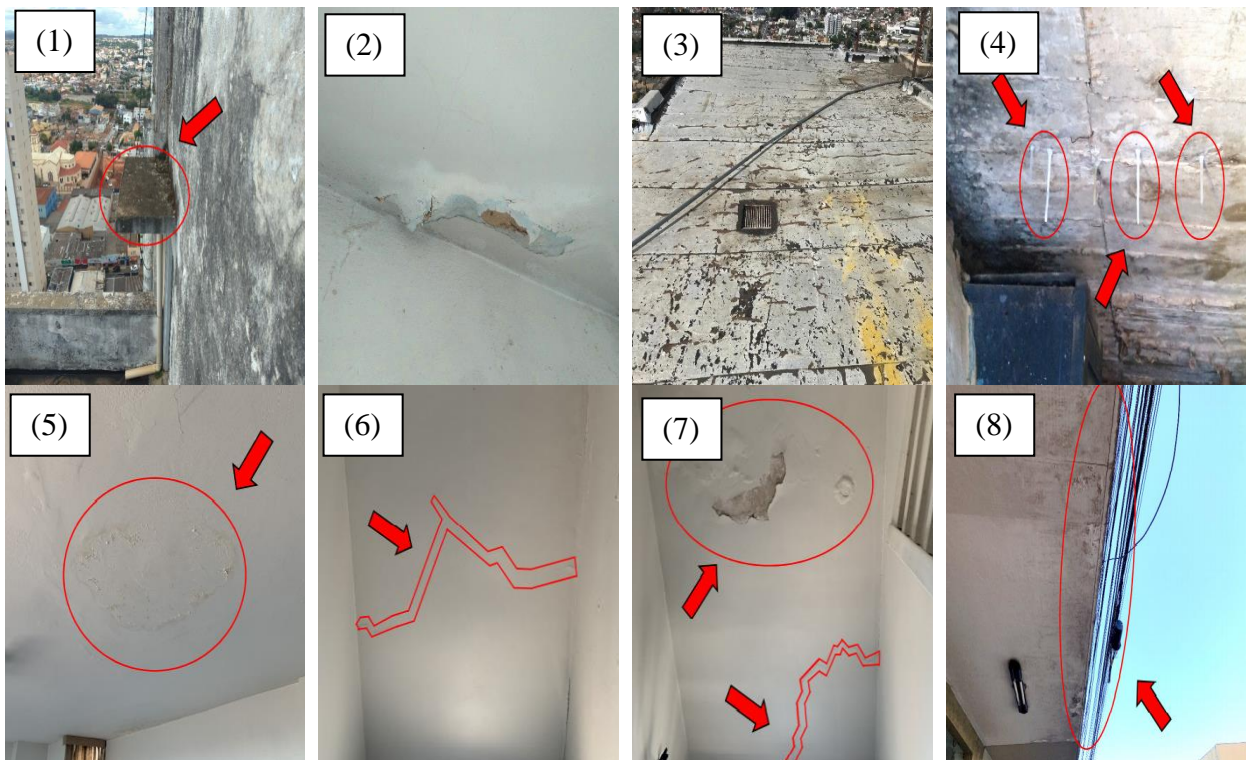
In the slabs family, elements L01 to L08 were identified, as shown in Figure 2, in which stands out the constant presence of moisture, generating dark spots in element L01, detachment of the paint in element L02, formation of calcium carbonate stalactites, due to efflorescence in element L04, small stains and cracks in elements L05 and L08 and wear of waterproofing in element L03. There are also cracks in elements L06 and L07 due to additional loads applied by a telephone antenna over the roof.

Figure 2. Pathological manifestations identified in the slabs. (1) Dark spots on element L01. (2) Detachment of the ping in element L02. (3) Wear of waterproofing on element L03. (4) Efflorescence with formation of stalactites in element L04. (5) Small moisture spots on the L05 element. (6) and (7) Cracks due to additional loading on the cover, on elements L06 and L07. (8) Dark spots of moisture on element L08.

So, in summary, the building's maintenance priorities are the L07 and L06 slabs, which need an in-depth investigation, to identify if there is a need for reinforcement to resist the additional loading and in addition to the recovery of their cracks in order not to the situation worsens.

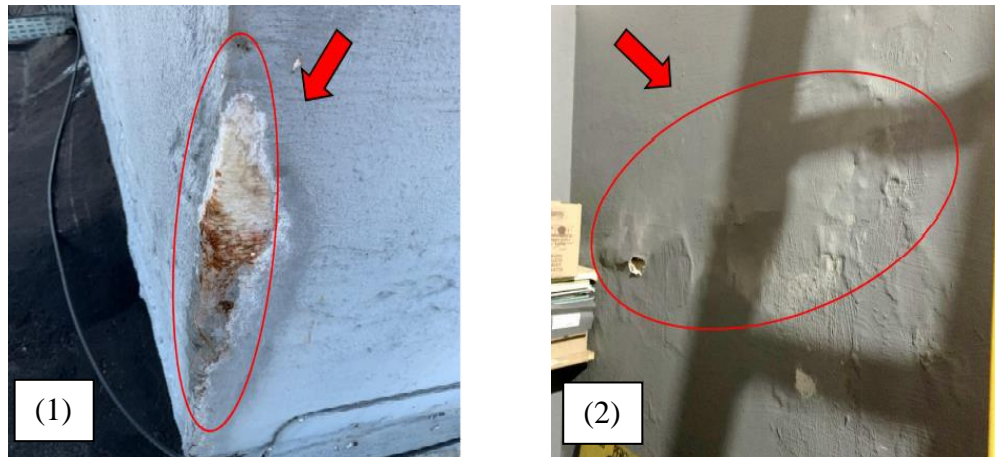
The upper reservoir family and the lower reservoir family showed possible flaws in their waterproofing, identified by the characteristic appearance of light efflorescence stains on elements R01 and R02.

Figure 3. Efflorescence spots in the reservoir. (1) R01. (2) R02.

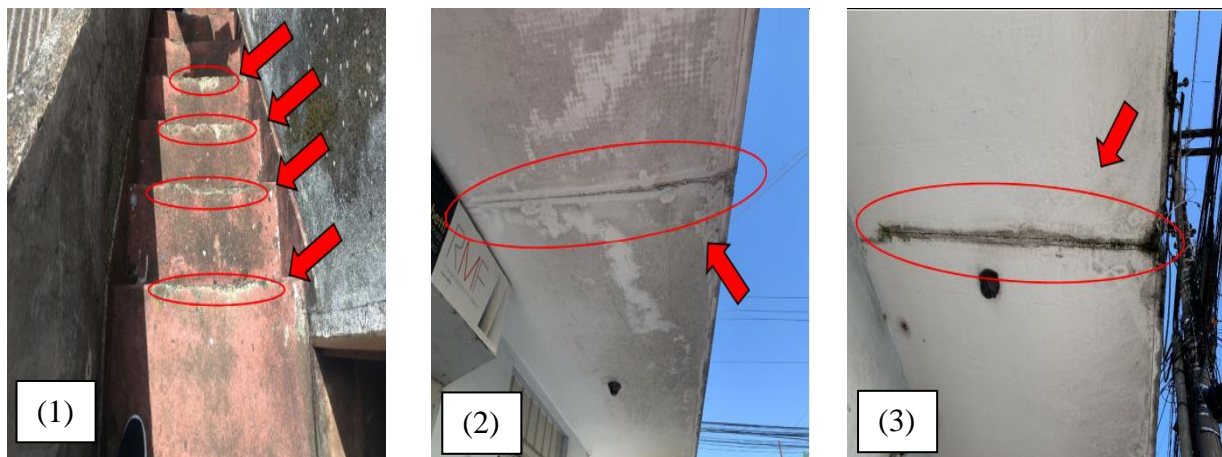
The elements of the family of stairs and expansion joints were E01 for the stairs and J01 and J02 for the expansion joints, as can be seen in Figure 4. In it, it is noted that the element E01 showed only wear on its steps due to the weather over the years and in elements J01 and J02, the constant presence of humidity resulted in the dark spots identified.

Figure 4. Efflorescence spots in the reservoir. (1) Wear of stair treads on element E01. (2) and (3) Stains due to humidity in elements J01 and J02.

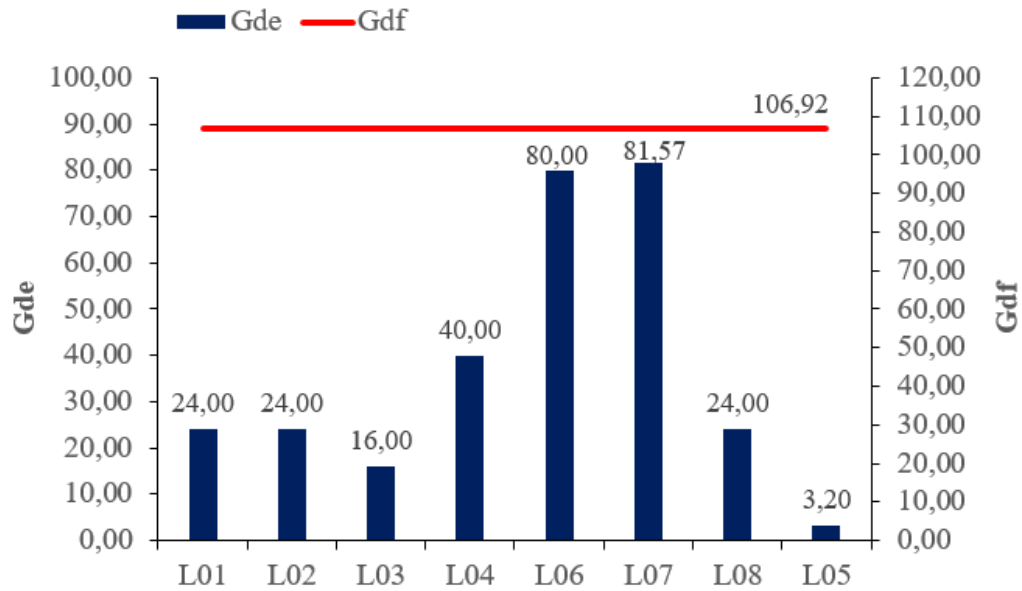
Figure 7. Degree of deterioration of the slabs.

Regarding the GDE/UnB (2007) methodology, it is possible to raise some analysis based on the graphic model used by Medeiros et al. (2020). In the slab family, elements L06 and L07 are the ones that most influence the calculation of the degree of deterioration of the family, as can be seen in figure 7. In addition, it is worth noting that element L05 is not taken into account for the G_{df} calculation for presenting G_{de} less than 15.

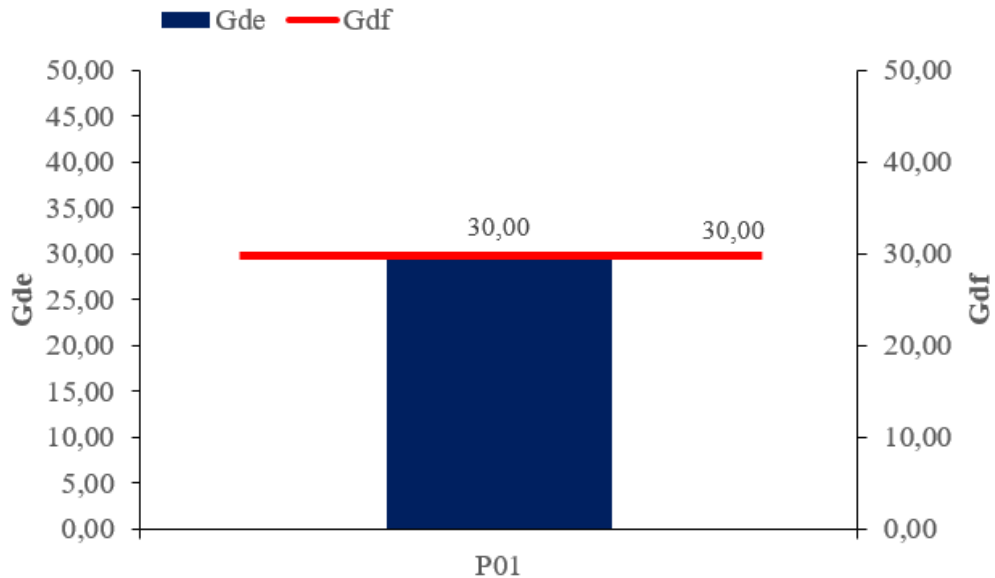
Figure 8. Degree of deterioration of the pillars.

The beam families have a null degree of deterioration, as no pathological manifestation was identified in the elements that compose them, in the family of stairs, the only identified element has G_{de} less than 15. Thus, for both, G_{df} equal to zero was calculated. As for the families of columns and upper and lower reservoirs, it is observed that they are composed of only one element, so the value of the degree of deterioration of the family corresponds to the value of the degree of deterioration of the element itself, this can be seen, respectively, in figures 8, 9 and 10.

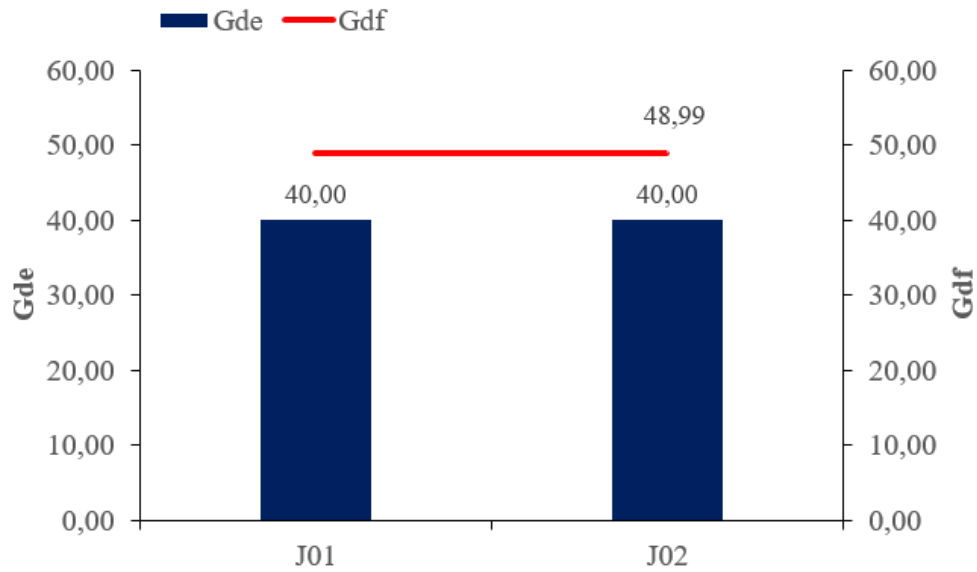
Figure 11. Degree of deterioration of expansion joints.

In addition, in the expansion joints, the presence of two elements that present the same degree of deterioration was found, but the degree of deterioration of the family is higher than the value obtained for the elements individually. Thus, by the mathematical formulations, it is possible to observe that the influence of the repetition of elements that have the same degree of deterioration does not represent such a significant increase since it has the maximum value as a reference, this value is multiplied by the result of the root that involves the sum and the maximum value. Figure 11 shows the value of G_{df} and the values of G_{de} for each element.

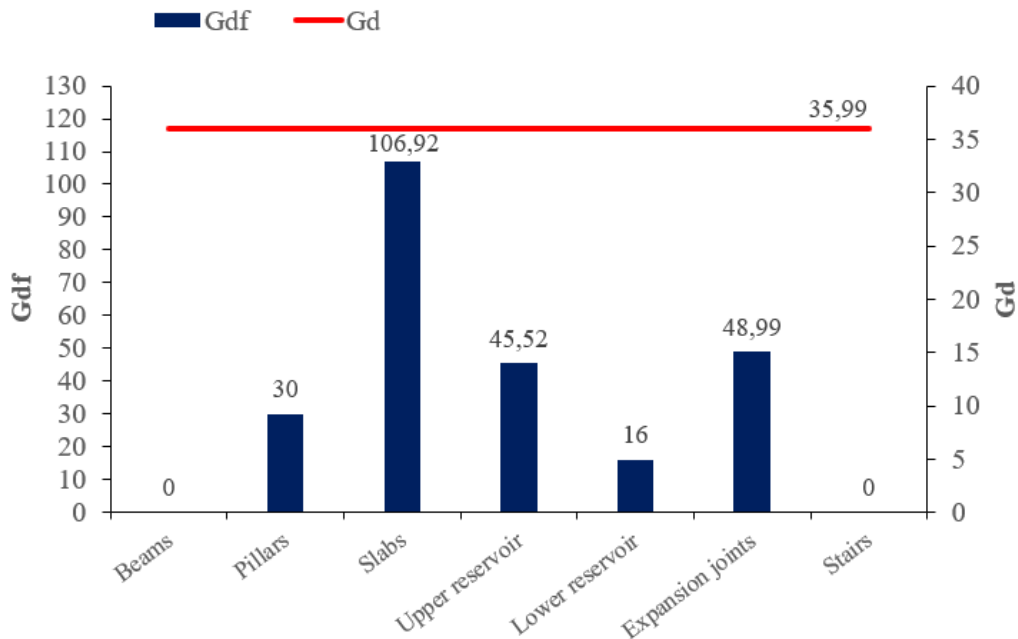
Figure 12. Degree of deterioration of the structure.

Thus, when evaluating the degree of deterioration of the families and the degree of deterioration of the structure, it is noted that the slabs are the ones that represent the greatest influence for the structure to be at an average deterioration level, 15 to 50, and therefore it needs intervention within a maximum period of 2 (two) years. Figure 12 shows the values of G_{df} of each family in comparison to the global value of the structure, G_d .
