Effects of the extremely aggressive atmosphere on structures and equipment of offshore platforms undergoing decommissioning.

DOI: <https://doi.org/10.21041/ra.v15i3.723>

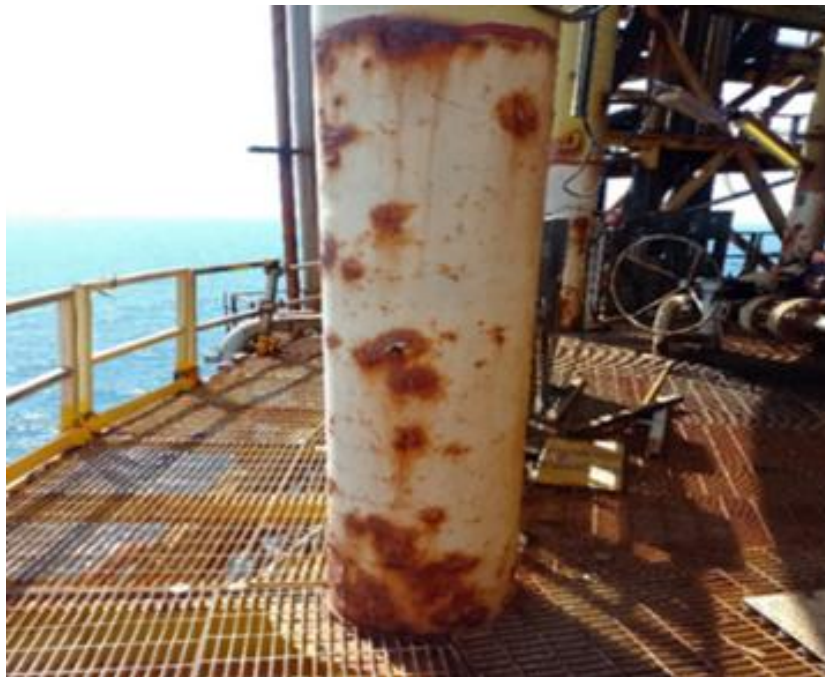
In honeycomb corrosion (Figure 3), the surface is characterized by the formation of cavities with small diameters and great depths, which can lead to holes in the part (Ballesteros et al., 2009).

Figure 3. Alveolar corrosion.

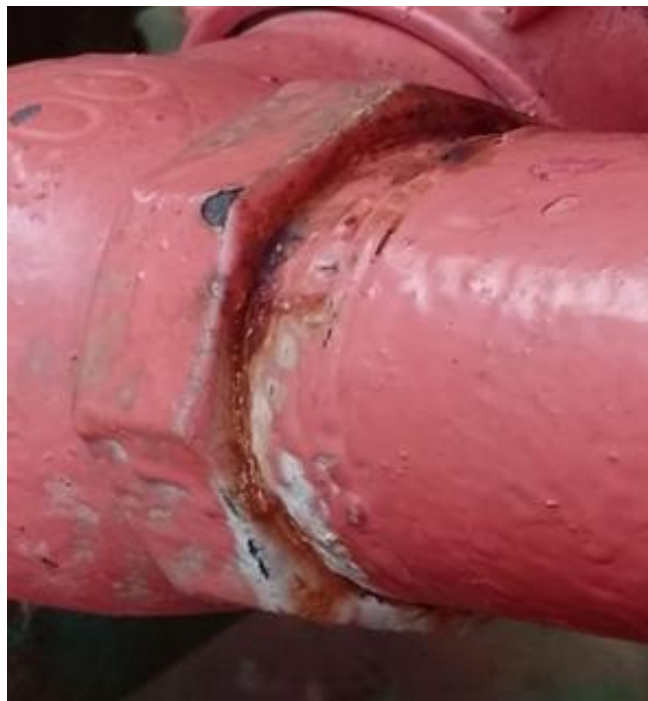
When material degradation begins in crevices, a concentration pile is formed, similar to the galvanic corrosion process. In this case, there is a difference in the concentration of ions or gases dissolved in the electrolytic solution between two regions of the same metal part, with deterioration in the region where there is a lower concentration of ions or dissolved gases (Callister & Rethwisch, 2020). Gaps are opening a thousandth of a centimeter (01) thick that are conducive to the entry and stagnation of electrolyte. Stagnation occurs between the openings in the metal part, which also serves as a deposit for dirt or corrosion products, providing conditions for dissolved oxygen to be exhausted in a localized way, starting the metal oxidation process in that region. This is possible due to the movement of electrons from electrochemical reactions to adjacent regions of the metal, where they will be reduced. Figure 4 shows this process occurring in a threaded connection along a fire-fighting line.

Figure 4. Corrosion in the threaded connection gap of a fire line.

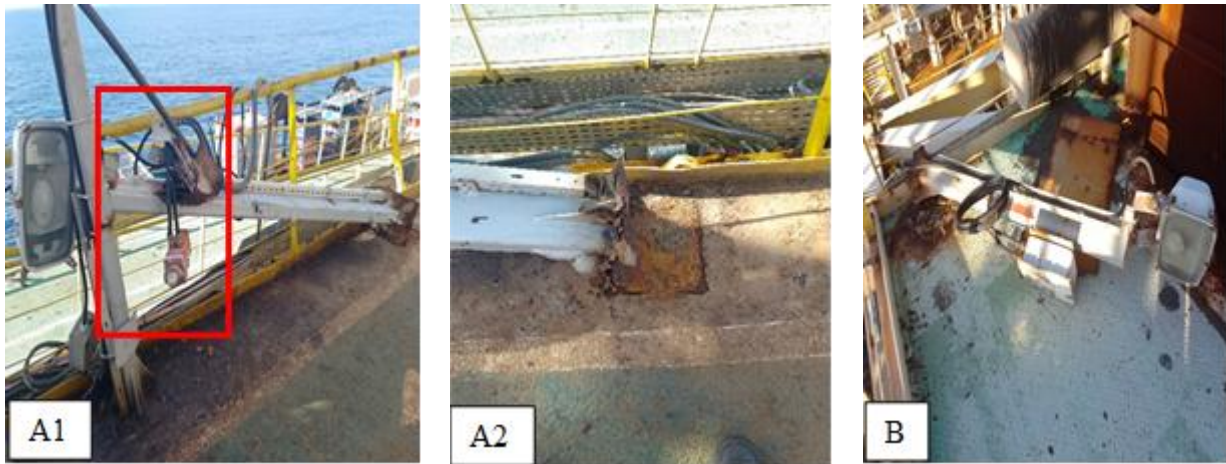
The lighting systems of a unit are designed to ensure good visibility in sheltered areas or at night. To ensure the continuity of the services necessary for decommissioning, they must be kept intact and in good working order, at least until the final destination of the offshore platform, unlike what occurs in Figure 5. In both cases, there was corrosion of the flat plate connected to the structure, base of the metal pole, causing severe loss of mass at the base of the poles (A1 and B), as detailed in “A2.” In addition, in “A1,” in the area highlighted in red, there is evidence of severe corrosion at the connection between the equipment support and the metal pole.

Figure 5. Collapses due to corrosion of the base of metal lighting poles.

Given its importance for the continuity of activities, in order to recover the structure, the areas affected by corrosion (including the floor) must be cleaned by mechanical treatment (using a pneumatic descender, commonly known as a pneumatic needle scaler, or sander), replacement of the flat plates at the base, and painting. It is important that the weld beads on the base are finished in such a way as to prevent the accumulation of electrolyte and solids.

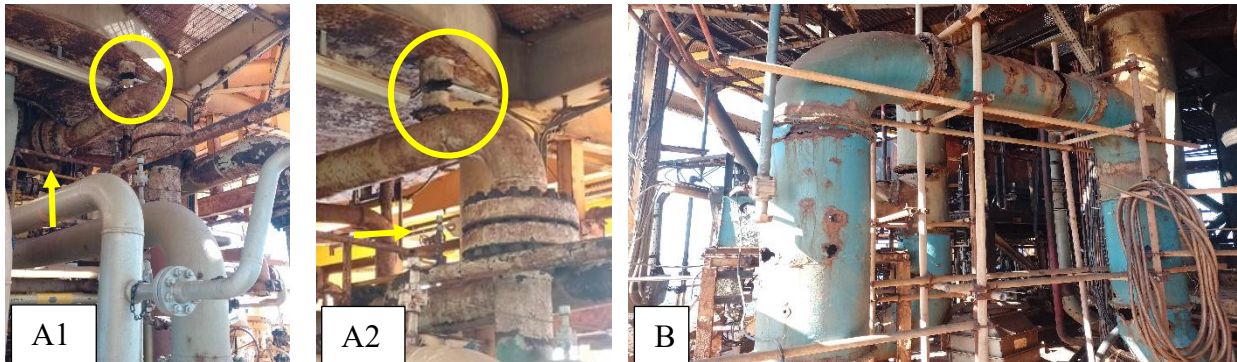
Below, Figure 6, in the riser receiving area, which is located near the physical boundaries of the offshore unit, “A” shows the corrosion-induced weakening of the cylindrical support of a decommissioned oil line, causing it to rupture and forcing the flanges (details A1 and A2) to support the section of the line. In “B,” the damage was more significant in the regions of the spool weld bead, which tend to accumulate dirt and electrolyte, completely compromising the line's load-bearing capacity, which needed to be shored up with tubular profiles. Considering that in both cases there is no interest in recovering the structure, which has already been decommissioned, the risk of structural collapse can be mitigated by cutting and removing it.

Figure 6. Damage to lines and accessories.

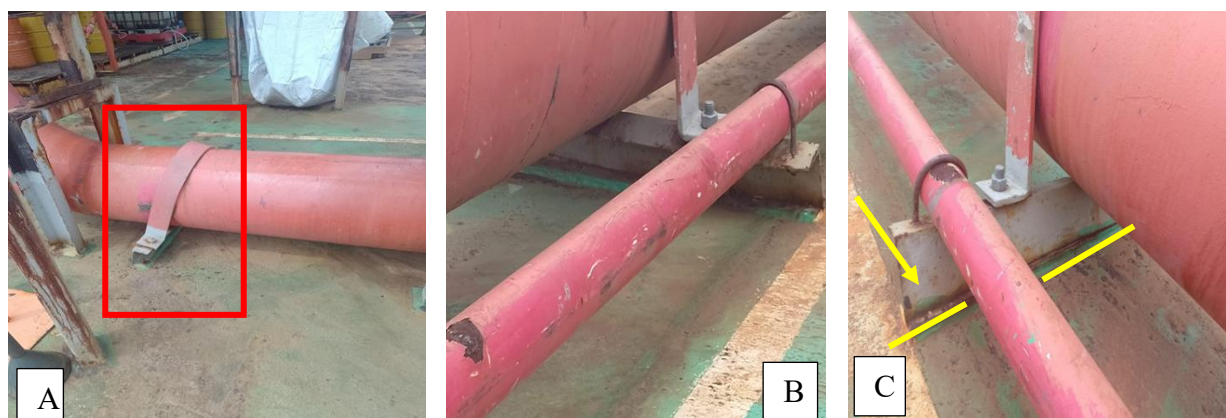
The fire ring, Figure 7, is responsible for the forced flow of water to fight fires in fixed systems, such as deluge, hydrants, manual and automatic cannons. In the section of the fire ring on the main deck of the marine unit, near the side of the platform, lateral buckling and twisting of the “U” profile (records B and C) occurred, which supports the lower generatrix of the section. Although the profile is painted, corrosion is noticeable in the bending region of the flange (record B) welded to the vessel's floor, where there is a concentration of stresses. In the detail shown in “C,” a crack area can be seen in the metal profile, with the rupture occurring at the right end of the “U” profile.

Figure 7. Deformation and crack in metal profile.

To avoid overloading the support by redistributing loads, precisely in the displacement of the section of the line that results in increased stress, the failed structural element can be replaced by another non-metallic support, fixed with epoxy resin, for example.

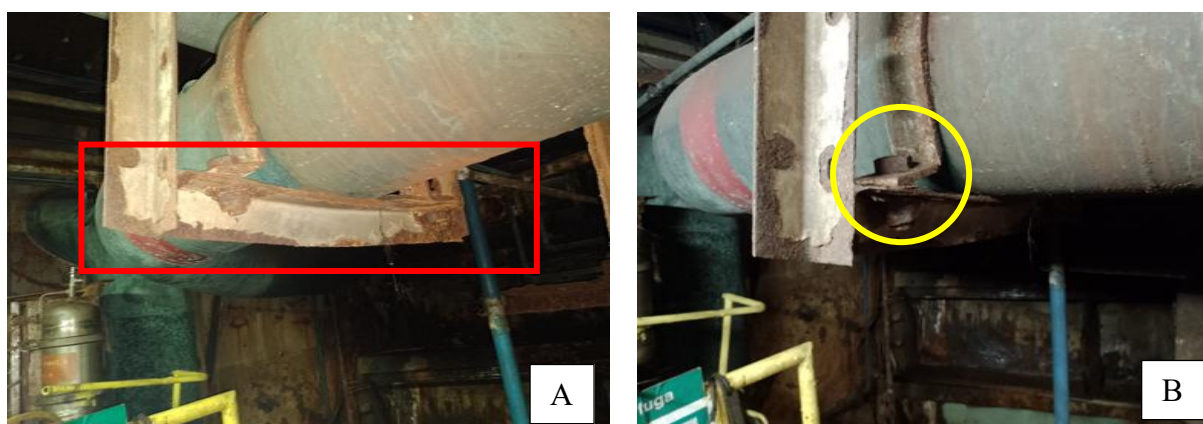
In the section of the fire ring inside the engine room—an area subject to fungicidal gas emissions (CO , CO_2 , and H_2) from equipment, high temperatures, and humidity—although damage has not yet occurred in registers ‘A’ and ‘B’ in Figure 8, the deformation of the angle iron that supports part of the fire ring section imposes bending stress on the bolt connecting the clamp and angle iron, where the greatest amount of mass loss is observed on the flange in contact with the lower generatrix of the piping. It is important to note that the actions to which the structure is subject are not only due to the weight of the ring section and the water column inside: the forces generated by the transfer of fluid mass and vibrations transmitted by the operation of the fire pumps when the system starts up must also be considered.

Figure 8. Screw bending and deformation of the angle bracket supporting the spool.

Given the possibility that the plastic patella of the angle iron supporting the detached section of the ring has already formed and the loss of mass has been verified, it is feasible to shore up or suspend the spool using hoists so that the lower angle iron can be replaced. The vertical angle brackets and clamp must be mechanically treated with a pneumatic needle scaler or sander and painted for corrosion protection, as well as the new one to be installed. The connection bolts need to be replaced and a strip of polymeric material must be applied to the inside of the clamp, as well as to the flange of the angle bracket that is in contact with the lower generatrix of the spool.

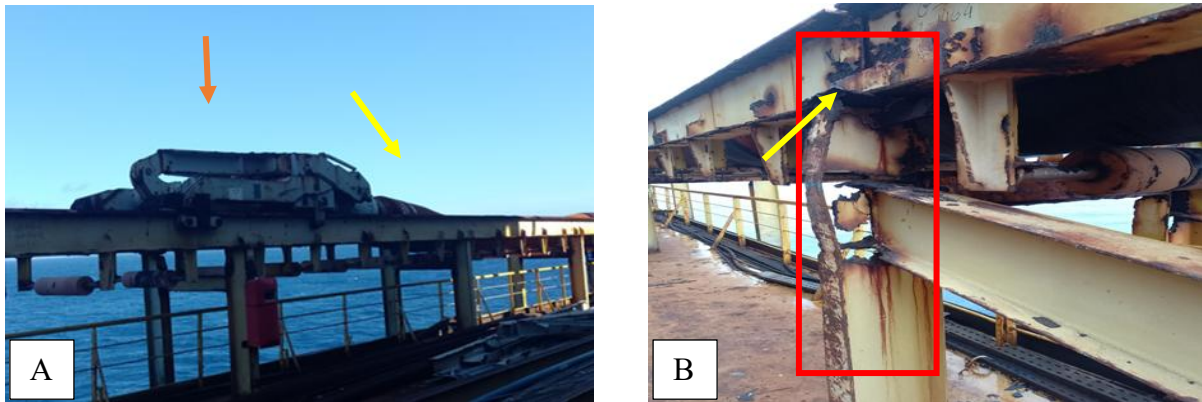
Closing the topic on deformations, Figure 9 shows the conveyor belt of an offloading line, responsible for its accommodation and transfer, loaded with its own weight, the weight of the trolley (A1, orange arrow) and the weight of the offloading hose, indicated by the yellow arrows at ‘A’ and ‘B’. The structure shows signs of corrosion along its entire length, with the section indicated at B showing the most severe damage. This is because the concentrated load, together

with the loss of mass due to excessive proximity to the support region, favoured the phenomenon of crippling of the structure, which can be interpreted as a localised failure caused by the ‘crushing’ of the web.

Figure 9. Crippling in the conveyor belt column of an offloading line.

In this case, the decommissioning of the offshore unit is in the stage of cleaning, inspection and repair of the cargo tanks, when necessary. In view of this, offloading operations have been suspended. Therefore, considering the reduction in available manpower and the expectations for removal of the platform from the location, it is recommended to remove the offloading hose, conveyor rollers and trolley, in order to reduce the load on the structure. As for the clipping of the structure, the section of the conveyor belt from the downstream column to the upstream column can be removed, considering the failed column as a reference, reducing the consumption of man-hours worked for the planning and execution of the activity.

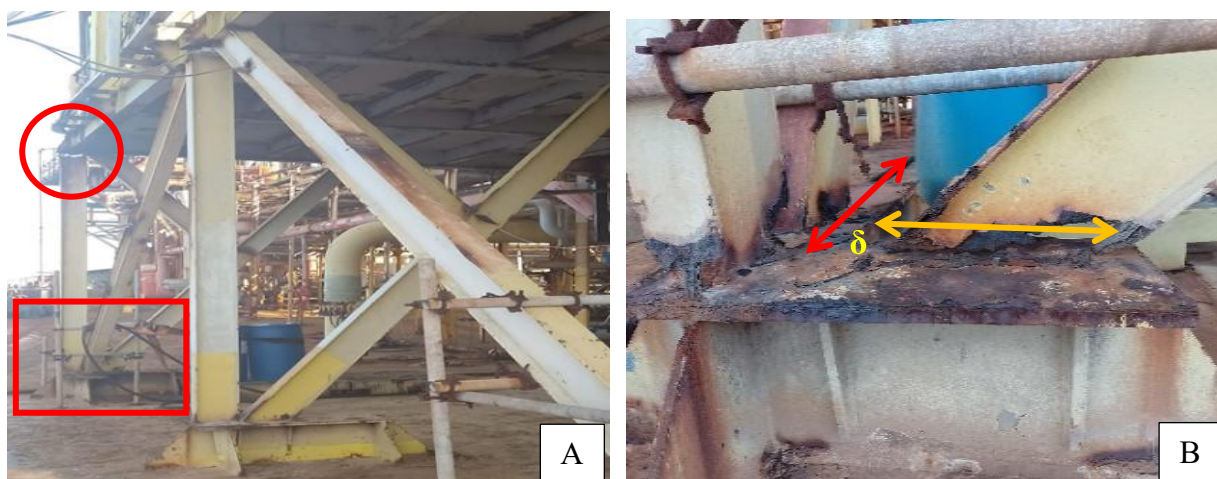
Connections in metal structures are areas that deserve close attention in extremely aggressive environments. These are areas that, when designed abnormally, i.e., without finishing or openings that prevent the accumulation of solids and water in crevices, are prime locations for corrosion to occur. In Figure 10, the truss structure receives loads from part of the floor of a production module and equipment on it. In the first detail highlighted, A, the top of the vertical bar, unlike the original configuration, remains restricted to vertical displacement only. In ‘B’, the node at the base of the structure highlighted, the loss of mass due to the advanced corrosion process resulted in the loss of the bond at the lower end of the diagonal, allowing the displacements proposed by the arrows drawn in ‘B’. To mitigate the problem, tubular profiles were used to prevent displacements in the structure.

Figure 10. Degradation of welded connections and changes in structural bonds.

In order to prevent the overall collapse of the structure, it is necessary to carry out the service design for: cutting the segments with mass loss; mechanical treatment of the top base region and other necessary points; replacement and welding of the removed segments, paying attention to the weld bead finishes that favour water drainage; painting and application of hydrophobic coating on the truss nodes.

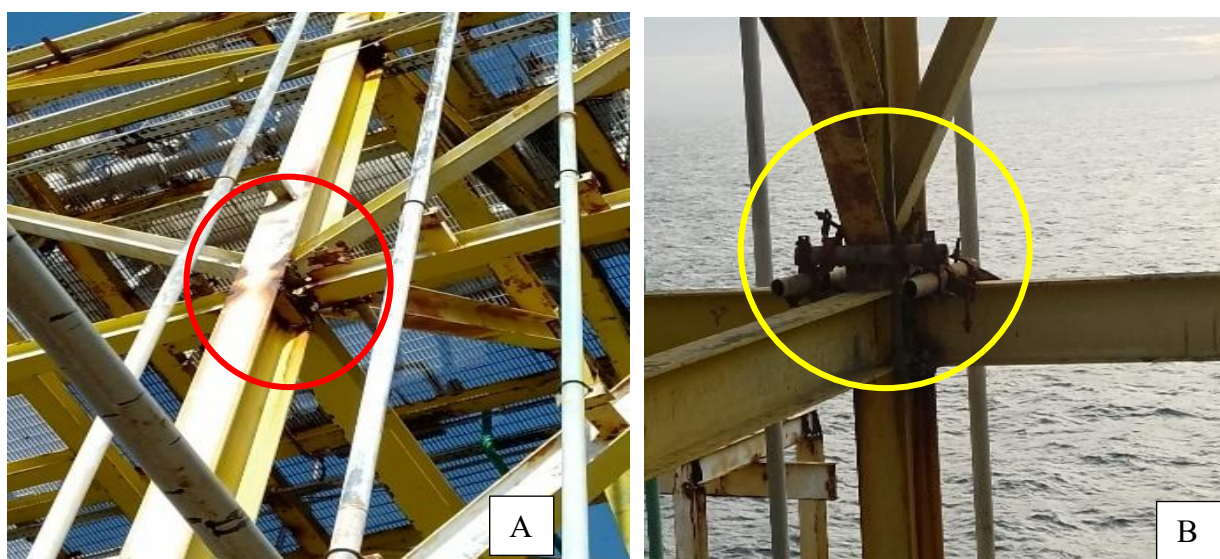
Similar to what occurred in Figure 10, the space truss located in the middle of the offshore platform, Figure 11, upper deck, shows almost total degradation of the node at a high height of the space truss, formed by welded profiles. One of the functions of this structure, formed by welded H-profiles, is to receive the loads transmitted by equipment on the grating floors. In this case, tubular profiles were also installed to prevent the node from shifting. To eliminate the risk of global collapse of the structure and the possibility of damage to people and equipment, as well as to the environment, the same process suggested in Figure 10 can be applied.

Figure 11. Local failure in the spatial truss node due to excessive mass loss caused by corrosion. Figure 1.

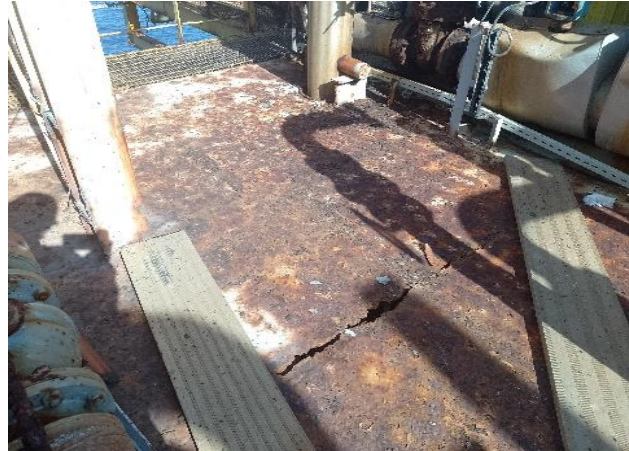
The plates used for floors on decommissioned platforms are also subject to corrosion, as shown in Figure 12. As a palliative solution, loose metal plates were placed on the floor, which does nothing to prevent the advance of widespread corrosion and loss of mass, responsible for the opening of cracks in the module floor plate. This situation can become a real trap for users, who, unaware of the extent of the damage to the structure, will have their perception of risk reduced due to the false sense of security conveyed. Therefore, it is essential to assess the extent of the damage caused by

Figure 12. Effects of corrosion on metal floors and beams.

generalized corrosion, removing and replacing areas with significant loss of mechanical strength, in addition to performing mechanical treatment and painting. It should be noted that covering the module floor with aluminum sheets without performing the appropriate treatment will make it difficult to visualize the progress of the corrosive process and, consequently, to satisfactorily assess the structural safety of the floor and structures connected to it.

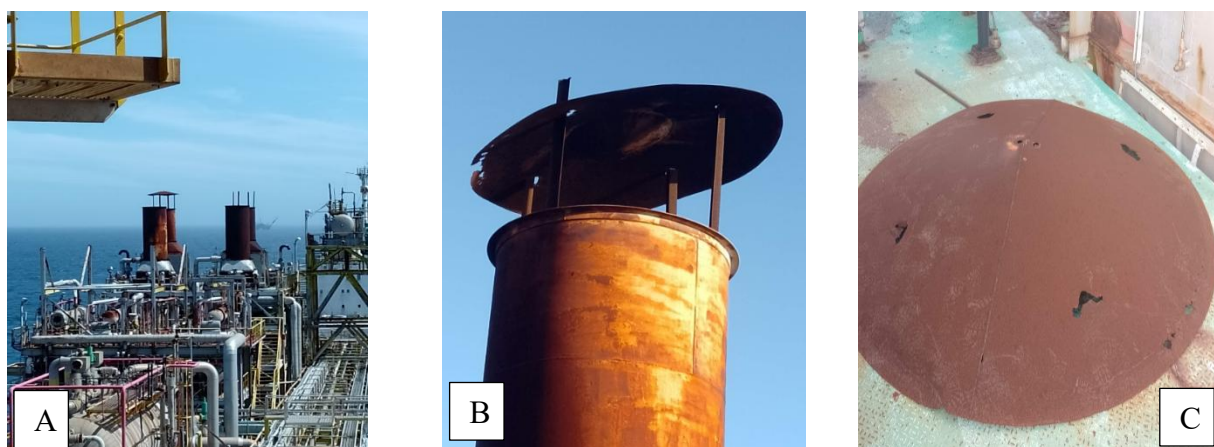
Some damage to metal structures occurs outside the field of vision of facility users, as they are in places that are difficult to access or at high altitudes, such as the case of the “witch's hat” over the hot gas discharge opening of an offshore turbomachine, as shown in Figure 14. In this case, the heated gases produced by the combustion of fossil fuel in the turbo compressor triggered the process of hot corrosion in the equipment's exhaust, producing widespread corrosion and reducing the mechanical strength of the material. The consequence of this was a puncture in the shell (B), which had to be removed (C) so that wind loads would not blow it onto people and equipment on the oil platform.

Figure 14. Puncture in metal shell.

Although the assessment of the integrity of elements such as the “witch's hat” is hampered by its location, it is possible to use drones with cameras to view and assess damage to structures such as this.
