## Pathological manifestations in a prestressed concrete flat slab building - a case study: part I - structure analysis.

The purpose of this study was to present a case study of a commercial building constructed with prestressed flat slabs with unbonded tendons and edge beams. During construction, grave pathological manifestations occurred with excessive deflection arrows, fissuring and partial rupturing. This Part I of the study presented descriptions of the pathological manifestations, structural analysis and a brief discussion of proposed reinforcement solutions to the structure.

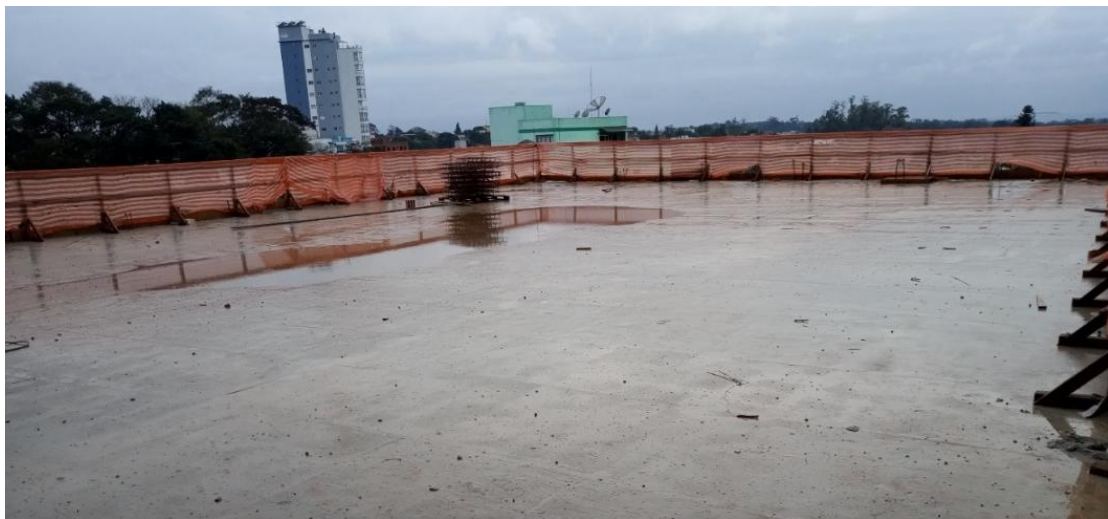
During construction, pathological manifestations such as excessive deflection arrows, fissures on the slabs, columns and beams and localized ruptures were observed. Figure 4 shows the auditorium cover slab (2<sup>nd</sup> floor slab) with visible rainwater accumulation. Excessive deformations were noticed on this slab once temporary bracing was removed. The survey determined a deflection arrow of 14 cm at the center of the slab with an unsupported span of 16.45 m. Figure 5 shows the bottom of the slab with temporary bracing restored once the excessive deflections were noted.

Figure 4. Rainwater accumulation on the cover slab of the auditorium

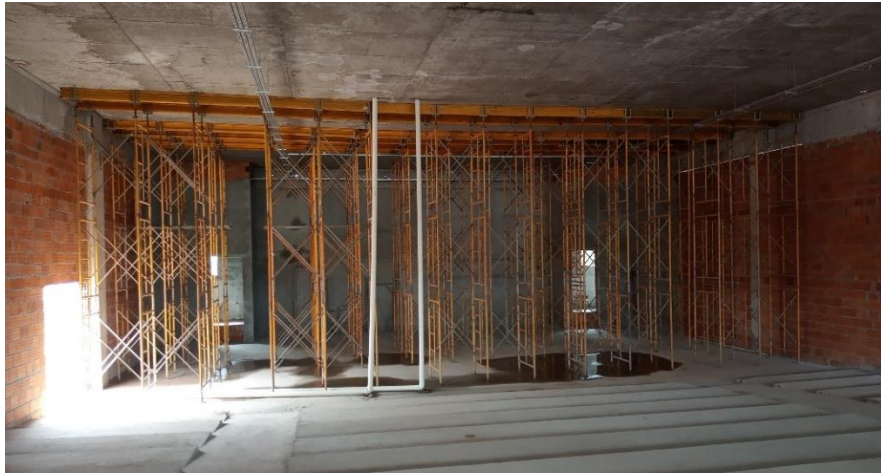
Figure 5. Restored temporary bracing of the cover slab of the auditorium

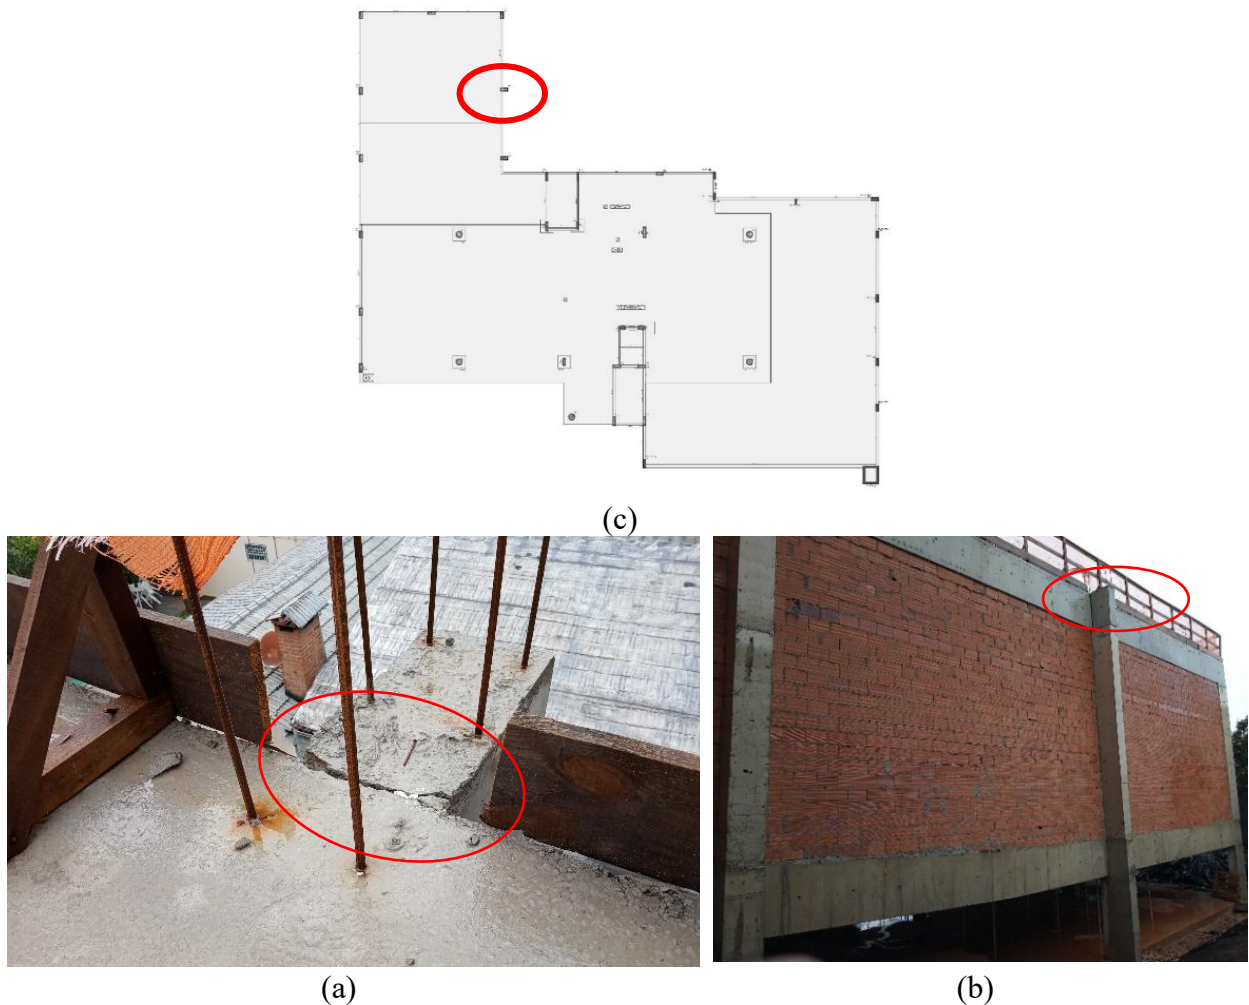
Figure 6 shows that, at the stage side of the auditorium, shifts of the 2<sup>nd</sup> floor slab and beams induced a rupture in the beam-column joint. It was likely that the excessive deflection arrow of the auditorium cover slab produced a retraction of the edge beam from the support column. This unpredicted horizontal load then caused the rupture of the beam-column joint.

Figure 6. (a) Localized rupture at the beam-column joint; (b) side view of the column with ruptured joint and (c) floor plan location where rupture occurred.

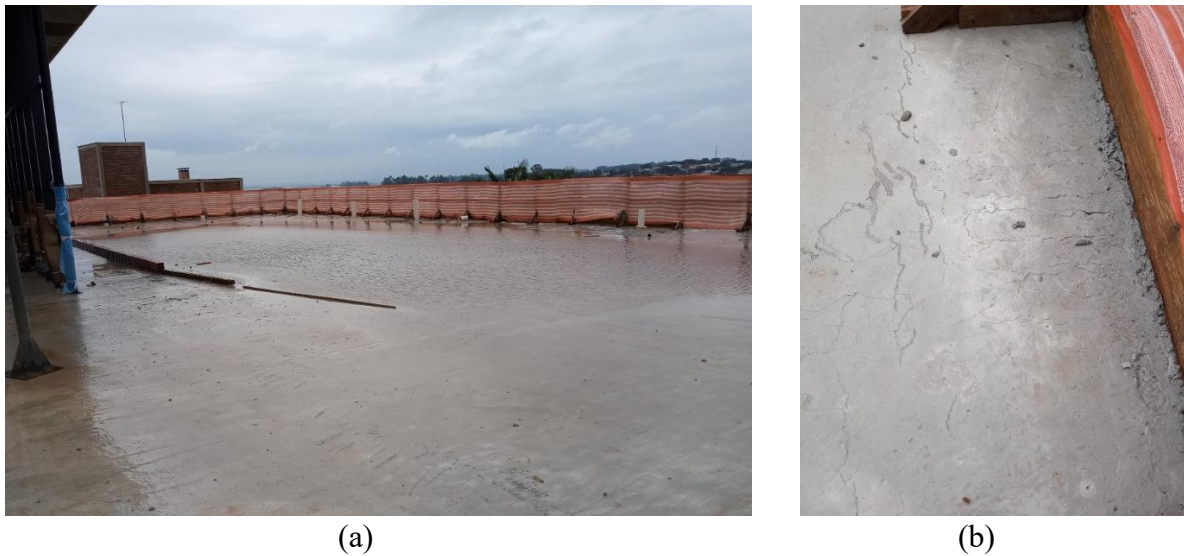
Figure 7 shows that the 2<sup>nd</sup> floor slab covering the reception area also presented water accumulation and had excessive deflection arrows measured in the order of 10 cm. Intense fissuring was also found on the top and bottom surfaces at the center of the span and along the edge beams. Curling and fissuring were also observed at the edges of the slab where the tendons were anchored.

Figure 7. Water accumulation on the cover slab over the reception area; (b) curling and fissuring at the edge of the slab near the columns and anchoring points.

The pathological manifestations of Figures 7 and 8 were most likely brought about by the same factors: lack of rigidity in the prestressed slab producing excessive deformation which resulted in twists and plastic behavior at the edges. Along the unsupported span, the excessive deformation produced large fissures surveyed on the top and bottom of the slab. At the edges of the slab, fissures were found to be parallel to the edge beams.

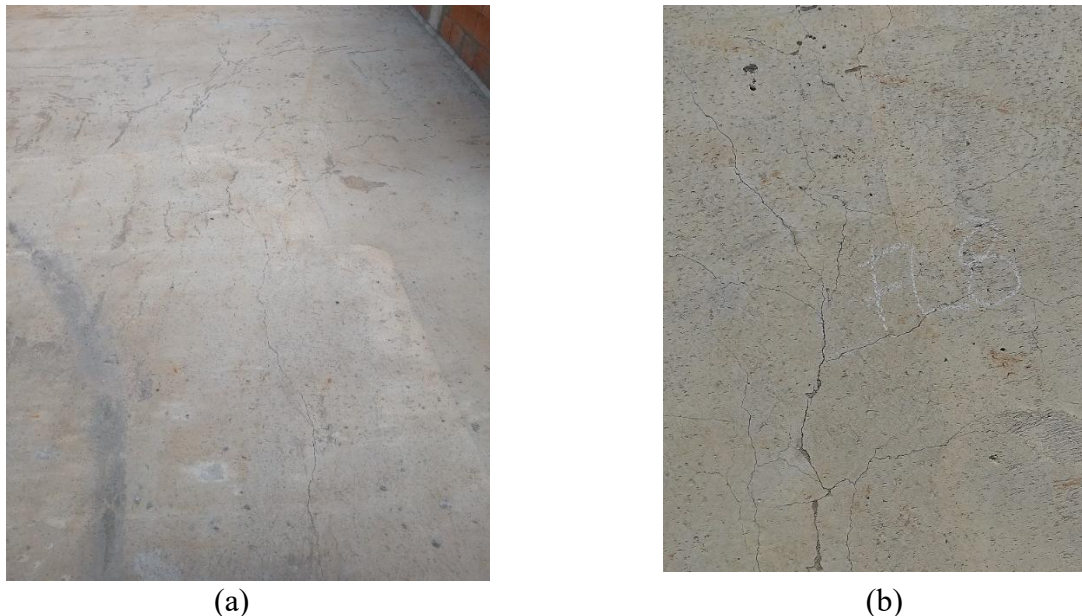
Intense fissuring was also observed on the cover slab over the 3<sup>rd</sup> floor as shown in Figure 8. These manifestations were noted mostly over the columns.

Figure 8. (a) Fissures on the 3<sup>rd</sup> floor cover slab; (b) surveyed fissure.

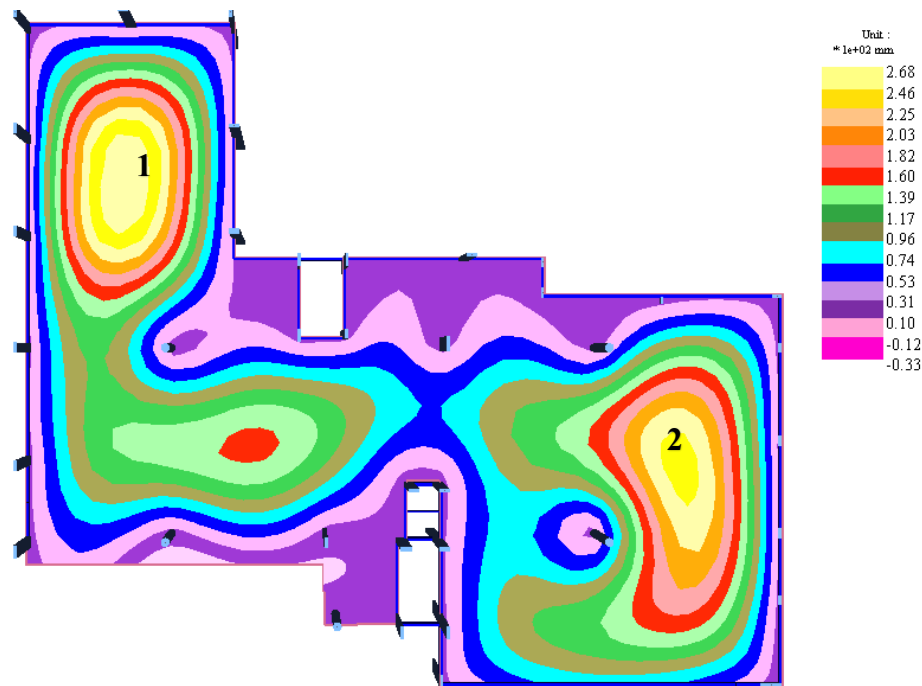
Figure 9. Contours of vertical deflection over time on the 2nd floor slab (values in  $\times 10^{-2}$  mm)

Figure 9 shows that region 1, which corresponded to the cover over the auditorium and had an unsupported span of 16.45 m, had a maximum deflection arrow over time of 26.8 cm. Standard NBR 6118 (ABNT, 2014) set the acceptable limit for visible deflections as a ratio equal to span/250, which in this case would result in a deflection of 6.58 cm. Thus, the analysis denoted a much higher deflection than allowed in the standard and, while the survey measured a deflection of 14 cm at the construction site, this was a result of only the slab's own weight and did not include all additional structural and architectural elements.

Similarly, Figure 9 shows that region 2, which corresponded to the cover over the reception area and had an unsupported span of 14.90 m, had a maximum deflection arrow over time of 26.8 cm. Following the same criteria from standard NBR 6118 (ABNT, 2014), the maximum acceptable visual deflection should have been 5.96 cm. Thus, region 2 presented the same above allowed deflection arrow issues as region 1.

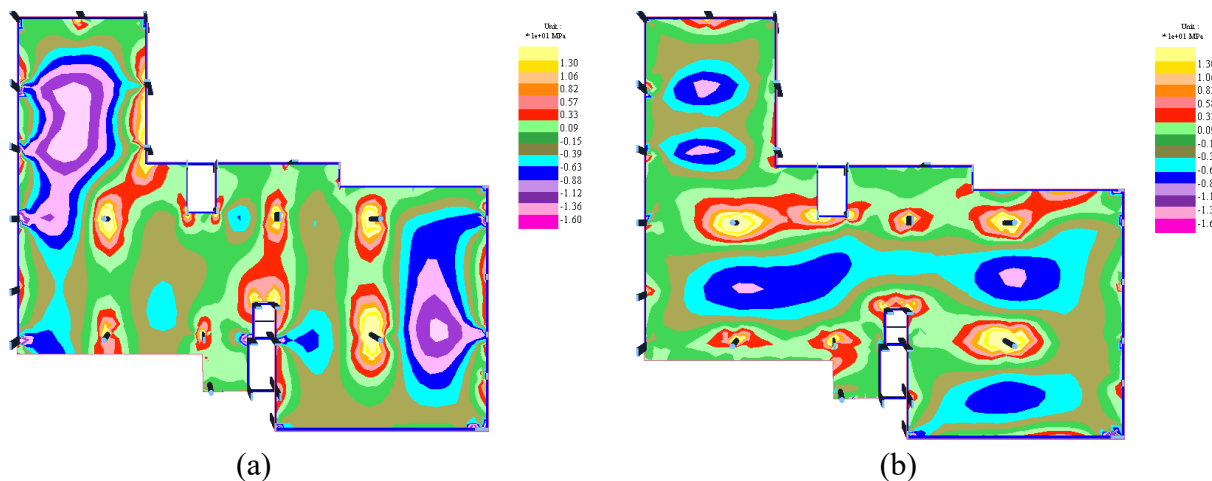
Results of Figure 10 show that the maximum tensile stresses on the top surface of the slab were between 9.0 MPa and 12 MPa around the columns in the right side of area 1 (over the auditorium) and between 8 MPa and 12 MPa in area 2 (over the reception). The location of these high stress values also corresponded to where fissures were found in the survey. Results of Figure 11 show that tensile stresses on the bottom surface of the slab were in the order of 10.0 MPa in area 1 and 8 MPa in area 2. Tensile stresses on the face of edge beams were also found to be in the order of 10 MPa.

Figure 10. Normal stresses ( $\times 10$  MPa) on the top surface of the 2nd floor slab (a) from loads in the x-direction and (b) loads in the y-direction.

Figures 10 and 11 demonstrated that normal stresses in some areas of both top and bottom surface of the slab exceeded the recommended tensile limit of 3.37 MPa and the tensile strength of the concrete. This condition is further confirmed by the fissures observed on both top and bottom surfaces of the slab during the survey. However, with respect to ULS-AP, the maximum tensile

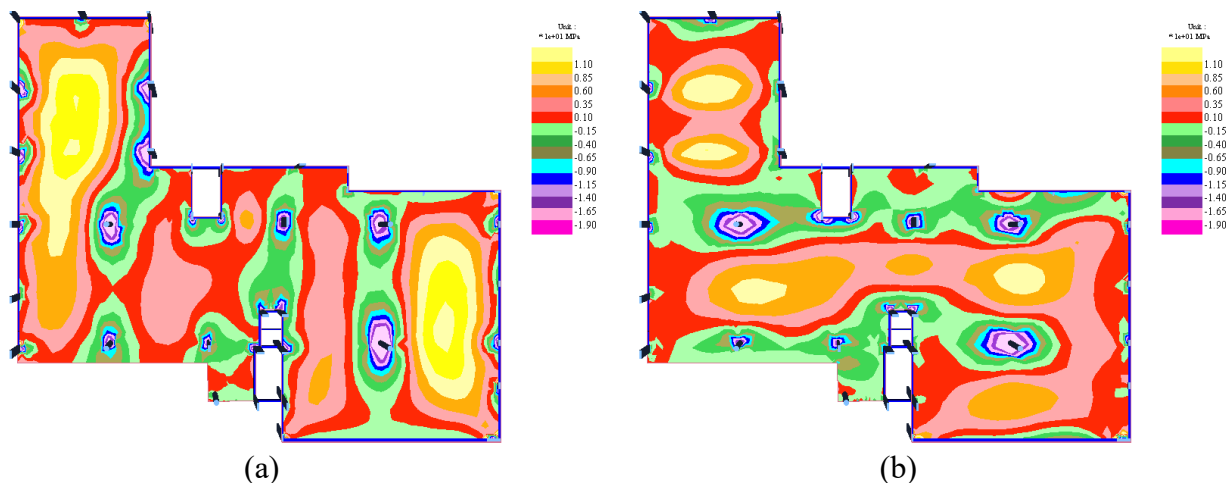
Figure 11. Normal stresses ( $\times 10$  MPa) on the bottom surface of the 2nd floor slab (a) from loads in the x-direction and (b) loads in the y-direction.

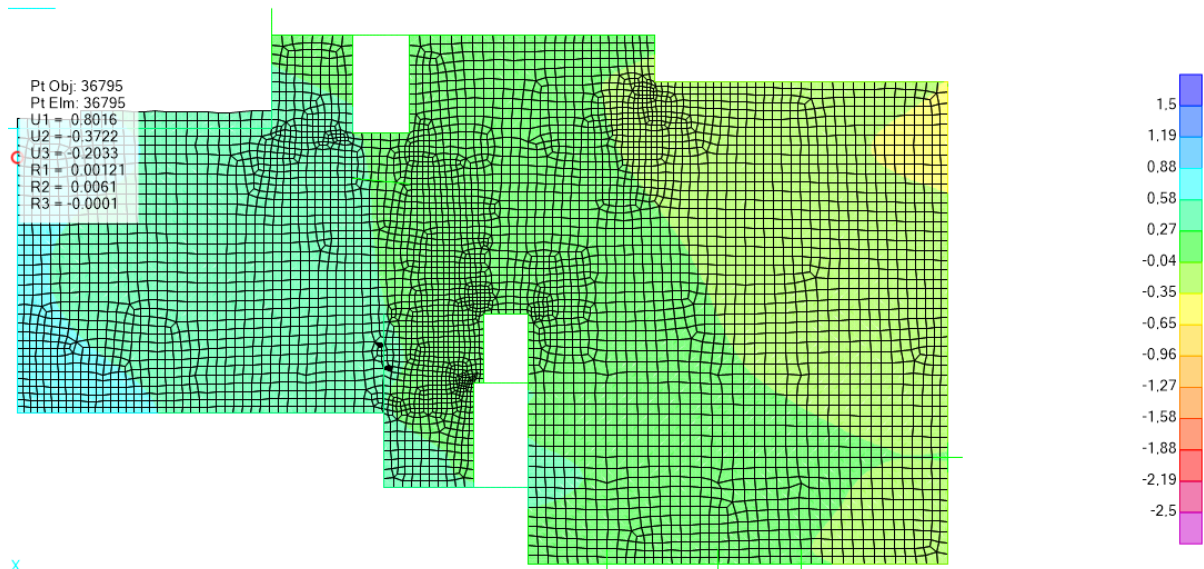
Shrinkage and thermal effects were analyzed with SAP 2000 V18 software. Thermal effects were applied as uniform variations in temperature in increments of  $\pm 15$  °C. Shrinkage was simulated as the slab being subjected to an ambient temperature of  $-30$  °C with a relative humidity of 75% and time  $t_0$  of 60 days as specified in Table 8.2 of standard NBR 6118 (ABNT, 2014). Results determined that on the ground and 2<sup>nd</sup> floor, where the entire length of the structure exceeded 60 m, shrinkage and thermal effects were significant. Figure 12 presents the displacements in the (horizontal) x-direction of the ground floor slab considering the permanent load, prestress and shrinkage in a 1:1:1 additive combination. Under these conditions, the maximum shrinkage calculated in the analysis was 1.4 cm.

Figure 12. Ground floor slab displacements in the (horizontal) x-direction for a combination of loads and shrinkage (units in cm).

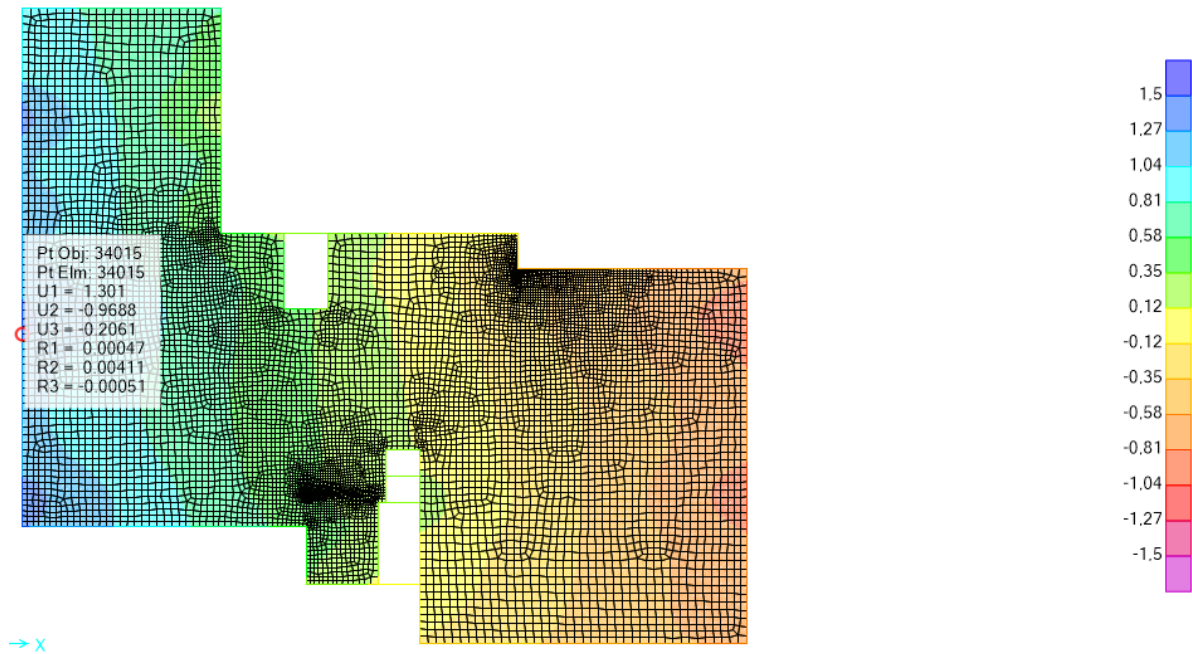
Figure 13 shows the result of the same load combination on the displacement in the (horizontal) x-direction for the 2<sup>nd</sup> floor slab. In this case, the maximum shrinkage was calculated to be up to 1.3 cm.

Figure 13. 2nd floor slab displacements in the (horizontal) x-direction for a combination of loads and shrinkage (units in cm).

Shrinkage tended to produce horizontal loads in the connections between the slab and columns. An analysis of the columns in the underground garage and ground floor determined high transversal loads which, for some columns, were 25 % above the load bearing capacity of the element. Since the survey identified fissures at the top of some of the garage columns, this was likely caused by shrinkage. These columns were repaired and reinforced as shown in Part II of this study.
