Mapping building facades using panoramic images captured by Unmanned Aerial Vehicle (UAV)

This work aims to verify the building pathologies of DTIC's building front (Diretoria de Tecnologia da Informação e Comunicação at Federal University of Pampa – Alegrete/RS, Brazil) by using an Unmanned Aerial Vehicle (UAV). The study was conducted before and six months after its maintenance. Images and inspection records were used to elaborate the Damage Maps and the Grid Method for pathologies quantifications. The comparison of the Damage Maps before and after maintenance has revealed that the intervention (paint) was not efficient, since it has disguised temporarily the anomalies without correcting them. The use of UAV proved to be a good tool for building inspections, providing effective diagnosis, time-saving and security for the operator without working at height.

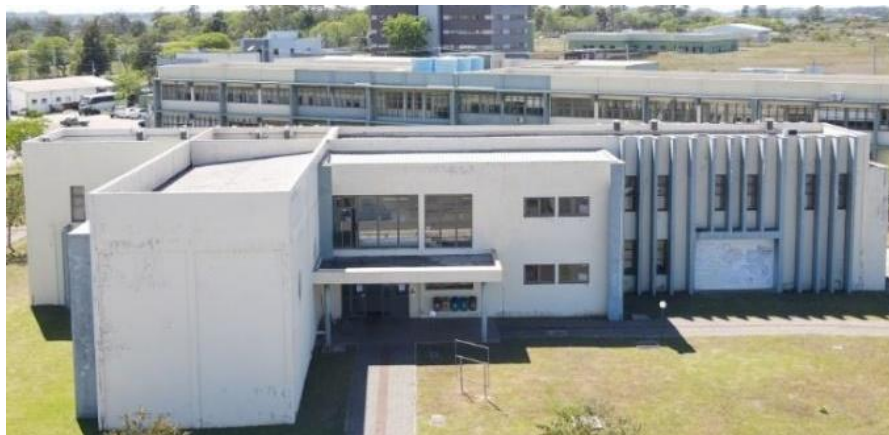
Figure 5. West facade before painting.

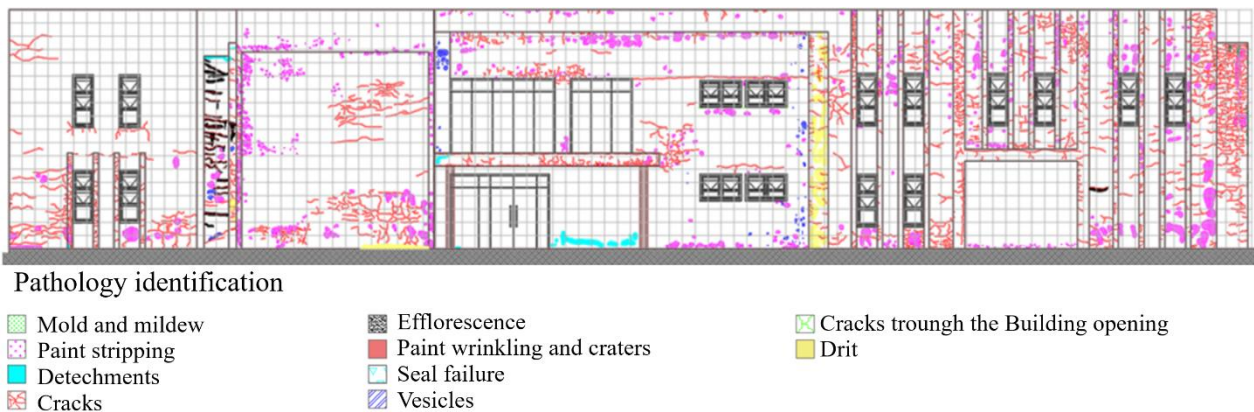
Figure 6. Damage map of the west facade with overlay grid before painting.

Facade: West	Facade area: 429.25 m ²		
Pathological manifestation	Mesh units	Percentage	Damage area (m ²)
Crack	683	40%	170.75
Paint stripping	369	21%	92.25
Vesicles	46	3%	11.50
Efflorescence	27	2%	6.75
Dirt	26	2%	6.50
Detachments	17	1%	4.25
Mold and mildew	14	1%	3.50
Total of damages	7	70%	295.50 m²

From Table 1, it can be seen that crack is presented in a large part of the facade, with an incidence of 40% in relation to the total area inspected. Painting stripping is the second one pathological manifestation most prevalent, representing 21% of the total facade area. Detachments, efflorescence, mold and mildew, vesicles and dirt corresponded to only 9% of the total area of the west facade. Cracks through the building openings, paint wrinkling and craters, and also seal failure were not identified over the west facade. According to the survey carried out and presented in Table 1, the west facade had 70% of its area (295.50 m²) compromised by pathological manifestations.

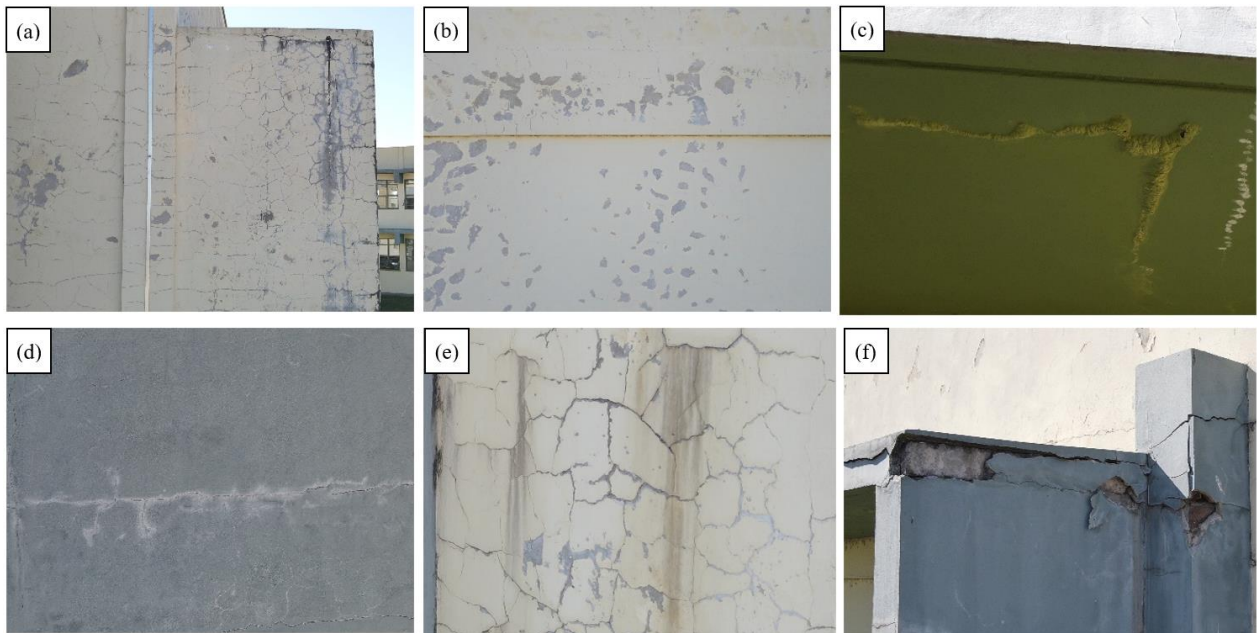
Figure 7. Pathological manifestations on the west facade six months before revitalization: crack and Mold and mildew (a), Paint stripping (b), Vesicles (c), Efflorescence, Dirt (d) and Detachments (e).

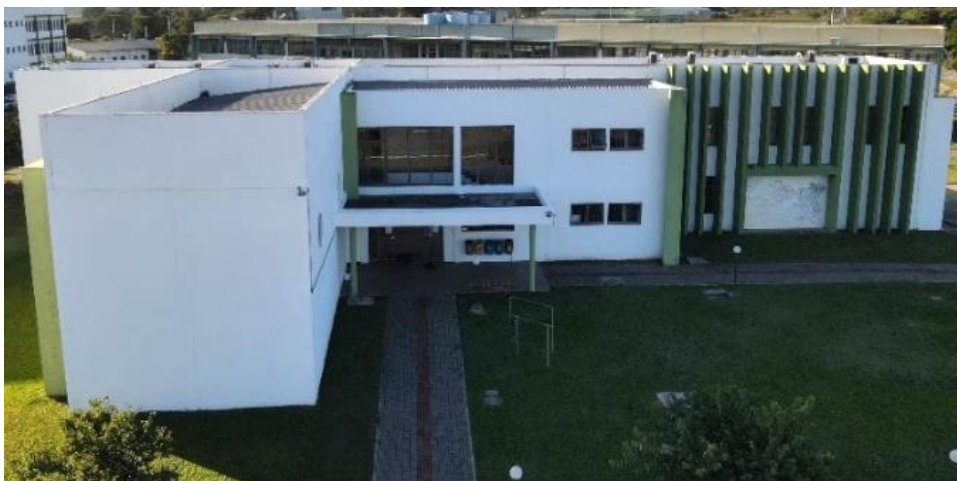
Figure 8. West facade six months after revitalization (painting).

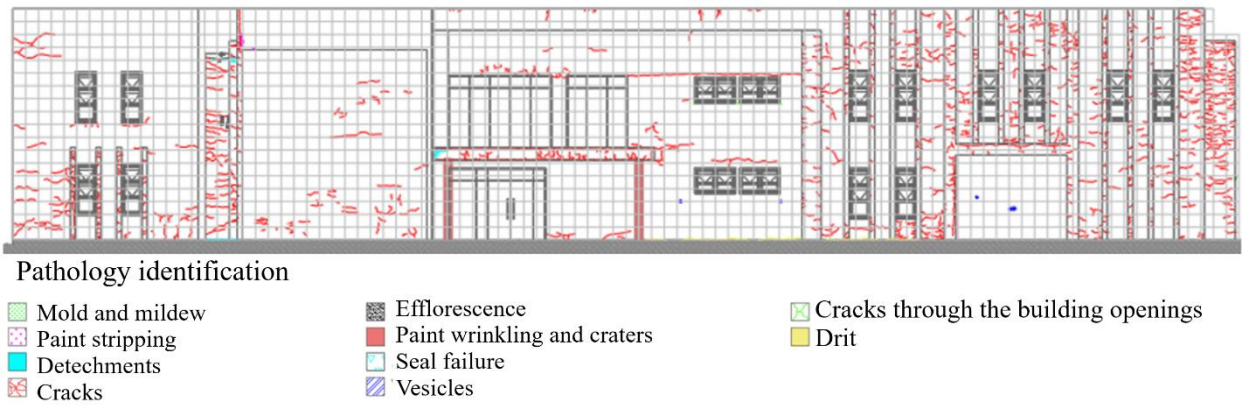
Figure 9. Damage map of the west facade with overlay grid after revitalization.

According to the data in Table 2, the west facade has 158.50 m² (36%) of its area affected by pathological issues six months after its revitalization. Among the observed anomalies, cracks in the coating were the most prevalent, affecting 34% of the total facade area. Additionally, dirt and detachment issues were observed, representing 1% of the total facade area. Anomalies such as peeling, vesicles, and efflorescence were identified but were considered insignificant and therefore disregarded. There were no signs of mold and mildew, cracks around openings, wrinkling, craters, or sealing failures six months post-revitalization. Figure 10 illustrate some pathological manifestations on west facade after painting.

Facade: West	Facade area: 429.25 m ²		
Pathological manifestation	Mesh units	Percentage	Damage area (m ²)
Crack	592	34%	148.00
Dirt	17	1%	4.25
Detachments	13	1%	3.25
Paint stripping	4	0%	1.00
Vesicles	4	0%	1.00
Efflorescence	4	0%	1.00
Total of damages	6	36%	158.50 m²

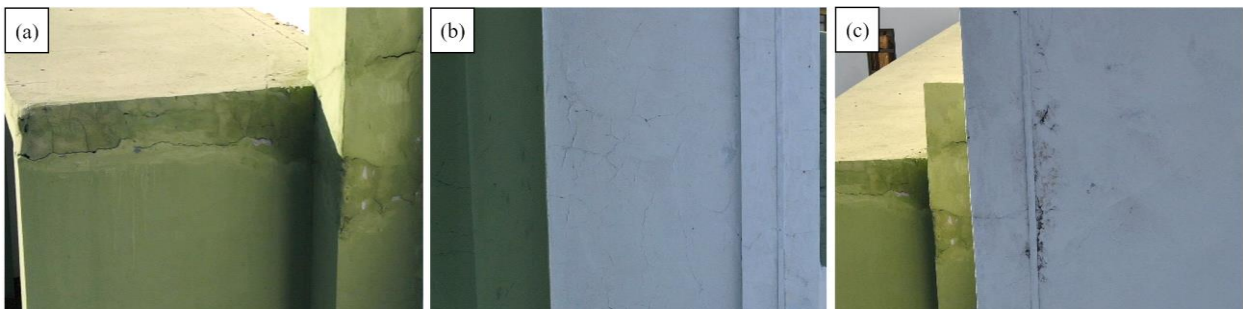
Figure 10. Pathological manifestations on the west facade six months after revitalization: crack, detachments and efflorescence (a), Vesicles and map cracking (b), Dirt and paint stripping (c).

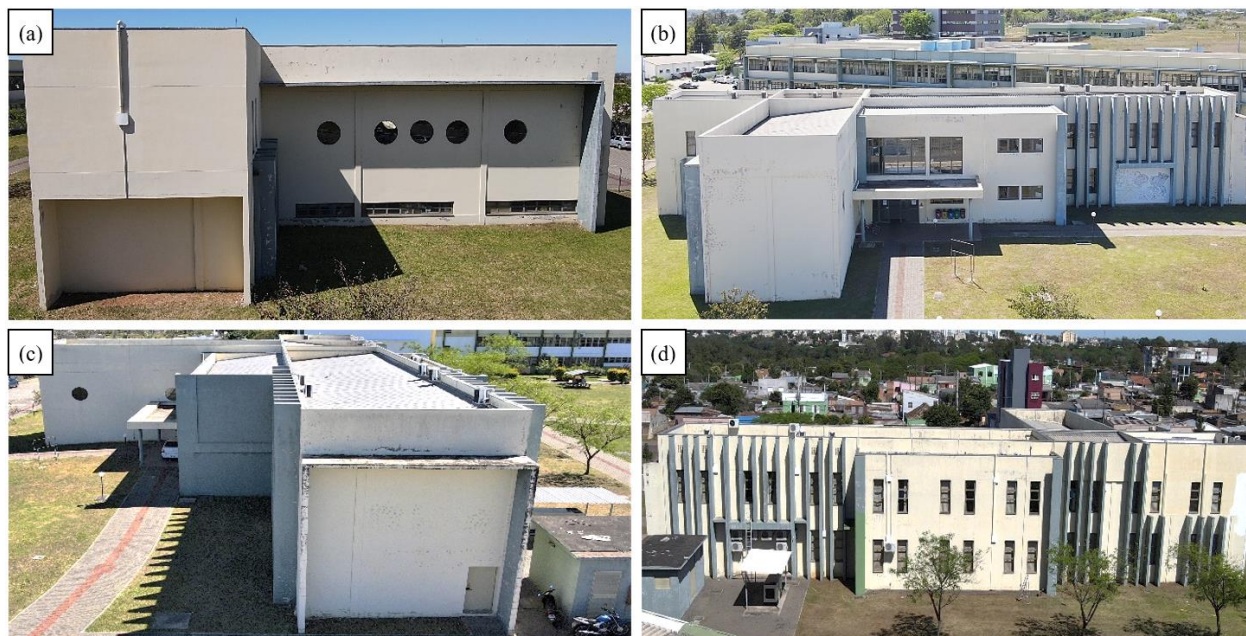
Figure 11. North facade (a), West facade (b), South facade (c), East facade (e) before revitalization

According to the information in Table 3, the west, south, and east facades each exhibited seven identified anomalies, while the north facade had six. The east, south, and west facades showed areas with anomalies covering more than 60% of their surface, whereas the north facade had the lowest coverage at 52%.

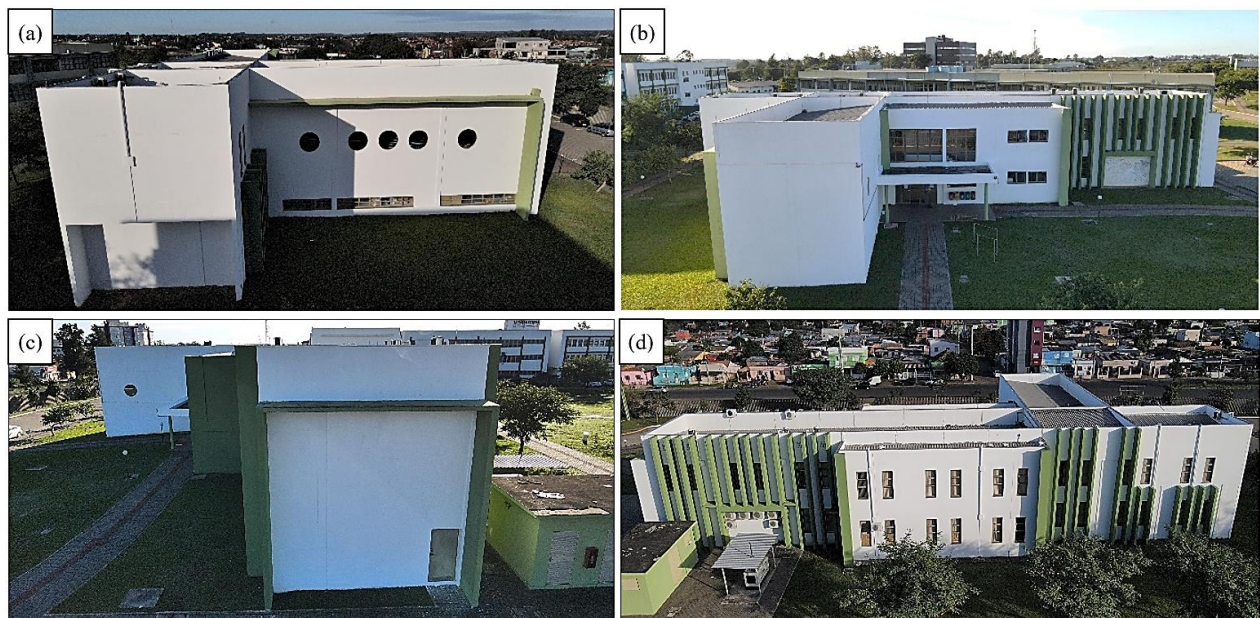
Figure 12 – North facade (a), West facade (b), South facade (c), East facade (e) after revitalization.

Among the anomalies observed (Table 4) six months after the building’s revitalization, cracking is the most predominant issue, with the east facade exhibiting the largest degraded area. Dirt anomalies were uniformly distributed, showing a 1% incidence across all four analyzed facades. In contrast, mold and mildew anomalies were slightly more prevalent on the south facade (2%)

Potential causes and origins of these pathological manifestations may include design errors and the use of inappropriate materials, all of which can predispose the building to premature issues. Even well-designed projects can fail if rigorous quality control is not maintained during execution. Factors such as poor application of mortar coatings, inadequate concrete curing, and unqualified labor are critical contributors to the development of cracks, paint stripping, dirt, and other pathological issues (Silva, 2008). The building's environment significantly impacts facade durability. Harsh climates, such as those with high humidity and significant temperature fluctuations, along with exposure to moisture and drying cycles, can lead to material movement and resulting damage. In buildings approximately 8 years old, pathological manifestations often reveal the initial conditions of design and execution. At this stage, observed anomalies frequently indicate premature material wear, where inferior or unsuitable materials for the specific application start to show clear signs of degradation (Souza, 2012).
