Pathological manifestations in a historic building: post-fire scenario at Casarão dos Fabricantes

DOI: <https://doi.org/10.21041/ra.v14i3.766>

Manifestações patológicas em edificação histórica: cenário pós-incêndio do Casarão dos Fabricantes

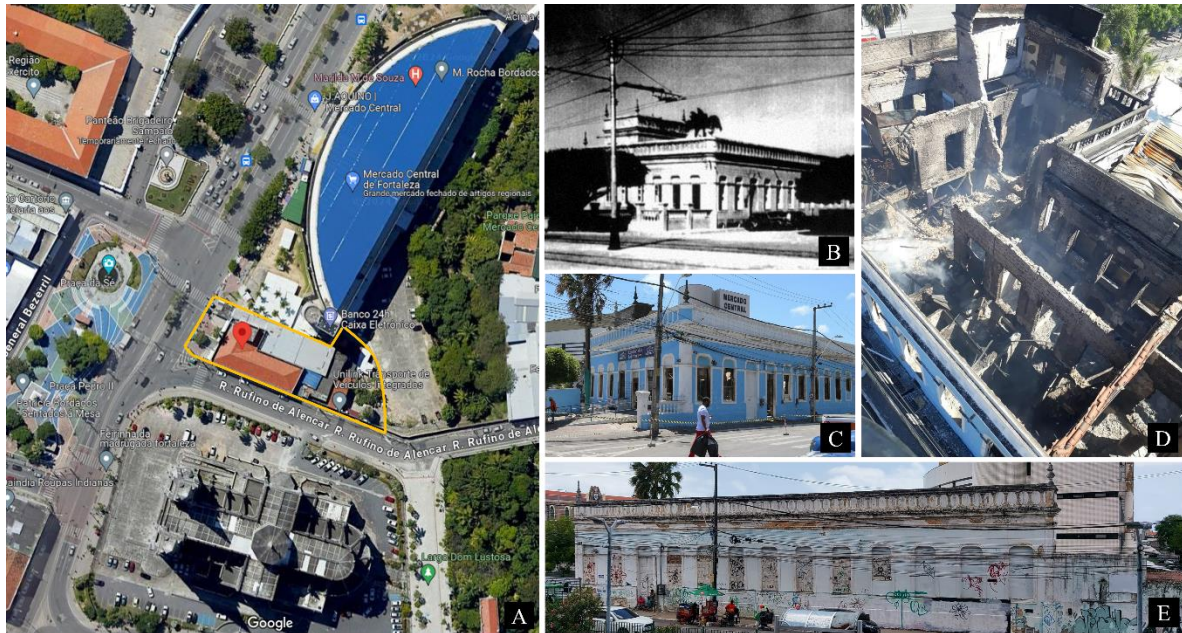
On the night of September 5, 2020, the commercial routine was interrupted by a large-scale fire. The flames consumed the goods and damaged the building's internal structures, causing irreparable damage. Figure 1D shows the current condition of the building after the fire. Immediately after the fire, Almeida (2020) reported that:

The flames consumed the goods and damaged the building's internal structures, causing the collapse of the roof, floor, and most of the internal walls, leaving only a few, whose structure was severely compromised, leading to their demolition. Only the external walls remained viable and were stabilized with a concrete structure on their inner face. Figure 1E shows the building's condition after the intervention.

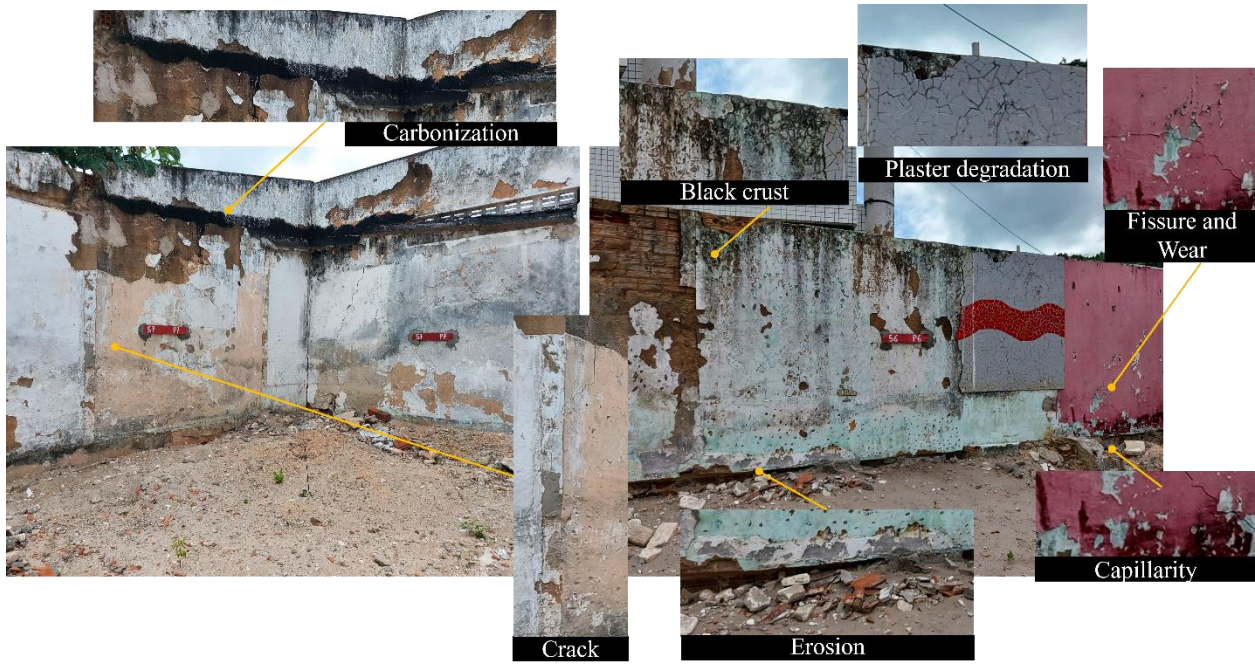
Figure 2. Pathological manifestations observed on the internal walls of the Casarão

Following a fire and considering the age of a masonry structure, various pathological manifestations can be observed. These variations depend on the intensity and duration of the fire, as well as the resistance of the building materials used. These conditions were assessed during the on-site inspection, where it was possible to observe and record the pathological manifestations present in the Casarão. These manifestations may have been caused by the fire or may have preceded this event due to the poor conservation conditions of the building. Figure 2 identifies the pathological manifestations on the walls of the Casarão, and the damage map (Figure 3) indicates the location of these and other degradation processes.

Each pathological manifestation exhibits specific characteristics that can be linked to different causes. Accurate identification of these manifestations and their causes is crucial for developing effective maintenance and repair strategies, ensuring the durability and safety of structures (Bezerra, 2024). The main manifestations identified are typical of historic buildings in inadequate conservation conditions: plaster degradation, black crust, cracking, capillarity, carbonization,

fissures, wear, and infiltration. Conversely, carbonization can be directly related to fire. When exposed to fire, wood undergoes a process called pyrolysis, during which the organic components of the wood decompose, forming by-products such as carbon. This carbon is deposited on the wood's surface as a black layer known as carbonization, also referred to as carbonaceous material (XU et al., 2015), which has insulating properties and can retard the spread of fire in wood.

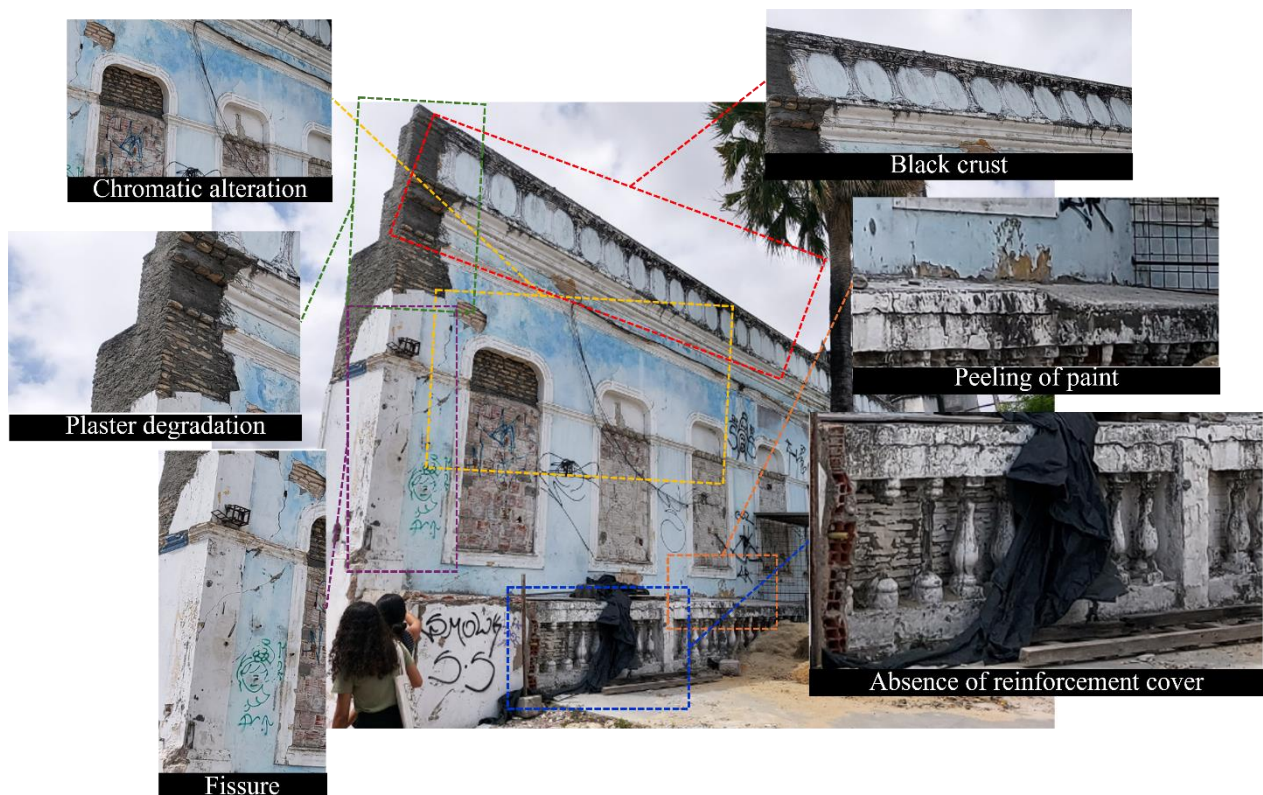
Figure 4. Pathological manifestations identified on the Casarão facades

Similar to the internal walls, pathological manifestations were identified on both façades of the Casarão, some of which are illustrated in Figure 4. Coloration changes on the surface were observed, which may be associated with exposure to weathering, altering the chemical composition (Occhipinti et al., 2021). Such pathological manifestations are frequently caused by exposure to atmospheric agents (e.g., sun and rain), pollution, the presence of fungi, algae, or other microorganisms, and chemical reactions between building materials and the environment. It is worth noting that the Casarão is located near the city's waterfront, where the high atmospheric aggression, particularly regarding chloride ion concentration, was confirmed by Cabral and Campos (2016). It is known that construction elements exposed to marine environments deteriorate more rapidly due to the highly aggressive environment, as the chloride ions in the saline mist are a significant cause of pathological manifestations due to their aggressiveness towards the cementitious matrix and reinforcement. Therefore, it is suggested that the diverse pathological manifestations in the Casarão result not only from the fire and neglect of conservation but also from local atmospheric aggression.

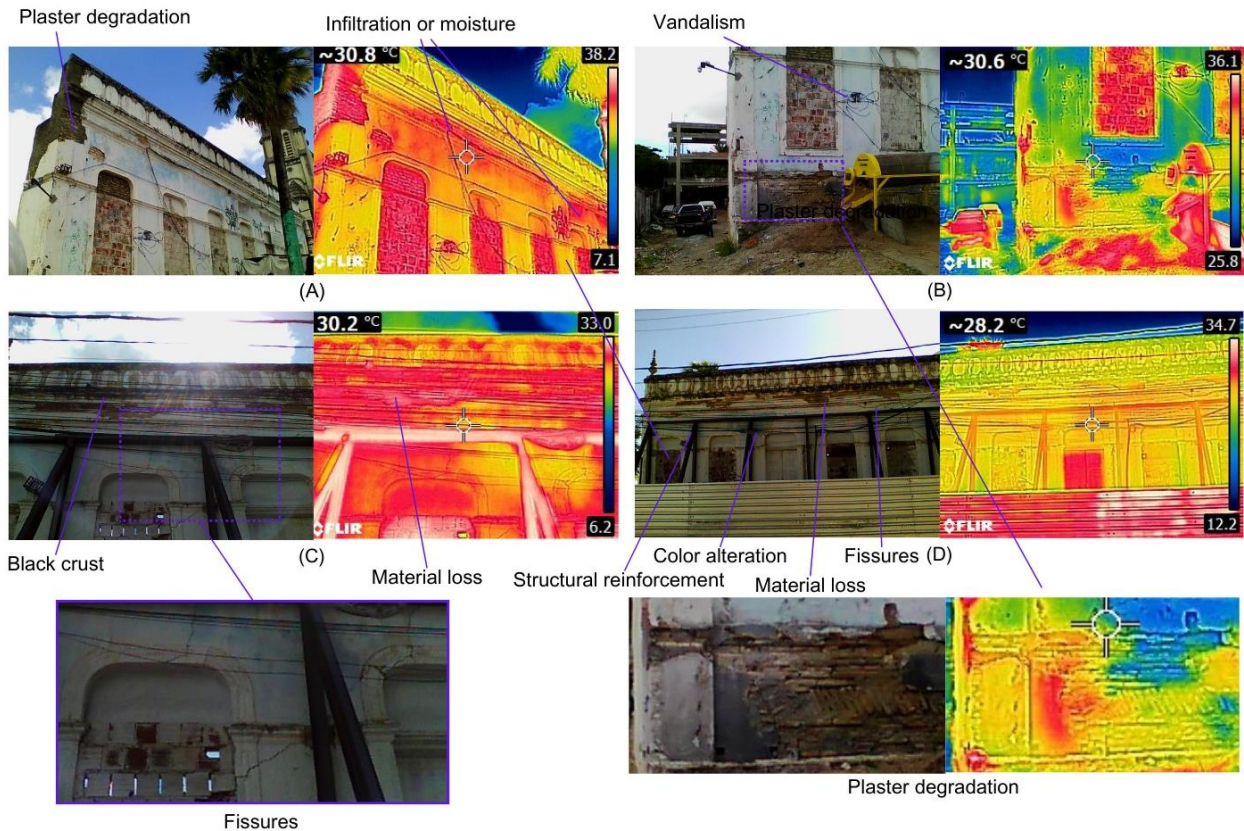
Figure 5. Thermographic images of specific regions of the two façades

Thermography of the Casarão shows areas of high temperatures (Figure 5A), indicating possible issues with thermal insulation or points of infiltration or moisture. Additionally, areas of plaster degradation were noted, exposing the white bricks of the structure, as well as several fissures,

vandalism, and black crust on the upper part of the façade. Infiltration has damaged the plaster on the lower part of the façade (Figure 5B), making the area more fragile and potentially damaging the structure, with vandalism and color alteration present. Moreover, there is material loss and black crust, along with numerous fissures (Figure 5C), necessitating structural reinforcement before restoration work begins. The red and yellow colors attest to the heterogeneity of the façades, causing problems with thermal insulation or moisture. Figure 5D shows the presence of black crust, material loss, fissures, color alteration, vandalism, and structural reinforcement.

According to Valero, Sasso, and Vicioso (2019), thermographic inspection allows for the observation of temperature differences in materials. These variations can indicate potential anomalies, such as moisture presence, providing important information for the restoration and conservation of monuments. Furthermore, these defects must be addressed to avoid irreversible damage to historic buildings. For thermal images, the iron color palette mode was used, with reference colors: blue for the coldest temperature range and yellow for the warmest temperature range. Thus, the coldest point can be identified in each image.

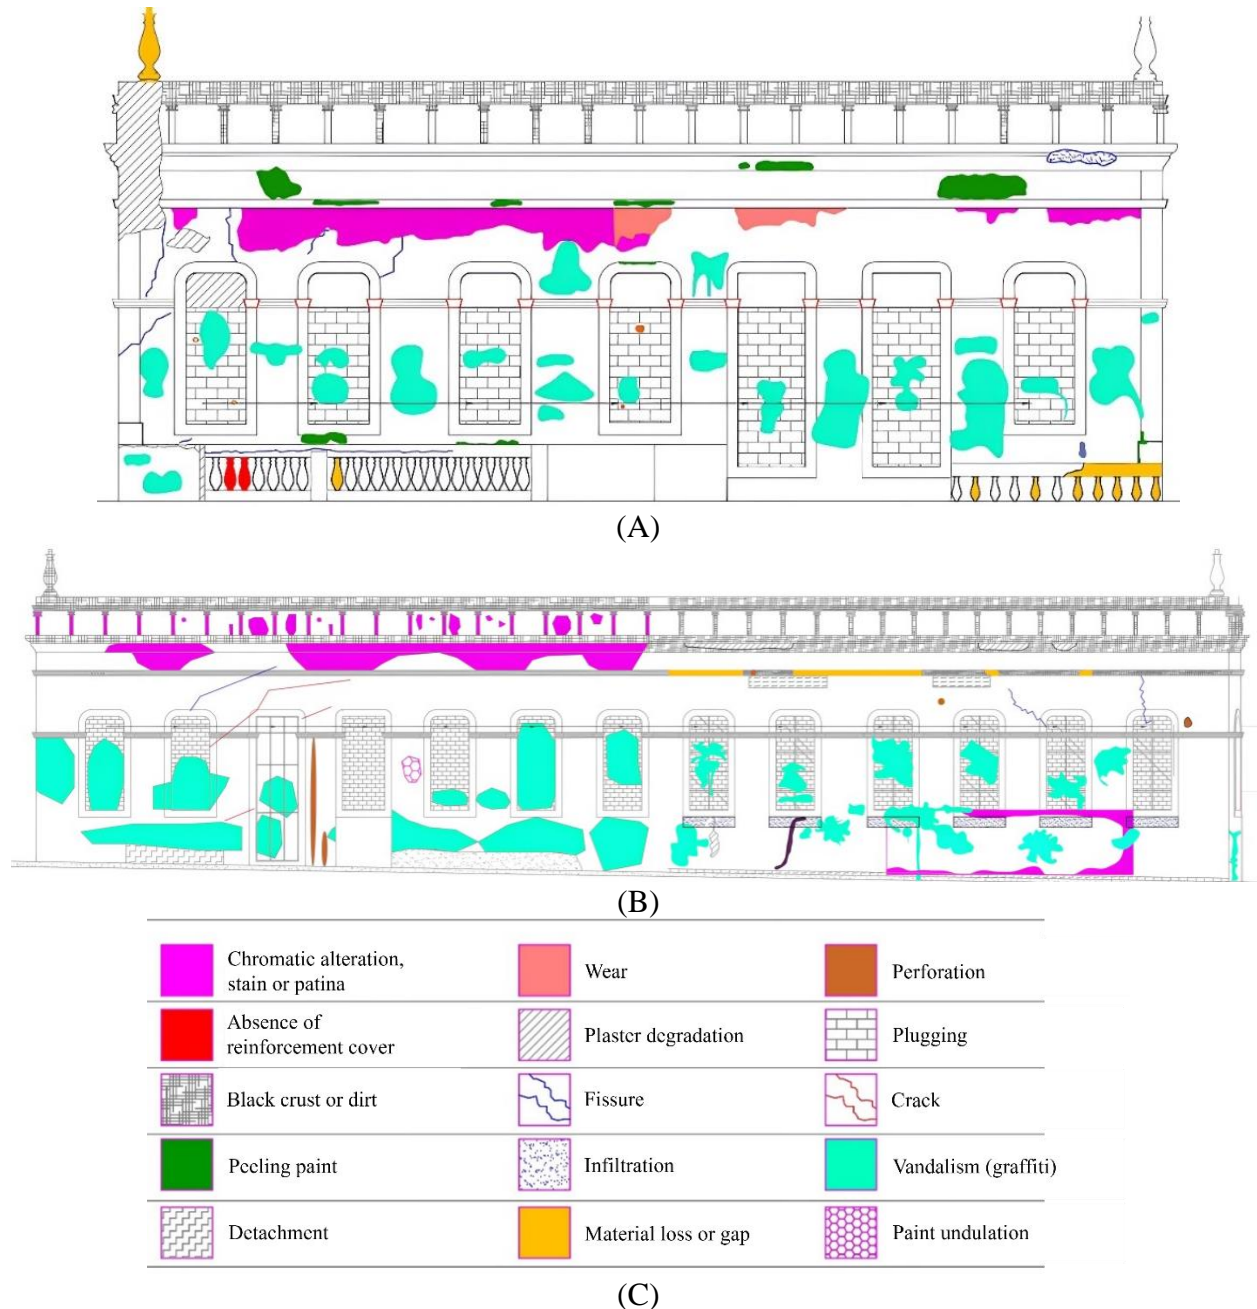
Figure 6. Damage map of the Casarão: (A) facade A, (B) facade B and (C) legend with symbols representing the pathological manifestations identified in the building

The development of the damage map for each façade enabled precise indication of the location of each identified pathological manifestation (Figure 6), highlighting various types of pathologies on both façades. The most recurrent pathologies in the building, as indicated on the damage map,

include color alterations, stains, or patinas, which are particularly frequent around windows and cornices, on both Facade A and Facade B. Paint peeling is extensive and appears in several parts of the façades. In many areas, the structural reinforcement of the architectural elements is exposed, indicating the absence of reinforcement covering, which is noticeable on both façades. Plaster degradation is widely visible in various areas, signaling significant wear. Small cracks, known as fissures, and larger cracks, referred to as fractures, are distributed along the façades. Infiltration issues are common in various areas, especially on the lower part of the building. Additionally, dirt accumulation or dark crust formation is observed in several sections. These pathologies indicate widespread degradation of the building, requiring conservation and restoration interventions in multiple areas to preserve the structural and aesthetic integrity of the building.

These pathologies demonstrate widespread degradation of the building, requiring conservation and restoration interventions in several areas to preserve the structural integrity and aesthetics of the building. During the site visit, the presence of structural reinforcement was observed on Facade B, due to the numerous fissures already present and exacerbated by the restoration work, likely due to earth movement and vibrations.
