Use of unmanned aerial vehicle (UAV) in the identification of surface pathology in asphalt pavement

D. Cardoso Parente*¹, N. Carvalho Felix², A. Pessoa Picanço³

Citation: D. Cardoso Parente, N. Carvalho Felix, A. Pessoa Picanço (2017), “Uso de vehículo aéreo no tripulado (VANT) en la identificación de falla superficial en pavimento asfáltico”, Revista ALCONPAT, 7 (2), pp. 160-171, DOI: <http://dx.doi.org/10.21041/ra.v7i1.161>

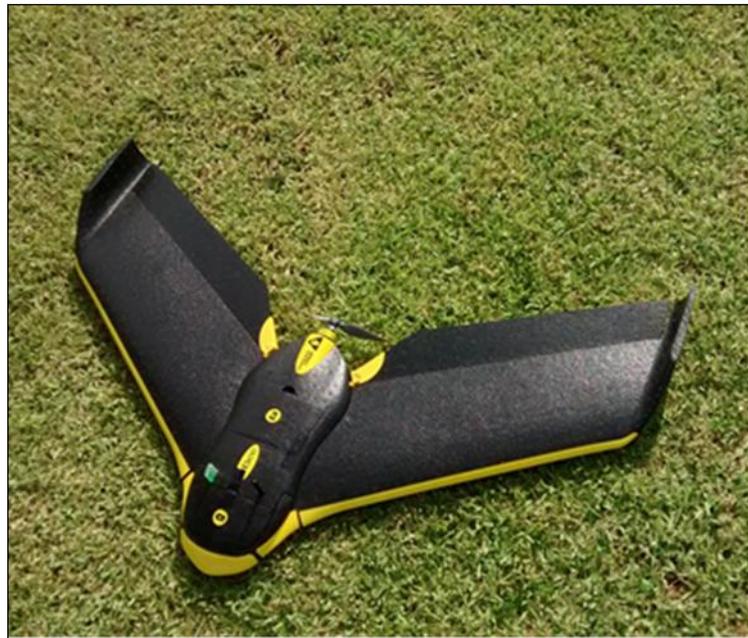
Image 2. UAV model eBee.

For collecting images an aircraft model eBee (Image 2) was used. It is comprehended as flying platform attached with specific sensors that allow the obtainment of photographs and videos. The aircraft has incorporated sensors that enables the stability of itself during a mission, as well as the transmission of data that guarantees the direct monitoring off light execution.

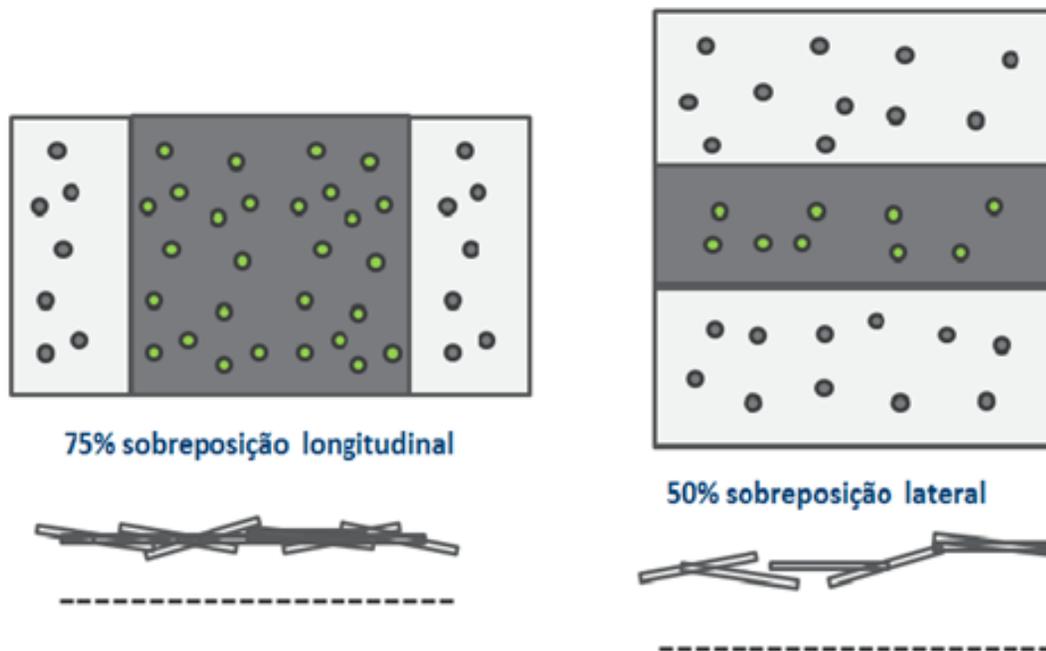
Image 3. Longitudinal and lateral image overlapping

Having selected the flight area and the pixel size, the software makes automatically available the area, the estimated flight time, elevation, space arrangement among the path lines and the distance that is going to be flown. The flight plan established for the current research caught sight of superficial pathologies in a three-kilometer patch of highway, using only one set of overlapping flight trajectories and two sensors to capture the images. Image 3 shows the detailed process of the image overlapping.

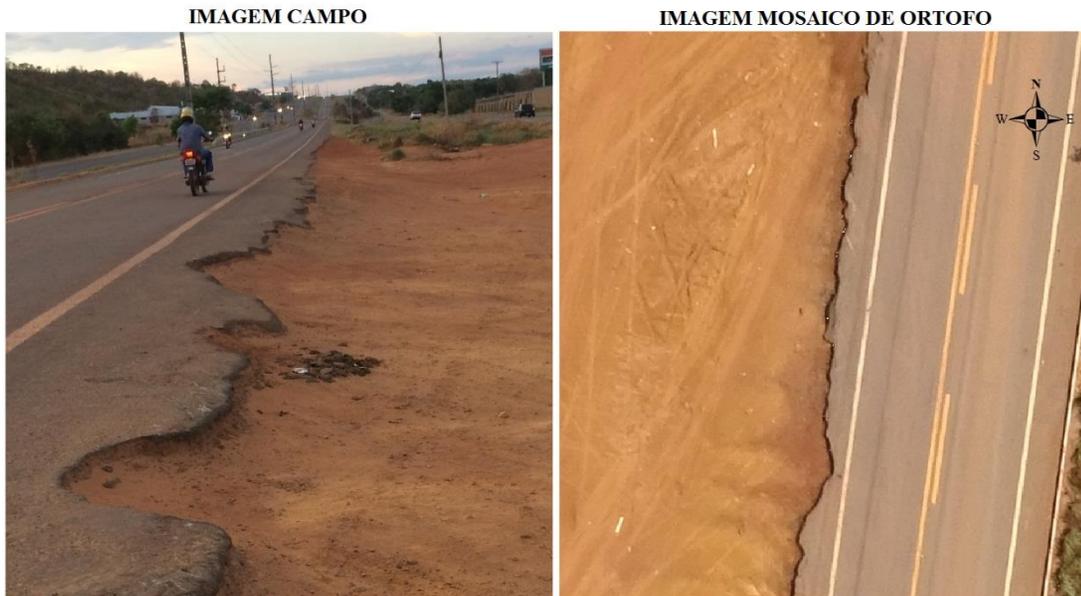
Image 4. Road shoulder pavement loss

Image 04 presents pavement edge breaks in a stretch of the road shoulder. As it can be seen in this image, the loss of material between the road shoulder and the road centerline, caused by an irregular detour and the absence of a curfew, makes it more vulnerable to this kind of weathering.

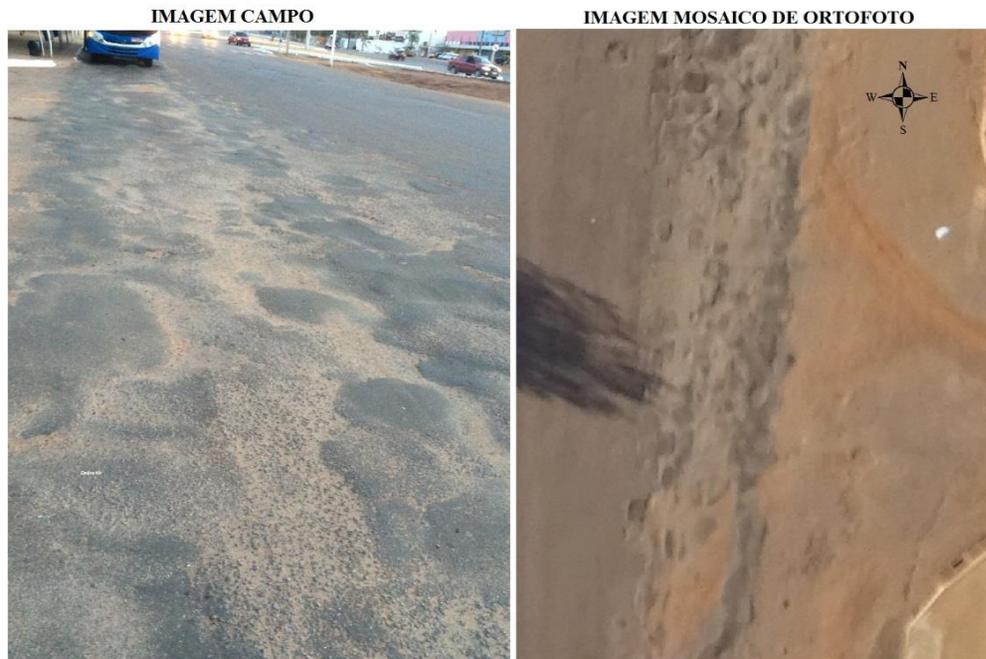
Image 5. Emergency Patching

In image 05 the areas affected by patching are being exposed, pathology which has the highest incidence in the stretch overflown. The patches are usually caused by attempts to correct pavement problems, which were in turn caused by depressions, rutting and raveling, alligator cracking and pot holes.

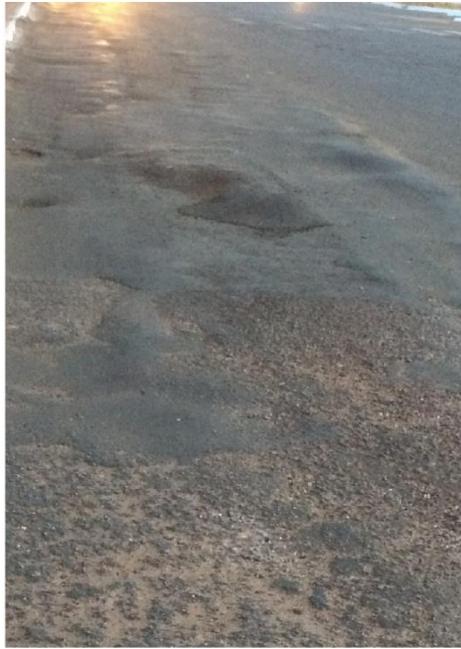
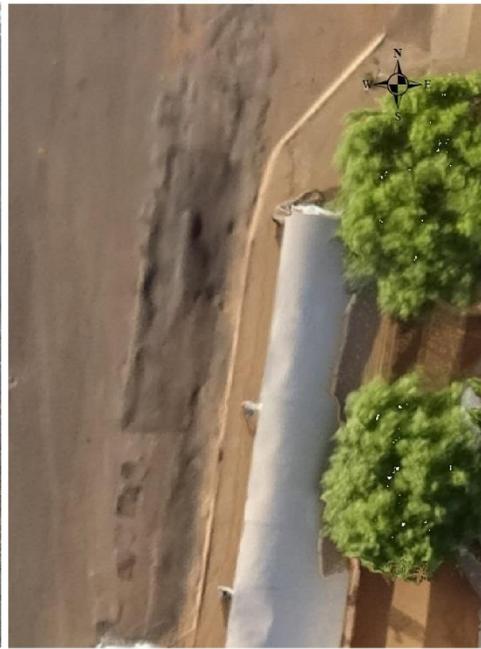
Image 6. Rutting in a stretch of heavy traffic.

Rutting is also present in some part of the stretch. The Image 6 illustrates this type of pathology, characterized by formation of depressions on the longitudinal way of the road, followed by rutting or elevation of adjoining areas. This pathological manifestation is related to traffic of heavy vehicles of public transportation (bus), which is more intense in this lane.

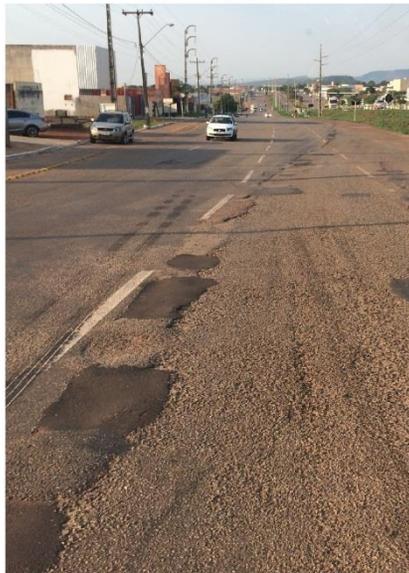
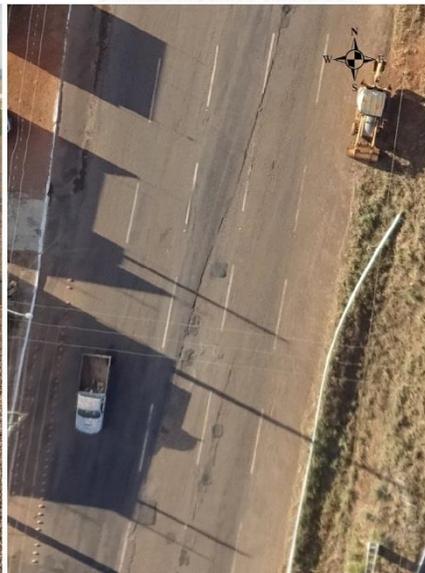
Image 7. Connection of repair.

The Image 7 evidence an area containing connection of repair on longitudinal direction, located between the old and new pavement executed for the enlargement of the road.

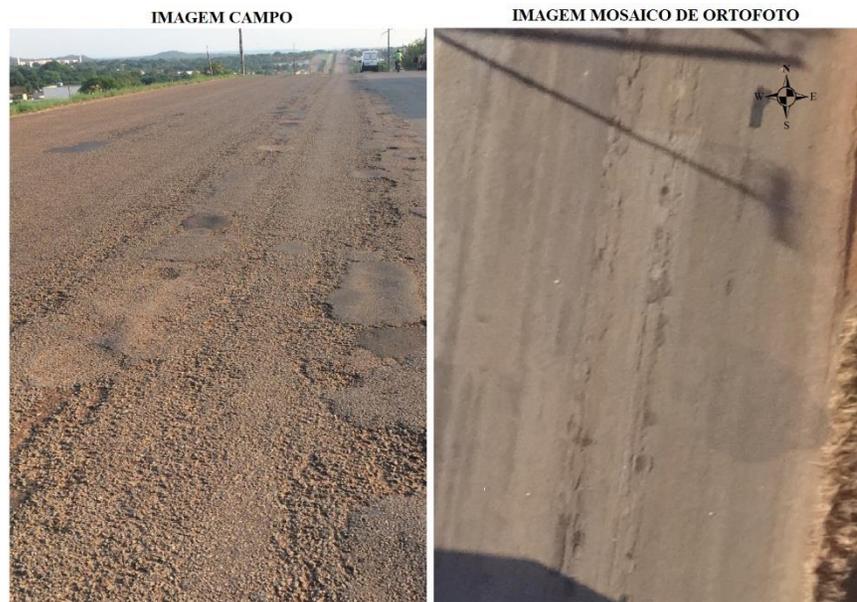
Image 8. Superficial wear

Compromised areas due to superficial wear can be observed on the Image 8. In these situations, the loss of the asphaltic surface course occurs. That involves the aggregate base, followed by the polishing of the aggregates, exposing them to the vehicles tires, aggravated by the abrasive action of heavy traffic, thus resulting in the loss of the aggregate base course and harshness of the pavement surface.

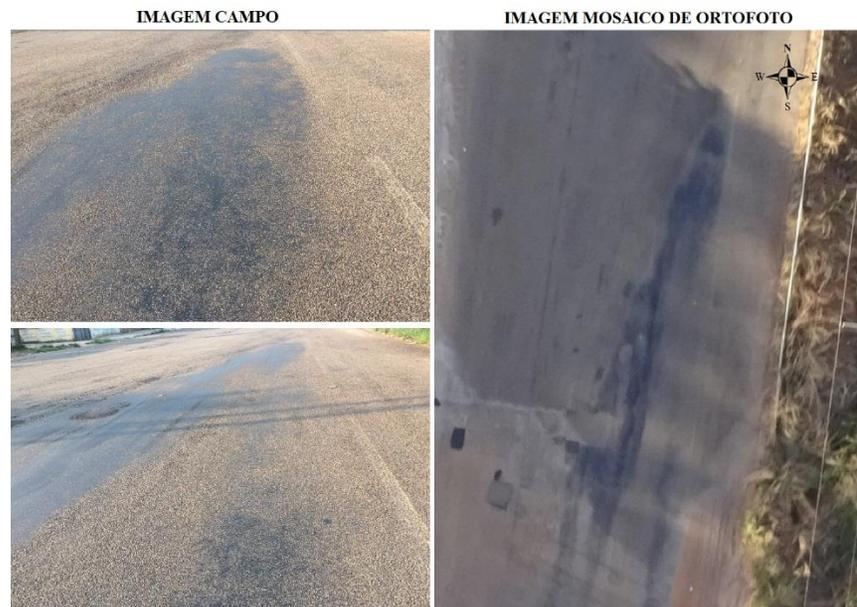
Image 9. Exudation

The appearance of bituminous material without the appearance of aggregate base course, also known as exudation, as shown in Image 9, is characterized by having a shiny surface and was also one of the kinds of pathologies identified.

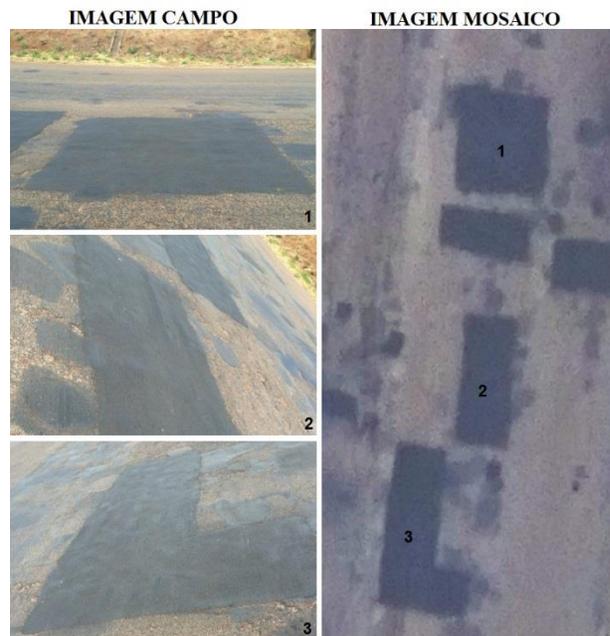
Image 10. Deep pot hole patching

In order to attest the reliability of the data collected through the observation of the images, a comparison was made between the area affected by the pathologies observed in the field and through the DSM of the TO-050. Image 10 exemplifies the process of data collection of an area deeply affected by road patching.

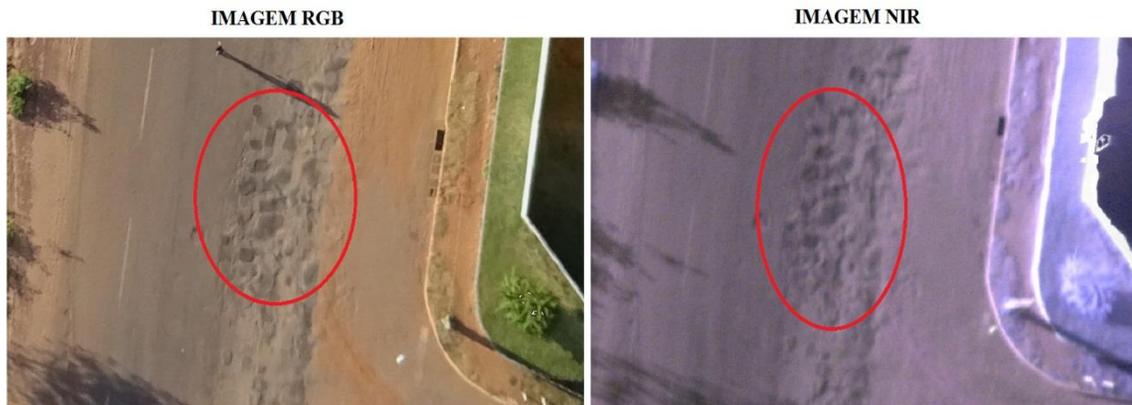
Image 11. Comparison between the images of the cameras RGB and NIR

Through the use of RGB images was possible to distinguish between the most recent and the oldest of the patches done to the road, by analyzing their colors and shapes; while through the analysis of the NIR images, the most recent patches are clearly evidenced for having a darker hue and better defined geometric form. Image 11 shows that older patched won't show up in the infrared images, having their color and shape concealed, and as a result it was harder to identify the right pathologies.

Concerning the results, a significative difference can be ascertained, taking into consideration that some pathologic manifestations won't show in the NIR sensor, especially the ones that have a lighter hue like road patches, superficial deterioration and rutting.
