## Evaluation of concrete flaw detection capability by means of ultrasonic tests

A. Lorenzi<sup>1\*</sup>, J. A. Chies<sup>1</sup>, D. S. Adamatti<sup>1</sup>, L. C. P. Silva Filho<sup>1</sup>

**Citation:** A. Lorenzi, J. A. Chies, D. S. Adamatti, L. C. P. Silva Filho (2017), “*Evaluation of concrete flaw detection capability by means of ultrasonic tests*”, Revista ALCONPAT, 7 (3), pp. 286-301, DOI: <http://dx.doi.org/10.21041/ra.v7i3.127>

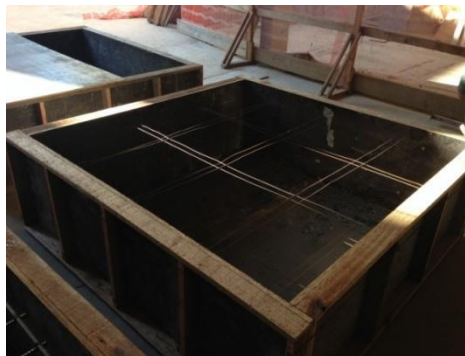
Figure 1. Molds for the concrete pouring of the wall

For the preparation of the test elements were generated molds using plasticised plywood and frame in eucalyptus wood, trying to approach the way of making a real concrete structure. The shapes were assembled in such a way as to obtain two square faces with a 1.70 m edge, with distinct roughnesses, one smooth (bottom of mold) and one rough (top of the mold - non - contact with the plywood). Figure 1 shows one of the molds used to make the walls.

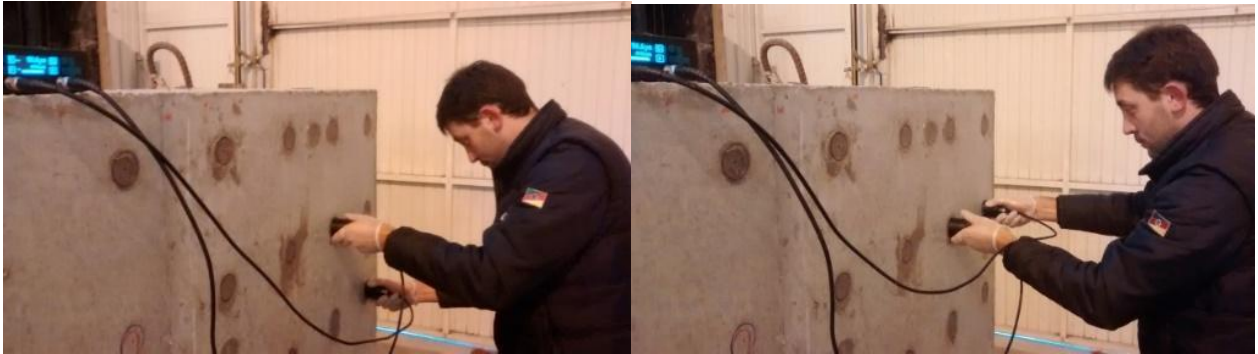
Figure 3. Sequence of readings

Figures 3 and 4 show the sequence and reading mode within a segment of the wall. With the values of UPV obtained, the velocity variations were mapped graphically. The results of the first stage provided good indications that the parameters armature, roughness, grid size and operator experience were shown to have greater potential in relation to the quality of interpretation and execution of the test. However, the applied methodology could not accurately define the ability to detect defects at different depths.

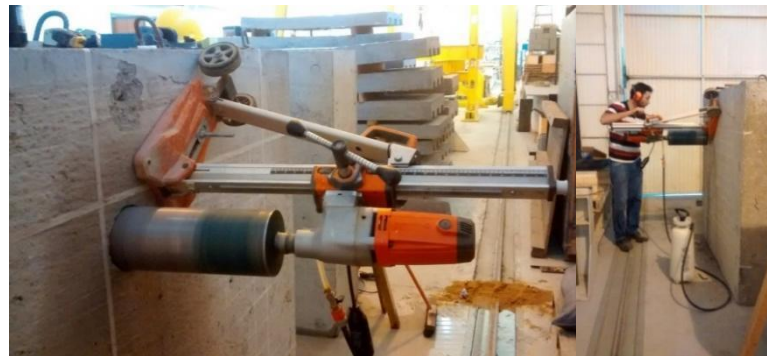
Figure 7. Drill advancement steps

This procedure was identical and strictly respected in the depths of advance of 15cm, 20cm, 25cm, 30cm, 35cm, 40cm, 50cm, 55cm and 60cm. Figure 7 shows the drilling equipment positioned and starting the job. After the closure of the perforations, UPV measurements were again made, even with the hole already apparent on the test face. As a last procedure, the hole was filled with mortar with a compressive strength of 4 MPa, which corresponds to approximately 10% of the compressive strength of the concrete used, simulating alternatively a void of concrete or non-resistant material trapped inside the structure. As in the other stages, UPV readings were acquired after 28 days of filling the hole with the mortar. Figure 8 shows one of the readings acquired at 60cm depth.

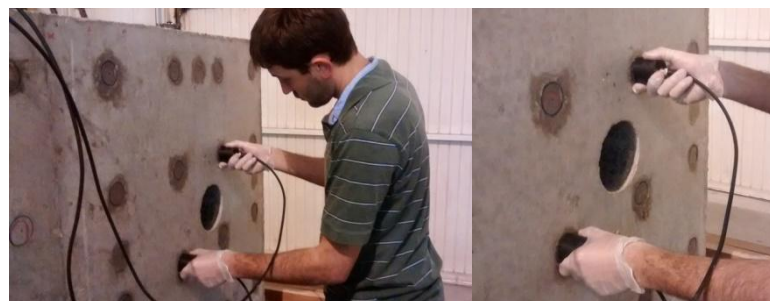
Figure 8. Measurements performed at 60 cm depth
