## Influence of the thickness of the coating of the elements of reinforced concrete exposed to corrosion processes and subjected to external loads

R. S. Meneses<sup>1</sup>, J. M. Moro<sup>1</sup>, R. R. Aveldaño<sup>1</sup>, N. F. Ortega<sup>1</sup>

<sup>1</sup> Engineering Department, Universidad Nacional del Sur, Bahía Blanca, Argentina

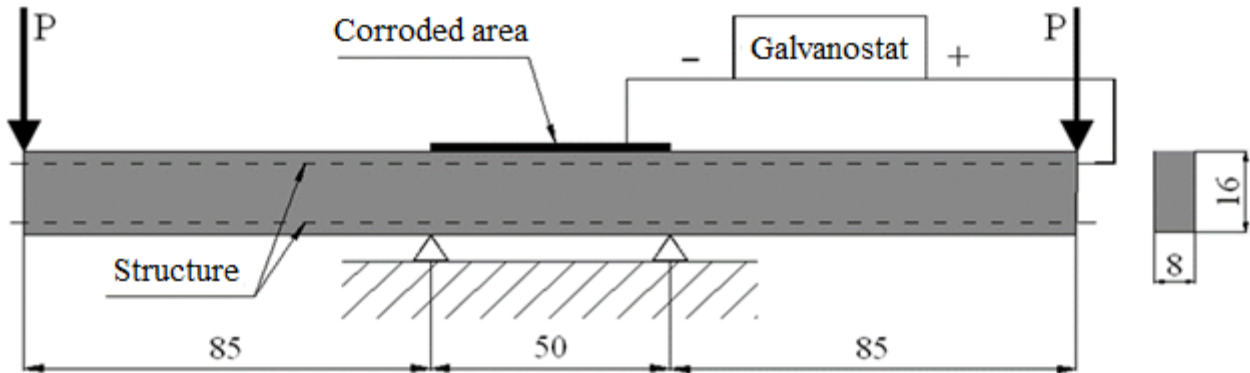
In order to obtain the tensile stress of the superior reinforcement (which would be the one that would have been subsequently subjected to a process of accelerated corrosion), loads were placed at the extremes of the beams, adopting an intermediate area as the area to be corroded, and leaving overhangs on the two lateral sides. Figure 1 shows the adopted structural outline. The area between the supports possesses an almost constant bending stress, therefore, the entire area of the bars affected by the corrosion is subject to a stress that is practically equal in intensity, by being subjected in each case to its own weight plus the effect of various loads that varied from 90 kg to 100 kg.

Figure 1. Outline of the Test

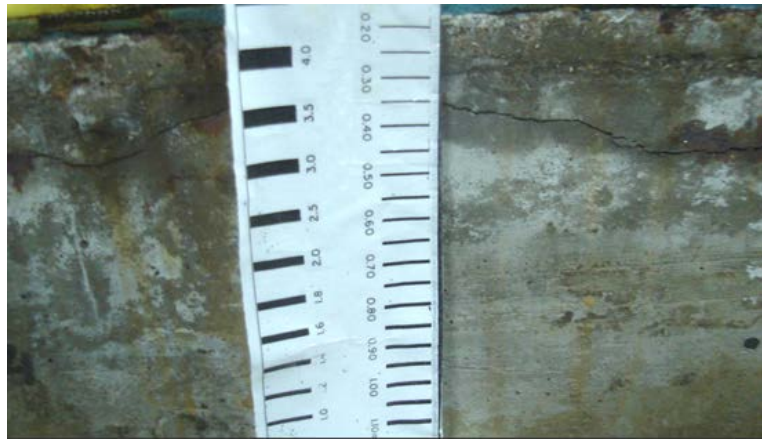
First of all, the beams were loaded and the initial cracking by flexion was measured prior to moistening. The follow-up of the surface of the beams was done by observing them daily and recording the moment the first stains and cracks appeared due to corrosion. From the emergence of these first cracks, the periodical measure of the width (by comparison with a graduated Vernier, with a minimum division of 0.05 mm (see Figure 2)) and length of the same (with a graduated ruler that possess a millimeter precision) was performed. This task was carried out in order to find the Maximum Crack Widths and the Cracking Areas, which are obtained as the sum of the lengths of each crack, multiplied by their respective width.

Figure 2. Measurement of the width of a crack generated by accelerated corrosion.

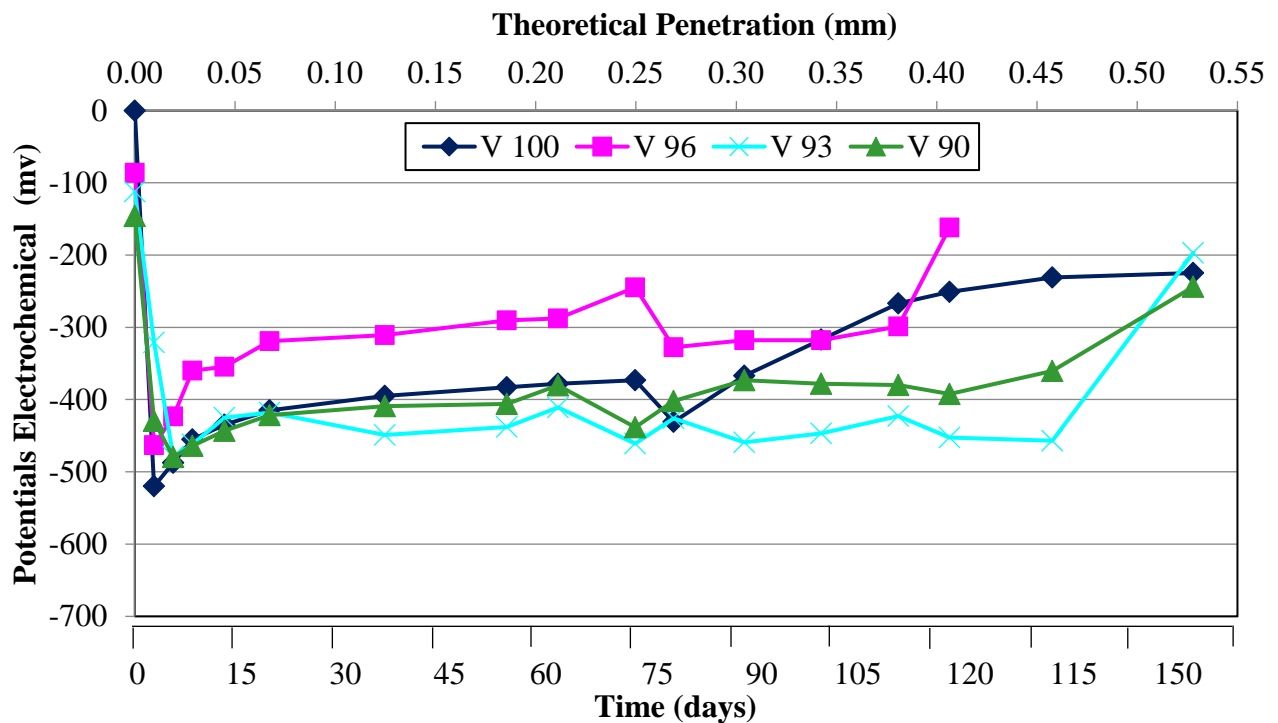
Figure 3 shows the electrochemical behavior of the reinforcement, where the evolution of the Corrosion Potentials was graphed, representing the average of the measurements obtained on 5 points located in the central area affected by corrosion on each of the 4 tested beams. There are two scales on the abscissa axis, one represented by the time passed since starting the test and, in the upper part of this figure, the Theoretical Penetration of the attack, which is an average value fixed with the Faraday Law (Equation (1)), applied to the material losses in the reinforcement located in the central area of the beams.

Figure 3. Average corrosion potentials (moistened area), in terms of the Theoretical Penetration and Time

The electrochemical behavior analyzed in the four beams, through the follow-up of their Corrosion Potentials, showed that in the course of the first 5 days, since connecting the accelerated corrosion process, the minimum potential value was reached; the beams with less coating (V96 and V100) were the ones that completed their activation period first (with minimum potentials between -478 and -531 mV). Subsequently, an increase of these potentials can be observed that could be considered as a pseudo-passivation process that is accompanied by the generalization of cracking (see Figure 5), which was similar on all the beams. Although the potentials of the two beams with lower coating / reinforcement diameter ratio are somewhat higher than the other two, it could be said that these are more passivated due to allowing an easier entry for oxygen from the exterior. This process was also found in previous works carried out in this laboratory (Aveldaño, 2011; Aveldaño, 2013; Schierloh, 2001).

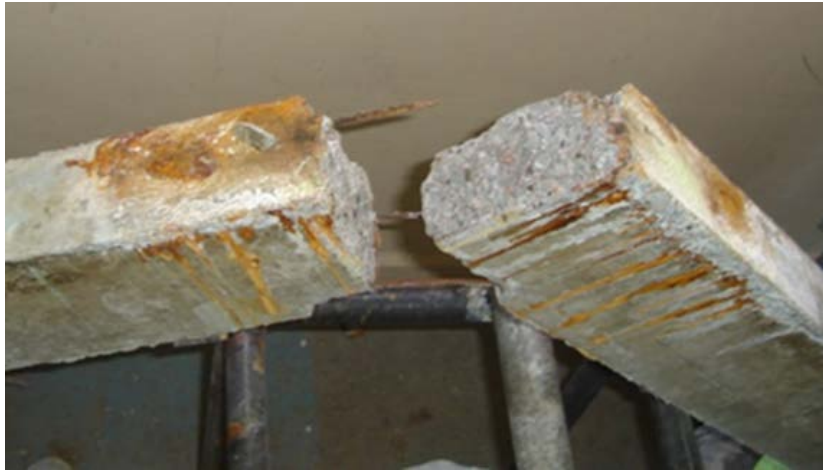
It is worth noting that while the test was prolonged for approximately 160 days, when reaching 140 days, beam V96 reached the point of collapse (Figure 4) due to a significant reduction of the cross-section of its reinforcement, produced by the depth of the pitting caused by the corrosion. Whereas beam V100 broke at 160 days, at which time the tests were finalized. This indicates that the corrosive process as is known, affects the residual life of the structural element affected, but that pitting, in particular, can decrease it even more.

Figure 4. Beam V96 after collapse

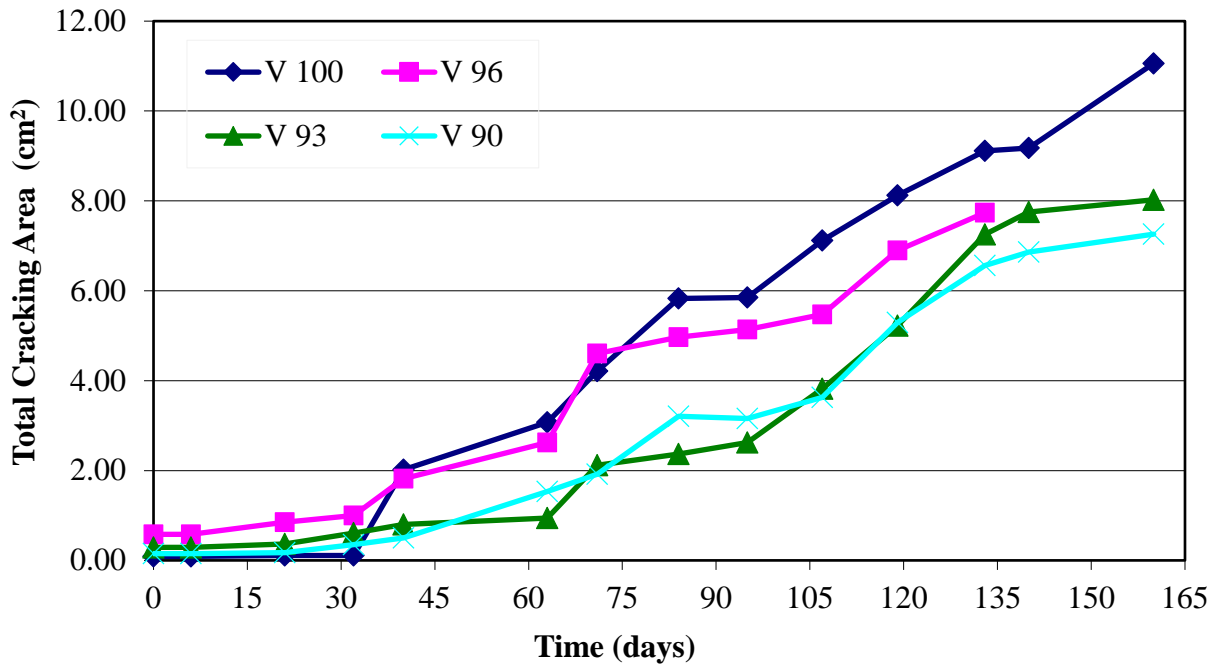
The cracks were measured from the moment the external loads were placed. Figure 5 shows the evolution of the Total Cracking Areas in each beam; that is to say, those obtained from the sum of the flex cracking areas, plus the areas of cracking by corrosion (in the same direction as the main reinforcement of the beam). It is worth remembering that the so-called Cracking Area is the sum of the products of the longitude by the width of each crack.

Figure 5. Total Cracking Area in terms of Time

As predicted, the start of the cracking by corrosion manifested later on the beams with greater coating. Beams V90 and V93 had a similar evolution of the Total Cracking Area throughout the duration of the test, taking into account the degree of dispersion that normally appears in most experimental works; whereas beams V96 and V100 showed a differentiated behavior, with Total Cracking Areas greater than those of the remaining beams, this is due to having a lower  $r/\phi$  ratio of the reinforcement. However, if the Flexural Cracking Area is analyzed separately (Figure 6), it can be observed that beam V96 showed higher values than the rest. This can be clearly observed with the state this beam reached, in which the deterioration by corrosion presented itself to a greater extent in the area of the flexural cracks, whereas the rest of the beams showed a more generalized cracking. Evidently, this greater initial cracking due to flexion was a significant means of entry for the chlorides that reached all the way to the reinforcement, with beam V96 showing the largest Total Cracking Areas (Figure 5) during the first 30 days of the test, after which their behavior was within the expected.

If the evolution of the Maximum Cracking Width is compared with that of the Cracking Areas (Figure 5), it can be observed that the latter are a more representative indicator of the general evolution of the deterioration, due to the fact that it is common for the Maximum Width to vary in its location on the beam throughout the corrosion process. Furthermore, it tends to evolve in jumps in terms of the emergence of new cracks that cause the redistribution of the internal stress in the coating. For example, Figure 8 shows that beam V90 has the most cracking between days 40 and 90, when in reality it ought to be the one with the lesser values. This situation was also found in other works (Aveldaño, 2009; Aveldaño, 2013). Nevertheless, this figure is included due to the fact that it is common to introduce limitations on the maximum width of the cracks in the standards, and therefore it is used as a reference in many international bibliographies. It is worth noting that it would be necessary to carry out research to standardize the Cracking Area, so that valid comparisons between various deteriorated beams could be carried out, for example, in terms of the length of the affected element or the length of the corroded area, to later establish representative deterioration indicators and then limit it.

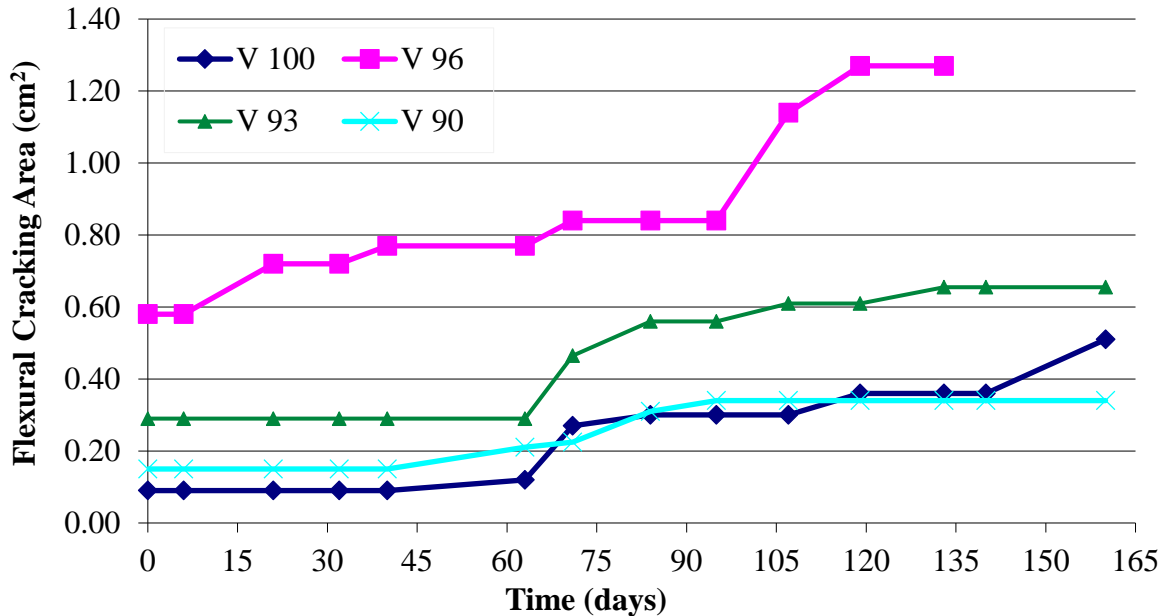
Figure 6. Flexural Cracking Area in terms of Time

This behavior observed in beam V96 explains its collapse prior to that of beam V100. However, this evidences the influence of the lesser  $r/\phi$  ratio of beam V100, which, having the least flexural cracking

during almost the entirety of the test, presented greater cracking by corrosion than the rest; as well as the importance that flexural cracking has in the deterioration of a structure subjected to corrosion, as is the case of beam V96.

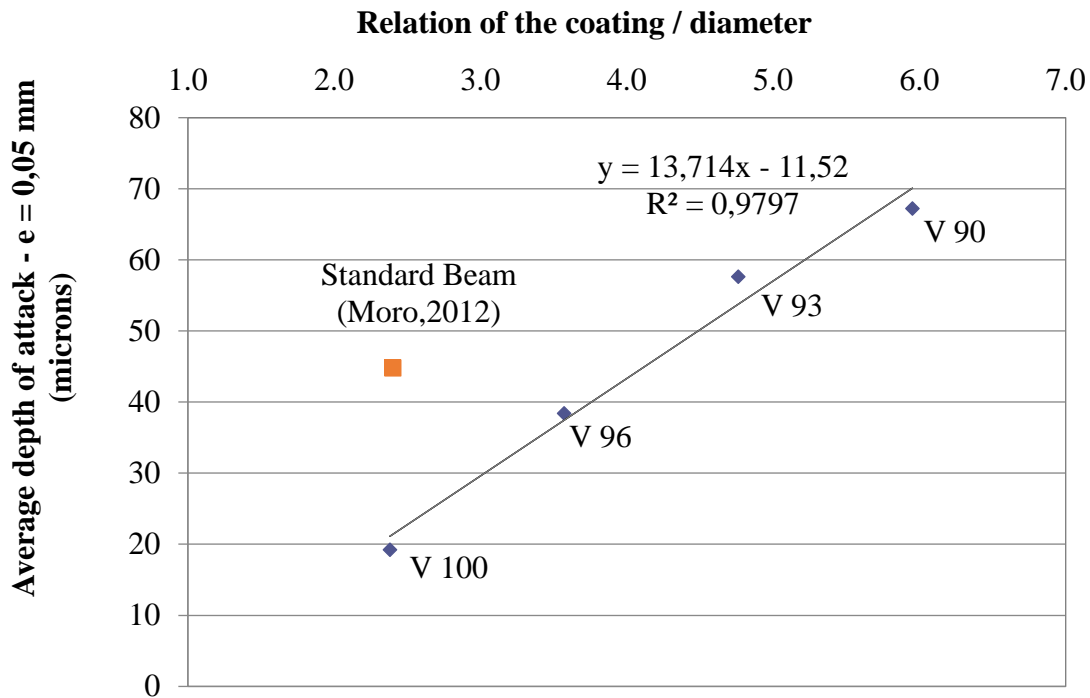
It can be observed in Figure 7 that the appearance of the first visible cracks due to corrosion is delayed (the average Depth of the attack is proportional to the time, expression (1)) as the thickness of the coating increases (greater  $r/\phi$  ratio). The increase in the thickness of the coating causes a delay in the appearance of the first cracks due to corrosion (Figure 7), as well as slowing their evolution (see Figure 5) due to the fact that the aggressive external elements (chlorides, oxygen, and water) take longer to reach the reinforcement. This situation, in the case of the tensile reinforcement with lower  $r/\phi$  ratios, is worrying due to the fact that this greater depth of attack on the bars, with less external symptoms (cracking), encloses a significant risk because it decreases the warning time in case of a structural collapse—more worrying still if there are chlorides that cause pitting. In Figure 7, a point corresponding to the standard beam (without external loads and a  $r/\phi$  ratio = 2.4) of the aforementioned work (Moro, 2012) was incorporated, where it can be observed that a greater depth of attack is necessary for the appearance of the first visible cracks.

The equation in Figure 7 obtained through a Regression Analysis ( $y = a + b x$ ) can be compared with the one obtained in other researches (Alonso, 1998) where concretes made with water/cement ratios between 0.52 and 0.65 were used, while the rest of the test conditions are similar, among which the following stand out: a slightly broader variance range of the coating/diameter ratio than the one adopted in this paper, in both works the abutments were placed, and the same current intensity was utilized. The results achieved in the cited work were:  $a = 7.53$  and  $b = 9.32$ , with  $R^2 = 0.92$ . The slope of this line is much lower than the one obtained in this work ( $a = 13.71$ ), therefore, it could be said that in structures subjected to external laws, the degradation generated by the corrosion of its reinforcement is accelerated, even for cements made with a water/cement ratio somewhat lower to that of the reference.

Figure 7. Relation between the average depth of attack on the reinforcement that produced the first visible crack ( $e = 0.05$  mm) due to corrosion, and the Relation of the Coating / Diameter of the bar.

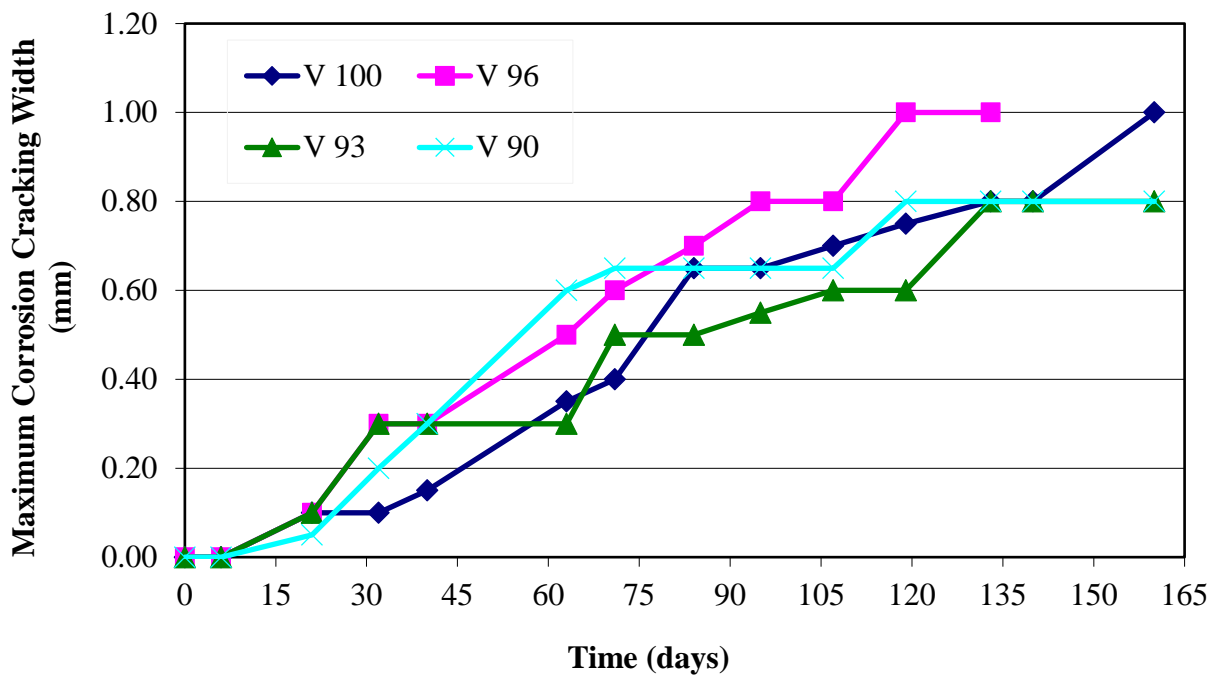
Figure 8 shows the variation of the Maximum Cracking Width in terms of Time. It can be observed that the Maximum Cracking Width, during the greater part of the test, was superior on Beam V96 due to the influence of the flexural cracking. No great differences were observed in the evolution of the rest of the beams, which was due to the fact that the distribution of the cracking was developed differently on each beam, whether in a more generalized or localized manner, without generating evident differences between the different samples tested.

Figure 8. Maximum Cracking Width in terms of Time
