## History, situation and reinforcement of the bell towers of the basilica of Penha-Recife-Brazil

This paper presents and discusses the history, current situation, original techniques and strategies used in the development of structural reinforcement design of both towers of the Basilica of Penha Church. Repair techniques poorly designed, conducted in 1981, along with lack of preventive maintenance, leaks and even the growth of bushes embedded in the masonry led to the instability of the towers of the Basilica of Penha Church.

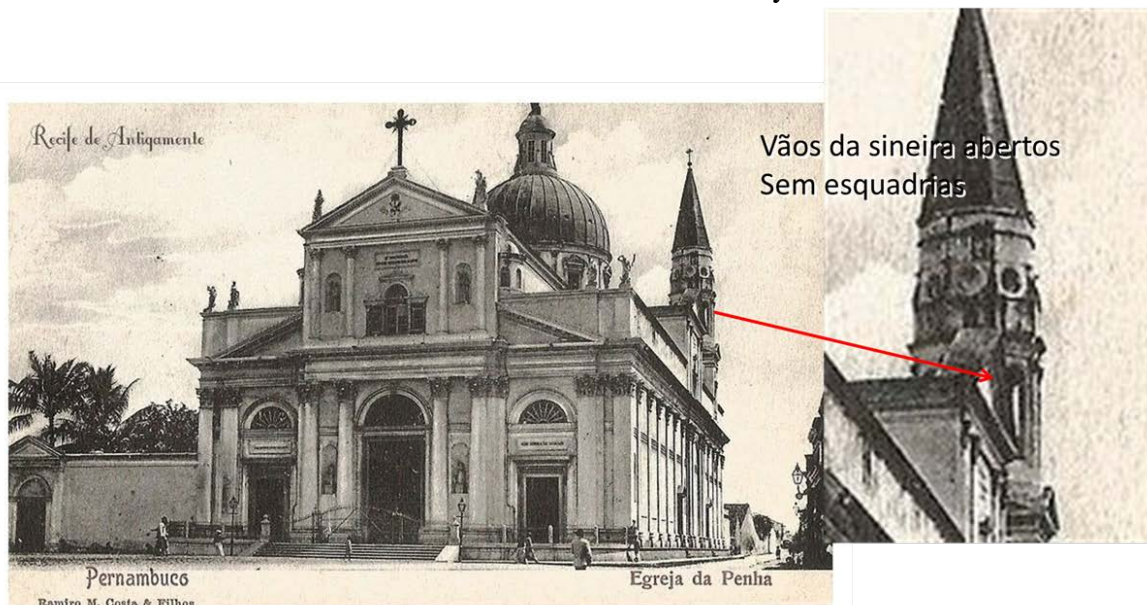
Figure 1 shows the historical record of the early 20th century building. The building has a central nave and a pair of towers (Epistolary and Belfry), each with eight columns called "minarets". In these columns a number of cracks and detachments of coatings were observed, due to the oxidation of the internal reinforcement, as well as pathologies due to the action of shrubs that grew on the outside and branched into the masonry of one of the towers.

Figure 1. Historical image of the Penha-detal Basilica of the bell tower without cobogo.

In 1981 reinforcement interventions and filling the windows with cobogos (Araujo 2010) were made, in the reinforcements were identified with the inclusion of some columns and bars of steel in elements of reinforced concrete.

In 2010, due to the aggravation of pathological manifestations in the openings fissures in some columns and loss of internal and external lining, reinforcements in wood structure were inserted in the windows between 8 columns of towers of structure of masonry.

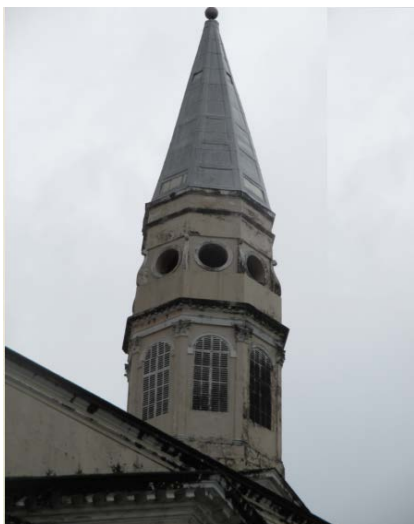
Figures 2 and 3 show of one of the towers as well as details of the type of reinforcement used in the columns the towers.

Figure 2. Current view of the tower

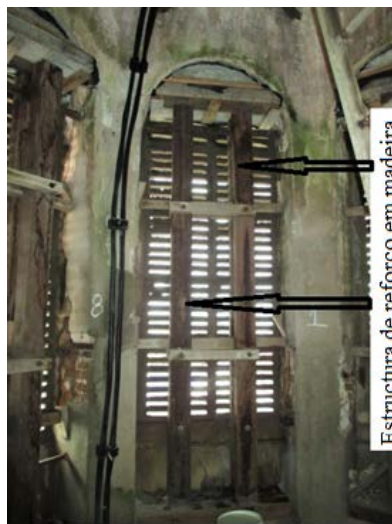
Figure 3. Reinforcement in tower columns

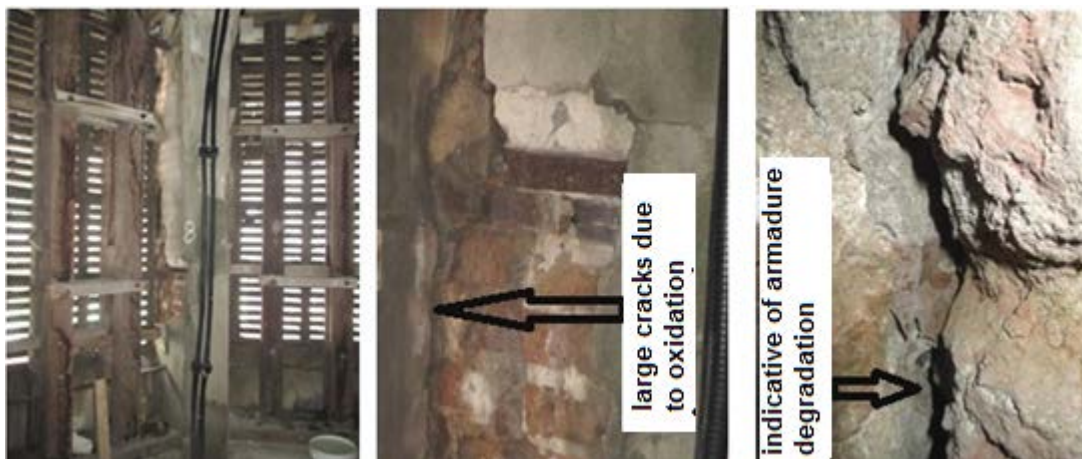
In Figures 4 to 6 it is possible to observe aspects of large cracks in columns generated by the oxidation of the reinforcements incorporated.

Figures 4 to 6. Fissures caused by the oxidation of the iron clamps inserted in the columns

In the fissured columns there is a need for cleaning and filling with epoxy resin for recovery of the moniliticity, shown schematically in figure 19 [5].

- A) Cleaning of cracks with compressed air blasting;
- B) removal of parts of impregnated reinforcements inside the cracks, so as not to cause major damage;
- C) Drilling of holes along the fissure and placement of masters, filling the outer side with cement grout tix;
- D) Injection of cement paste, with low pressure, in the pugadores, from bottom up, in order to fill the fissures.

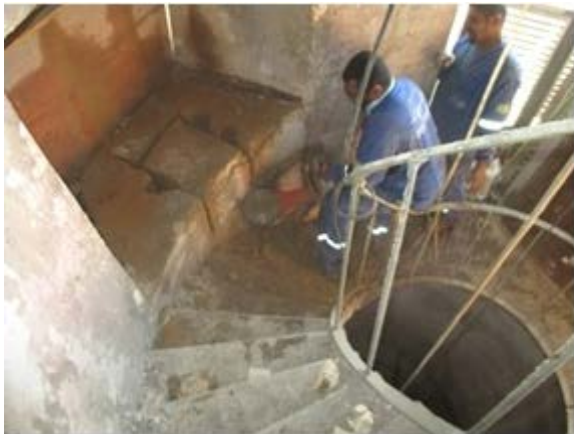
Attempts to obtain samples using a 4 "diamond drill bit were not efficient, since the need to cut with hydraulic lubrication favored the solubilization of the mortar and the brick itself, since both the lime-based mortar and the Not completely burned brick suffered with action of disk movements and water action. In order to obtain samples of the masonry, it was necessary to use a double diamond disc cutter, as shown in figures 7 and 8.

Figure 7. Sample removal process using double diamond disc.

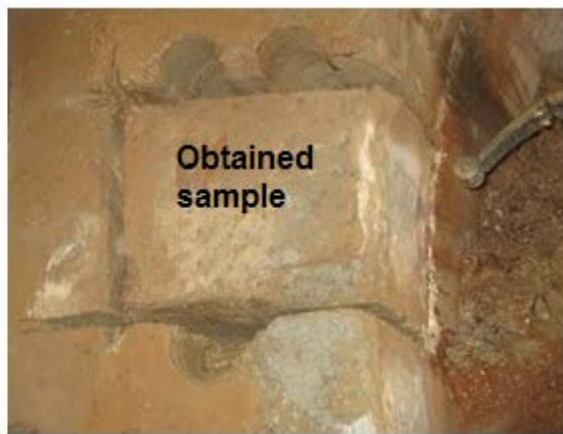
Figure 8. Sample removed from masonry sent to the laboratory.

Samples were cut and rigged in four specimens for achieving the compressive behavior tests, being used press with displacement control, with capacity of 300kN, allowing register the post rupture behavior.

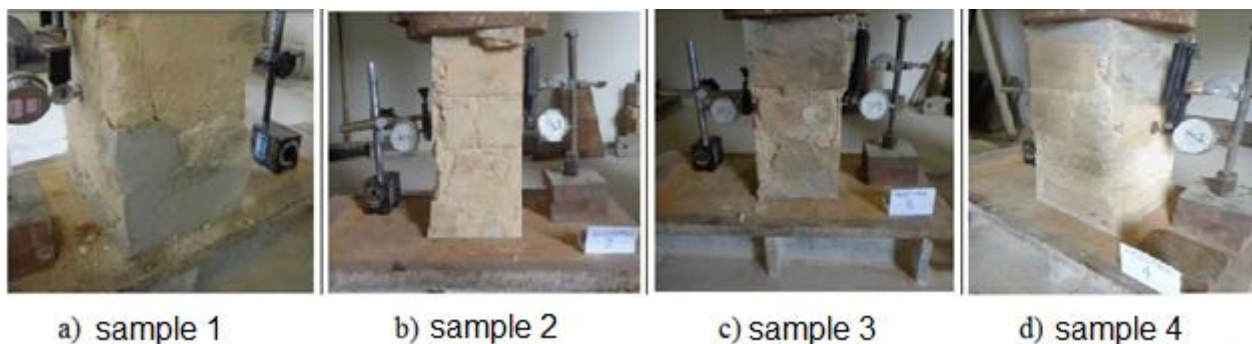
For the determination of the longitudinal and transverse modulus, deflectometers with precision of thousandths of a millimeter were installed in the cross section of load application and LVDts were used in the measurement of longitudinal and transverse displacements. The composition of Figures 9a-d shows characteristics of the tests on the compressive behavior of the samples.

Figures 9a-d. Compressive behavior of the assays in the samples

From this evaluation, on analysis of determination of the characteristic resistance, according to the recommendations of ABNT NBR 15182-2 was obtained

$$f_{pk} = 1,15 \text{ MPa}$$

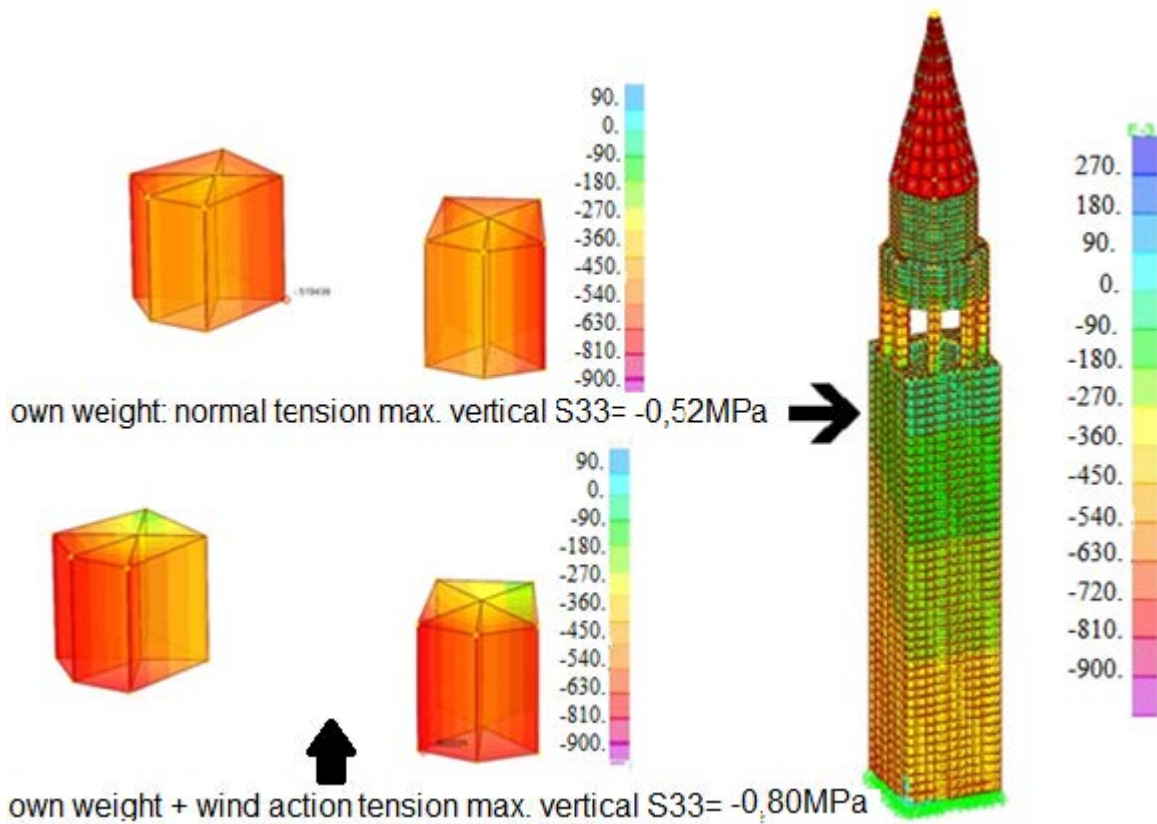
Figure 10 shows aspects of the solid elements used and the results of the tensions in the various elements that make up one of the towers.

Figure 10. Results of the numerical analysis of the tower of the Basilica

The images in figure 10 show that the most critical regions of stress concentration are located at the base of the columns, reaching a value of 0.52MPa due only to its own weight and of 0.80MPa when considering the combined action of weight and wind action.

Considering the results of the requesting tensions, especially in the region near the bases of the columns, reaching maximum values were between 0.52MPa to 0,80MPa and considering that the characteristic resistance of the samples was determined at 0.63MPa.

These values show that in the performance of the wind the tensions surpass the resistant capacity of the columns, even without considering the safety factors, normally existing when proceeding to a dimensioning. In this way the temporary reinforcement structures, built with wooden structures in the windows of the towers are acting decisively, avoiding collapse in this region.

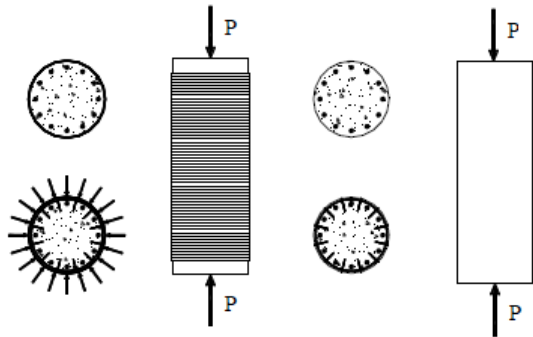
Figures 11 and 12 show the difference in compressive behavior of a concrete element, which could be masonry, without and with transverse confinement.

Figure 11. Tensions and strains in confined and unconfined systems

The effect of the confinement pressure is to induce a triaxial stress state in the masonry and under these conditions masonry, or other fragile material, substantially alters its compressive behavior, both in strength and ductility (Fiorelli, 2002).

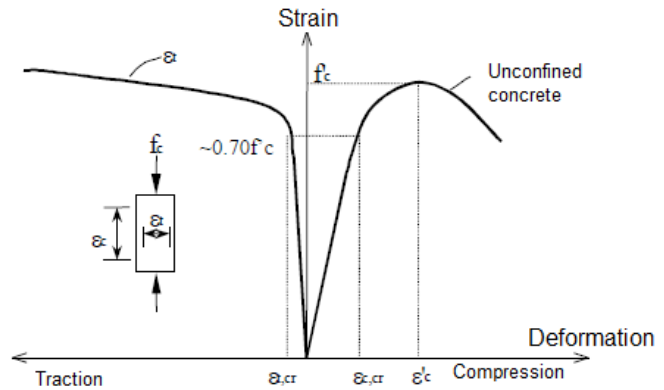
Figure 12. Typical configuration of a piece of concrete confined and unconfined

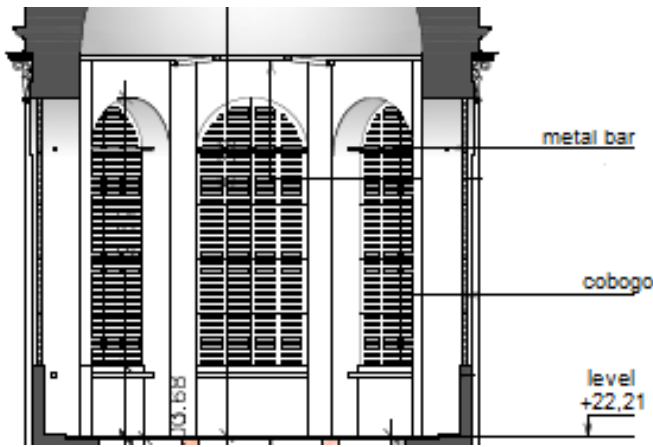
Figures 13 and 14 show the positioning of the columns that present the most critical situations in terms of stress concentration.

Figure 13. Drum region

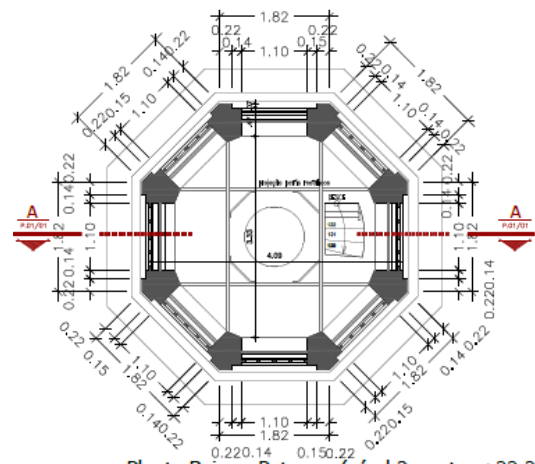
Planta Baixa - Patamar (nível 3 - cota: +22.21)

Figure 14. Low plant at the base of the columns

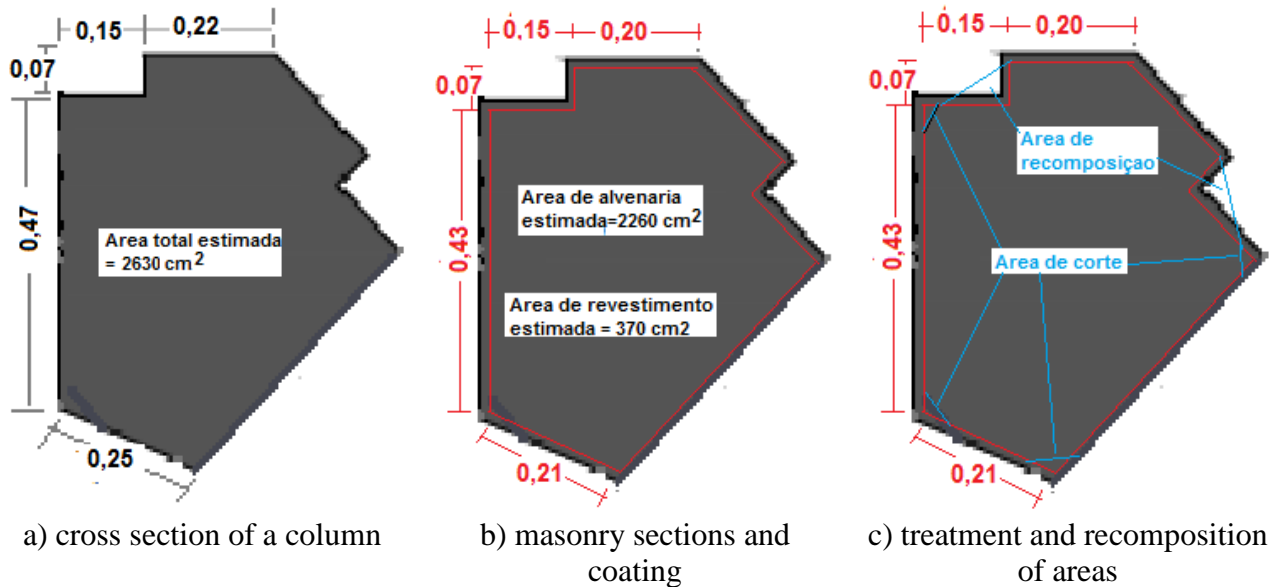
The evaluation of the cross-sectional areas of one of the columns to be reinforced is considered in figure 15.

Practically after the cutting interventions (corners roughing) and rigging, necessary to enable cross-sectional casting of the columns, the estimated areas of masonry and cladding do not change.

Figure 15. Evaluation of areas after interventions required for treatment to strengthen

The evaluation of the active and resistant loads at the base of columns can be estimated in:

$$R_{r1} = 6,30 * 2260 + 300 * 370 = 127,569 \text{ ton}$$

$$R_{r2} = 127,569 * 1,20 = 153,082 \text{ ton}$$

In this way, it can be considered that the proposed reinforcement allows a resistance increase of the columns in 7 times its resistant capacity and if compared to the load acting on the base of the columns due to combined action of own weight and wind action. In this way, the proposed reinforcement presents a security coefficient of the order of 7.0, well above the 2.0 recommended by masonry standards.

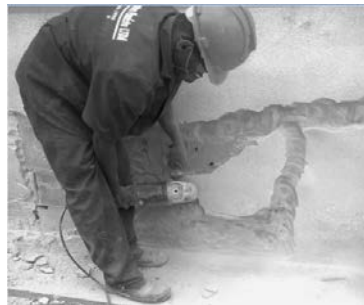
In the areas to be reinforced, the existing coatings must be removed, using corodur grinding wheel coupled to a rotating sander, in this way there will be no significant impacts on the masonry structure, as shown in figure 16a.

Figure 16a. Roughing process with grinding wheel

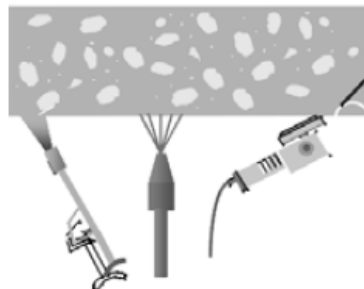
After skirting the corners and removing the entire coating, the areas should be clean and free of dust and can be used with slightly moist air, as shown in the diagram of figure 16b.

Figure 16b. blasting scheme and thinning of the corners

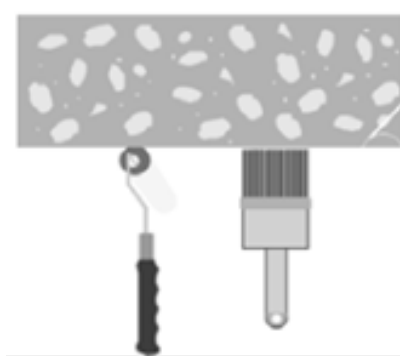
In the areas that will receive reinforcement, outlined by the project, they must prepare the surfaces receiving application of primer to make it possible to fill the voids to receive the layer of polymerizing mortar, as indicated in figures 17a and 17b.

Figure 17a. Scheme of the preparation process

This mortar should have adequate consistency with its application with a metal trowel on the primed surface.

The final surface must be smooth and compact.

After 3 days of application of the mortar, a new primer coat is applied.

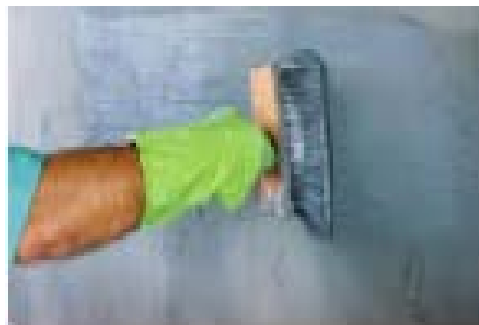
Figure 17b. Primer application as surface preparation

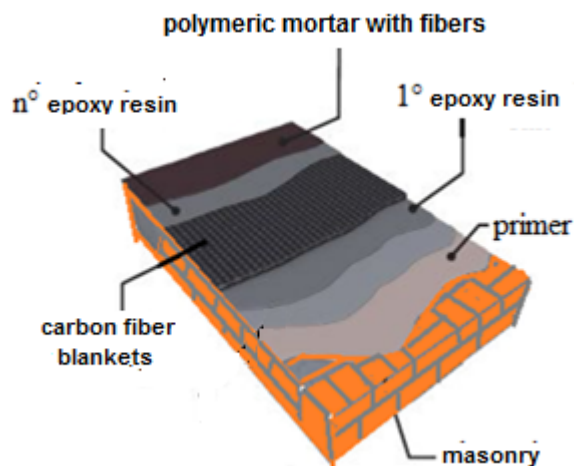
Figure 18 shows the procedures for the application of carbon fiber blankets.

Figura 18. CFC System

The surface of the masonry already prepared an epoxy resin layer is applied with a roller. Typically, this product has a low viscosity - which facilitates its penetration into masonry. The function of this layer is to provide adequate adhesion to the surface of the structure (Grande 2011).

After application mass regularization is then applied an epoxy mass + carbonates to correct and eliminate surface defects that can detract from the application.

After perfect regularization, the first layer of resin is applied. The surface of the structure is covered with epoxy resin saturation. This resin, high viscosity, helps to maintain the CFC and the correct position. The impregnated saturation in the blanket being applied, it also helps in the efforts of the fibers and abrasion protection.

The application of the carbon fiber blankets cut into the size of the surfaces and the area geometry is applied to the epoxy resin saturation.

Continues with saturated resin application of the reinforced top layer are made throughout the entire area so that the system is hidden.

After all CFC layers have been applied, regularization with polymer composite and plastic fibers is promoted.

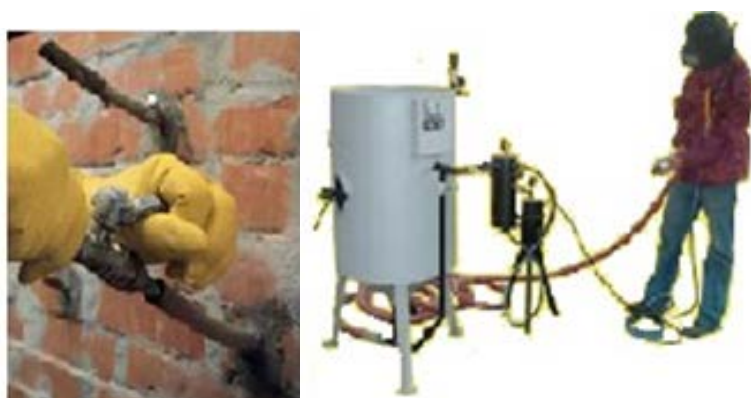
Figure 19. Injection process: placement of masters and injection through injection pump

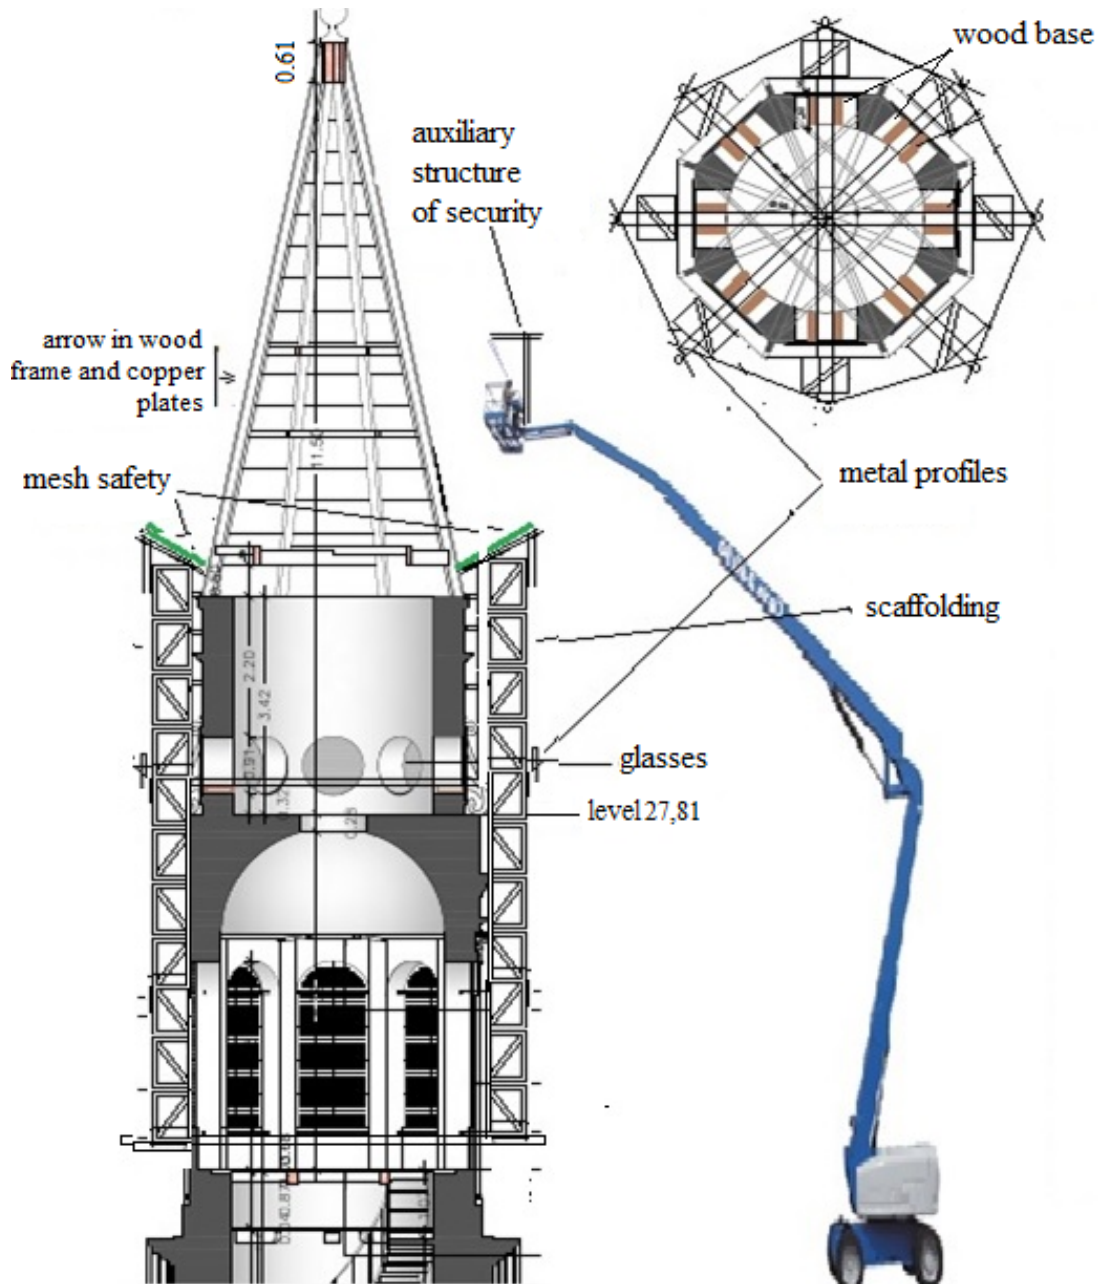
Figure 20. Scheme of the process

Preparation of an auxiliary structure to support a scaffolding platform: Insert into the bases of the wooden elements 4 transverse metal profiles, which supported the scaffolding lines.

- A) Mount the 8 columns of scaffolding until reaching the edge of the base of the arrow, securing them against the walls of masonry;
- B) Place a grid / net of protection on the scaffolds in order to avoid falling objects of the arrow;
- C) With the aid of a boom crane coupled to a protective structure, remove the copper pieces from the cover of the arrows.

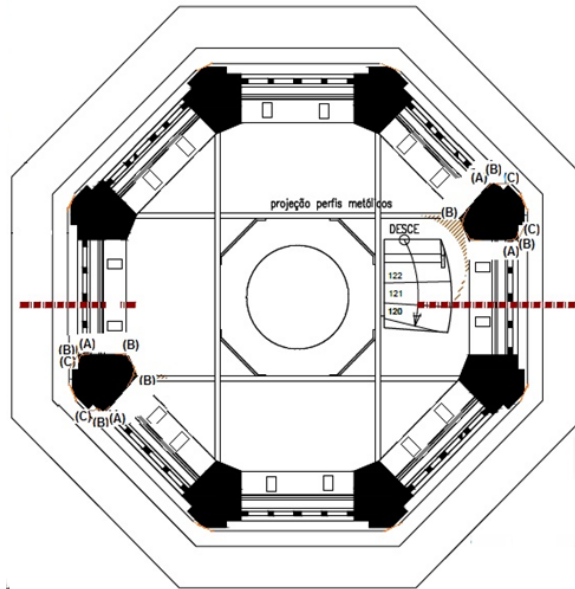
Figura 21. Planta baixa no nível 22.21

The eight columns that make up each one of the towers, are currently with provisional reinforcement fomó by wooden structure and with closure in cobogo.

To promote reinforcement of these columns, in pairs and opposites, the reinforcement technique should be used with replacement of the existing coating and carbon fiber sheeting.

- A) It starts soon after the treatment of fissures, according to 2.2.1.
- B) It is promoted the cut of the area of cobogó surroundings of the pair of selected columns;
- C) The coating and the thinning of the corners are removed, as described in 2.1.1;
- D) The reinforcement is promoted as described in 2.1.2 and 2.1.3;
- E) Repeat this procedure for other pairs of opposing columns.

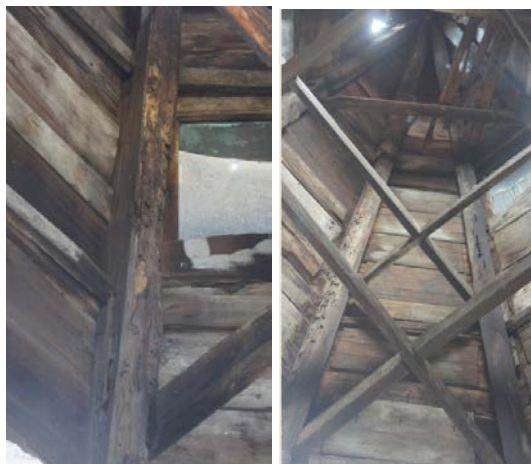
The shrubs that have grown and rooted in the tower of the Epistle need to be carefully removed. After the removal of the coating of the arrows the investigation of the wood structure that composes the covering arrows of the towers is carried out.

Figure 22. Cover situation detail

- A) Identify the damaged wood elements and promote their reinforcement;
- B) The reinforcements can use steel plates and stainless steel screws, and it may be necessary to fit new pieces of wood.

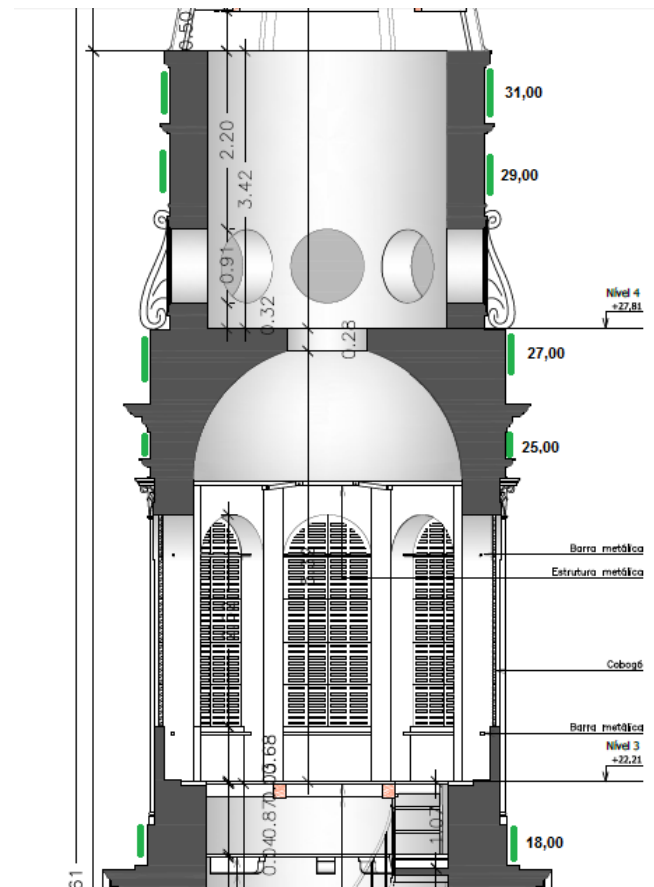
In the outer contour regions of the towers, at levels 18.00, 25.00, 27.00, 29.00 and 31.00, reinforcements will be developed, according to the following steps and illustrated in figure 23:

Figure 23. Reinforcing by grating the columns

A) Preparation of an auxiliary structure to support a scaffolding platform: Insert into the base of the columns wooden elements that will support 4 transverse metal profiles, which supported the scaffolding lines.

B) Mount the 8 columns of scaffolding until reaching the edge of the base of the arrow, securing them against the walls of masonry;

C) Place a grid / net of protection on the scaffolds in order to avoid falling objects of the arrow;

D) With the aid of a boom crane attached to a protective structure, remove the copper parts from the cover of the arrows.
