## Structural and functional conditions of bridges and viaducts on federal highways in Pernambuco

**Keywords:** pathological manifestations; structures; inspection; bridges and viaducts.

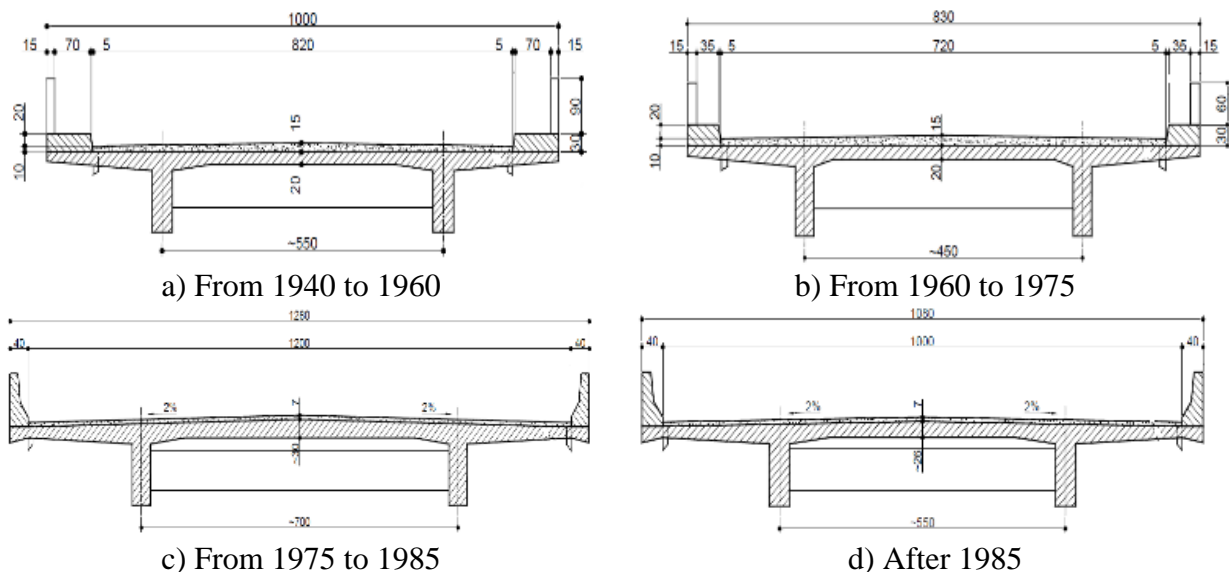
Figure 1. Evolution of the transverse cross-section of federal road bridges (Measurements in cm)

A survey was also carried out to identify the construction periods and the typical mobile loads of each structure. Failure to supply most of the original designs meant that much of this information was obtained by comparing the evolution of the bridge cross-sections of federal highways over time with the mobile loads that were used on bridges built in the respective periods, as shown in Figure 1.

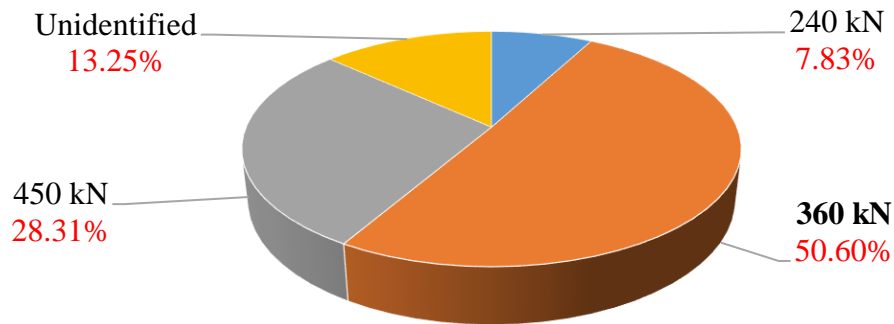
Regarding the project model load, Figure 2 shows that 50.60% of the structures were qualified with 360 kN loading. The mobile loads of 450 kN, currently used, represent 28.31% and those of 240 kN represent 7.83% of the total sample. There were also 13.25% of structures whose project model loads were not possible to identify.

Figure 2. Project model load of bridges evaluated

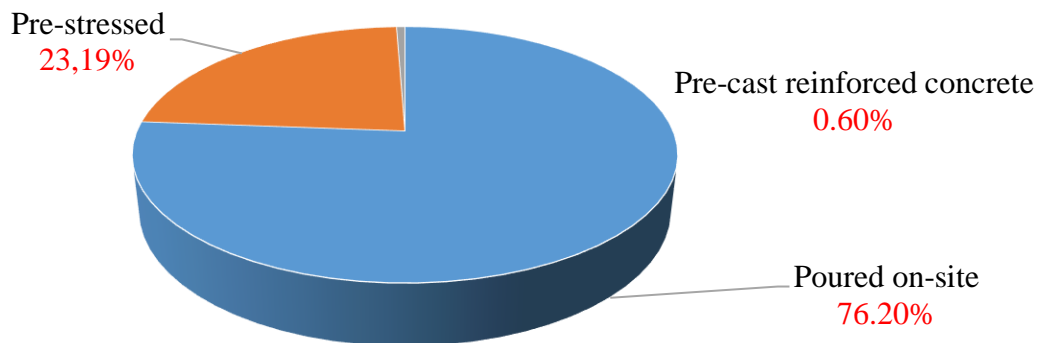
Regarding the constructive system, it was verified that reinforced concrete poured on-site was predominant, used in 76.20% of the bridges and viaducts. The second most prominent system was prestressed concrete, adopted in 23.19% of the structures. Pre-cast reinforced concrete accounted for 0.60%. These data are shown in Figure 3.

Figure 3. Constructive systems used on evaluated bridges

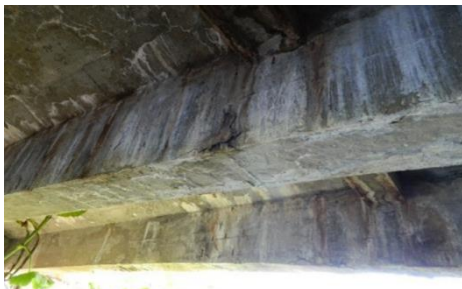
Figure 4. Presence of efflorescence, displacement of concrete coating, and reddish-brown spots due to the corrosion of reinforcement

- Restoration of the superstructure drainage system, due to the fact that 88.25% of the bridges analyzed had infiltrations and efflorescence in the deck concrete and 27.71% had damaged and/or destroyed drains.
- Recuperation with the application of a concrete layer over the bridge deck, since 52.71% of the sample bridges showed concrete displacement.
- Treatment and/or replacement of corroded reinforcements, which were found in 51.81% of the structures inspected.

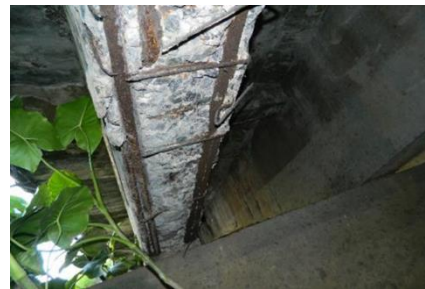
Figure 5. Exposed and rusty reinforcement on beams, some with broken strips

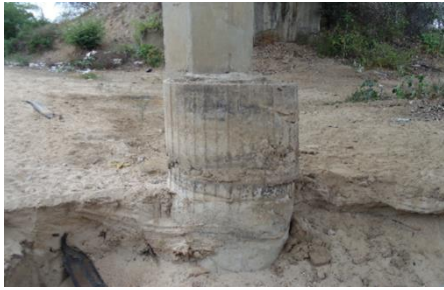
Figure 6. Erosion of the foundation and misalignment of the pillar in relation to the pipe

- Replacement of damaged or destroyed New Jersey barriers and guardrails, observed in 18.07% of the bridges studied.
- Correction of joint failures, many caused by differential pressure and erosion, found in 16.26% of the bridges. In such cases, it is necessary to carry out geotechnical and hydrological studies to verify the safety of the foundations and the flow section, to determine the necessity of reinforcement and protection against erosion.

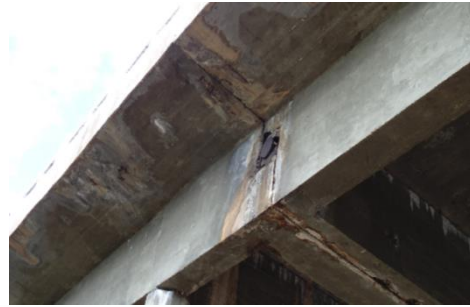
Figure 7. Metal bearing on a Gerber tooth with visible damage and infiltration

- Replacement of damaged support units responsible for changes in the transmission of the forces on the bridge deck to the mesostructure, occurring in 7.53% of the bridges.

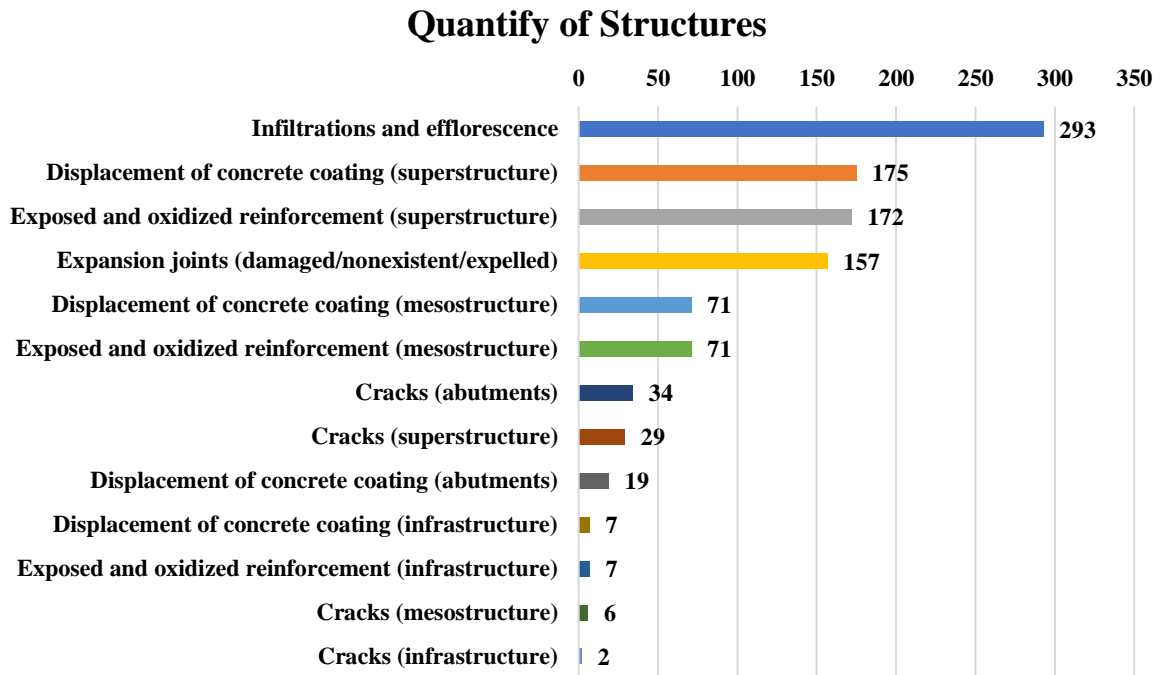
Figure 8. Occurrences of pathological manifestations in the analyzed structures

Figure 8 synthesizes the highest incidences of pathological manifestations for the evaluated set, showing the predominance of infiltrations and efflorescence, present in 293 SES. The following anomalies are also worth mentioning: displacement of the concrete (of the superstructure) in 175 structures, exposed and oxidized reinforcement (of the superstructure) in 172 structures, and damaged and/or nonexistent expansion joints in 157 SES.

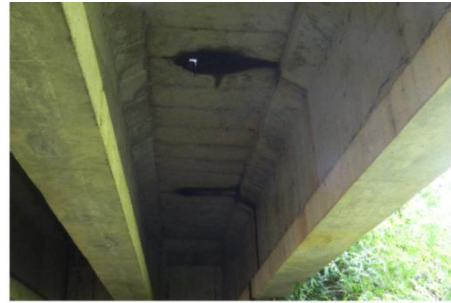
Figure 10. Damaged drain causing infiltration and moisture spots between the beams

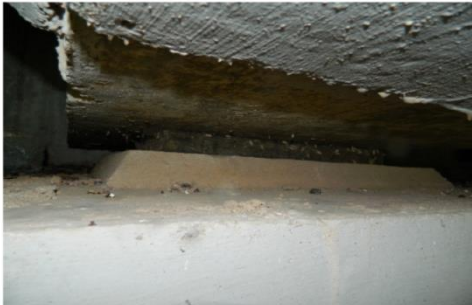
Figure 11. Deformed elastomeric bearing

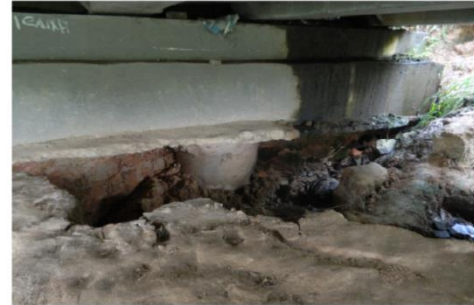
Figure 12. Extreme erosion around the foundation

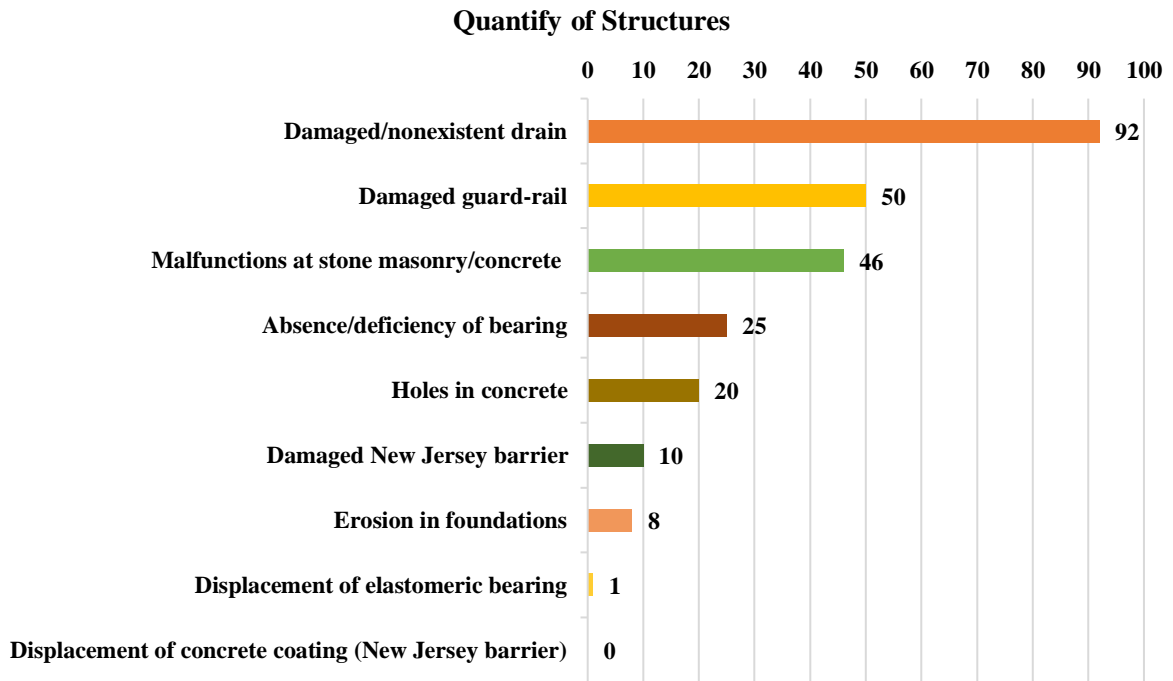
Figure 13 quantifies the principal damage types found in the analyzed set of structures. It was verified that 92 bridges had damaged and/or nonexistent drains. Next most prevalent were damaged guardrails (50 SES), followed by breakdowns in stone/concrete masonry (46 SES), as well as the lack or deficiency of bearings (25 SES), and holes in the concrete (20 SES). Other types of damage occurred less frequently.

Figure 13. Principal types of structural damage found in the set of structures analyzed

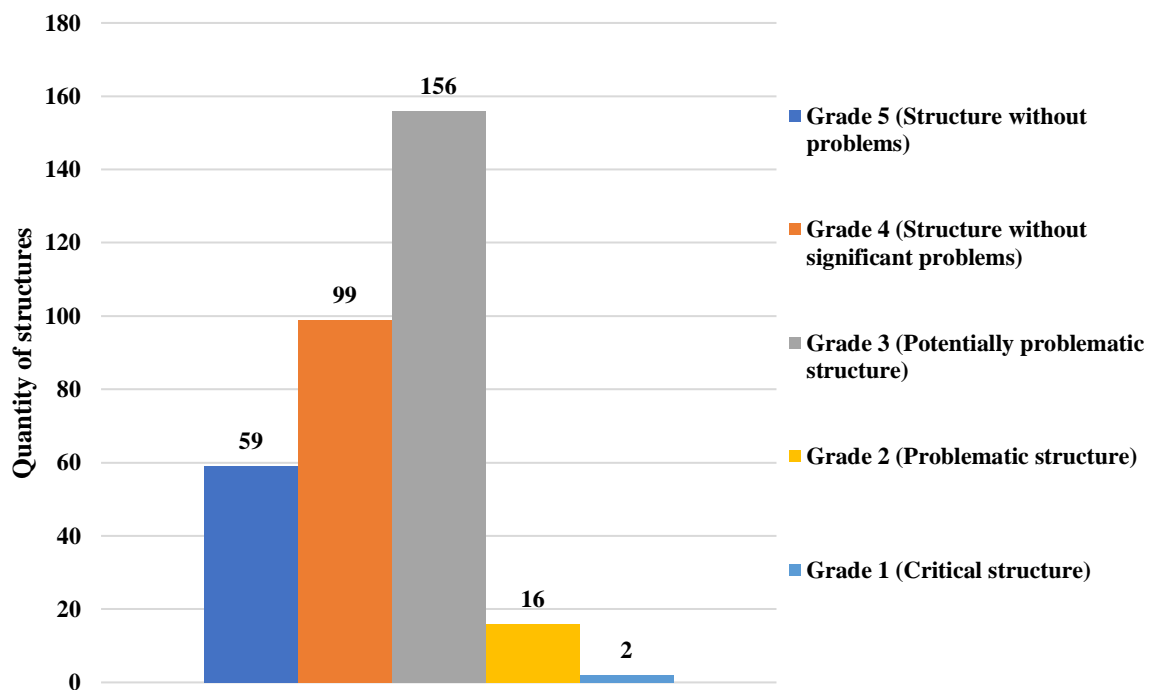
The application of these criteria to the sample studied is shown in Figure 14, which indicates that 156 SES can be classified as potentially problematic (grade 3), or 46.99%. It is important to note that 174 structures were evaluated as having grades between 1 and 3 (critical to potentially problematic), which is equivalent to 52.41% of the sample studied. Only 59 structures (17.77%) received a grade of 5.

Figure 14. Stability conditions according to DNIT 010/2004-PRO
