## Infrared thermography as a non-destructive test for the inspection of reinforced concrete bridges: A review of the state of the art

J. H. A. Rocha<sup>1\*</sup>, Y. V. Póvoas<sup>1</sup>

This article aims to present the methodologies, advantages and limitations of the infrared thermography test for the inspection of reinforced concrete bridges. A systematic review of area-related articles and academic material was carried out. This review focus mainly on passive thermography in both laboratory and field studies. A critical approach to the available information regarding its scope was used. This technique is presents a real alternative for detecting defects in reinforced concrete bridges because the more superficial the anomalies in these structures are, the more effective it is. Also, depending on the work to be carried out, a variety of factors should be taken into consideration for better results. Moreover, infrared thermography is more effective when combined with other non-destructive tests.

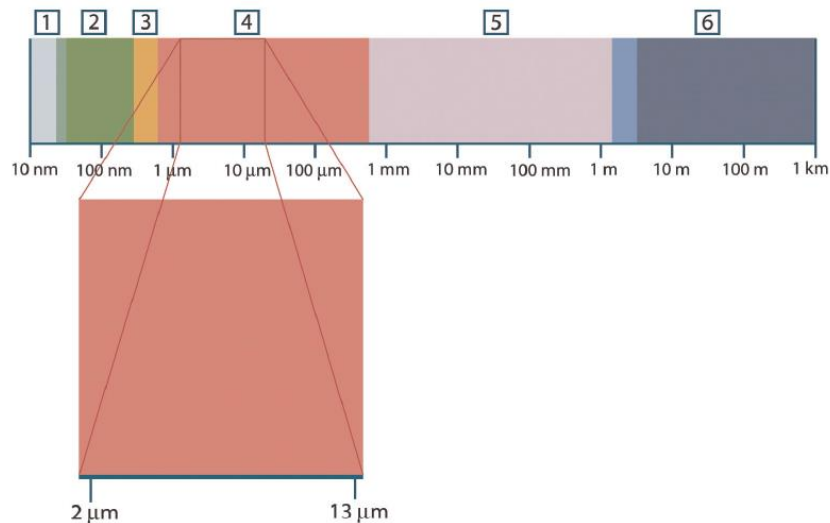
Figure 1. Electromagnetic spectrum. 1: X-ray; 2: Ultraviolet; 3: Visible; 4: Infrared; 5: Microwave; 6: Radio wave (FLIR, 2013)

All objects with temperature above absolute zero (0 K) emit radiation in the infrared range of the electromagnetic spectrum. According to the wavelength, infrared radiation is in the range of 0.75 to 1000  $\mu\text{m}$  (micrometer), located between the visible and microwave range (Figure 1) (Clark; McCann; Forde, 2003; Meola, 2012; Bagavathiappan et al., 2013).

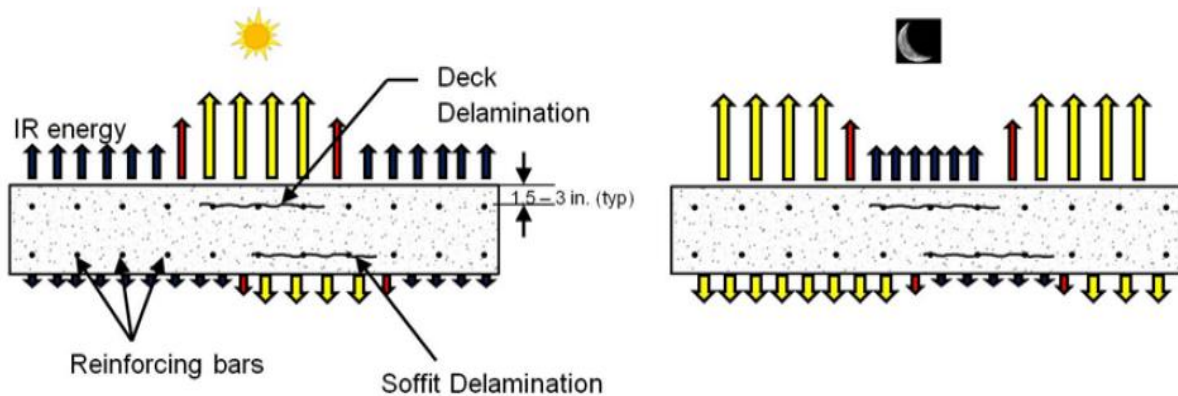
Figure 2. Infrared energy emitted from concrete under day and night conditions (Washer et al., 2015)

The concept of infrared thermography applied for inspection is based on the fact that the voids, defects or anomalies within the concrete affect the heat transfer properties of the structure. As the temperature rises during the day, the defects interrupt the heat transfer inside the concrete,

heating these areas rapidly, and this is because the defects are filled with air or water, which have a different thermal conductivity from that of concrete. Conversely, at night, when temperatures drop, the same defect areas are cooled faster than problem-free areas (Figure 2). The cameras can detect these defects through the measurement of the radiation emitted by the surface of the concrete surface with the Stefan-Boltzmann equation (1) (Maser and Roddis, 1990; Washer; Fenwick; Bolleni, 2010; Sham; Lo; Memon, 2012; ACI, 2013; Gucunski et al., 2013; Farrag; Yehia; Qaddoumi, 2016; Rehman et al., 2016; Vemuri and Atadero, 2017).

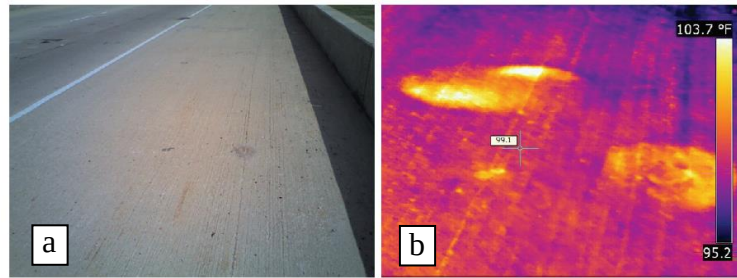
Figure 3. Detection of delaminations: a) Digital photography and b) Thermogram (Washer; Fenwick; Bolleni, 2009)

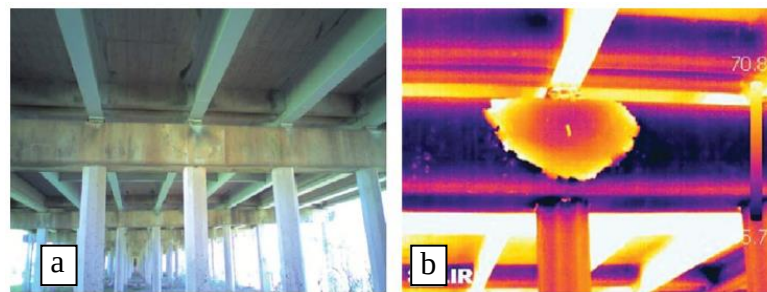
Figure 4. Application in bridge infrastructure: a) Digital photography and b) Thermogram (Washer, 2012)

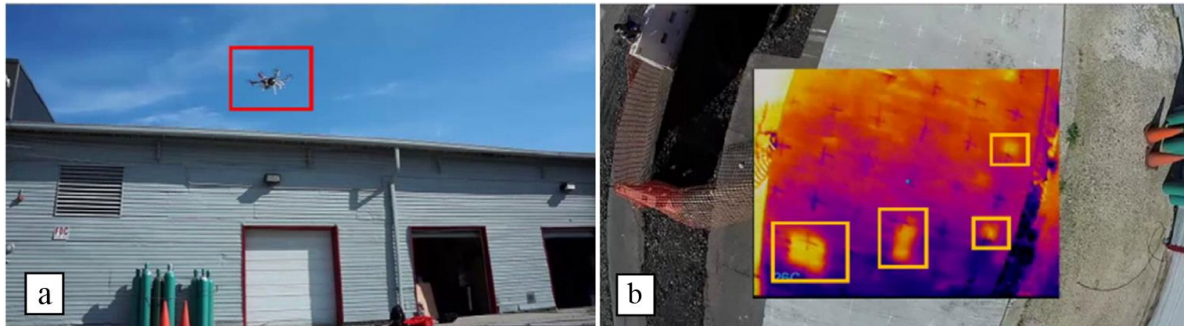
Figure 5. a) UAV on the location of the delaminations, and b) Delaminations identified in real time from the drone (Ellenberg et al., 2016)

Ellenberg et al. (2016) demonstrates the ability to use UAV (Unmanned Aerial Vehicle) equipped with a thermographic camera to identify delaminations during the inspection of bridges, as shown in Figure 5.
