## Experimental evaluation of colored HSC column in fire conditions

C. Britéz<sup>1</sup>, P. Castro-Borges<sup>2</sup>, A. Berto<sup>3</sup>, P. Helene<sup>1</sup>

In recent times it has been common to associate high-strength concrete with a greater susceptibility to explosive type spalling, when subjected to high temperatures. In part, this doubt is a result of some experimental programs that are carried out on small unreinforced concrete samples (specimens), which could substantially influence the structural concrete behavior in fire conditions. This paper presents an experimental program, carried out in Brazil on a high strength colored reinforced concrete column (HSCC), eight years-old,  $f_c, 8 \text{ years} = 140 \text{ MPa}$ , basalt coarse aggregate, cross section of 700mm x 700mm, tested under no load and with three faces exposed to standard fire curve ISO 834 for 180min (3h). The results demonstrated, in this case, that HSCC maintained integrity under experimental fire and that the iron oxide pigments can work as an excellent natural thermometer, contributing to the evaluation of the structure post-fire simulation.

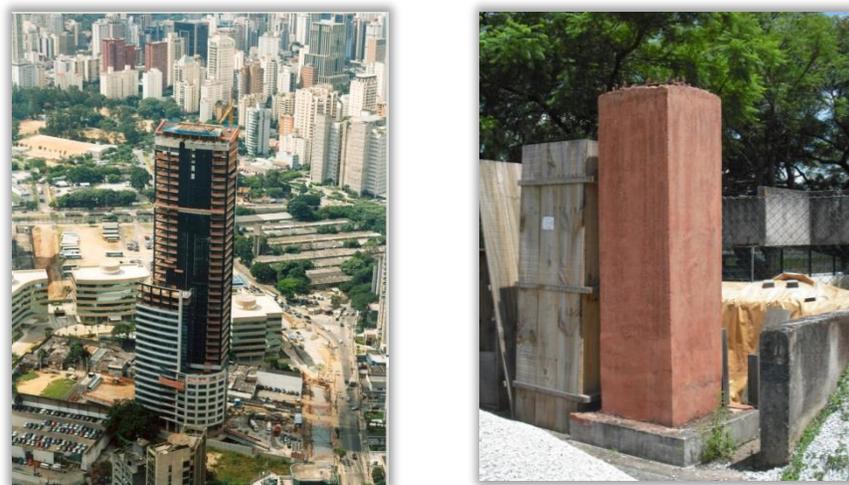
Figure 1. (a) *e-Tower* building, 162m high; (b) HSCC prototype replica, cast at the EPUSP laboratory yard, São Paulo, Brazil

Recently, Brazil was recognized internationally by breaking the record of cast-in-place high strength colored concrete, HSCC, which was employed in several columns of the *e-Tower* building in São Paulo City at the southwest region of the Country (Hartmann; Helene, 2003). When *e-Tower* was built in 2002, some replicas of these columns were cast-in-place at the yard of the Escola Politécnica of the University of São Paulo *EPUSP* (Figure 1) to serve as prototypes for future tests regarding mechanical behavior, durability and fire simulation.

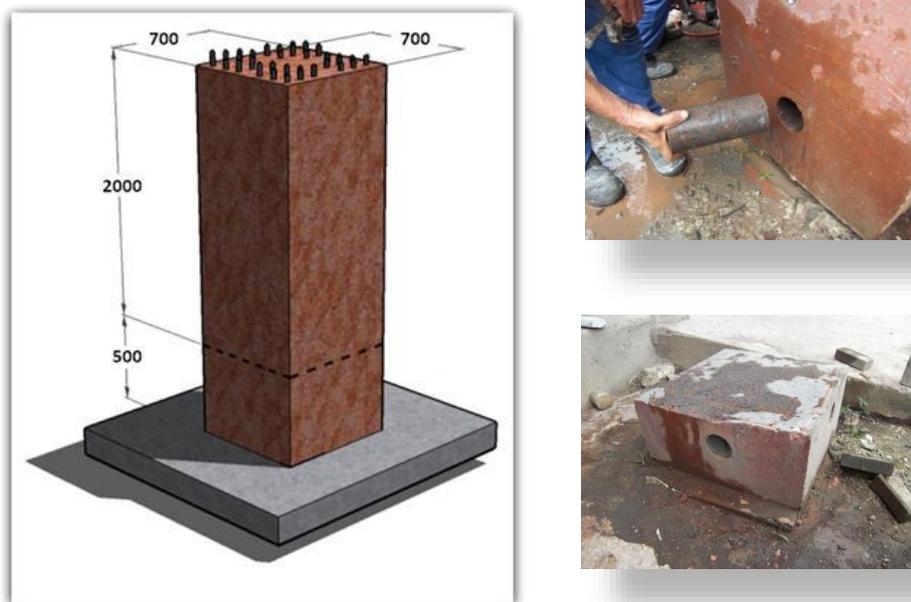
Figure 2. Place at the bottom of the prototype columns where the samples were removed and this lower part of prototype column (remaining), after cutting and extraction. (Note: measures are in mm)

At the beginning of year 2010, before starting the experimental program, cylindrical samples were extracted from the bottom of one of the prototype columns, from a region previously planned for remaining as reference concrete (Figure 2). These samples were tested for compressive strength and presented the characteristic compressive strength of  $f_{c,8years} = 140\text{MPa}$ , higher than compressive strength obtained from test samples cast in 2002, of  $f_{cm,28days} = 125\text{MPa}$  (Hartmann; Helene, 2003). The original dosing of this high strength colored concrete used at both *e-Tower* Building and prototype columns can be seen at Table 1.

The prototype-column with an approximate weight of 2.5ton was cut next to the bottom (Figure 2), leaving a remaining reference specimen of the same column to be tested and later on was rigged and transported to the place where the fire simulation test was to be carried out. The experimental program was developed at the furnace of the Fire Safety Laboratory of the Technological Research Institute (Instituto de Pesquisas Tecnológicas - IPT) of São Paulo State. They have a furnace whose dimensions are compatible with the devised technical program. The furnace that was utilized has five burners for natural gas, located at both lateral walls in a way to avoid any frontal contact between them.

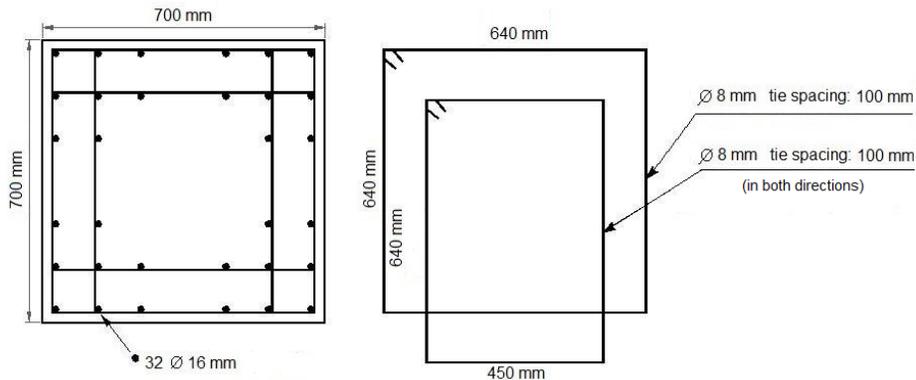
Figure 3. Geometry of the cross-section and reinforcement arrangement of prototype column

The prototype cross section was a square, 700mm x 700mm, with no variation all the way up its 2000mm height. The prototype (Figure 3) had a mean concrete rebar cover of 25mm, longitudinal  $\phi = 16\text{mm}$  reinforcing and transversal reinforcement (stirrups), of  $\phi = 8\text{mm}$  each 100mm (in both directions). Reinforcement steel is CA 50 grade (yielding strength  $f_y = 500\text{MPa}$ ).

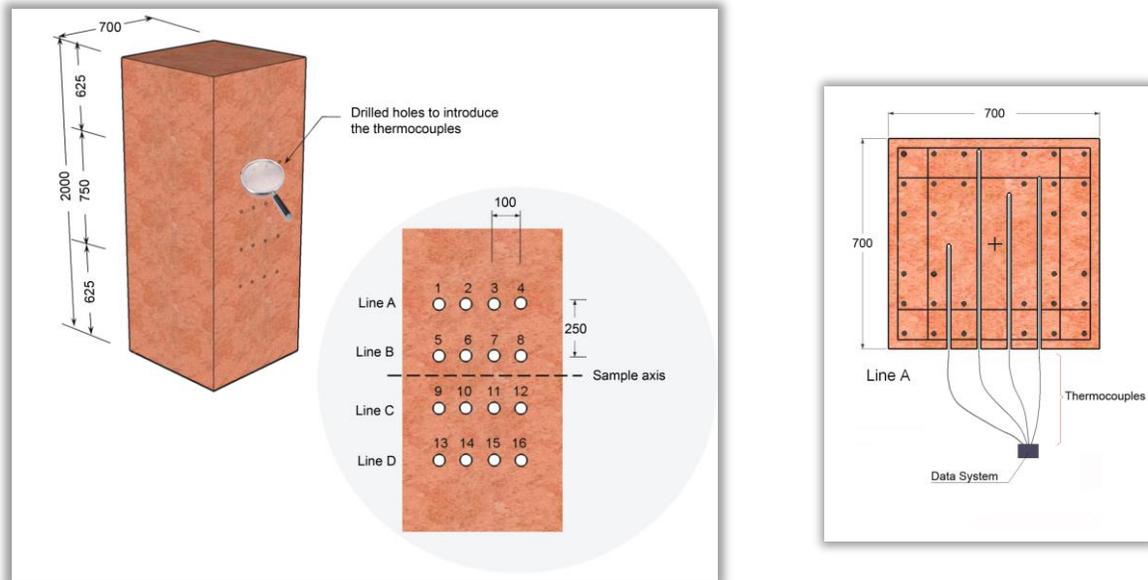
Figure 4. Thermocouples: position and depths (mm) on HSCC prototype-column

Thermocouples embedded inside the prototype column were installed in the region close to the central axis of one of the faces of the column, in four independent lines and with random depths and each line always had four different depths. In all sixteen K-type,  $\phi = 3\text{mm}$  thermocouples were installed with an AISI 316 stainless steel sheath (Figure 4).

The furnace temperature (complying to ISO 834 standard heating curve) was controlled and measured through six K-type thermocouples, maintained at a distance of 150mm of the specimen faces, distributed in strategic points, being two for each face exposed to the fire; positioned at 1/3 and 2/3 of the total height of the prototype column. The K-type thermocouples used for this purpose were of *cromel-alumel*, isolated with ceramic elements and protected by a metal sheath, with 1.2mm diameter cables.

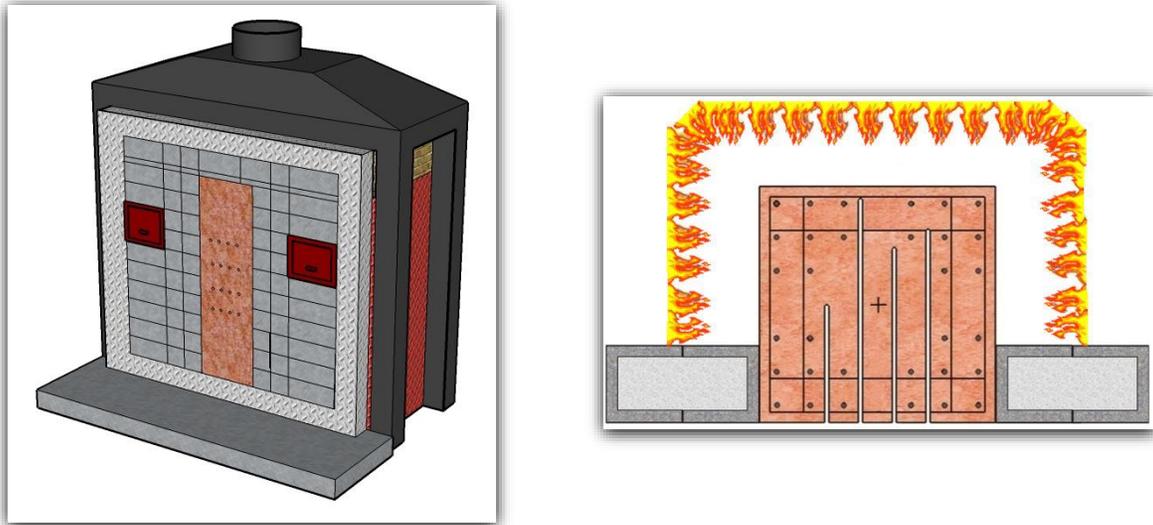
Figure 5. Testing furnace, prototype cross-section and thermocouples placing, and surfaces subjected to direct heating.

The prototype column was tested without load and with three faces exposed to fire, as a result of the furnace dimensions, which enabled that one of the faces, (where thermocouples were installed), could be kept with free access during the test (Fig. 5). The prototype column was covered with a refractory ceramic fiber blanket “XE” type, density 64kg/m<sup>3</sup> at both ends (extremities: bottom and top) to simulate the unidirectional heat propagation during the test. An auxiliary masonry wall was built to close the frontal face of the furnace and two steel hatch windows were installed for any inspection emergency during the test.

Schemes of actual and hypothetical transversal section colors after the fire simulation test can be observed in Figure 10. Colors were produced by the existence and chemical reduction reactions of the synthetic iron oxide inorganic pigment ( $\text{Fe}_2\text{O}_3$ ) promoted by the heat. At Figure 9(b) a hypothetical schematic drawing of the transversal section, admits by inference a symmetrical damage of the column at four sides, not taking into account the parts that were sided by masonry (see Figure 5).

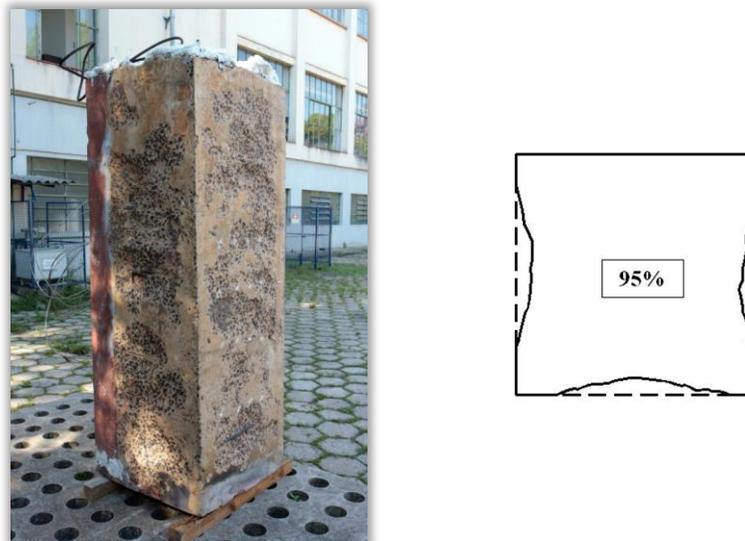
Figure 6. Column integrity and preserved cross section detail, after 180min of standard fire curve.

During the test, spalling effects were mainly observed and analyzed. A series of short pop outs (*popping* type, as per *fib* Bulletin n° 38 classification<sup>18</sup>) began after 3 min indicating surface spalling on the three faces exposed to fire, continuing up to about 40 min of testing. After having opened the furnace (3days after the test, to enable natural air cooling) and the specimen removed, it was verified that the spalling was uniform and just at surface over the three heated sides, characterized by little delaminations, without evidence of significant concrete fragments on the furnace floor (Figure 6).

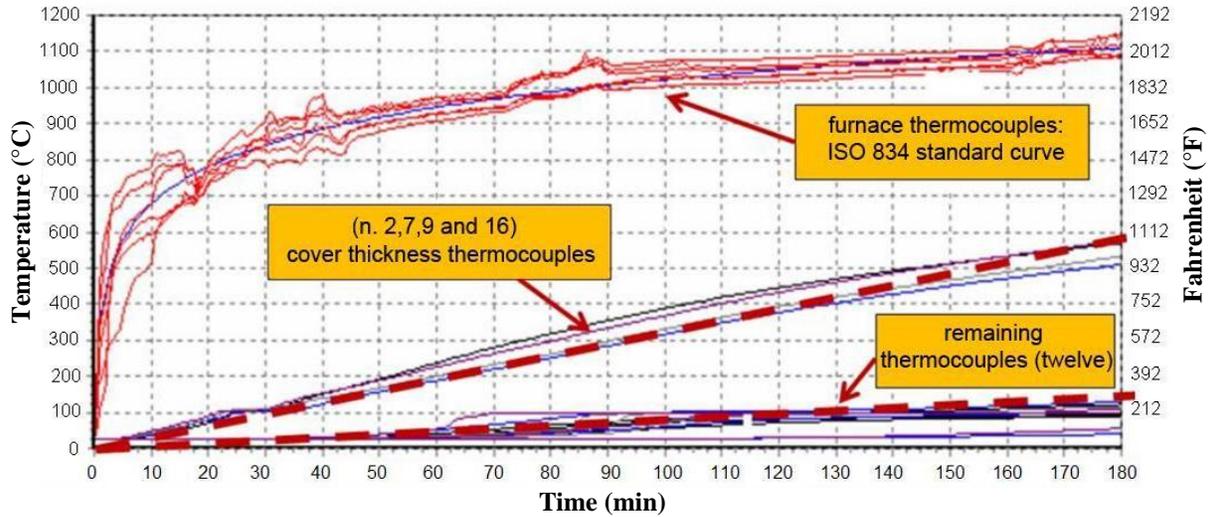
Figure 7. Temperature history in furnace (fire standard ISO 834) and inside the HSCC specimen.

During the 180min (3hr) fire test, six thermocouples monitored the ISO 384 standard curve evolution inside the furnace and other sixteen thermocouples monitored heat propagation inside the prototype column (embedded). Heat propagation (Figure 7) at column interior was uniform according to the depth of the thermocouples. It is possible to observe (Figure 8) that at 180min the thermocouples positioned at the rebar cover depth (25mm from the surface) did not registered temperatures higher than 600°C although inside the furnace, temperature was about 1100°C. In this case, the low heat diffusion and the consequent high thermal gradient could be attributed to the coarse aggregate type (basalt), which has favorable thermal properties when exposed to heat (*fib* Bulletin n° 38, 2007).

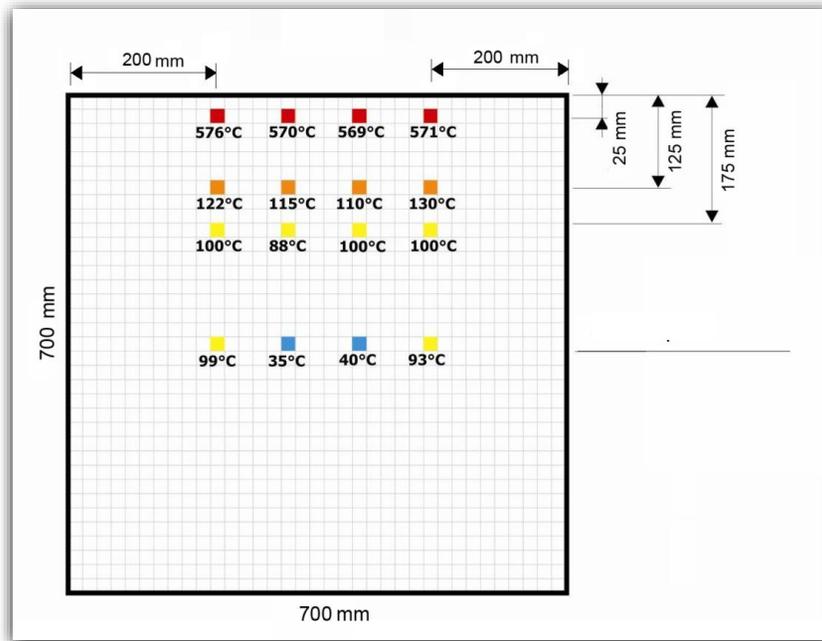
Figure 8. Cross section temperature map in the specimen at 180min of the standard fire curve.

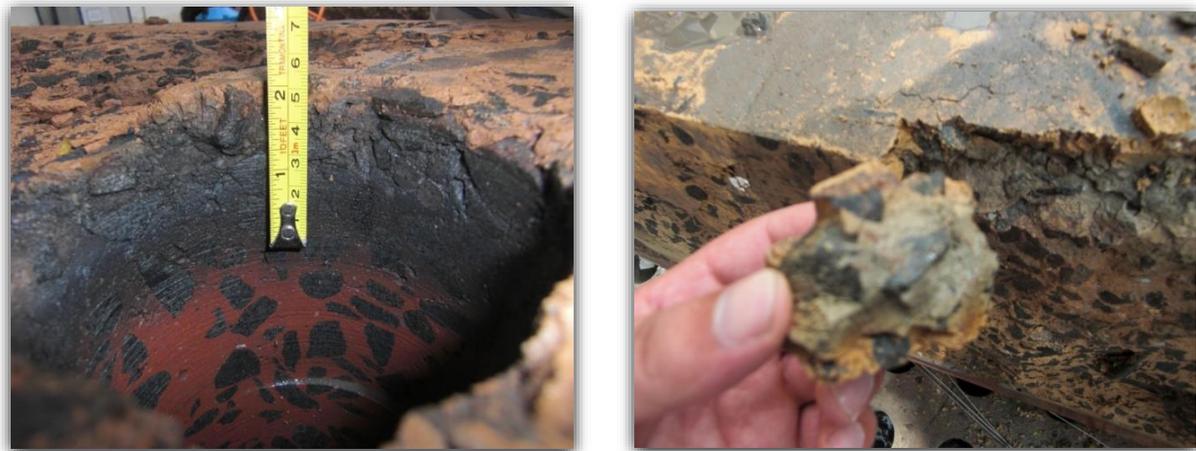
Figure 9. Colorimetric index prototype column.

Due to the use of inorganic pigmentation with iron oxide, which was added to the high strength colored concrete mix (4% in cement weight), it was possible to evaluate qualitatively the column prototype region which was damaged by the exposure to heat during 180min (3hr).

In this case, principally due to the geometry and the size of the transversal size of the column, as well as the conditions of the experiment (slightly reducing atmosphere and a long exposure time to fire), it was verified that at least a depth of 55mm of the specimen showed a darker or black coloration at the central part of the sides and also that color alteration was not so evident at the column surface and at some depth of the corners (Fig. 9), where color was less dark and a more faded (orange hue).

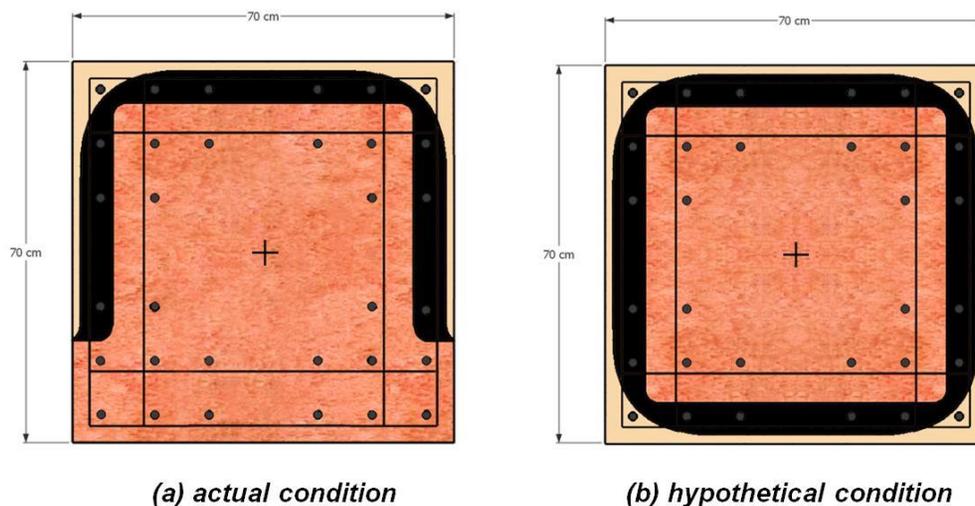
Figure 10. Schemes of actual and hypothetical cross-section colors after the fire simulation test

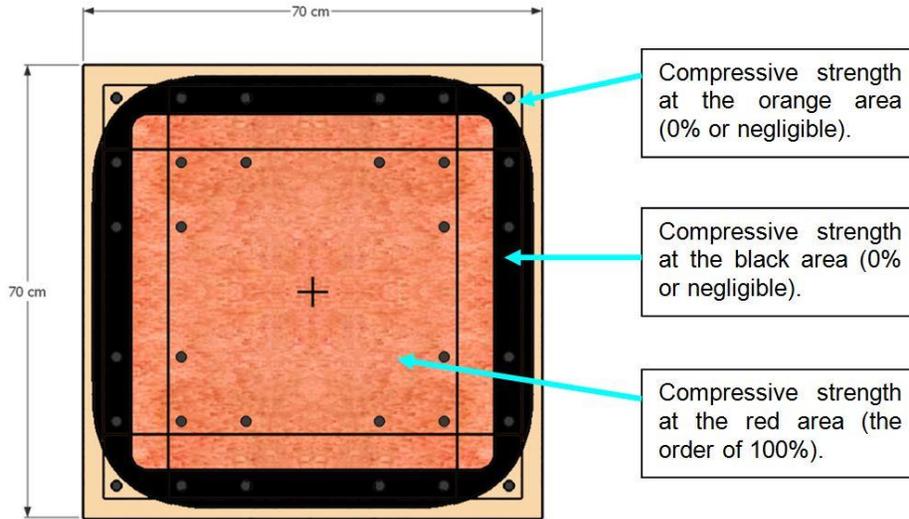
Figure 11. Concrete residual mechanical properties, post-fire simulation.

Several cores were extracted orthogonally from the transversal section, and these extractions were done in regions coinciding with the different depth of the thermocouples, excepting thermocouples located at rebar cover region mean depth (25mm), where the compressive strength was negligible (friable concrete). Core sample extractions were performed by the IPT Construction Materials Laboratory Team with an electrical core drilling machine, model HCCB 6 *Hydrostress* made by *Tyrolit do Brasil*. Compressive strength tests were performed on a *Mohr & Federhaff – AG* hydraulic press, with a 200tf capacity and a precision of 100kgf.

The results obtained showed that the dark (black) region do not have a significant mechanical strength (it can be considered negligible: friable concrete) and that the region where the reddish original color was preserved (immediately after the dark color, at a 55mm distance from the external face, measured orthogonally) maintained residual mechanical strength very similar to that of the column central portion, i.e., the original mechanical resistance (prior to fire simulation,  $f_{ck} = 140\text{MPa}$ ). Color scheme of Fig. 11 shows a good correlation (Fig. 12) with precursor investigation done by Anderberg (1978b) *apud* Purkiss (1996), commonly known as the “500°C Method” (exclusion of peripheral portion that reached temperatures about 500°C or higher, by admitting a significant reduction of mechanical strengths in these regions).

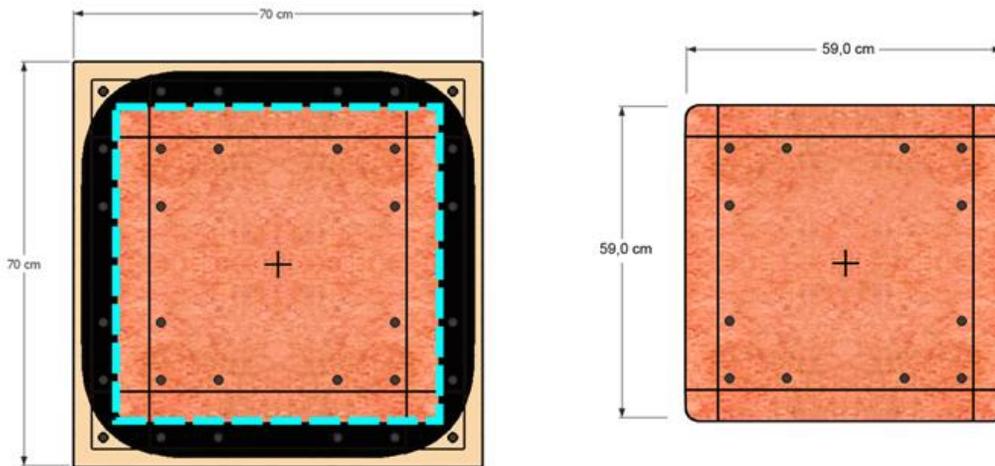
Figure 12. Virtual cross-section reduction due to the residual compressive strength post-fire simulation (hypothetical condition).

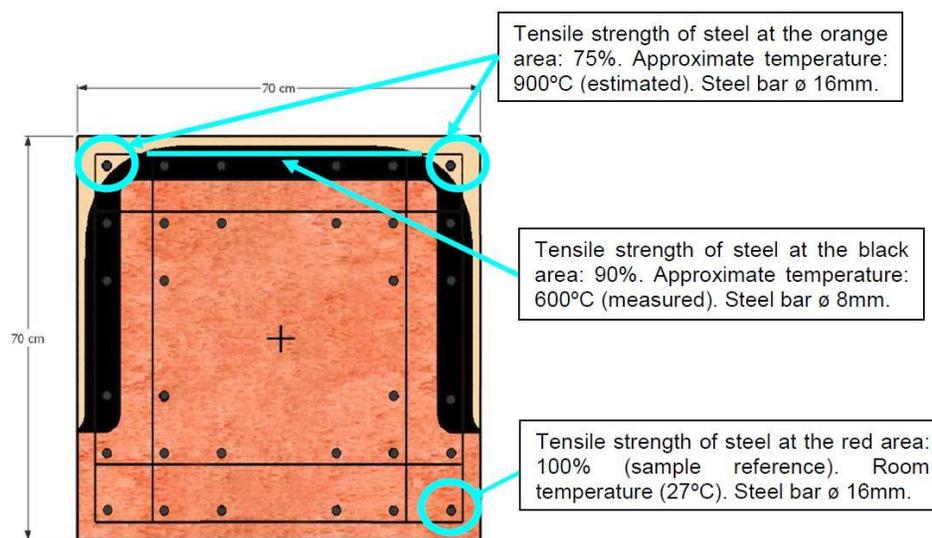
Figure 13. Steel residual mechanical properties, post-fire simulation.

As per the test results obtained, it was possible to observe that the corner longitudinal rebars ( $\phi$  16mm), after a slow cooling at room temperature, underwent a reduction of about 25% of their mean tensile strength, if compared to reference samples. At the central part of the sides, (transversal rebars,  $\phi$  8mm), a quite lesser reduction of about 10% was observed. The results obtained show a good correlation with other experimental works (Suprenant, 1983; Cabrita Neves; Rodrigues; Loureiro, 1996; Purkiss, 1996), which unanimously point to the fact that residual properties of steel submitted to temperatures above approximately 550°C undergo irreversible losses and that above 700°C these losses become higher, and they can reach 30% or even more. Reaserchers (Cabrita Neves; Rodrigues; Loureiro, 1996) also remarked that the lesser the rebar diameter, the lesser the strength reduction. Strength reduction is higher for bigger diameter rebars and, principally, when they are cooled at room temperature. Color scheme at Figure 13 indicates the extraction locations, comparing them with the temperature estimates and the rebar tensile strength reduction.

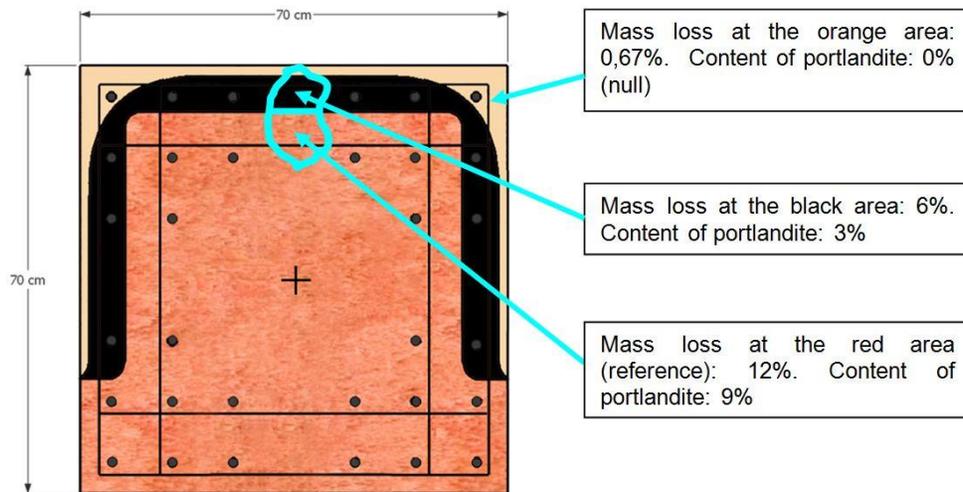
Figure 14. Mass loss and content of portlandite identified post-fire simulation.

On the other hand, it was seen that thermal analysis potentially contributed to indicate concrete degradation extents, which was more evident by verifying the mass loss of the samples. It was possible to verify that samples located at peripheral regions of the prototype column had less significant mass losses related to regions that maintained the original red color. At dark (black) regions it was found a total mass loss of about 6% and at orange regions (corners) a total mass loss of only 0.67%. The *portlandite* contents also underwent significant reductions in these regions, being null at corner region samples (orange color) and 3% at dark regions. As a comparison basis, the sample extracted from the region that maintained the red color had a total mass loss of about 12% and a portlandite content of about 9%, which indicates the existence of compounds that are still hydrated at these regions (Figure 14).

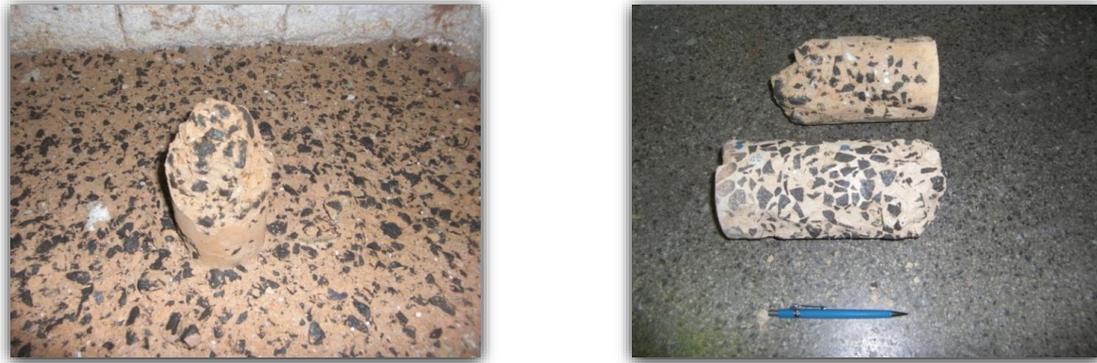
Figure 15. Small cylindrical unreinforced HSCC specimens partially disintegrated after fire testing; they had been placed together with the large prototype column.

1. The specimen dimensions, the cross section and the rebar arrangement and reinforcement ratio of the prototype column seem to have decisively and positively influenced the thermal performance and the high strength colored concrete behavior under fire exposure;
2. It should be observed that in this experimental program, just as an example, three cylindrical (100mm x 200m unreinforced concrete specimens and with the same age and mix concrete, were placed inside the furnace, which were in general disintegrated (see Figure 15) after

180min (3hr) of fire testing. Thus, it is recommended that small unreinforced concrete specimens not be utilized to evaluate spalling. Although they are useful for evaluating thermal concrete properties at different temperatures, they are not recommended to evaluate spalling of structural concrete members, as they may underestimate, in some cases, the high strength concrete performance in fire situations;
