Performance of fire protective coatings in reinforced concrete elements submitted to high temperatures

C. Brites^{1*}, V. P. Silva², M. Carvalho³, P. Helene⁴

DOI: <http://dx.doi.org/10.21041/ra.v10i1.430>

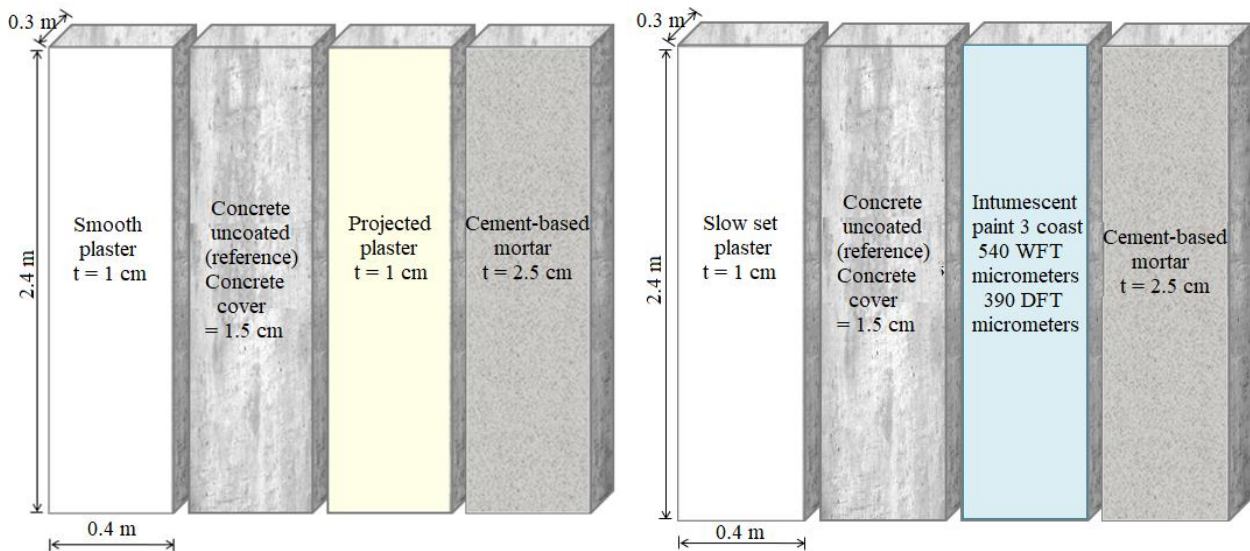
Figure 1. Concrete elements and coating systems that went through tests in both fire simulations (1st test event at left and 2nd test event at right).

In addition, the protective capacity of each coating and its insulation were analyzed through the evolution of temperatures inside the concrete elements, which were monitored using seven thermocouples per element (28 thermocouples per test), strategically installed. Per element, six thermocouples were positioned inside the concrete mass and one outside, to measure the temperature insulation capacity), as shown in Figures 1 and 2.

On the four elements related to the first test event, three types of coating were applied (in one of them, the reference one, no coating was applied): a) type M30 smooth formulated plaster, hand applied with a steel trowel; b) type P80 projected plaster, applied using M280 projection machine; and c) general purpose industrialized mortar, sold in 20 kg bags.

On the four elements related to the second test event, three types of coating were also applied (as in the first event, in one of the elements, the reference one, no coating was applied): a) slow-set plaster, hand applied with a steel trowel; b) intumescent paint, type CKC-333; and c) general purpose industrialized mortar, sold in 20 kg bags.

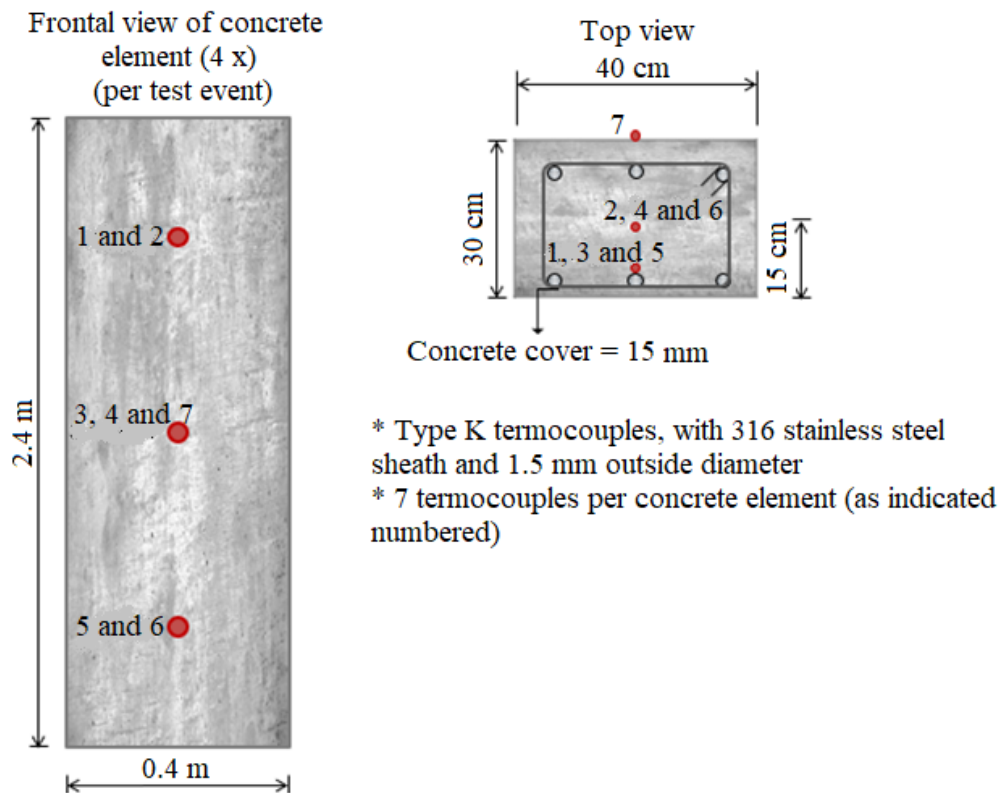
Figure 2. Detail of thermocouples location for both test events.

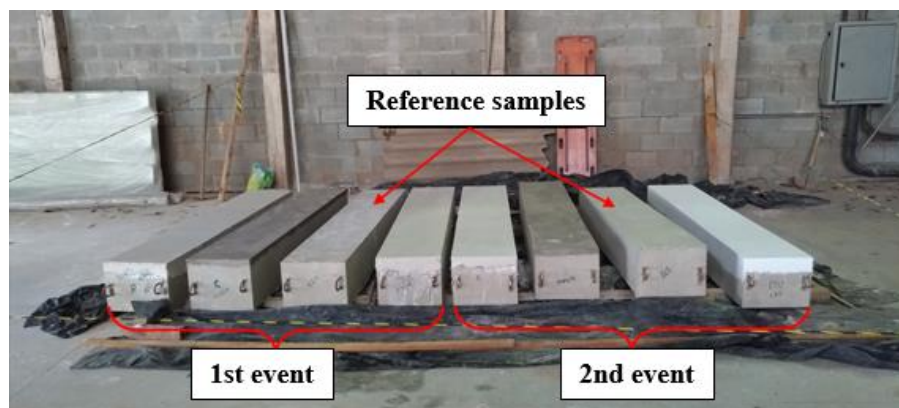
Figure 3. Detail of the finished elements with coatings applied, except for the reference samples.

The coating layers themselves were applied approximately 15 days after the preparation of the roughcast mortar [rolled for plaster and troweled for mortar], following the deadlines that commonly occur on site. From March 2018 to the end of August 2018, the elements were kept uncovered within IPT shed in order to promote enough hydration degree of the coatings, as in a normal work situation, as shown in Figure 3.

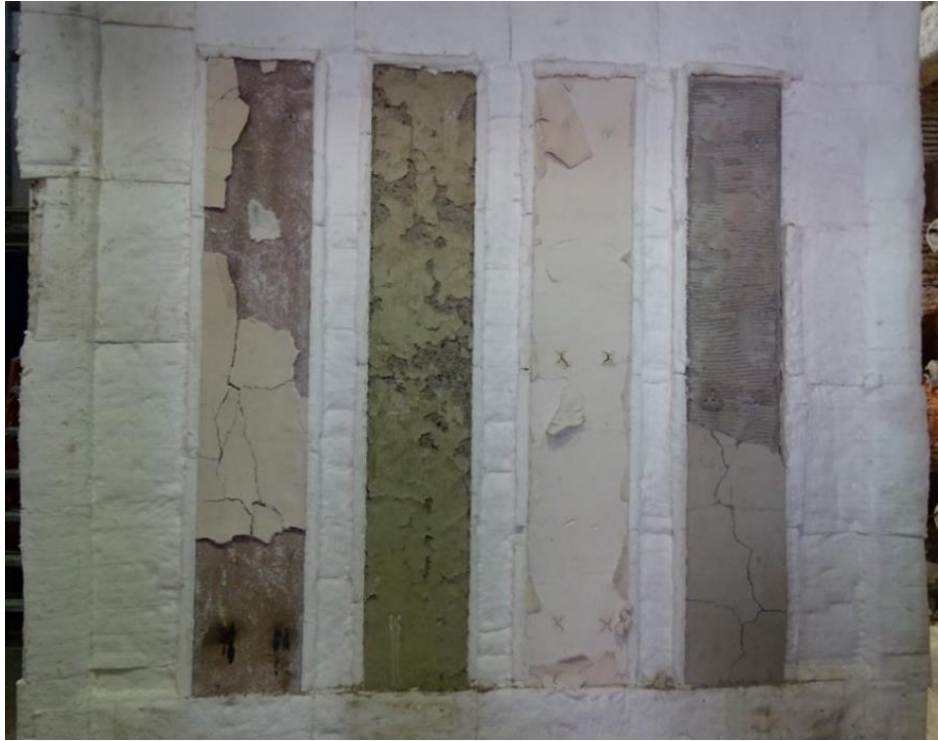
Figure 4. Detail of the elements and coatings condition after furnace opening (event 1): smooth formulated plaster coating, reference element, projected plaster coating and cement-based mortar coating.

24 hours after the end of the test, the furnace was opened for visual inspection of the elements. Surface spalling was observed, uniformly distributed on the face of the reference element. No reinforcement exposure was detected. Partial fall of the coatings was verified on the other elements, but no superficial damage to the concrete, as shown in Figure 4.

The smooth formulated plaster sample still had some coating remaining upon the furnace opening (without any integrity or adhesion), an amount of 46% of the total area exposed to the fire. For the cement-based mortar sample, this number was 41%. Carefully investigating the elements using a hammer, it was found that the remaining coatings of smooth formulated plaster and mortar were completely friable and the remaining part almost spontaneously displaced, however, the roughcast mortar applied as adhesion was intact in both elements.

Notably, the sample coated with projected plaster still had part of the plaster adhered (in 100% of the sample), partially intact and with little hollow sound. However, there was not enough integrity for a pullout test by conventional methods, as the sample could easily be removed by mechanical scraping. It was found that the remaining layer was working only as a sacrificial layer (physical barrier) and with poor adherence. Using a digital caliper, it was verified that a delamination of the projected plaster occurred, with a thickness of the order of 5 mm and remaining in the concrete sample a thickness of the order of 6 mm (1 mm deviation from the original predicted thickness of 10 mm).

The reference sample, uncoated, also caught attention for the small amount and depth of spalling, corresponding to an area of the order of 19% of the original sample at a typical (maximum) depth of about 6 mm (measured at several points). In other words, even in the uncoated reference element, there was no exposure of the reinforcement (which had a 15mm concrete cover). In fact, there was no exposure of the reinforcement in any element tested in this first event.

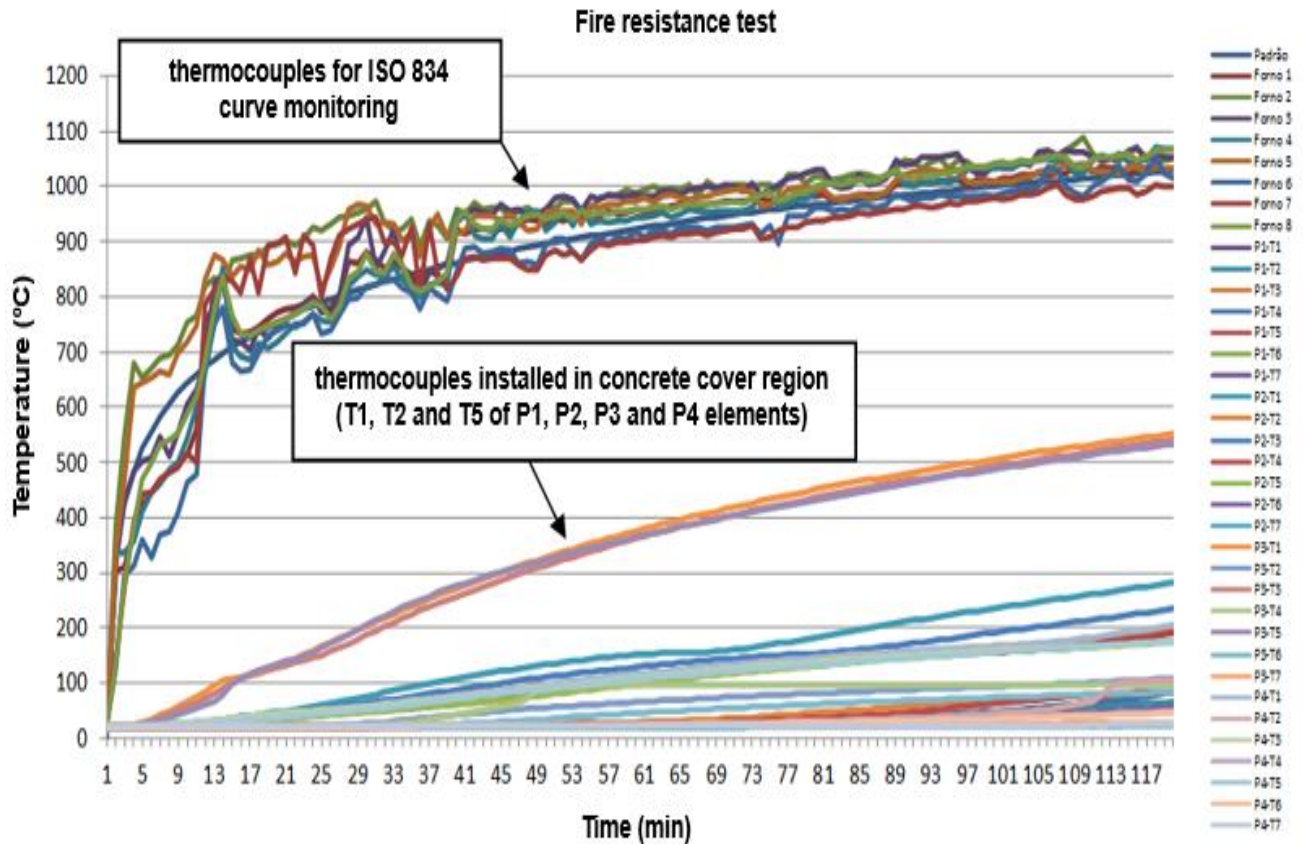
Figure 5. Temperatures obtained inside the furnace and inside the elements of 1st event.

The temperature evolution obtained inside the samples confirmed the visual and qualitative analysis of the fireproof coatings' performance. As observed in Figure 5, the heat distribution was uniform within the samples, according to the depth of each thermocouple. It is also noted that the three thermocouples located in the concrete cover region of the reference element differ greatly from the rest.

Also, regarding the measured temperatures (in the reference samples), there are a lot of similarities between the two test events, as it can be seen in Figures 5 and 8 (maximum 10 °C difference). In this case, on the average of the two test events, it can be stated that 15 mm of concrete cover thickness (without any coatings) was enough to record a temperature below 550 °C (on average 538 °C), for a temperature of almost 1000 °C in the furnace within 120 minutes of testing. That is, the 15 mm cover insulated a temperature of the order of 450 °C, without any reinforcement exposure for a maximum flaking of 7.5 mm with the rest of the cover (about 50%) still quite intact, as exposed in Table 3.

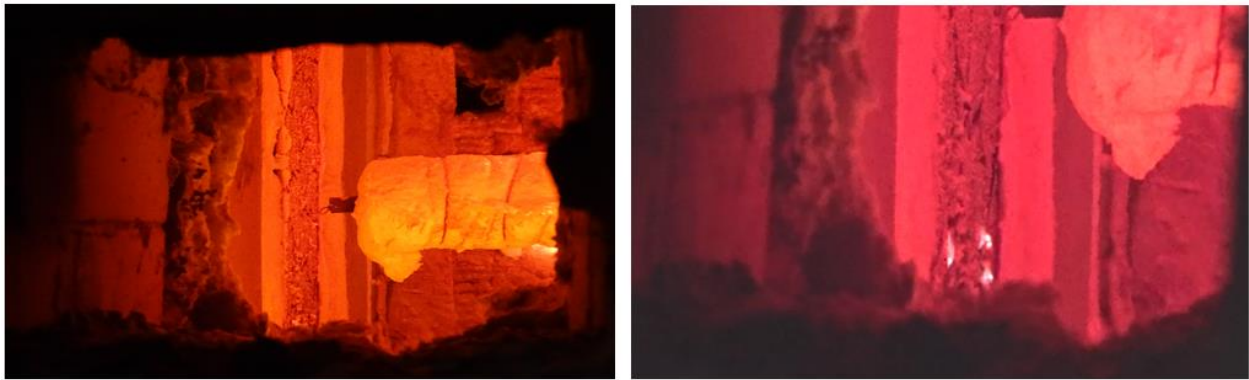
Figure 6. Detail of the “red-hot element” appearance of the intumescent paint-coated element (dark on the left) and small glowing spots on this same element (on the right).

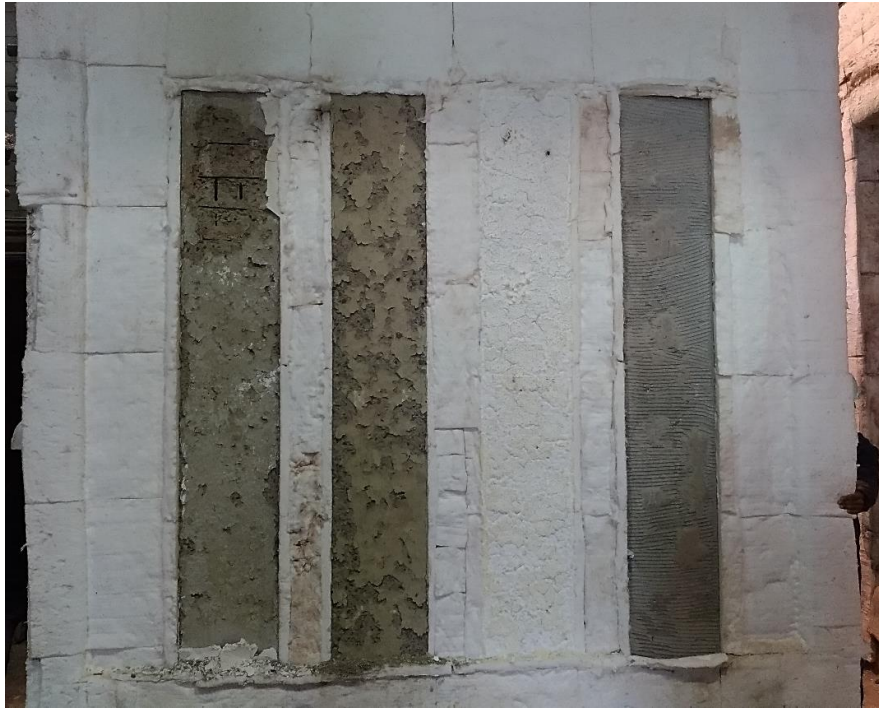
Figure 7. Detail of the elements and coatings condition after furnace opening (event 2): slow-set plaster coating, reference element, intumescent paint coating and cement-based mortar coating.

In the element coated with cement-based mortar, all the roughcast mortar kept adhered in the element and the coating itself detached almost entirely. Finally, the intumescent paint was detected covering the entire face of its concrete element, expanded and white colored, without exposing the concrete surface or reinforcement, as shown in Figure 7.

Using a digital caliper, it was found that there was severe spalling in the slow-set plaster coated sample, from 19 mm to 27 mm (maximum), over an area of approximately 20% of the total sample area (60 cm x 30 cm), as shown in Figure 7. The remaining friable part, in turn, had a thickness of the order of 2 mm to 3 mm (Figure 7), which was smaller than the reference sample one in of both events, as will be noted below.

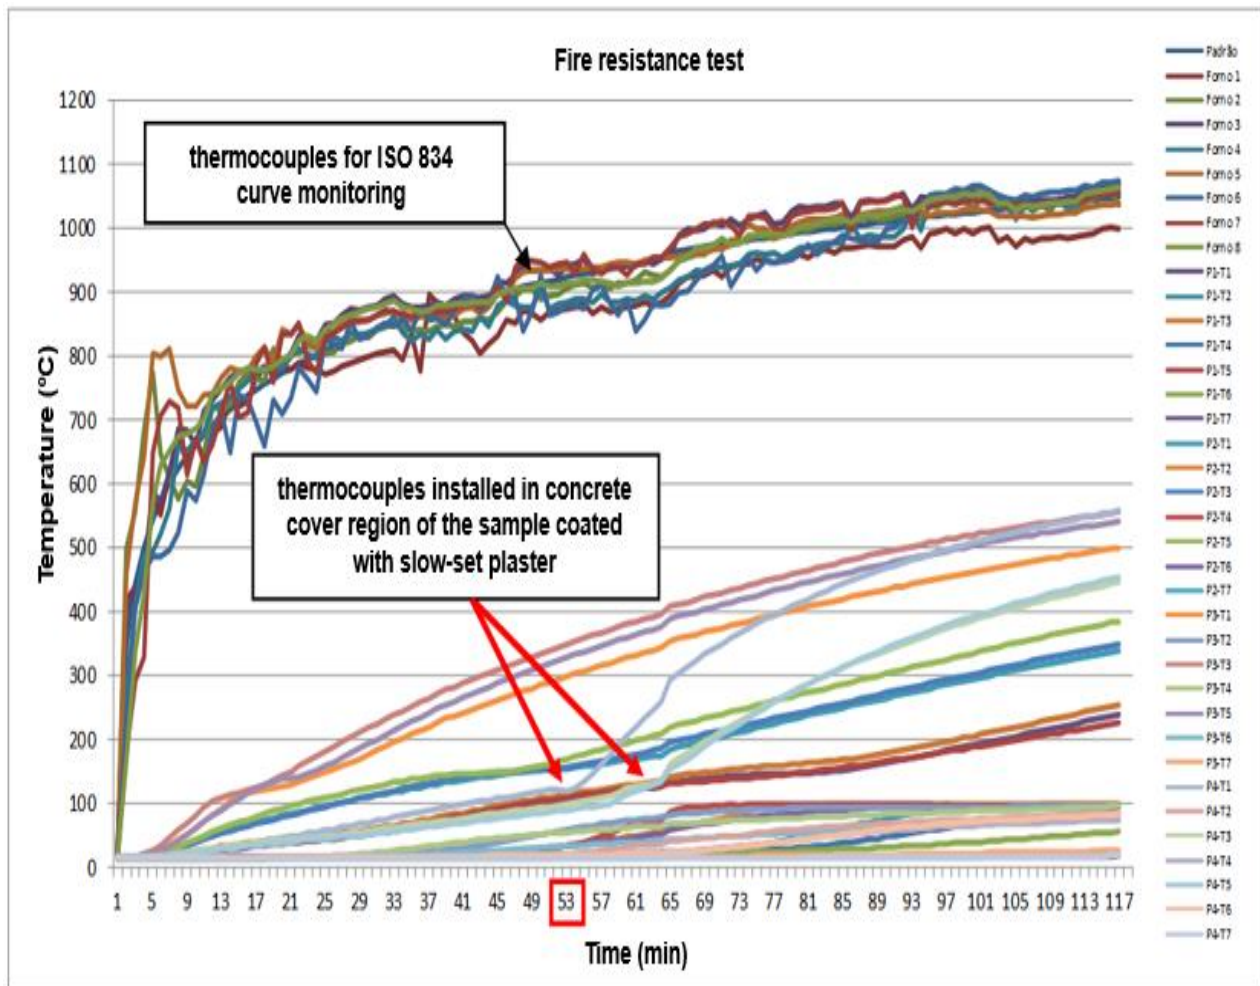
Figure 8. Temperatures obtained inside the furnace and inside the elements of 2nd event.

The evolution of temperatures obtained inside the samples also confirmed the visual and qualitative analyzes of the performance of the fireproof coatings. As observed in Figure 8, the heat distribution was uniform within the sample according to the depth of each thermocouple. A substantial increase in temperature was also noted in the three thermocouples of the reference sample in the concrete cover region, as well as in the three for slow-set plaster coated sample, from 53 min (highlighted in red), probably when the total detachment of this coating took place, taking with it part of the concrete and exposing the reinforcement. This behavior differs greatly from the exhibited by the rest of the thermocouples.

Although the reinforcement was not exposed to fire by spalling in the region of thermocouples 3 and 5, under these conditions (after spalling), for approximately 65 minutes, due to the thermal conductivity of the steel, the temperature of the reinforcement measured at these points was only 20% lower than in the exposed region. It was expected to be 66% lower, if compared to the first test event involving smooth formulated plaster, where there was no spalling.
