Inspection of pathological manifestations in buildings by using a thermal imaging camera integrated with an Unmanned Aerial Vehicle (UAV): a documental research

DOI: <https://doi.org/10.21041/ra.v11i1.447>

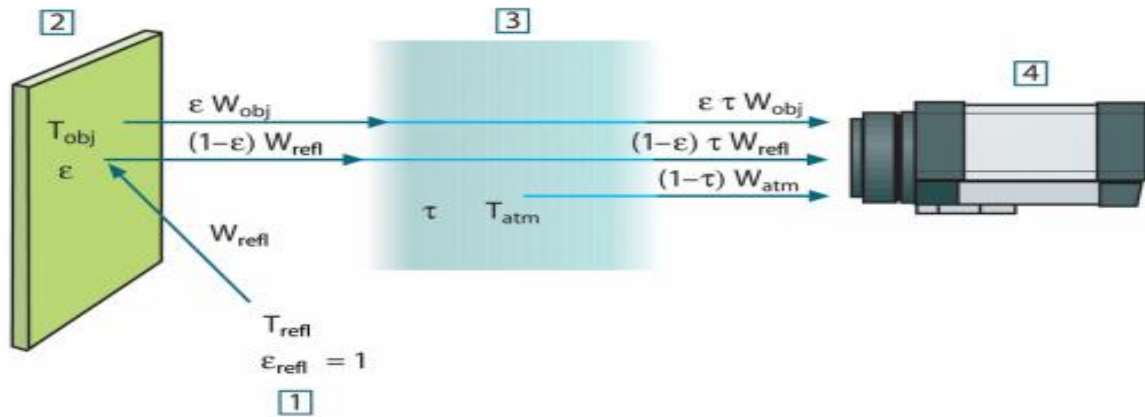
Figure 1. Schematic representation of general thermographic measurement location. 1) adjacent environment, 2) object, 3) atmosphere, 4) camera. T_{obj} : object temperature, T_{refl} : reflected temperature, T_{atm} : atmospheric temperature. W_{obj} : radiation power emitted by the object, W_{refl} : radiation power emitted by surrounding environment, W_{atm} : radiation power emitted by atmosphere (Caldeira & Padaratz, 2015).

On the other hand, using passive thermography where no artificial stimulation is used, involves a natural temperature difference that must be present between the study subject and the medium where it is inserted, which is frequently at a higher temperature. A passive method analysis relies on natural conditions for a studied structure and its surroundings, sun heat being a determining factor (Cortizo, 2007). Therefore, as shown in Figure 1, thermographic cameras capture infrared energy emitted by objects to convert this energy into an electrical signal and, finally, into a visible image, in which each level of energy is represented in a color scale (Meola & Carlomagno, 2004).

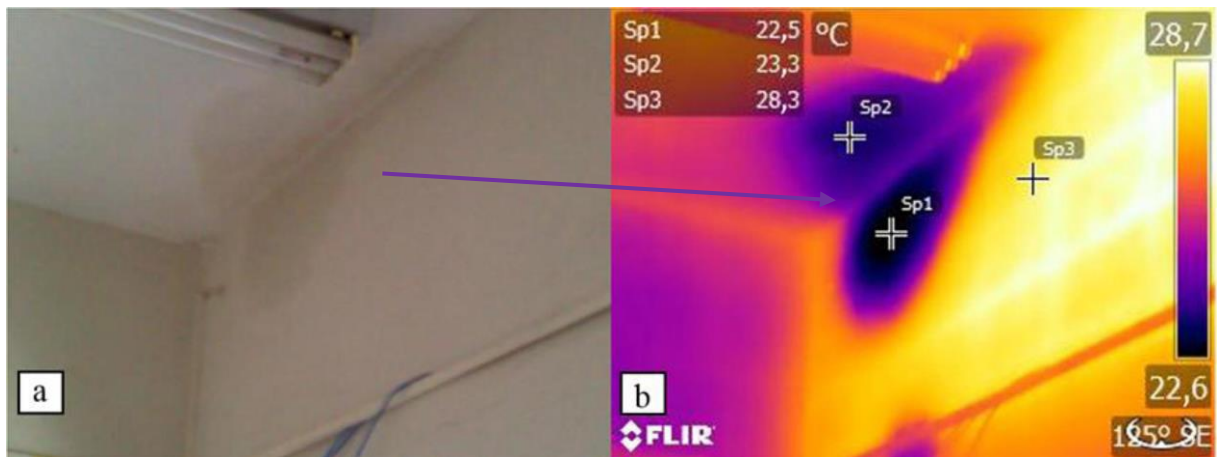
Figure 2. Pluvial water penetration: (a) digital image and (b) thermogram (Rocha et al., 2018).

Thus, this technique implemented in buildings may be used to evaluate comfort on floor covering (Barreira et al., 2013), detect insulation defects, air leaks (Ocaña et al., 2004) moisture problems (roof damage, moisture on walls), thermal bridges (Asdrubali et al, 2012), and inspect HVAC systems (Heating, Ventilating and Air Conditioning), construction details (Cerdeira et al., 2011; Barreira et al., 2013) and also in building inspection (Brique, 2016), as shown in Figure 2.

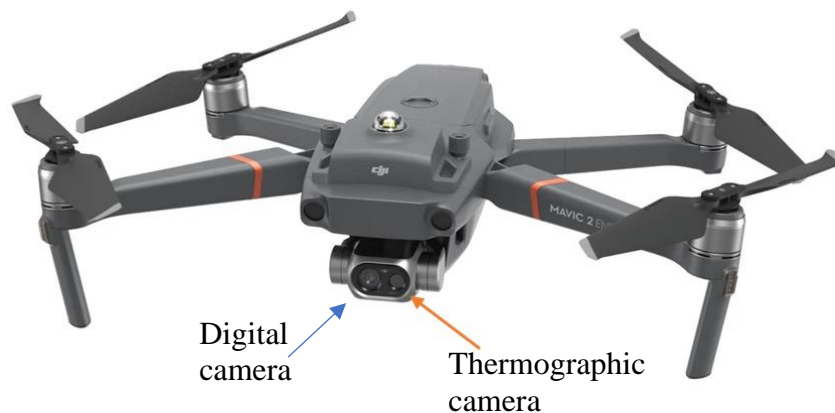
Figure 3. UAV with a thermographic camera attached to a digital camera (Topdrone, 2020).

Therefore, combining infrared thermography and UAVs enables optimization of maintenance tasks (Muñoz et al., 2017), and consequently, bringing significant economic advantages (Ramírez et al., 2018). Such aspects are due to the fact that UAVs may be equipped with high-resolution cameras allowing users to obtain data in real-time. Furthermore, aerial images previously captured from another light aircraft or helicopter and their fuel cost are disadvantages that make UAVs more viable, since power source for their flight can be easily recharged (Lavars, 2015). Therefore, being equipped with a high-resolution thermographic camera, an UAV becomes an excellent tool to collect thermal information from buildings (Zhang et al., 2015). In that sense, Figure 3 shows an UAV model that is already integrated with a digital camera as well as a thermographic camera, different from other models. Removing the first camera to install the second camera is required.

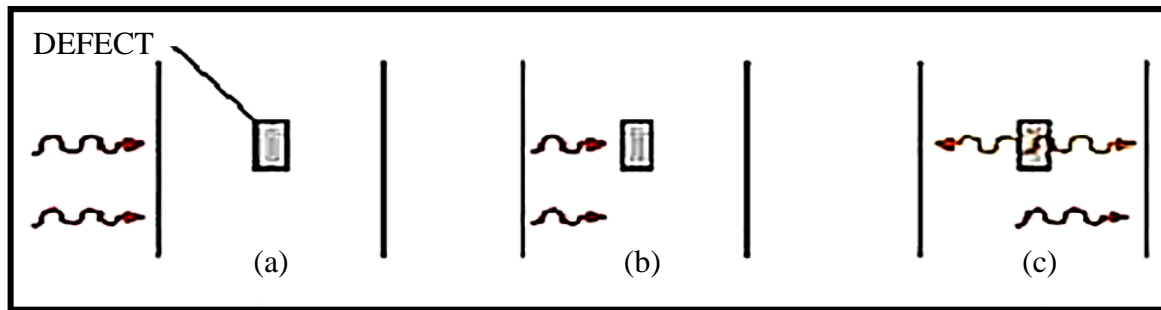
Figure 4. Modeled propagation of a single heat pulse in a material: (a) An energy pulse applied to the surface; (b) A heat pulse travels inside the material and finds a defect; (c) This defect partially reflects and partially transmits the pulse (Cortizo, 2007).

Thermography implementation in inspection processes is based on existing anomalies or defects that impact thermal properties in the structure. Figure 4 shows defects interrupting heat transfer from concrete, since existing voids are filled with air or water, and due to different thermal conductivity in materials, temperature variation along the structure is verified (Rocha & Póvoas, 2017).

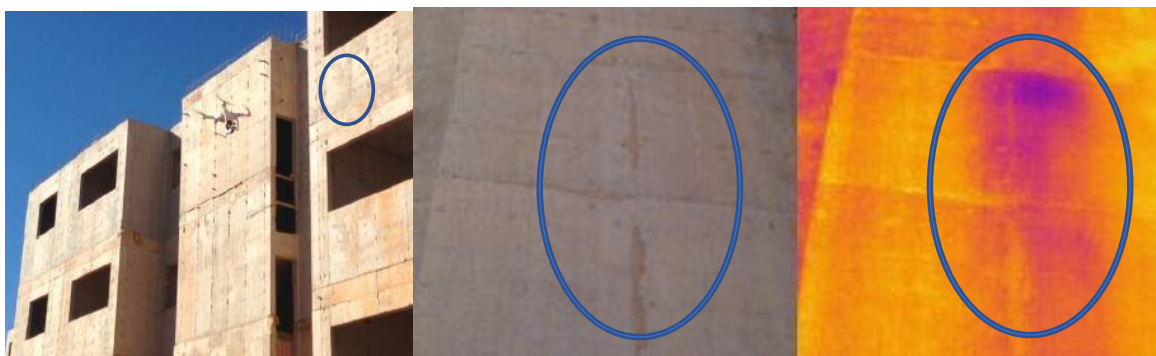
Figure 5. Inspection using an UAV integrated with a thermal camera (Nascimento, 2014)

In the case shown in Figure 5, according to Nascimento (2014), images were obtained in the early morning, making it possible to recognize areas including cracks and infiltrations, as the weather was mild and allowed a greater difference in temperature gradient, with lighter regions being those that have a higher temperature than those that are represented in darker tones.

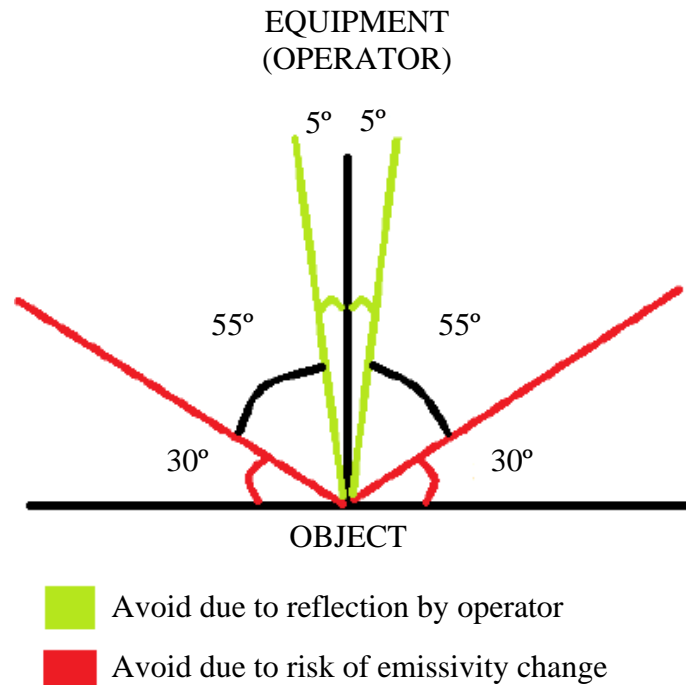
Figure 6. Measurement angles: precautions (Viégas, 2015)

According to Standard NBR 15572 (ABNT, 2013), an angle between the thermal imager and the inspected point must be as perpendicular as possible, so that no emissivity reduction due to inadequate observation angles (greater than 60°) is present. For this reason, Viégas (2015) states that nobody should remain directly facing the target so thermographer heat is not reflected. Therefore, positioning at an angulation of about 5°, in relation to object horizontal line to be thermally analyzed is recommended, as shown in Figure 6.

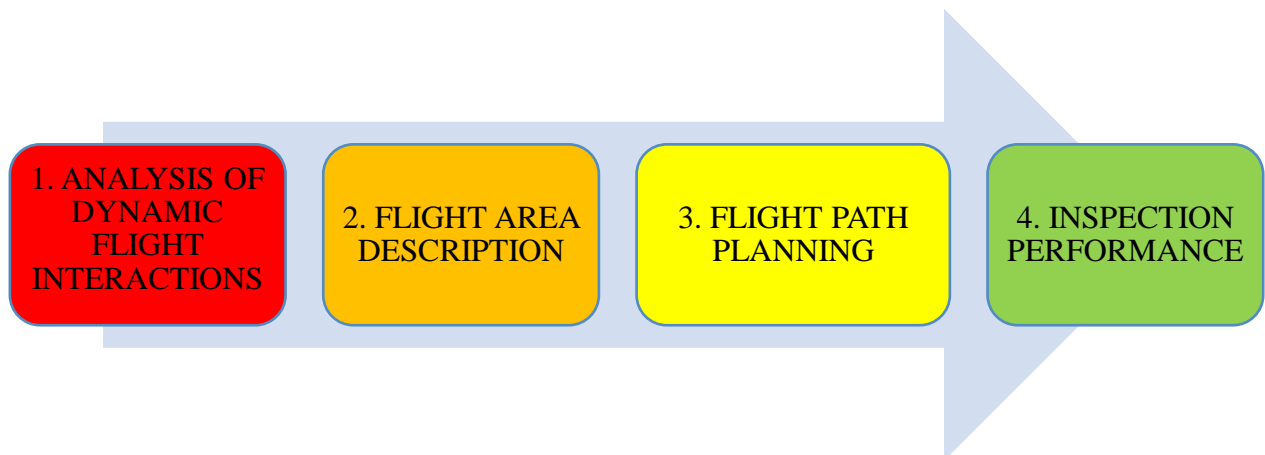
Figure 7. Flight protocol steps.

Project planning and development may vary according to flight capacity, being influenced by their accuracy and course (Agostinho, 2012). However, it is perceived that commercially available flight preparation tools, in some cases are still insufficient to perform certain inspections, and it is up to an operator to create their own tools and protocols (Seibert & Teizer, 2014). As a result, the protocol shown below in Figure 7 and Table 4, was developed according to studies by several authors (Agostinho, 2012; Siebert & Teizer, 2014; Ariwoola, 2016; Ellenberg et al., 2016; Entrop & Vasenv, 2017; Freimuth & König, 2018).
