Revista ALCONTIPAT

Latin American Journal of Quality Control, Pathology and Construction Recovery

Volume 10

January - April 2020

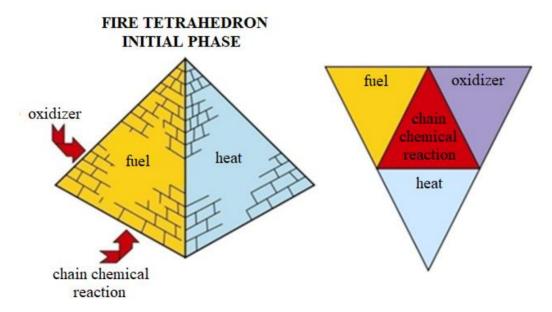
Heat is the element used to start a fire, maintain and increase its spread. Oxidizer (oxygen) is required for combustion and is present in the air surrounding us. Fuel is the propagating element of fire and can be solid, liquid or gaseous. The chain reaction makes the burning process self-sustaining. Basically, the radiated heat from the flames reaches the fuel and it is broken down into smaller particles, which combine with oxygen and burn, radiating heat back into the fuel, thus forming a constant (self-sustaining) cycle.

Figure 2. Fire tetrahedron (adapted from Seito et al., 2008).

It can be said, therefore, that concrete is not a fundamental element of Fire Tetrahedron because it is not a solid fuel. In a fire event, concrete suffers the consequences of the burning of any flammable material, whether solid, liquid or gaseous. Generally, in commercial and residential buildings, this flammable charge comes from solid cellulosic base materials such as doors, furniture, office supplies, carpeting, curtains, etc.

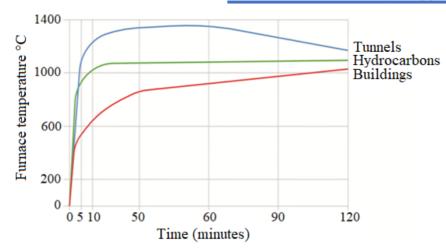
Figure 4 shows the temperature profiles that simulate three standard fire scenarios that are commonly used in experimental studies, as follows: (a) the tunnel fire scenario; (b) the one caused by hydrocarbon-based materials and (c) the one caused by buildings (by cellulosic materials).

Figure 4. "Idealized" curves for three fire simulation scenarios: tunnels, hydrocarbons and buildings - cellulosic materials - up to 120 minutes (The Concrete Center, 2004).

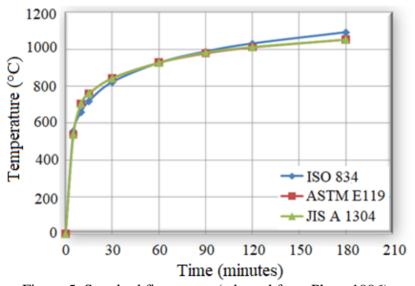
The three most widespread idealized and standardized curves in the technical field used in experimental studies involving fire scenario simulations caused by cellulosic-based materials in concrete elements are the curves: ISO 834, ASTM E119 and JIS A 1304 (Phan, 1996). These curves are very similar and can be seen, overlapping, in the Figure 5. Tunnel and hydrocarbon standard curves will not be addressed in this article and can be consulted in Leonardo Da Vinci Pilot Project: Handbook 5 (2005).

Figure 5. Standard fire curves (adapted from Phan, 1996).

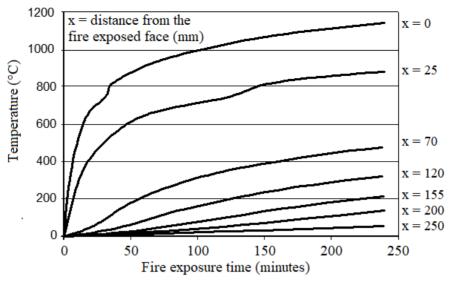
To exemplify the behavior of the temperature field evolution as a function of time in a concrete element, we present the computer simulation study by Ongah, Mendis & Sanjayan (2002) in high strength concrete walls (Figure 6) with only one side exposed to fire. The graph indicates the significant thermal gradient inside the material (concrete) according to a heat flow model that numerically simulates the fire scenario.

Figure 6. Temperature field evolution in a high strength concrete wall as a function of fire exposure time (Ongah, Mendis & Sanjayan, 2002).

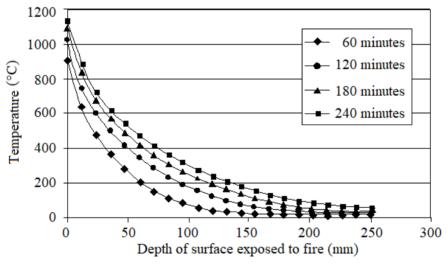
Another way to present the temperature evolution inside a concrete element, prescribed by the main international codes, can be seen in Figure 7. In this case, the instantaneous curves of standardized times as a function of the temperature and depth of the surface exposed to fire are presented, this is a very common model adopted by researchers and in the codes of various countries.

Figure 7. Calculated temperature distribution as a function of the depth of surface exposed to fire and fire exposure time, by using a numerical model (Ongah, Mendis & Sanjayan, 2002).

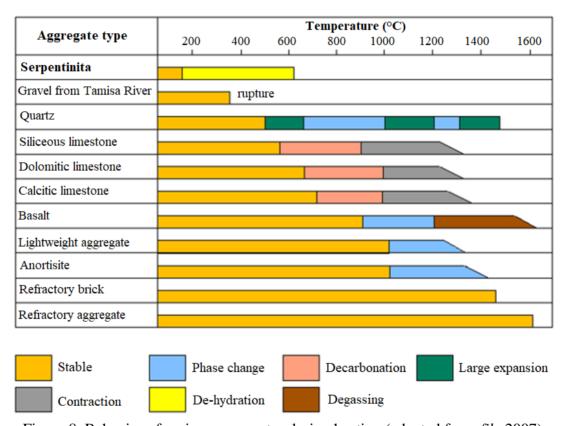
Figure 8. Behavior of various aggregates during heating (adapted from fib, 2007).

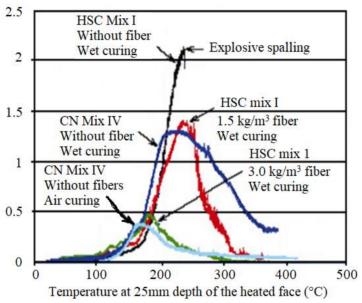
This fact was verified by studying the pore pressure exerted on these two types of concrete (normal and high strength), coming from the high temperatures that can be reached in a fire, as shown in Figure 11 (Phan, 2002).

Figure 11. Equivalent pressure of the two concrete types (CN: normal and HSC: high strength) with the introduction of polypropylene fibers into high strength concrete (at high temperatures) (Phan, 2002).

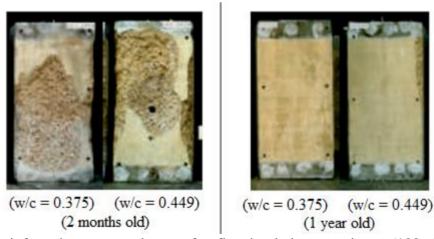
The experiment conducted by Morita et al. (2002) seems to contribute to highlight how much the conducted research may be limited to evaluate spalling severity in concrete elements at premature ages, since the occurrence of this type of phenomenon depends significantly on the time factor (sample age).

Figure 14. Reinforced concrete columns after fire simulation experiment (180min): effect of water/cement ratio and age on the occurrence of spalling phenomenon, 70cm square cross-section (Morita et al., 2002).

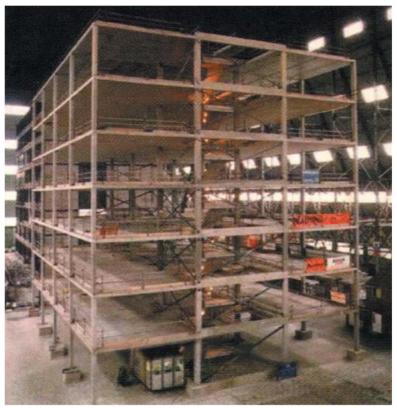
Figure 16. Perspective of the reinforced concrete prototype structure designed for the Cardington fire simulation experiment (Chana & Price, 2003).

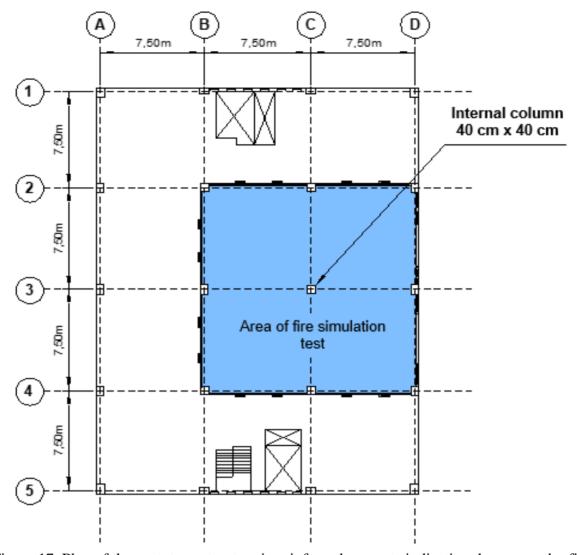
As described by Chana & Price (2003), the fire simulation took place in a region occupied by four compartments in a total area of 225m² with a height of 4.25m (ceiling height) on the ground floor of the building. Intentionally, an internal column was exposed on all four faces and some of its end partially, as observed in the plan of Figure 17. The experiment also involved ventilation openings projected on the outer walls of the compartments to be ignited, as well as the loading simulation. The slabs were evenly loaded with sandbags for a load of 3.25kN/m² (325kgf/m²) and in the column region additional bags were positioned to simulate an axial stress of 925kN (92.5tf).

Figure 17. Plan of the prototype structure in reinforced concrete indicating the area under fire simulation (Chana & Price, 2003).

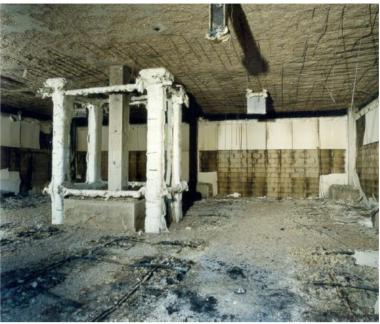
During the fire simulation, in the first 10 minutes of the experiment, there was the occurrence of low intensity, superficial spalling characterized by a discreet popping sound. However, after this period and for a further 15 minutes, the intensity was much higher, indicating a probable explosive spalling, which was later found mainly on the slab (ceiling) of the burning compartments ($f_{ck} = 74$ MPa). After 25 minutes, spalling occurrences decreased significantly. The extent and severity of the occurrence of the spalling phenomenon after the experiment can be observed in Figure 18.

Figure 18. Detail of extent and severity of slab spalling ($f_{ck} = 74$ MPa) after fire simulation. Highlighting, observe the integrity conditions of the high strength concrete column ($f_{ck} = 103$ MPa) (Chana & Price, 2003).

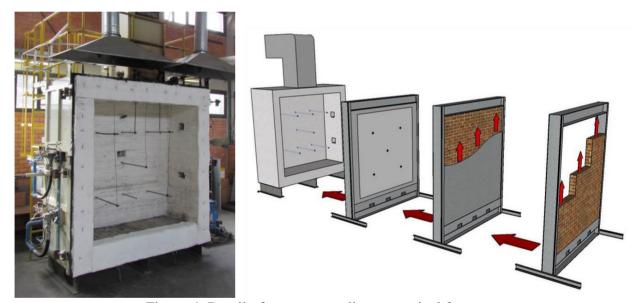
The test was performed at Unisinos' Fire Safety Laboratory. The wall was tested after 56 days of curing in a vertical furnace. The furnace has four burners arranged according to Figure 4, controlled by two thermocouples that allow the measurement of temperature evolution by ISO 834 (2014). Figure 4 also shows the wall mounting and installation sequence in the test furnace. The furnace has a chimney that regulates the flow of gases generated by the heating and the internal pressure throughout the test, as well as thermal insulation composed by ceramic fiber blanket and four gas burners, digitally controlled by a digital control center.

Figure 4. Detail of system coupling to vertical furnace.

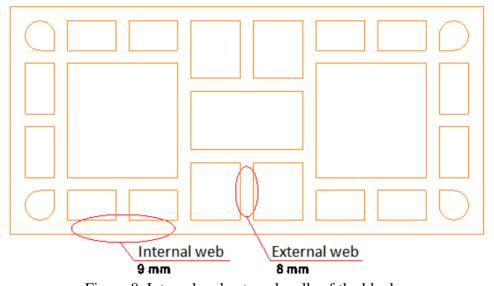
With the calibration performed according to the experimental result, the process of computational extrapolation for different block geometries began. For this, three commercial thicknesses of 11,5, 14 and 19 cm of ceramic blocks were used. For each of these thicknesses, three blocks were defined, varying the number of alveoli and, therefore, percentage of voids. Three distinct geometries were proposed, but the thickness of the internal walls of the block were constant, with 9 mm externally and 8 mm internally, as shown in Figure 8.

Figure 8. Internal and external walls of the blocks.

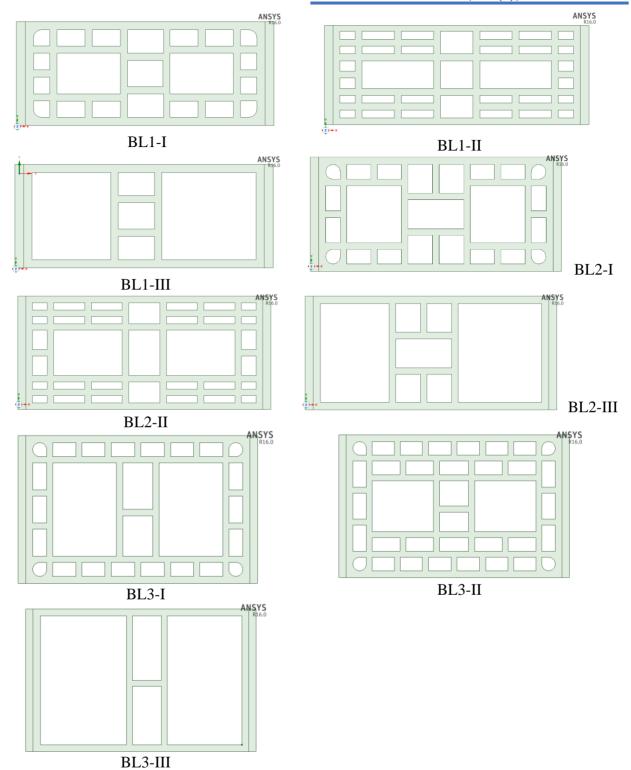
The 11,5 cm thick block family was called BL1; 14 cm thick BL2; and the 19 cm thick BL3. The percentage variations of voids within the same block family were calculated using the ratio between gross area and net area, and referred to as indexes I, II and III. Figure 9 details the blocks used in this study. The blocks were named sequentially BL1 to BL3. It is observed that the blocks with II index (BL1-II, BL2-II and BL3-II) are found in the market, the commercial ones. From there, it has been proposed blocks with smaller and slightly larger alveoli, those with I index (BL1-II, BL2-I and BL3-I), and blocks with larger alveoli and in small quantity, those with III index (BL1-III, BL2-III e BL3-III).

Figure 9. Used blocks.

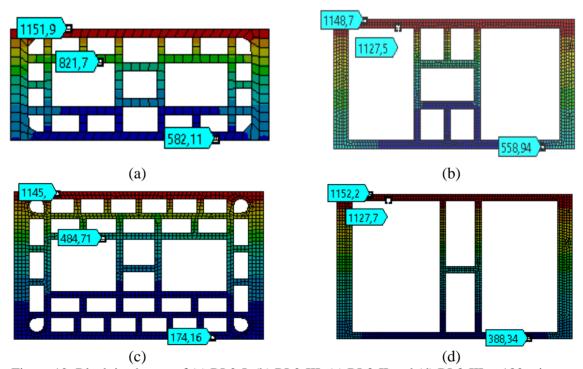
Due to the predominant criterion of FRT definition being the temperature of the unexposed face of the block, these measurements were used for the analysis, with the limit temperature of 200 °C on the unexposed face. Block isotherms were collected in the computational program at 30, 60, 90, 120, 180 and 240 minutes. Figure 10 presents the isotherms of some of the blocks used in this study and Figure 11 displays the comparison among all the blocks, with variation in geometry, percentage of voids and thicknesses.

Figure 10. Block isotherms of (a) BL2-I, (b) BL2-III, (c) BL3-II and (d) BL3-III at 180 minutes.

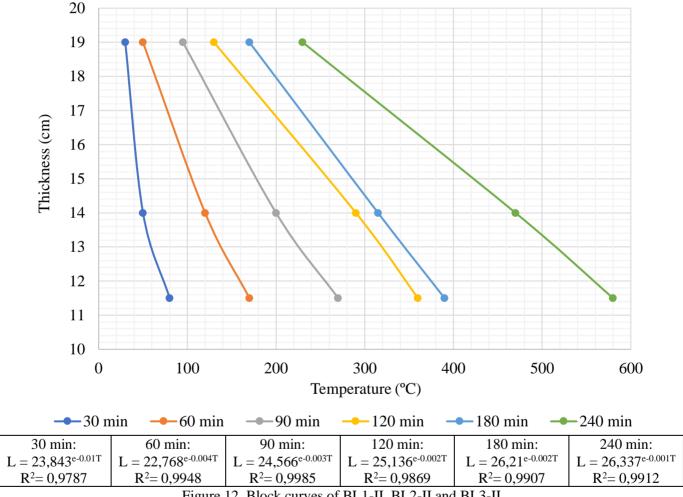
For comparison purpose, temperature evolution curves of the unexposed face of the Index II blocks were generated, in order to compare the influence of the block's thicknesses, presented in Figure 12.

Figure 12. Block curves of BL1-II, BL2-II and BL3-II

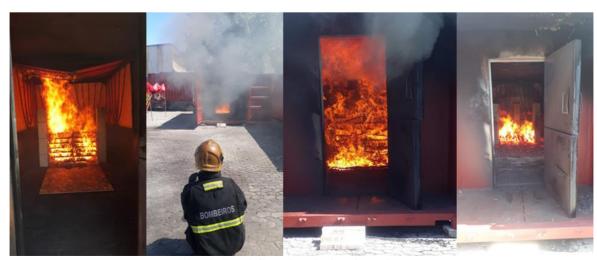
Fig. 3. Real fire simulation in columns

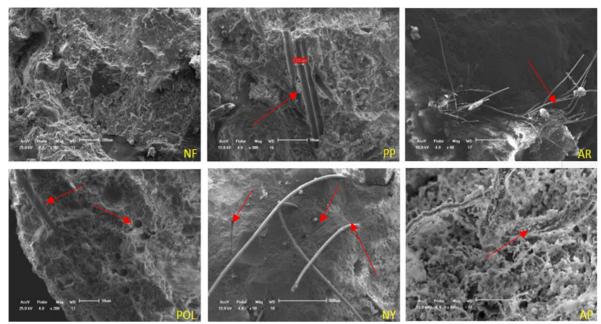
From the generated images, the interaction of the fibers was considered satisfactory. In the furnace tests in the range of 700°C it was not observed the presence of fibers in any concrete, which was to be expected, since the melting point of the all fibers did not exceed 500°C, as seen in Table 1. The Fig. 4 shows the concretes after being subjected to a temperature of 500°C in furnace.

Fig. 4. SEM of concretes after being subjected to a temperature of 500°C

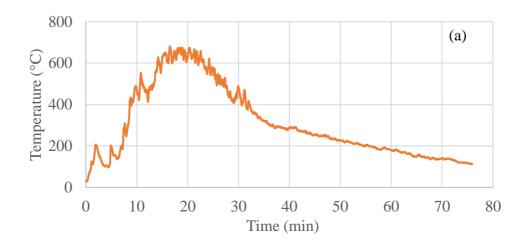
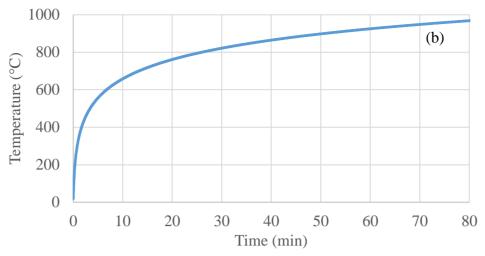
The type K thermocouple sensors gauged the behavior of real temperature evolution over time in the grill fire test and live fire simulator test. It is observed that the behavior is quite different from the standard ISO 834 curve of an electric furnace. Such a difference can be seen in Fig. 5.

Fig. 5. Temperature x time in the grill fire test (a) and ISO 834 (b) curve

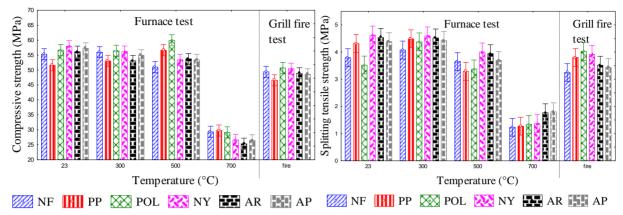
The compressive strength data of the concretes tested in furnace were submitted to ANOVA. It was observed that the isolated effect of the concrete type (NF, PP, POL, NY, AR and AP) and the temperature variation (23, 300, 500 and 700°C) were significant, as well as the interaction between the two variables. Fig. 7a shows the compressive strength as a function of the temperature of the concretes analyzed.

Fig. 7. Compressive strength (a) and splitting tensile strength (b) as a function of the temperature in the furnace and in the grill fire test.

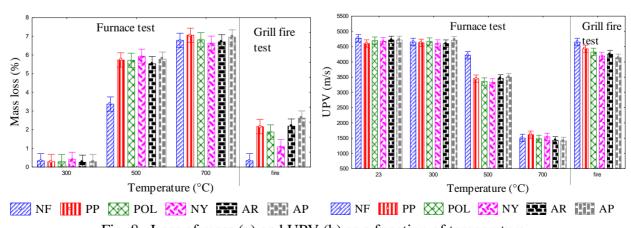
In the range of $500\,^\circ$ C it is verified that NF obtained the smaller loss of mass than the other concretes. This temperature range is enough to melt a large part of the fibers, providing the expected increase in pores, but not yet enough to perform all the chemical transformations of the concrete. The graph of mass loss as a function of temperature is in Fig. 8a.

Fig. 8. Loss of mass (a) and UPV (b) as a function of temperature.

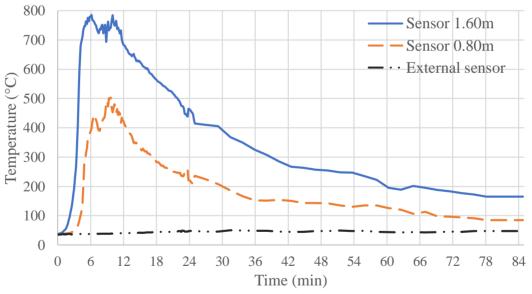
In the Fig.9 are shown the temperature indices as a function of time of each of the sensors that monitored the fire in the live fire simulator.

Fig. 9. Temperature vs time in the live fire simulator for the three sensors.

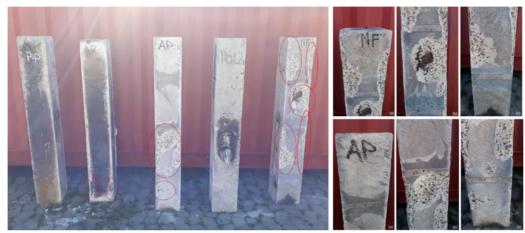
After the test and the total cooling of the site, the visual analysis of each column was performed in the following day. Fig. 10 shows the columns side by side. The signs made in the columns show the displacements that happened in some of the concretes.

Fig. 10. Columns after being subjected to the fire and focus in NF and AP post fire, showing the top (a), center (b) and base (c).

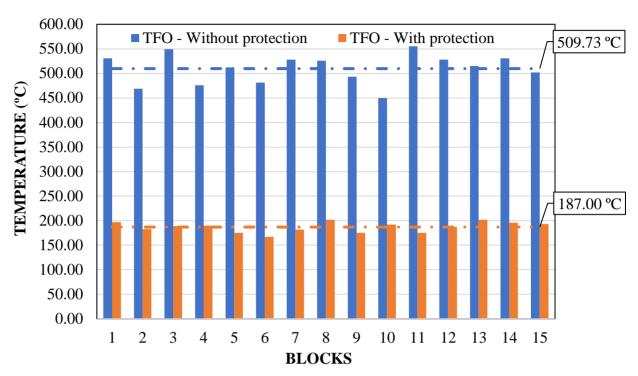
Figure 8. Comparison of the temperatures of the immediately opposing faces for the blocks with and without passive protection, types 3 and 4 respectively.

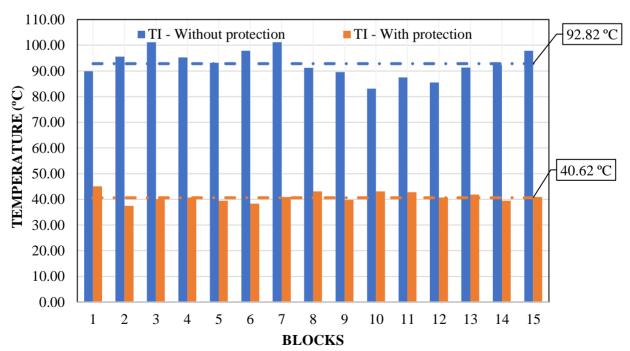
Figure 9. Comparison of the temperatures in the opposite faces for the blocks with and without passive protection, types 3 and 4 respectively.

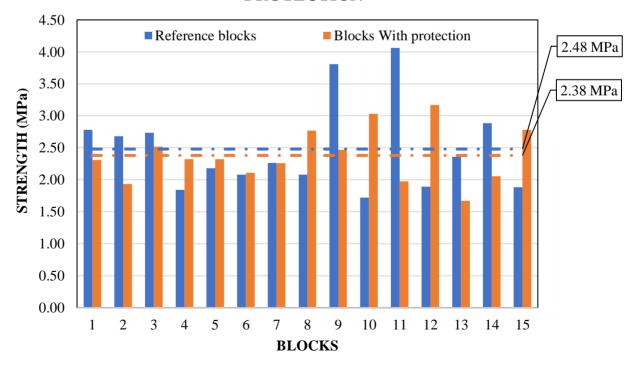
Figure 11. Compressive Strength: comparison between Reference Blocks and Blocks with Passive Protection.

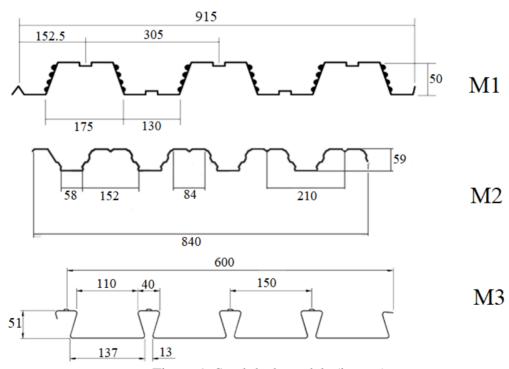
Figure 1. Steel deck models (in mm).

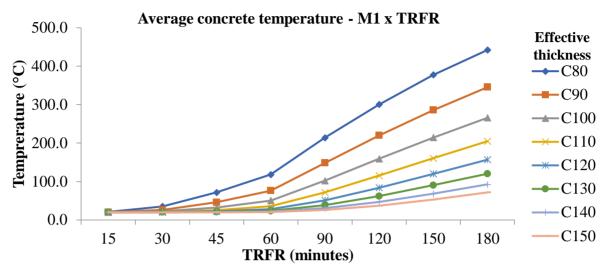
Figure 3. Average concrete temperature in steel deck model M1

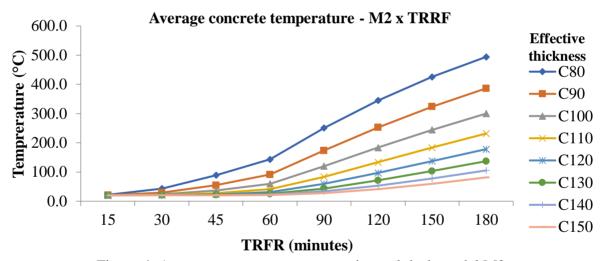
Figure 4. Average concrete temperature in steel deck model M2

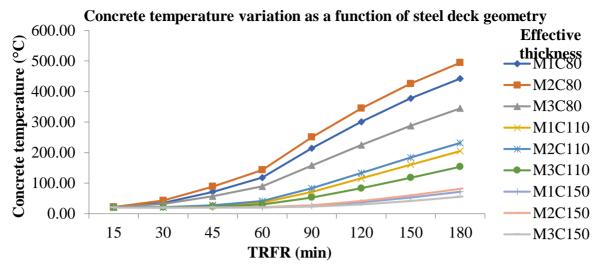
Figure 6. Concrete temperature variation as a function of steel deck geometry

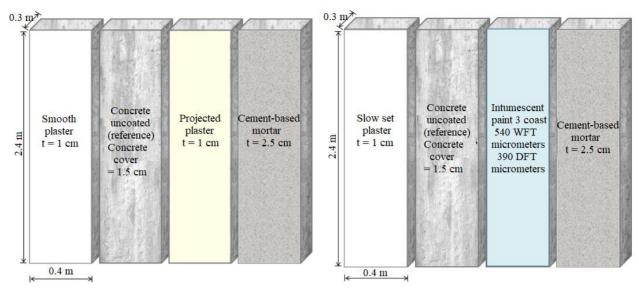
Figure 1. Concrete elements and coating systems that went through tests in both fire simulations (1st test event at left and 2nd test event at right).

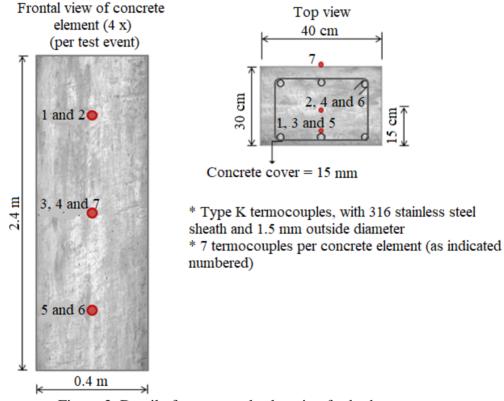
Figure 2. Detail of termocouples location for both test events.

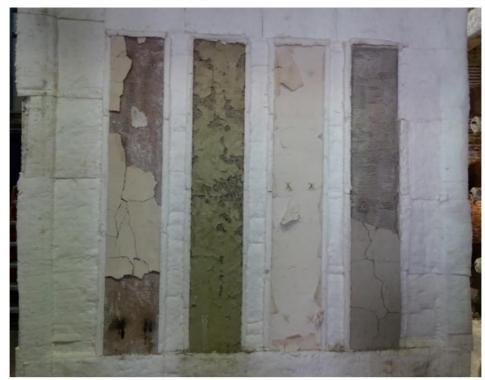
Figure 4. Detail of the elements and coatings condition after furnace opening (event 1): smooth formulated plaster coating, reference element, projected plaster coating and cement-based mortar coating.

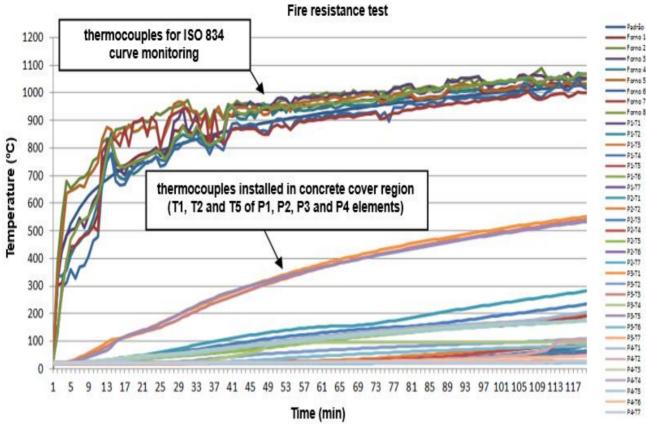
Figure 5. Temperatures obtained inside the furnace and inside the elements of 1st event.

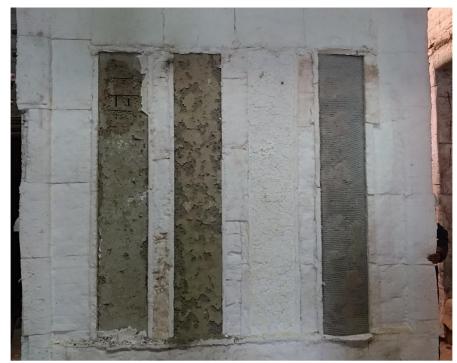
Figure 7. Detail of the elements and coatings condition after furnace opening (event 2): slow-set plaster coating, reference element, intumescent paint coating and cement-based mortar coating.

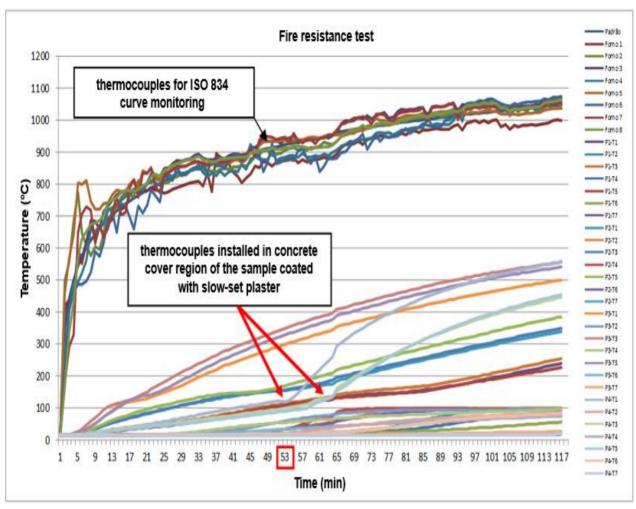
Figure 8. Temperatures obtained inside the furnace and inside the elements of 2nd event.

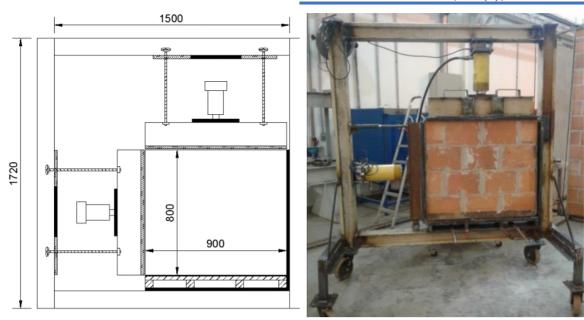
Figure 2. Reaction frame used in the tests.

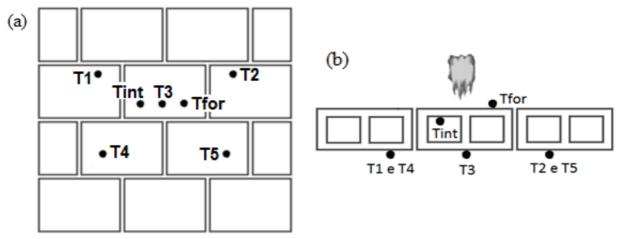
Figure 3. Thermocouple positioning in the samples. (a) Frontal view. (b) Upper View.

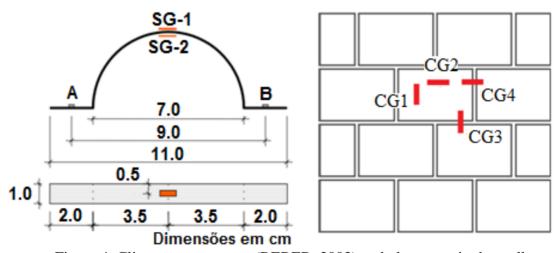
Figure 4. Clip-gages geometry (BEBER, 2003) and placement in the wall.

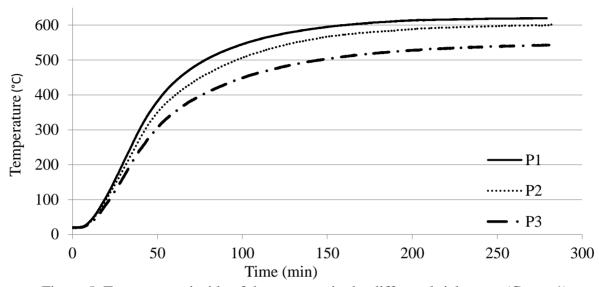
Figure 5. Temperature inside of the masonry in the different brick types (Group 1).

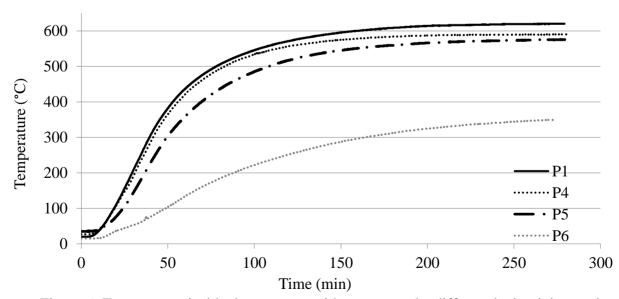
Figure 6. Temperature inside the masonry with respect to the different laying joints and coating (Group 2).

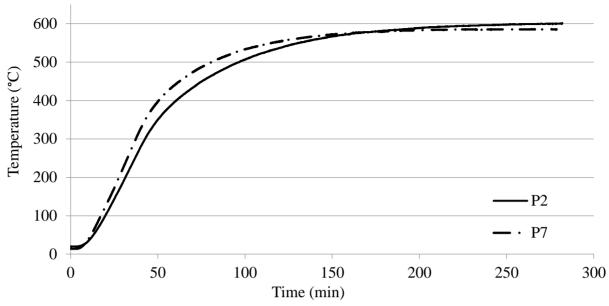
Figure 7. Temperature inside the masonry with respect to the different laying joints with traditional mortar and polymeric mortar (Group 3).

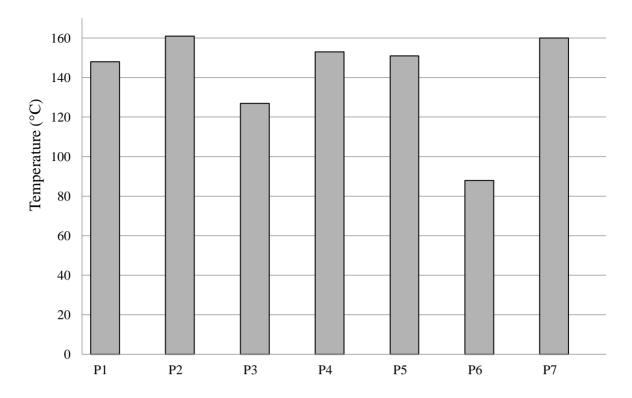
Figure 8. Maximum temperature on the unexposed face.

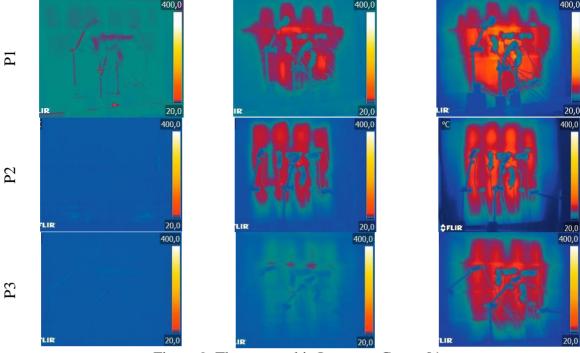
Figure 9. Thermographic Images – Group 01.

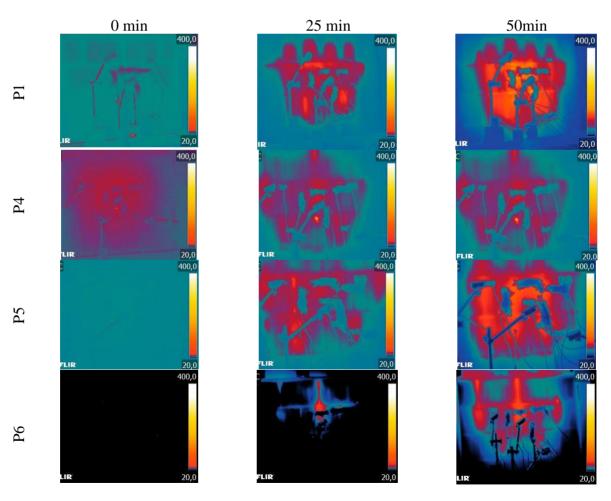
Figure 10. Thermographic Images – Group 02.

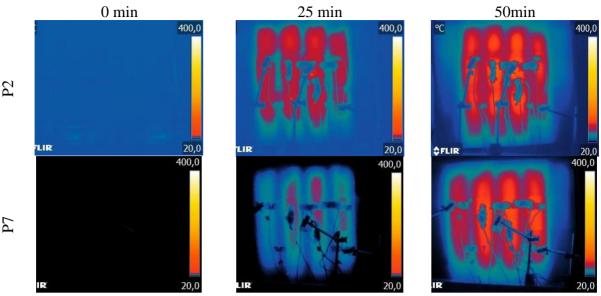
Figure 11. Thermographic Images – Group 03.

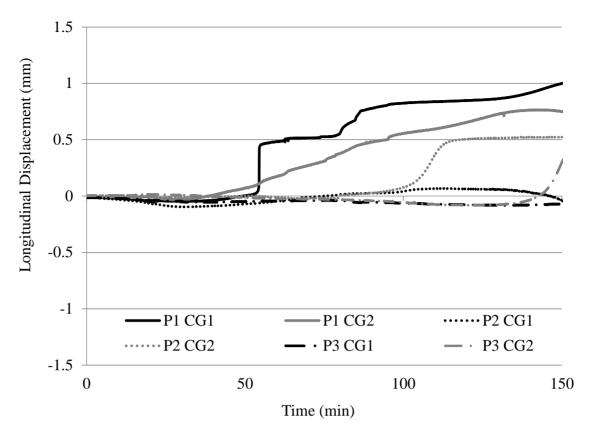
Figure 12. Longitudinal Displacement of the bricks – Group 01.

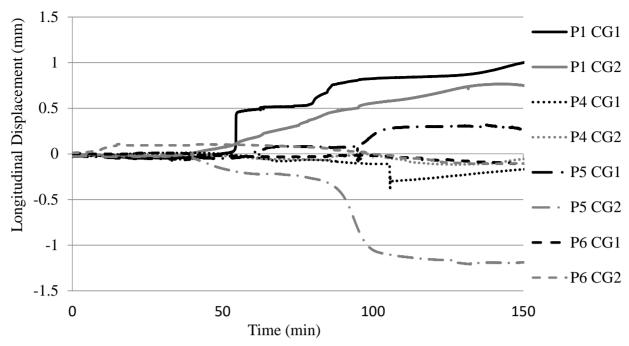
Figure 13. Longitudinal Displacement of the bricks – Group 02.

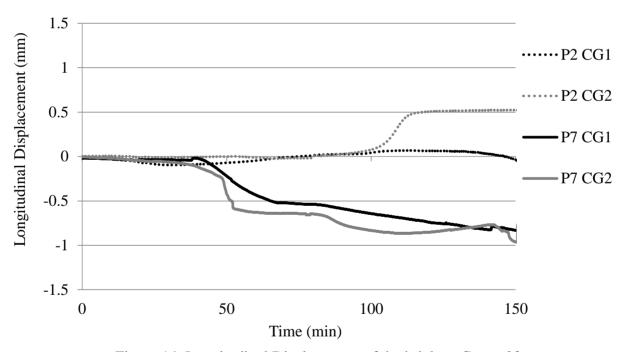
Figure 14. Longitudinal Displacement of the bricks – Group 03.

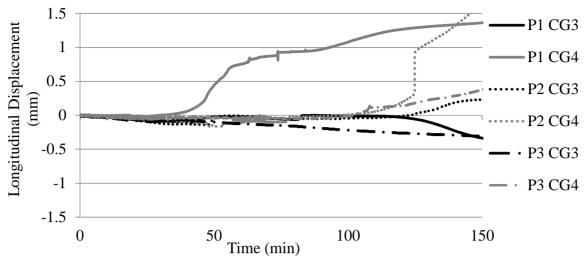
Figure 15. Longitudinal Displacement of the bricks – Group 01.

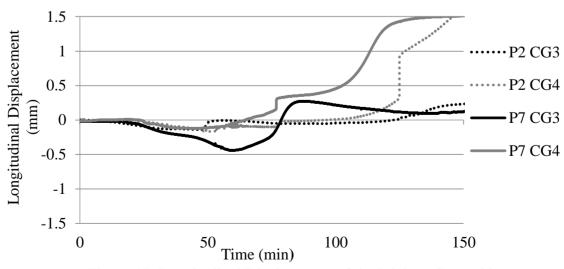
Figure 17. Longitudinal Displacement of the bricks – Group 03

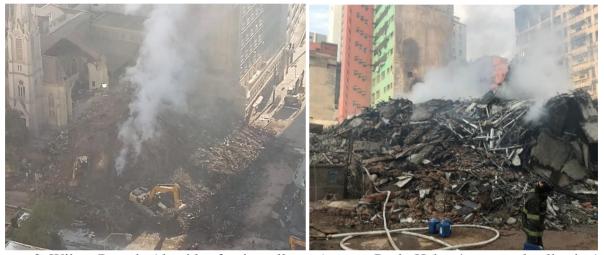
Figure 2. Wilton Paes de Almeida after its collapse (source: Paulo Helene's personal collection).

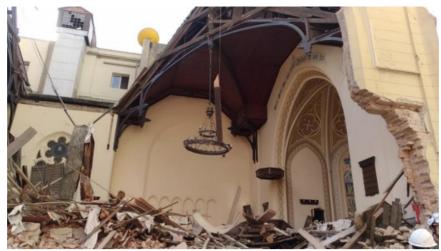
Figure 3. Damage to the Lutheran Church, next to Ed. Wilton Paes de Almeida (source: Paulo Helene's personal collection)

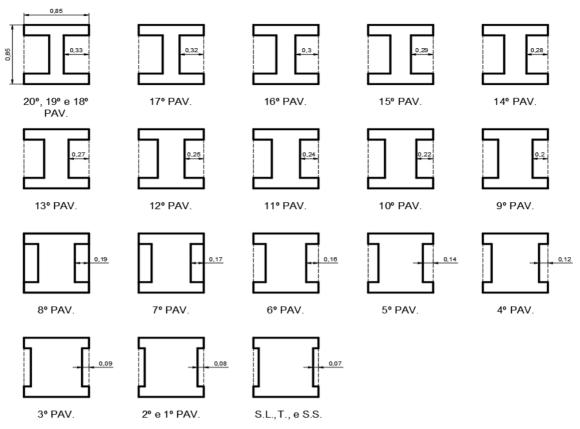
Figure 5. Scheduling of the columns (Source: executive architectural design found in the library of FAU. USP)

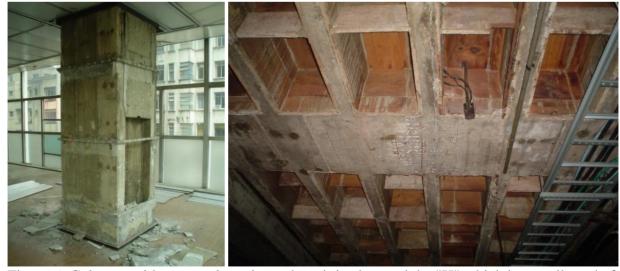
Figure 6. Columns without metal coating, where it is observed the "H" which is actually a shaft of the air conditioner and l grate beam track with AJE still forms wood.

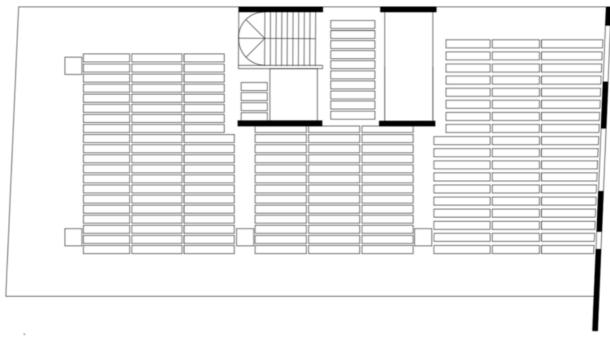
Figure 7. Grid Slab Scheme (Source: FAU-USP)

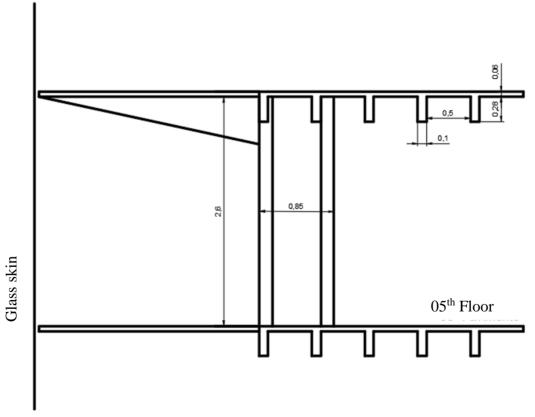
Figure 8. Grate slab cutting (Source: FAU-USP)

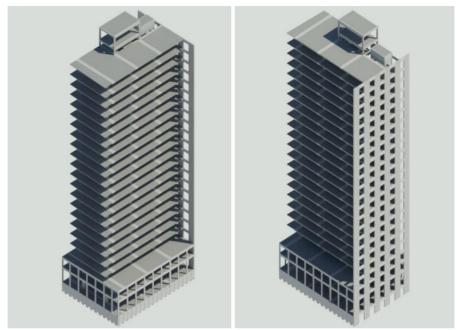
Figure 9. Frontal and posterior perspectives of the structure of Ed. Wilton Paes de Almeida (source: interpretation of existing projects at FAU-USP, SPU and Acrópole Magazine).

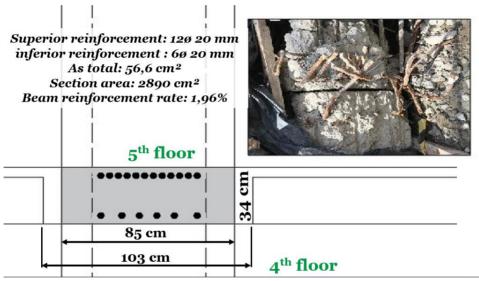
Figure 12. Configuration of the strip-beam reinforcement.

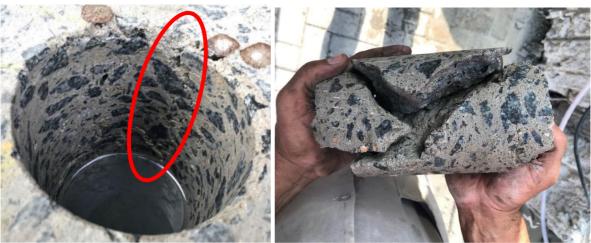
Figure 13. Visible cracks during extraction and decomposed core. (Source: Paulo Helene's personal collection)

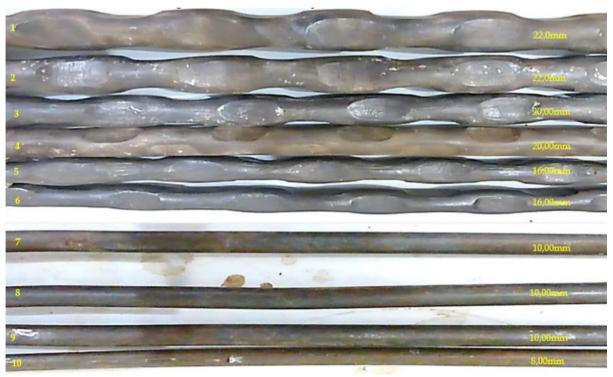
Figure 14. Classification of steel samples according to his gauge (Source: Arcellor Mittal)

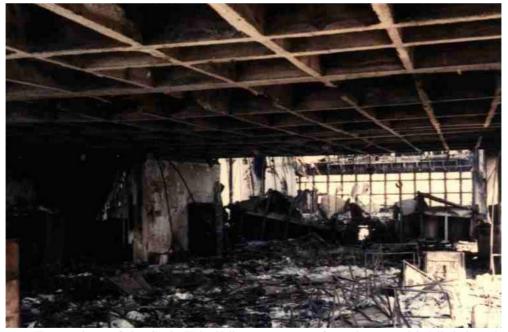
Figure 15. Front view of the Sede II building structure, from its rear, highlighting the void left by the collapse of the central part
