## Recommendations for rehabilitation and corrosion protection of a 100-year-old steel bridge (Durgadee) across heavily polluted river near Mumbai, India

DOI: <http://dx.doi.org/10.21041/ra.v10i2.476>

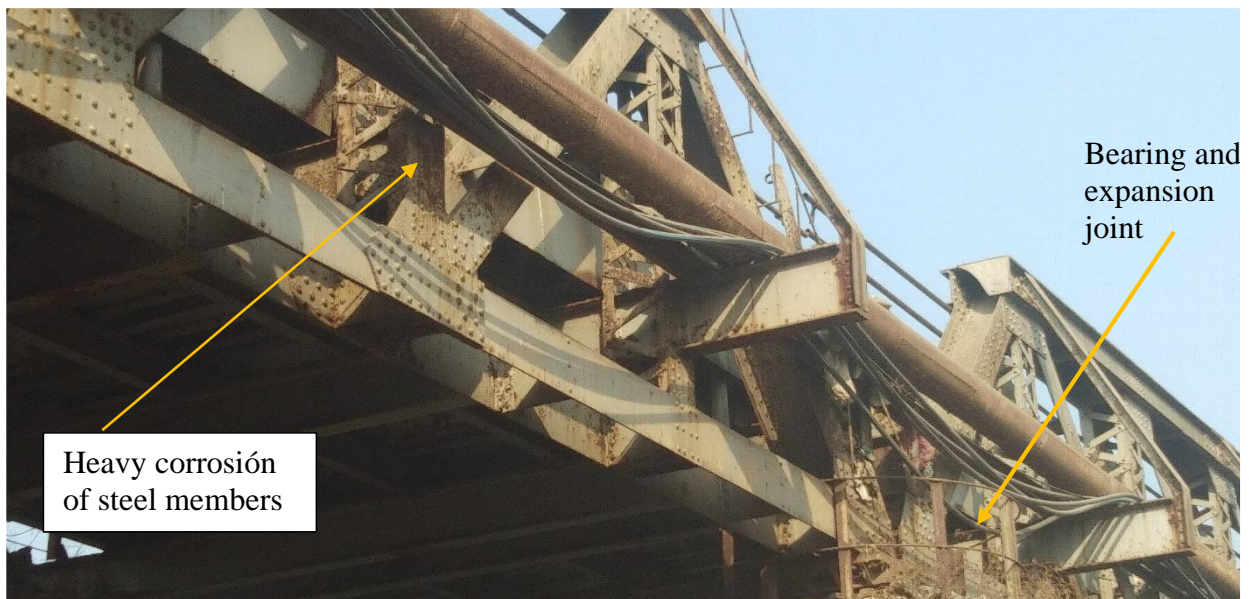
Figure 2. Photo of bridge showing bearing and expansion joint location

Suspended or hanging platform will be needed for working below the soffit. Detailed drawings will be prepared for above cases considering site situation and methodology of repair. Ideally floating pontoon with small boat along with winch machine will be very useful for speedy execution of work. Figure 2 is a photo of bridge showing bearing and expansion joint location.

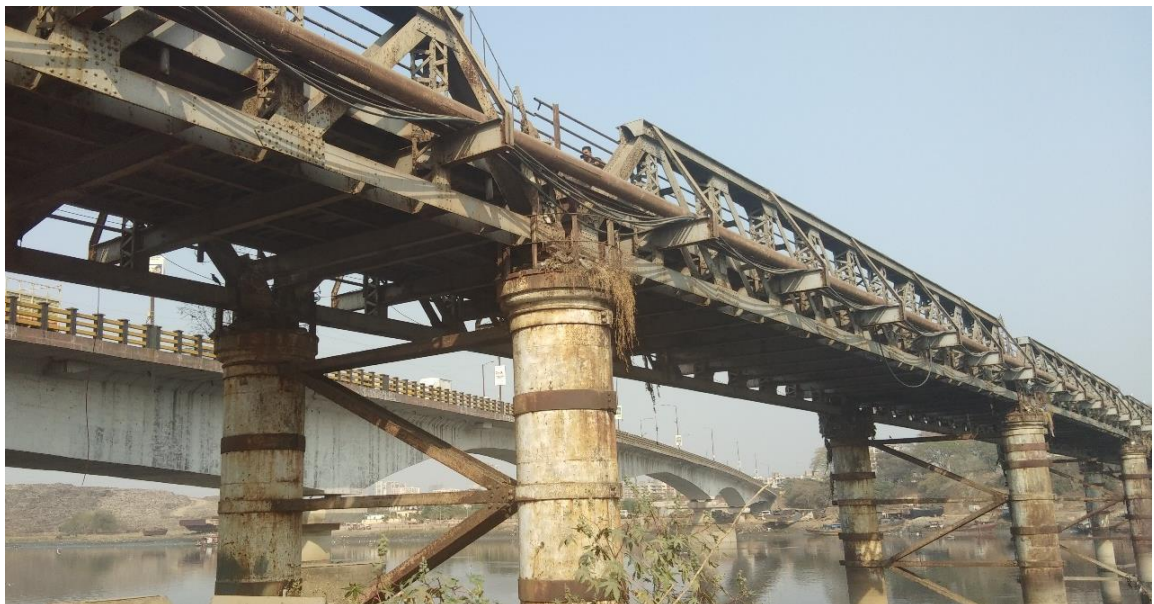
Figure 3. Photo of bridge showing warren truss type structure.

Figure 3 is a photo of the bridge showing the warren truss type structure. The work of repairing built-up steel girders by restoring or replacing damaged or deteriorated elements include, but is not limited to, providing temporary supports for jacking; modifying girders to accept jacking loads; temporarily supporting or reducing loads carried by girders; disconnecting or removing elements from girders by removing bolts or rivets; drilling and reaming holes; grinding to provide required finish or tolerances on steel surfaces; making minor repairs to decks within the work area; erecting repaired or replaced elements and incidental items by welding or high tensile strength bolting; and preparing surfaces damaged or left bare by the work and applying a prime coat of paint.
