## Advances in the implementation of optical fiber on structures. The present of an implementation with a future

V. Alegre<sup>1\*</sup>, S. Villalba<sup>2</sup>

DOI: <https://doi.org/10.21041/ra.v11i1.485>

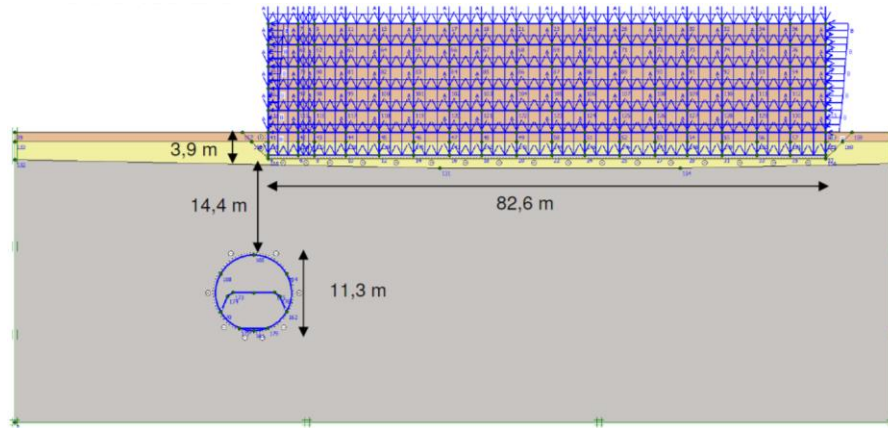
Figure 1. Geometry of the calculation section.

The modelling of the different stages was carried out with the SAP2000 program and the two-dimensional PLAXIS, and gave, from the geometry defined in Figure, the following results indicated in Figure 1, Table 1 and Figure 2:

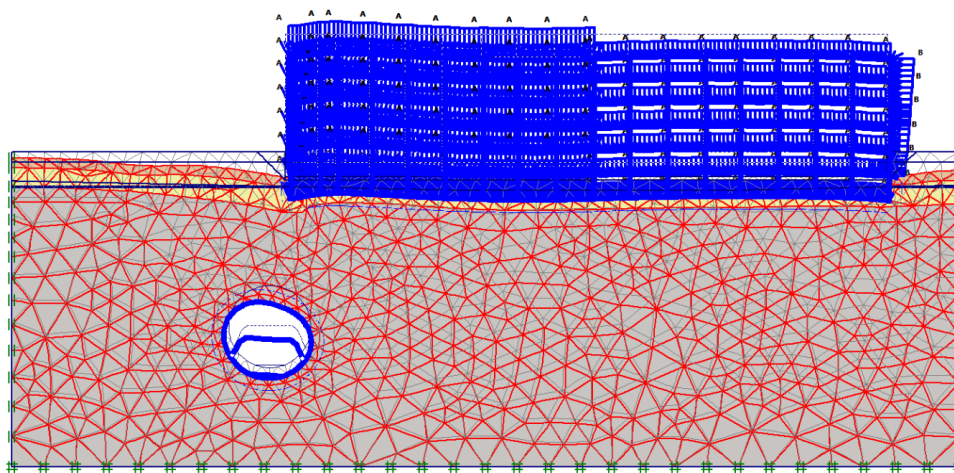
Figure 2. First breakage mechanism found, for a safety factor of 2.29.

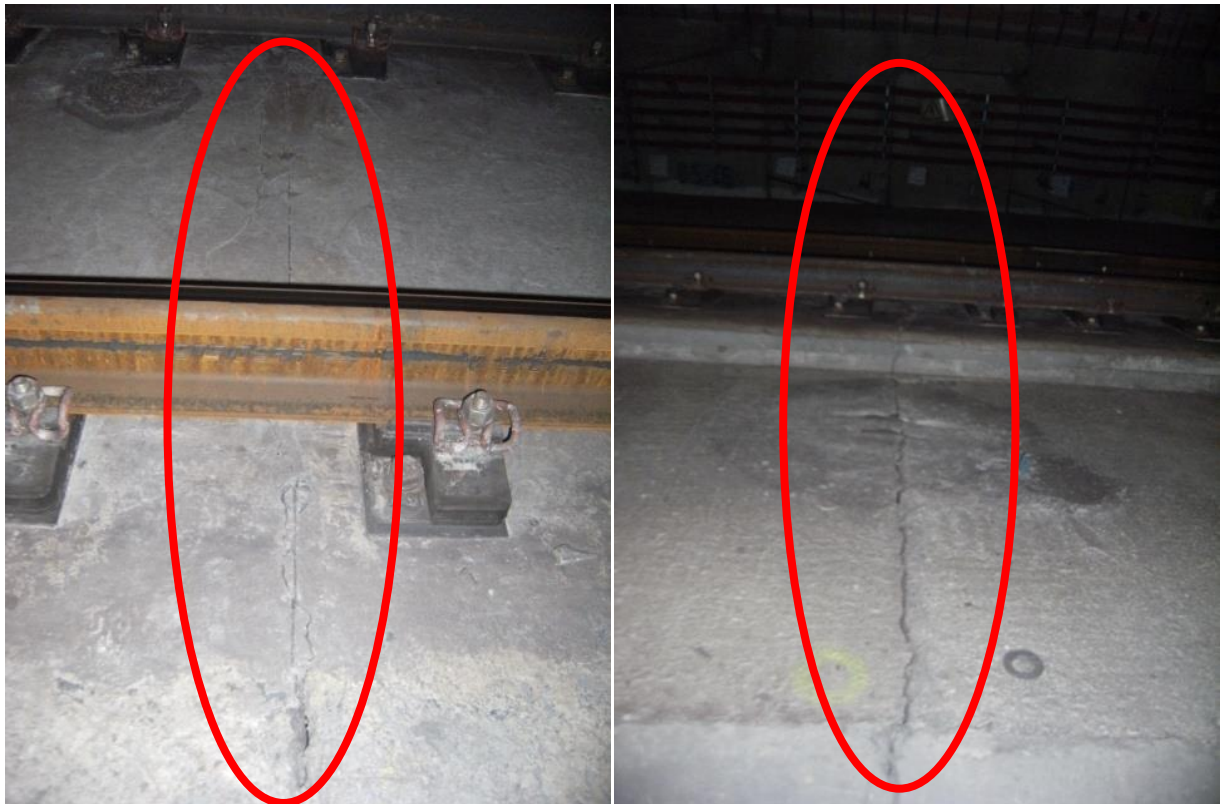
Figure 4. Joints on the track, which exist every 25m.

The proposed instrumentation measures microdeformations in the cross-section of the tunnel, i.e. possible movements, or dysfunctions of the cross section. In the initial reading of zeros with optical fiber a catalogue of current dysfunctions (cracks, humidity, coqueries, anomalous roughness, etc.) is made. Figure 4, Figure 5 and Figure 6 show some of the found dysfunctions in the initial inspection.

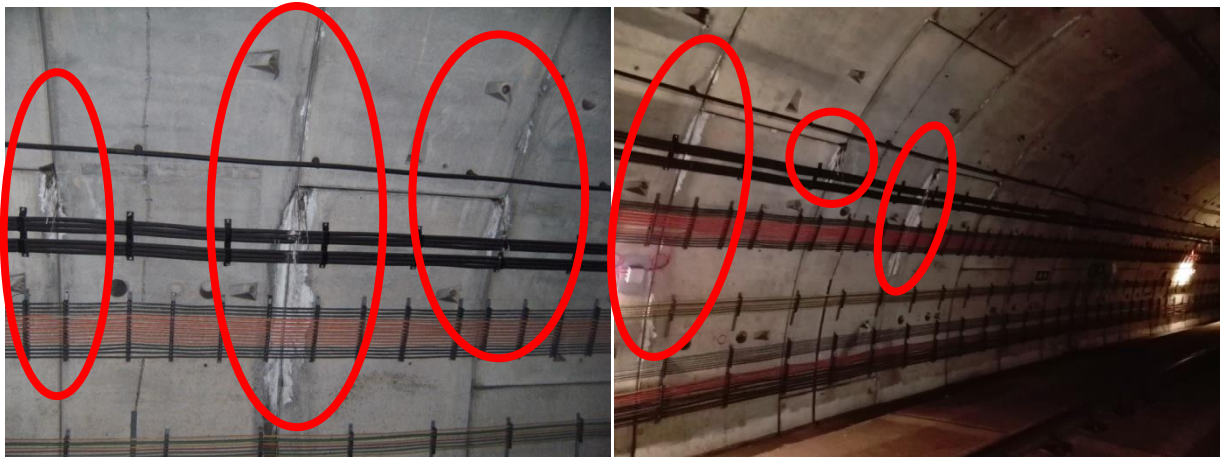
Figure 5. Filtrations (leachings of cement limes).

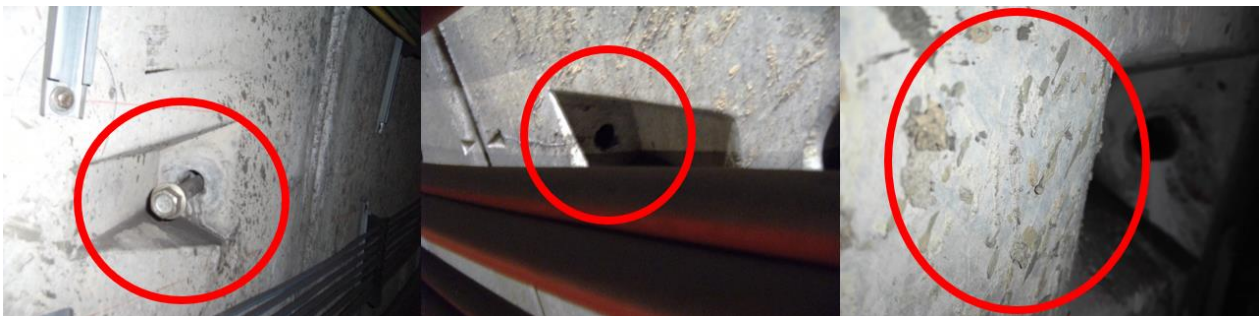
Figure 6 Roughness and clamping bolts that could affect the placement of the fiber.

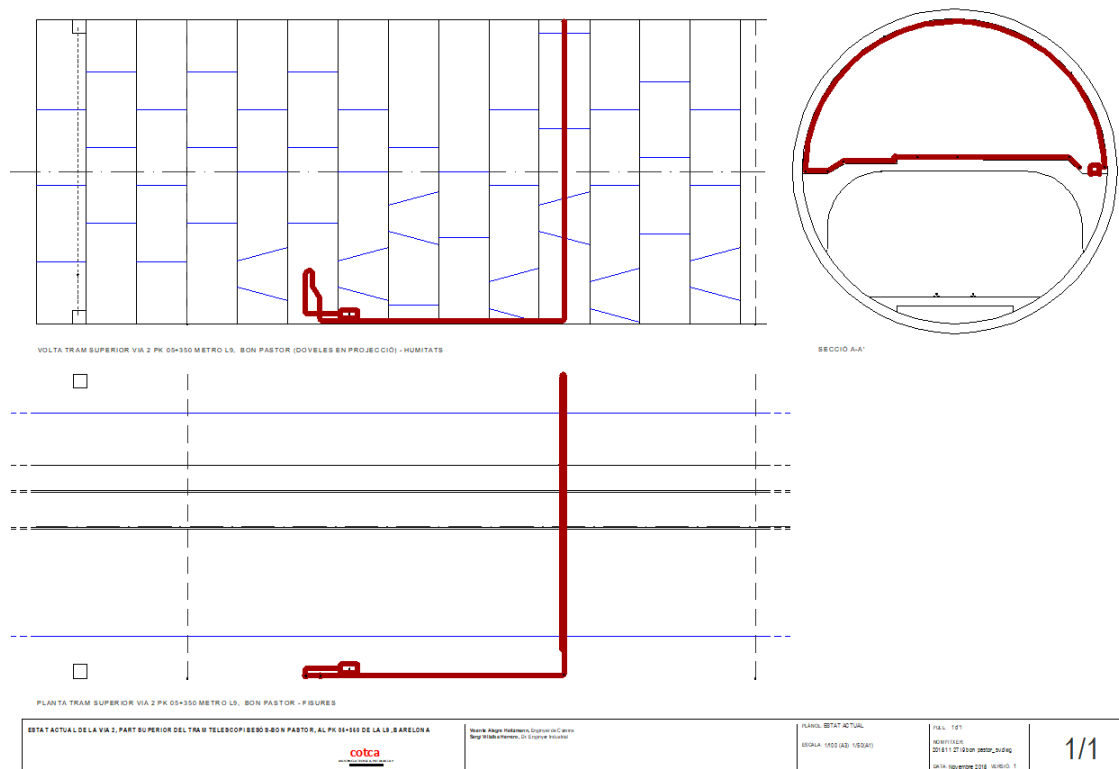
Figure 7 General tunnel scheme. Elevation and plant. The red line indicates the path of the optical fiber.

Below is the scope of monitoring used (see Figure 7).

The actual tunnel monitoring length is adjusted to the actual length of a cross section and longitudinal section, this being 50.00m in length. That is, FOD1 optical fiber (Distributed Optical Fiber) is attached 40m and the last 10m were kept on the reel containing the optical fiber (without attaching), which was attached to the structure with American tape. This detail is shown in Figure 8, Figure 9 and Figure 10 along with the system installed within the tunnel cross section.

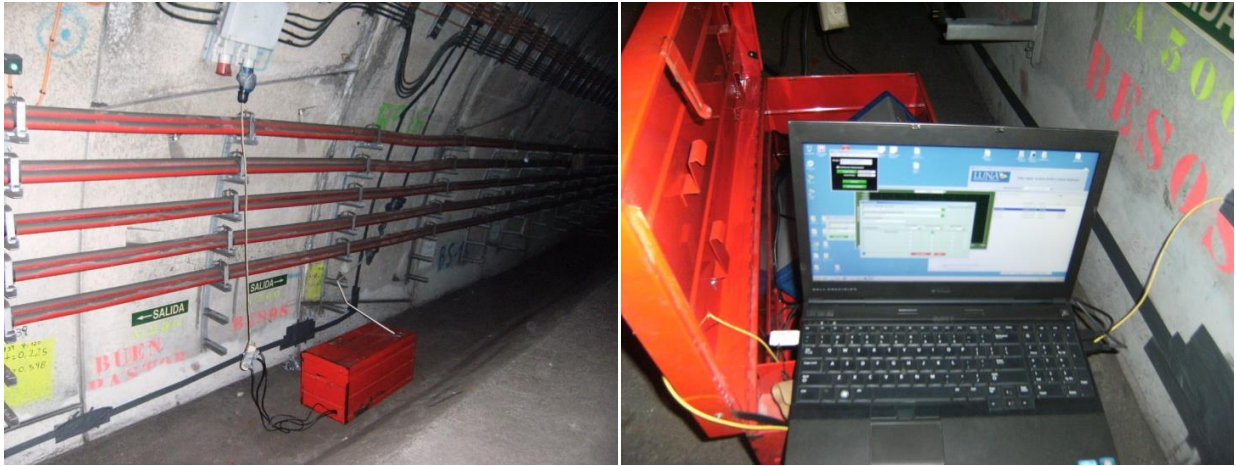
Figure 8. Remaining optical fiber reel subject to the structure and ODiSI (Optical Distributed Sensor Interrogator, by LUNA Technologies, Model A50) in operation.

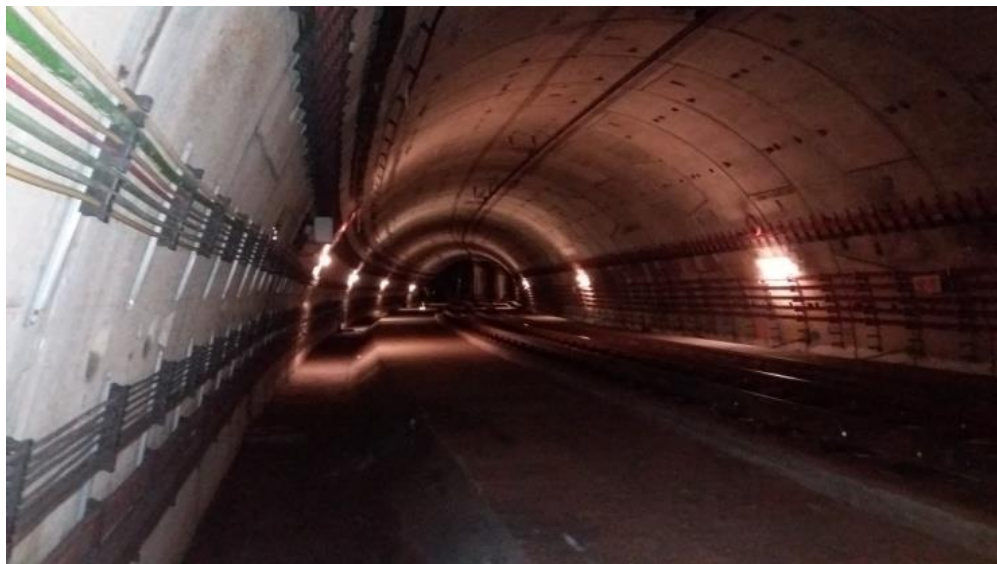
Figure 9. Overview of the tunnel in the instrumented section.

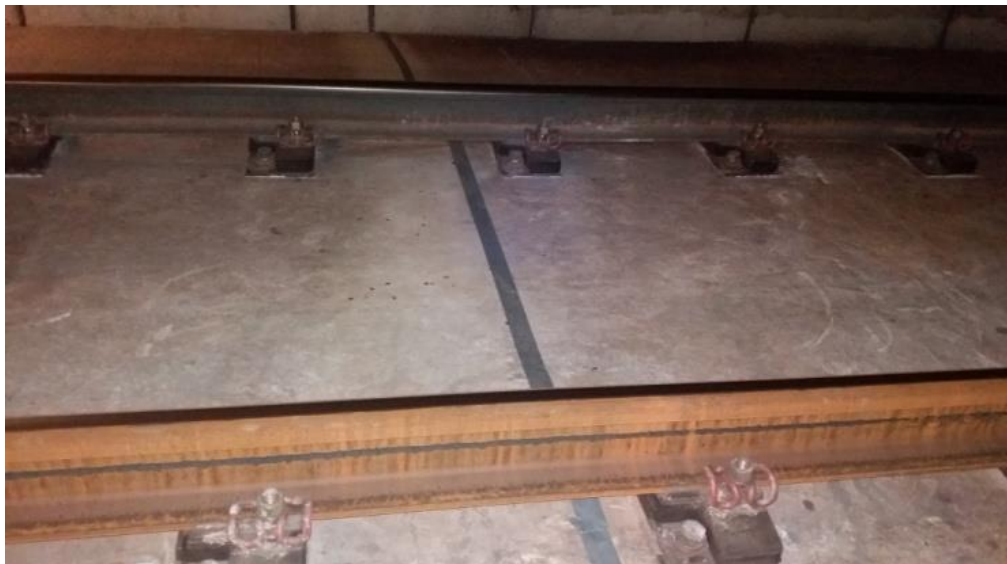
Figure 10. Optical fiber protected under train tracks.

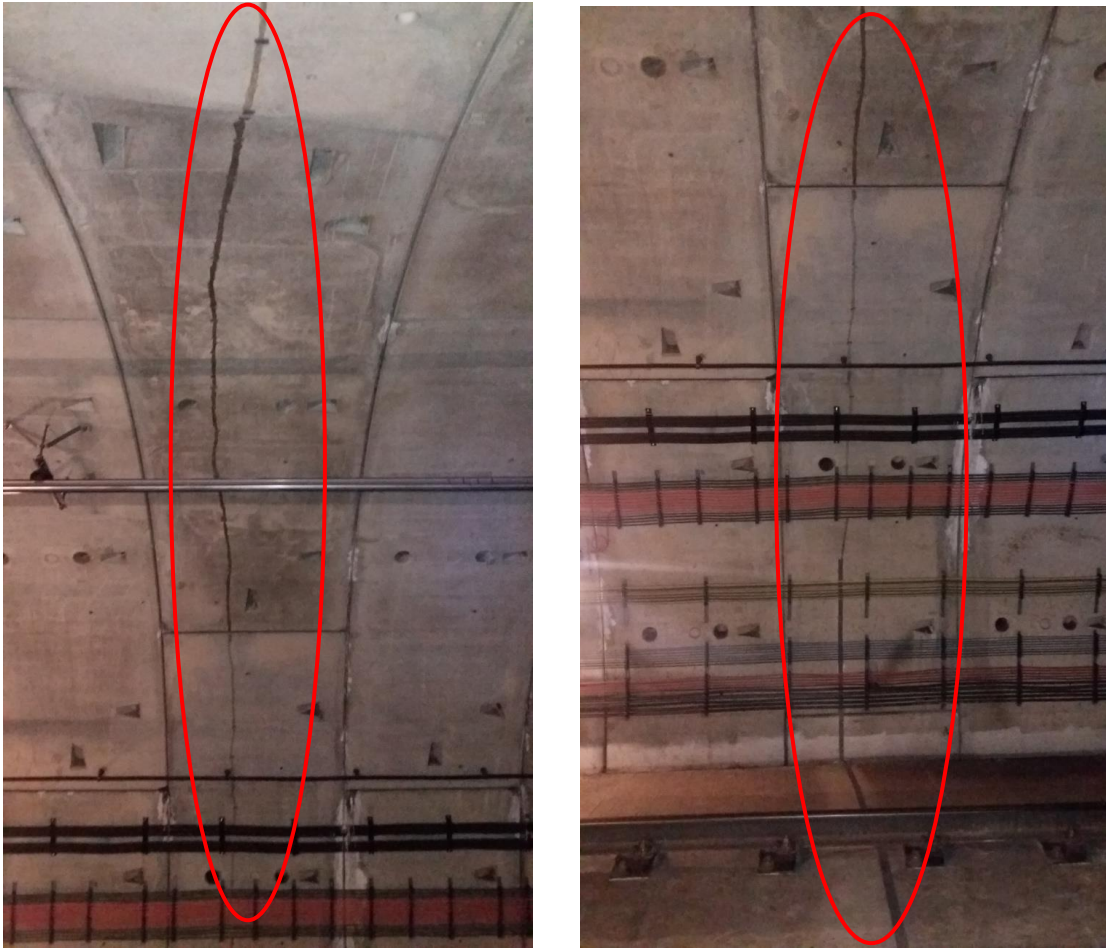
Figure 11. Optical fiber adhesion procedure on the steed of the track 2 circulation lane and in the tunnel vault.

Figure 11 shows the adhesion procedure performed with the optical fiber on the traffic lane steed of track 2 and in the tunnel vault.

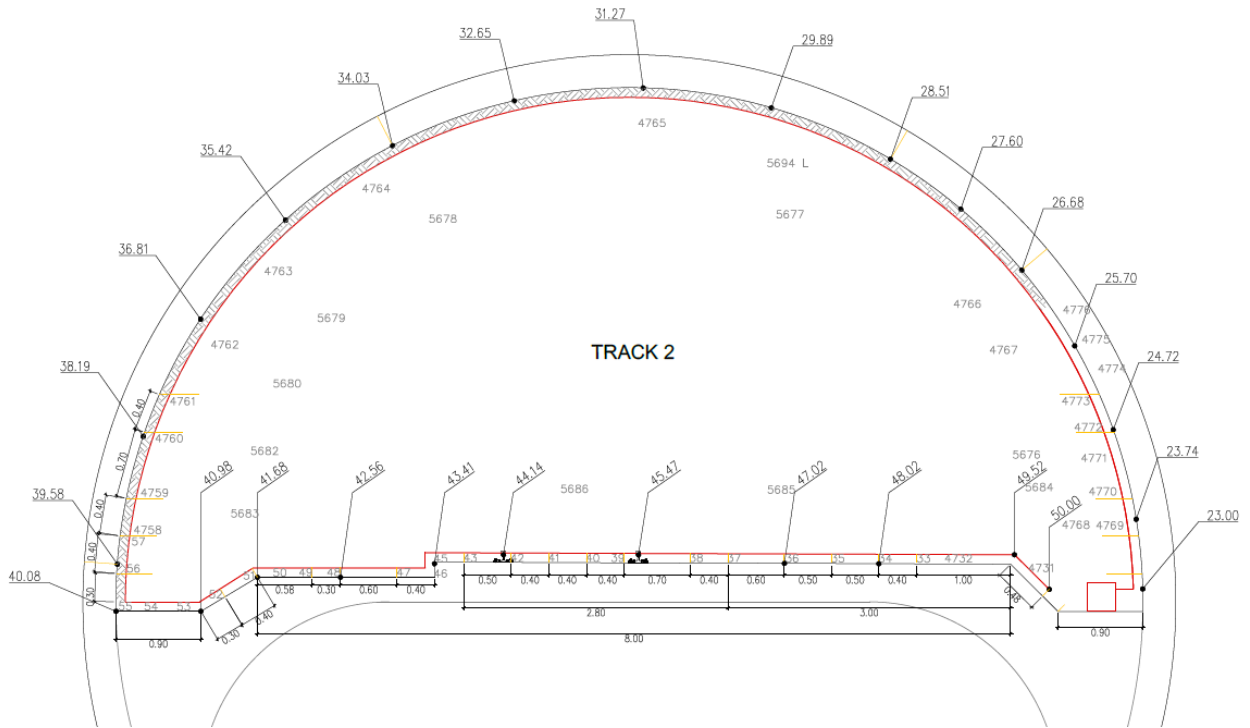
Figure 12. Tunnel section and FOD processing.

The following are the most significant results obtained from the monitoring raised, as seen in Figure 12 FOD processing.

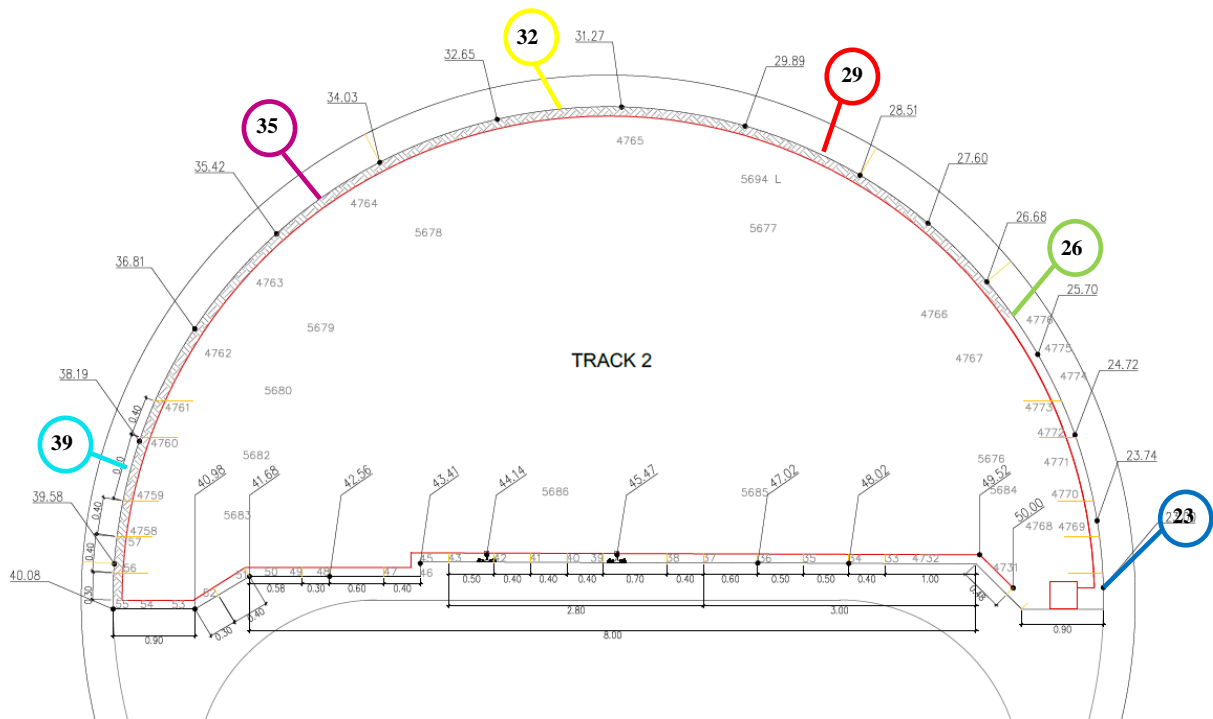
Figure 18. Identification of critical control points in the Tunnel vault.

Figure 18 and Figure 19 incorporate the reading log at 6 critical points along the tunnel vault section.

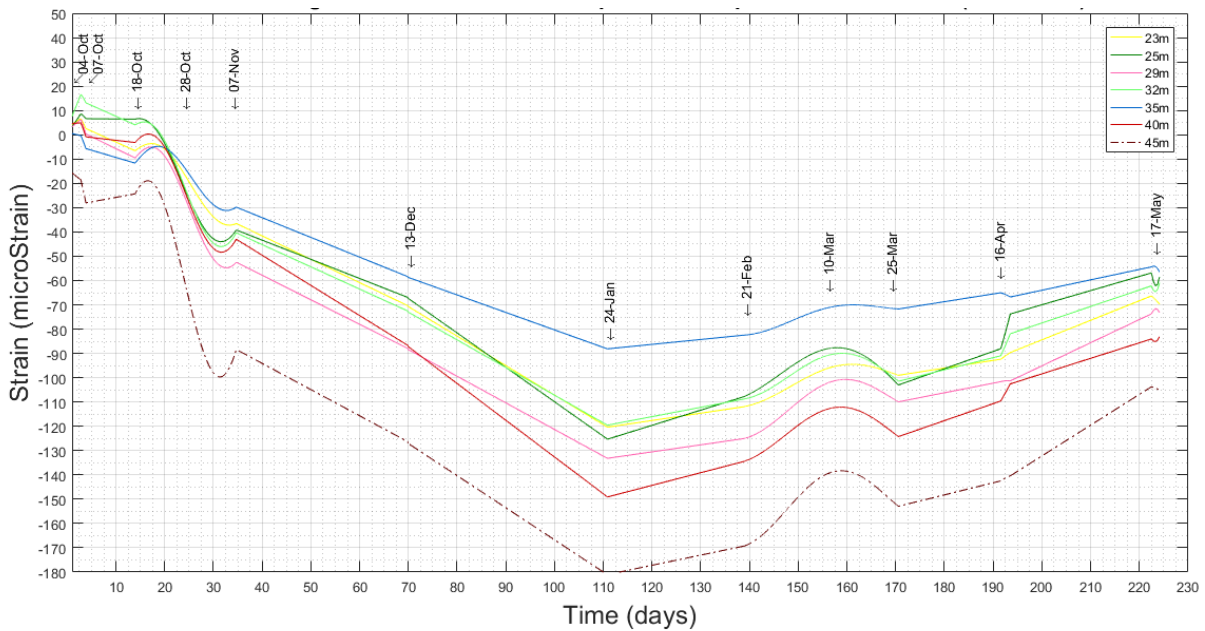
Figure 19. Temporary evolution from October 4, 2018 to May 17, 2019 at critical checkpoints.

- 1) The fiber section between 40 and 50m→ corresponds to the track area. In this section is where there is more excitement of the fiber given the railway step. The vibration caused by the railway circulation results in more distortion of readings in this section. Even so, it is observed how these variations of recorded microdeformations have a tendency to increase to compression, which is consistent with the decompression and ovalization suffered by the curved section of the tunnel and which causes the slab to perform a strut function in response of this action. The ovalization of the tunnel is explained at the next point. Likewise, under no circumstances do the obtained values exceed the notice limit set out in the Auscultation and Contingency Plan.

- 2) The fiber section between 23 and 40m →corresponds to the area of the vault. This section shows how, in general, there has been an increase in compression microdeformations throughout the instrumentation. This is due to the decompression caused by the excavation and emptying of land from the work, so that this decompression produces a certain "ovalization" of the section, which results in an increase in compression in the inner fiber of the section (the inner fiber of the section is compressed and the outer fiber of the decompression section). It can be clearly seen as going from a green color (null and initial deformation) to a blue color indicating compression. Likewise, under no circumstances do the obtained values exceed the notice limit set out in the Auscultation and Contingency Plan.

- 3) The fiber bouquet between 10 and 23m corresponds → to the longitudinal monitoring section. In this area we see values for compression and traction, but that throughout their evolution have been constant at all times, that is, without variation in the origin of the readings and calibration. This fact indicates that there have been no variations in this section in response to the structure, i.e. that the actions carried out have not led to appreciable changes in the structure.
- 4) The fiber section between 0 and 10m→ corresponds to the non-adhered fiber section. In this area there is a linear evolution without differential changes, where it is found that there are no substantial variations in temperature that induce significant tension variations, so that they do not influence the other zonas areas of FOD attached.
