## **ALCONPAT International**

## **Revista ALCONPAT**

## The importance of underpaint corrosion caused by damage to paint on steel structures

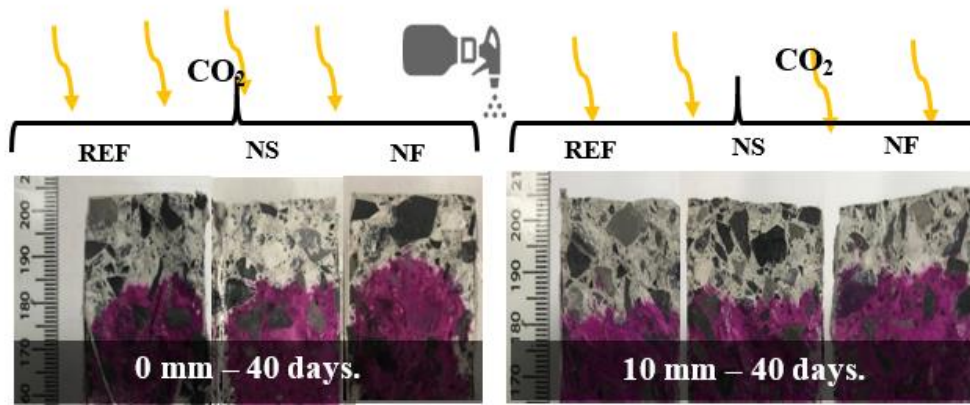
Figure 2. Advance of carbonation in samples of 0 and 10 mm of initial carbonation at 40 days of re-exposure, measured with Phenolphthalein.

For the measurement of the depth of carbonation, phenolphthalein was used as a conventional indicator. The pink color it gives is an indicator of a concrete in good condition, that is, it still does not have carbonation problems. Figure 2 illustrates the carbonation advance for the concrete sample with and without treatments. For the measurements, the Image J program and a graduated ruler were used as a reference scale, 10 measurements were made per carbonate side of the specimen, having 3 specimens per treatment.

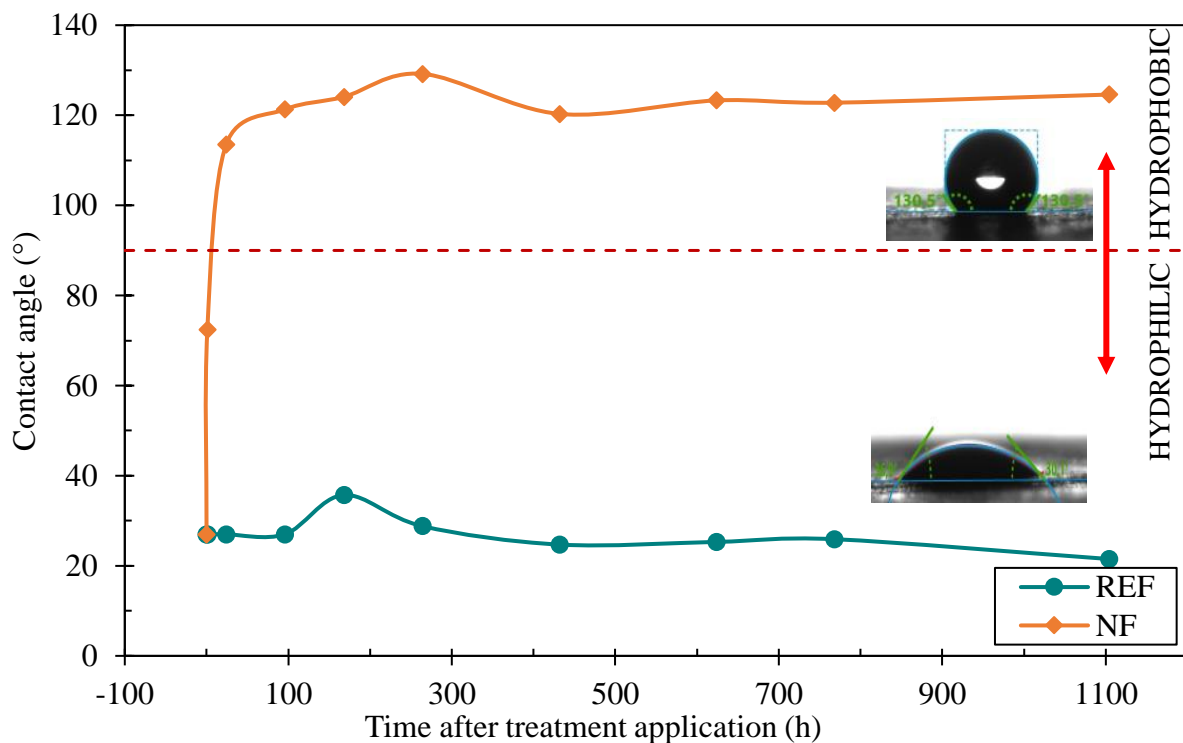
Figure 3. Contact angle behavior in samples with NF treatments hours after application.

In the Figure 3, the results of the REF and NF specimens are shown, in which the contact angle was monitored in order to know the behavior of the development of hydrophobicity on the concrete surface. Measurements were made on specimens without prior aging for more than 1000 h after application of the treatment. It can be seen that the REF sample had a practically constant behavior, with an average contact angle of 26.9°. On the other hand, the samples with NF treatment had a uniform behavior from 96 h after application, reaching a maximum angle of 123.7°. According to these results, after 24 h the surface changed from being hydrophilic to hydrophobic; and around 96 h, the NF has a stable AC in the concrete.

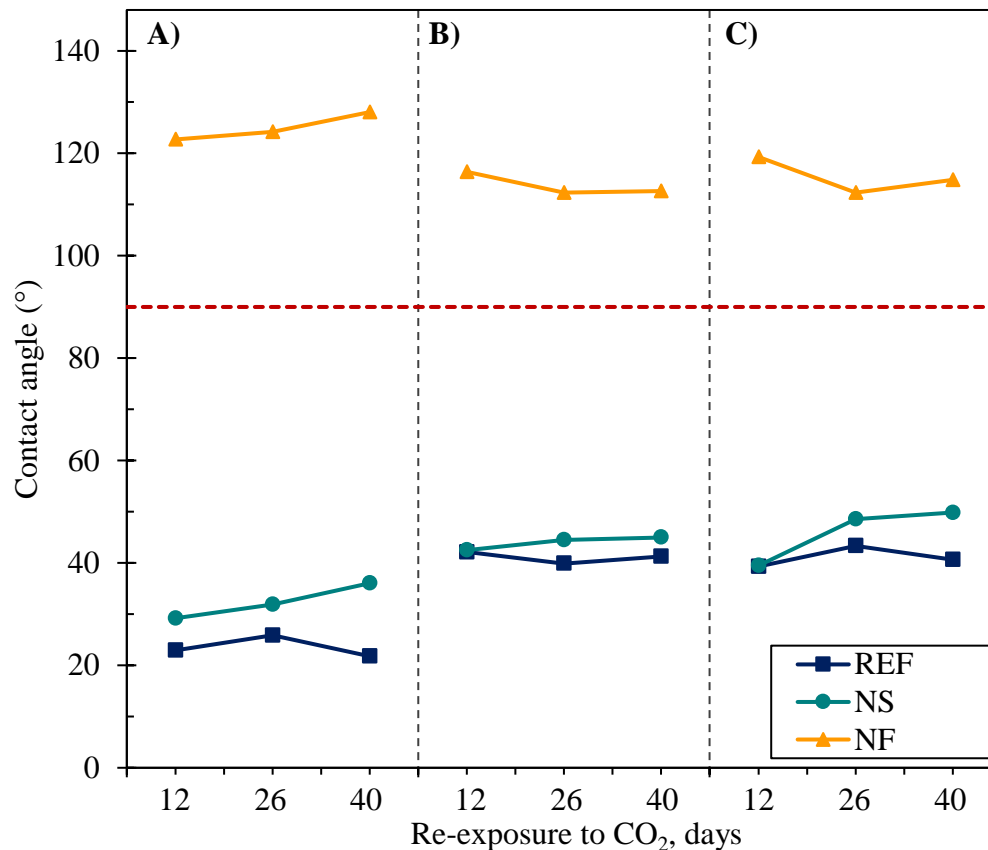
Figure 4. Variation of the contact angle of specimens with an initial aging of A) 0mm, B) 5mm and C) 10 mm of carbonation, after re-exposure to carbonation

In Figure 4.B and 4.C, the results obtained from specimens with an aging of 5 mm and 10 mm carbonation are presented. In both cases, it can be verified that the AC remained in a range between 115 and 120°, but without showing a clear trend. Based on the above, it can be concluded that aging caused by exposure to a CO<sub>2</sub> environment does not affect contact angle behavior, and therefore the development of hydrophobicity.

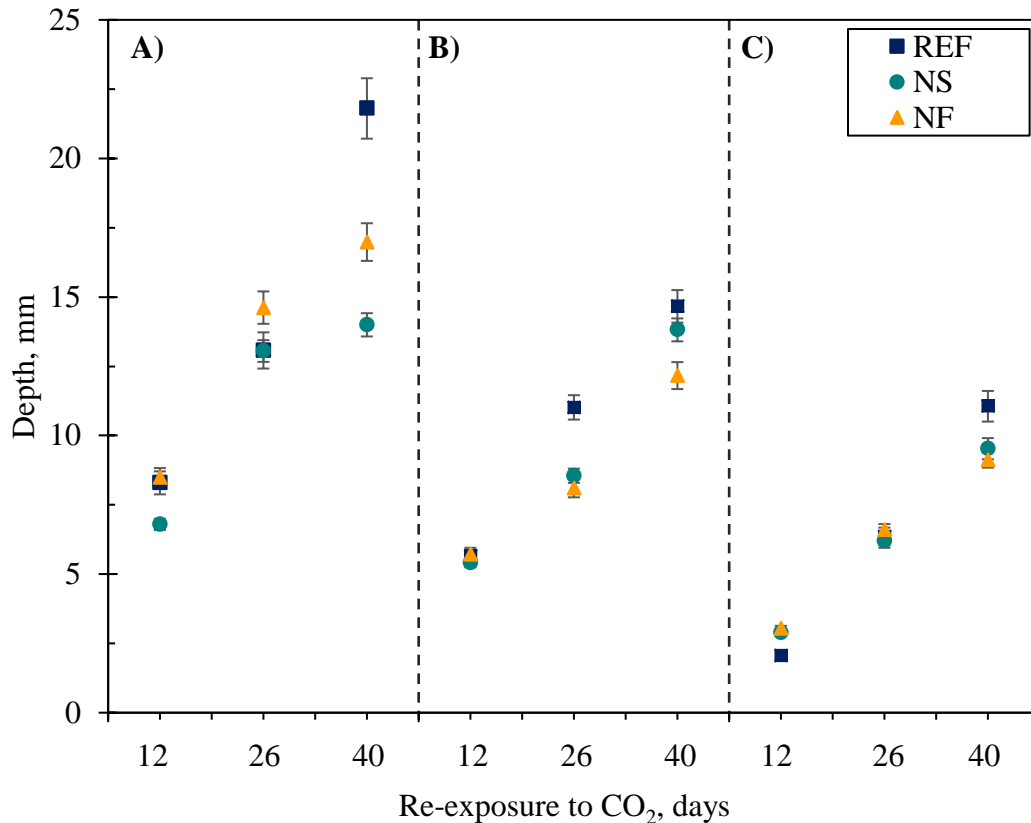
Figure 5. Depth of carbonation in specimens with A) 0 mm B) 5 mm and C) 10 mm carbonation prior to application of the treatment.

In Figure 5, the results of the carbonation progress of the NS and NF surface treatments are presented, including the series without treatment (REF). It can be observed how the untreated series tends to have a greater carbonation depth compared to the treated samples, regardless of the degree of aging.

Specifically, in Figure 5.A, towards the end of the test period, a 36% decrease in the carbonation depth is observed in the NS-treated specimens, compared to the REF samples. While the treatment with NF obtained a 22% reduction. This is attributed to the formation of hydrated compounds as a result of the reaction of the nanoparticles with Ca(OH)<sub>2</sub>, obtaining a greater amount of gels that leads to reduced permeability. These results are in agreement with the literature, where the use of NS generates a barrier effect that improves the resistance of aggressive agents[4] [6]. The treatment with NF produces a hydrophobic effect on the surface of the concrete, which gives it the ability to yield the passage of gases such as CO<sub>2</sub> insider, but stopping the entry of water through the repulsion of molecules of OH, for example, which are necessary to generate the reactions of the carbonation process.

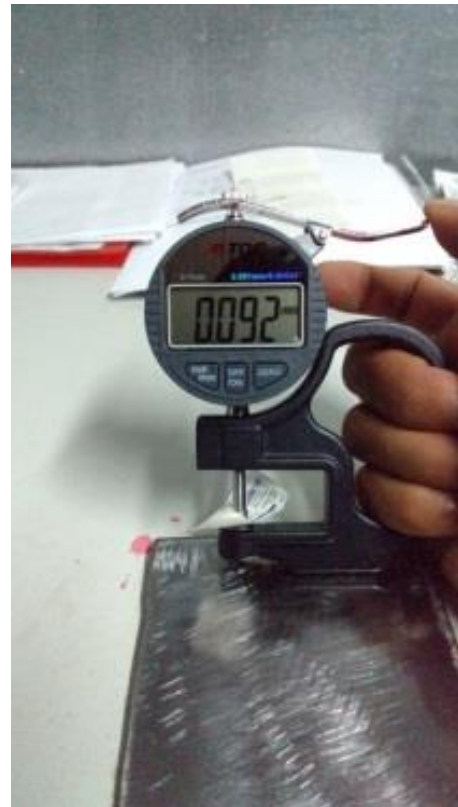
Figure 2 Roughness meter used to measure the roughness of a St3 standard plate (Ribeiro Filho, 2018)

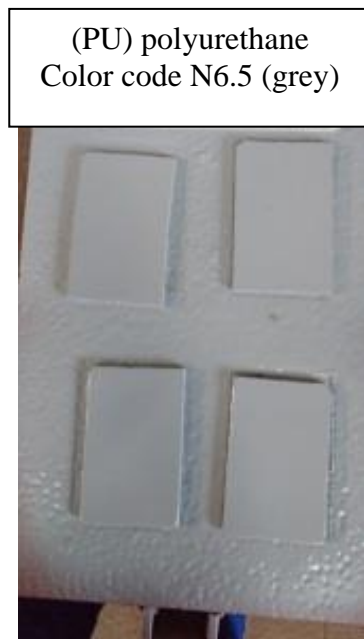
Figure 3. Finishing the paint (Ribeiro Filho, 2018).

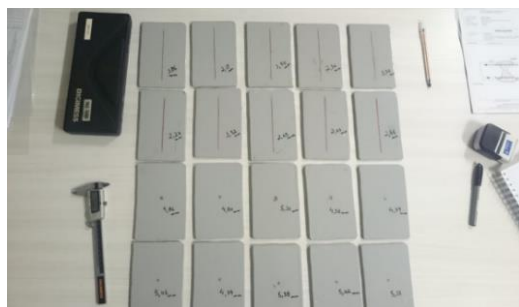
Figure 5. Specimens with experimentally damaged paint (Ribeiro Filho, 2018).

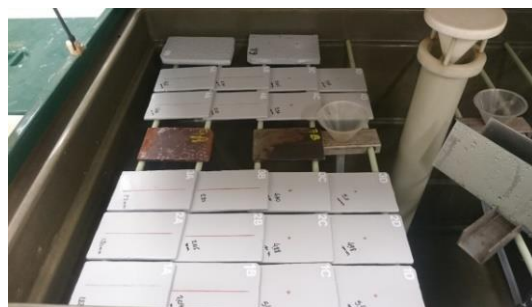
Figure 6. Specimens in the salt chamber before exposure to the mist (Ribeiro Filho, 2018).

All specimens were subjected to a salt spray chamber (Figure 6) with a 5% sodium chloride (NaCl) saline mist, in which the mist was uniformly sprayed at a controlled temperature, according to ISO 9227 (ISO, 2012), NBR-8094 (ABNT, 1983) and B117-16 (ASTM, 2001). The temperature was maintained within the interval of  $35 \pm 2^\circ\text{C}$ , and the specimens remained in the salt spray chamber for 1550 h.

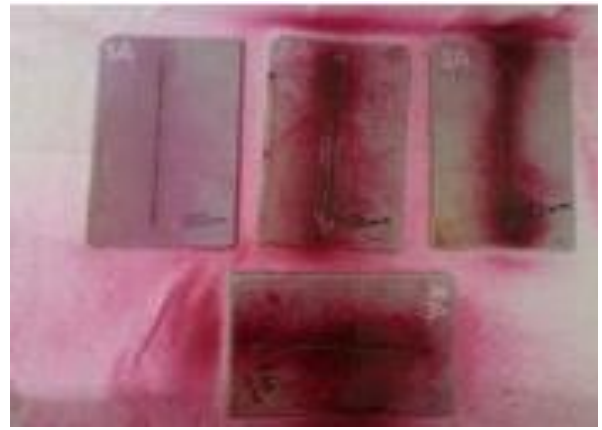
Figure 8. PL test awaiting development (Ribeiro Filho, 2018).

After removing the specimens from the saline chamber (Figure 7), the specimens were washed with clean running water at room temperature ( $<40^\circ\text{C}$ ) to remove the salt deposits and immediately dried. Subsequently, the specimens were subjected to a penetrant liquid (PL) test, according to the standard NBR 9583 (ABNT, 1997), and the points of higher corrosion incidence were determined (Figures 8 and 9).

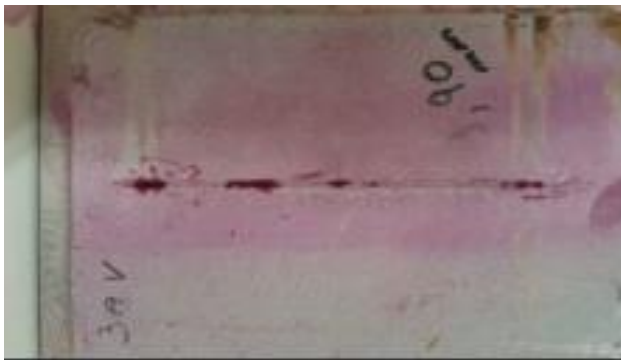
Figure 9. Specimen awaiting development (Ribeiro Filho, 2018).

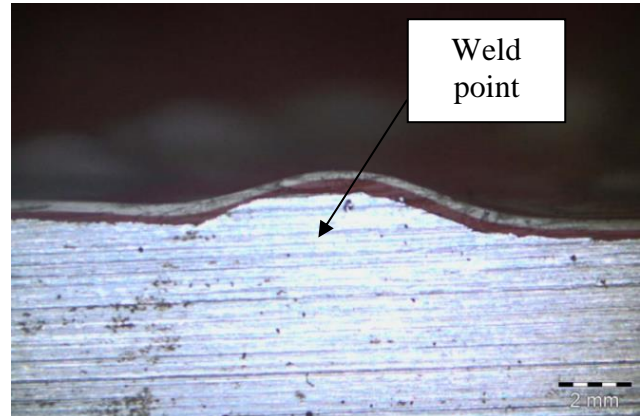
Figure 14. Cross section of specimen 6A (Ribeiro Filho, 2018).

Figure 14 shows the image of specimen 6A, in which the paint thickness on a welded point varied significantly. However, due to its integrity, the anticorrosion protection of the system was preserved, even with a film thickness of 283  $\mu\text{m}$ .

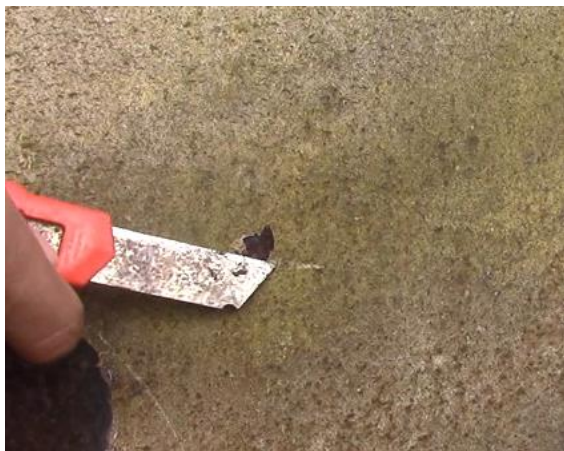
Figure 15. Mechanical damage to the field paint (Ribeiro Filho, 2018).

To compare the results obtained in the laboratory with those of a real platform situation, a surface with intact paint, except for a single isolated region of mechanical damage throughout the film, was identified during the field visit. By radially removing the paint from this central point, the limits of corrosion exhibited a circumferential configuration, denoting that equal corrosion occurred in all directions, which can be verified by the existence of sandblasting steel without corrosion, exhibiting a Sa2½ pattern from the limits of the corrosion edge, which reached a radius of 21 mm (Figures 15 and 16).

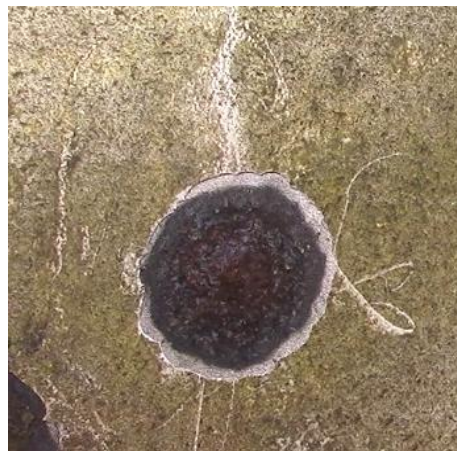
Figure 16. Edge of the corroded area and the area without corrosion (Ribeiro Filho, 2018).

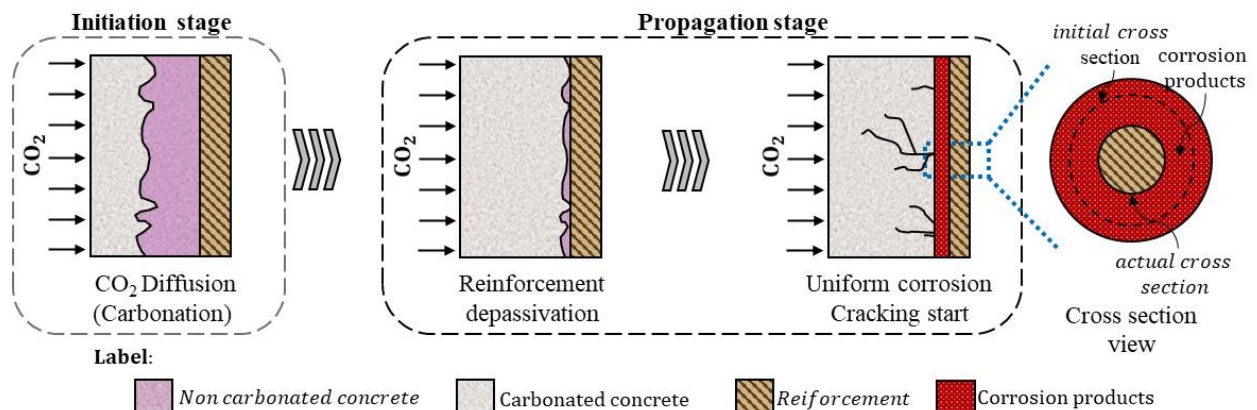
Figure 1. Corrosion development in concrete.

With the formation of corrosion products, internal stresses are developed at the interface between steel and concrete. As stresses increase, surpassing concrete tensile strength, micro cracks appear in the concrete matrix which increases in size and thickness as the pathological manifestation progress, spreading throughout the structural element until it spalls the concrete cover, affecting the durability and reducing the service life of the structure. The degradation process is presented in Figure 1.

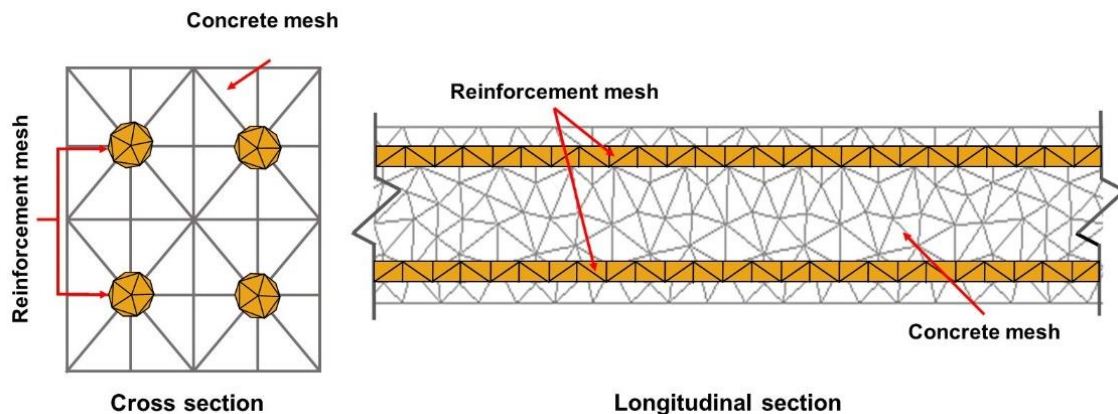
Figure 2. Example of discretization of a reinforced concrete beam cross and longitudinal sections.

In order to simulate the expansion of reinforced concrete structures due to uniform corrosion, especially the formation of corrosion products, a numerical tool based on the Positional Finite Element Method was developed. The Fortran code combines a few analytical formulations to evaluate representative corrosion parameters. The mechanical behavior of the reinforced concrete is evaluated by a formulation based on the Positional Finite Element Method for composite solids, initially developed by Vanalli et al. (2008) and recently extended by Paccola e Coda (2016), in which the nodal parameters are the positions, and the deformations are related to the initial position of the body. Green strain measure and Saint-Venant-Kirchhoff constitutive law are employed.

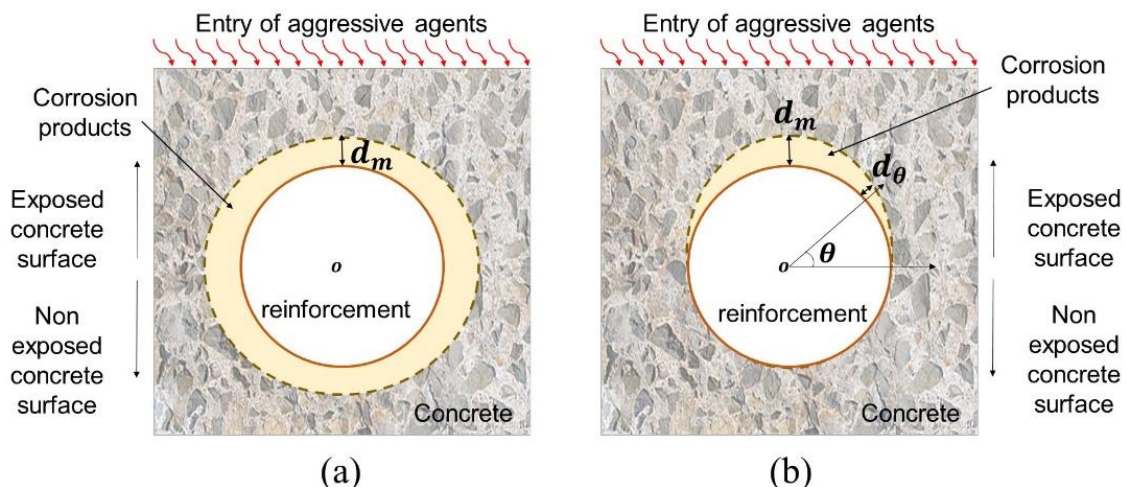
Figure 3. Rust formation profile: (a) linear e (b) non linear.

Over the past few years, some models have been proposed to describe the distribution of rust around the reinforcement, i.e., Liu and Weyers (1998), Yuan and Ji (2009), Balafas and Burgoyne (2010) and Kiani and Shodja (2011). These models are divided into linear and non-linear, as shown in Figure 3.

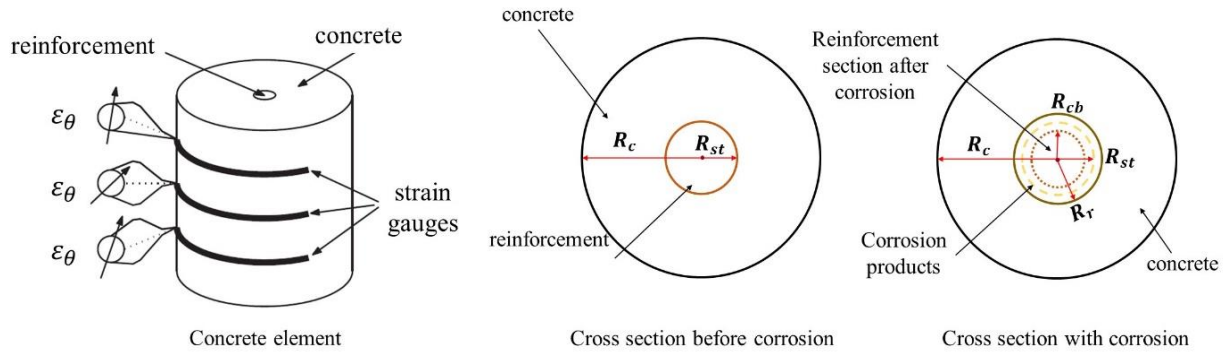
Figure 4. Model schematics of Kiani and Shodja (2011).

Kiani and Shodja (2011) developed a linear model for the formation of rust in reinforced concrete structures, fitting experimental data from cylindrical reinforced concrete specimens of known diameter and physical properties (see Figure 4).

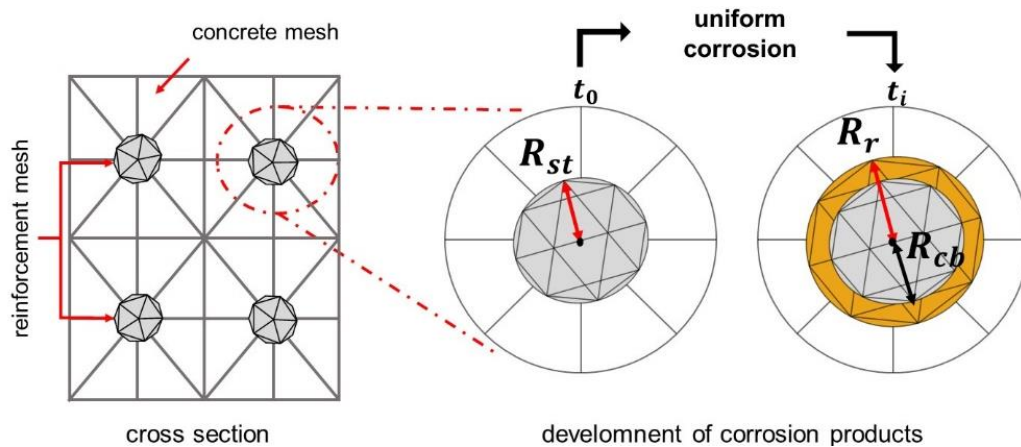
Figure 5. Representation of uniform corrosion via FEM.

Considering that the cross section of a reinforced concrete structural element is represented by a particulate composite element, as shown in Figure 5, the expansion of the concrete cover due to the formation of corrosion products is simulated through the expansion of the particle element, since the reinforcement is perfectly adhered to the concrete matrix (imposed by the coupling technique).

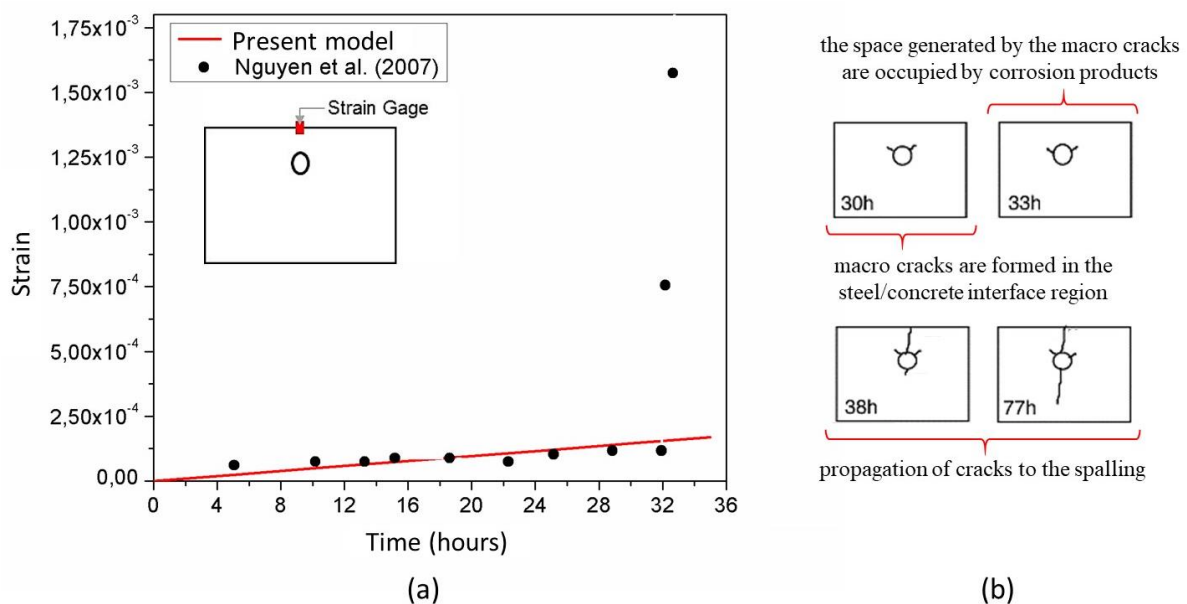
Figure 7. (a) Strain development and (b) Cracking evolution by Nguyen et al. (2007).

Figure 7a presents the strain measured in the plate upper region, comparing the results obtained by the numerical simulation and by the experimental program of Nguyen et al. (2007).

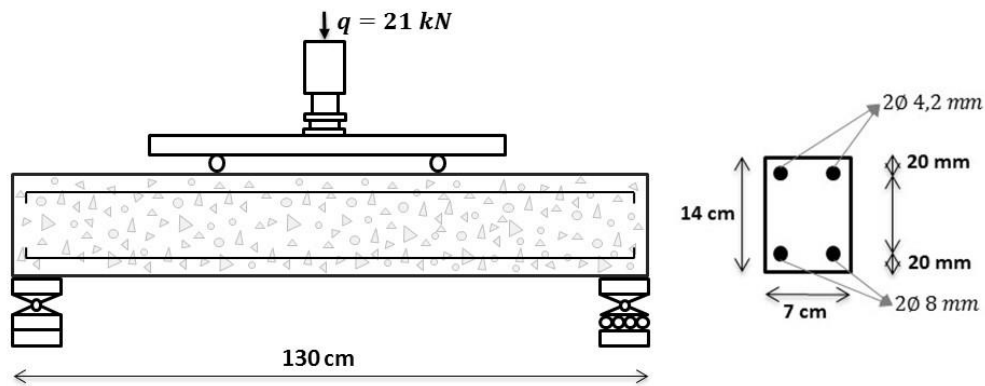
Figure 10. Reinforced concrete beam details.

In the second example, a reinforced concrete beam is simulated, based in the experimental assessment of Graeff (2007), see Figure 10. The simply supported beam of length 130 cm has a rectangular cross section 7 cm wide and 14 cm high, with a span of 120 cm between supports, see Figure 10 for more details.

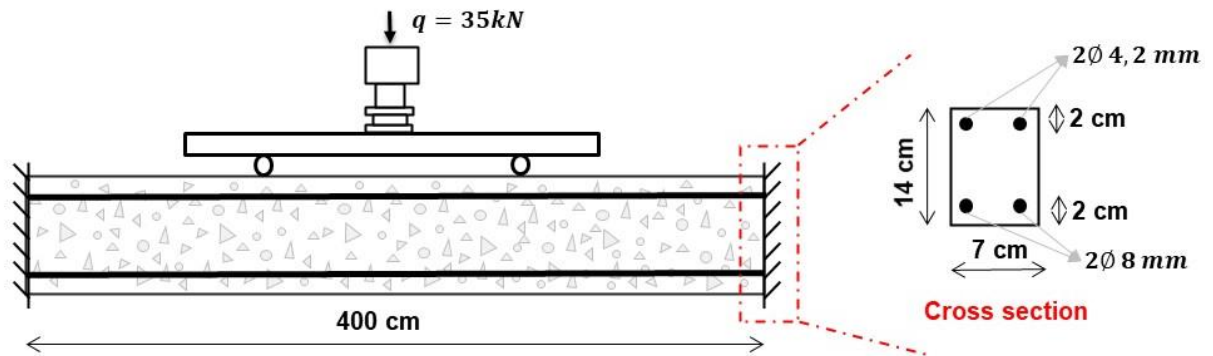
Figure 12. Beam geometry, dimensions and boundary conditions.

Third example consists of a clamped reinforced concrete beam under uniform corrosion. The objective of this analysis is to evaluate the effect of the corrosion on the displacement of the concrete structure, as well on the stress distribution. The beam geometry, dimensions, loading and boundary conditions are shown in Figure 12.

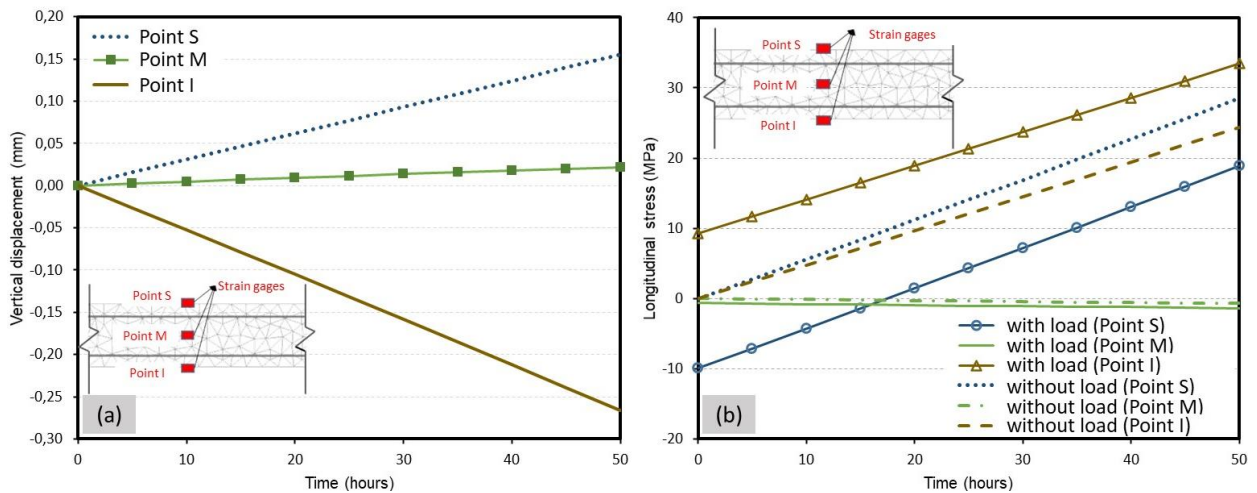
Figure 13. (a) Vertical displacement and (b) Longitudinal stresses.

It is noted in Figure 13.a that after 50 hours of accelerated corrosion, the structure experiences an increase in displacement of 0.26 mm (for low) for a point located in the lower part of the center of the beam (point "I"), as for a point located in the upper part of the center of the beam (point "S"), the increase was 0.14 mm, almost half of the value observed in the lower point.

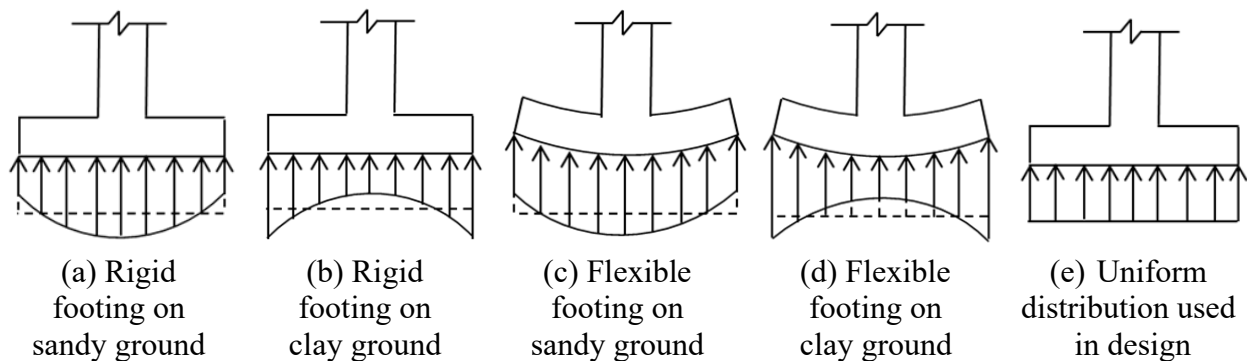
Figure 1. Soil pressure below of the footing

The ground pressure under a footing depends on the type of ground, the relative rigidity of the ground and the footing, and the depth of foundation at level of contact between footing and ground. Figure 1 shows the distribution of ground pressure under the footing according to the type of ground and the stiffness of the footing (Bowles, 2001).

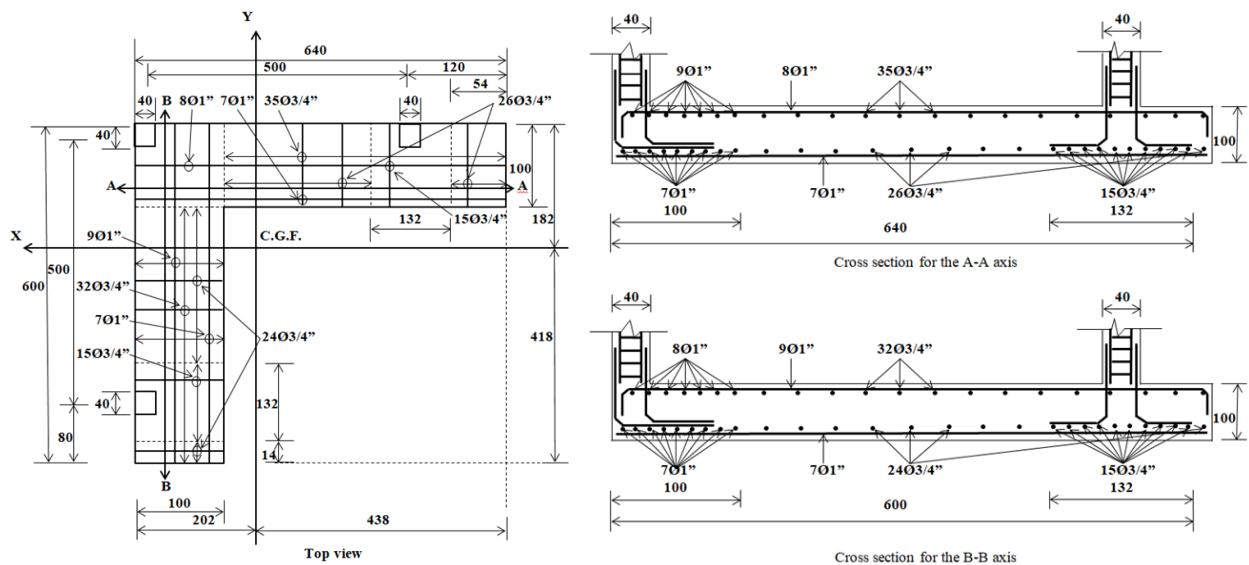
Figure 6. Final design of the corner combined footing

Figure 6 shows in detail the reinforcing steel and the dimensions of the corner combined footing.

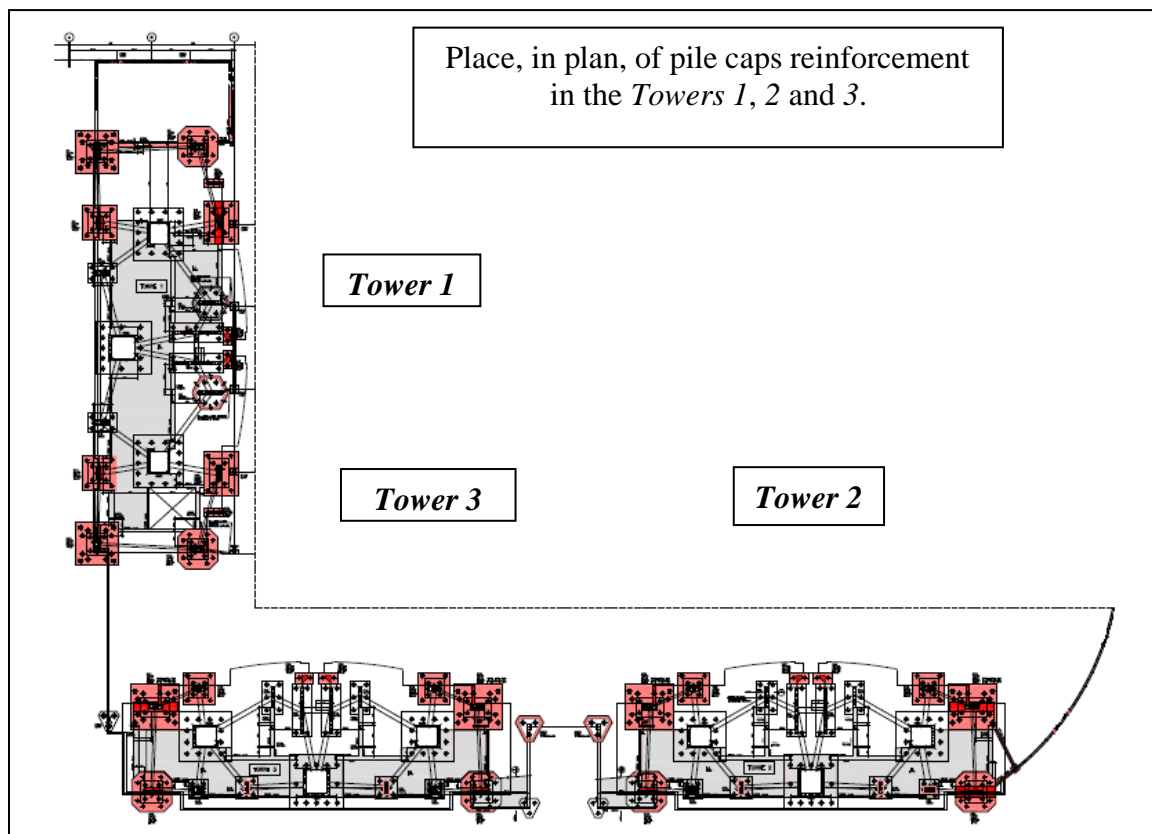
Figure 1. Location detail, in plan, of pile caps structural reinforcement in the residential towers.

The structural reinforcement project for the residential tower pile caps was prepared according the recommendations of standard ABNT NBR 6118:2014. This project includes the reinforcement of 20 structural elements, as highlighted in Figures 1 and 2, which presents the structural reinforcements executed in floor plan and in perspective (highlighted in red), respectively.

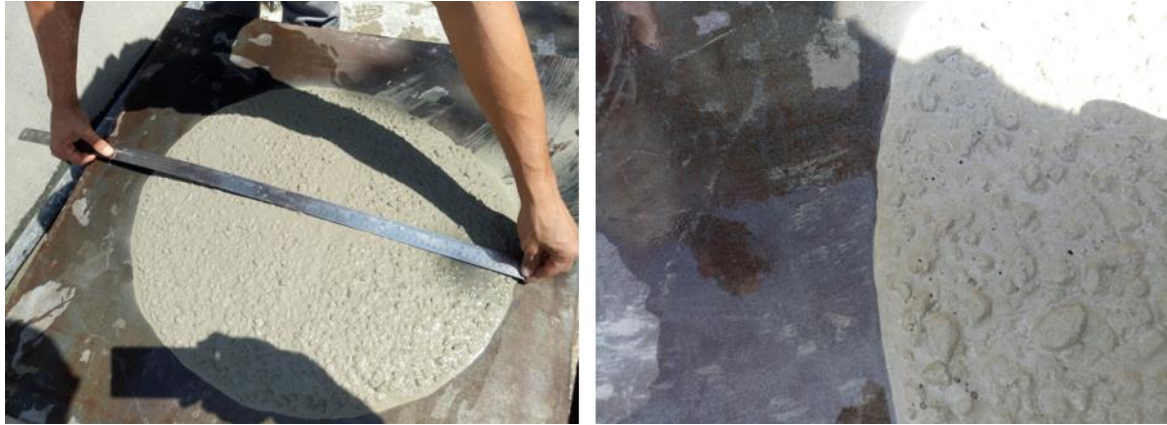
Figure 3. Detail of spreading test performed in the laboratory during the dosage study.

The visual aspect of concrete in question can be seen in Figures 3, 4 and 5, which show the spreading tests, passing skill in J ring and passing skill in box L, performed in accordance with standards ABNT NBR 15823-2:2017, ABNT NBR 15823-3:2017 and ABNT NBR 15823-4:2017, respectively. Still, in Figure 3, it is also possible to observe the visual stability index (IEV) of concrete that was developed especially for the structural reinforcement of pile cap on this project.

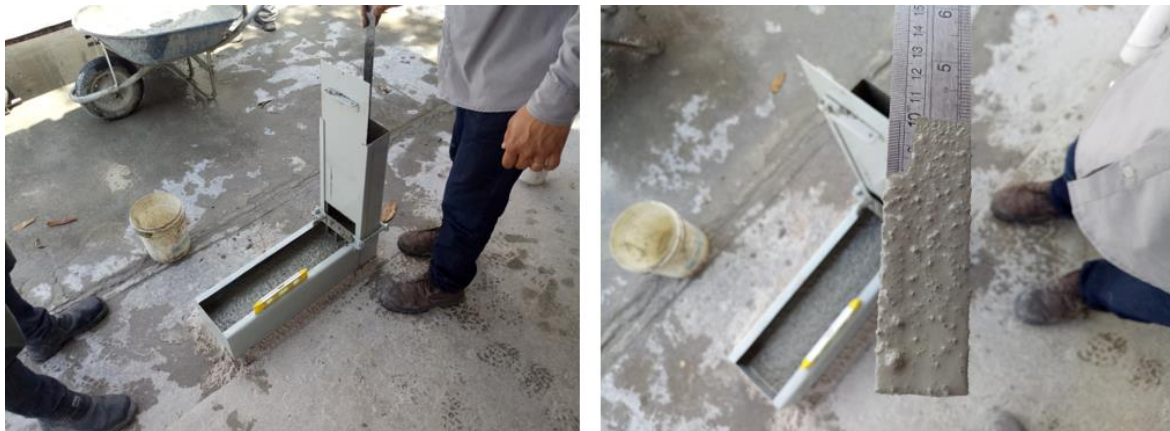
Figure 4. Detail of passing skill test through box L, performed in the laboratory during the dosage study.

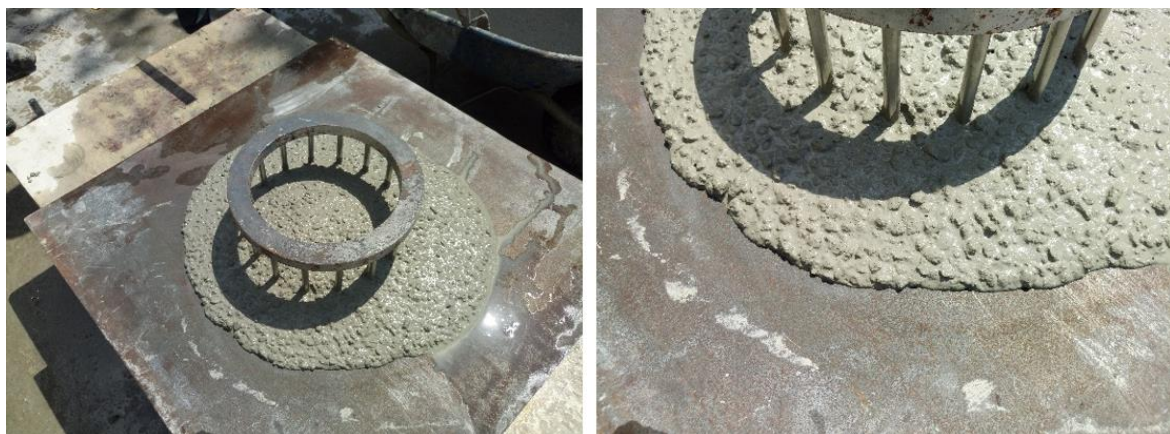
Figure 5. Detail of passing skill test through the J ring, performed in the laboratory during the dosage study.

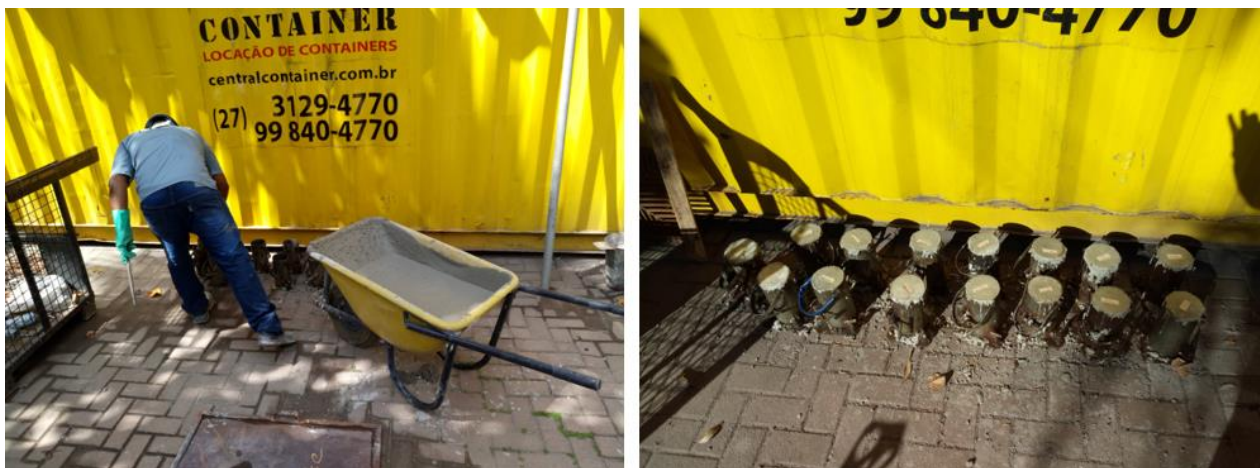
Figure 6. Detail of the molding of cylindrical specimens in the prototype concreting event for tests of resistance to compression and modulus of elasticity.

At the opportunity of prototype concreting event, cylindrical specimens were also molded for compression strength tests at 3, 7, 14, 28 and 45 days of age and elasticity modulus at 28 days, as shown in Figure 6.

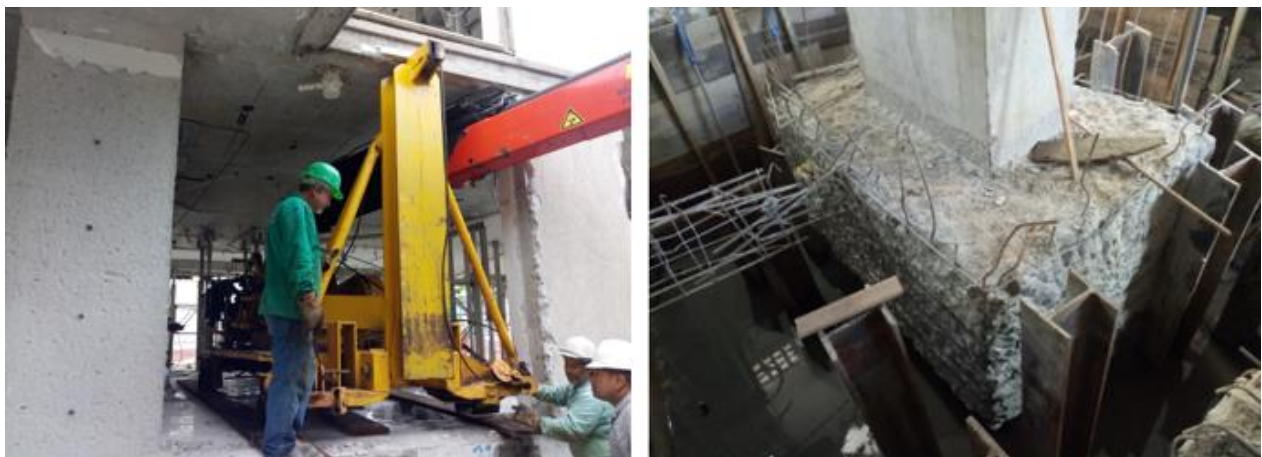
Figure 8. Detail of execution of spiking services (on the left) and of steel piles spiked around the pile cap to be reinforced (on the right).

In this way the metal segments piles were spiked and immediately welded to the subsequent segments, as the services progressed. Figure 8 illustrates the execution of services and the piles spiked in the periphery of one of pile caps. In the latter case, for better visualization, the image registration made after excavating the pile cap surroundings.

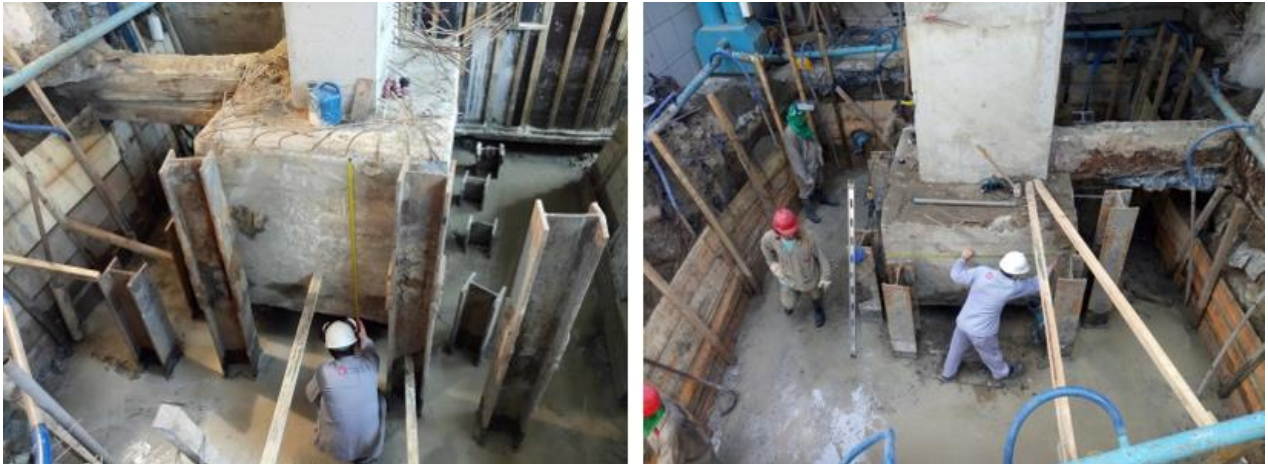
In the sequence, the thin concrete coverage with 5 cm thickness was executed, as well measure of dimensions of existing piles caps, through the topography, possible eccentricities of existing piles (under load), as shown in Figure 9.

Figure 9. Detail of measurement dimensions of existing pile cap and of the steel piles, after excavation and execution of thin concrete.

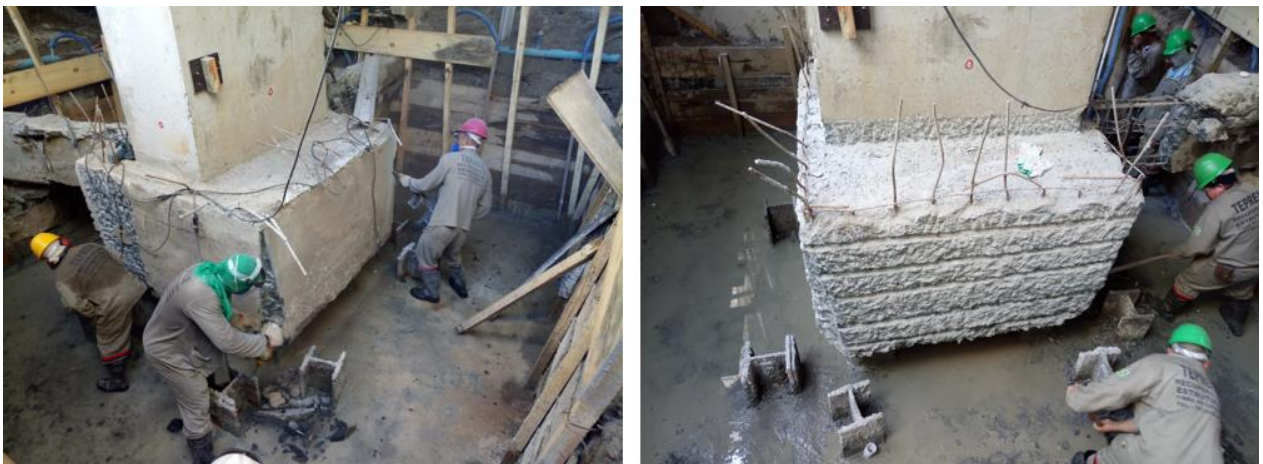
After this stage, the services of cutting the piles began, whose top should be 35 cm above the lower level of reinforcement pile cap, and preparation of lateral surfaces of pile cap, as shown in Figure 10. In this stage, chamfers and ridges were made in the edges and lateral surfaces of pile caps, in addition to chipping of all faces, except the lower one, according to structural design requirements.

Figure 10. Detail of execution of chamfers and ridges in the edges and lateral surfaces of pile cap.

The execution of chamfers and ridges on the sides of existing blocks were essential and very important, since they aimed to guarantee the quality of concreting joint in the old concrete/new concrete interface (to be launched) and to collaborate in the transmission of efforts. The execution of chamfers on the lateral edges provided a cone-like geometry (or stopper) that dispensed the verification of adherence between the existing block and structural reinforcement.

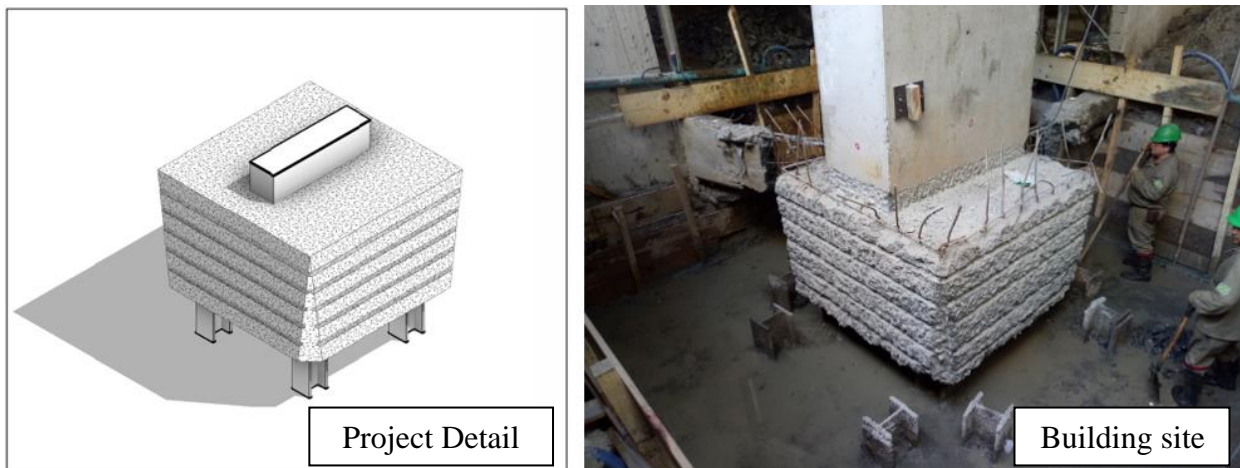
Figure 12. Detail of the surface treatment of pile cap. Detail of the project (left) and the situation “building site” (right).

The Figure 12 shows the pile cap after the completion of concrete surface treatment services.

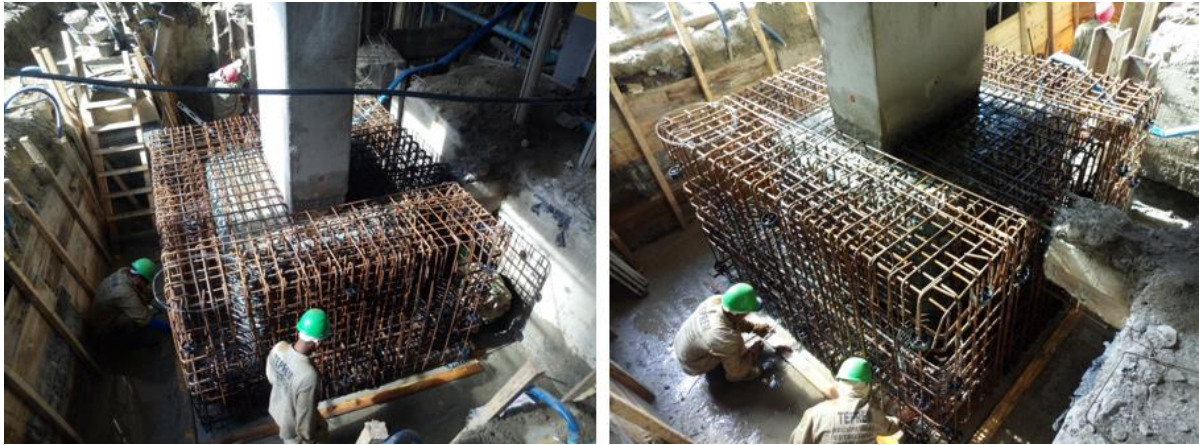
It is recorded that that the steel bars used in the structural reinforcement of pile caps (gauges 25 mm, 20 mm, 16 mm and 12,5 mm) were delivered to the work cut/folded and properly identified. Figure 13 shows the execution of reinforcement frame services for the pile caps.

Figure 13. Detail of execution of reinforcement frame services of pile caps.

After preparing the surface, the structural reinforcement services started by a specialized company and certified labor began, through monitoring and verification of services, with regard to positioning, gauges, number of bars and other steps involving quality control, including the use of multi-support spacers on sides and bottom of pile cap, in order to guarantee the specified coverage of project (40 mm).

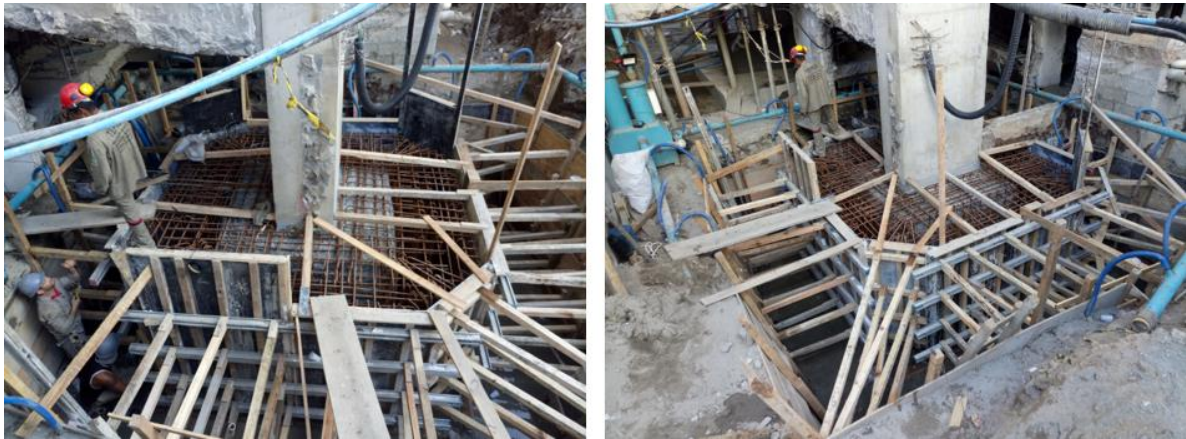
Upon verification of frame and release by the engineering staff, initiated the assembling the wooden forms and shoring, as shown in Figure 14. All of these services were also monitored and checked for flatness, plumbs, dimensions, locking system and water tightness.

Figure 14. Detail of the formwork of structural reinforcement pile caps.

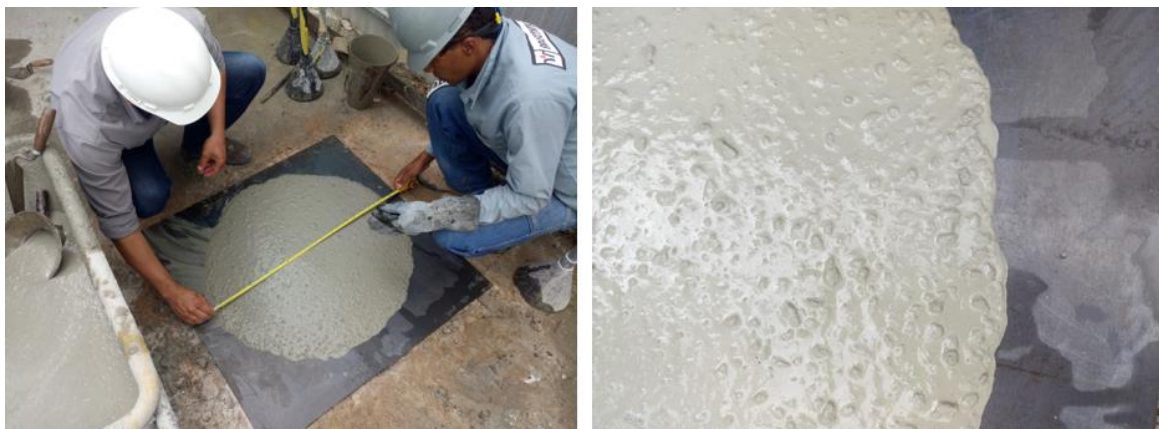
Finishing the structural reinforcement services, the concreting of reinforcement structural element was carried out, through the use of self-compacting, pumped concrete, as detailed in item 2 “*Basic Data of Reinforcement and Concrete Design*” of this paper. Figure 15 shows the visual aspect of concrete observed in the field.

Figure 15. Visual aspect of self-compacting concrete used to reinforce structural pile caps.

At this stage, it was indispensable that the concrete was cast at a low speed to avoid trapping air on the lower surface of pile cap, thus avoiding possible hidden concrete failures. In order to avoid non-conformities of this nature, the concrete from the lower portion of pile cap was launched slowly, on only one side of pile cap, and moderately vibrated with immersion vibrators with a diameter needle of 40 mm.
