## **ALCONPAT International**

## **Revista ALCONPAT**

## The importance of underpaint corrosion caused by damage to paint on steel structures

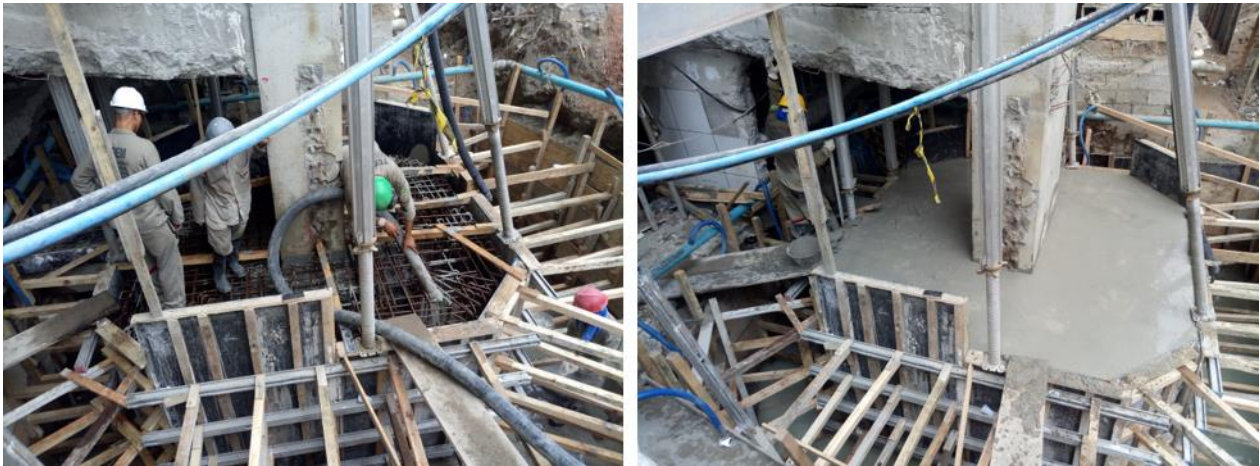
The Figure 16 shows the concreting event of reinforcement of one pile cap, performed with self-compacting concrete, respecting the premises mentioned in the previous paragraph.

Figure 16. Detail of the concreting of reinforcement of pile cap, made with self-compacting concrete.

It is important to note that the treated surface of existing pile cap, the region of interface with the new concrete, was previously cleaned with a pressurized water jet, in order to remove all dust, powdery material or any other type of contaminant. The self-compacting concrete was cast on a clean surface in a dry saturated condition.

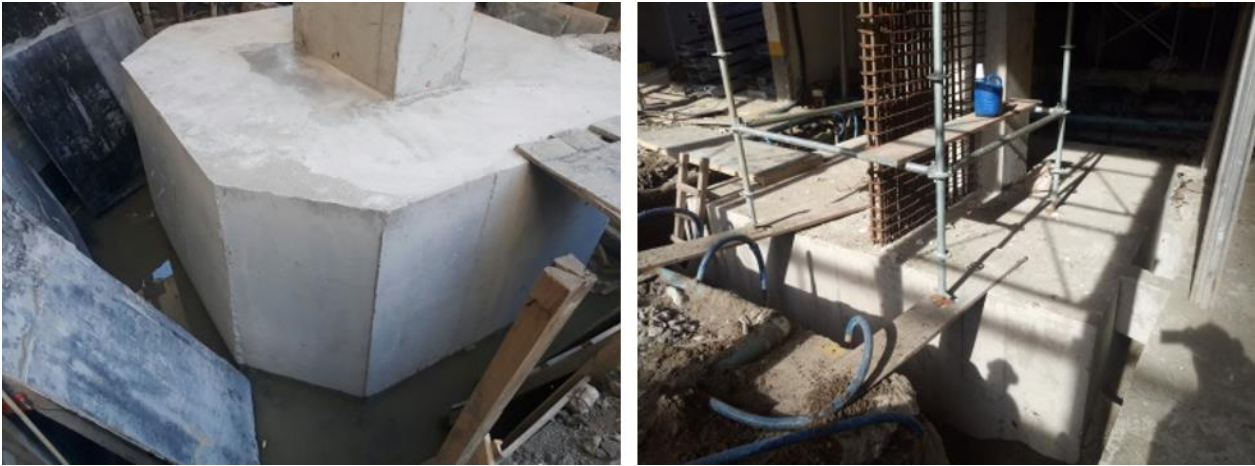
Figure 17 shows the visual aspect and the surface finish of concrete in the hardened state applied in the reinforcement of pile caps.

Figure 17. Detail of the visual aspect and the surface finish of concrete of reinforced pile caps.

Subsequently, after removing the formwork, thorough inspections were carried out on all surfaces of reinforcement performed and in the regions of new concrete/old concrete interface. It is registered that no type of non-conformity was found related to concreting failure, fissures etc.

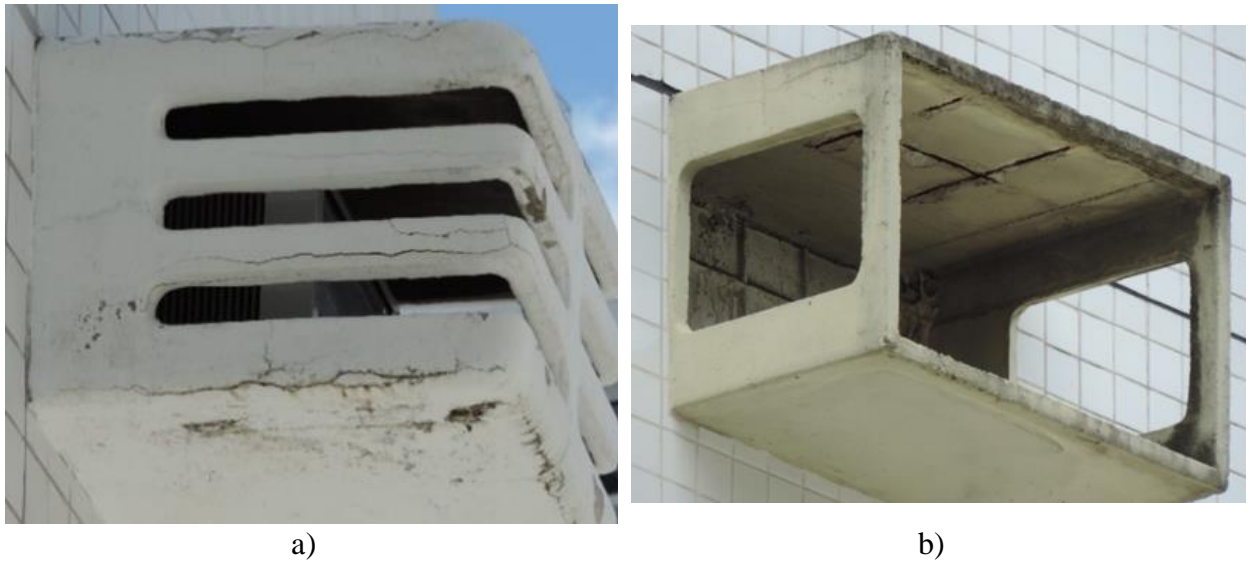
Figure 12. Reinforcement corrosion in window type model: a) fissures; b) concrete detachment.

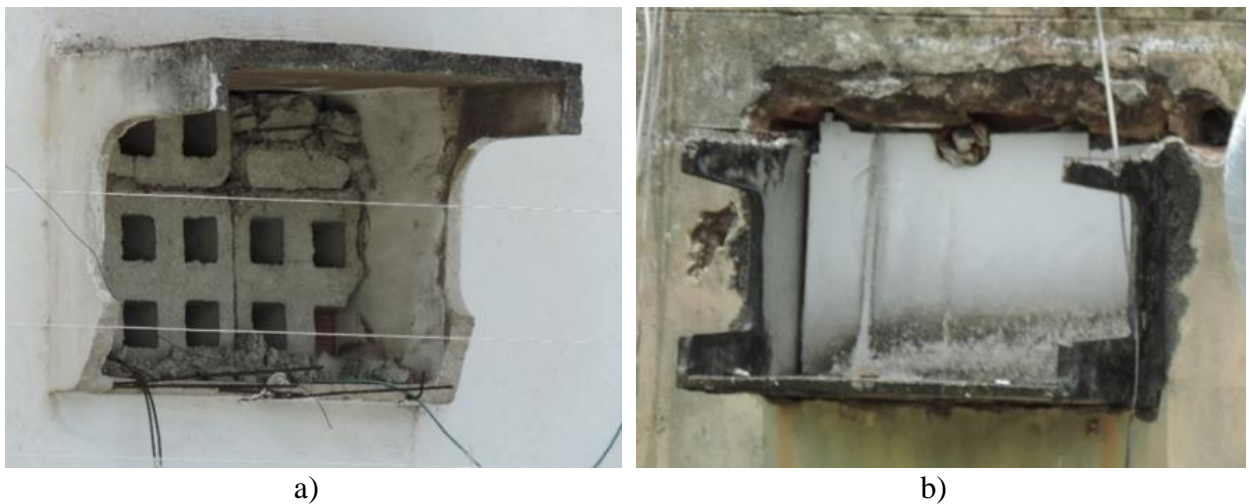
Figure 13. Partial break in open window model: a) absence of lower slab; b) absence of upper slab.
