## Mapping of pathological manifestations in asphalt pavement through the use of drones

R. T. Vasconcelos Fernandes<sup>1</sup>, A. Fonseca Cabral<sup>1</sup>, G. C. Batista Dantas<sup>1\*</sup>,  
V. N. Varela Tinoco<sup>1</sup>, B. D. Azevedo da Silveira<sup>1</sup>, A. M. Sousa Junior<sup>1</sup>

DOI: <https://doi.org/10.21041/ra.v11i1.521>

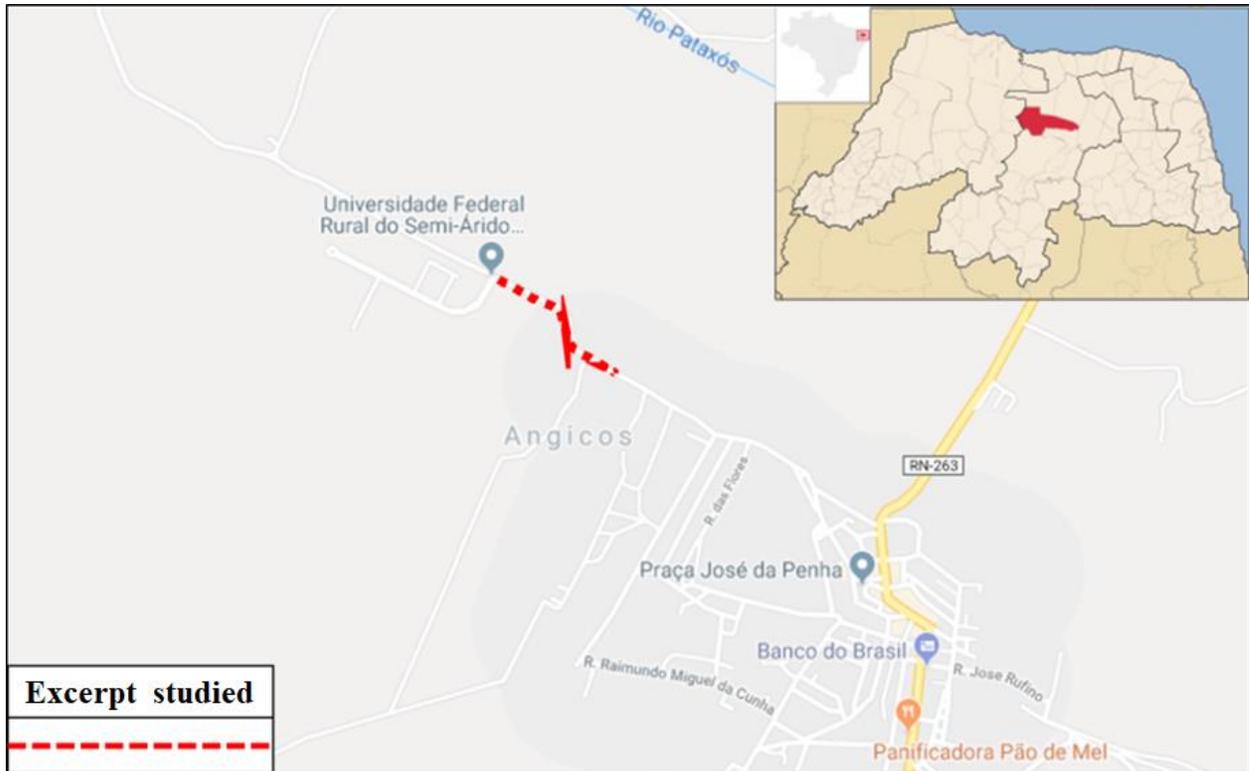
Figure 1. Research Area (Lat. 5°39'17.32"S; Lon. 36°36'37.48"O).

It was used as a sample unit of the present research, a stretch of single way asphalt track with approximately 0.5 km in length that gives access to the campus of the Federal Rural University of the Semi-Arid / UFERSA, in the municipality of Angicos, state of Rio Grande do Norte - Brazil (Figure 1). This stretch, although small in length, proved to be ideal for carrying out the study due to the large number of pathological manifestations on the pavement.

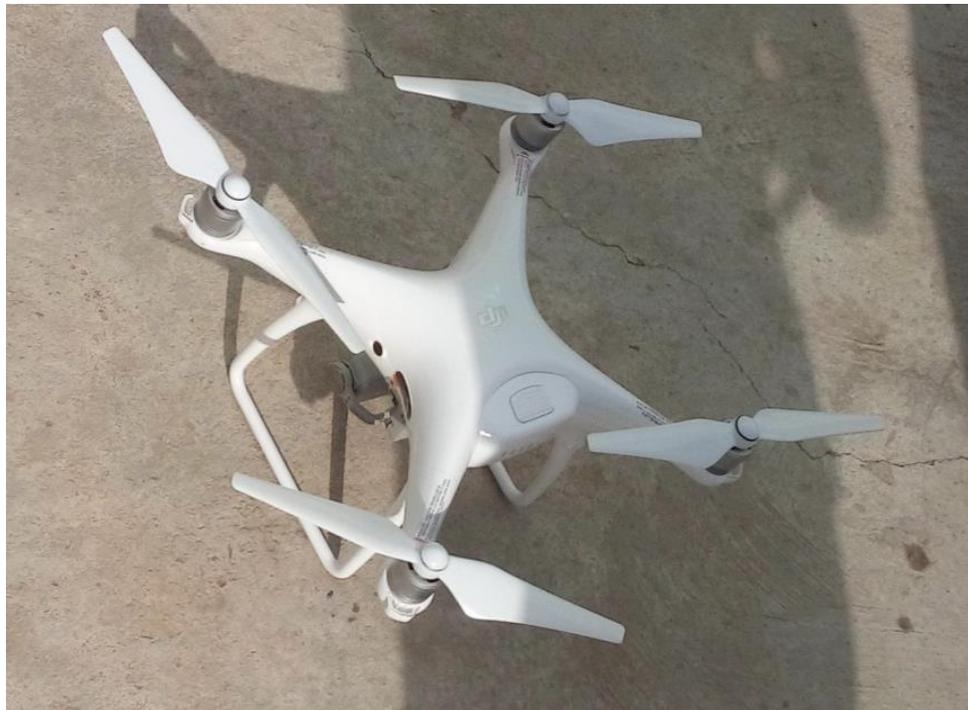
Figure 3. DJI model Phantom 4 PRO - UAV used in the study.

To acquire the images of the research area, an Unmanned Aerial Vehicle - UAV, from the manufacturer DJI model Phantom 4 PRO (Figure 3) was used. The referred UAV is a multirotor type weighing approximately 1.5 kg and is equipped with a 20 megapixel camera (capable of shooting at 4 k / 60 fps), with a video transmission range of 7 km. The choice of equipment was based on its ease of use, flight stability, quality of the images generated and affordable price.

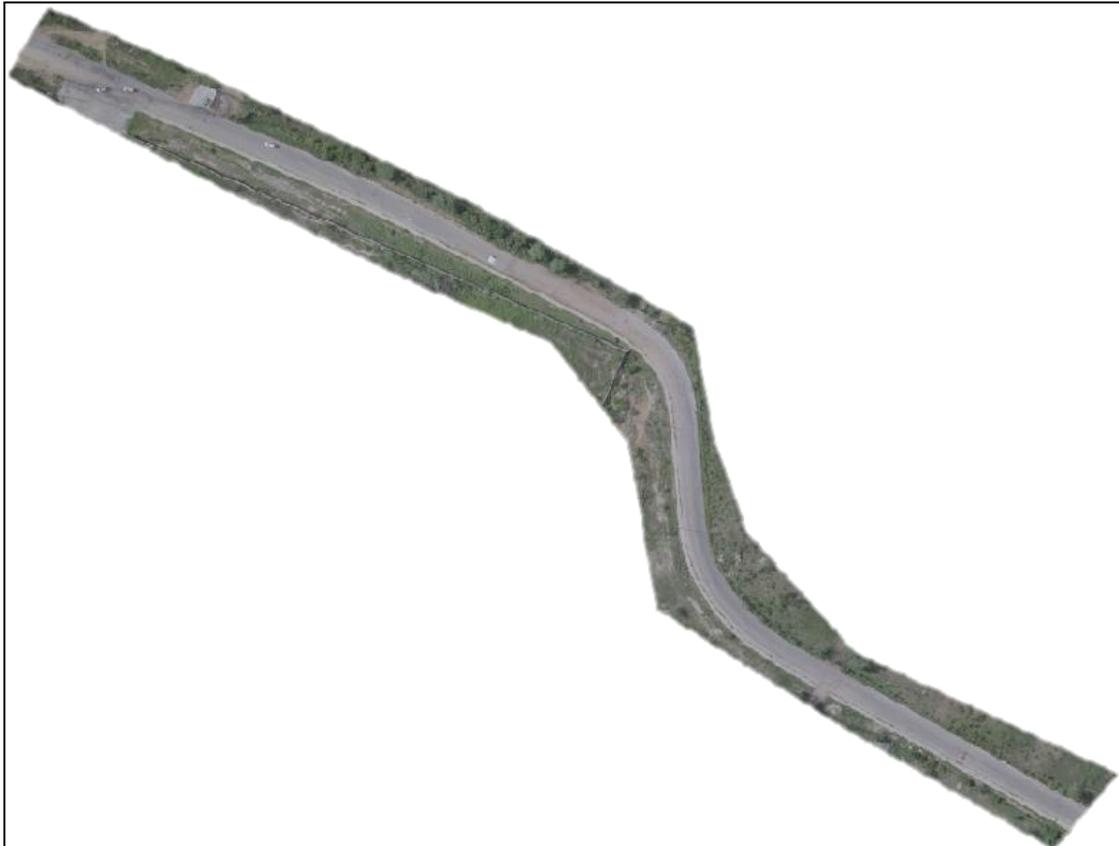
Figure 4. Research area ortoimage generated by Drone Deploy application.

For the flight planning stages and subsequent composition of the orthoimage, the Drone Deploy application was used. It allows the flight plan to be parameterized according to the desired resolution for the original images, image overlay rate, flight lines and resulting resolution. The flight parameters used in the present study can be seen in Table 1. The orthoimage was automatically generated by the application and exported for later analysis (Figure 4).

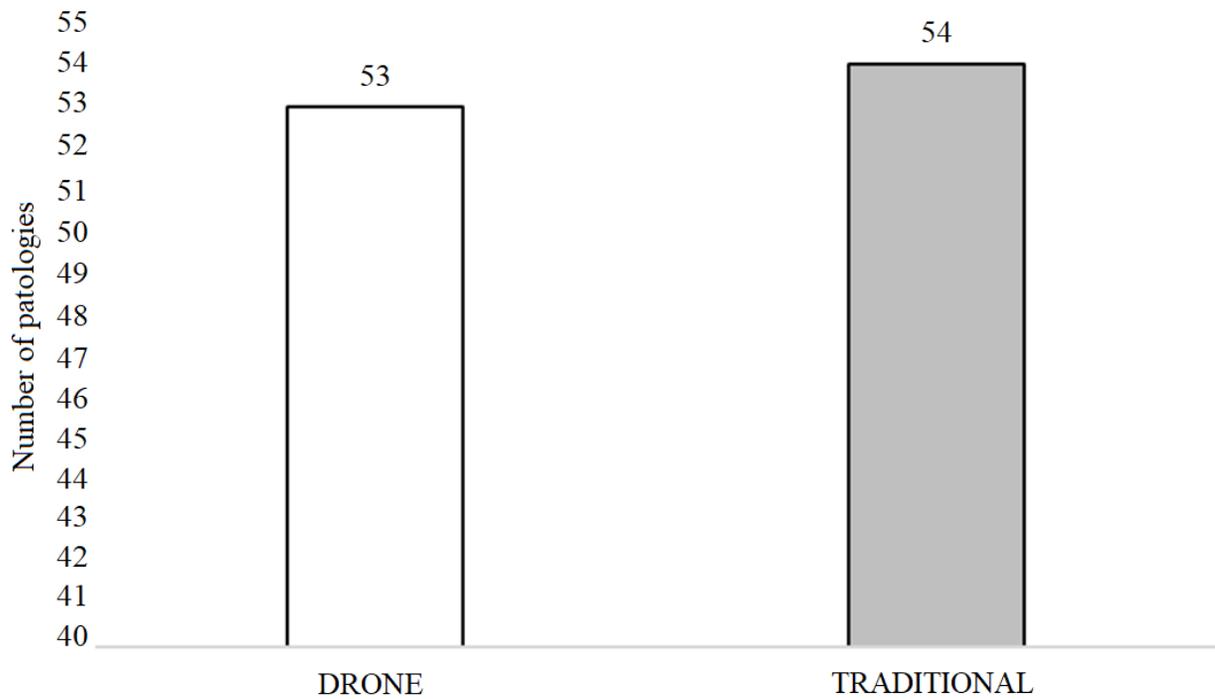
Figure 5. Identified pathologies according to inspection method.

The analyzed section presented a large number of pathologies in both methods employed. The total quantification of pathologies, within the 20 plots evaluated, showed very close values for both methods, being 54 for traditional inspection and 53 for inspection with the Drone, which demonstrates the viability of using the Drone to quantify pathologies on pavements (Figure 5).

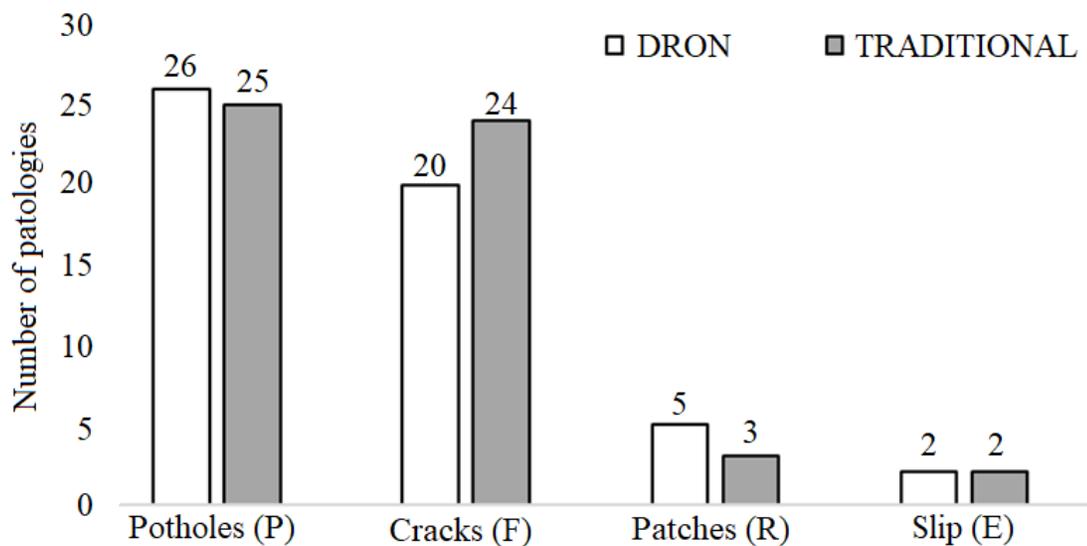
Figure 6. Identified pathologies according to its types and inspection methods.

As for the qualitative aspect, the inspection carried out with the Drone enabled the identification of 04 types of pathologies, which are: potholes (P) - concavity or hole that forms in the coating and can reach the base; cracks (F) - characterized as openings in the asphalt surface that are visible to the naked eye; patches (R) - defect characterized by the filling of pots or any other orifice, hole or depression with asphalt mix; and slip (E) - displacement in relation to the pavement layer. Regarding the types of pathologies, there was no difference between the traditional inspection method and the Drone inspection method. Regarding the number of defects by type of pathologies, there were small differences between the methods used, as shown in figure 6.

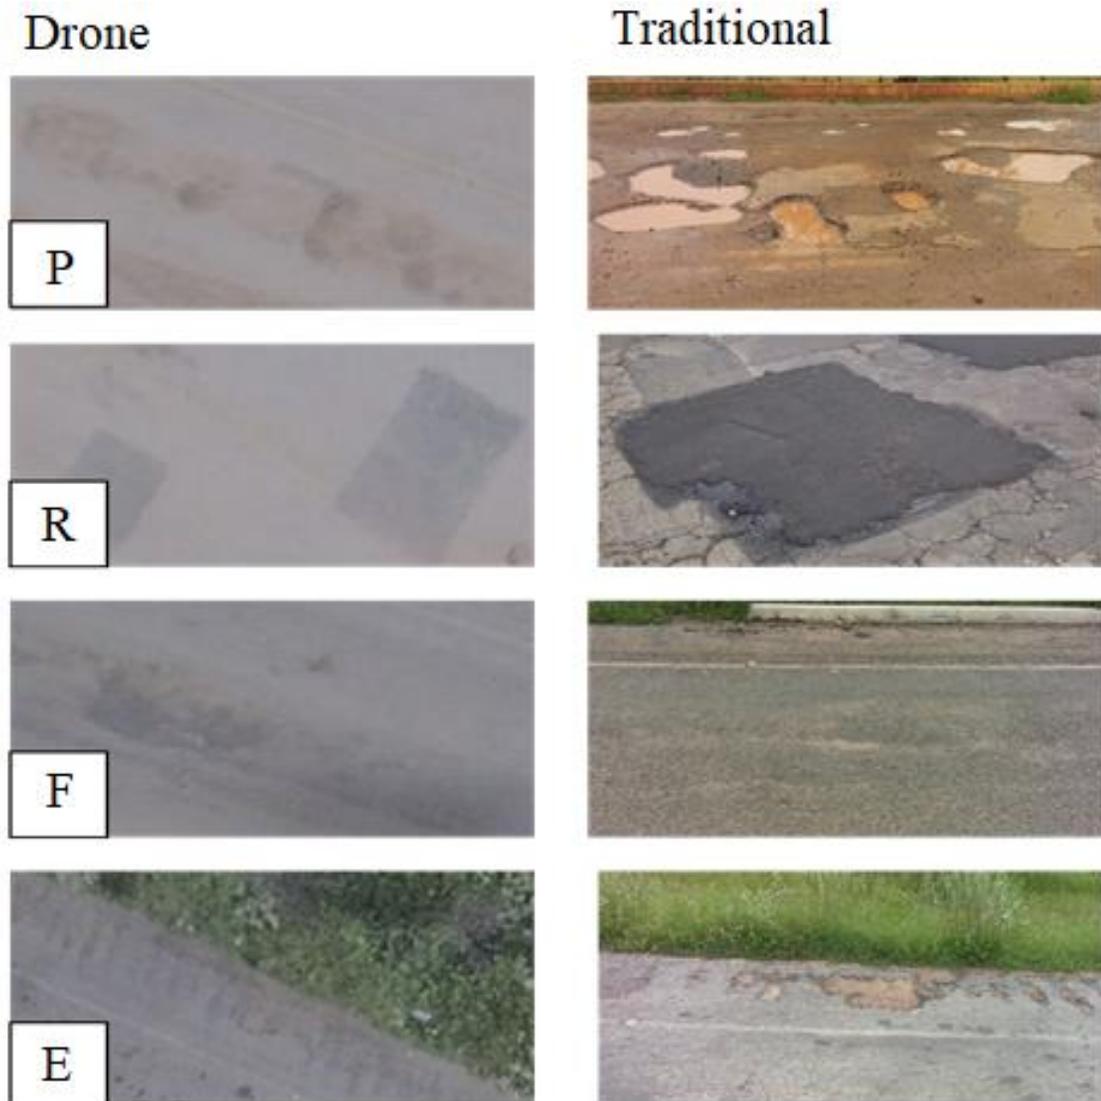
Figure 7. Identified pathologies according to type and inspection method.

It should be noted that the most probable cause for these differences is due to the fact that some types of pathologies can be difficult to identify by the use of images obtained by UAVs due to their quality, while traditional inspection can resolve any doubts regarding the occurrence of a pathology because it is an on-site analysis. As an example, one can compare pots and cracks. In the first case, it is easier to identify by the very nature of the pathology, which in general stands out from the rest of the pavement. In the second, it is much more difficult to identify, sometimes needing confirmation through on-site inspection. In Figure 7, it is possible to compare the images obtained with the Drone and using the traditional method, for each of the types of pathologies identified.

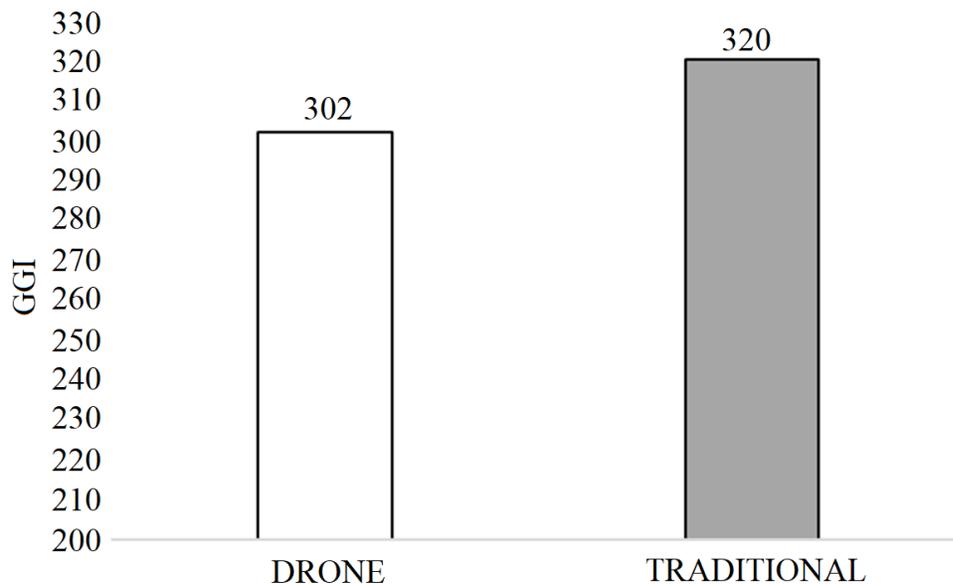
Figure 9. Global Gravity Index - GGI according to used method.

The value obtained for the Global Gravity Index - GGI, was 302 for the realization performed with the Drone and 320 for the traditional method (Figure 9), and in both cases, according to DNIT Standard 006/2003 - PRO, the evaluated stretch was considered to be terrible ( $GGI > 160$ ). One of the points that influences this result is the presence of a large number of Potholes (P), which was found in all the studied plots, which is the pathology that most impacts traffic and contributes to accelerating the degradation of the pavement. Although there are different values, it is observed that the existing difference is not as long as, demonstrating that navigation with the aid of Drones is technically feasible.
