## **ALCONPAT International**

## **Revista ALCONPAT**

## Corrosion effect on reinforced concrete with the addition of graphite powder and its evaluation on physical-electrochemical properties

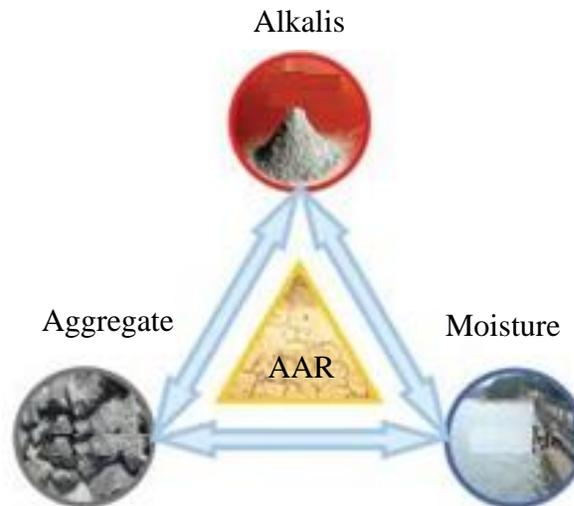
Figure 1. Determining factors for AAR occurrence and evolution (Couto, 2008).

The AAR is one of the most frequent pathological cement structure phenomena and one of the most relevant concerning durability. Briefly, it can be defined as chemical reactions between certain aggregate components and alkaline hydroxides present within the pores of the cementitious matrix. These reactions do not exhibit a pre-established time for their appearance, since they are associated to several factors, such as the amount of alkalis in the matrix susceptible to the reaction, ambient temperature and humidity, aggregate reactivity and, finally, the nature of the material (Figure 1) (Silva, 2007).

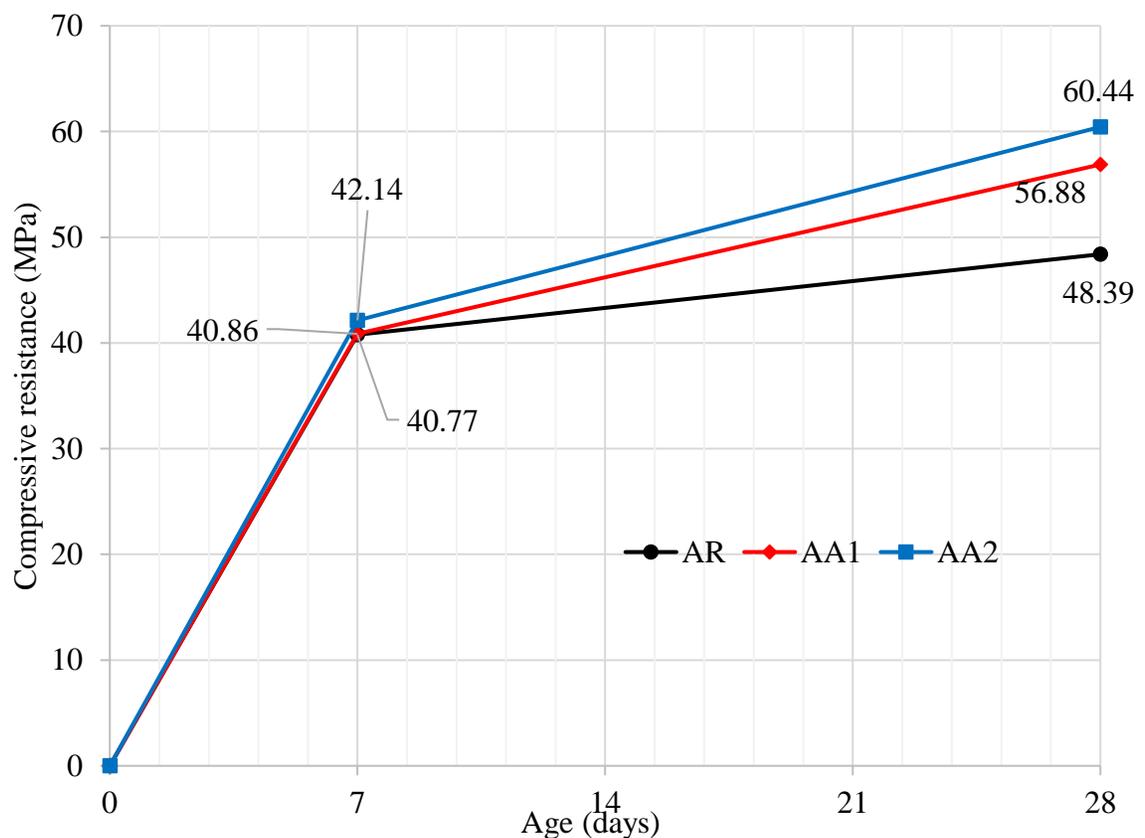
Figure 6. Results of the mortar compressive strength tests (MPa) at 7 and 28 days.

The hardened assay results are presented in Figures 6 to 13. Figure 6 presents the results regarding the compressive strength of the tested mortars. Increasing additive resulted in increased compressive strength, as the AA2 mixture obtained the best performance, followed by AA1 and AR, respectively.

the short period of time elapsed since the mortar production for the admixture reaction, since their reactivity is dependent on cement hydration reactions. However, at 28 days, a noticeable resistance gain of the admixture containing samples compared to the reference mixture is observed. Mortar AA2 reached a resistance 24.9% higher than AR, while AA1 reached a value around 17.5% higher than AR. As no information between the mixtures was altered other than the use of the admixture, resistance gain is solely due to the admixture use.

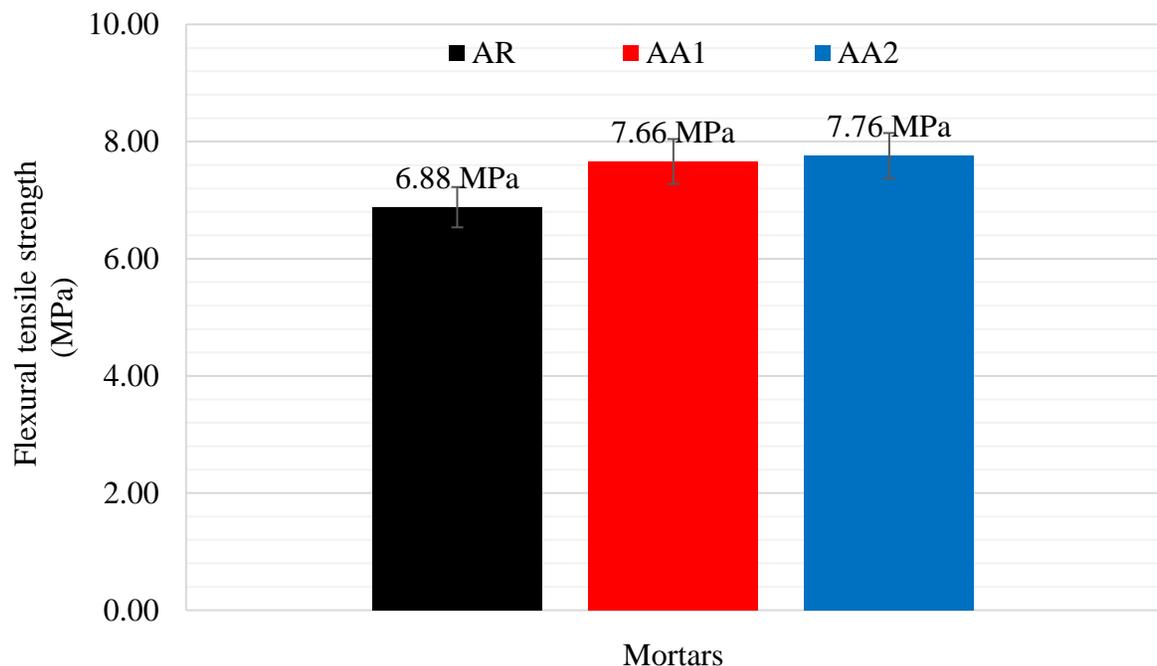
Figure 7. Flexural tensile strength tests (MPa) results of the evaluated mortars.

Figure 7 presents the results related to the flexural tensile strength tests, where a performance gain is verified with the use of the crystallizing product, similarly to what was noted in the compressive strengths assays. The AA2 mixture once again achieved the best result, reaching a value approximately 12.8% higher than AR, while AA1 presented a resistance 11.3% higher than the reference.

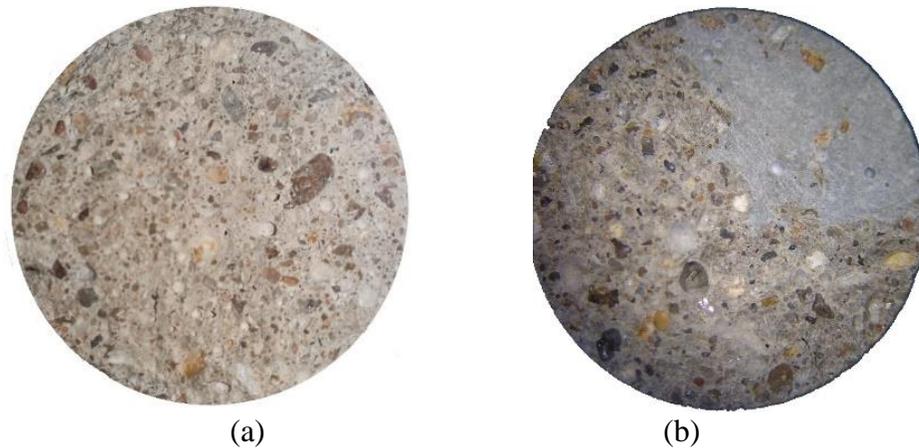
Figure 8. Microscopic image of the cross section of the specimen without the admixture (a) and containing 2% of the admixture (b), both after rupture at 28 days. Images under 35x magnification.

According to the admixture manufacturer, this material is capable of filling cracks and voids of up to 0.5 mm. Figure 8 presents microscopic images under a 35x magnification of the cross sections of the specimens containing (Figure 8a) and not containing (Figure 8b) the admixture. Figure 8b also displays a portion of the material of a different color from the standard without the admixture, indicative of the healing power of this chemical.

Bearing in mind that the specimen contained some internal irregularities, possibly caused during its production, the admixture reacted and filled the small internal voids located inside the specimens. Its distribution was homogeneous, although crystallization occurs exclusively in the mass voids and, for this reason, a region was formed resulting from the admixture action, displayed in Figure 8. No fine aggregate concentrations are found in the “healed” area, which, in accordance to data presented by the Japan Concrete Institute at JCI-TC075B (2009), corroborate the idea of the crystallizing effect.

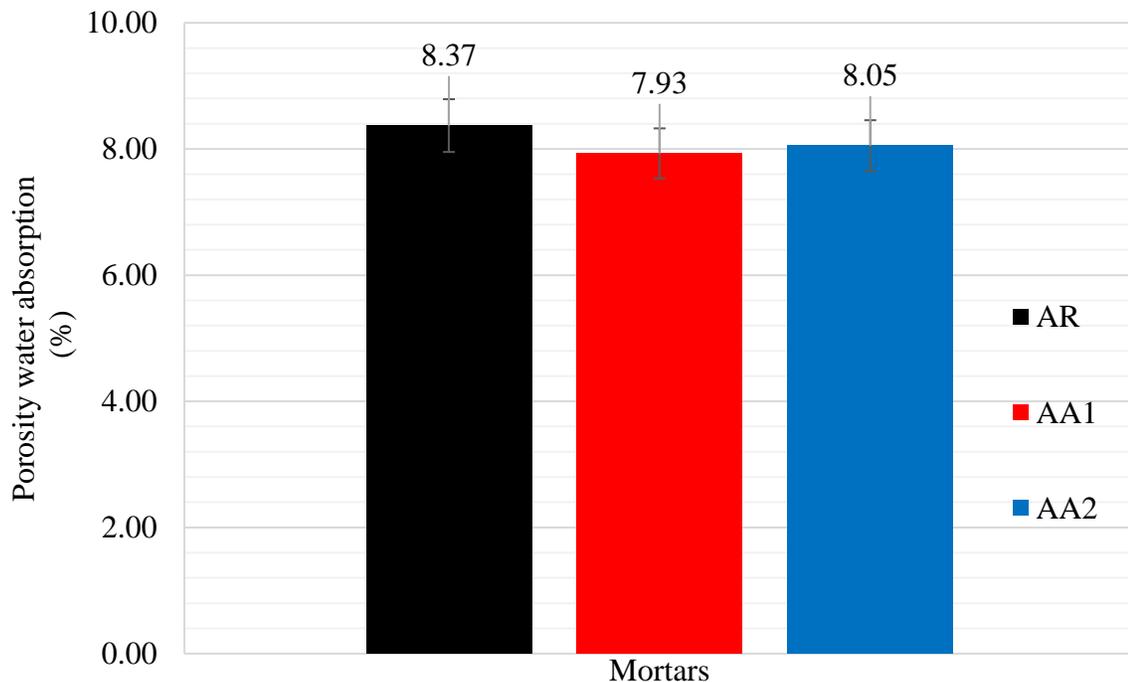
Figure 9. Porosity water absorption test or pressure water absorption (%) results in mortar specimens immersed in water at 28 days.

Figures 9 and 10 display the results obtained through the porosity water absorption test and void indices performed according to the requirements of the NBR 9778 standard (ABNT, 2005). The presence of the healing admixture reduces both mixture porosity water absorption and void indices.

This test, because it is carried out with specimens under pressure, identifies the open and closed porosity and the total void indices of the mortars. The specimen containing 1% of the admixture attained the best results, attesting that the range of contents indicated by the manufacturer is adequate. By increasing the admixture content to a value higher than the indicated range, a new increase is observed both in porosity and in the void index. However, even though the results of mortars containing the admixture are better than the reference mixture, the difference between them is not significant, with the largest reduction in porosity and void rate of around 5.3%.

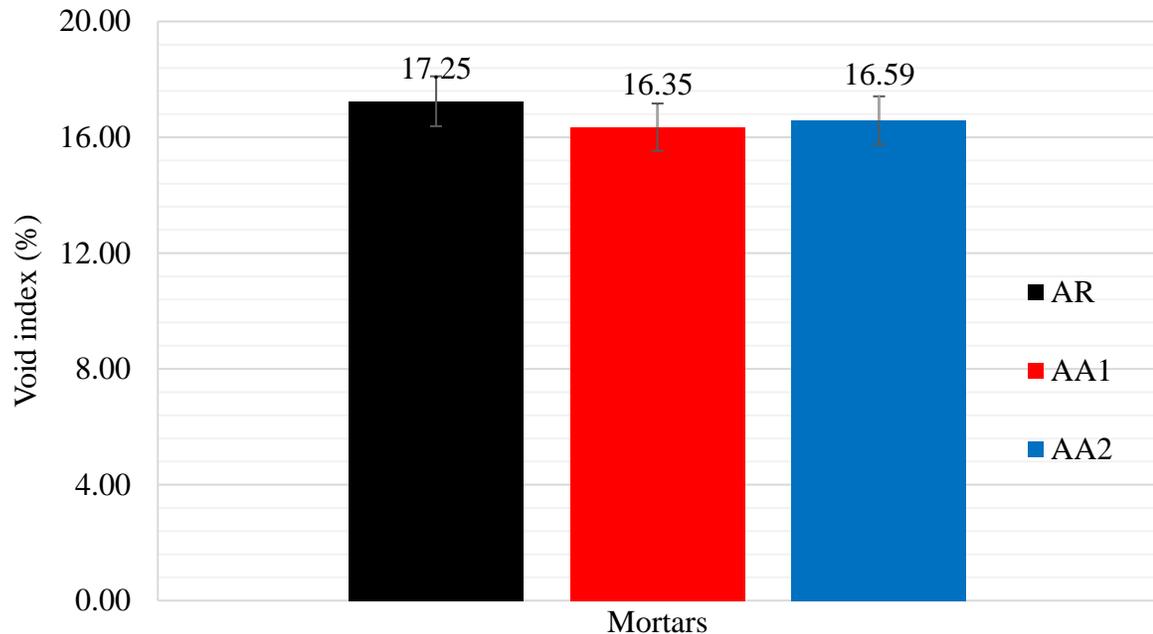
Figure 10. Void index (%) test results of mortar specimens immersed in water at 28 days.

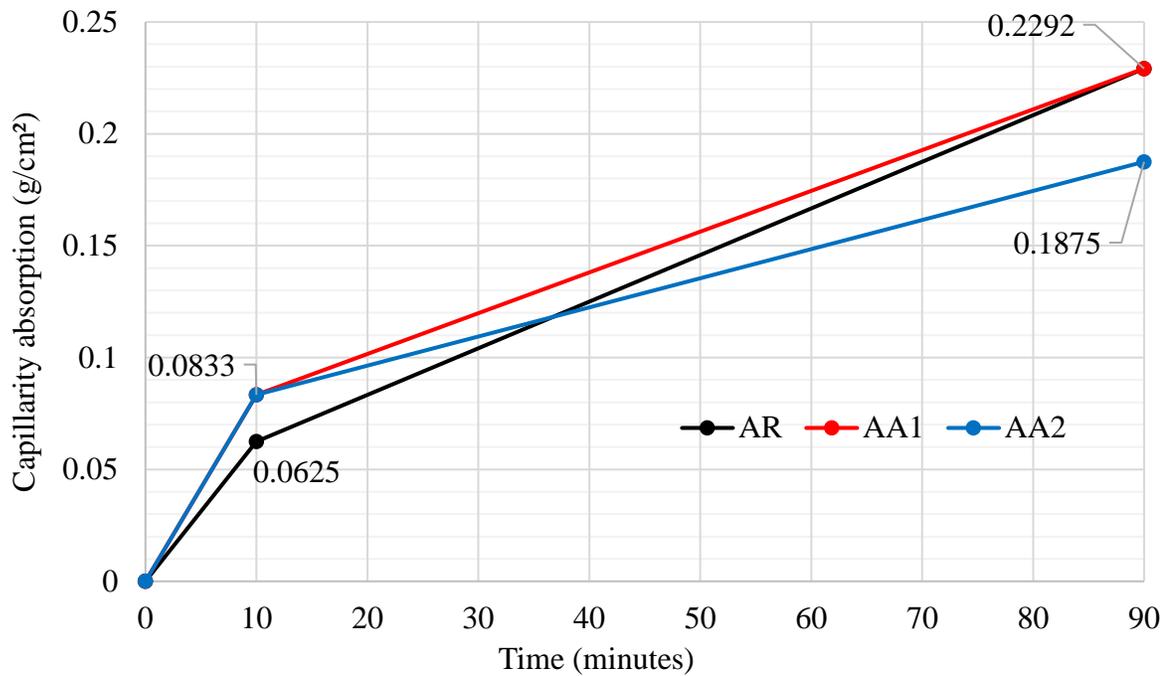
Figure 11. Water absorption capillarity (%) test results in a mortar specimen in contact with a water layer at a constant level of 5mm.

The capillarity values, given the result shown in Figure 11, can reduce by approximately 20%, again attesting the sealing power of the admixture. Similar results were reported by Takagi, Lima and Helene (2012) and Pazderka and Hájková (2016), both using 2% admixture.

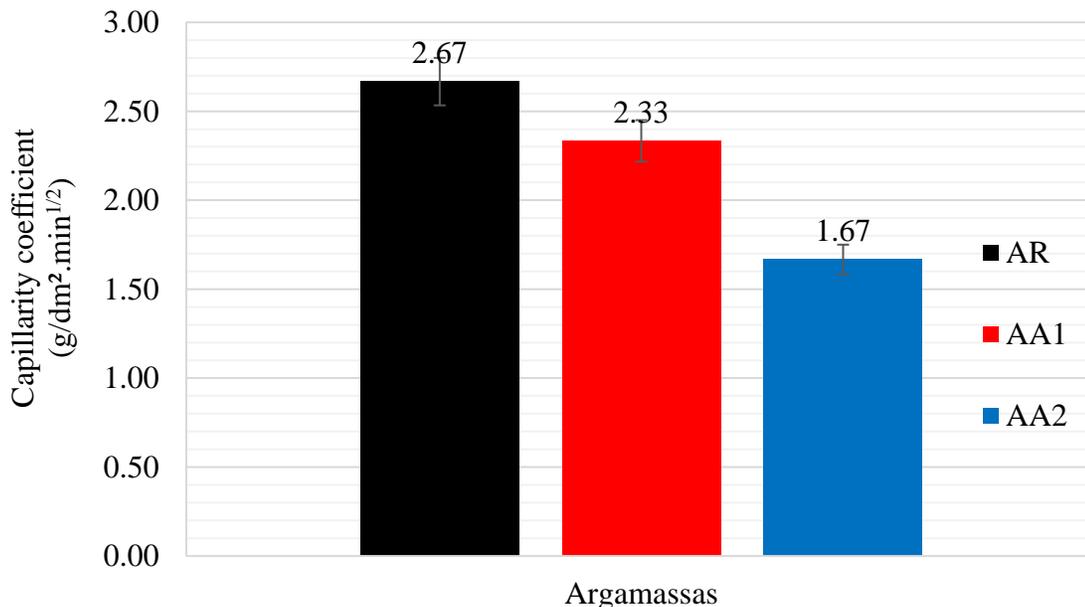
Figure 12. Capillarity coefficients (g/dm<sup>2</sup>.min<sup>1/2</sup>) of the mortars, determined with readings taken at 10 and 90 minutes.

The higher the admixture content, the lower the capillarity coefficient and, consequently, the lower the capillarity absorption for a fraction of time. As in the previous data, the AA2 mixture presented the best results, reaching a coefficient about 37.5% lower than the RA, while AA1 reached a reduction of 12.7% compared to the RA.

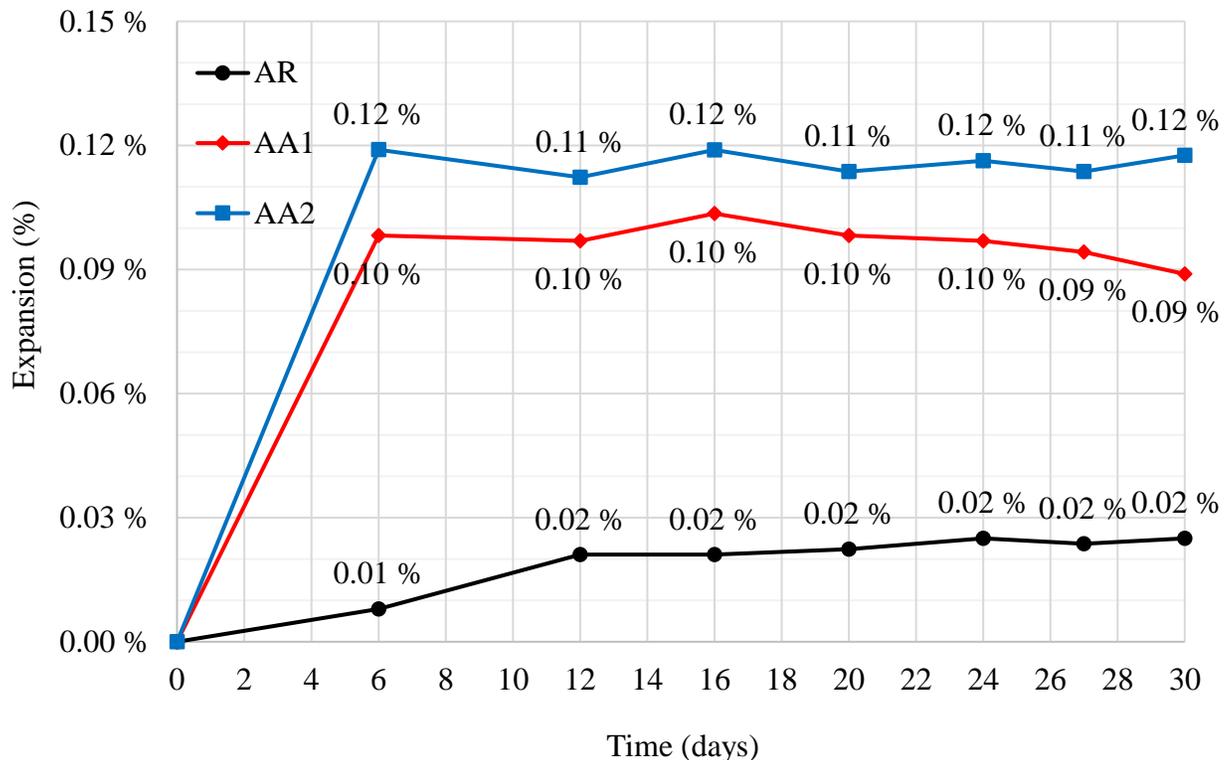
Figure 13. Expansion (%) of mortar specimens during accelerated AAR tests recorded for 30 days after molding.

Figure 13 presents the results regarding the expansion determinations during the accelerated ARR mortars tests according to the NBR 15577-4 standard (ABNT, 2018). A high initial expansion, at 6 days, was observed in mortars containing the crystallizing admixture.

This result indicates that the alkaline products present in the admixture composition, described in Table 5, may have led to the evolution of the expansions in the first week, considering that an evident initial volumetric evolution increase is noted with increasing admixture contents.

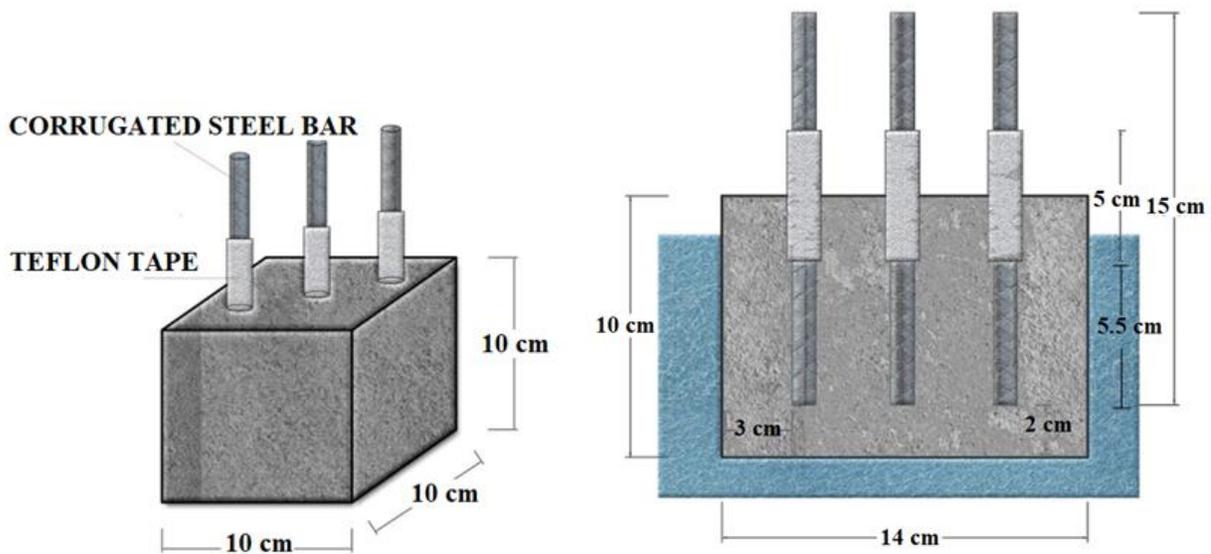
Figure 1. Cubic dimensions of concrete specimen.

The preparation of concrete samples was done according to (ASTM C-31, 2019). For electrochemical tests 3 cubic specimens 10 cm per side were made from the same mix design, as shown in Figure 1. Three corrugated rods were embedded in each cubic specimen, of dimensions 0.95 mm in diameter. The length of the embedded rod was 5.5 cm. At the interface between the paste and the atmospheric environment, the rod was covered with approximately 5 cm long with teflon tape around the rod.

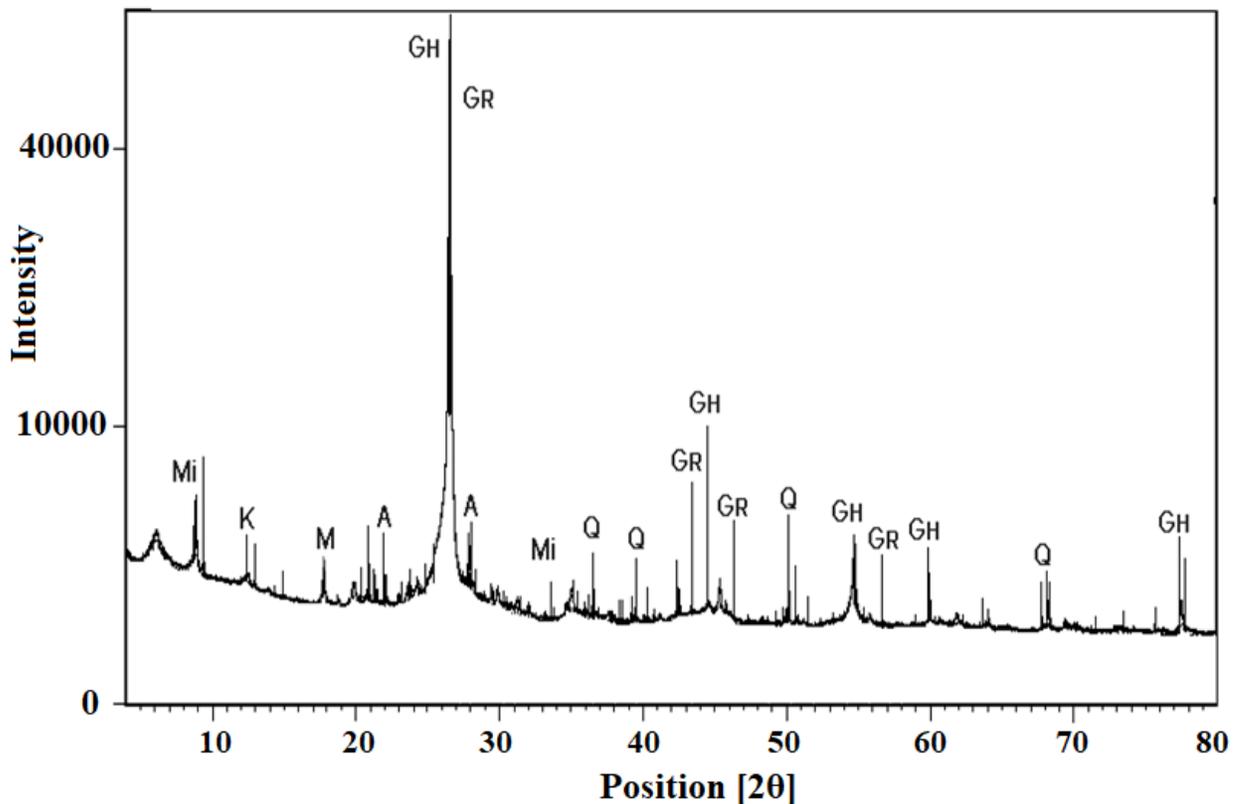
Figure 2. X-ray diffractograms of the GP. Mi: mica; K: kaolinite; M: montmorillonite; G<sub>H</sub>: graphite (2H); G<sub>R</sub>: graphite (3R); A: anortite; Q: Quartz.

The 2H structure, is the most common form in the phases identified with 39.9% values and the 3R with 27.4% values, with a total addition of 67.3% in carbon content. The sample contains 32.6% of clay components as: quartz, smectic phyllosilicates, kaolinite, mica.

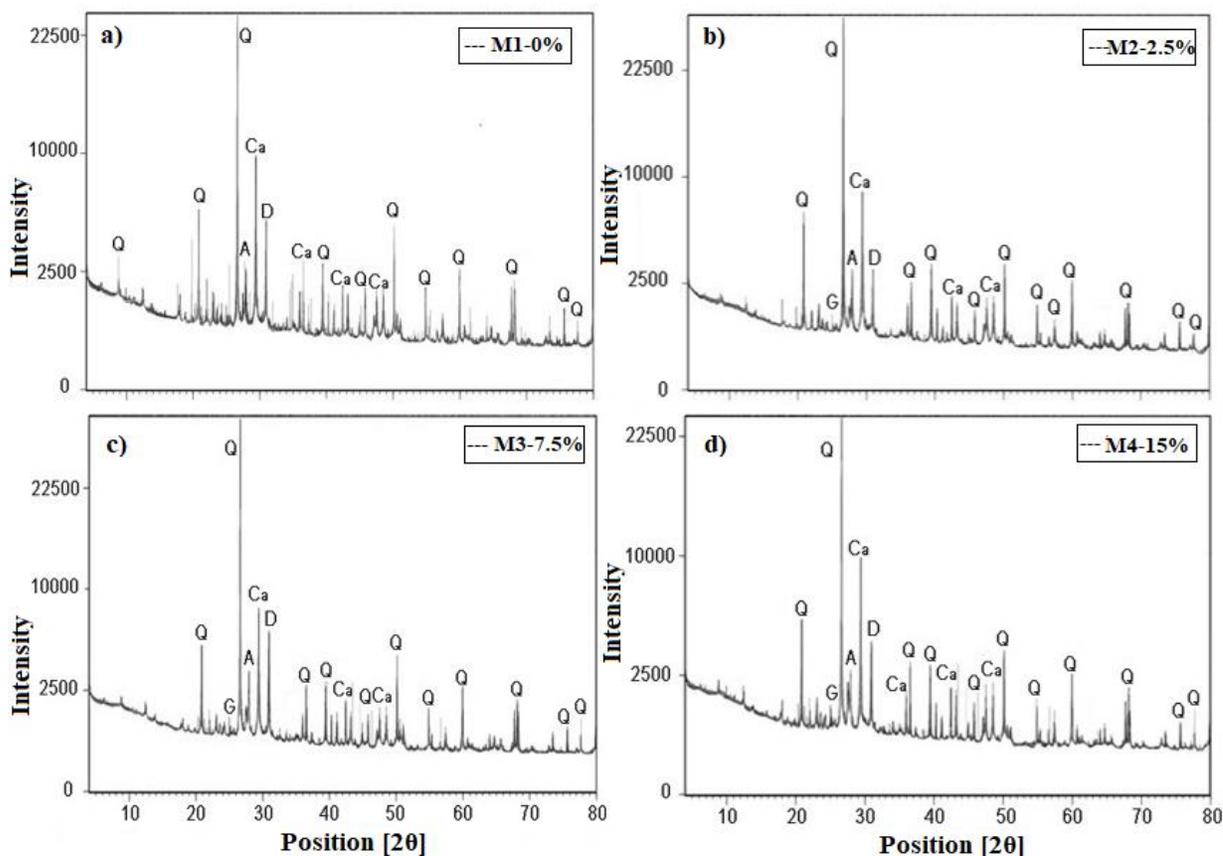
Figure 3. X-ray diffractograms of concrete paste. a) M1-0%, b) M2-2.5% c) M3-7.5% y d) M4-15%. Q: quartz; Ca: calcite; D: dolomite; G: graphite; A: andesine, cured at 28 days.

Figure 3 b), c) and d) show the samples with different percentage of graphite, as it can be seen a peak intensity that does not increase with increasing GP, which shows that there is an absence of direct participation in the hydration of the concrete paste. It is observed that the XRD analysis does not show a strong intensity in the CH and CSH peaks; various authors indicate that peaks with values of  $2\theta$  approximately  $29^\circ$  can be assigned to the CSH phase, and peaks with  $2\theta$  values approximately  $18^\circ$  and  $34^\circ$  can be assigned to CH (Giraldo and Tobón, 2006; Becerra, 2014). The absence of portlandite in the diffractogram may be due to the fact that the sample comes from the cylinder surface, where carbonation effects can obscure identification (Vetter et. al., 2019).

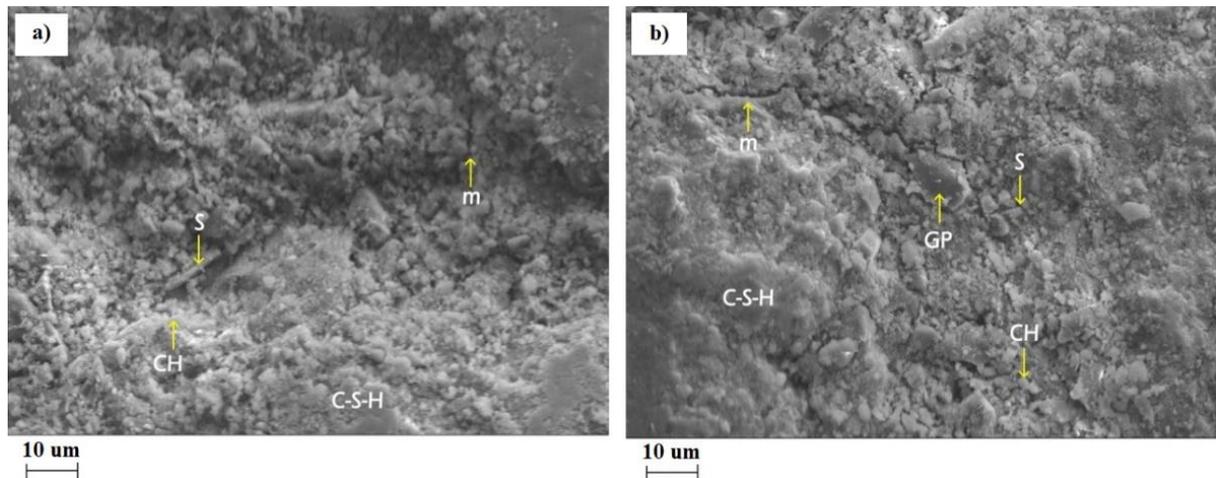
Figure 4. SEM micrograph, a) M1-0% and b) M37.5% of GP, cured for 28 days.

Figure 4b corresponds to the micrograph of sample M3 with 7.5% GP, a compact structure with greater CSH formation is visualized, filling the empty areas of the cement matrix, reducing the porosity of the concrete and improving the adhesion on the carbon particle (GP).

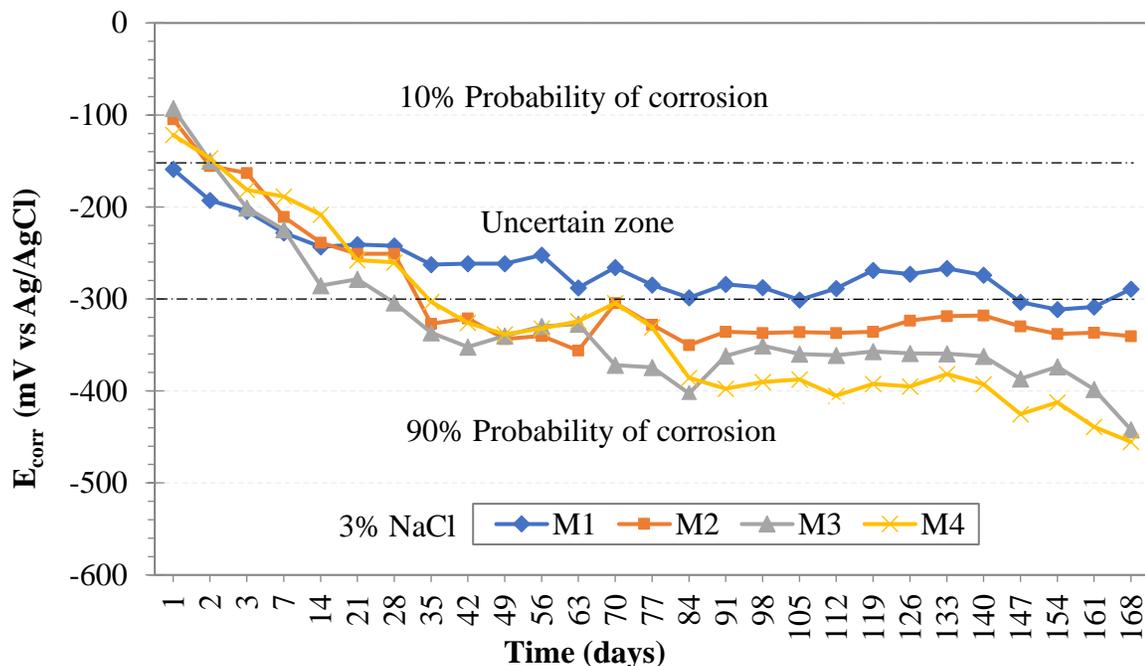
Figure 5. Corrosion potential values ( $E_{corr}$ ).

All samples at the end of the experiment on day 168 of immersion, are located in the 90% corrosion probability zone, the sample M4 with 15% GP is the one with the most negative potential value of -460 mV due to the factors described above and also an amount of water added.

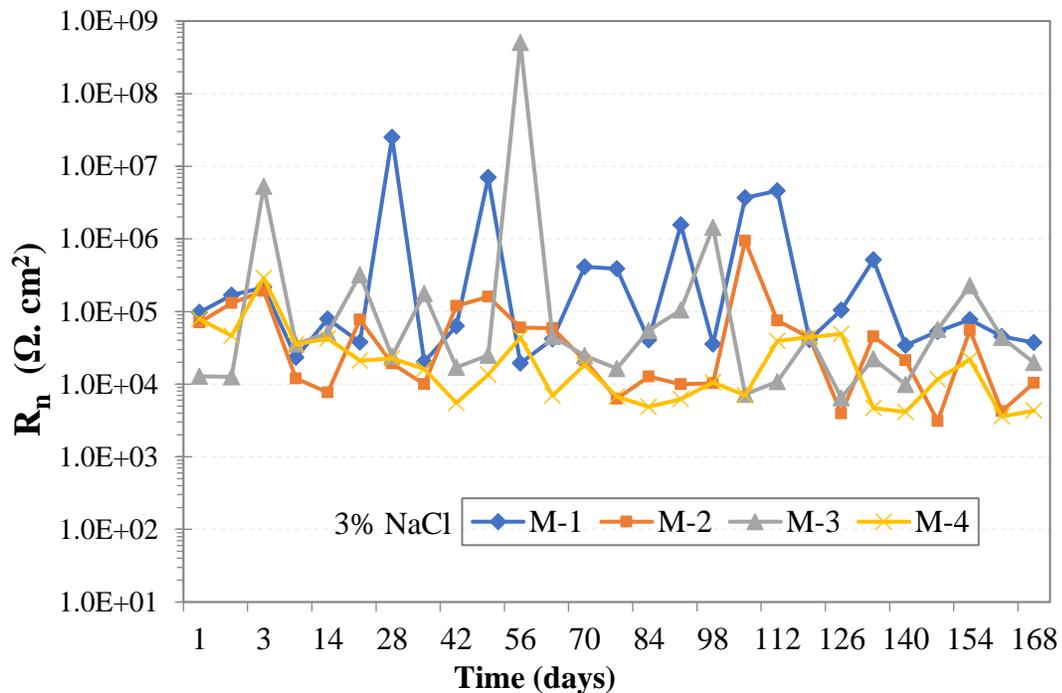
Figure 6. Electrochemical noise values ( $R_n$ ).

The GP addition in concrete paste in different percentage, affects the electrochemical properties of the metal, acquiring very low  $R_n$  values, This event can be explained due to the change of oxygen at the steel/concrete interface, as a consequence of the change of the porosity percentage of the paste. Also, the content of GP decreases the resistivity of the concrete; with lower  $R_n$  values indicating high corrosion process of the metal over time (Zhao et. al., 2007).

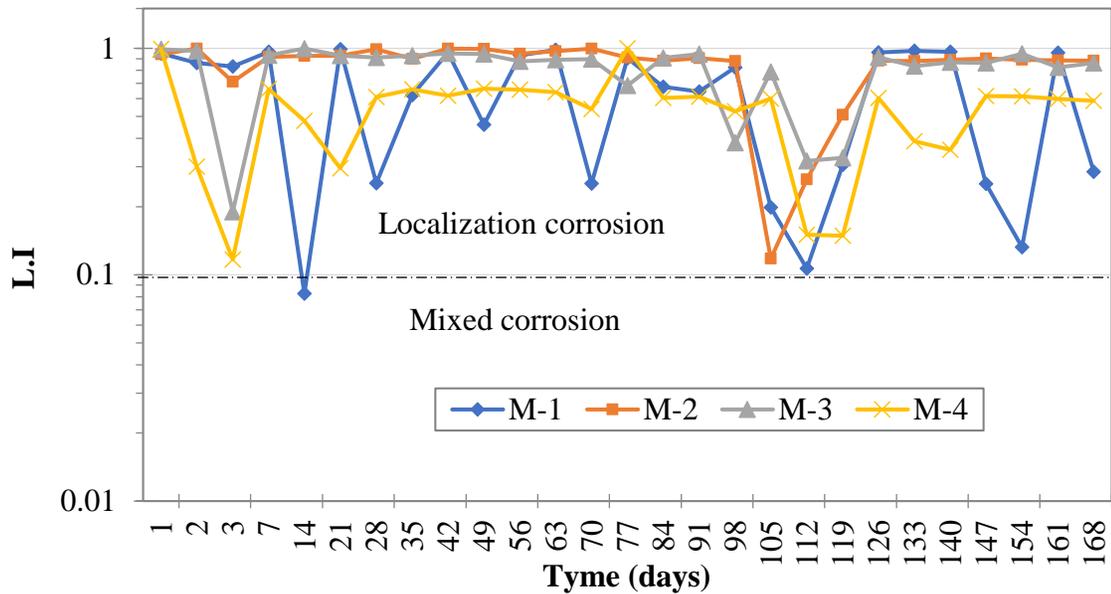
Figure 7. Localization index (L. I.) values of the reinforcing steel.

The values of the localization index are shown in Figure 7, at the beginning of the test until the end of the exposure. Localized type events or corrosion may be observed, because there is a high dissolution rate of the metal at discrete places on its surface (Sanz et. al., 1999). This represents a higher potential risk, due to its difficult detectability as it manifests itself in specific areas (Salazar-Jiménez, 2015). If the exposure time is prolonged, the start of pitting can occur in the metal.

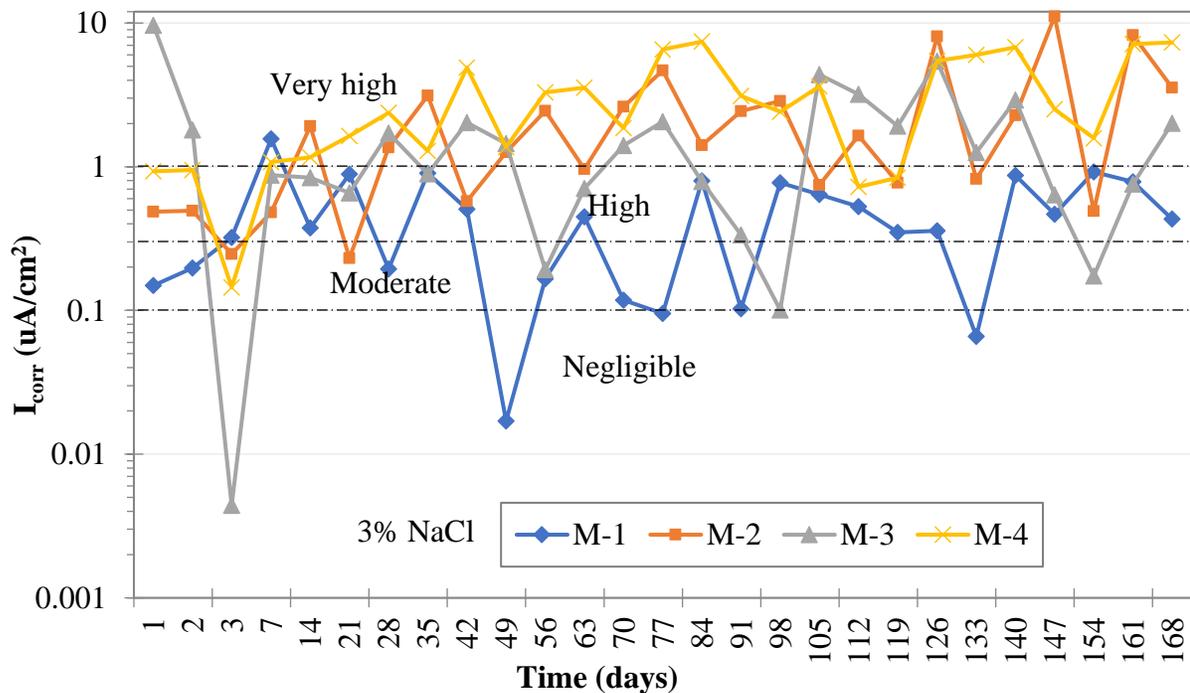
Figure 8. Level of useful life of reinforced concrete.

The values of the useful life level of reinforced concrete are detailed in Figure 8, where all samples at the time of being immersed in an environment after 24 hours were registered. Very high  $i_{corr}$  values can be observed, between 0.1 and 0.5  $\mu\text{A}/\text{cm}^2$ , presenting a range of corrosion between moderate and very high. This behavior coincides with the negative values of the corrosion potential test. Samples with replacement level of GP respectively present very high  $i_{corr}$  values as can be seen and it increases over time, demonstrating very high corrosion on reinforcing steel and in the useful life of concrete.

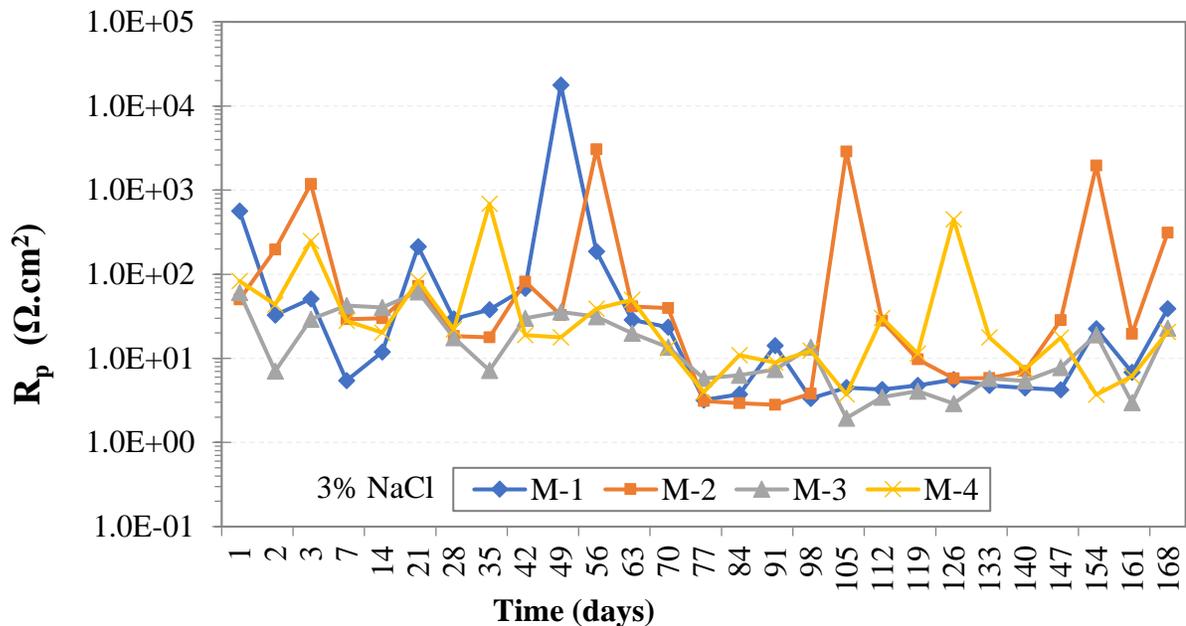
Figure 9. Polarization resistance values ( $R_p$ ) in the course of time.

Figure 9 shows the polarization resistance values over time, and very low  $R_p$  values can be observed in the 24 hours of immersion and until the end of the measurements in the LPR experiment. During days 42 and 70 there is an increase in the  $R_p$  of samples M1 and M2, maybe indicating a decrease in the rate of metal corrosion. Such high  $R_p$  values are an indication that the steel is passive (Blanco et. al., 2019). Samples with GP content, acquired constant values between  $1 \times 10^1 \Omega \cdot \text{cm}^2$  and  $1 \times 10^3 \Omega \cdot \text{cm}^2$ . High interaction with chloride ions can occur at the steel/ concrete interface registering very low  $R_p$  values. Chloride ions are shown to have depassivated the metal and the material has high corrosion at certain times as immersion times progress.

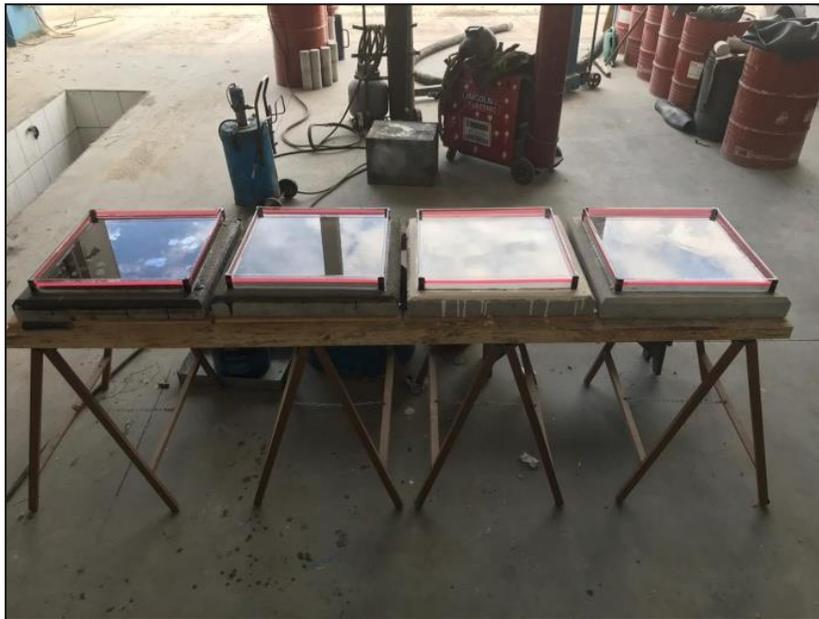
Figure 1. Waterproofing test performed in the laboratory.

For the waterproofing test, four slabs were used, three of them with the products selected for the research and one for the comparison of unprotected behavior, the reference sample. The slabs were subjected to the waterproofing test, which consists of exposing the samples to a 0.03 m water slide for 72 hours, through a transparent and sealed container, as recommended by Annex C NBR 15575-3 (ABNT, 2013), Figure 1.

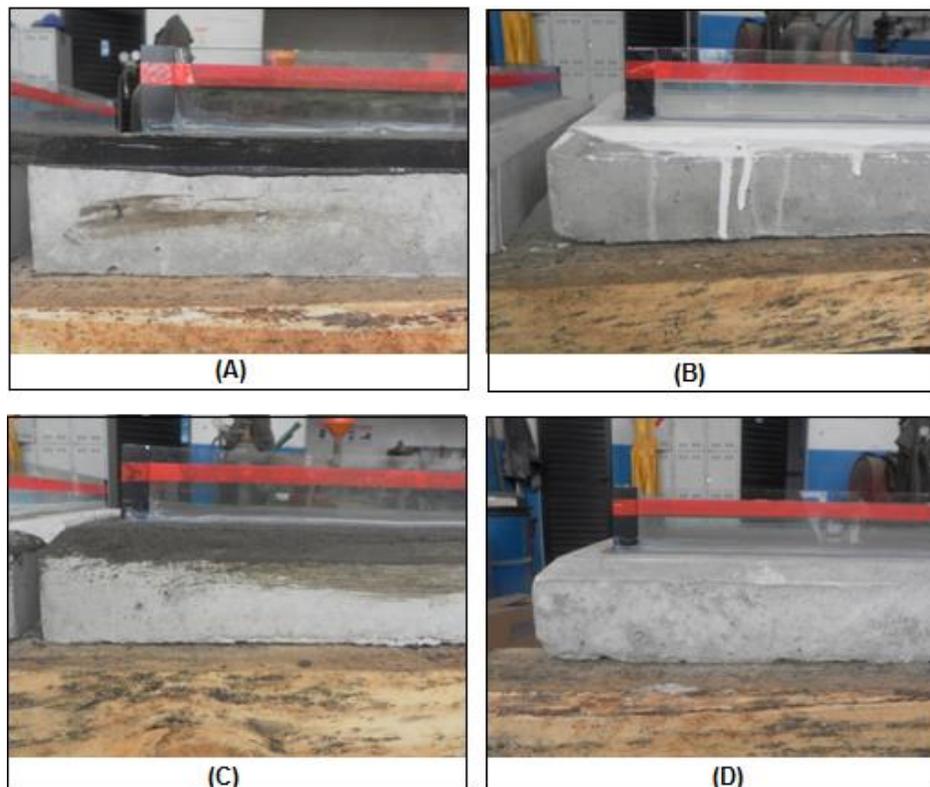
Figure 2. Waterproofing test result after 72 hours. A - Slab with asphalt emulsion; B - Slab with acrylic membrane; C - Slab with thermoplastic resin; D - Reference slab.

As all the slabs were considered watertight, no behavioral difference that could be identified by this test was verified between the reference sample (without protection) and the waterproofed samples.

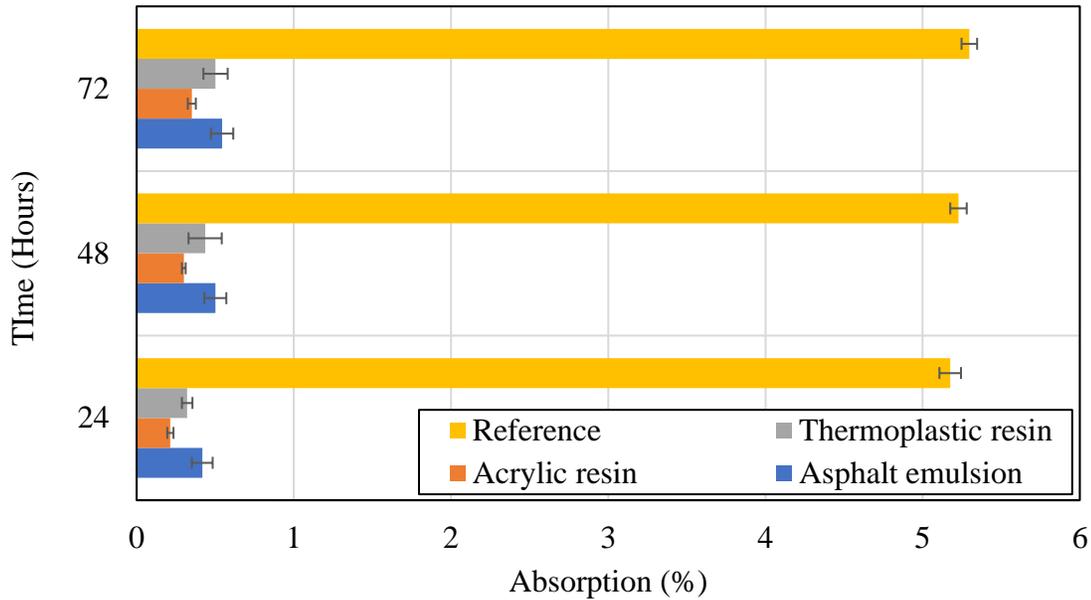
Figure 3. Result of the immersion absorption test.

By comparatively analyzing the results obtained for the waterproofed series, a very similar behavior was noted between them, and a satisfactory one if compared to the reference series. By the standard deviation obtained, the asphalt emulsion and thermoplastic resin series could be considered statistically equivalent, by the Tukey test, in all readings performed. At the final age evaluated, 72 hours of testing, the acrylic membrane revealed the lowest value statistically validated, among all series evaluated, indicating the best performance during this test.

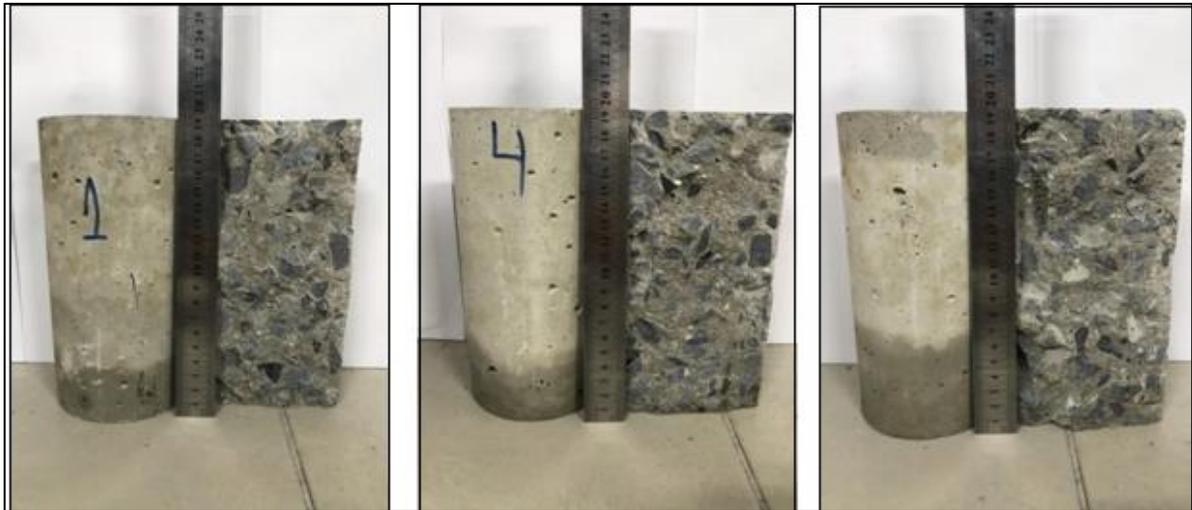
Figure 5. Specimens of the reference series after the diametrical compression test.

Figure 5 shows the specimens of the reference series that were submitted to the diametrical compression test. For the case of this series an average capillary rise height of 4.3 cm was noted.

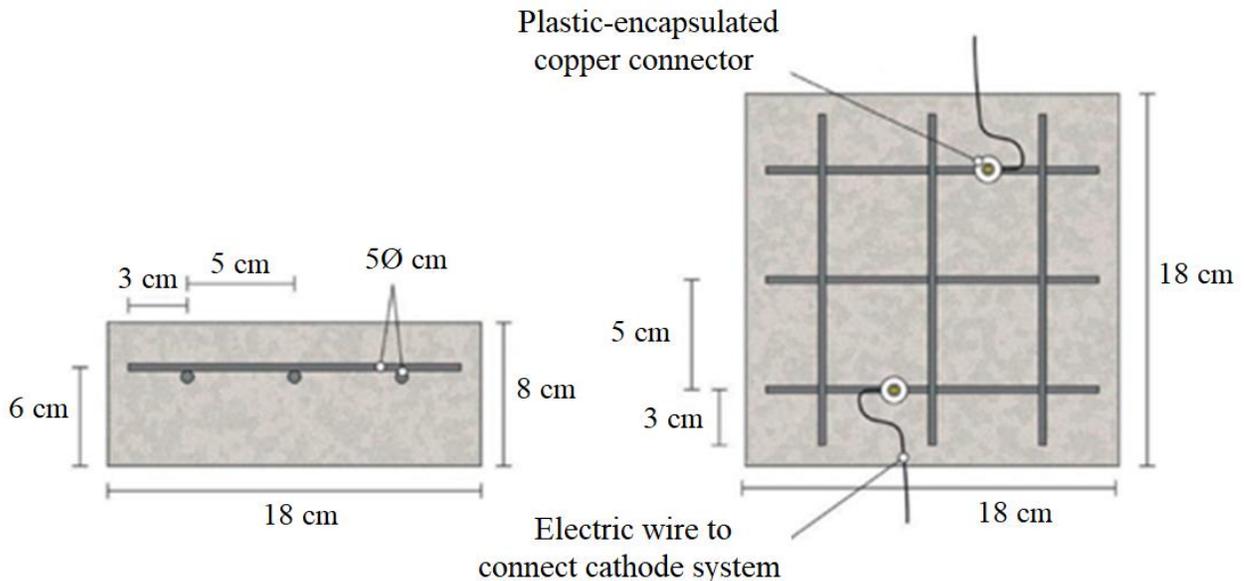
Figure 1. Sketch of reinforcement of samples and connection of the cathodic system (steel reinforcement). Adapted from (Carmona, et al, 2015).

The specimens were prism-shaped reinforced concrete elements, with a dimension of  $18 \times 18 \times 8$  cm<sup>3</sup>, which were reinforced by a grid  $16 \times 16$  cm<sup>2</sup> composed of six steel bars (5 mm diameter) welded symmetrically forming squares of 5 cm side, and placed 2 cm under the anode, Fig. 1.

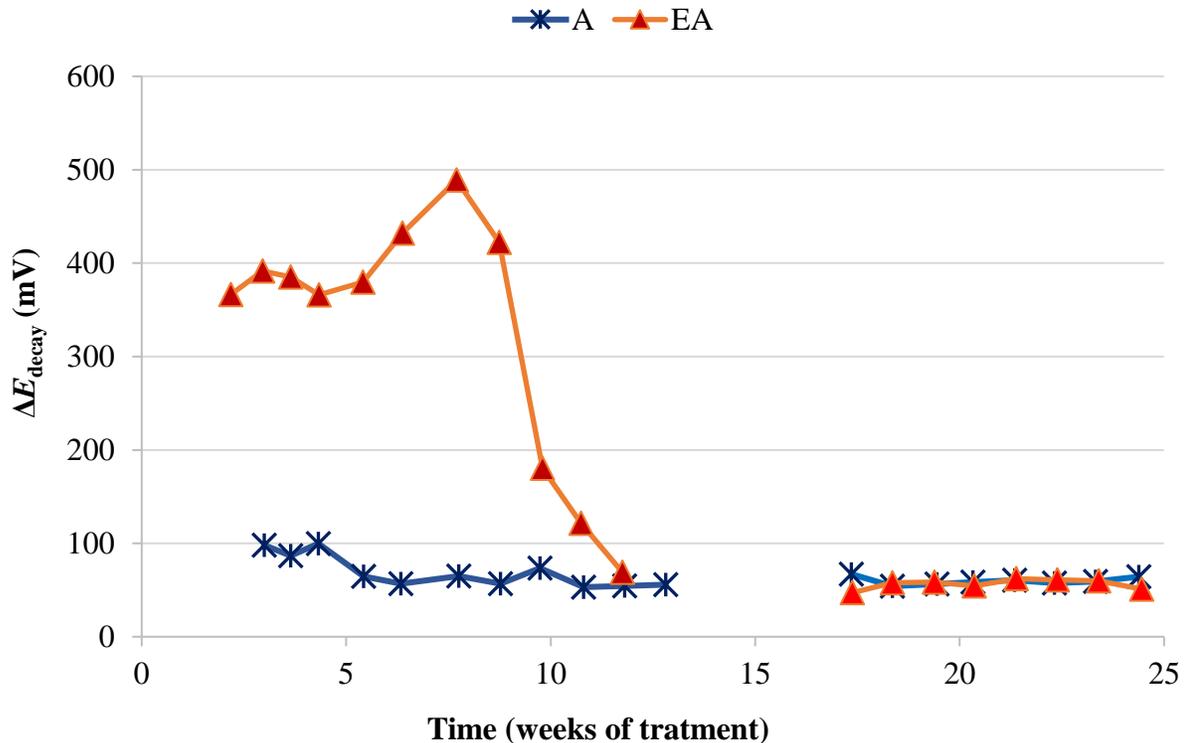
Figure 3. Evolution of  $\Delta E_{decay}$  during the CP treatments. A: CP; EA: ECE + CP. All of them subjected to  $\text{Cl}^-$  contamination during the 24 weeks. The electrochemical treatments were interrupted between week 13 and week 17. Adapted from (Carmona, et al, 2015).

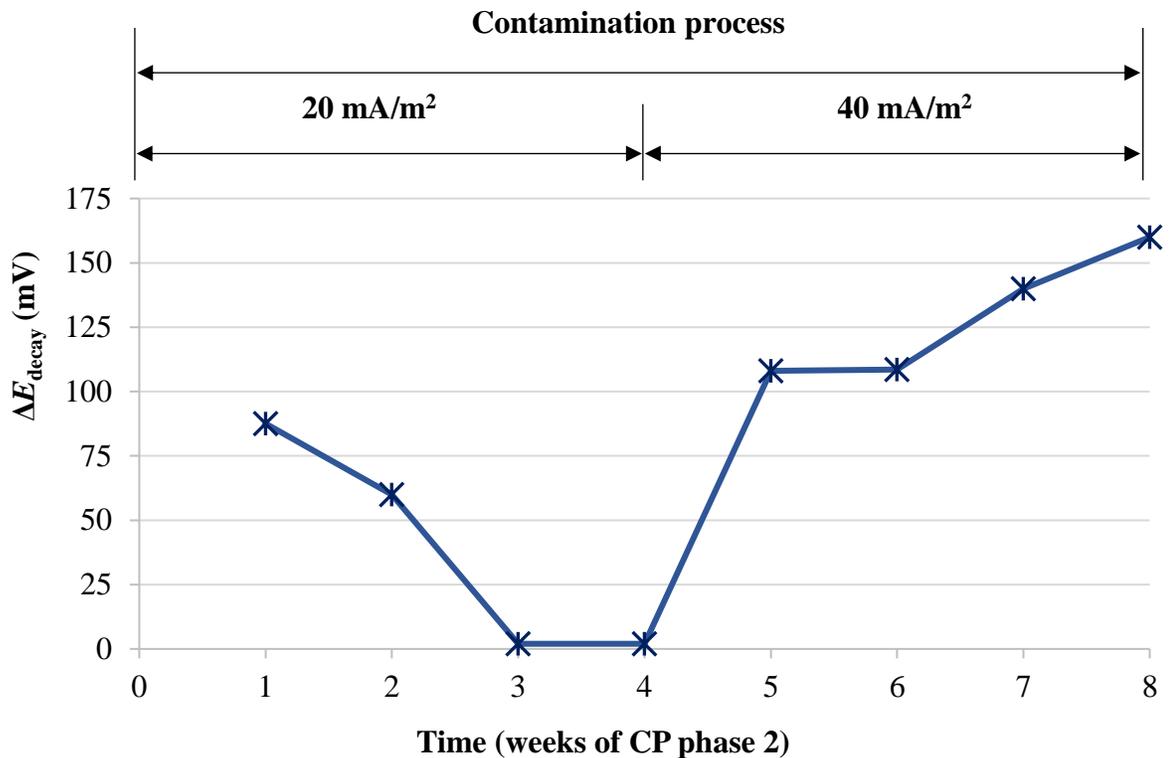
Figure 4. Evolution of  $\Delta E_{\text{decay}}$  during phase 2 of CP. First step of 4 weeks with  $20 \text{ mA/m}^2$  of current density, and third step with  $40 \text{ mA/m}^2$ . Adapted from (Carmona, et al, 2015).

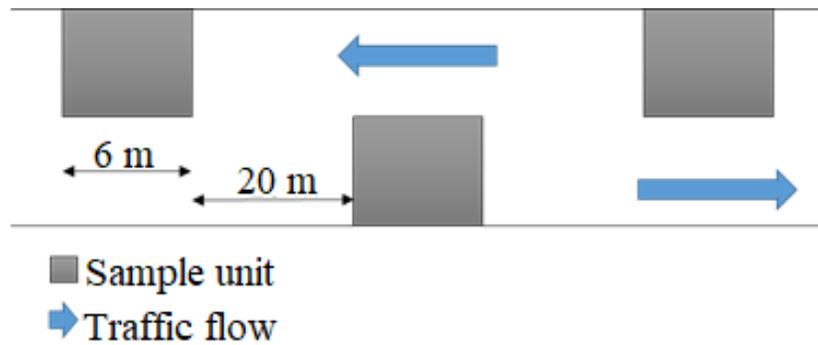
Figure 2. Distribution scheme of established sample units in the research.
