## **ALCONPAT International**

## **Revista ALCONPAT**

## Corrosion effect on reinforced concrete with the addition of graphite powder and its evaluation on physical-electrochemical properties

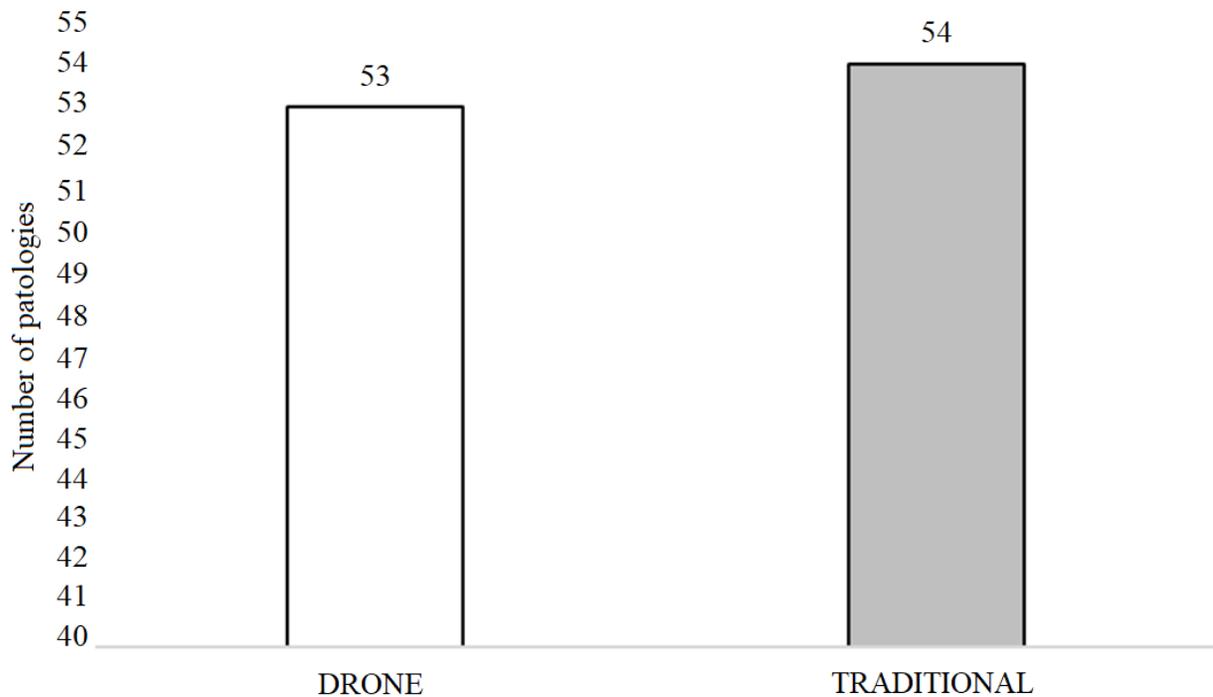
Figure 5. Identified pathologies according to inspection method.

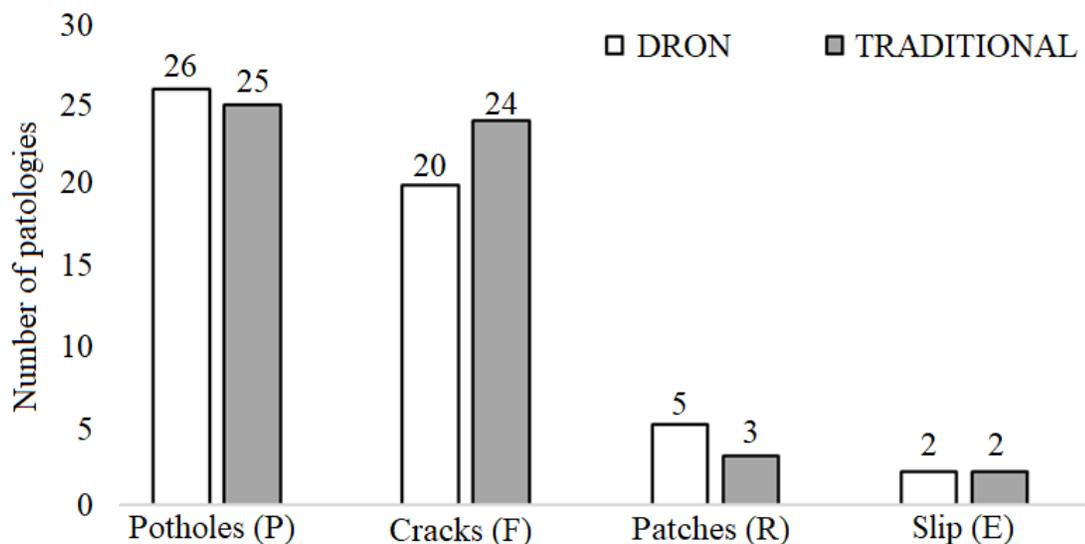
Figure 6. Identified pathologies according to its types and inspection methods.

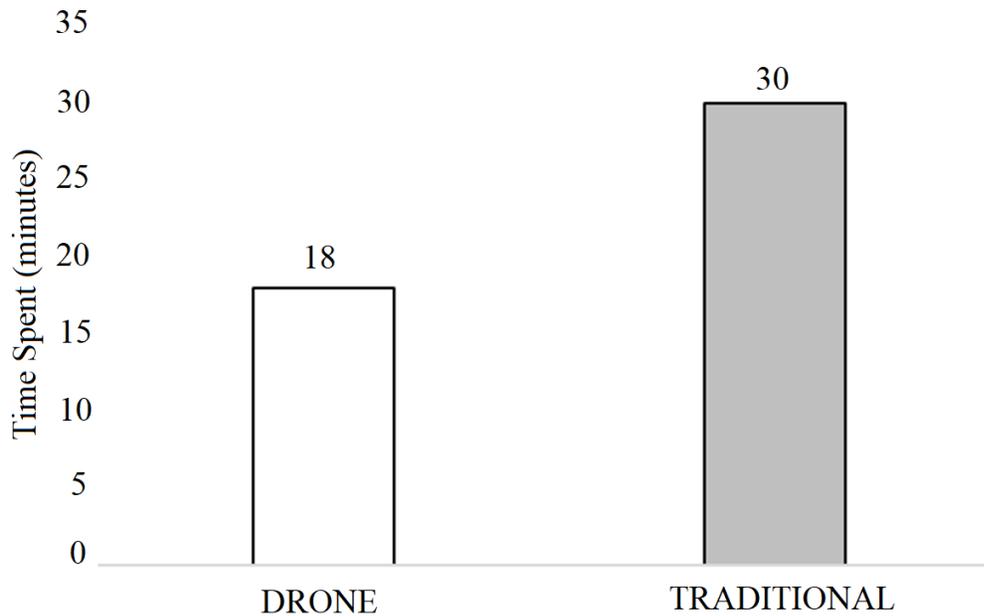
Figure 8. Time spent for inspection realization according to used methods.

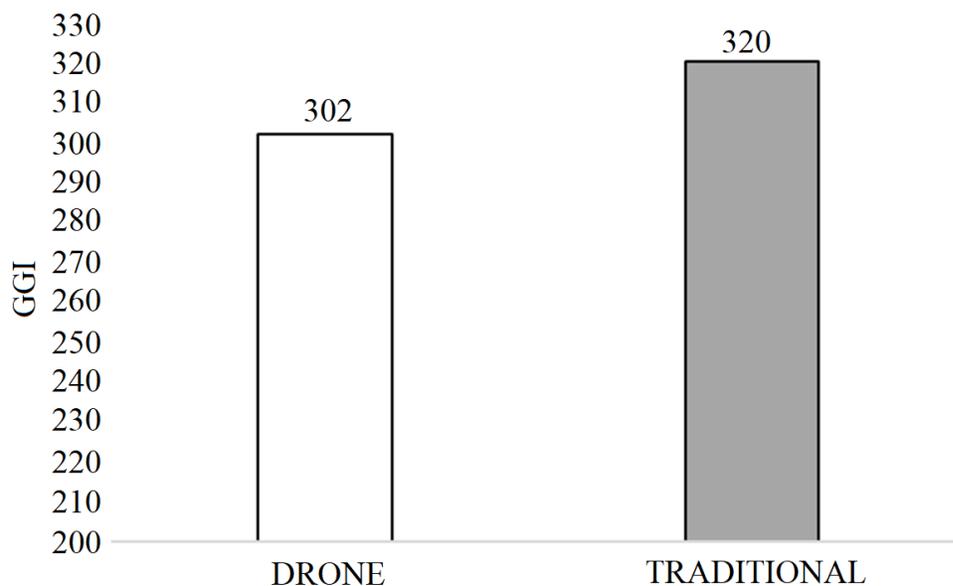
Figure 9. Global Gravity Index - GGI according to used method.

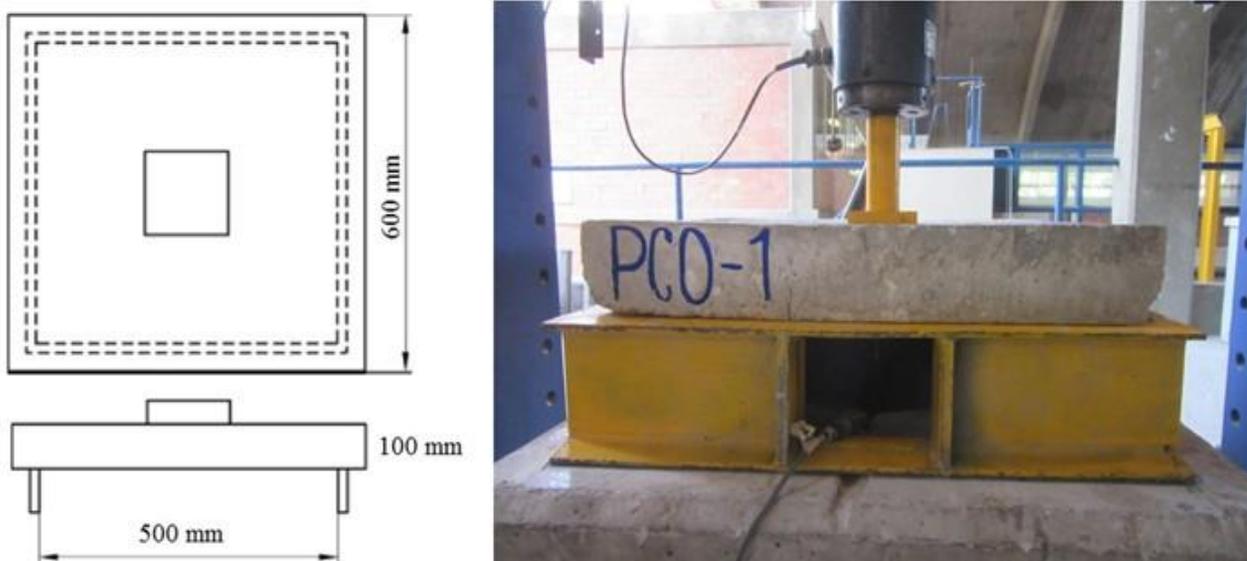
Figure 2. Panel test configuration diagram, according to EN 14488-5

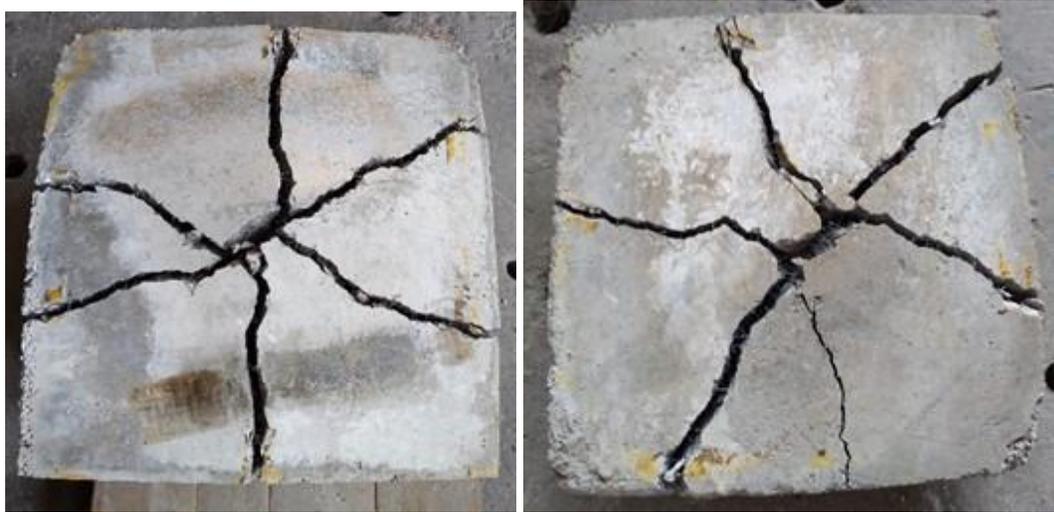
Panel 1 – PCO-1                      Panel 2 – PCO-2  
 Figure 3. Typical failure mode of the tested square panels

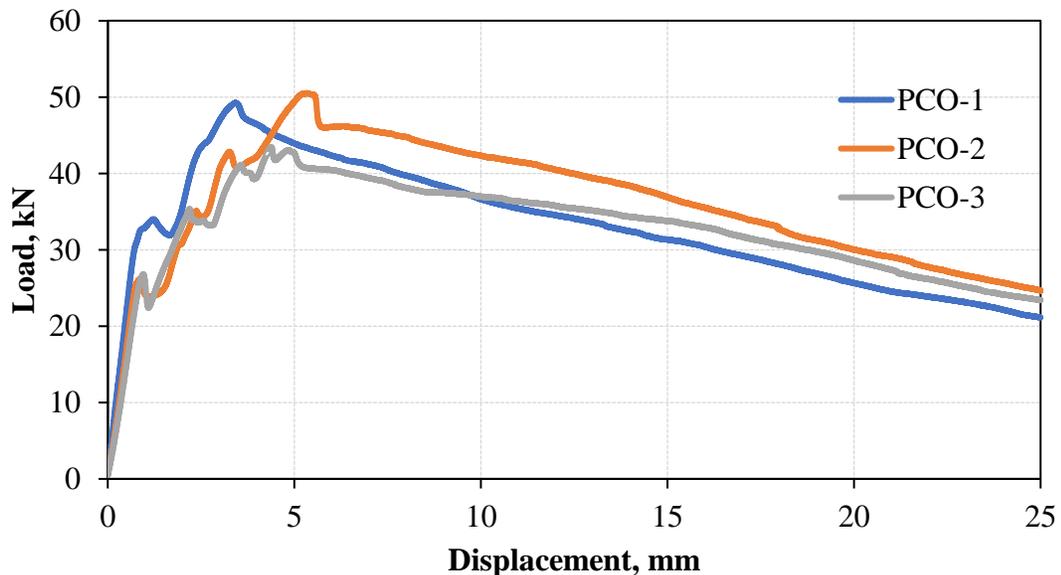
Figure 4. Load-displacement curves of the tested square panels

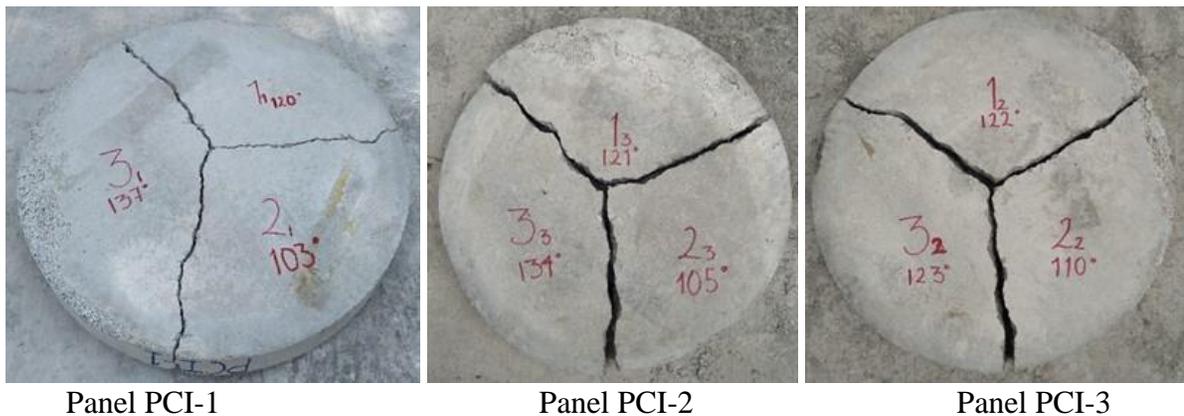
Figure 6. Round panels failure mode

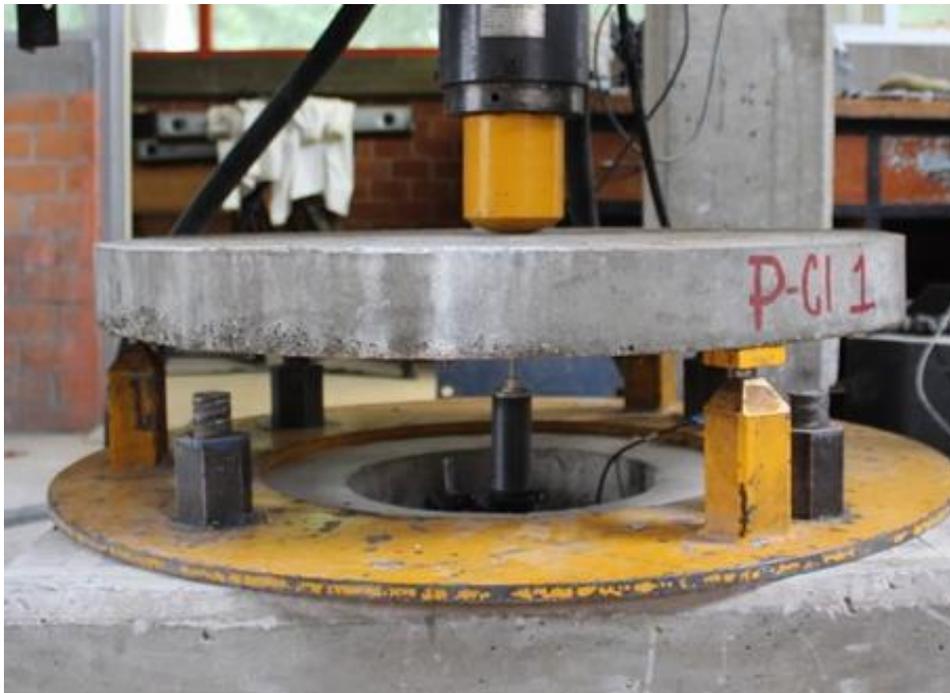
Figure 7. Round panel test setup, ASTM C1550

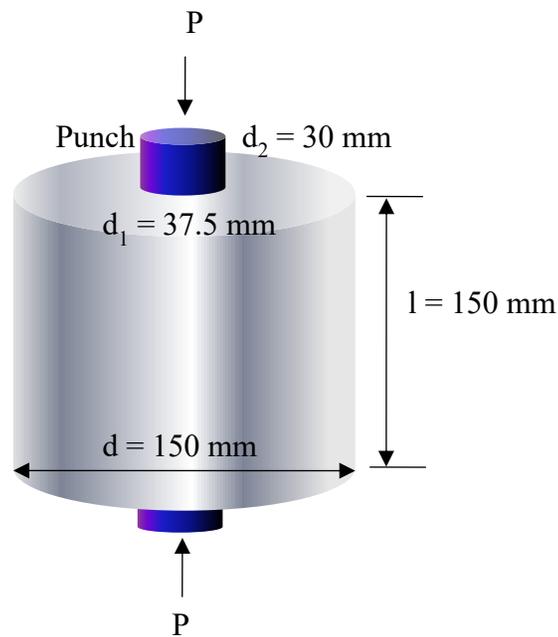
Figure 9 Barcelona test configuration – UNE 83515

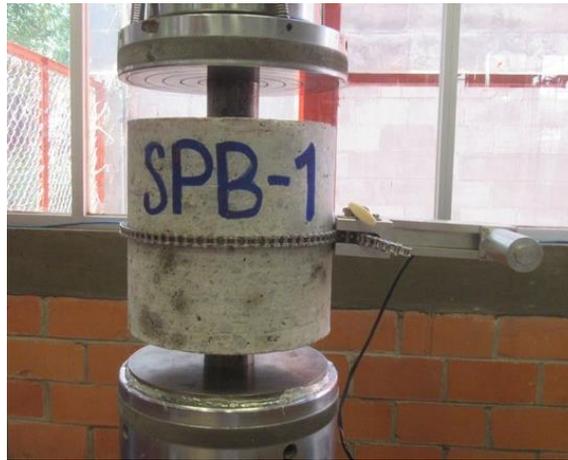
Figure 11. Double punching test, configuration, UNE 83515

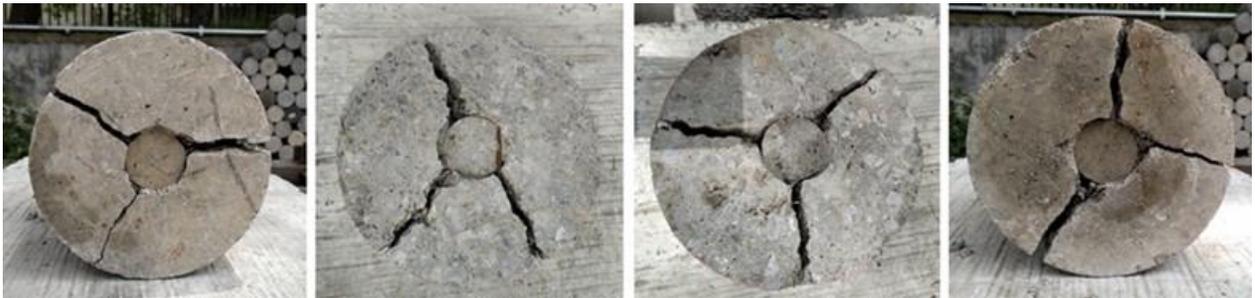
Figure 12. Cylinders typical failure mode, Barcelona Test.

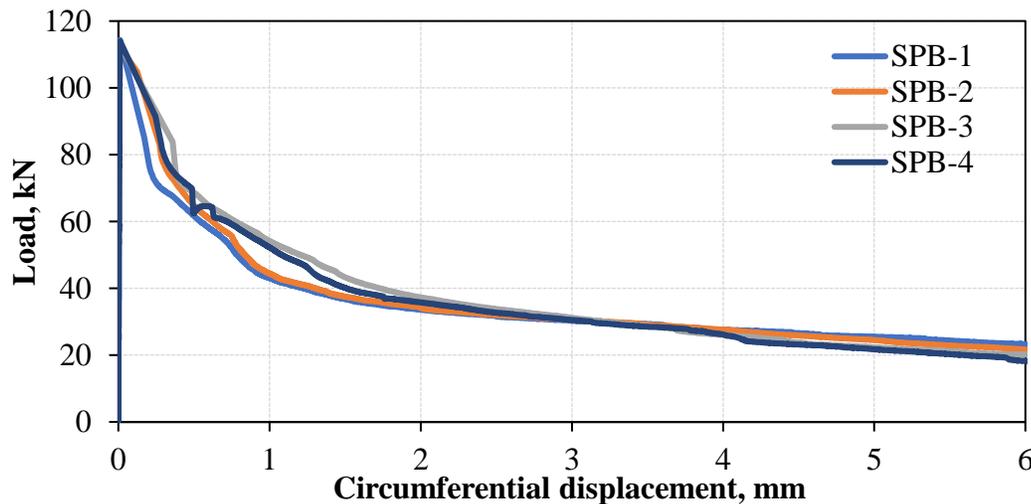
Figure 13. Circumferential load-opening curves from Barcelona test

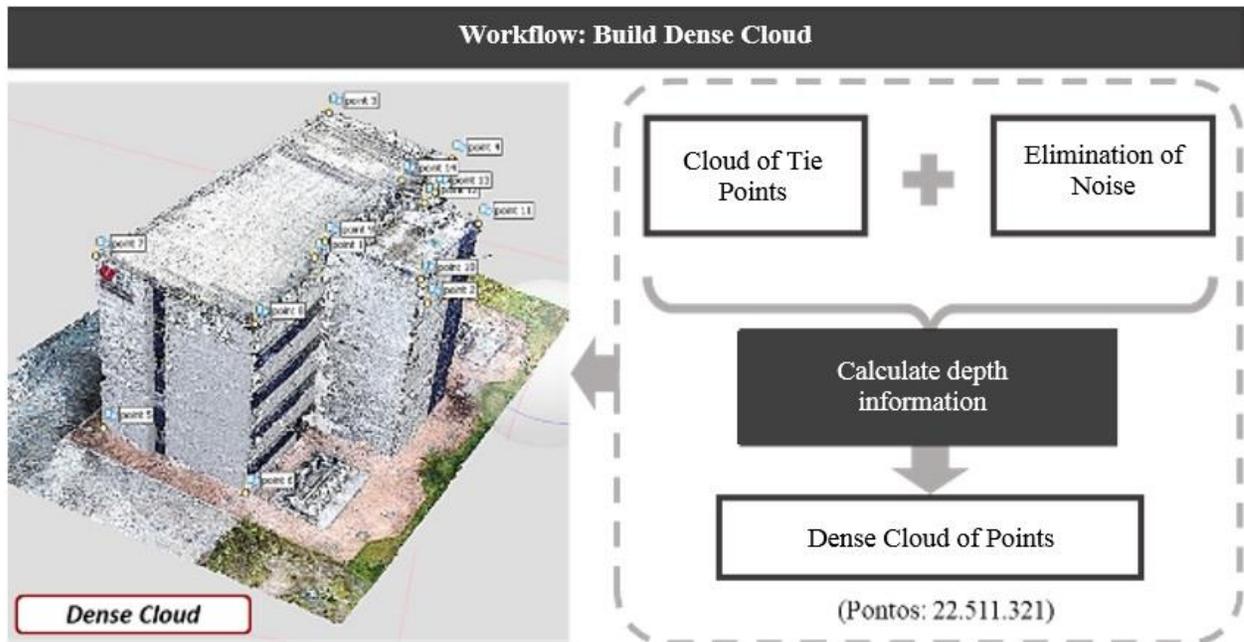
Figure 7. Densified point cloud for IIT-UPE

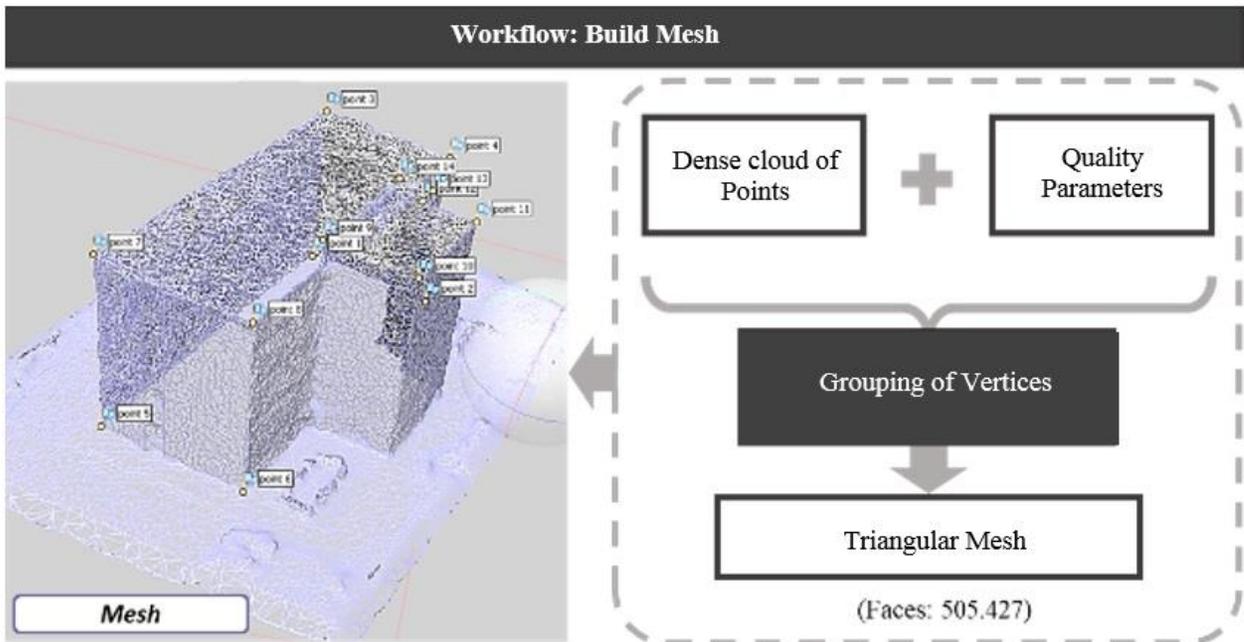
Figure 8. Triangular mesh model of IIT-UPE

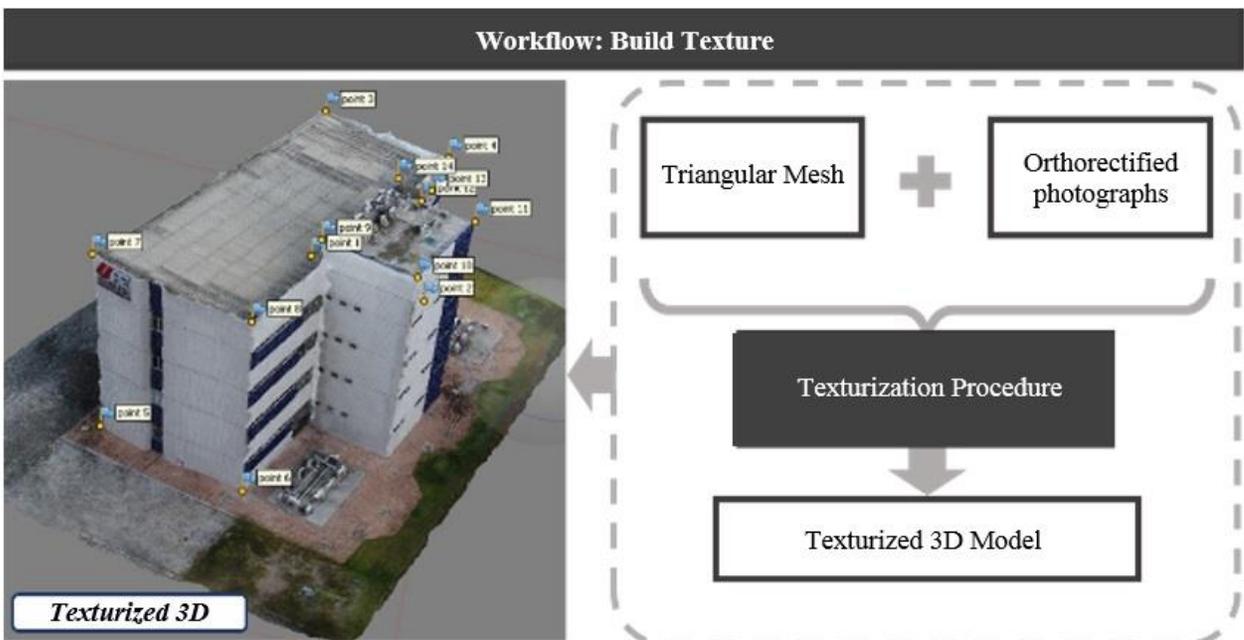
Figure 9. Texturized model of IIT-UPE

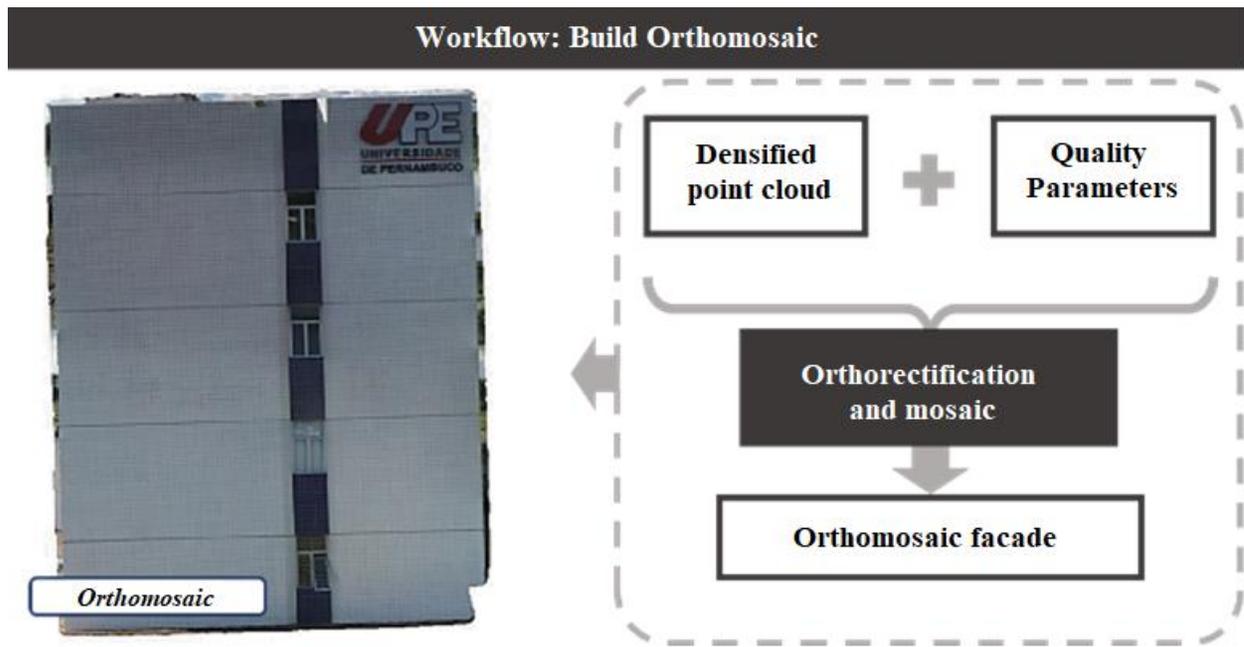
Figure 10. Orthomosaic model of IIT-UPE south Orthomosaic facade

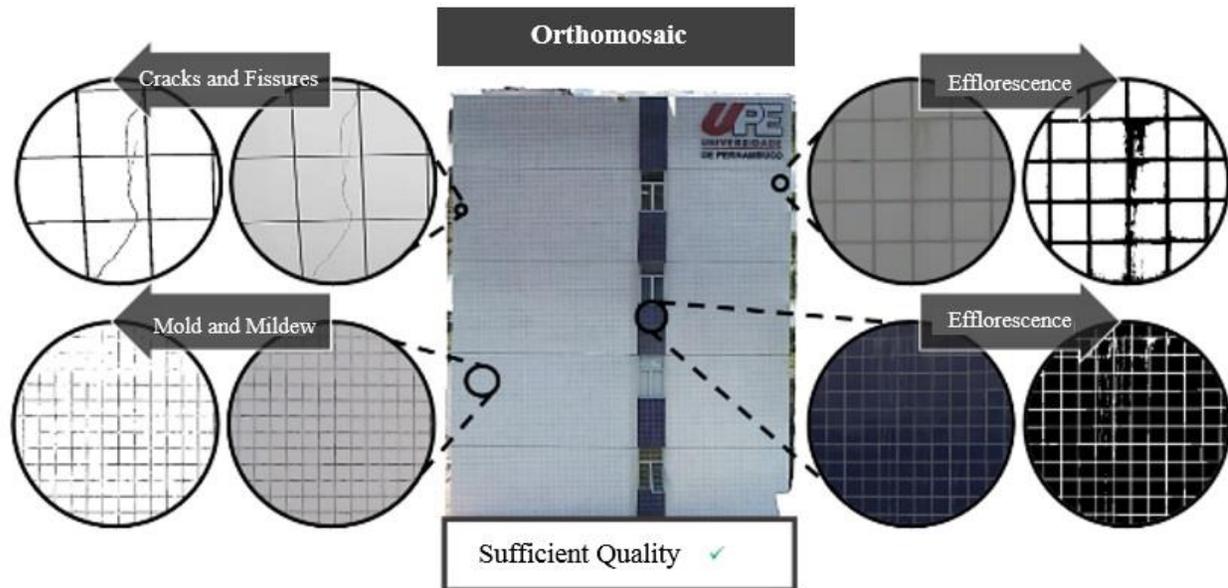
Figure 12. Detection of pathological manifestation on the south facade of IIT-UPE

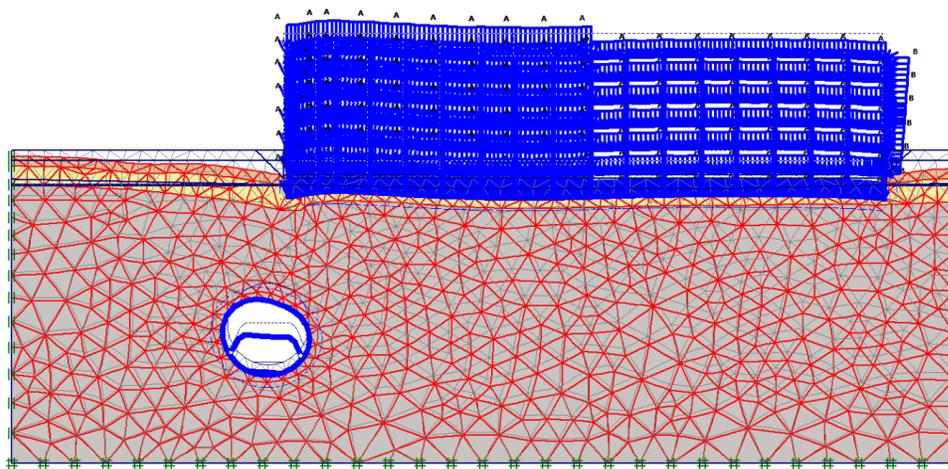
Figure 2. First breakage mechanism found, for a safety factor of 2.29.

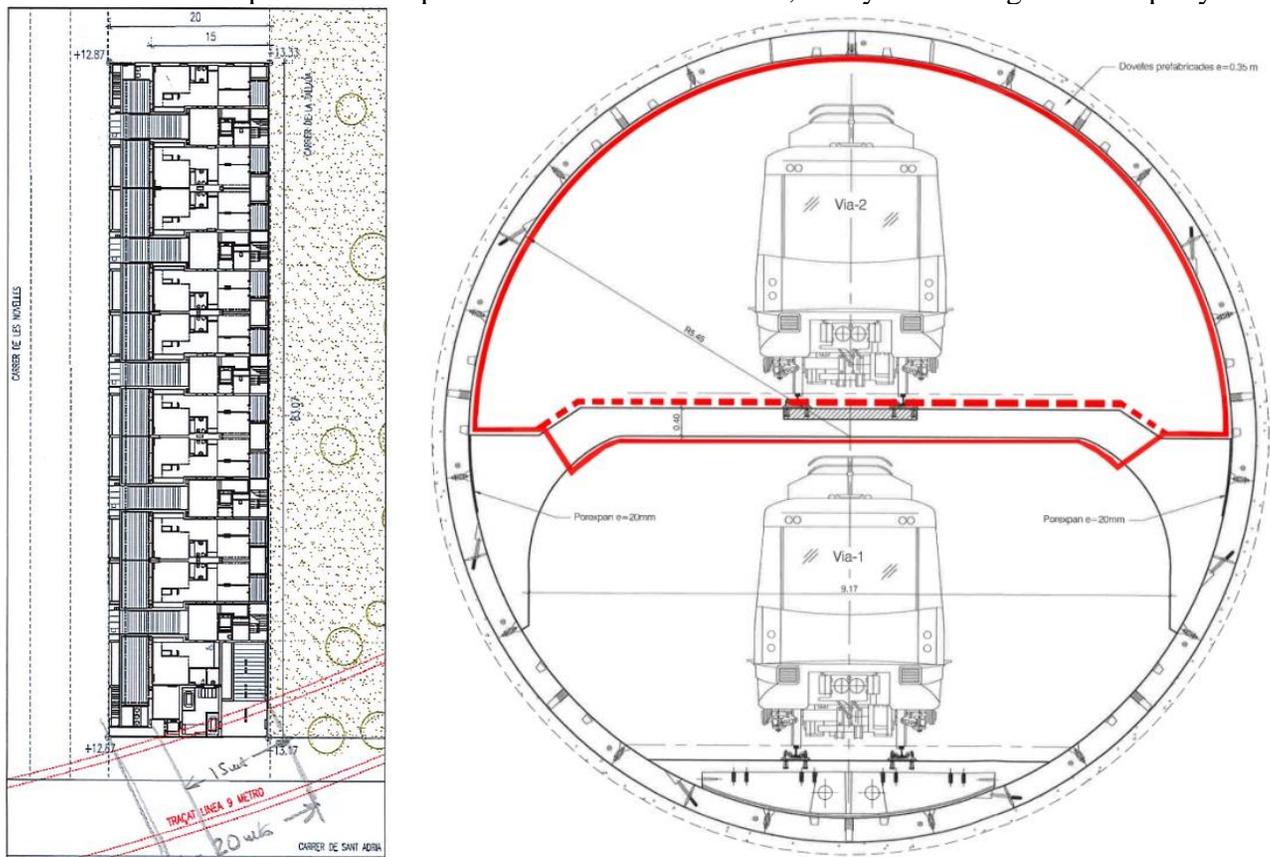
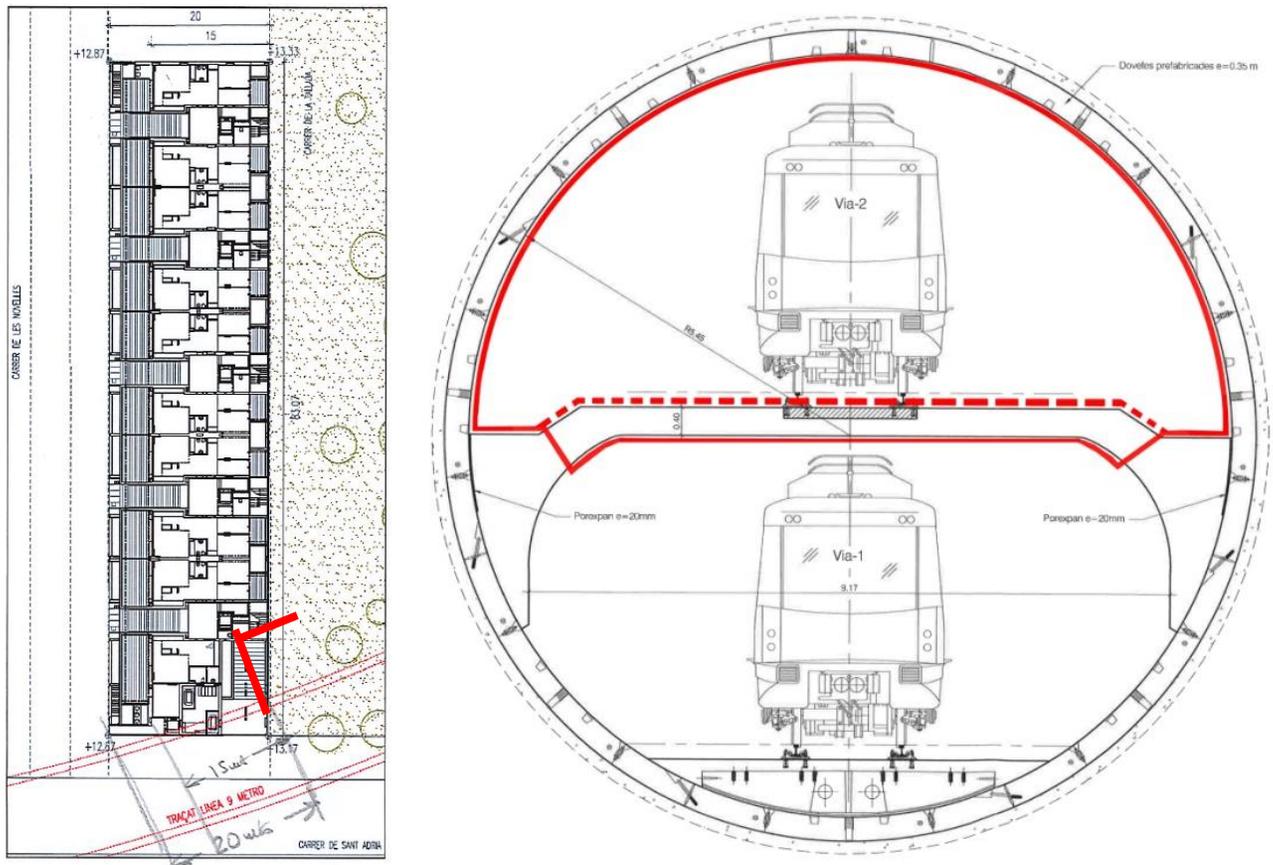
Figure 3. Detail floor of the building in relation to the subway tunnel and section of the optical fiber layout.

Figure 3 shows its placement. Fiber placement has been carried out following the perimeter of a cross section in the position indicated in the plant.

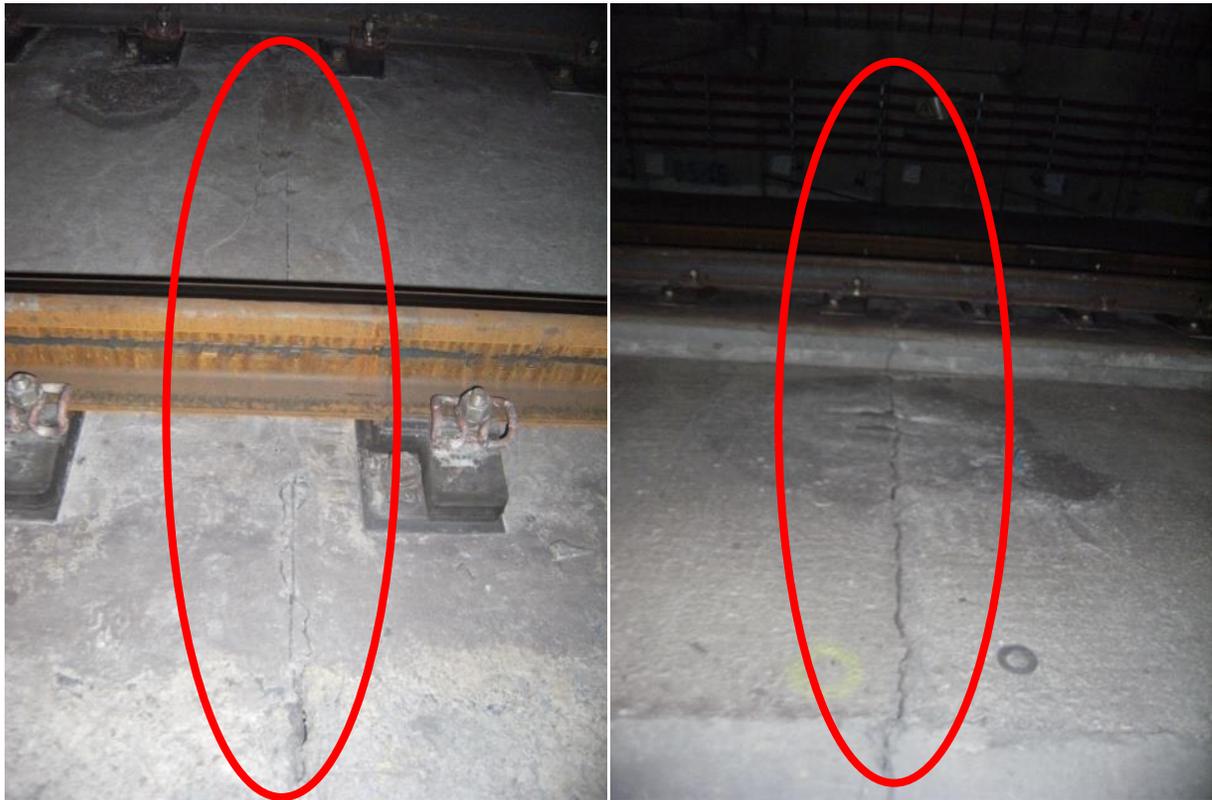
Figure 4. Joints on the track, which exist every 25m.

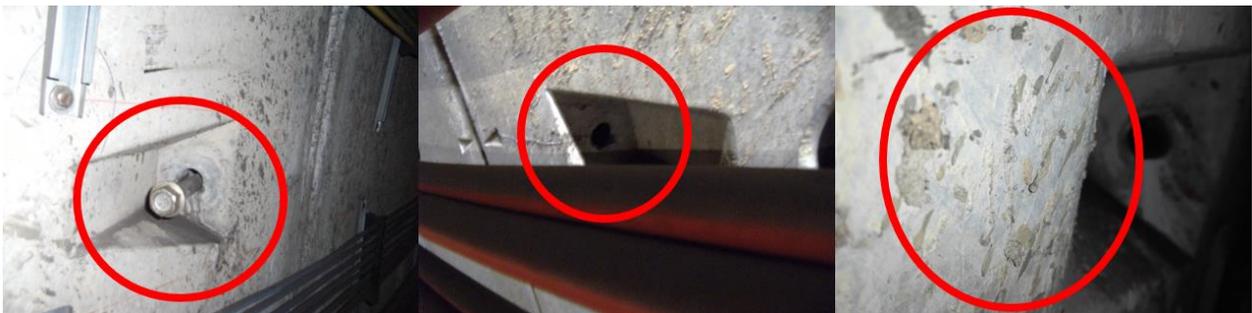
Figure 6 Roughness and clamping bolts that could affect the placement of the fiber.

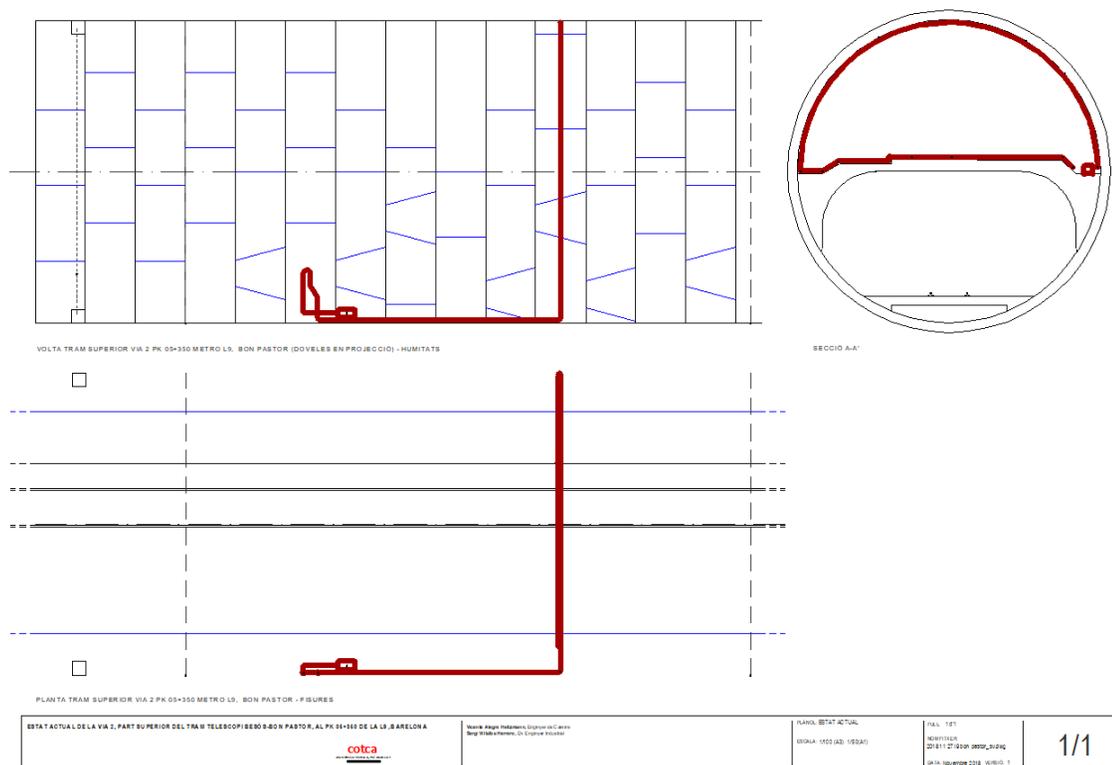
Figure 7 General tunnel scheme. Elevation and plant. The red line indicates the path of the optical fiber.

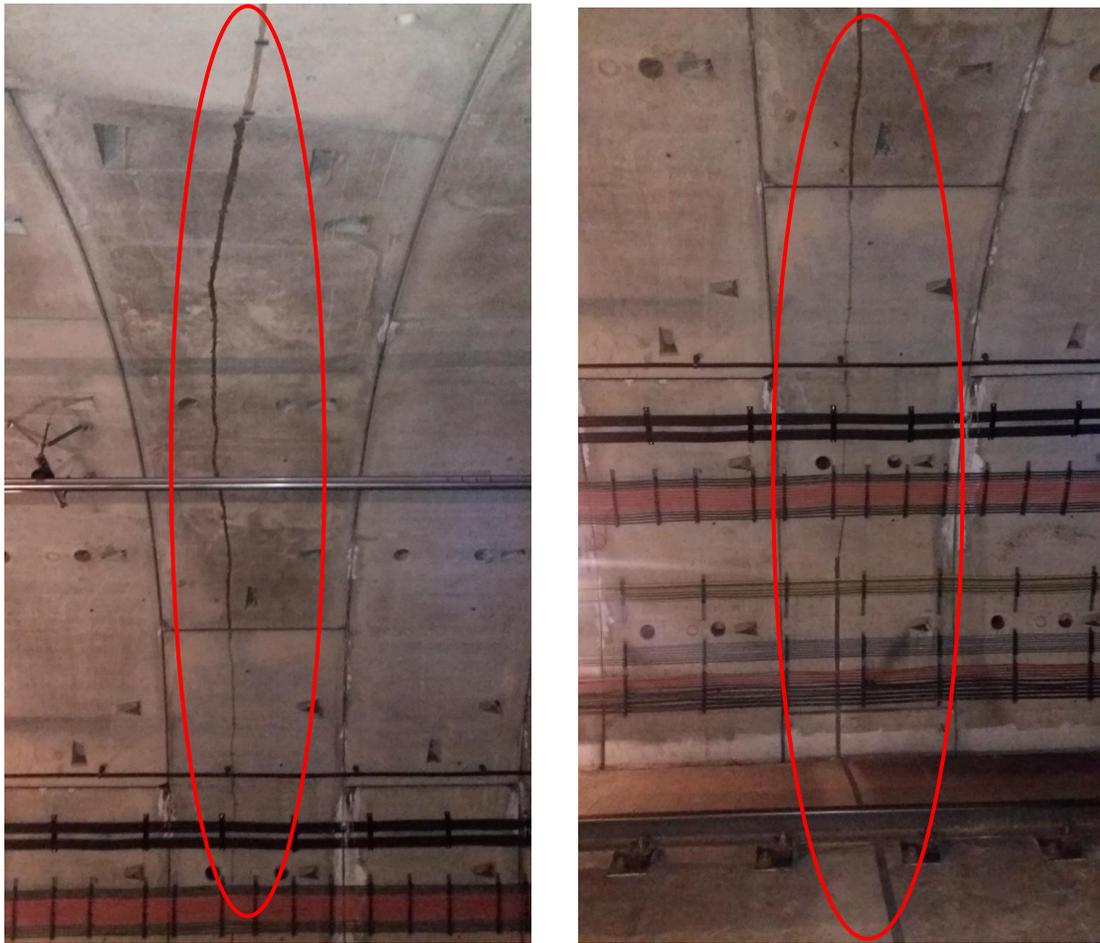
Figure 11. Optical fiber adhesion procedure on the steed of the track 2 circulation lane and in the tunnel vault.

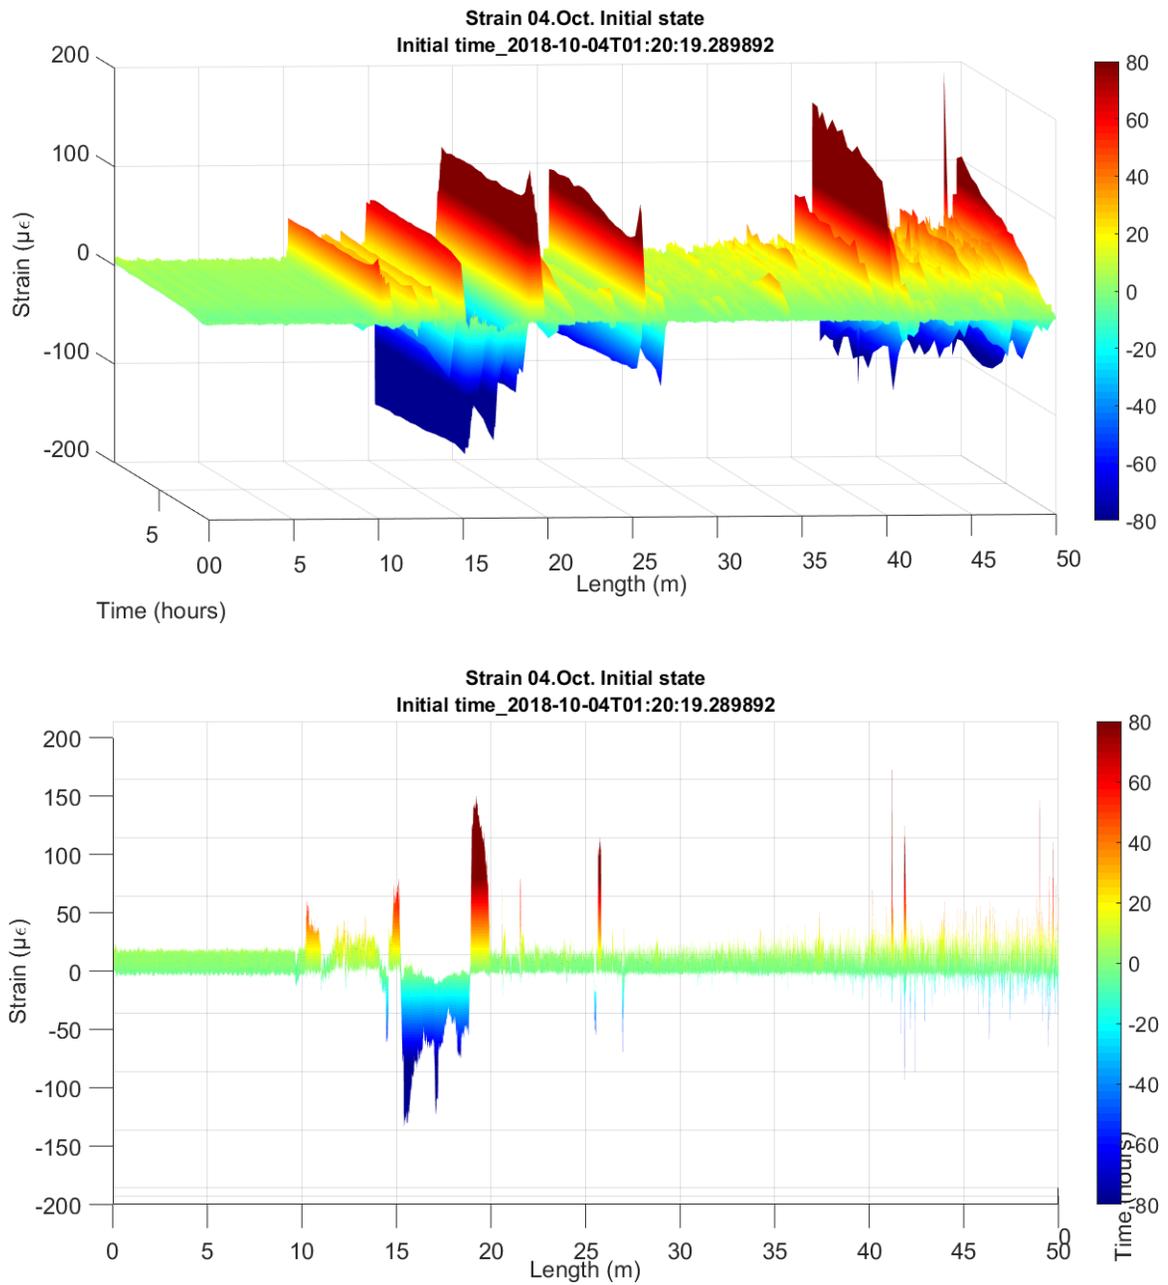
Figure 13. Initial and calibration status. Length 50m FOD. Axonometric and frontal view.

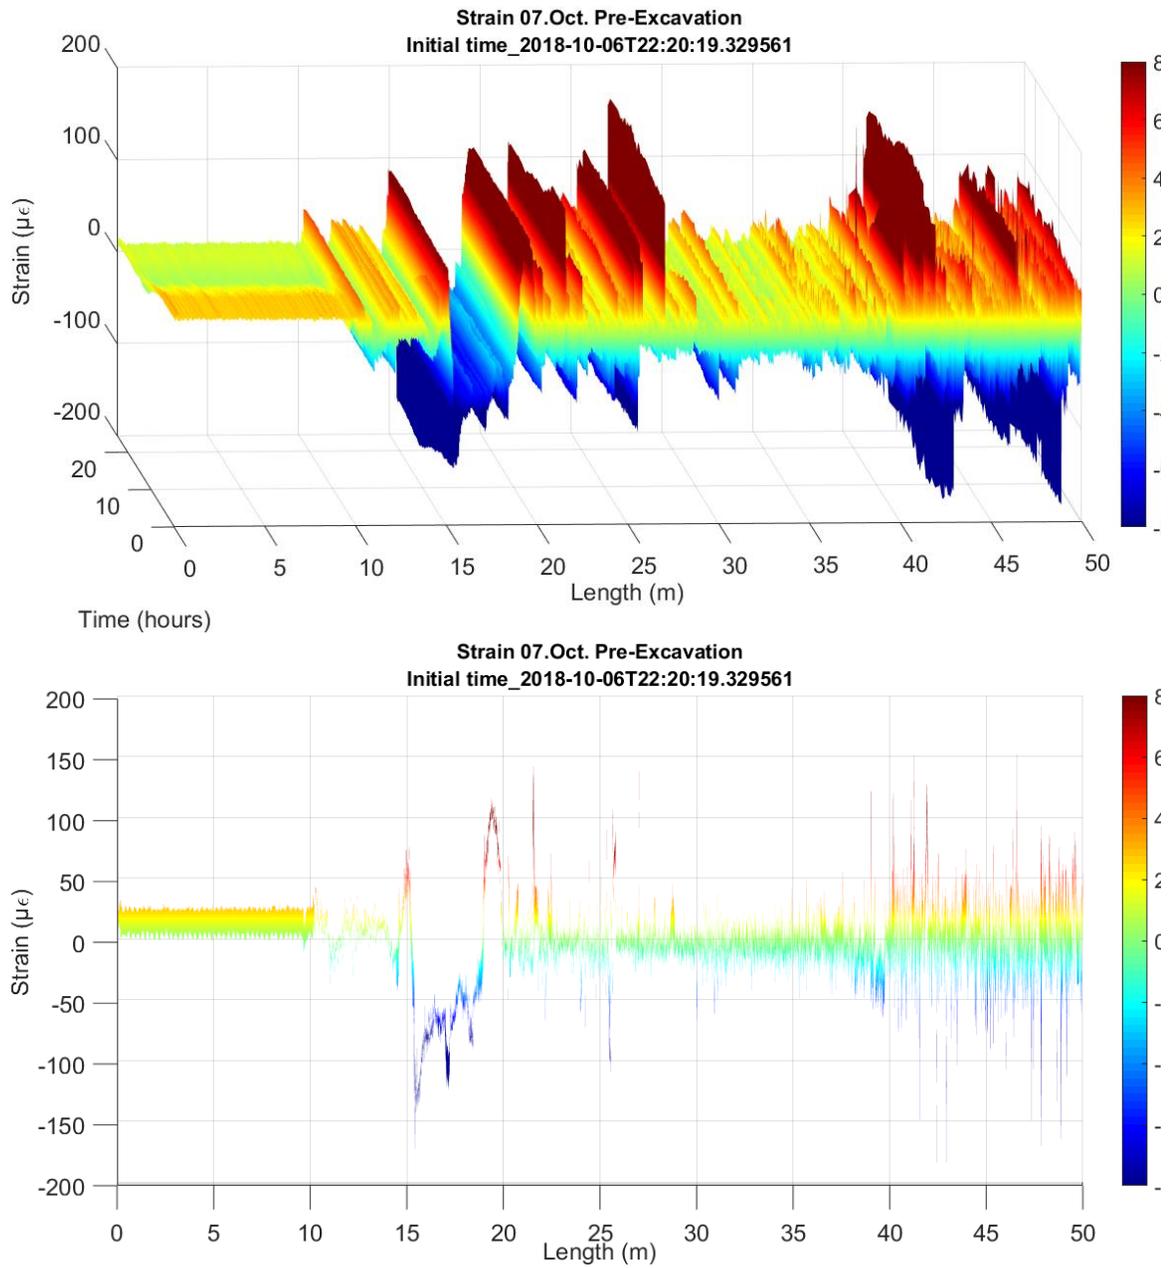
Figure 14. Pre-excitation. Length 50m FOD. Axonometric and frontal view.

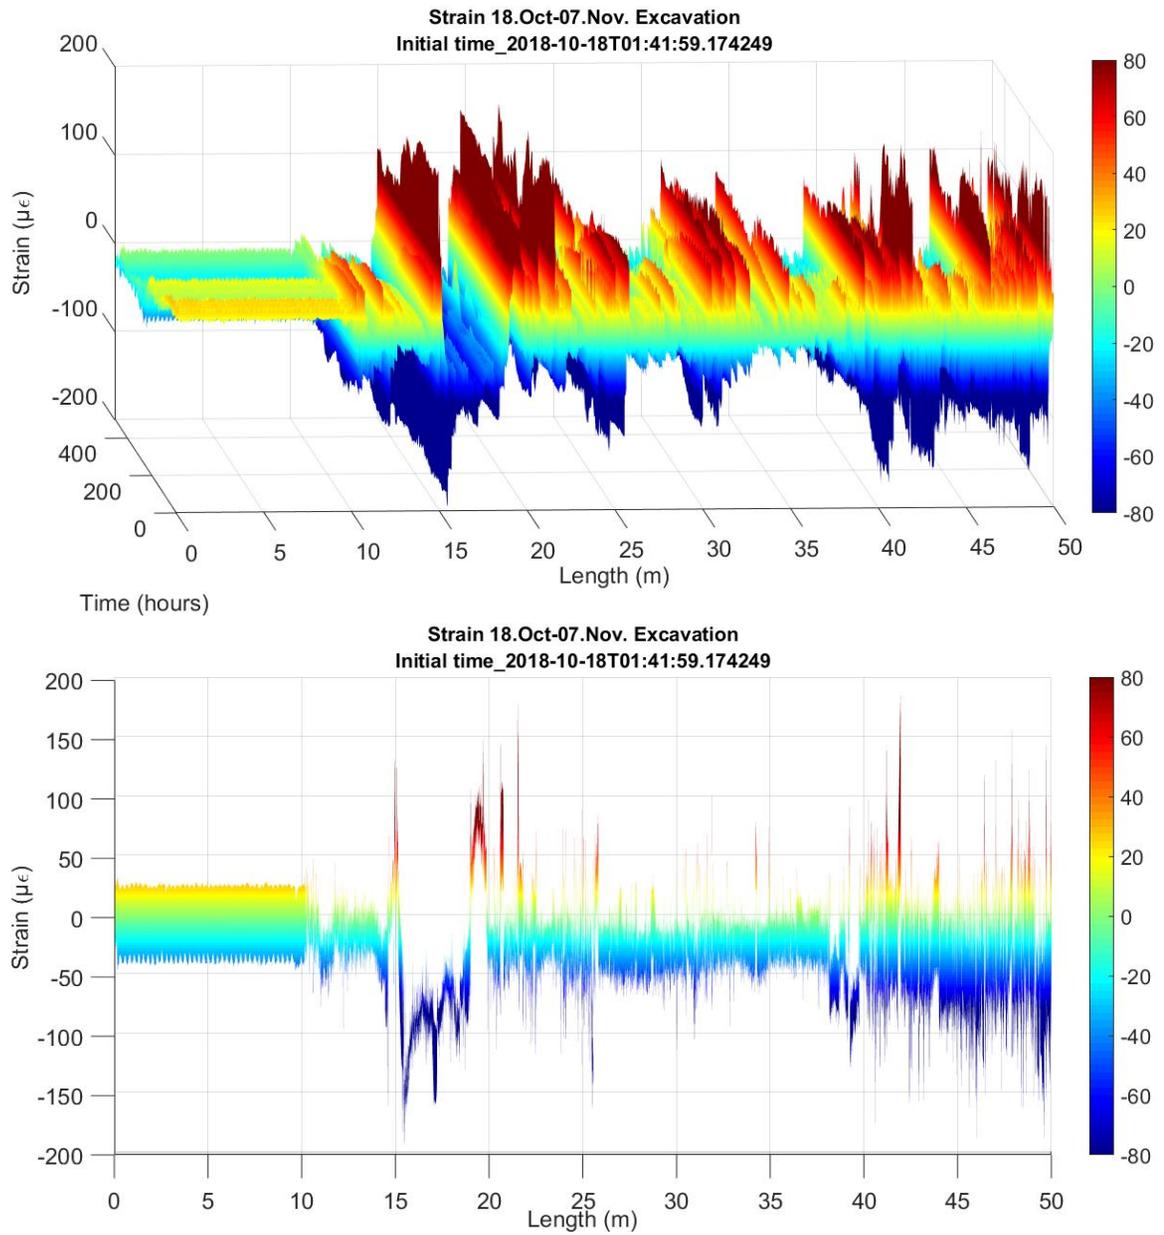
Figure 15. Complete excavation. Length 50m FOD. Axonometric and frontal view.
