## **ALCONPAT International**

## **Revista ALCONPAT**

## Corrosion effect on reinforced concrete with the addition of graphite powder and its evaluation on physical-electrochemical properties

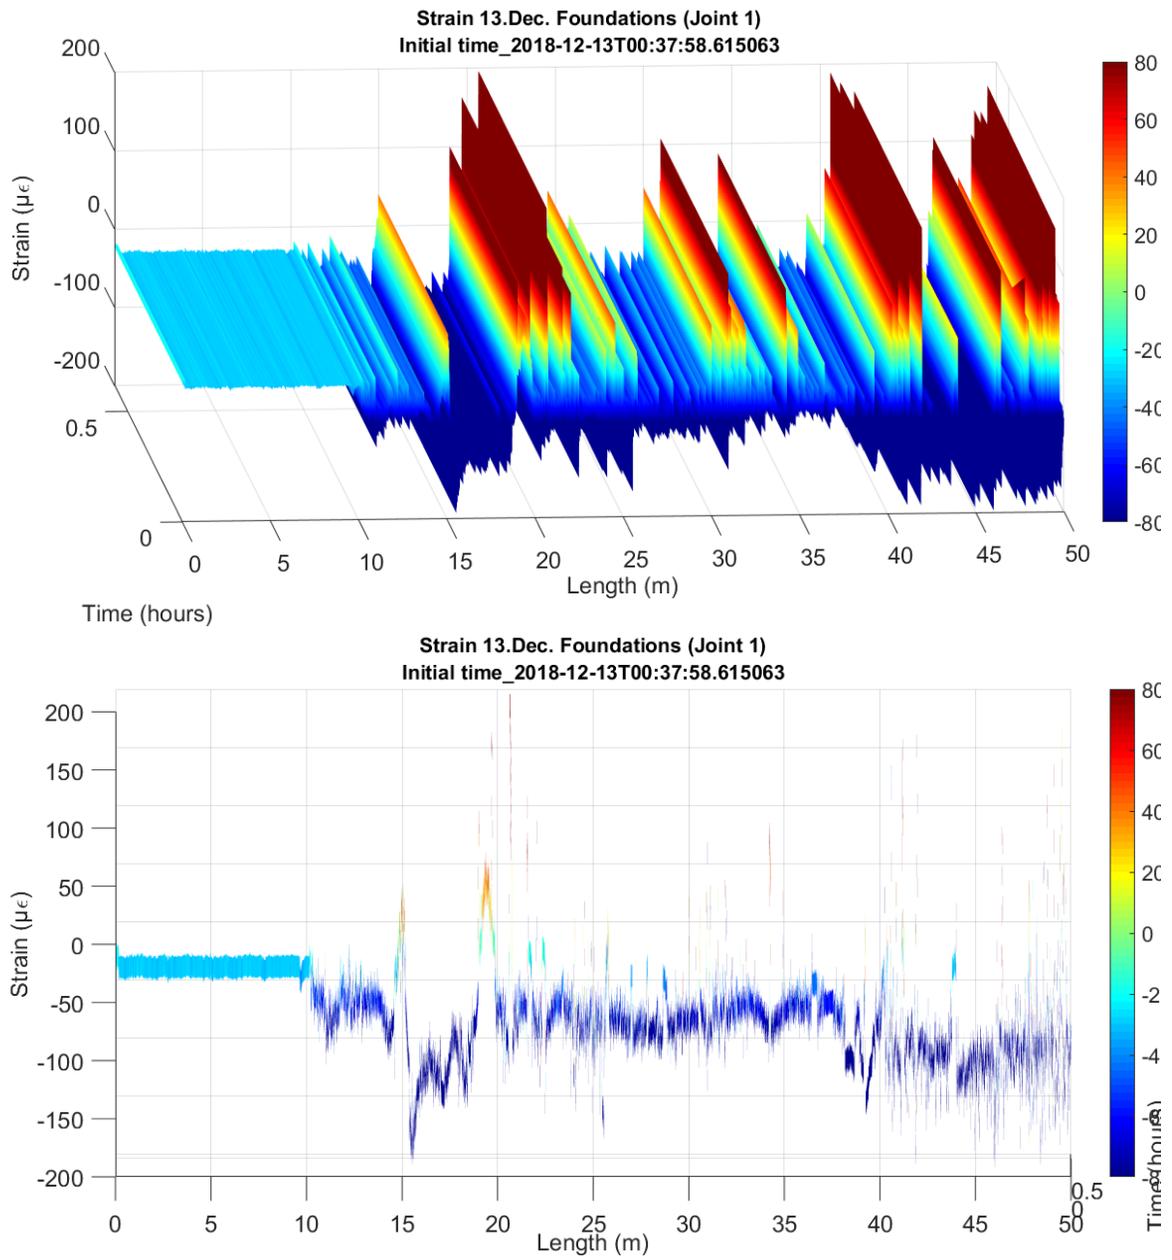
Figure 16. Execution of first section on foundation slab. Length 50m FOD. Axonometric and frontal view.

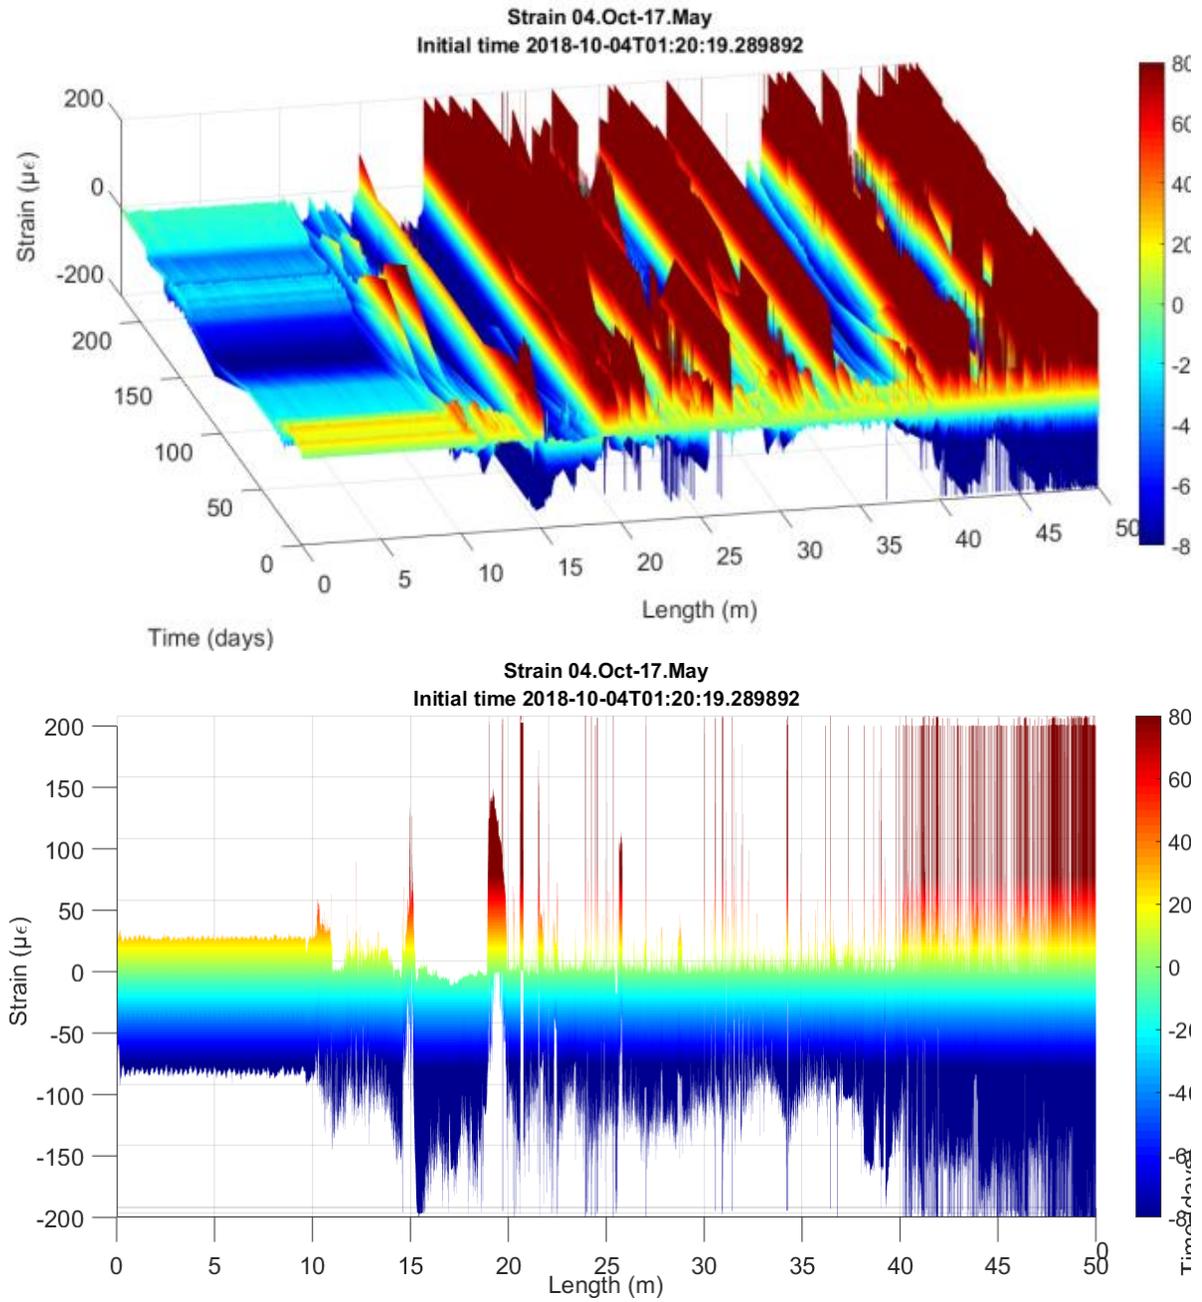
Figure 17 Temporary evolution of 4 October and 17 May. Length 50m FOD. Axonometric and frontal view.

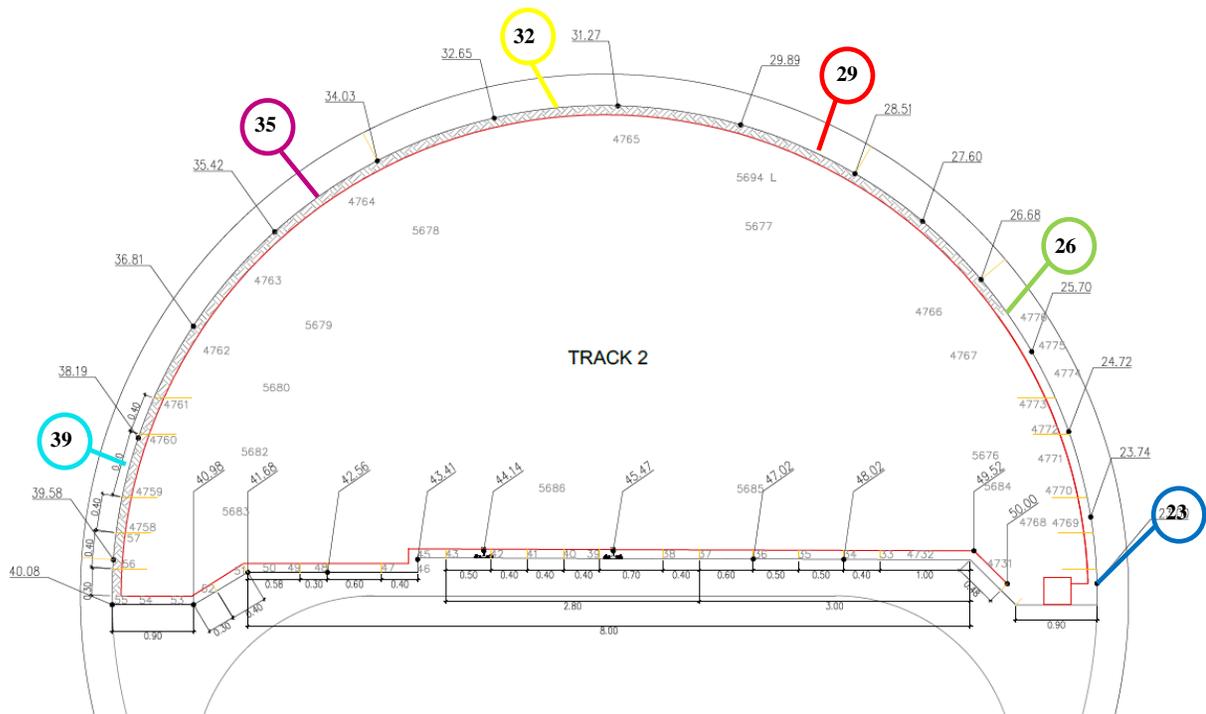
Figure 18. Identification of critical control points in the Tunnel vault.

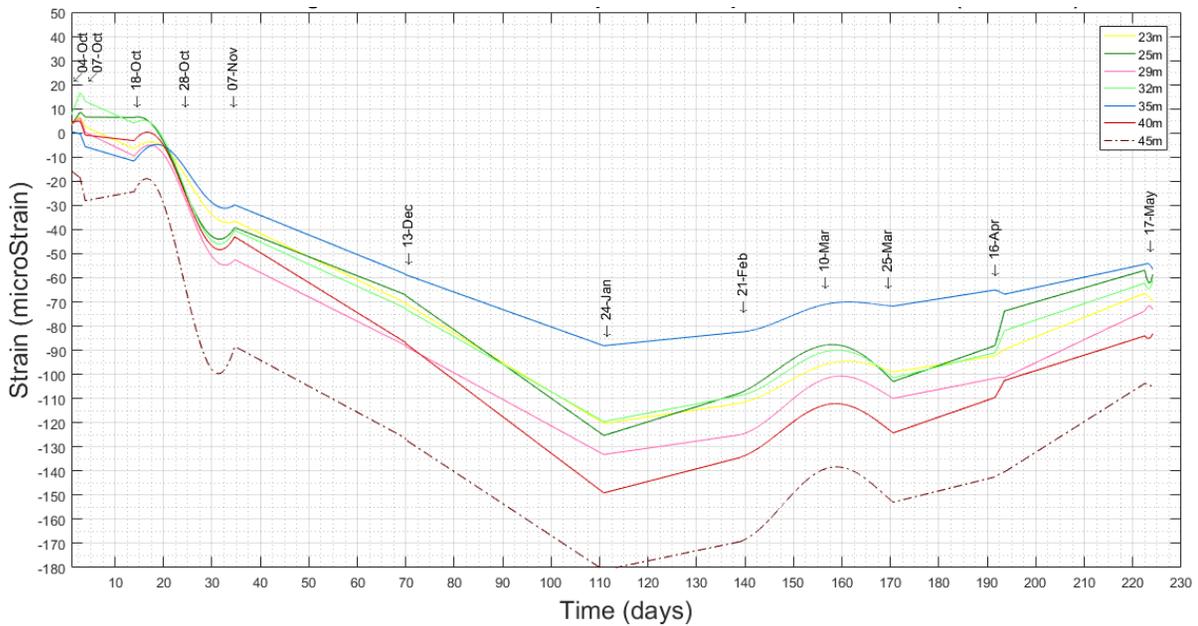
Figure 19. Temporary evolution from October 4, 2018 to May 17, 2019 at critical checkpoints.

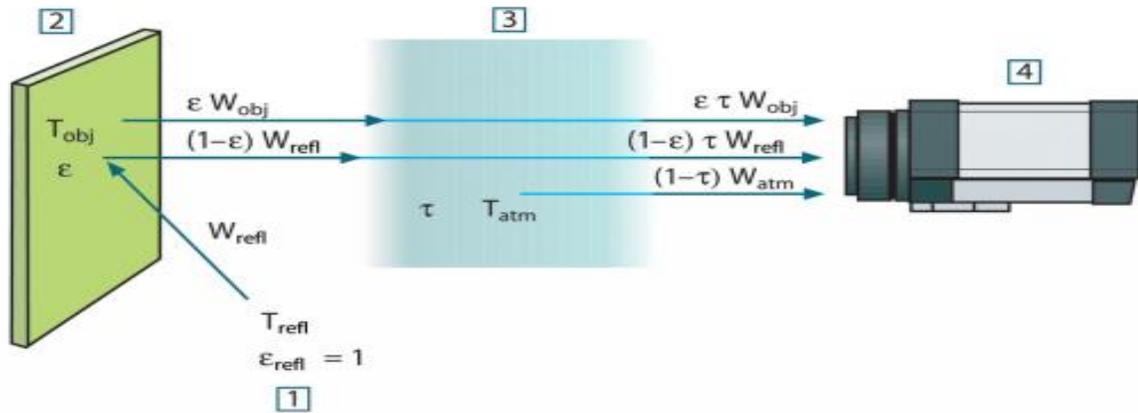
Figure 1. Schematic representation of general thermographic measurement location. 1) adjacent environment, 2) object, 3) atmosphere, 4) camera.  $T_{obj}$ : object temperature,  $T_{refl}$ : reflected temperature,  $T_{atm}$ : atmospheric temperature.  $W_{obj}$ : radiation power emitted by the object,  $W_{refl}$ : radiation power emitted by surrounding environment,  $W_{atm}$ : radiation power emitted by atmosphere (Caldeira & Padaratz, 2015).

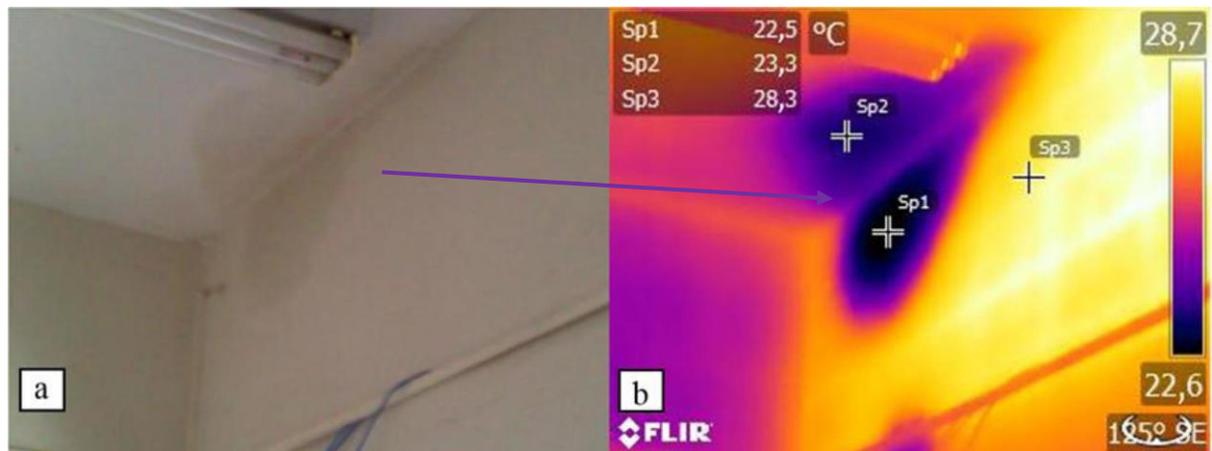
Figure 2. Pluvial water penetration: (a) digital image and (b) thermogram (Rocha et al., 2018).

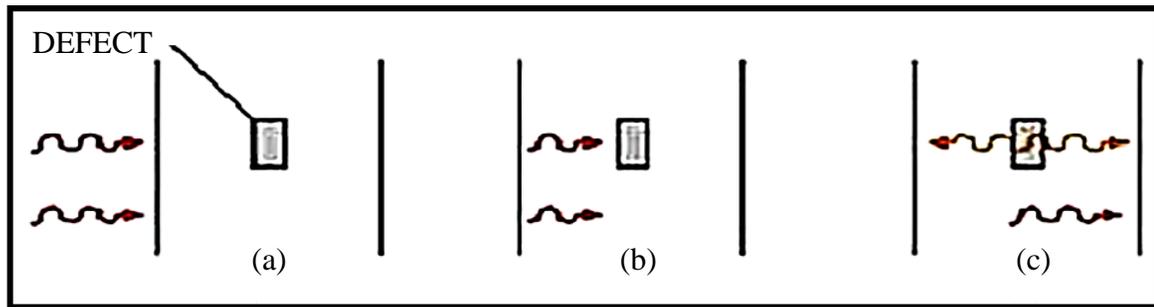
Figure 4. Modeled propagation of a single heat pulse in a material: (a) An energy pulse applied to the surface; (b) A heat pulse travels inside the material and finds a defect; (c) This defect partially reflects and partially transmits the pulse (Cortizo, 2007).

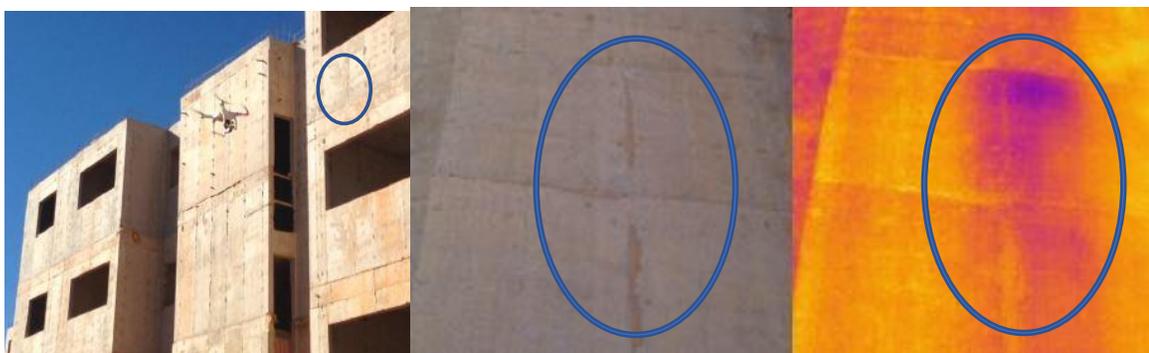
Figure 5. Inspection using an UAV integrated with a thermal camera (Nascimento, 2014)

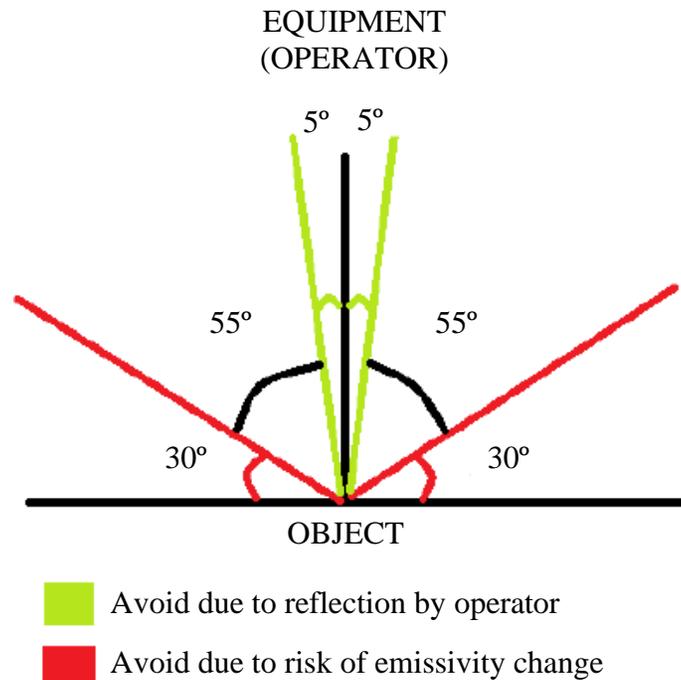
Figure 6. Measurement angles: precautions (Viégas, 2015)
