Latin American Journal of Quality Control, Pathology and Construction Recovery

Volume 11

May – August 2021

Issue 2

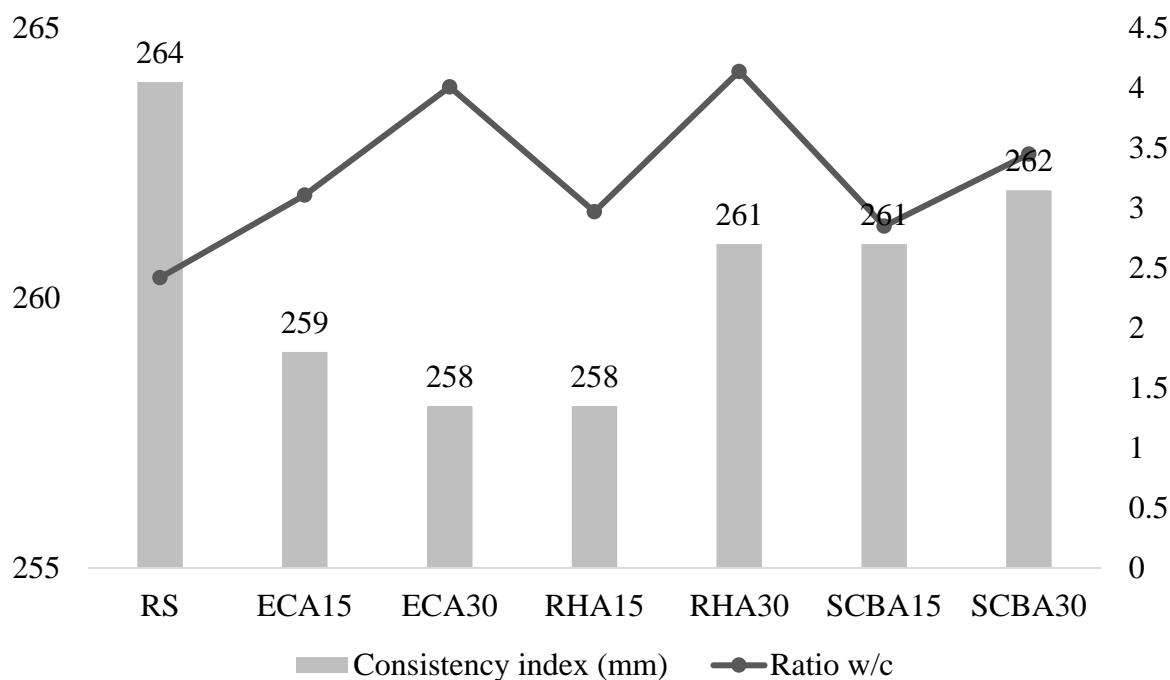
While for fresh mortar, the fineness index reveals those of lesser value, in the SCBA case, there is no change in workability for any substitution range because particles larger than 45 µm affect the plasticity of the mixture (Netto, 2006). Similarly, for the RHA, there is a greater loss of workability, especially when the increase in cement replacement is from 15 to 30%. These are assertions that are equally proven by the consistency index, which are within the limits established by NBR 13276 (ABNT, 2016), Figure 1.

Figure 1. Chart results for consistency index and w/c ratio.

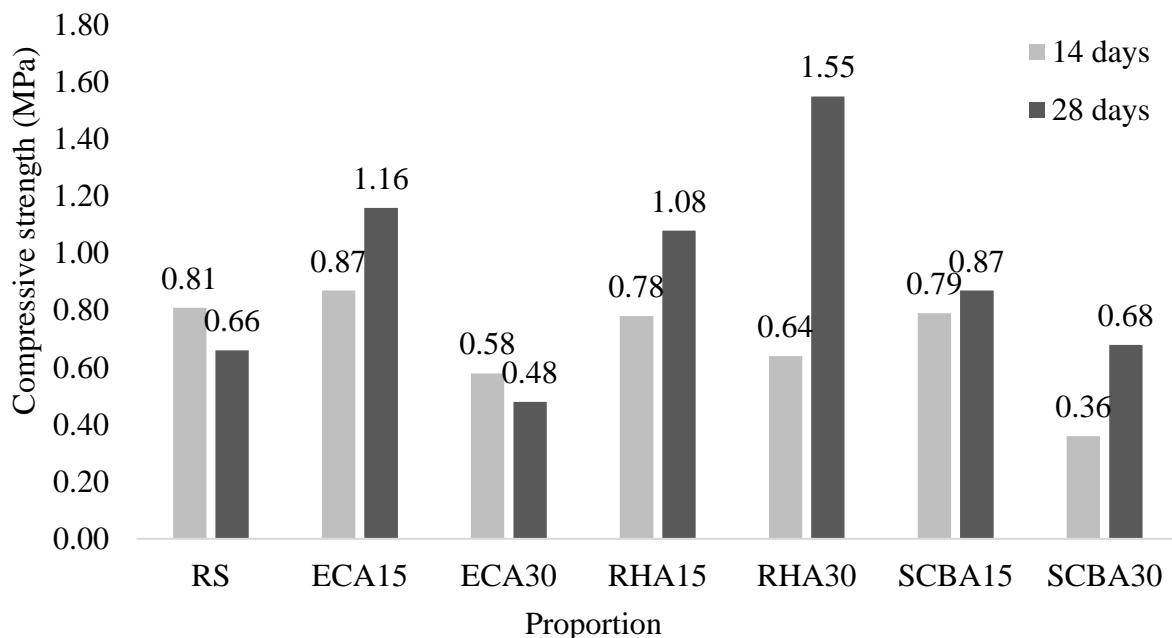
Therefore, regarding the results, there was no significant gain in compressive strength at 14 days for any of the samples, Figure 2, as shown in Paris et al. (2016) and Abbas et al. (2017). CPDs with a 15% cement replacement content achieved better mechanical performance, especially for ECA15. This is related to factors such as the lower rate of cement replacement (Garcia and Sousa-Coutinho, 2013; Carrasco et al., 2014; Ukrainczyk et al., 2016), the greater amount of reactive material, the better workability, when compared to CDP, and greater water absorption.

Figure 2. Bar chart showing a comparison between the average resistance achieved in the simple compression test for each trace at 14 and 28 days (Tukey method $p < 0.05$).

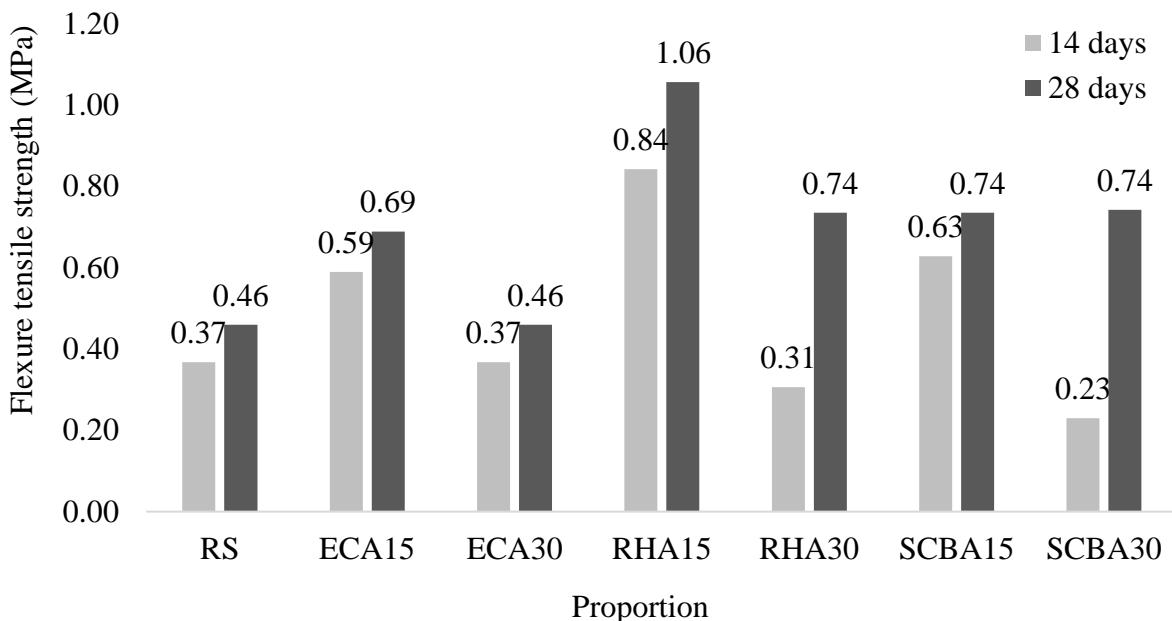
Figure 3. Comparison between the average resistance achieved in the flexural tensile test for each trace at 14 and 28 days (Tukey method $p < 0.05$).

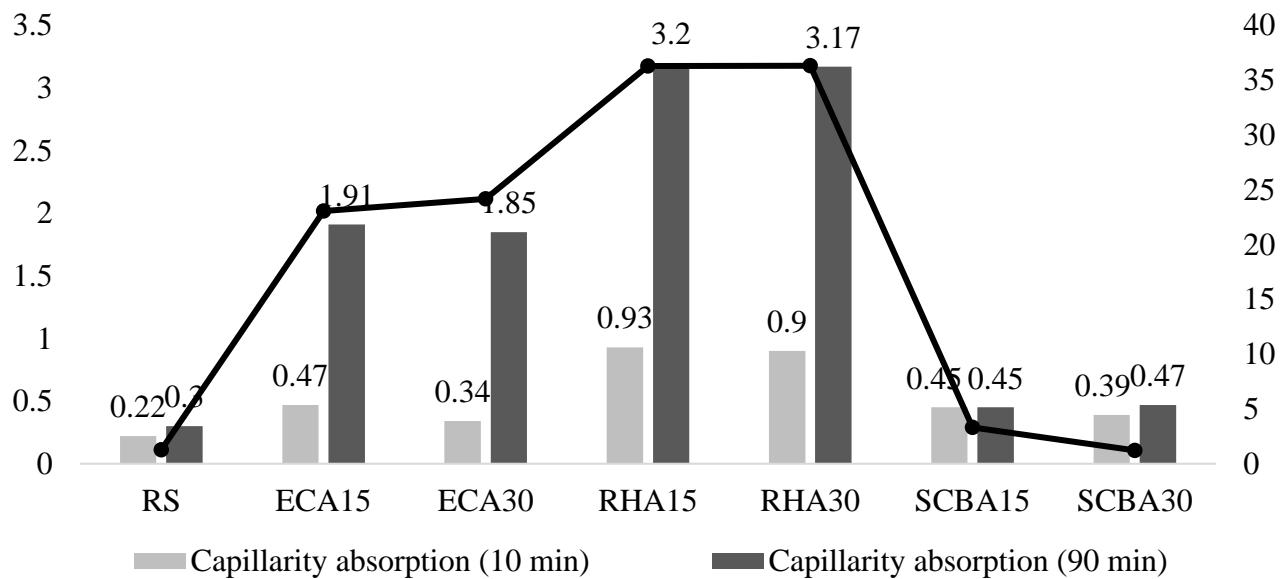
Finally, to identify the water absorption phenomenon, the specifications presented by NBR 15259 (ABNT 2005) were followed. It states that the capillarity absorption index must be calculated as the average of the three specimens submitted to immersion in water for 10 min and 90 min, Figure 4.

Figure 4. Absorption test at 28 days.

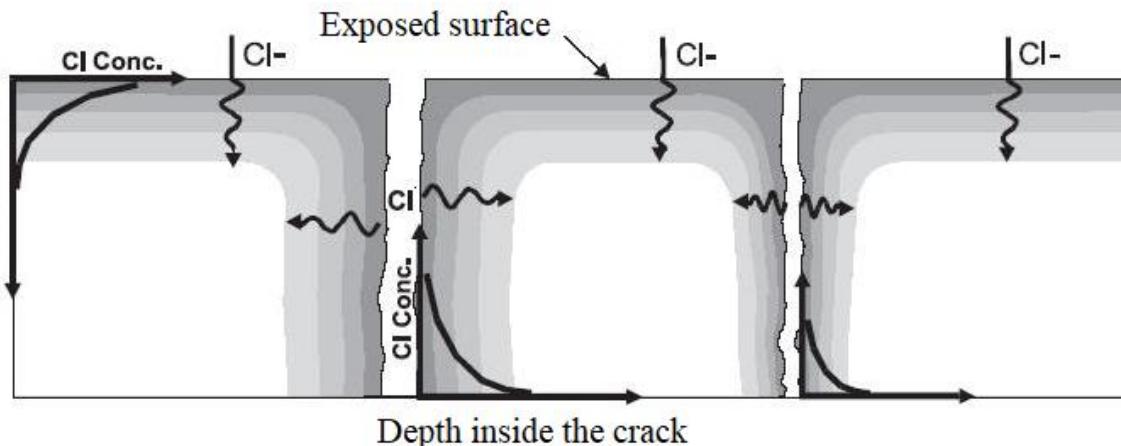
The penetration and diffusion of chloride ions can occur through the crack as shown in Figure 1.

Figure 1. Penetration of chlorides on the surface and between cracks (Ismail et al., 2006).

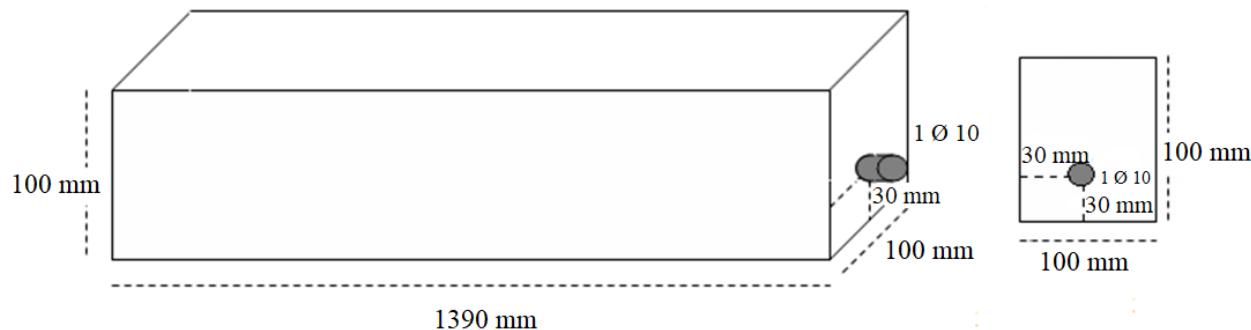
The prismatic specimens were molded two by two. To maintain coverage, 3 spacers of 30 mm were placed along the steel bar. Figure 2 shows the dimensions of the prismatic specimen and the position of the steel bar.

Figure 2. Scheme of dimensions of the prismatic specimens.

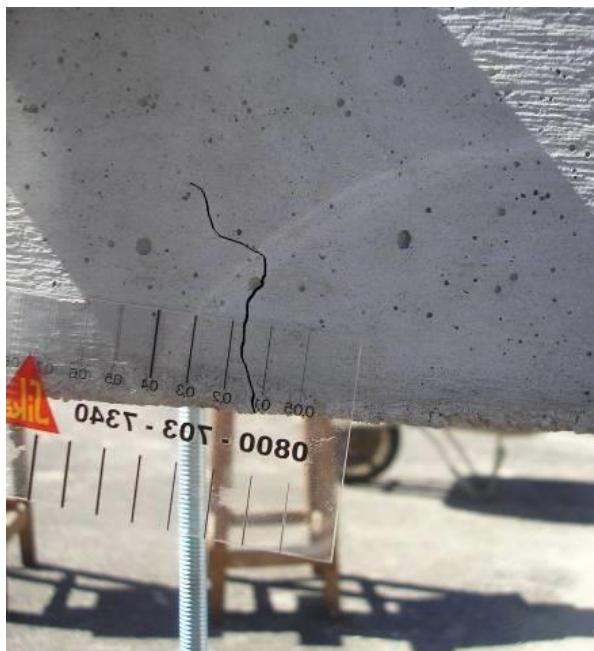
For the maximum crack opening, the limit established by the NBR 6118 standard (ABNT, 2014) for durability, related to cracking and protection of the reinforcement, according to the class of environmental aggressiveness, was adopted as a parameter. Thus, the maximum crack opening in the prismatic specimens, which were under constant loading, was between 0.3 mm and 0.4 mm (Figure 3). The openings of cracks were mapped over time, up to the test date of the specimens.

Figure 3. Measurement of the crack opening in the center of the prismatic specimen with a crack meter.

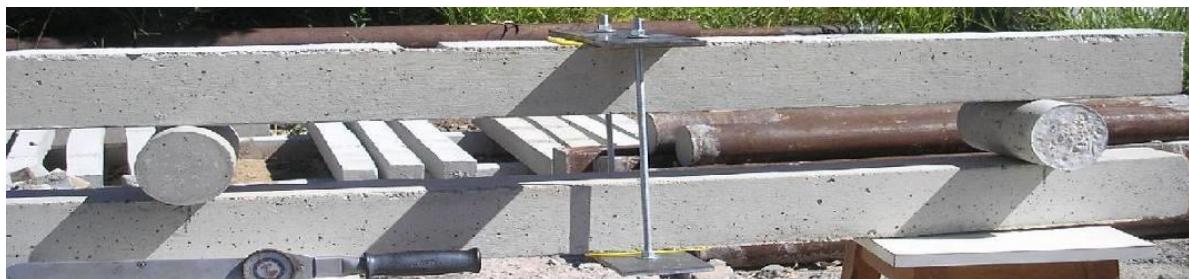
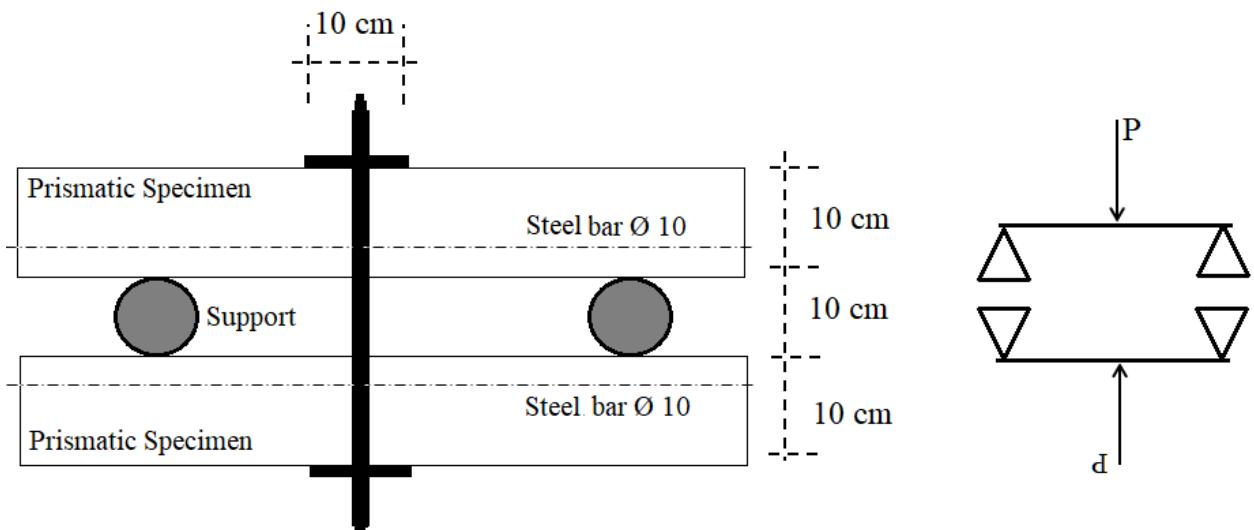
The prismatic specimens were under constant loading until the test dates. The diagram shown in Figure 4 shows the prismatic specimens supported by cylindrical concrete specimens (10 x 20 cm) with a central porch composed of two steel plates and two threaded bars (9.5 mm, 3 nuts, 3 washers and two steel plates of 8 x 300 x 100 mm) applying the load of 250 kgf, causing holes in the center of the beams, with openings of up to 0.3 mm (within the limits of the NBR 6118 standard). The loading was carried out by applying a torque of 0.5 Kgf m, with a torque wrench, to the threaded bars and, consequently, the concentrated force was applied to the prismatic specimen causing the crack.

Figure 4. Permanent central loading (CCP) in the prisms.

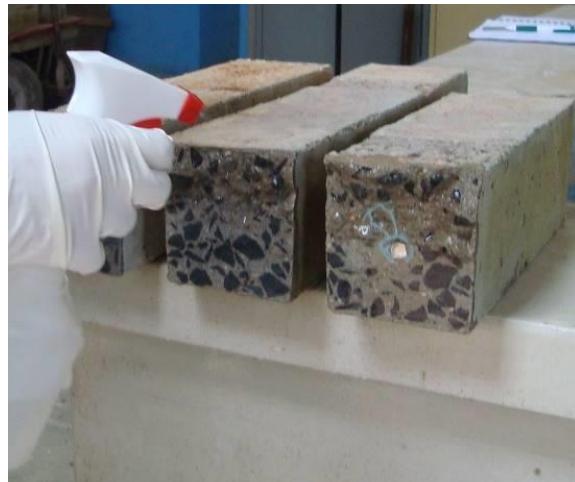
The cut in these prismatic specimens was carried out in the middle thirds, where you can see the compressed and stretched areas of the prismatic specimens.

Figure 5. Chloride penetration tests with silver nitrate spray.

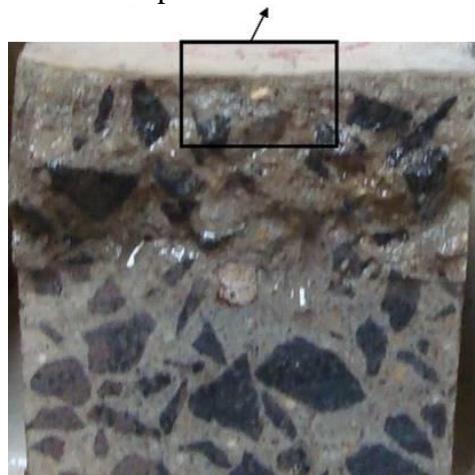
Area where the sample was removed for microstructure tests.

Figure 6. Place where the sample was taken for microstructure tests.

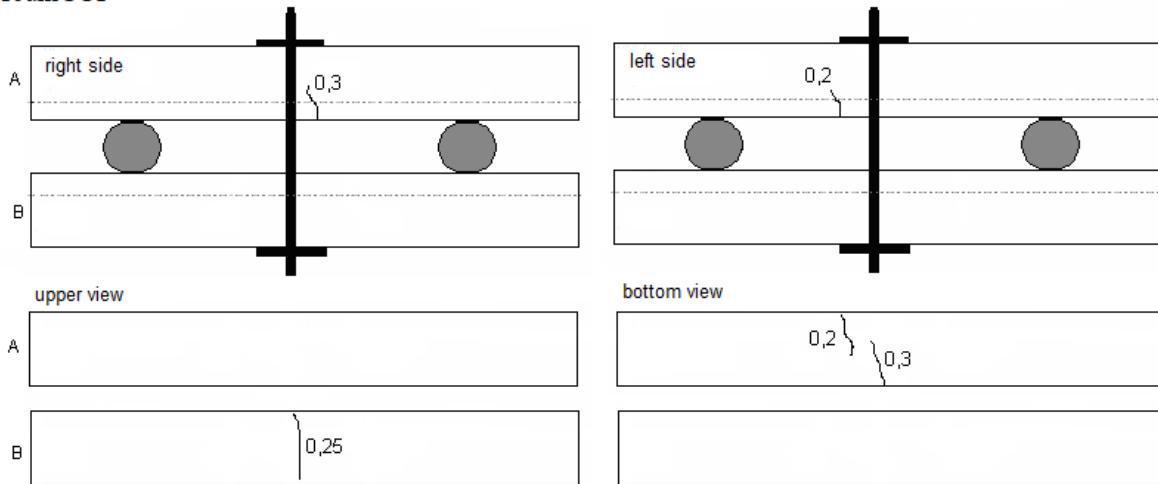
M6umCCP

Figure 7. Mapping of cracks in concretes that have been under permanent central loading for 6 months (M6umCCP).

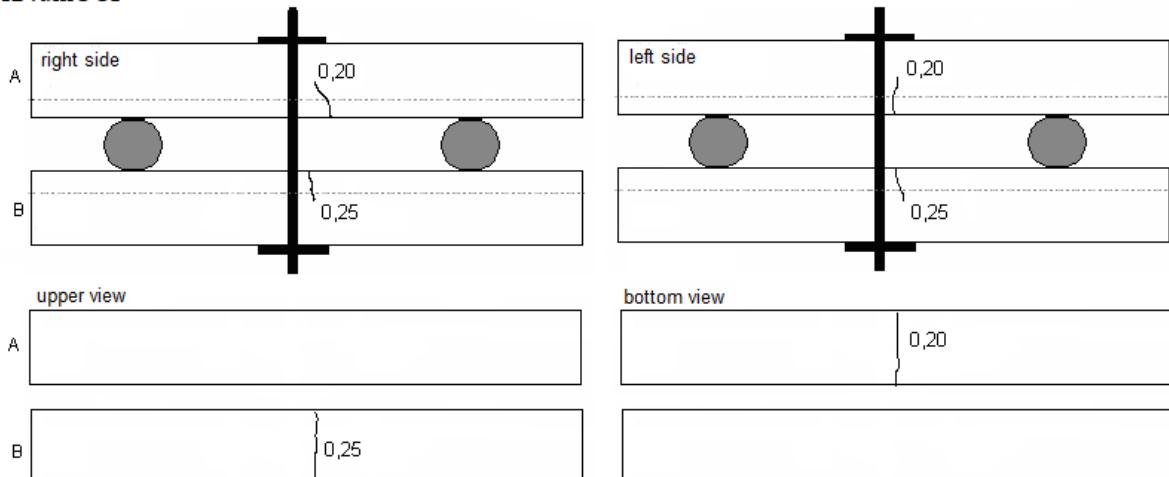
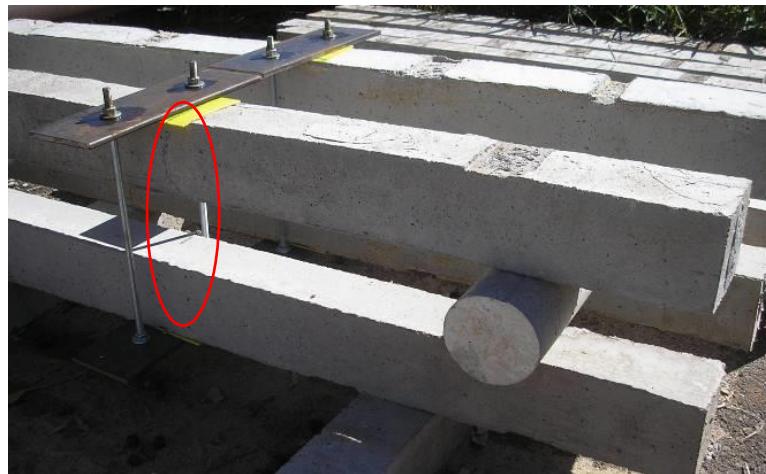
M24umCCP

Figure 8. Mapping of cracks in concretes that have been under permanent central loading for 24 months (M24umCCP).

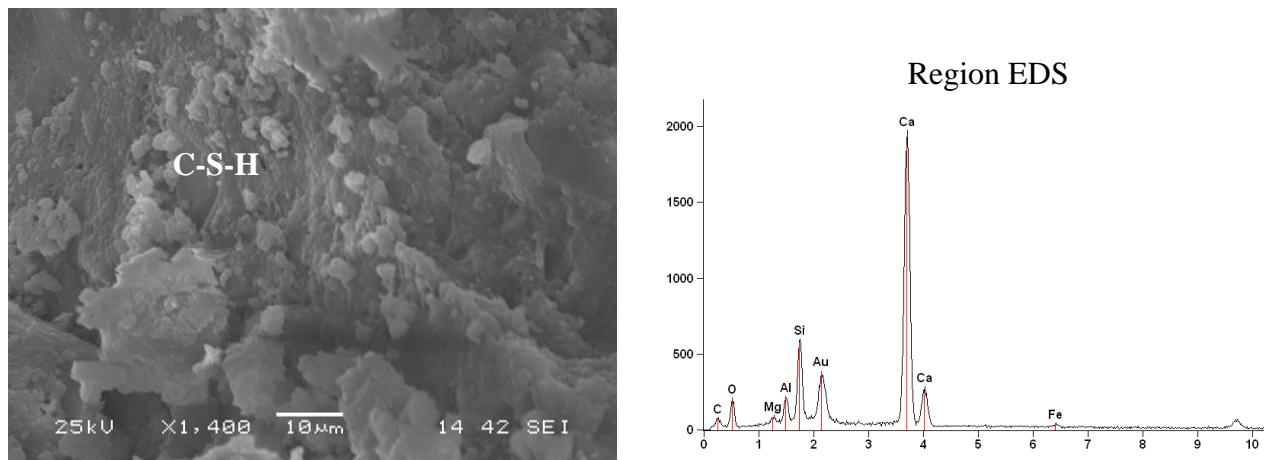
At six months of age, only two types of samples were selected for microstructure tests. These samples were taken from the traction region of the prismatic specimens without loading (SC) and subjected to Permanent Central Loading (CCP). Both were in wet cure for 7 days before undergoing shipments. Figure 9 shows a sample without loading.

Figure 9. Concrete subjected to wet curing, without loading, at six months of age.

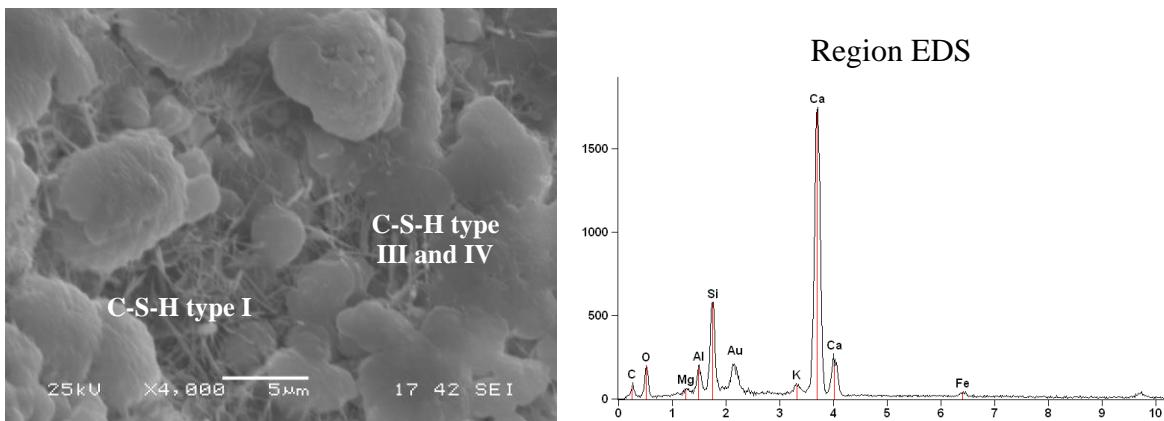
Figure 10 shows the microstructure of the concrete subjected to permanent central loading in wet curing for 7 days, at six months of age; and Figure 11 shows the microanalysis in three points of this same concrete.

Figure 10. Concrete subjected to wet curing for 7 days and permanent central loading, at six months of age.

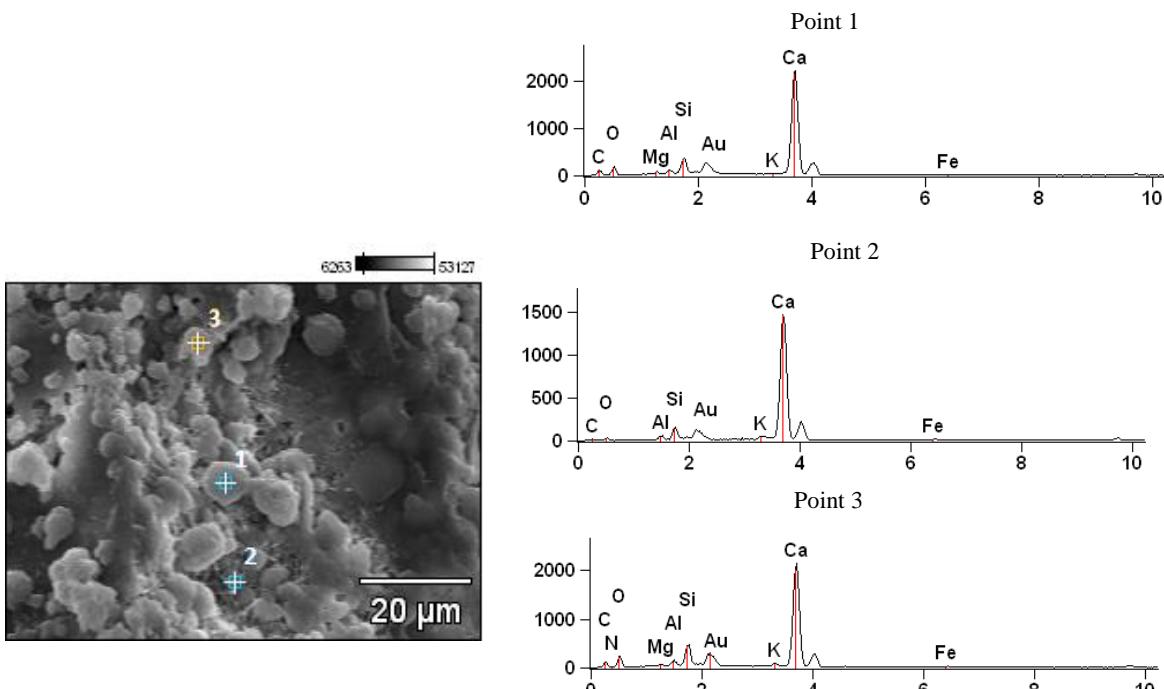
Figure 11 shows three selected points of the concrete subjected to wet curing for 7 days and permanent central loading. In the elementary composition by the EDS of the three points, the same elements Ca, Si, Al and Mg are found.

Figure 11. EDS microanalysis at three points of the concrete under permanent central loading (CCP).

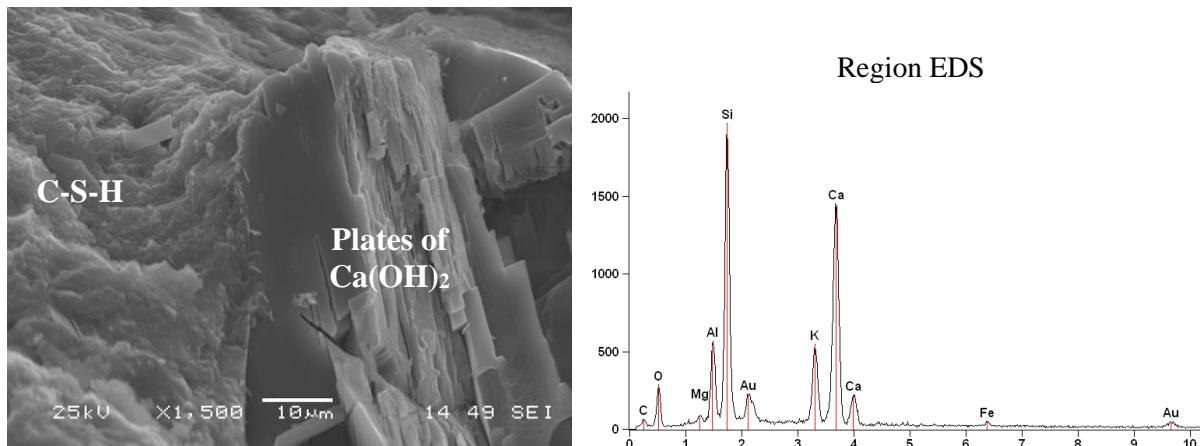
In Figure 12, a micrograph of a sample of unloaded concrete is presented, submitted to moist curing for 7 days, at 24 months of age.

Figure 12. Micrograph and microanalysis of the unloaded concrete sample, at 24 months of age.

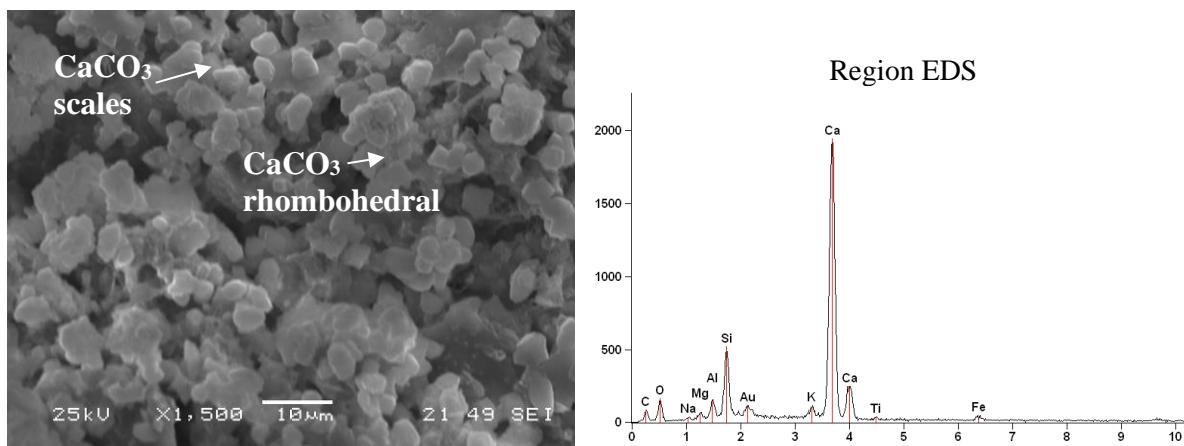
Figure 13 shows the micrographs and EDS of the concrete subjected to short-term central loading, at 24 months of age.

Figure 13. Micrograph and microanalysis of the concrete sample submitted to short-term central loading, at 24 months of age.

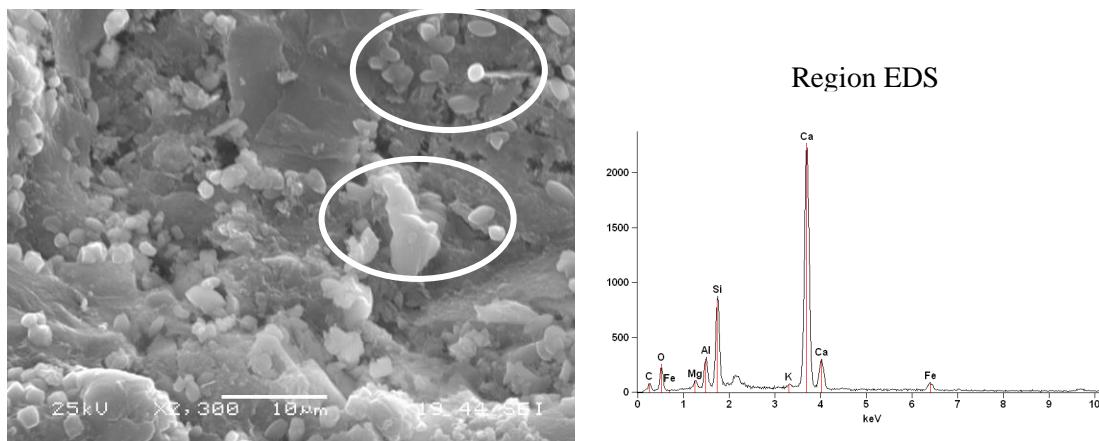
Figure 14 shows the micrograph and microanalysis of the concrete subjected to permanent central loading (CCP), at 24 months of age.

Figure 14. Micrographs and microanalyses of concretes with permanent central loading.

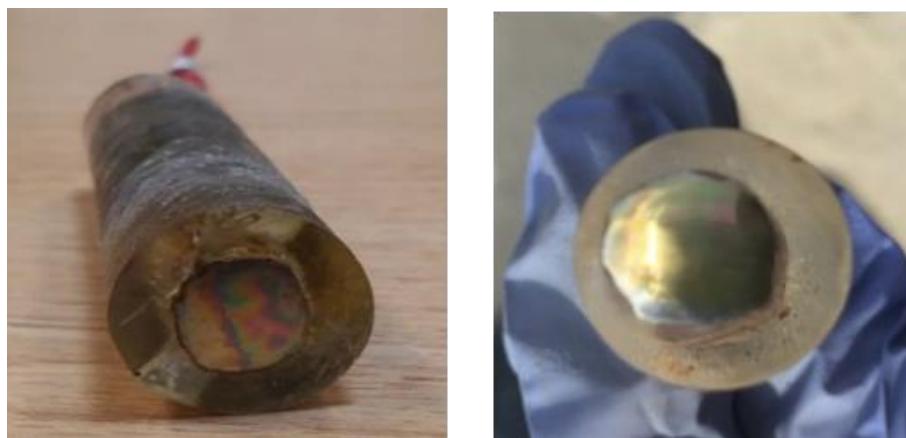
From the coatings obtained of chitosan in the acetic acid solvents of reagent grade, apple vinegar and white vinegar of sugarcane alcohol, the specimens were immersed (dip coating) in the previously synthesized solutions with chitosan. Once the coating is formed, the samples are dried for 15 min. This process was repeated two to four more times until the surface of exposed rod was covered with several layers. With this process, coatings between 2 and 3 μm thick were achieved. The surface of encapsulated coated steel is shown in Figure 1.

Figure 1. Tone observed on the specimen surface with coating.

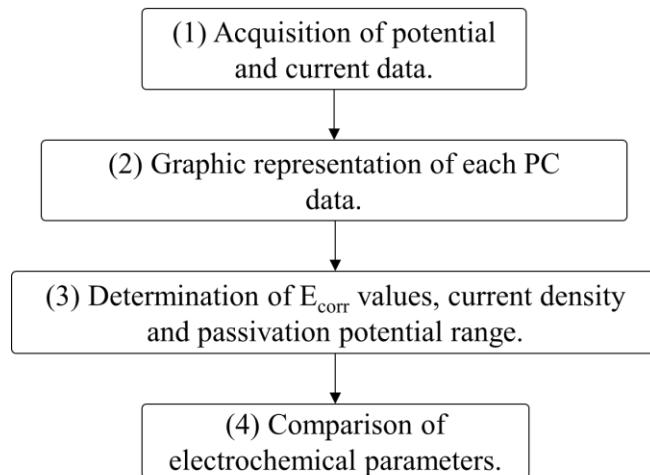
1. Application of the PC technique to obtain potential and current density data, according to the operating parameters established in the study.
2. Graphic representation with Origin Pro software of the data obtained for each PC.
3. Determination of the electrochemical parameters of each PC such as: corrosion potential (E_{corr}), passivation current density, range of passivation potential and pitting potential.
4. Comparison of all the electrochemical parameters to determine the effect of the organic coating, according to the variables measured in the study.

Figure 3. Block diagram for the data analysis obtained by the PC technique.

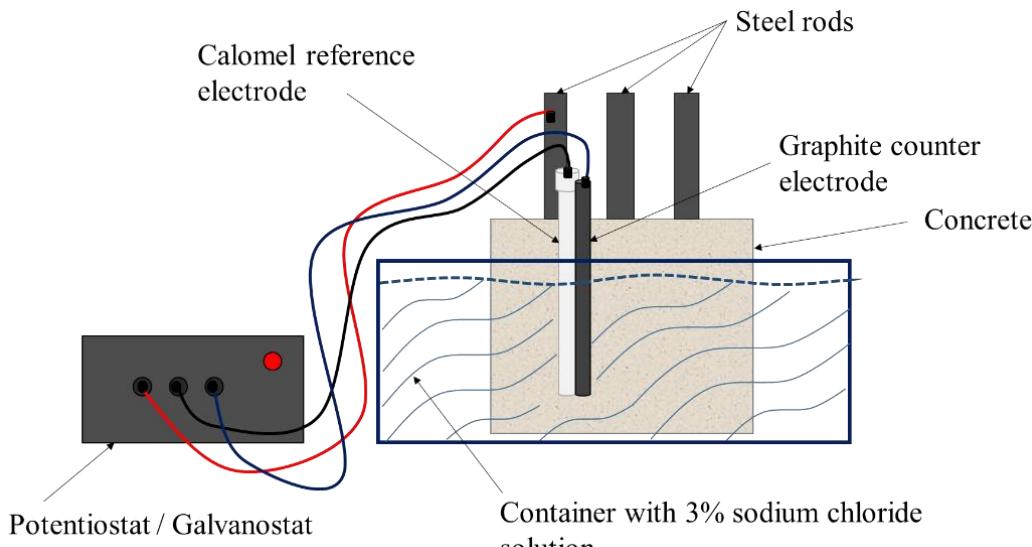
The LPR technique has been used in recent decades as a powerful tool for the analysis of CRS corrosion (Feliu et. al., 1989; Papavinasam, 2008; Zhou et. al., 2018). For the LRP measurement, an arrangement of three electrodes was used: a graphite counter electrode, the SCE as a reference electrode and the steel rods as working electrodes; with one measurement per sample according to the established test days. Both electrodes were placed as close as possible to the working electrode, next to the concrete block and inside the 3% NaCl solution, as shown in Figure 4. The LPR technique was measured according to the standard (ASTM G59, 2014), with operating parameters of ± 20 mV with respect to the E_{corr} , at a scanning rate of 10 mV/min and it was plotted as a function of time. The measurement equipment used was a Potentiostat/Galvanostat/ZRA, Gamry Instruments, interface 1000, Gamry framework software. The polarization resistance (R_p) was determined as the slope of the PC around the E_{corr} (Andrade and Alonso, 1996; Díaz Blanco et. al., 2019). Table 5 shows the intervals of current density (I_{corr}) and corrosion rate (CR), as well as the condition of steel bars according to the advance degree of corrosion (Andrade and Martínez, 2010).

Figure 4. Representation of an electrochemical cell for the LPR measurement.

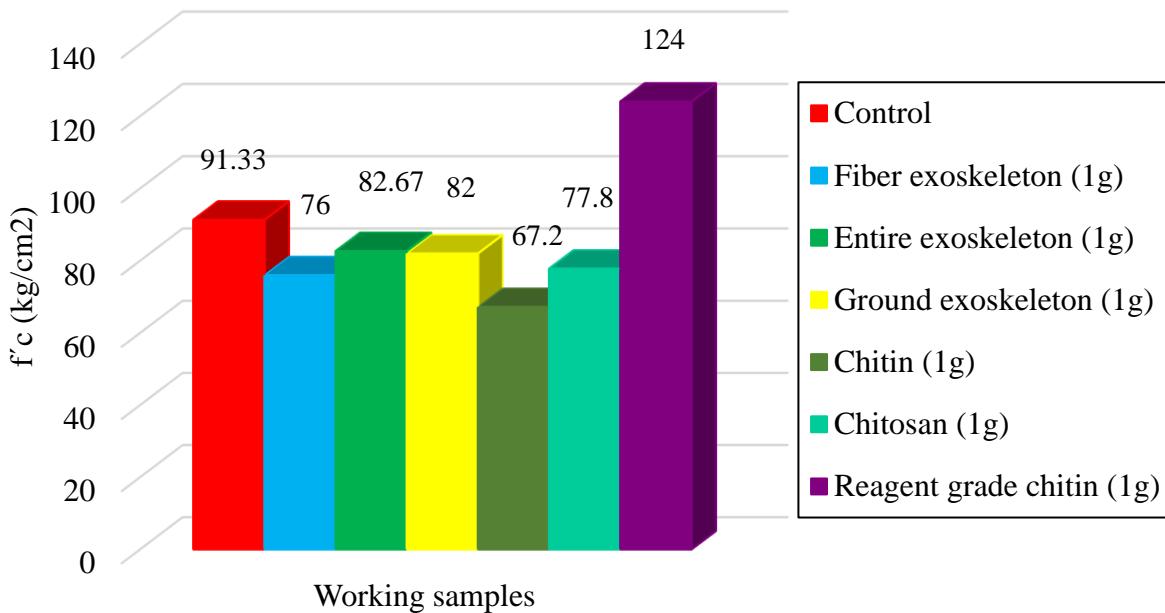
Figure 6 shows the results of the compressive strength test for the specimens with different proposed aggregates, with the aim of observing if there were improvements in the mechanical properties of mortar (Aydin and Saribiyik, 2010).

Figure 6. Compressive strength tests of the mortar specimens with different aggregates at 28 days of curing.

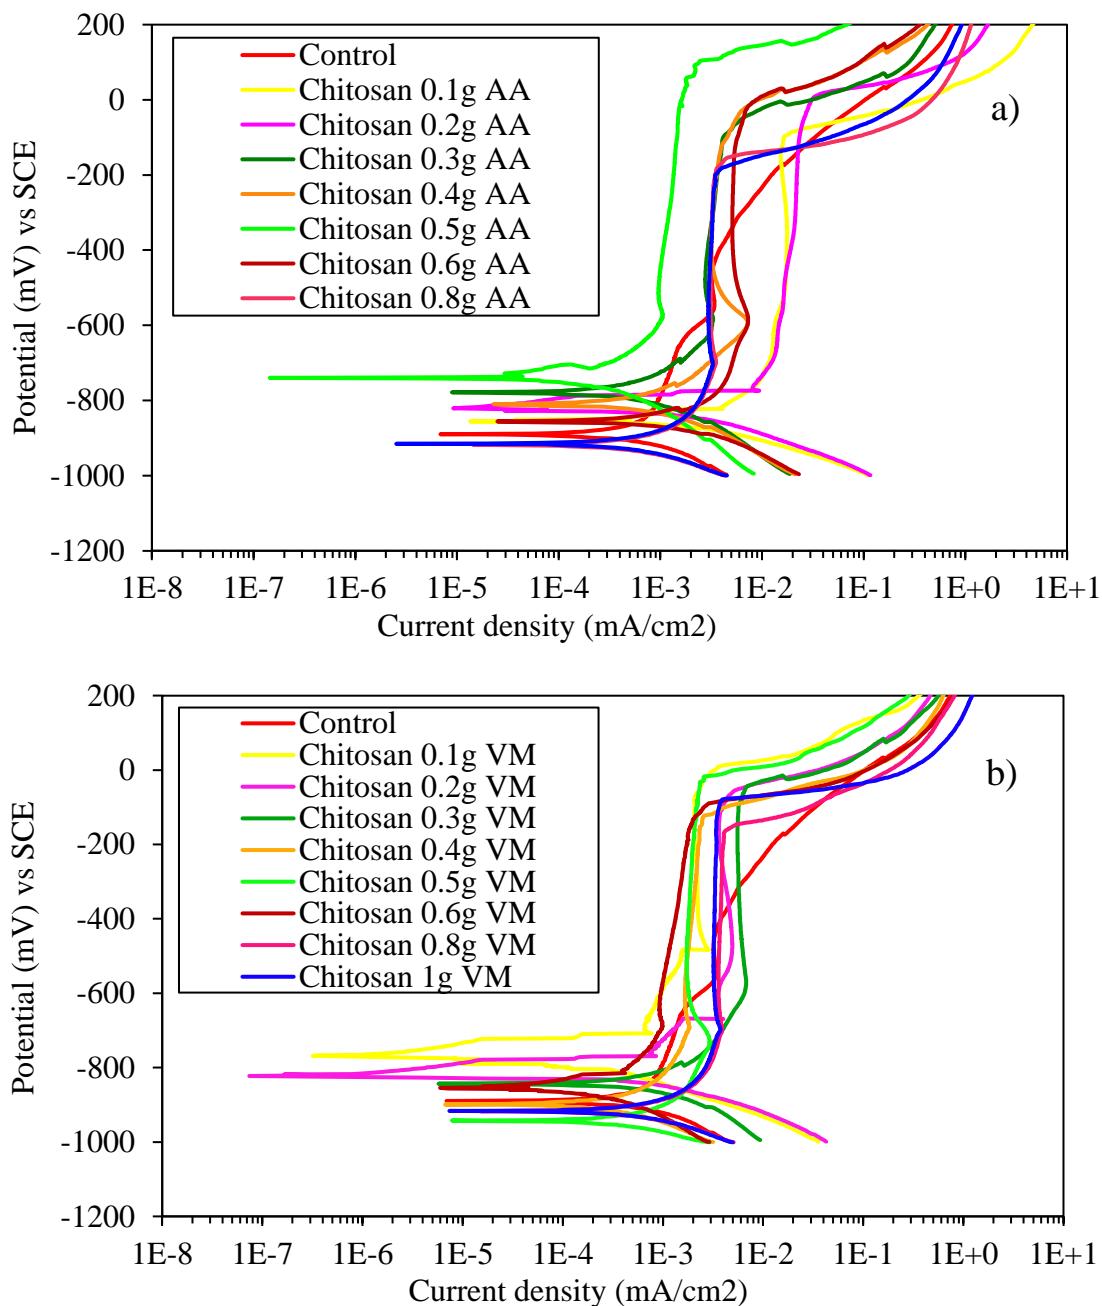
Figure 7 shows the PC graphs for the encapsulated samples coated with different amounts of chitosan dissolved in acetic acid and apple vinegar, and immersed in a solution of calcium hydroxide with calcium chloride. Both graphs present a similar behavior, more noble E_{corr} values are observed for the samples coated with low amounts of chitosan. On the contrary, E_{corr} becomes more active for the control sample and the samples coated with the highest amount of dissolved chitosan, except for the sample with the 0.5 g coating in acetic acid that presents a more noble corrosion potential.

Figure 7. Polarization curves of samples coated with chitosan dissolved in a) acetic acid and b) apple vinegar, exposed to a solution of calcium hydroxide with calcium chloride.

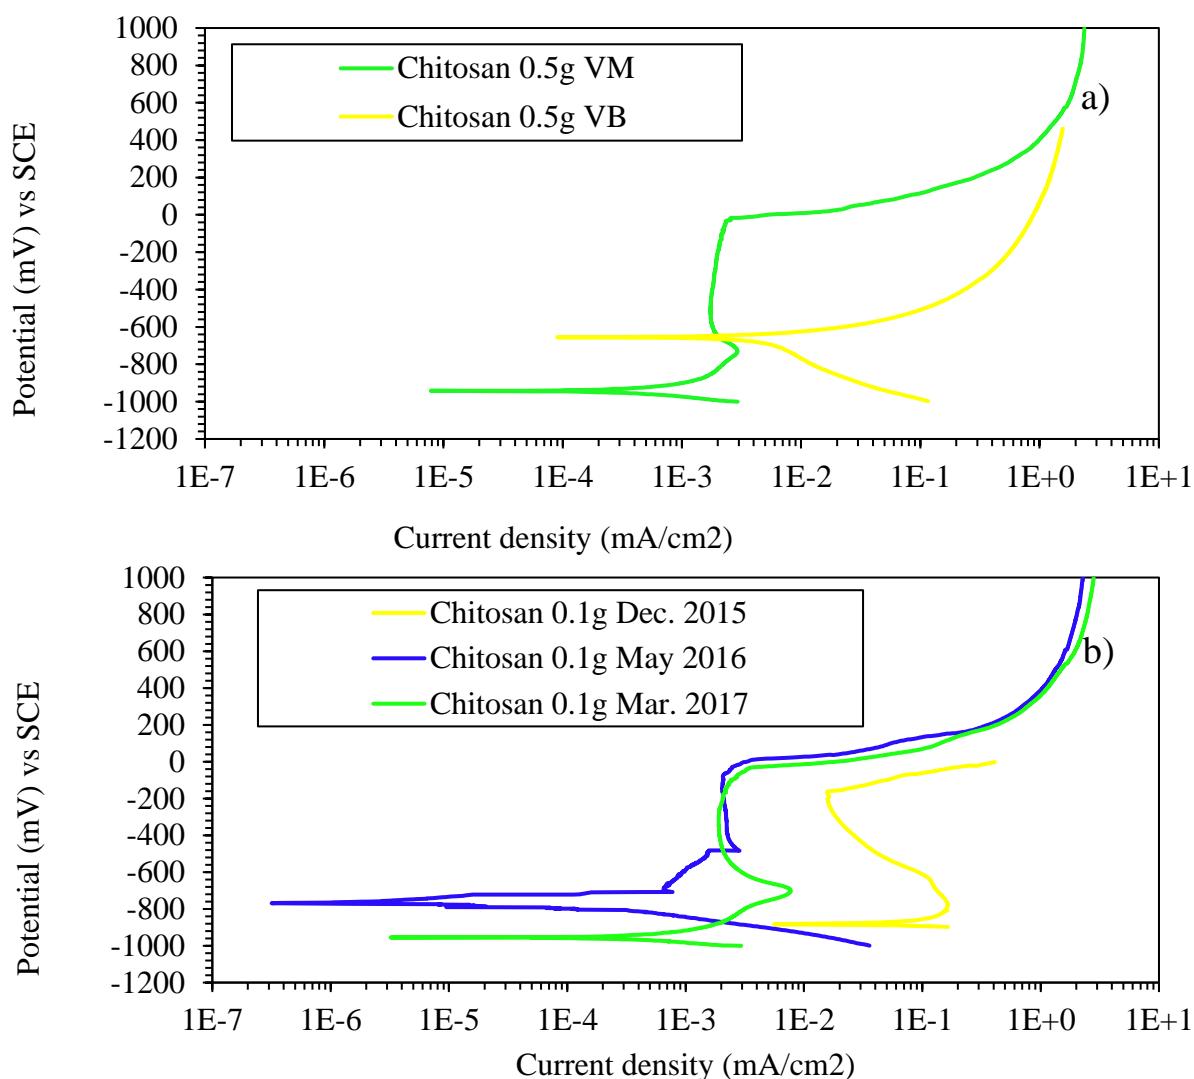
Being chitosan an organic biopolymer, a degradation of the compound as a function of time would be expected. In this sense, a concentration of 0.1 g of chitosan dissolved in apple vinegar was prepared and stored in a closed container for 17 months. The effect of the storage time and subsequent application on the metal surface was observed through the PC technique, as represented in Figure 8b.

Figure 8. Polarization curves of samples with a) chitosan coating dissolved in white vinegar of cane alcohol and apple vinegar and b) chitosan coating stored and dissolved in apple vinegar; exposed to the simulated solution.

As can be seen, after 5 months of storage the chitosan coating improved its performance considerably. The passivation current decreased from the first application by more than three orders of magnitude. After 17 months of storage, the passivation potential range was wider between -1000 and 50 mV and the passivation current was two orders of magnitude lower with respect to the first application. The preservation for a long time, the favorable adhesion properties, the possible interactions of chemisorption and physisorption chitosan on the metal surface, and the availability of N and O heteroatoms of the coating are some of the characteristics that directly affect its anticorrosive behavior (Ashassi-Sorkhabi and Kazempour, 2020).

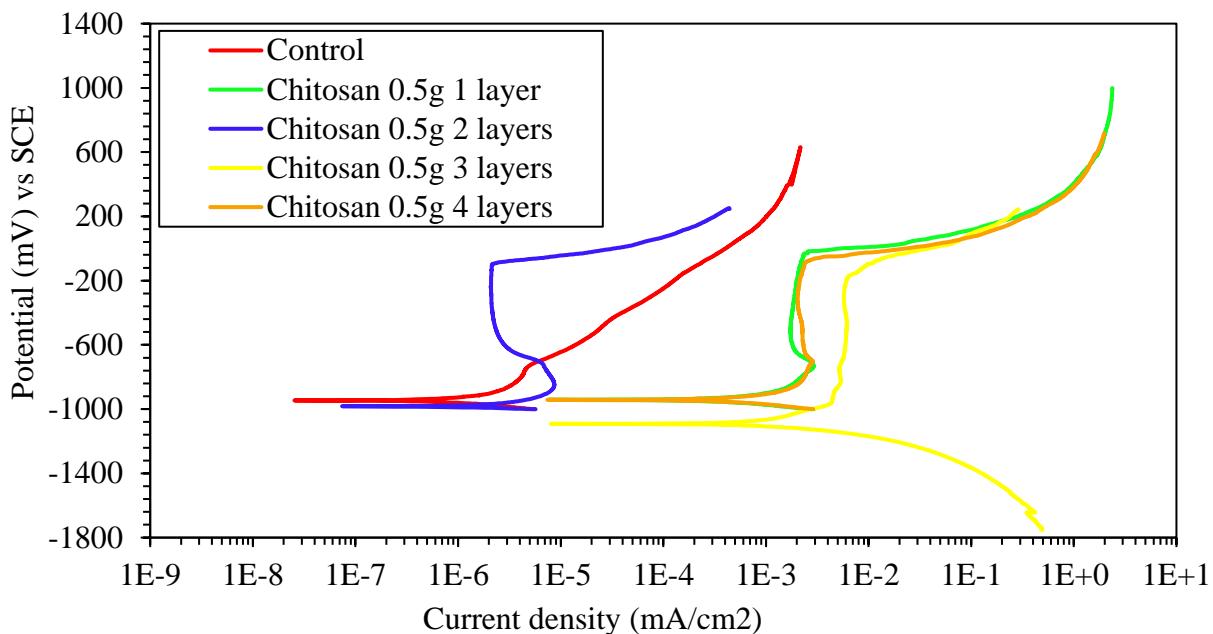
Figure 9. Polarization curves of samples with different layers (dip coating) of chitosan coating in apple vinegar, in solution of calcium hydroxide with calcium chloride.

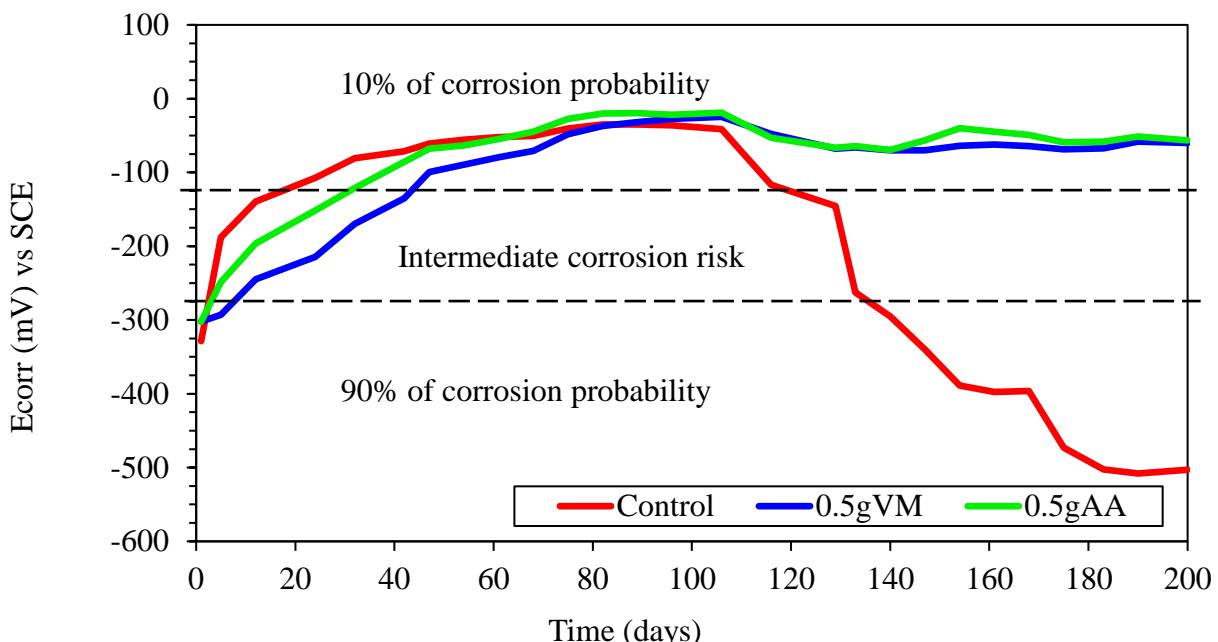
Figure 10 shows the results of the E_{corr} variation as a function of time for the SR embedded in the concrete coated with 0.5 g of chitosan, dissolved in apple vinegar (0.5 g VM) and in acetic acid (0.5 g AA).

Figure 10. Variation of E_{corr} over time for coated and uncoated steel embedded in concrete and exposed to a 3% NaCl solution.

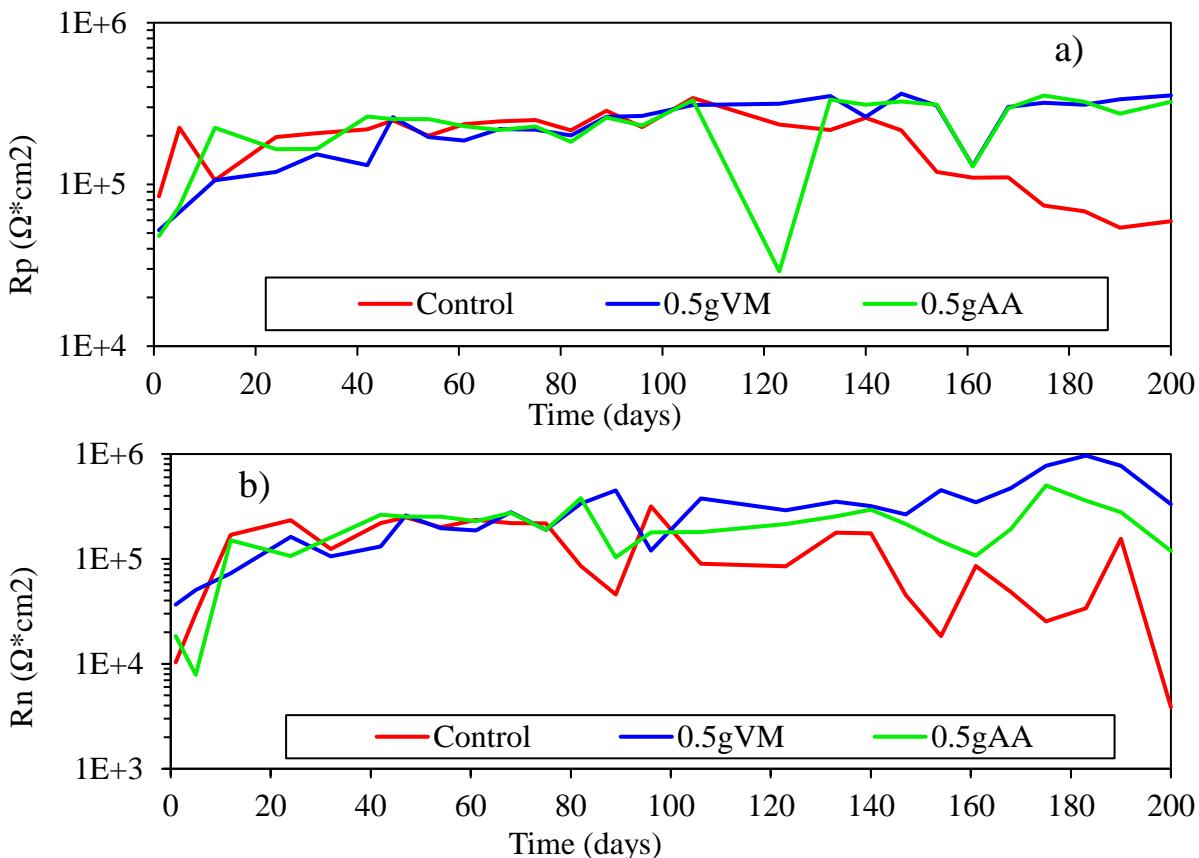
In Figure 11a and 11b the R_p and R_n values are presented for the concrete samples with steel coated with chitosan, dissolved in apple vinegar and acetic acid.

Figure 11. Variation of a) R_p and b) R_n for the reinforcing steel with and without coating embedded in the concrete, in 3% NaCl solution.

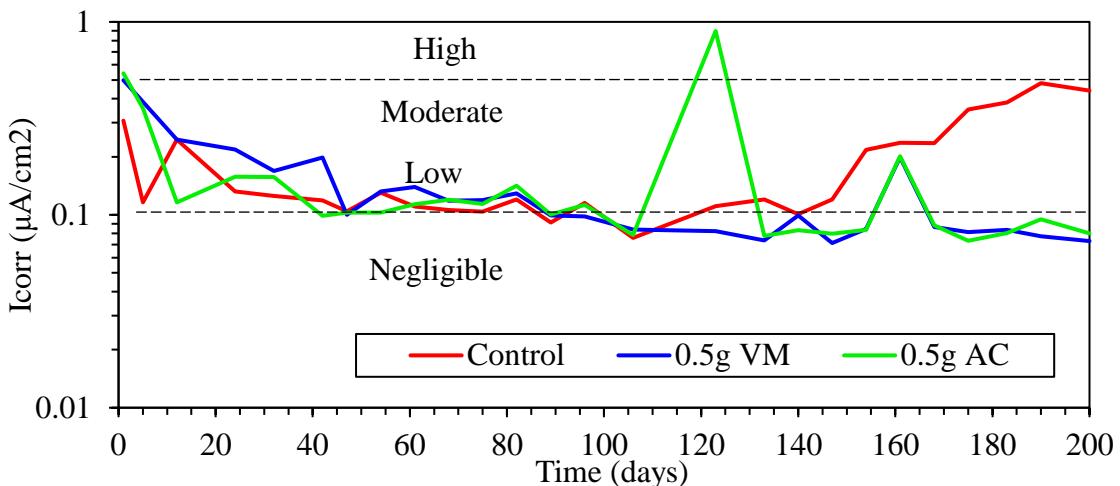
From R_p data, the corrosion rate was determined in terms of the I_{corr} using the Stern and Geary equation (Stern and Geary, 1957; Zhou et. al., 2018), as shown in Figure 12. Results at the beginning show, a high level of corrosion for the control sample, located in the moderate to high corrosion zone. The concrete samples that have coated rods are in the low to negligible corrosion zone according to the criteria established in the literature (Andrade and Martínez, 2010), which indicates that the coating with both solvents is effective as protection against chloride-induced corrosion.

Figure 12. Graph of I_{corr} (corrosion rate) of concrete for RS with and without coating, in 3% NaCl solution.

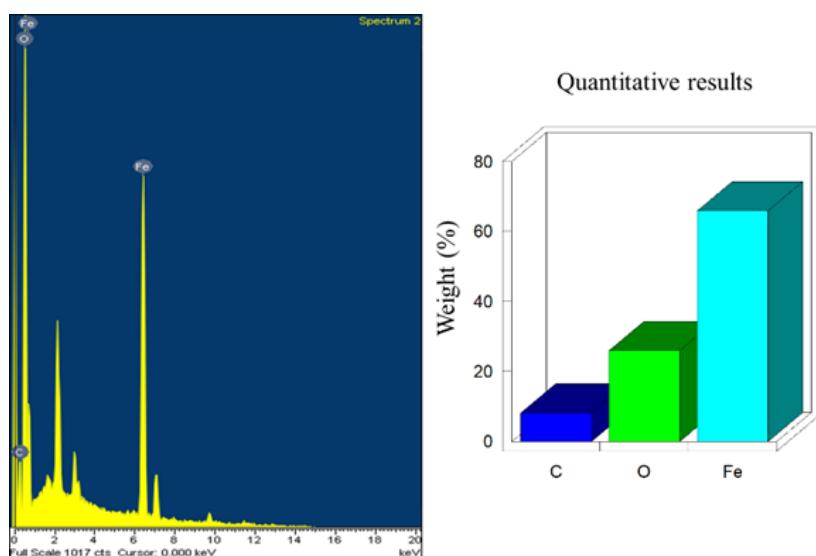
Figure 14. SEM elemental chemical analysis of the 0.5 g of chitosan coating with apple vinegar solvent.
