Latin American Journal of Quality Control, Pathology and Construction Recovery

Volume 11

May – August 2021

Issue 2

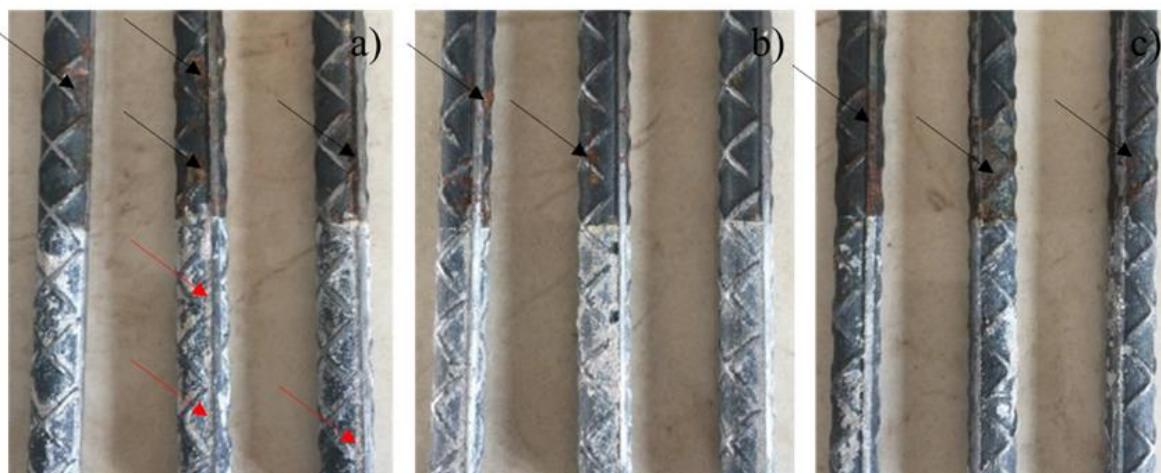
The lower part represents the zone that was embedded in the concrete and the rods from the control sample present some corrosion products of tenuous orange, associated with the action of the aggressive medium (red arrows) which speaks of the good protection that concrete has alone. In the rods with chitosan coating, no rust products are observed, evidencing the good electrochemical behavior of the organic coating. Finally, in the upper part of the steel bars there are corrosion products caused by the action of the atmosphere, being very similar in all (black arrows).

Figure 15. Physical state of the rods embedded in concrete partially submerged for 200 days in a 3% NaCl solution for a) control sample, b) steel coated with 0.5g VM and c) steel coated with 0.5g AA.

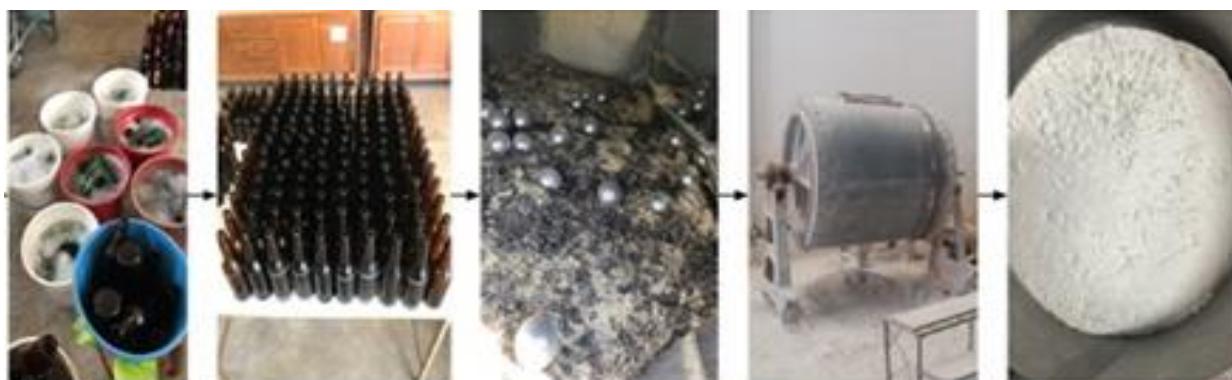
Figure 1. Recycled glass powder processing.

Portland cement type CPV-ARI, silica fume and glass powder were used as binders. Glass powder with particles size smaller than 75 µm was used. Glasses classified as soda-lime were processed from post-consumption amber bottles to minimize uncontrolled variations due to pigments. After collecting, the glass bottles were washed in water with detergent to remove labels, caps, glue, and impurities. It was air dried and crushed in a concrete mixer loaded with chrome-steel spheres. After grinding, the crushed glass was grounded in a ball mill, with balls of the same material. The glass resulting from grinding in ball mill was dried in an oven at 110°C ± 5°C for 24 hours. After dried,

the glass was sifted in a mechanical sieve shaker in batches of 200g for 15 minutes. Figure 1 presents the glass powder processing.

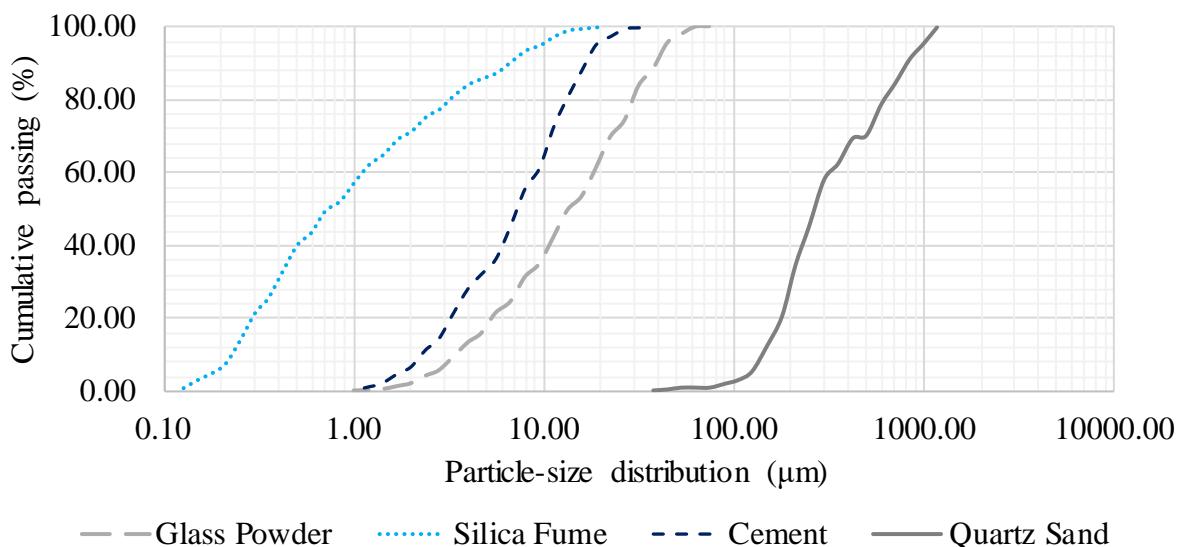
Figure 2. Particle-size distribution.

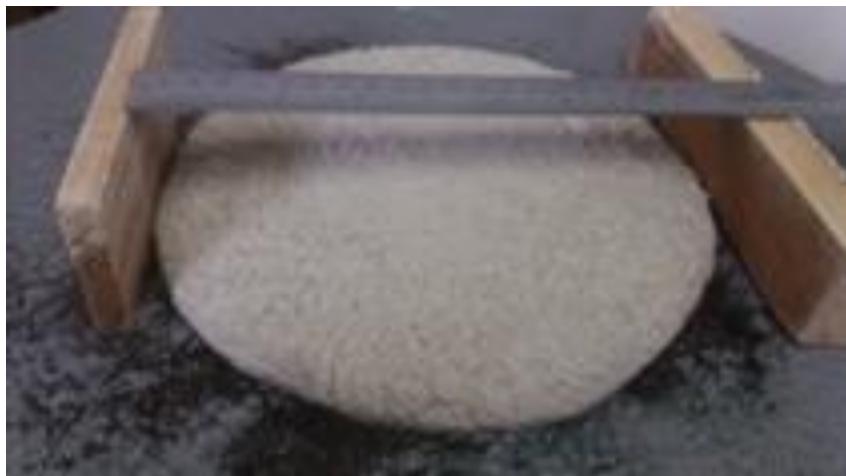
Figure 3. Slump flow test for consistency determination.

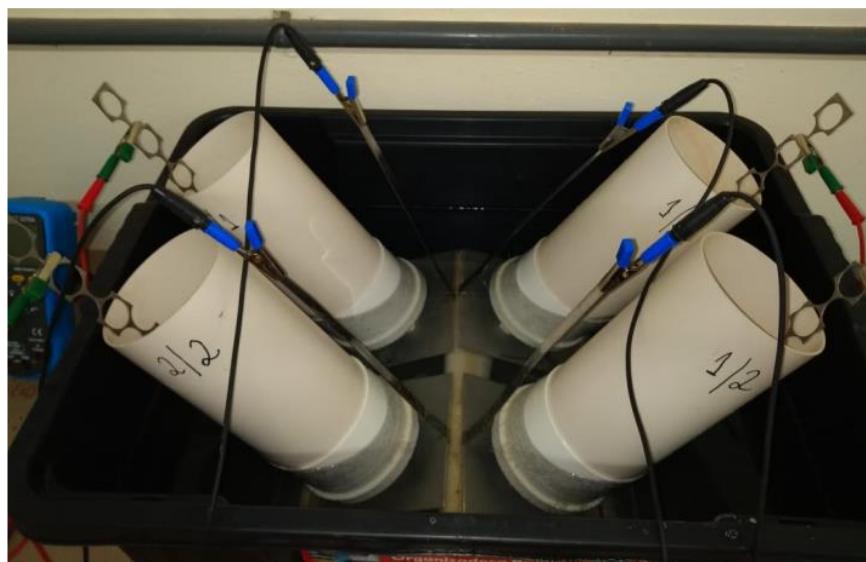
The chloride diffusion test device is shown in Figure 4.

Figure 4. Chloride diffusion test apparatus.

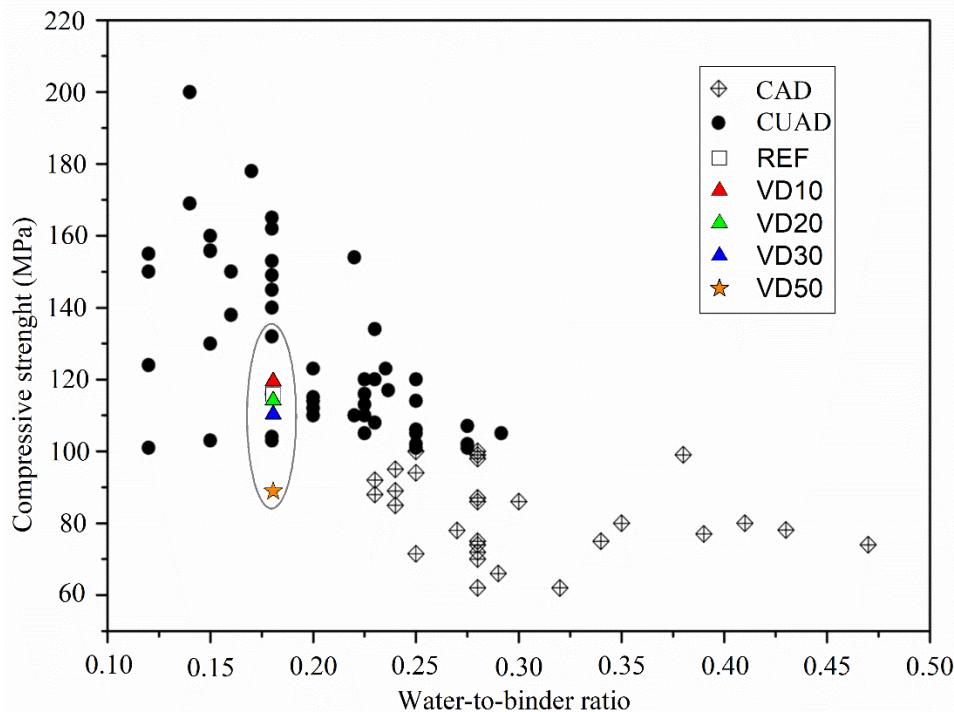
Figure 5. Effect of water-to-binder ratio on compressive strength of HPC and UHPC
Fonte: Adapted from Sohail et al. (2018).

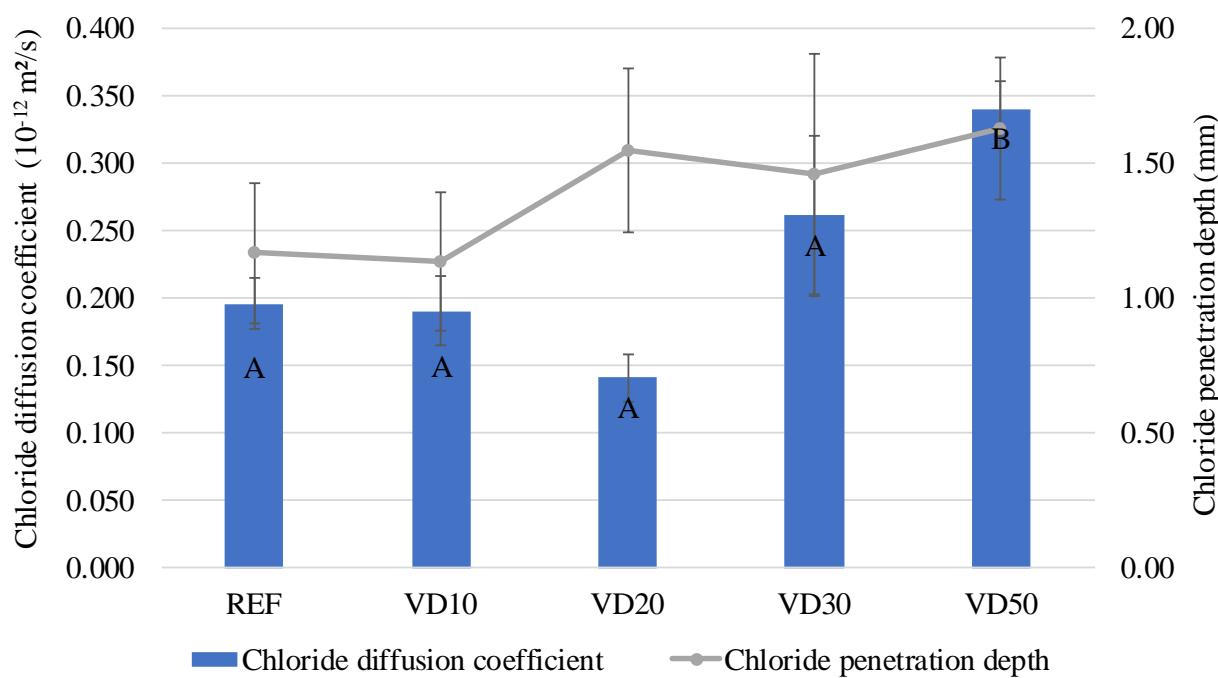
Figure 6. Chloride diffusion coefficient and penetration depth.

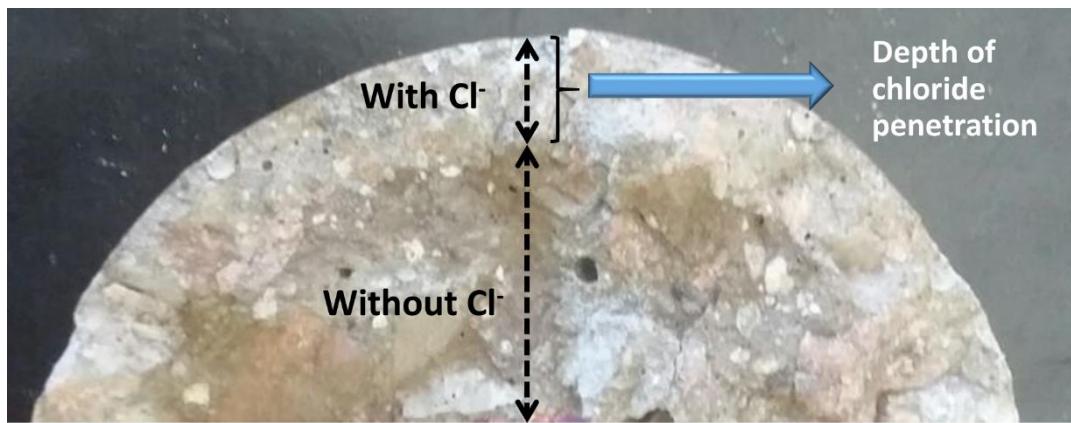
Figure 1. Chloride penetration depth measurement by visual colorimetric method by spraying an aqueous solution of 0.1 M AgNO₃.

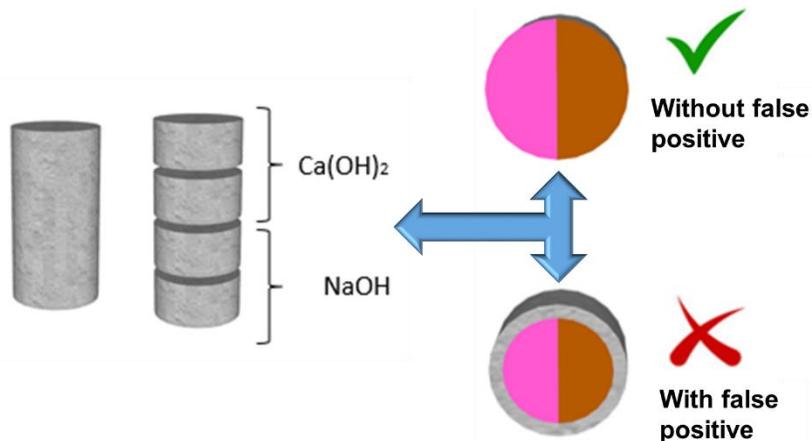
Figure 2. Schematic of the experiment to eliminate the false positive result caused by carbonation.

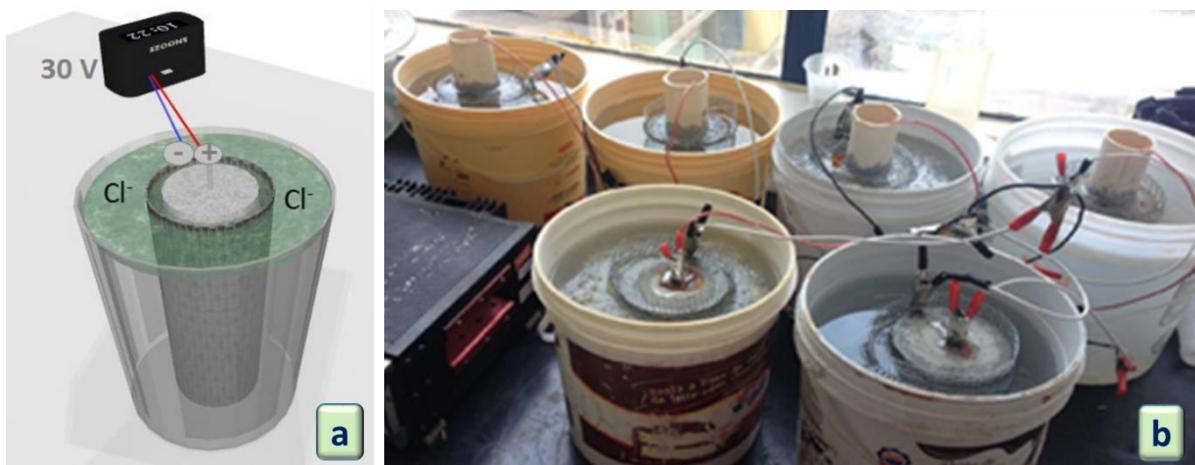
Figure 3. Schematic of the chloride migration test: (a) schematic of the electrical connection; (b) photo of the assembled experiment.

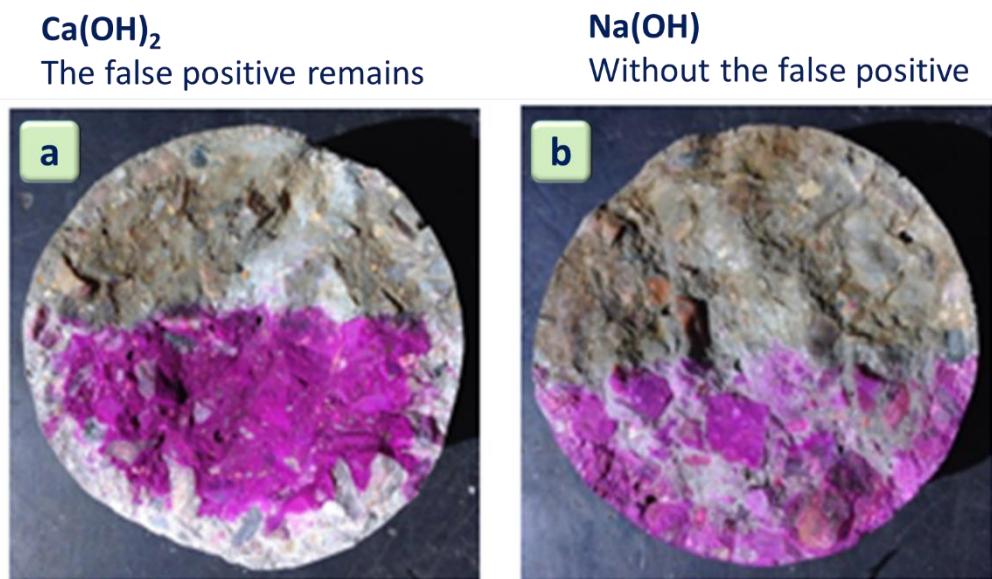
Figure 5. Carbonated specimens with (a) previous spraying of $\text{Ca}(\text{OH})_2$ solution (b) previous spraying of NaOH solution.

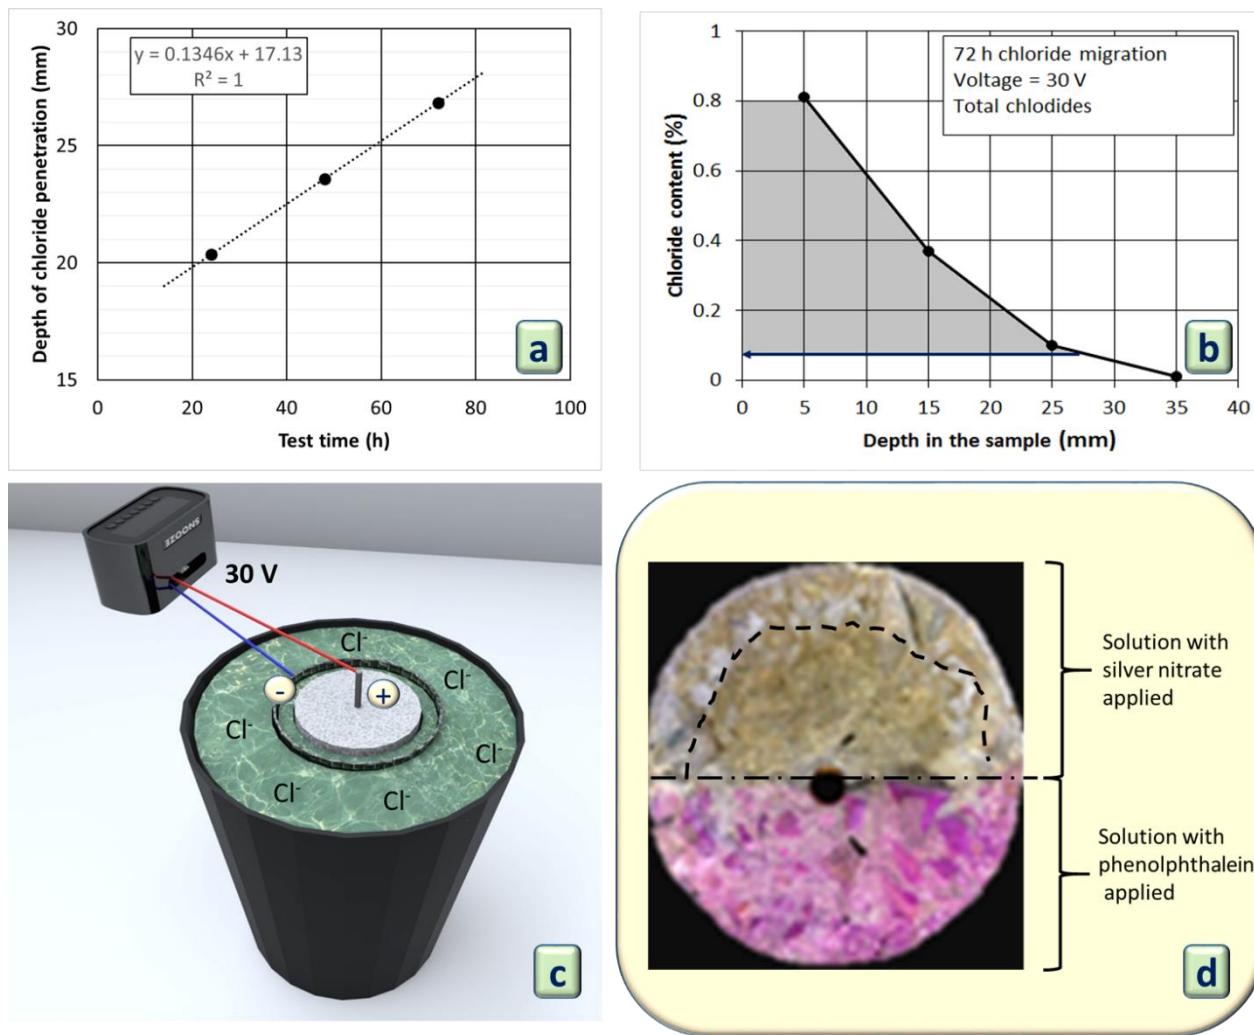
Figure 6. Results in the specimens of carbonated concrete and concrete contaminated with chlorides: (a) Depth of penetration of chlorides with the colorimetric method; (b) Chloride profile to verify the effectiveness of the colorimetric method; (c) Illustration of the acceleration of the entry of chlorides by migration; (d) Carbonated specimens with chloride penetration - pretreatment with NaOH solution and subsequent application of AgNO_3 solution.

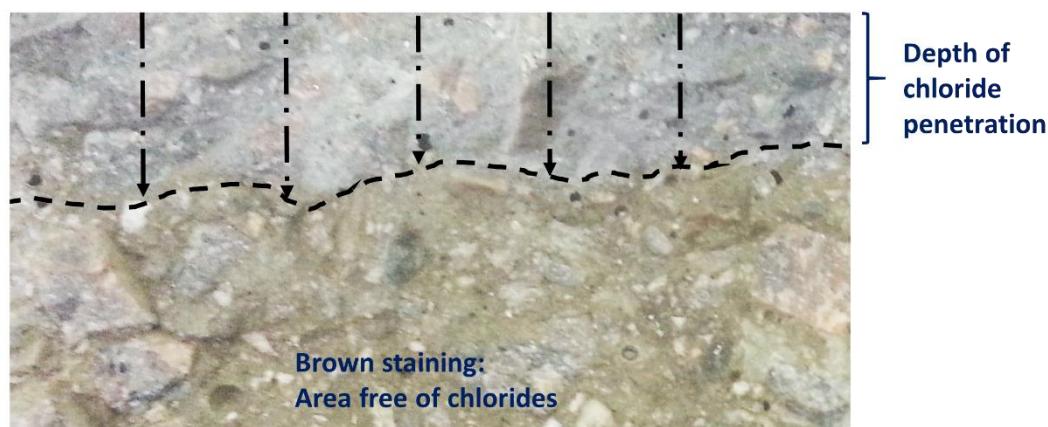
Figure 7. Illustration of the contrast obtained with the application of the colorimetric method to determine the depth of penetration of chlorides, using a spray of a solution of NaOH and one of AgNO₃.

Step 2 - Spray a solution of silver nitrate twice in succession (5 minutes interval between each time) at a concentration of 0.10 mol/L. Wait about an hour for the surface to dry and the reactions to occur, generating the color contrast. As illustrated in Figure 7, the brown color corresponds to the region without chlorides, and the other without color change corresponds to the region affected by chlorides;

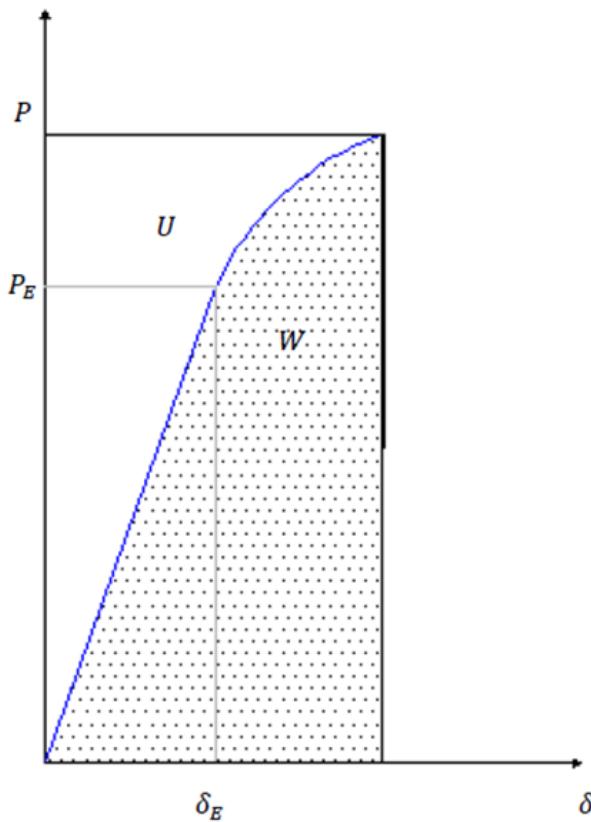
Figure 1. Load displacement relationship

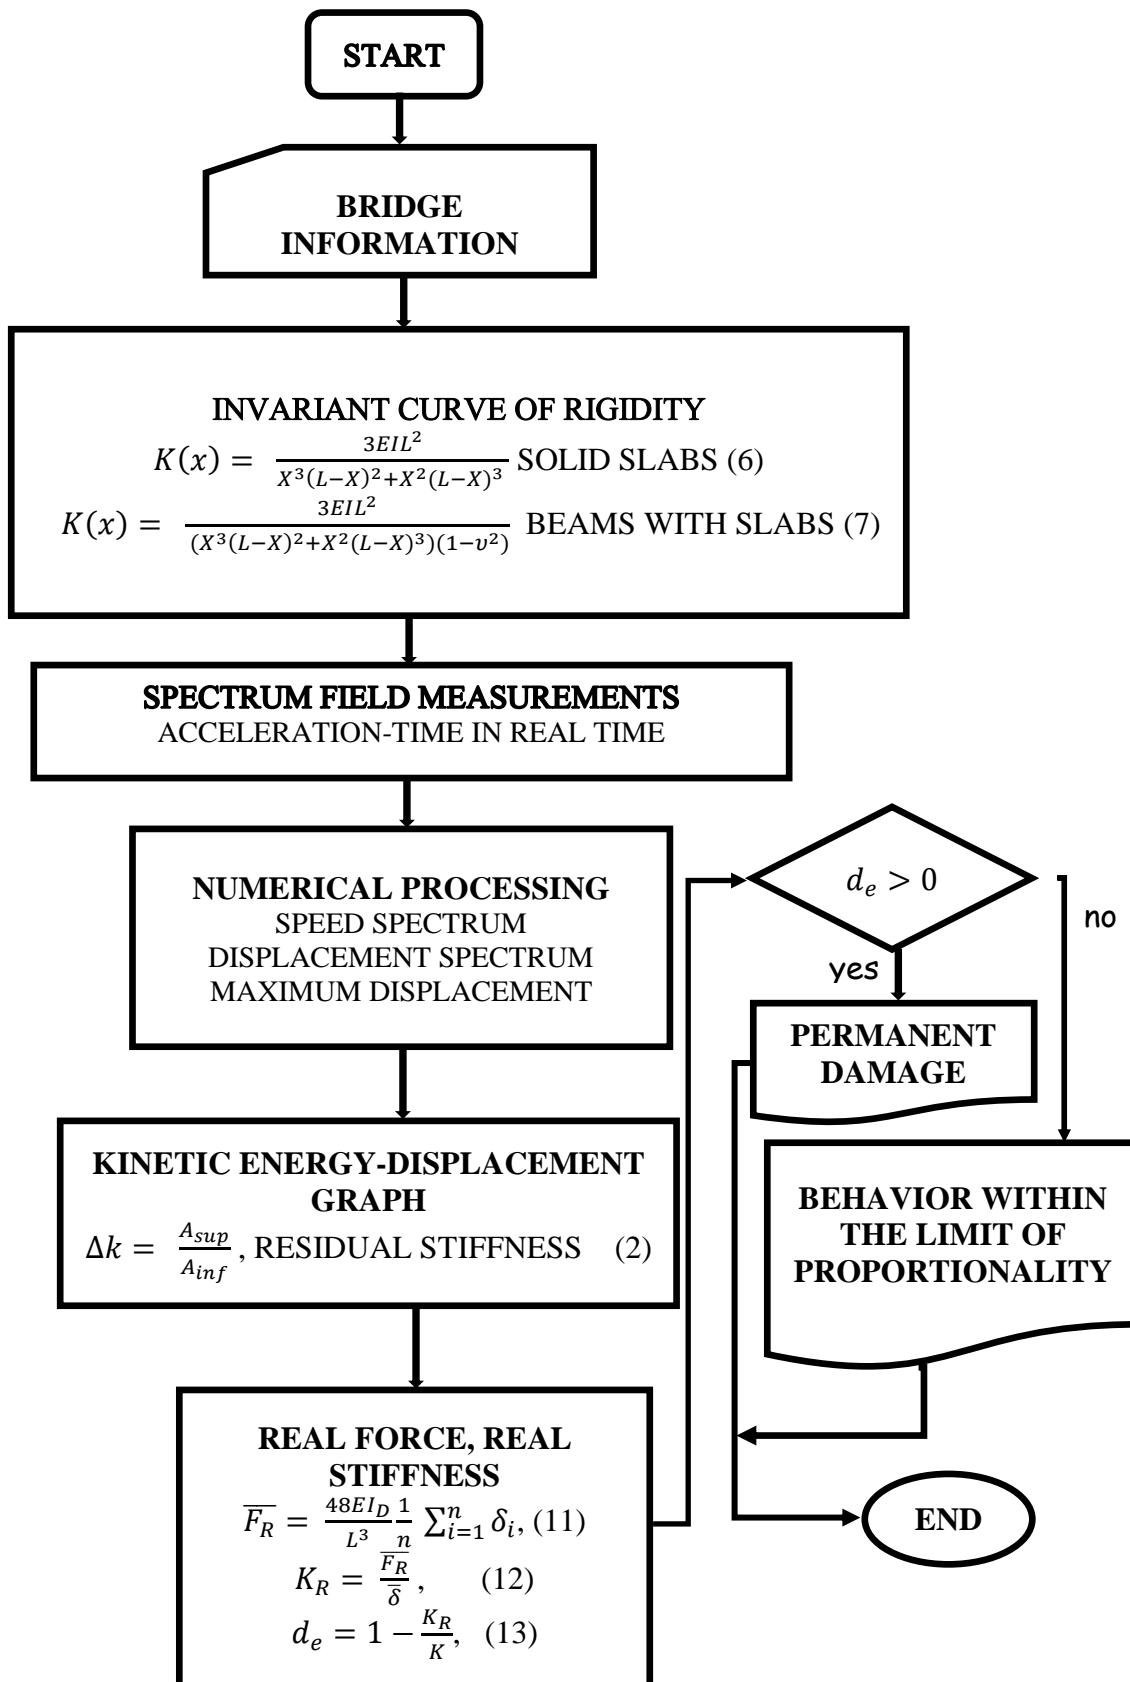
Figura 3. Flow diagram, Stiffness invariant method.

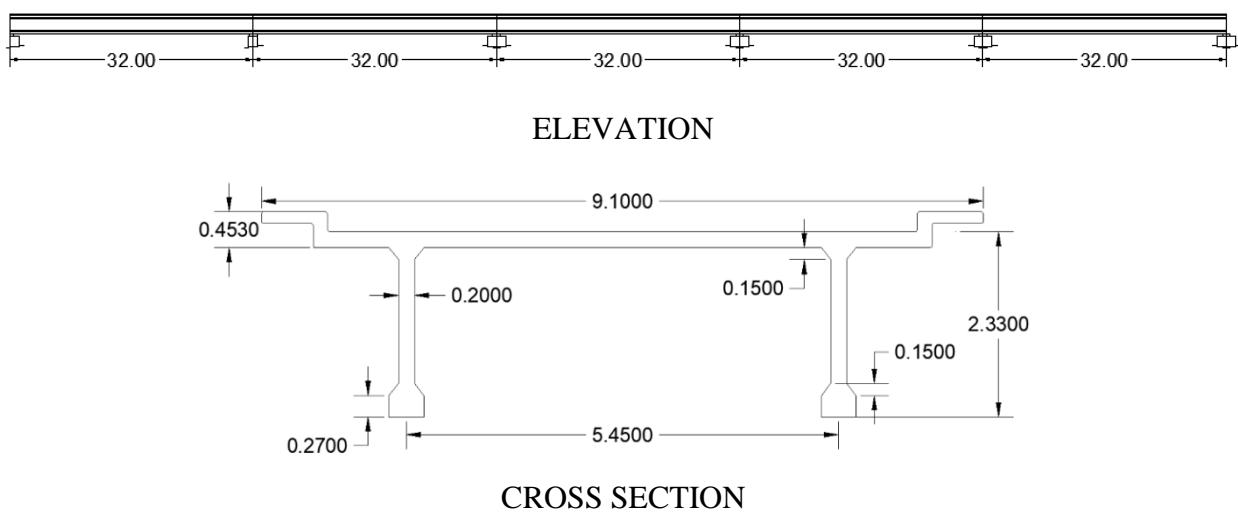
Figure 5. "El Gavilán" bridge superstructure geometry (Dimension m).

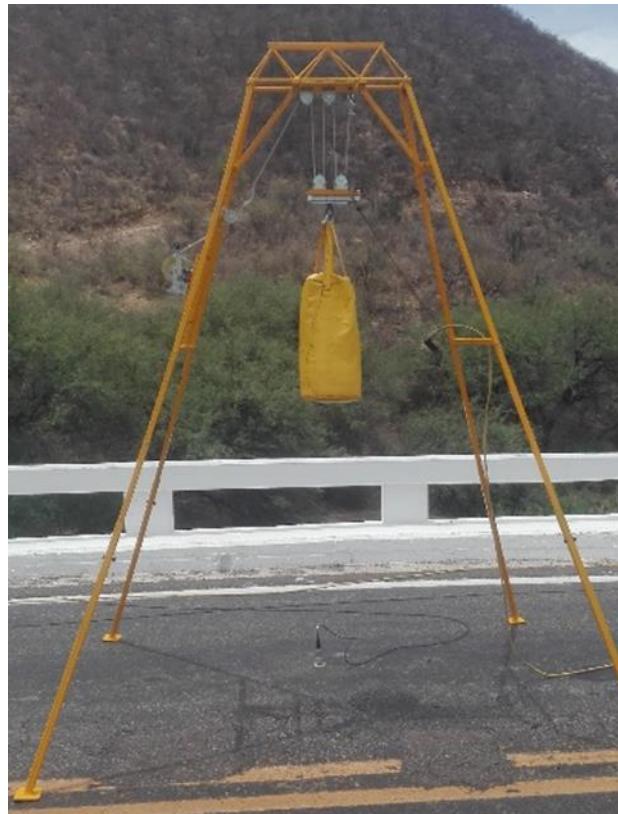
Figure 8. General appearance of the field test equipment.

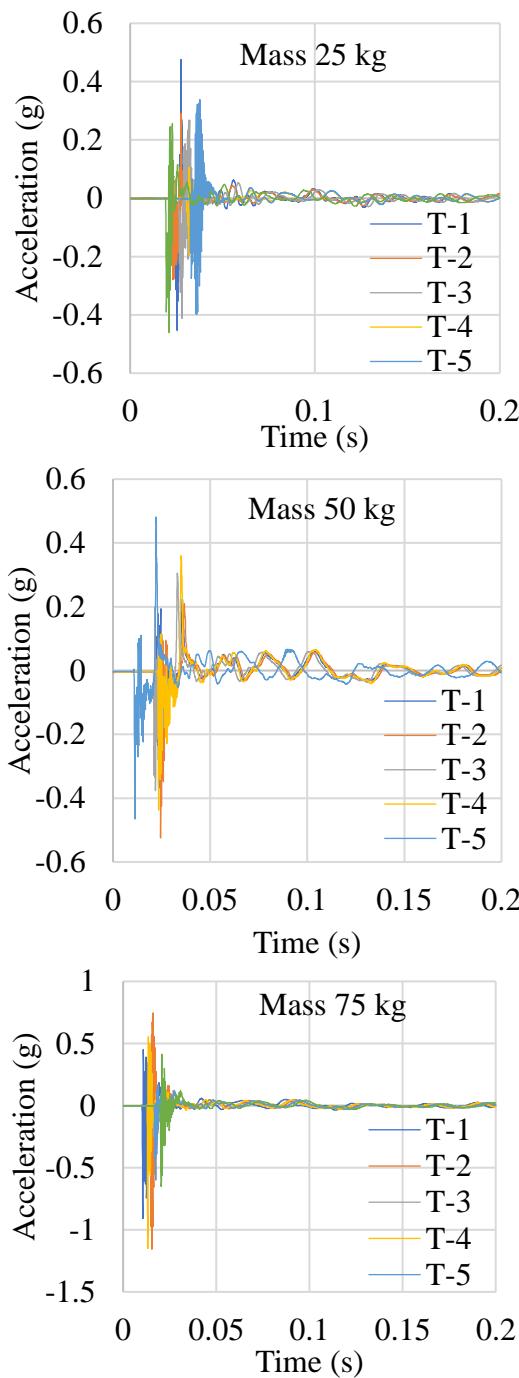
Figure 9. Acceleration-real time spectrum, "El Testarazo" bridge.

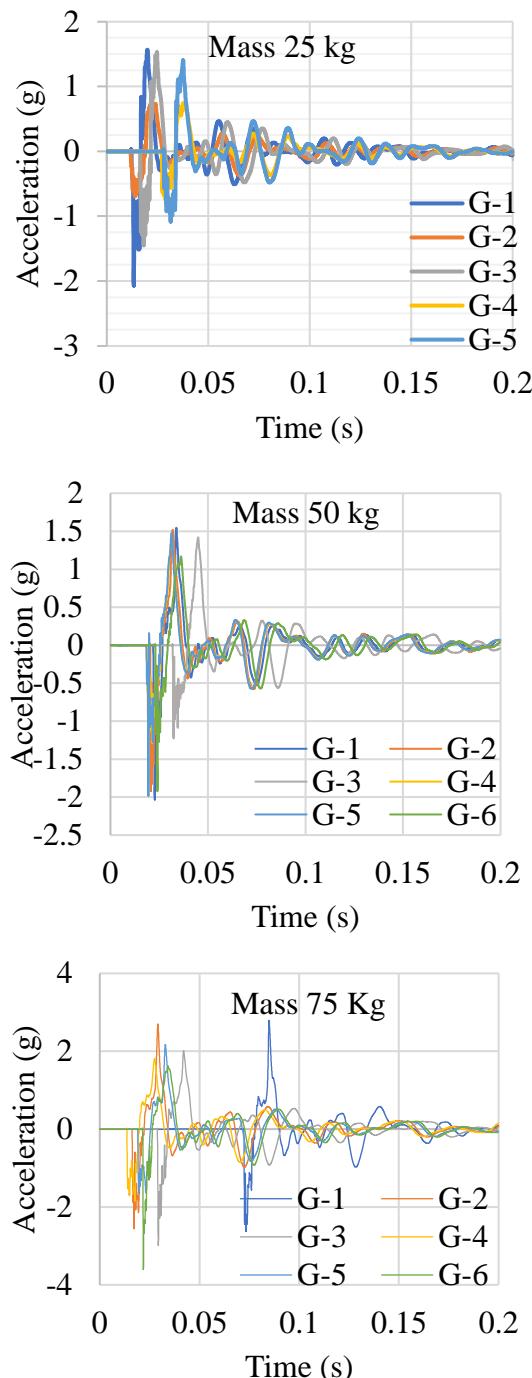
Figure 10. Acceleration-real time spectrum, "El Gavilán" bridge.

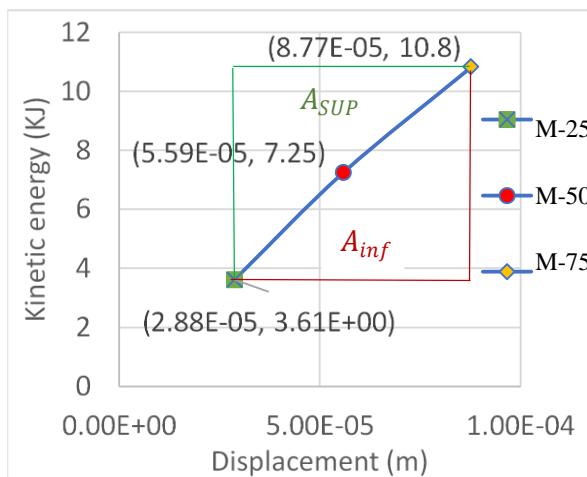
Figure 11. Kinetic Energy-Displacement graph, “El Testarazo” bridge

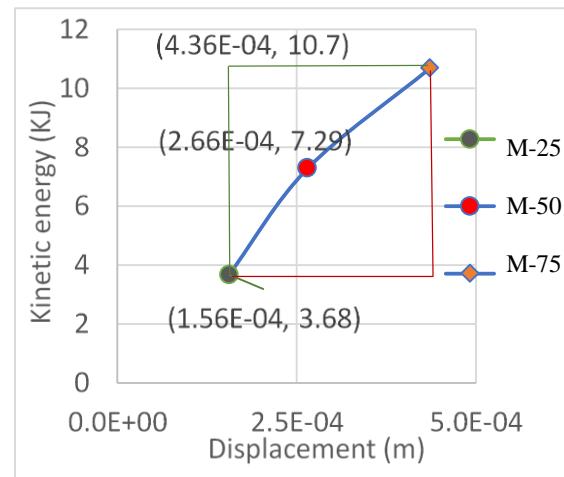
Figure 12. Kinetic Energy-Displacement graph, “El Gavilán” Bridge

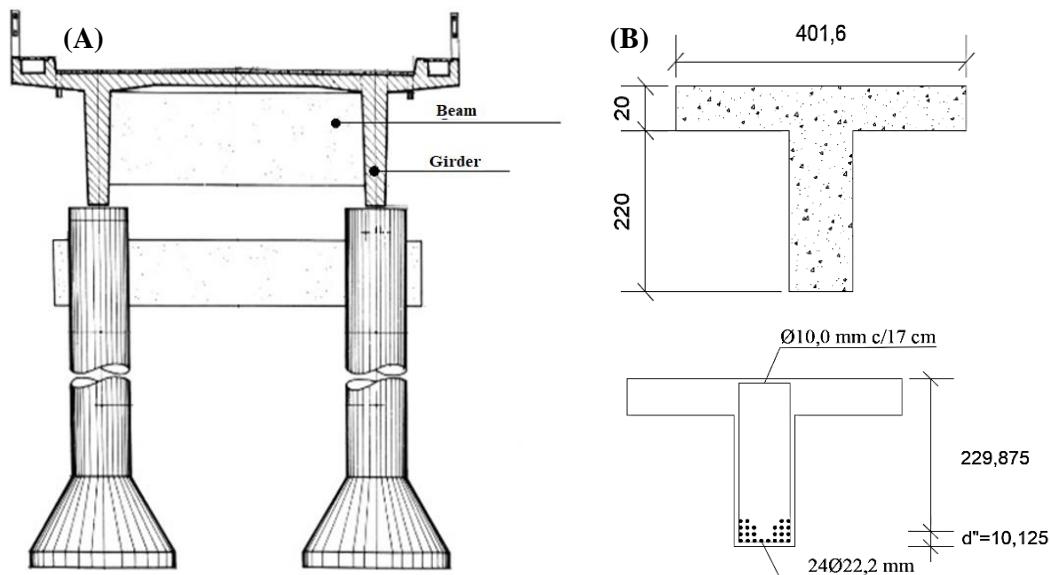
Figure 1. (A) Bridge's cross section over the Chapecó River; (B) Cross section, in centimeters, of the investigated section of the girder (Adapted from the Departamento de Estradas e Rodagem Santa Catarina, 1987).

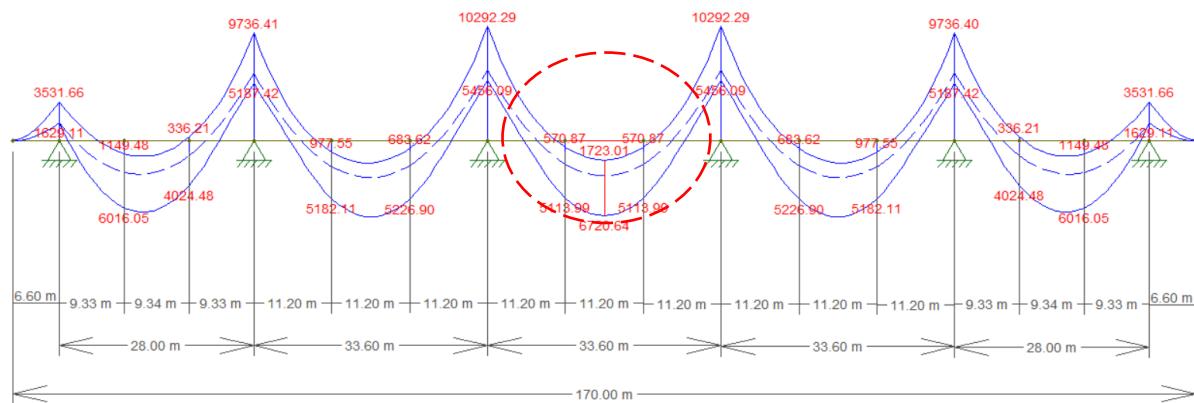
Figure 2. Envelopment of efforts due to the 300 Brazilian Load Model and $\phi = 1.23$.

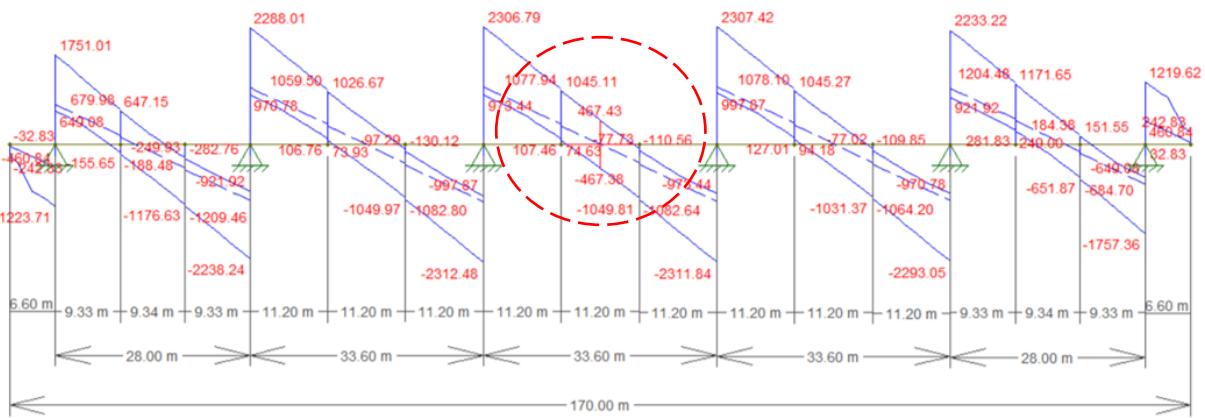
Figure 3. Shearing envelope with TB-450 increased by WCV (ABNT NBR 7188, 2013).

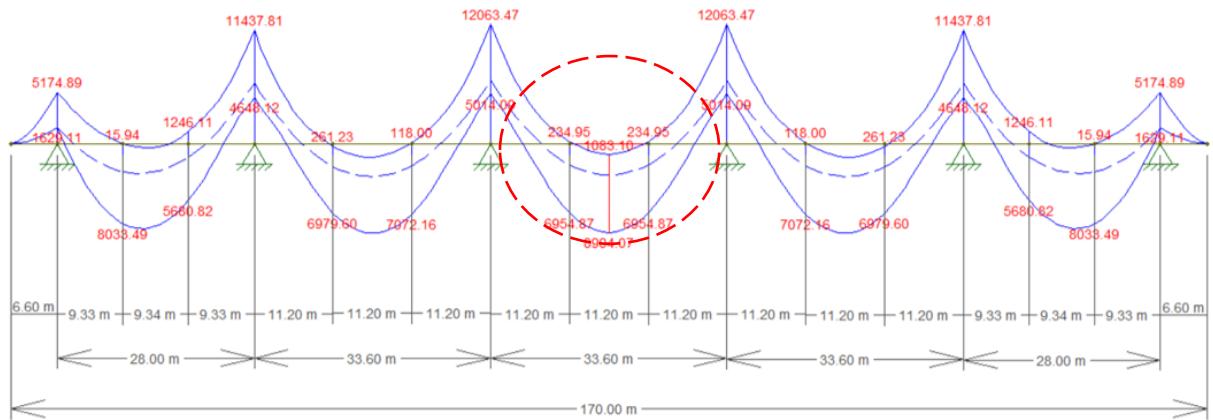
Figure 4. Bending moment envelope with TB-450 increased by WCV (ABNT NBR 7188, 2013).

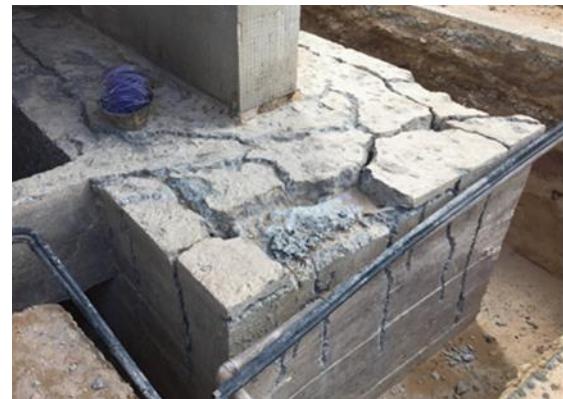
Figure 8. Cracks on a block with AAR.

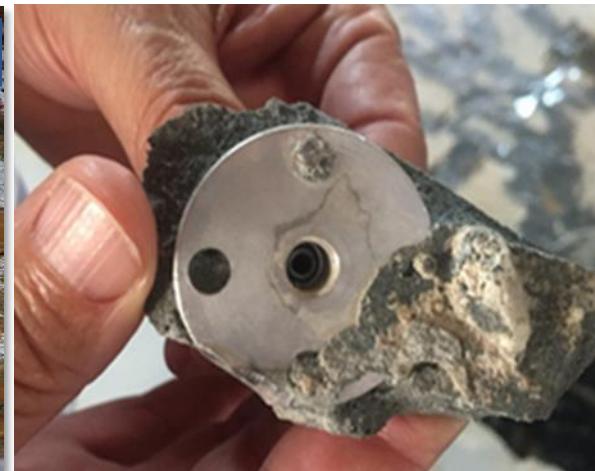
Figure 11. Metallic ports.

In the injection process, plastic and metallic ports were used, as shown in Figures 10 and 11. The metallic ports are part of the new advances in the injection process, to which an injection can be applied under higher pressure, and consequently the penetration of the material to areas of greater depths can occur in a shorter span of time. However, from the data collected in this study, filling was done to close external cracks and ensure the injection, and the most used materials were plastic ports, which are simpler and easier to find on the market.

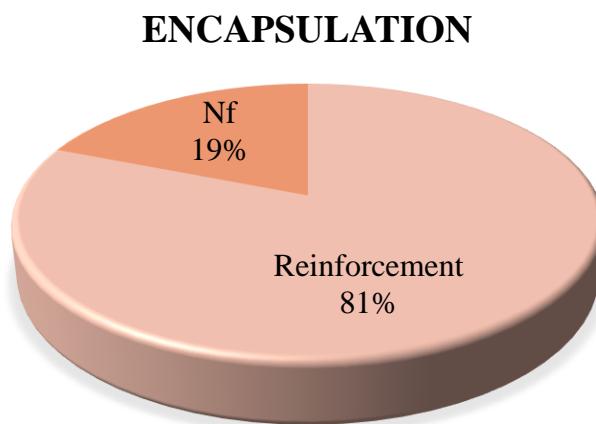
Figura 12. Use of reinforcement.

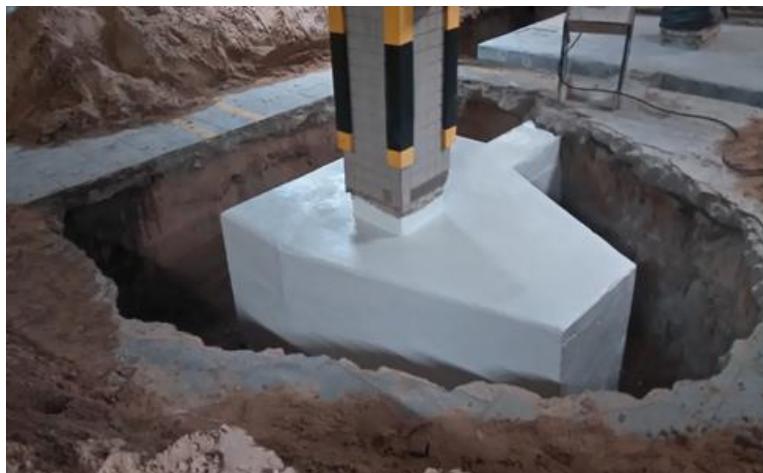
Figure 13. Waterproofed block.

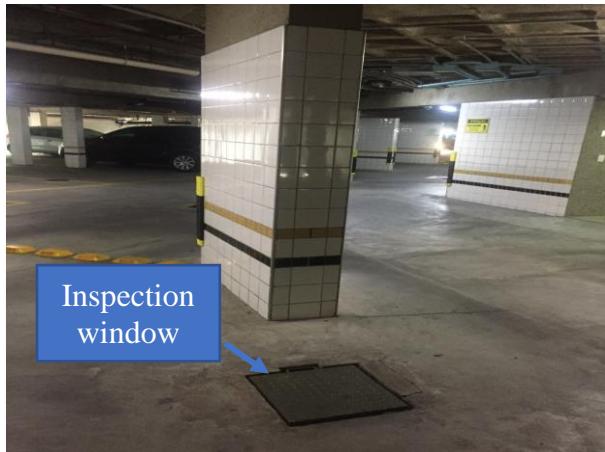
Figure 14. Inspection window.

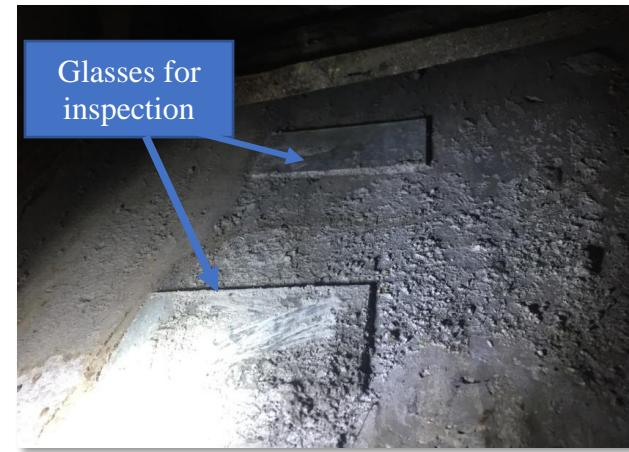
Figure 15. Interior of inspection window.

As a result, it was found that, of the 50 foundations surveyed, only two left the inspection windows. The windows are small openings left in the foundation elements that make it possible to monitor the recoveries from the floors above, as shown in Figure 14. Internally, small pieces of glass are placed, shown in Figure 15, where cracks had previously been identified, so that they can be periodically monitored after their recovery. If any new movement of the foundation block occurs, the tendency will be for this glass to break, indicating a possible continuing of the ASR, or of some other pathological manifestation.
