Revista **ALCONPAT**

Latin American Journal of Quality Control, Pathology and Construction Recovery

Volume 11

Issue 3

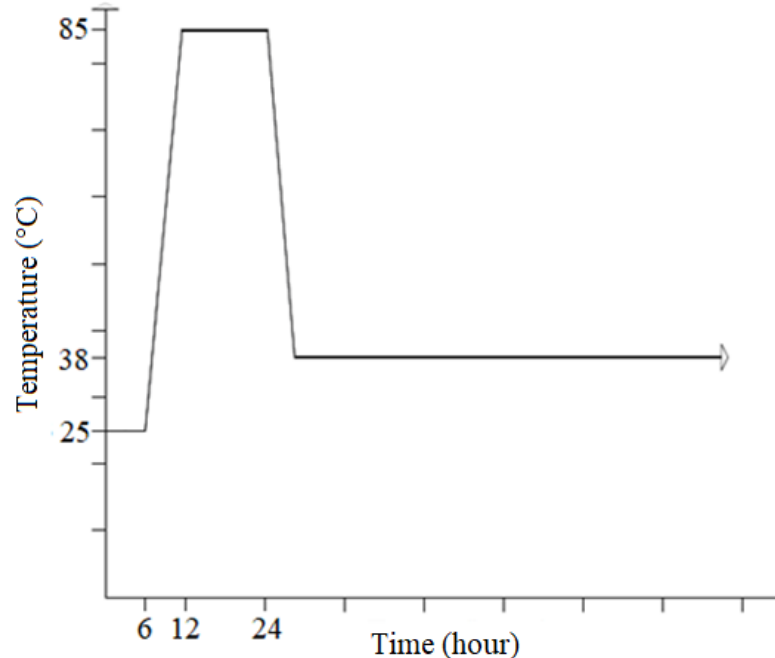
The procedure and thermal cycle adopted to induce DEF was previously proposed by Schovanz (2019) and Hasparyk et al. (2020). Specimens were cast and maintained for 6 hours in a moist room until the beginning of the thermal cycle (pre-curing period). In the sequence, specimens were submerged in water with a gradual increase of temperature from 25°C up to 85°C, remaining in this condition for 12 hours, followed by cooling up to 38°C. Both the heating and cooling rate was 10°C per hour over time and up to one year (Figure 1).

Figure 1. Thermal cycle and exposure environment

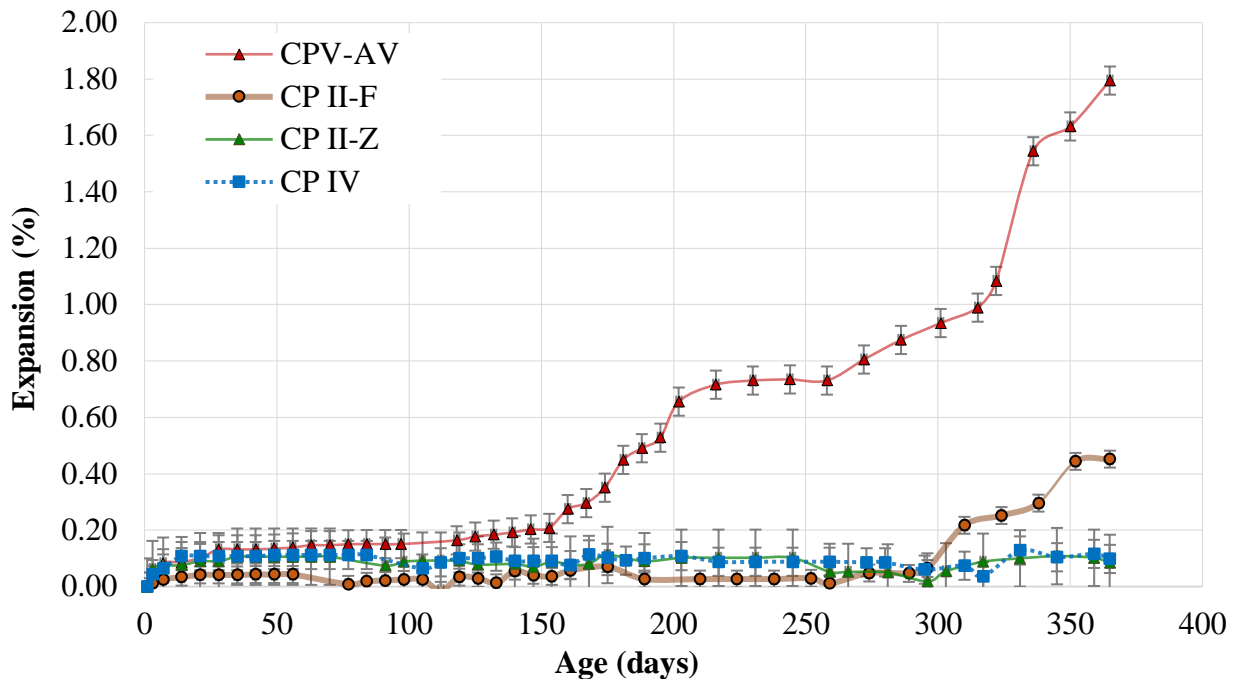
According to Figure 2, values of expansion for mortars containing cement with no admixture were much higher than those in the presence of some admixture. The first major increase began after 150 days and lasted up to 200 days; after that, a dormancy period was observed for up to 260 days, followed by another increase in expansion for up to about 300 days. Then, the growing rate of expansion was intensified up to 365 days (the maximum expansion was 1.8%). Although the fly-ash cements (both, CP II-Z and CP IV) produced reduced expansions (below 0.10% at 365 days), a higher dispersion for expansions was observed over time. Cement with limestone filler (CP II-F type) performed entirely differently from the others. Over time and up to about 300 days, there were minor expansions below 0.06%. After this period, a significant growth rate was perceived for up to 365 days, when mortar achieved an average expansion of 0.45%.

Figure 2. Evolution of DEF expansions over time

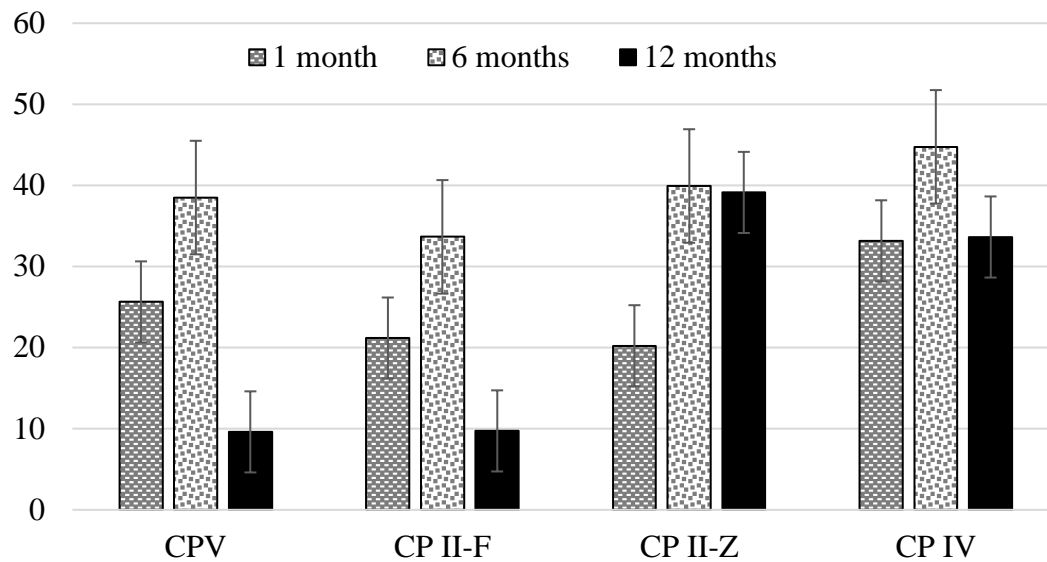
In the presence of fly-ash, and especially for the CP II-Z, a decrease was not observed at one year, considering low expansions (less than 0.10%), but in relation to 6 months, there was a reduction of just about 2% in the presence of this cement, meanwhile pozzolanic cement (CP IV) suffered a decrease of about 25% for the same period (Figure 3 and Table 2).

Figure 3. Compressive strength over time

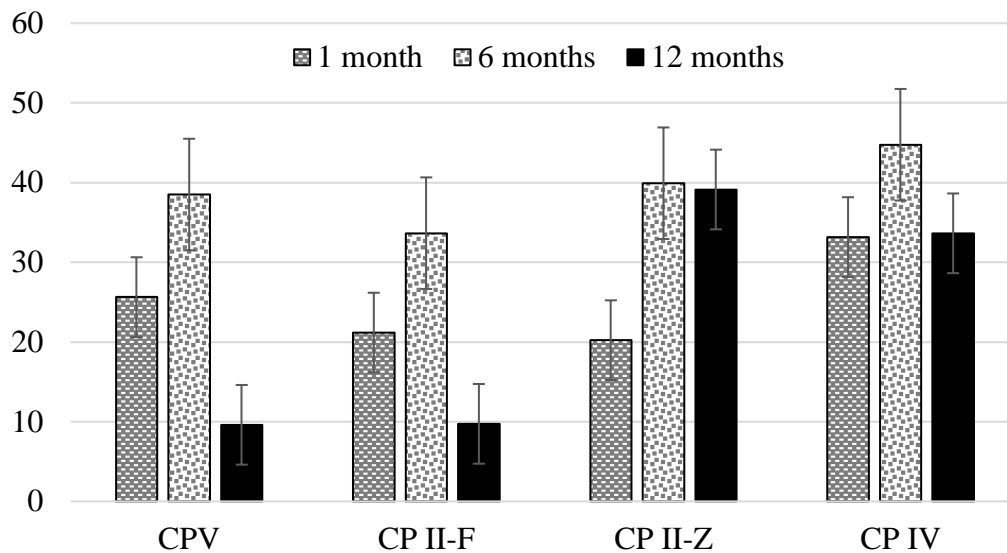
Mortars with fly-ash performed differently due to an increase of tensile strength up to the first six months, somewhat following the behavior of compressive strength, but over time and at 12 months, there was a drop of 19% and 12% for CP II-Z and CP IV, respectively (Figure 4). The initial gain in the tensile strength occurs due to the pozzolanic reactions involving the mineral admixtures that are present in these cements.

Figure 4. Tensile strength over time

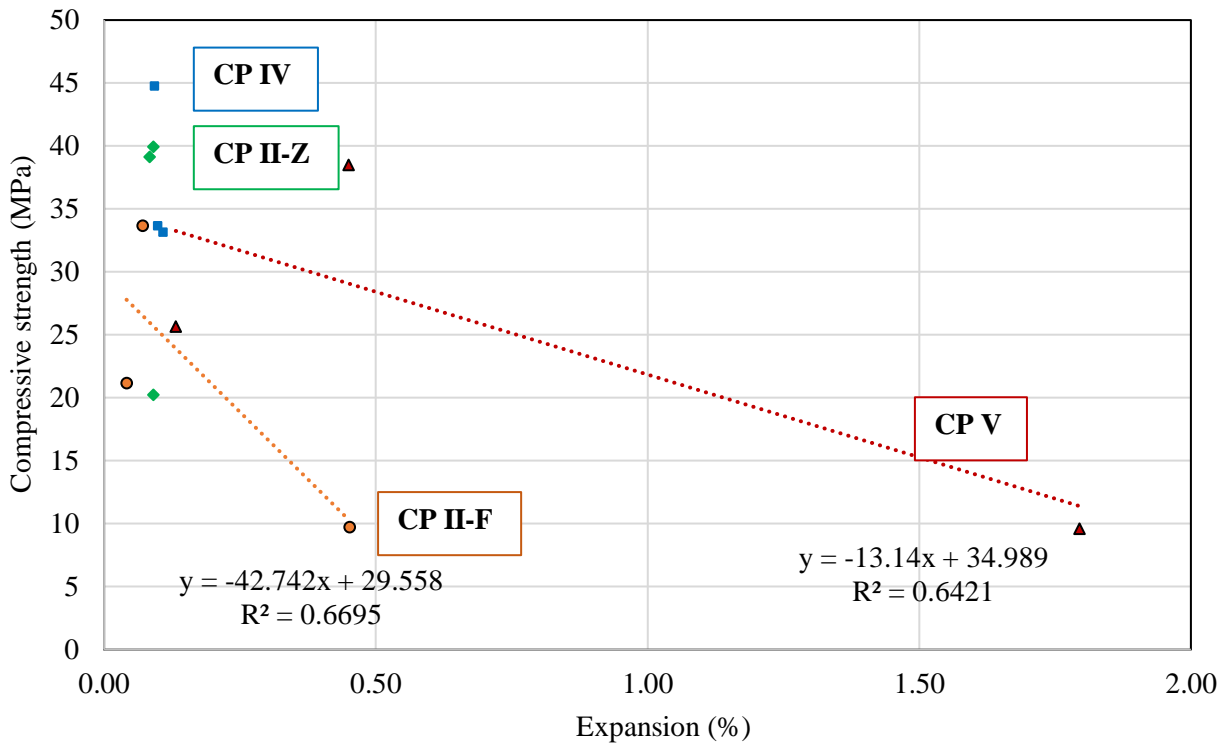
Figure 5. Correlation between compressive strength and expansion

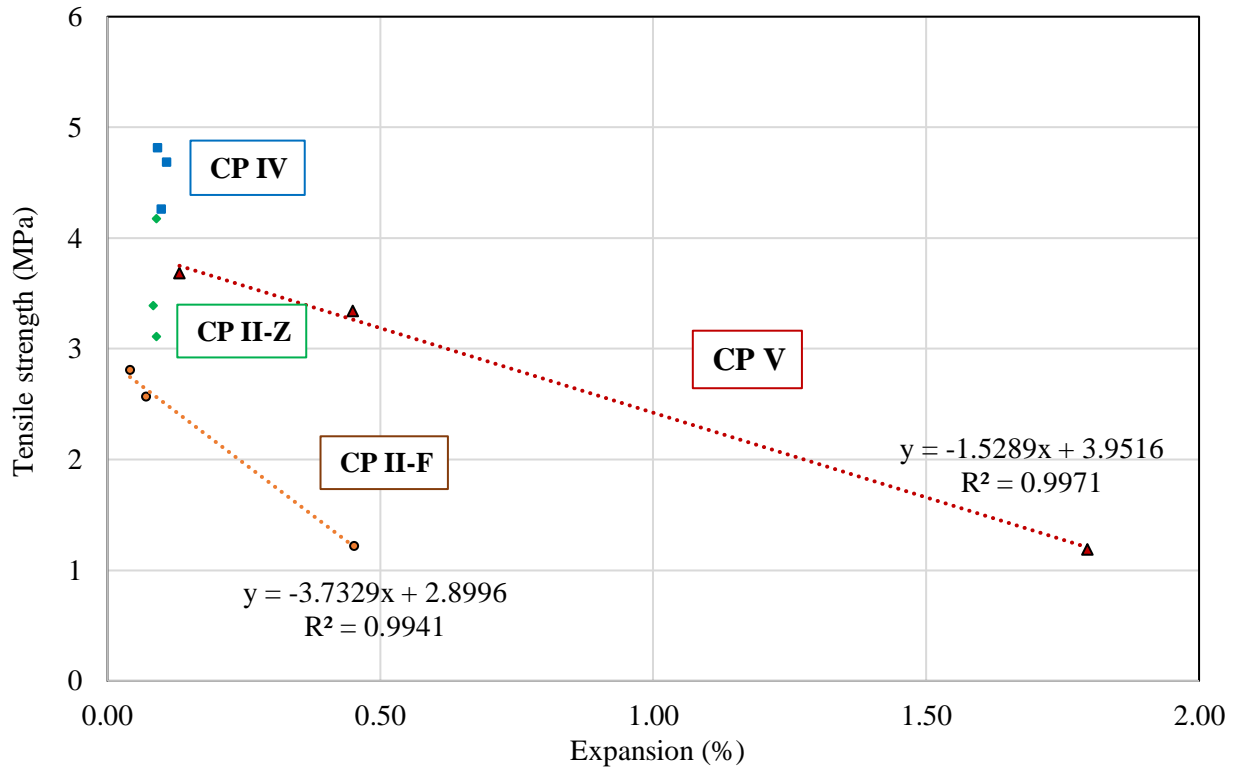
Figure 6. Correlation between tensile strength and expansion

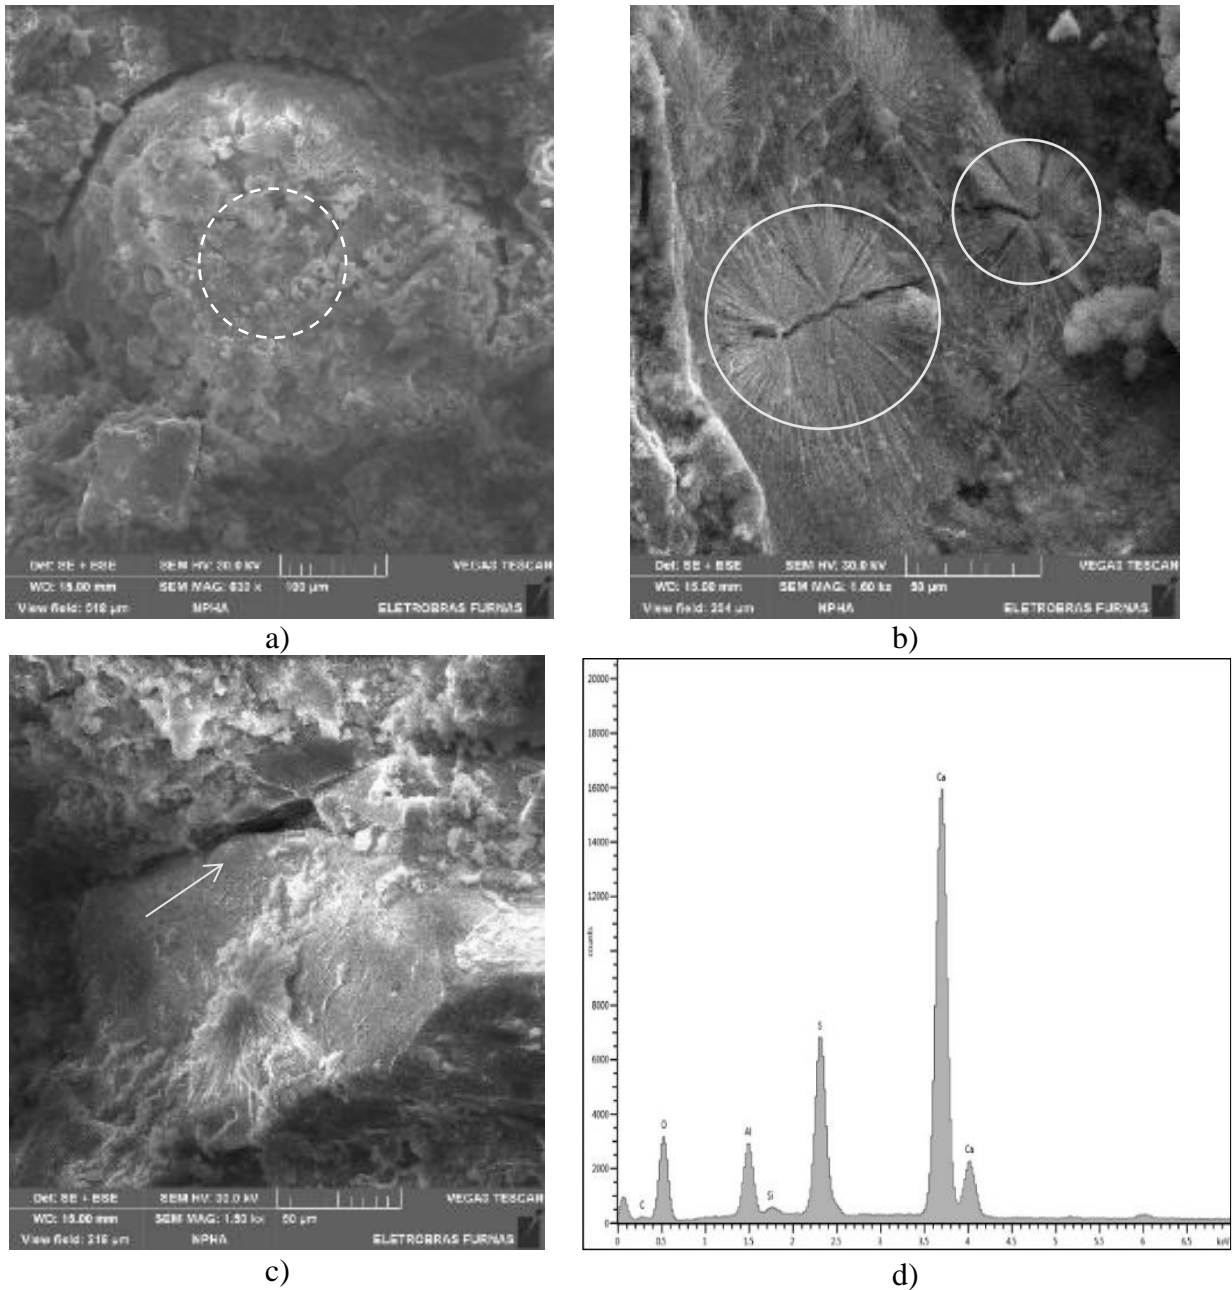
Figure 8. Micrographs of mortars with CP II-F at one year: a) DEF filling a void; b) Compressed Ettringite crystals in the cement paste; c) Loss of adherence between cement paste and aggregate and neoformations in the surface of aggregate; d) EDS spectrum of massive ettringite indicated in Fig. 8a.

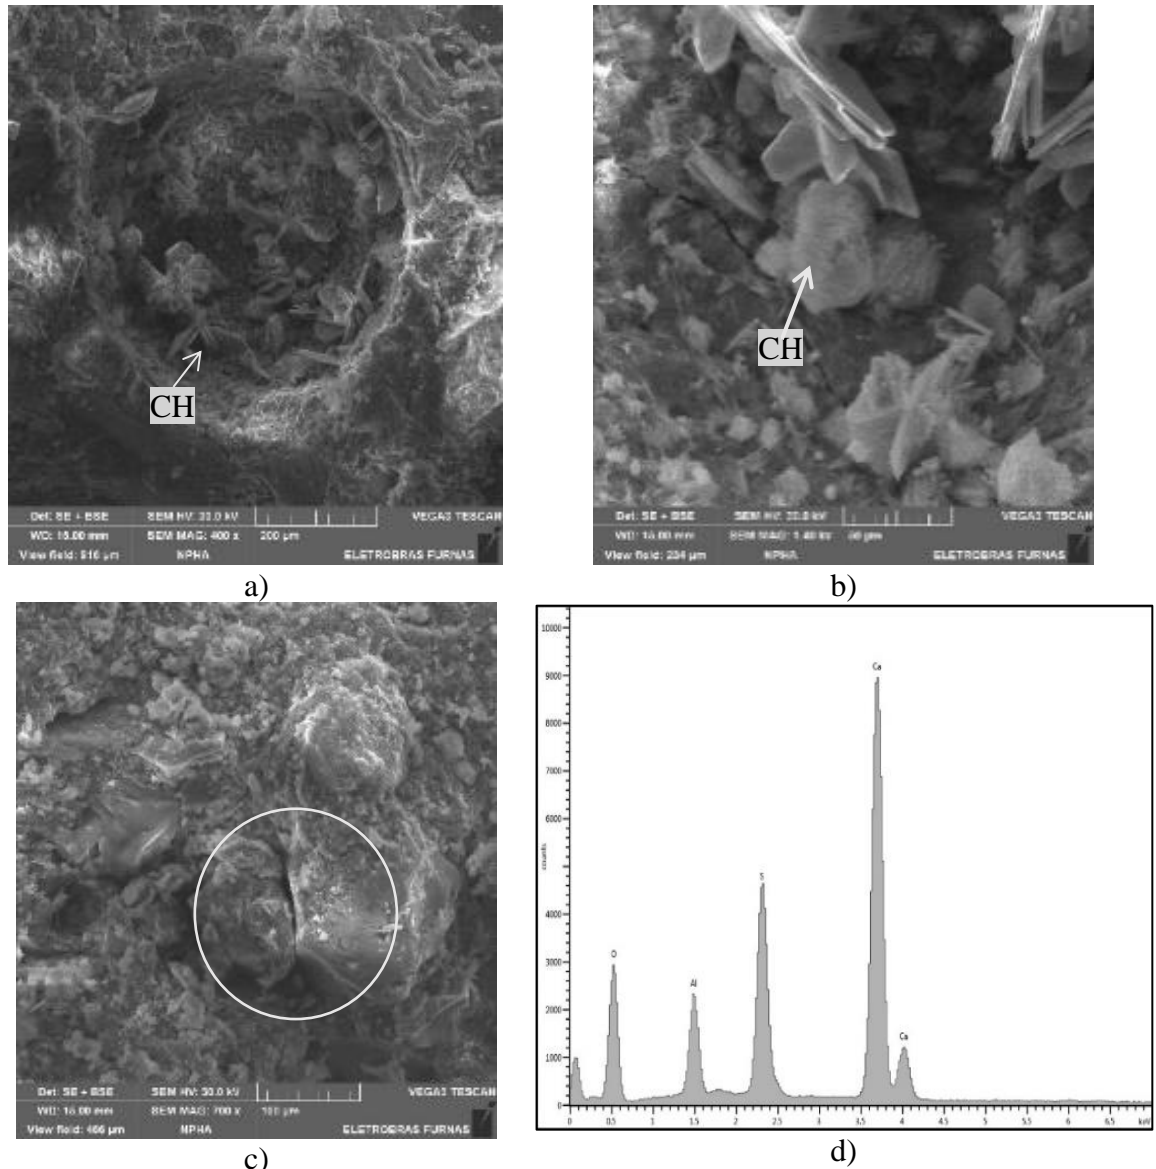
Figure 10. Micrographs of mortars with CP IV at one year:

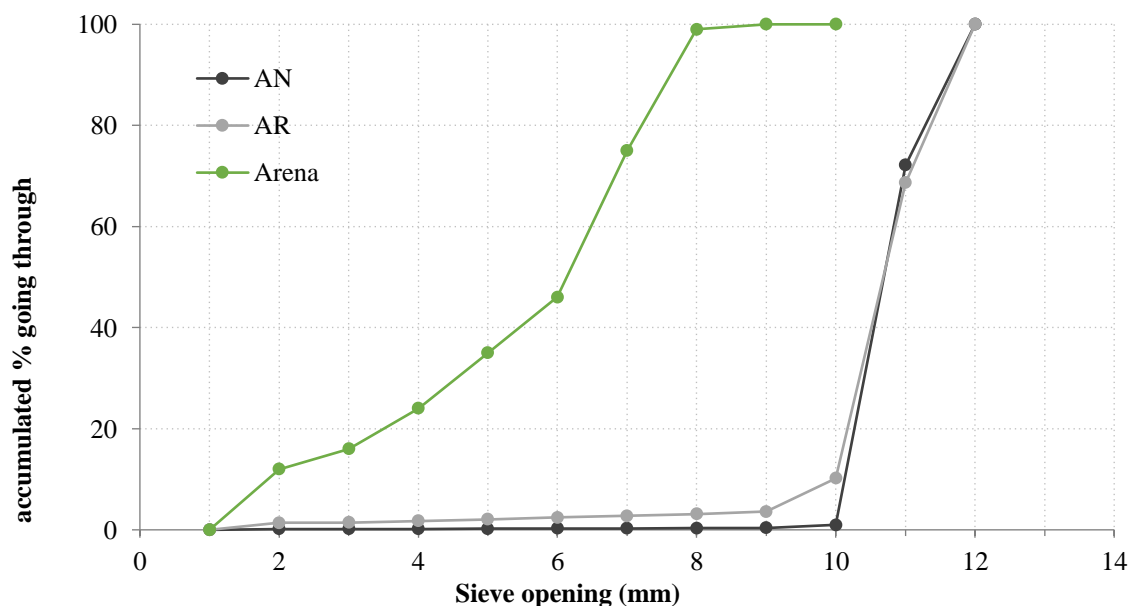
Figure 1. Granulometry of the aggregates used.

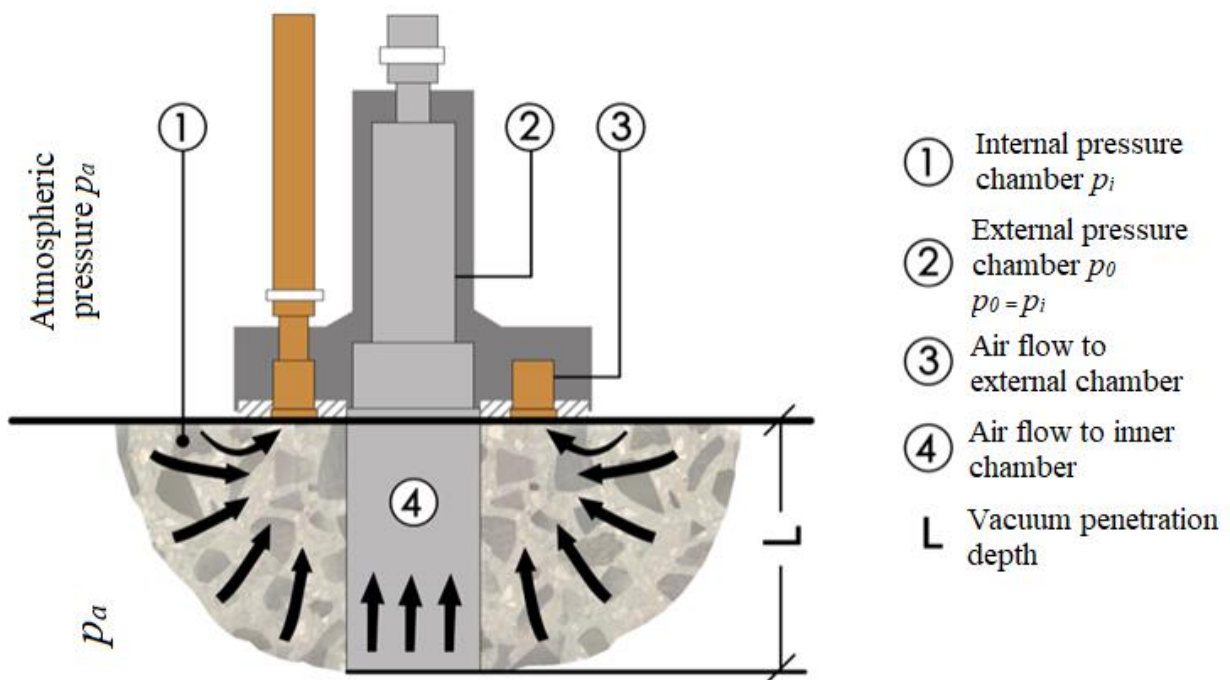
The air permeability coefficient (kT) in concretes with a GS of 65% is obtained with the Proceq Torrent Permeability Tester equipment. This equipment consists of a cell with a double vacuum chamber and a pressure regulator that ensures that the air flows at the correct angle from the surface to its internal chamber (see Figure 2). This allows the calculation of kT through a rapid and non-destructive test that can be carried out both in the laboratory and on site. Measurements are made on 3 specimens on both sides for each dosage studied.

Figure 2. Permeability test with the Torrent Permeability Tester equipment and the equipment's operating diagram.

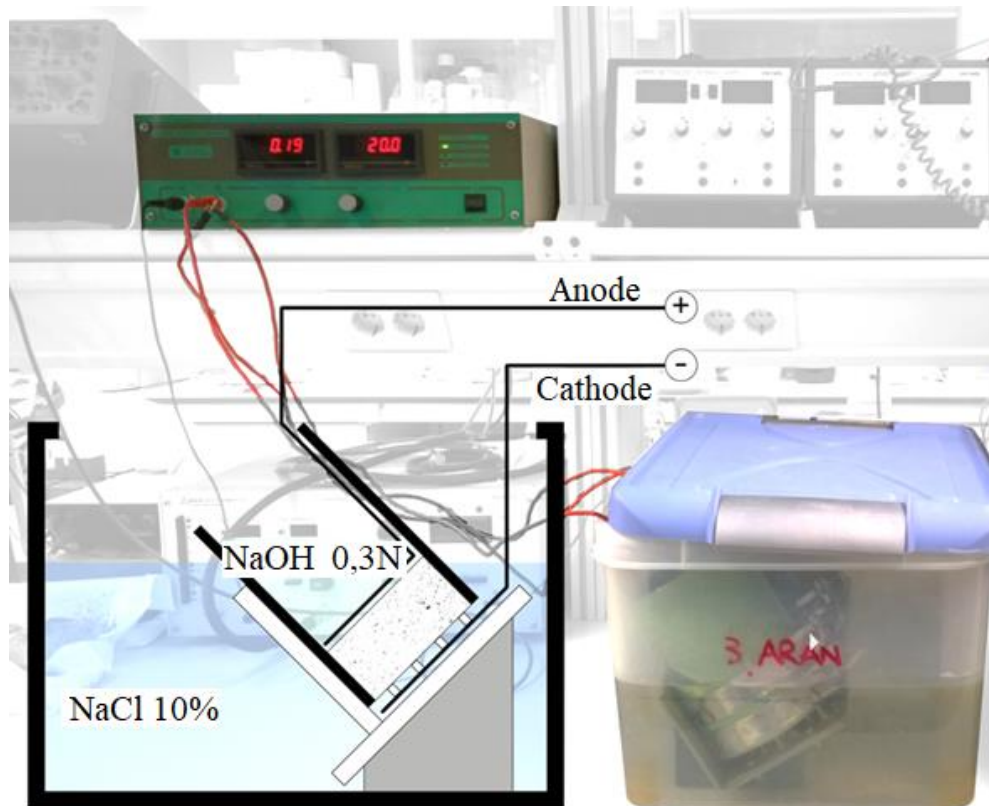
Figure 3. Chloride migration in concrete. Test scheme according to the NT Build 492 standard.

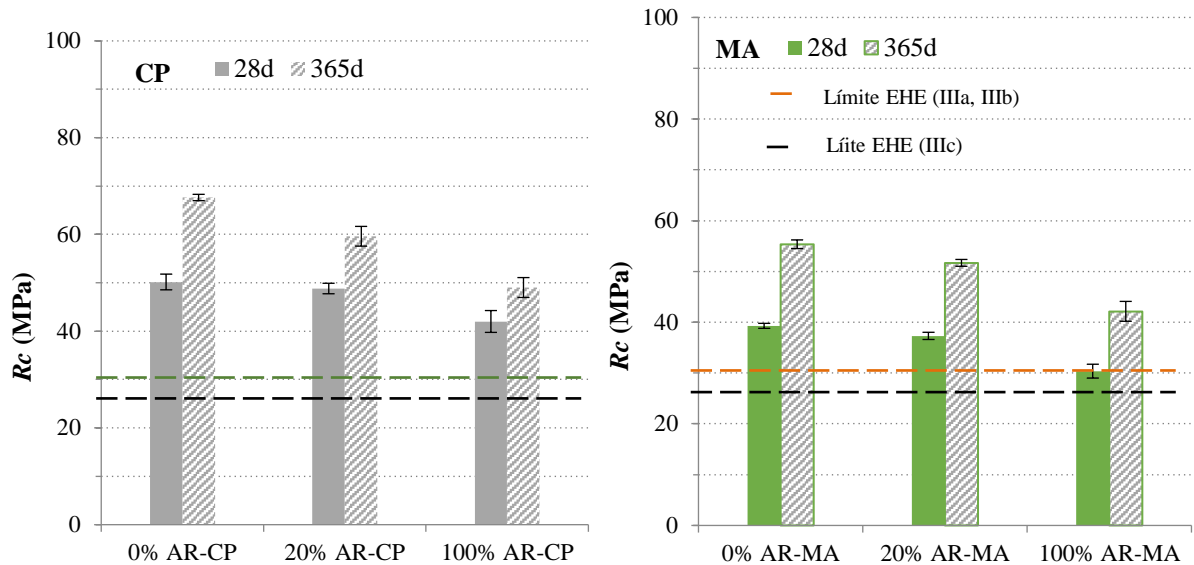
Regarding the mechanical characterization of the concretes, the mean value of four specimens has been used for the analysis of the compressive strength. Figure 4 shows the values obtained for compressive strength, where the expressed percentage, followed by *AR*, refers to the amount of recycled aggregate present in the mixture; *CP*, refers to the cementitious matrix composed of *CEM* I 52.5 R; and *MA* to the alternative cementitious matrix (35% fly ash, 15% catalytic cracking catalyst and 50% *CP*). In general, it is observed that all concretes exceed the limits established by the EHE-08 to be used as structural concrete (25 MPa) and as concrete in atmospheric areas exposed to a marine environment (30 MPa), although it is notable that the values compressive strength are lower in all concretes with respect to the pattern (0% *AR-CP*), both at 28 and 365 days. The results show that as the percentage of substitution of natural aggregate for recycled aggregate increases, there is a decrease in resistance, coinciding with the results obtained by other authors (Hansen, 1992, Poon, 2004, Etxebarria et al., 2007, Corinaldesi, 2010). This happens in both, concrete with *CP* and in those made with *MA*. The use of recycled aggregates affects this property due to its greater porosity and the weak behavior of the microstructure, due to the existence of different interface zones. In addition to the paste-aggregate junction that the recycled aggregate presents, another contact zone appears between the recycled aggregate paste and the new paste.

Figure 4. Compressive strength values at 28 and 365 days for the different concretes studied.

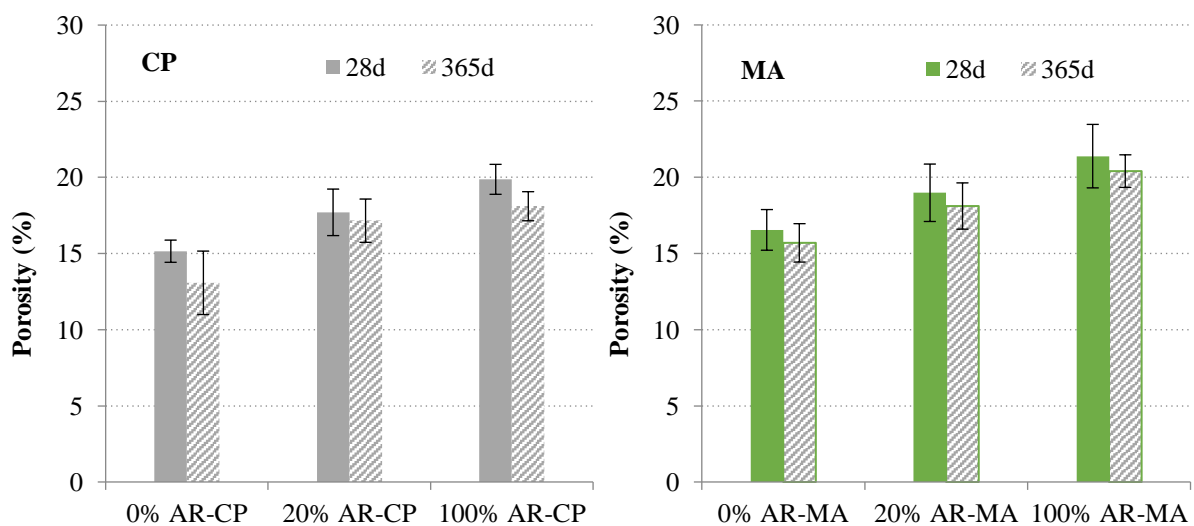
Regarding porosity (Figure 5), it increases as the substitution of AN by RA increases (Chaofeng et al., 2021, Kou et al., 2011). This increase is due in large part to the greater porosity of the recycled aggregate (Etxebarria et al., 2006). It is clearly observable in the results at 28 days that the most porous concretes are those with total replacement of natural aggregate by recycling (100% AR-CP and 100% AR-MA) and that the porosity remains practically constant in both cases, without distinction of the cementitious matrix.

Figure 5. Porosity values at 28 and 365 days in the concretes studied.

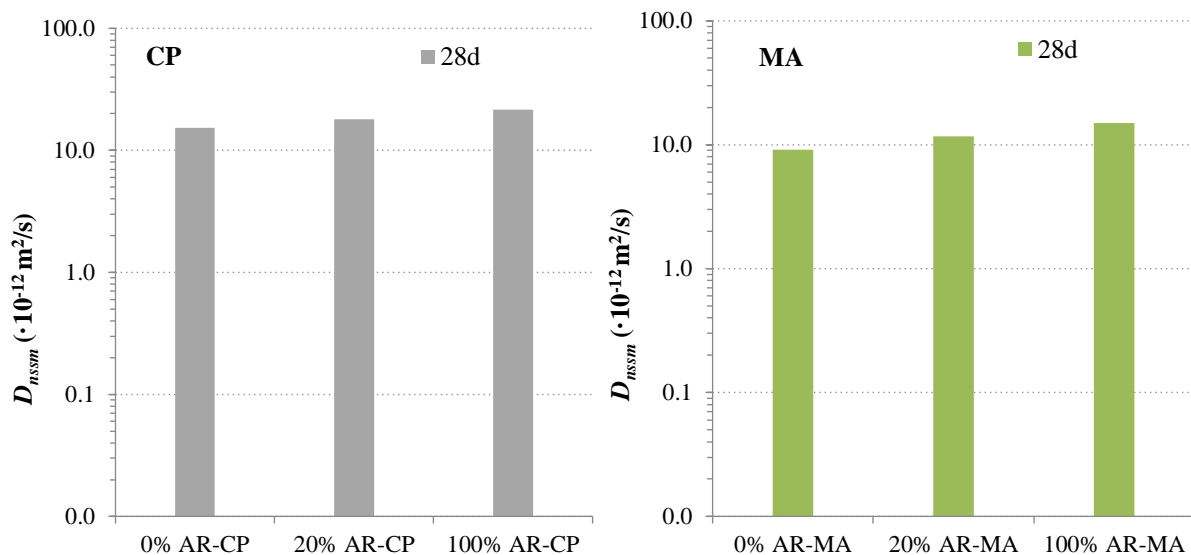
Figure 6. Chloride migration coefficient at 28 days.

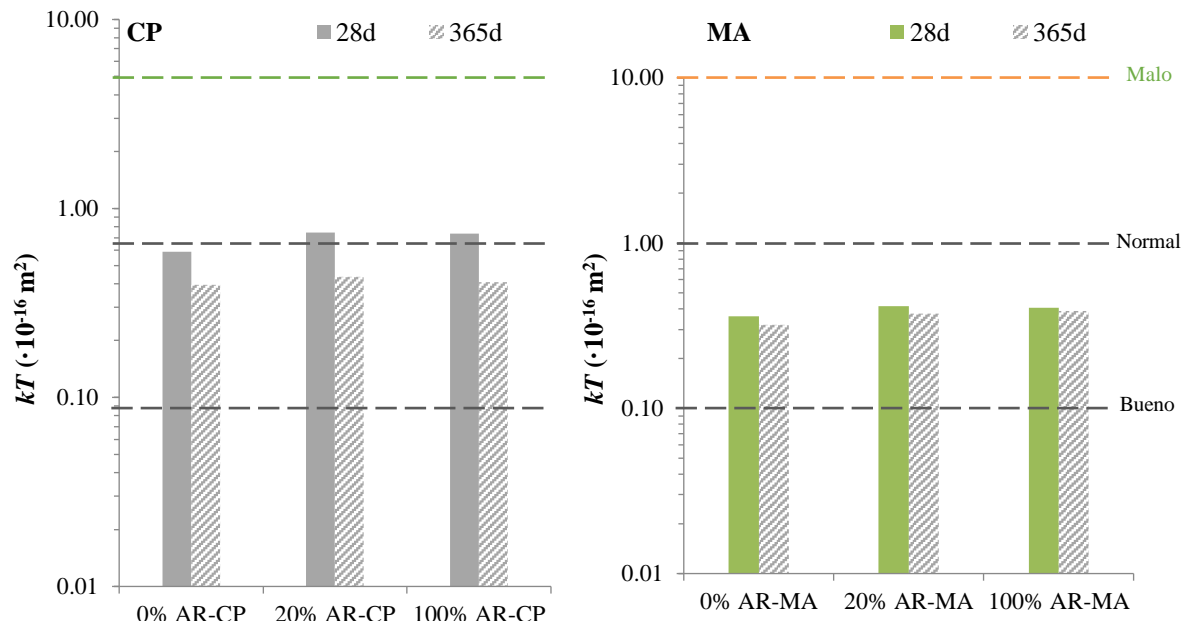
Regarding the evolution of this property, it is observed that the permeability values of all the concretes decrease with the curing time, due to the complete development of the microstructure.

Figure 7. Air permeability coefficients at 28 and 365 days.

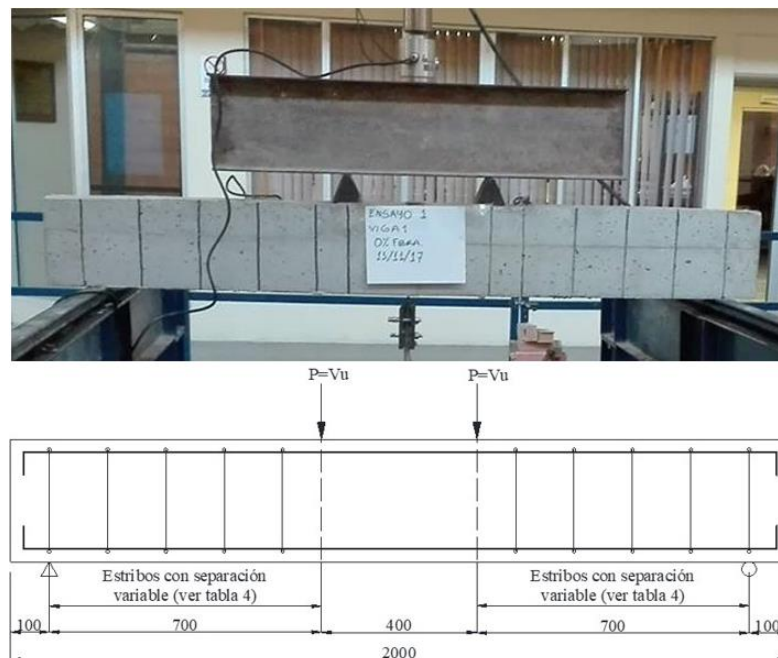
Figure 1. General detailing of the tested beams

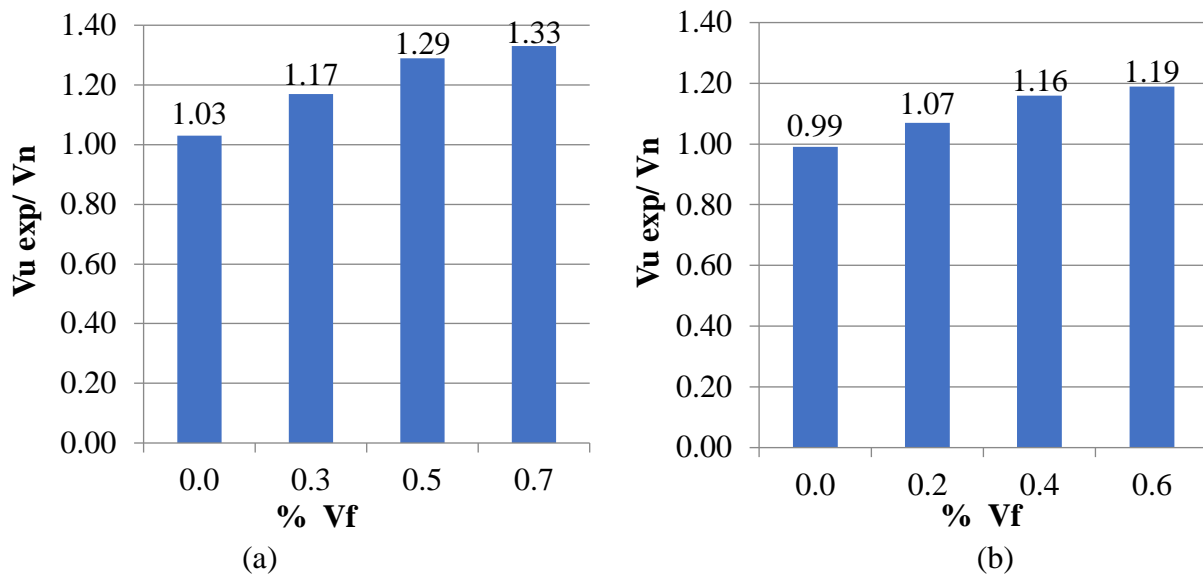
The effect in the ultimate shear strength provided by the reinforcement with steel fibers is evident just by comparing tables 5, 7, and 8, however, it is more convenient to make a direct relation between the experimental strength obtained and the analytical strength. In figure 2a, in a graphical manner, these values are presented, which were obtained by dividing column 3 of table 8 by the nominal shear strength (equation 1) for the ratio $w/c = 0.55$, and figure 2b shows the values obtained by dividing column 6 of table 8 by the nominal shear strength (equation 1) for the ratio $w/c = 0.35$.

Figure 2. Contribution of the reinforcement with fibers compared with the experimental shear strength of the fiber-reinforced concrete beams with stirrups obtained from table 8 vs the nominal shear strength obtained from table 5. (a) Ratio $w/c=0.55$. (b) Ratio $w/c=0.35$.

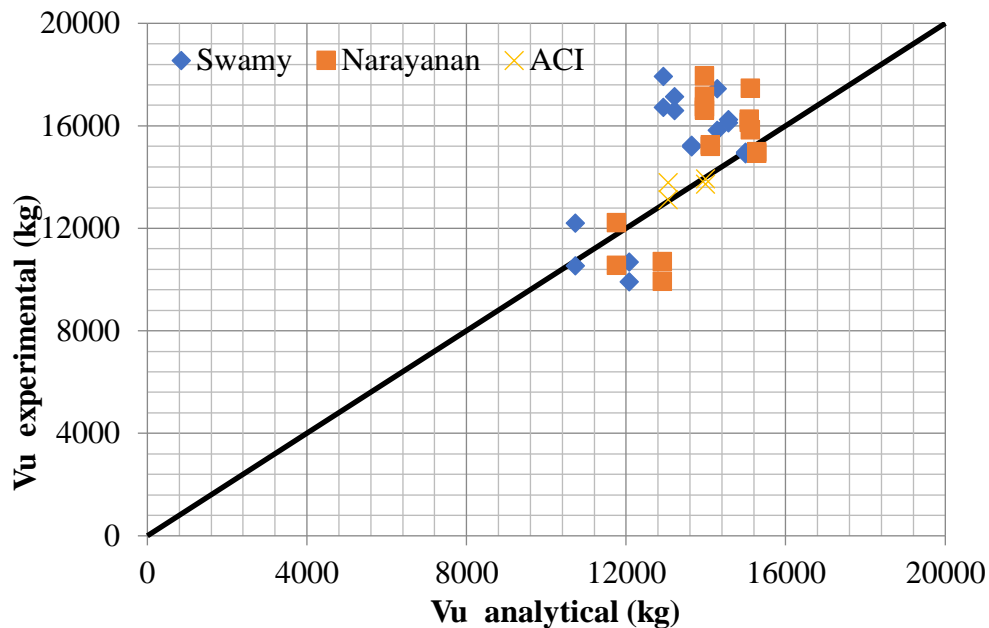
The graphical behavior of the aforementioned is presented in figure 3, where it can be observed a relationship between the results of the ultimate experimental shear strength and the results of the analytical models. It is noted that the prediction of the values obtained from the models that approach the diagonal is equal to the experiments, otherwise, all the values that are under this diagonal are slightly conservative. Such is the case for some points of the Narayanan model, which presents a lower degree of approximation with respect to the other analytical models proposed by Swamy and ACI. The majority of the plotted points of the three models show similitude in their results and they are considered conservative since they are over the diagonal.

Figure 3. Experimental shear strength vs the ultimate shear strength obtained from the three analytical models proposed, for fiber-reinforced beams with both w/c ratios, with stirrups and without stirrups.

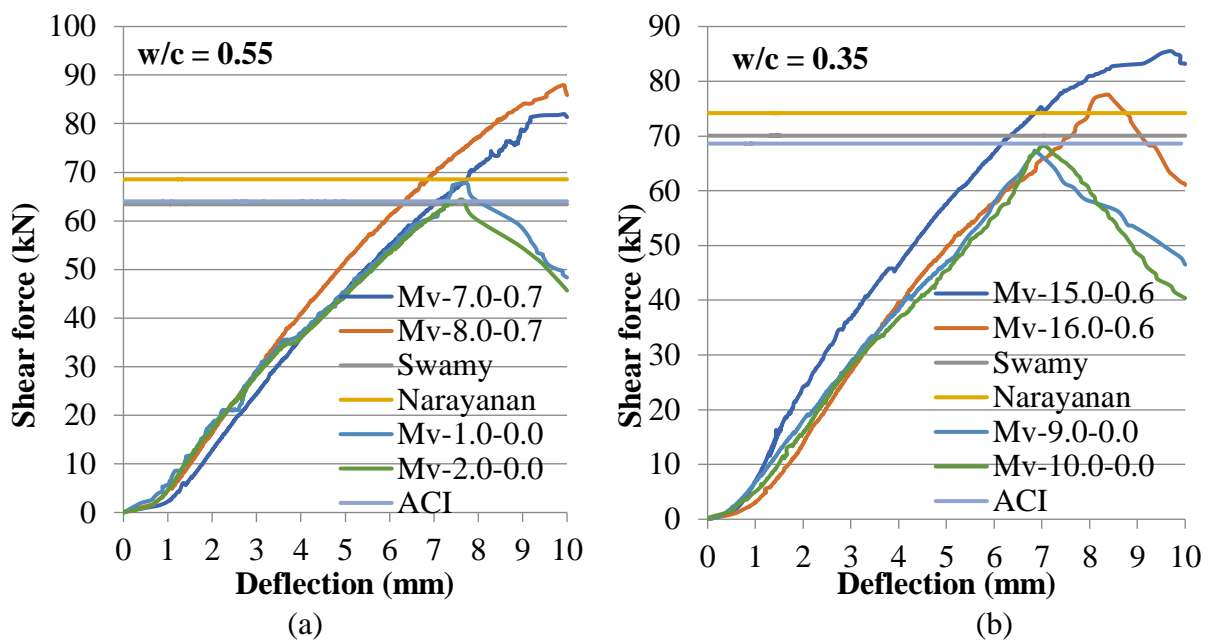
not sufficient to at least reach the same experimental strength of the control beams (1, 2, 9, and 10) that have no fibers, but which have the higher amount of stirrups. Even just the beams with the ratio $w/c = 0.55$ reach the theoretical strength predicted by the models, this was not the case for the beams with ratio $w/c = 0.35$, this can be attributed to the lower V_f which leads to an insufficient increment of the concrete strength, nevertheless, it can be observed that the post-cracking behavior in the reinforced beams only with fibers had a lower reduction of the shear strength than those with only stirrups, this is due to the fiber-matrix adherence, which allows for the transfer of stresses. The control beams show an appropriate behavior and they reach the predicted value by the ACI. On the other hand, it can be observed in figure 5, where the fiber-reinforced beams with the maximum V_f and with the lesser amount of stirrups had a higher shear strength than the control beams, even they were exceeded significantly for both w/c ratios the limit values of the models. The contribution of the fibers, in combination with half of the area of the transverse steel that the beams have, increased the ultimate shear strength with respect to the theoretical nominal strength, and this resulted to be larger in comparison to the results obtained for the control beams with the greater amount of stirrups.

Figure 5. Behavior of fiber-reinforced beams with a minimum amount of stirrups compared with control beams. (a) Ratio $w/c=0.55$. (b) Ratio $w/c=0.35$.

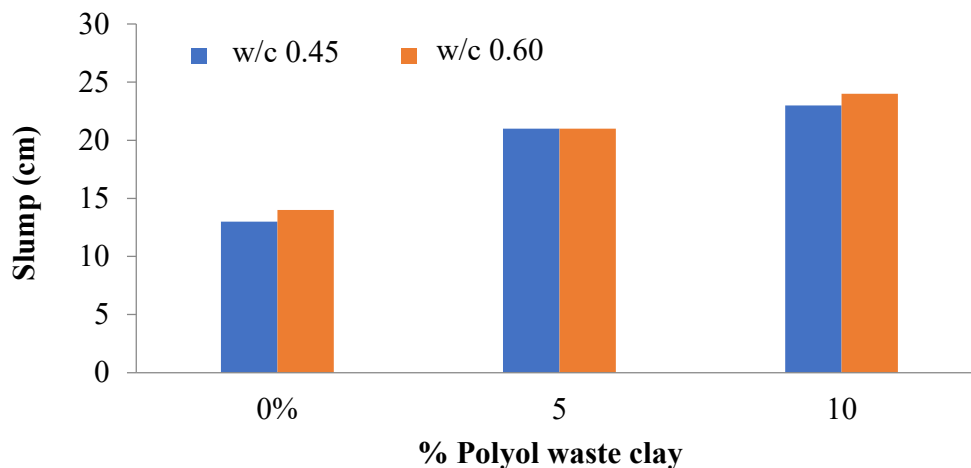
For the 0.45 and 0.60 mixtures with 5% substitution, a slump of 21 cm was recorded for both fresh mixtures, with an approximate increase of 8 cm with respect to the values recorded for the reference mixtures (blanks). For the 0.45 and 0.60 mixtures with 10% substitution, 23 and 24 cm of settlement were recorded, respectively, with an increase of 10 cm compared to their reference mixtures. These results show an effect on the workability of the fresh mix due to the addition of clay as a partial substitute for cement, the effect being more noticeable with respect to blank specimens for the lower dosages of clay, since the difference in workability of the mix between 5 and 10% substitution is minimal (2 cm slump approximately).

Figure 1. Results of the slump test in concrete fresh mix.

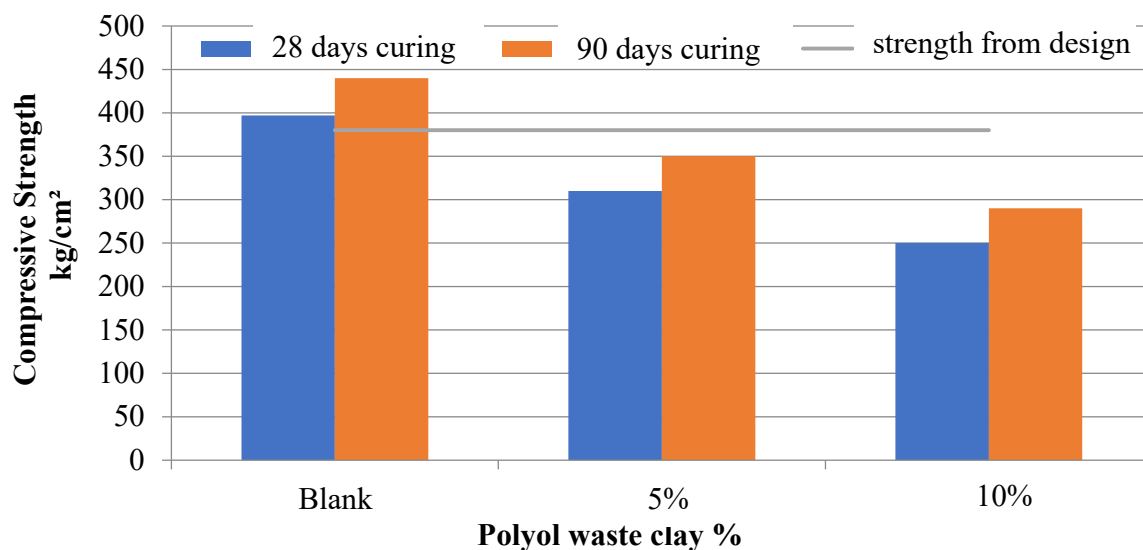
Figure 2. Compressive strength for w/c ratio of 0.45.

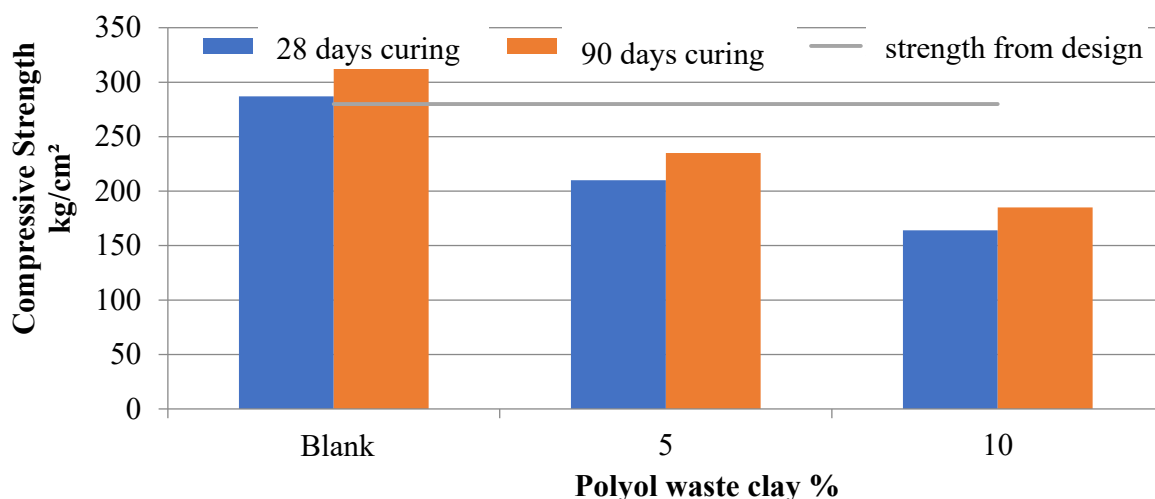
Figure 3. Compressive strength for R a / c 0.60.

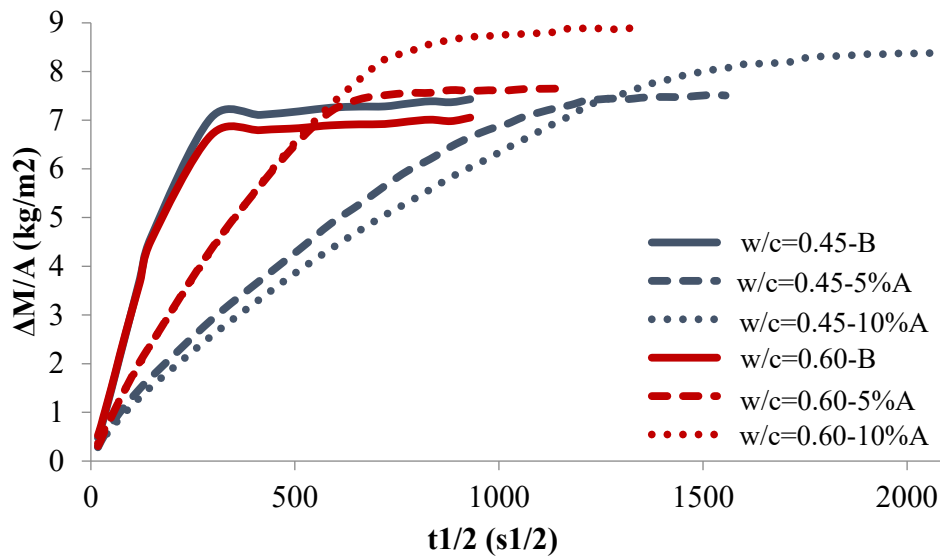
In Figure 4 it is observed that the blanks in both w/c ratios are very similar, however, the slopes change drastically for w/c of 0.45 when substituting clay; a marked difference is also noticeably between the mixtures with partial replacement of the polyol waste clay (with w/c 0.45 and 0.60) with regard to the water gain (k); where this value is represented by the slope of the linear region of the curve. With these results it is evident that the use of polyol clay offers greater resistance to water penetration. This property confers a greater resistance to the penetration of aggressive ions such as chloride ion (Cl^-). However, the effective porosity (ξ), slightly increased with the clay content, independent of the w/c ratio; Therefore, it seems that the polyol exerts a hydrophobic effect on the mixture.

Figure 4. Capillary absorption profile

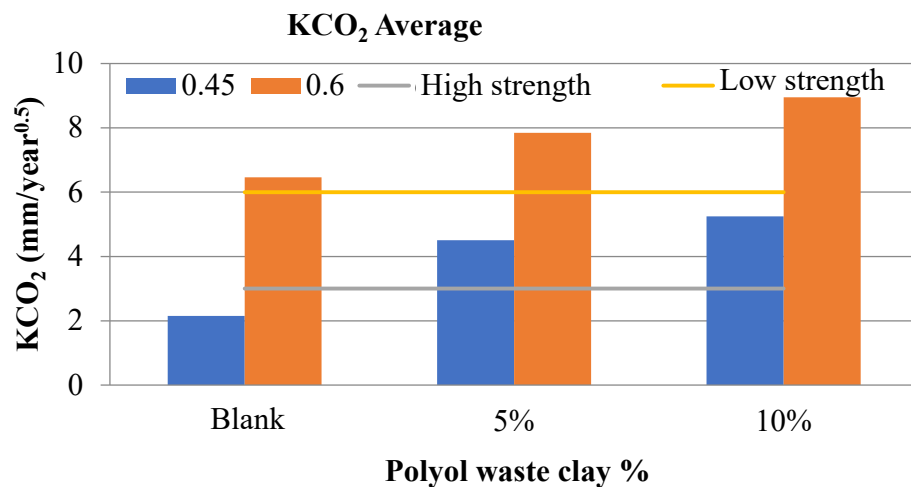
Figure 5 shows the effect of clay on the natural carbonation rate. It can be seen that the increase in the polyol clay concentration is accompanied by an increase in the carbonation front for the two w/c ratios; which matches the results of effective porosity.

Figure 5. Natural carbonation rate.

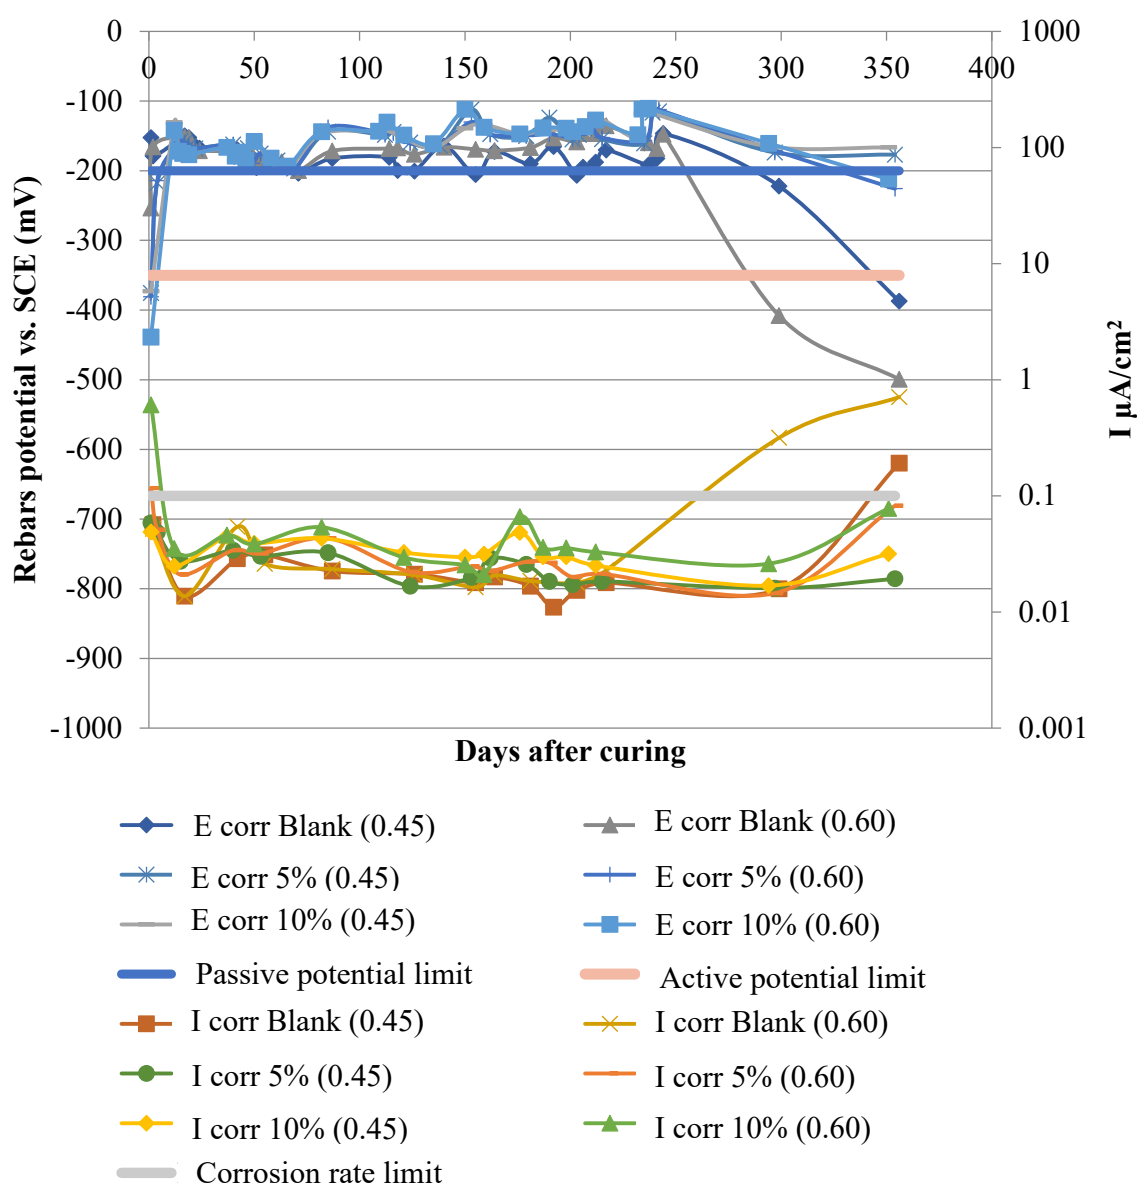
Figure 6 shows the average corrosion potentials and rates as a function of time, after 350 days of exposure to this accelerated test. Note the beneficial effect of polyol clay on the corrosion rate, where the bars for both w/c ratios were active for the blanks in the time where the specimens with partial substitution of cement for polyol clay were passive. Moreover, when the bars in the specimen with w/c 0.45 were activated, those located in the specimen with w/c 0.60 and polyol waste clay had not yet been activated. This effect was expected, given the greater resistance to water penetration in the clay specimens.

Figure 6. Variation of the corrosion rates and potentials as a function of time, of the steel in the specimens exposed to the ISO 11474 accelerated test.

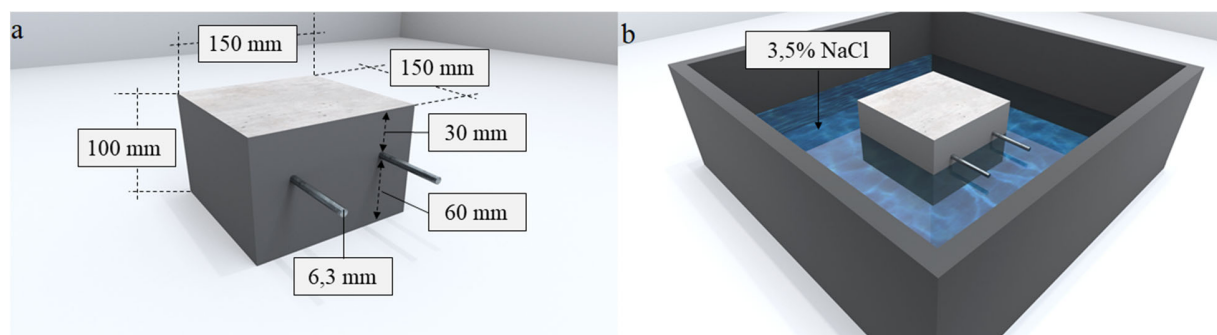
The experimental program consisted of the analysis of the behavior of galvanic sensors installed in prismatic reinforced concrete specimens, with dimensions: (150 x 150 x 100) mm and two CA-50 steel bars with a diameter of 6.3 mm (1/4") placed parallel to each other. Figure 1 illustrates the specimen configuration. For each concrete, 4 specimens were produced, totaling 8 samples.

Figure 1. (a) Configuration of the reinforced prismatic concrete specimen. (b) Partially immersed specimen.
