Revista **ALCONPAT**

Latin American Journal of Quality Control, Pathology and Construction Recovery

Volume 11

Issue 3

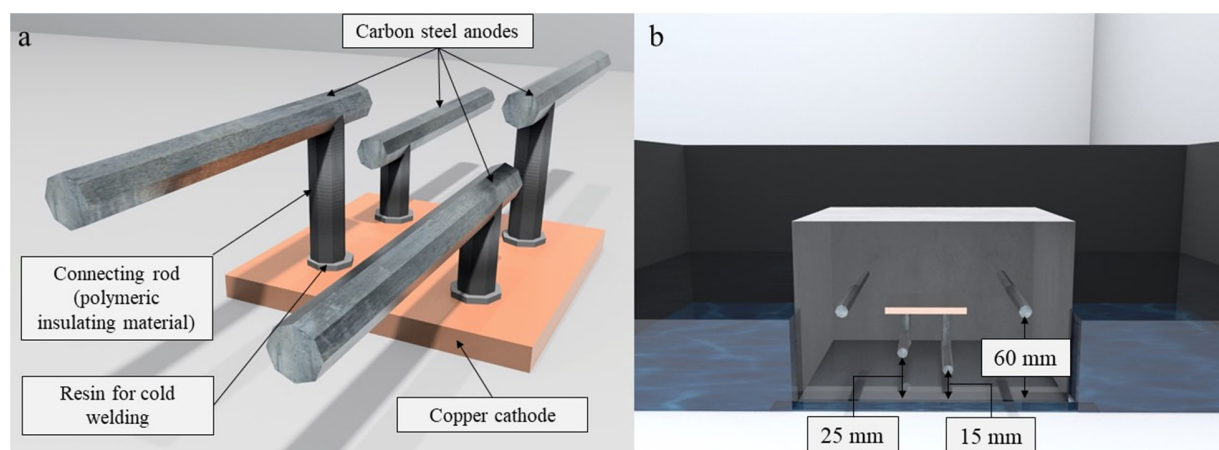
The galvanic macrocell considered in the study is formed by copper and carbon steel. Carbon steel bars 60 mm in length and 6.3 mm (1/4") in diameter (anode) were used at different heights and installed on a copper plate (cathode) 50 by 50 mm and 4 mm thick. All metals were polished with steel brush. Then, they were rinsed with distilled water, immersed in alcohol and air dried. The area of the copper plate that acts as the cathode (A_c) in the galvanic sensor designed in the work was configured so that it was equal to the sum of the surface area of the anodes (A_a) that make up the galvanic macrocell for an A_c/A_a ratio = 0.97. Figure 2 shows a drawing of the galvanic sensor used in the study.

Figure 2. a) Galvanic sensor used in the study. b) Galvanic sensor installed inside the specimen. Source: Author.

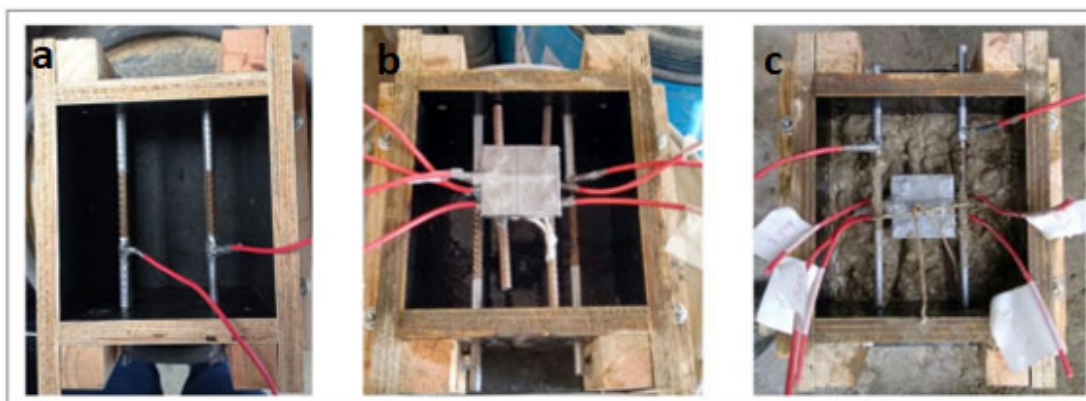
Figure 3. a) Installation of main bars. b) Molds coated with oil and with the sensor positioned. c) Molding with the sensor embedded. Source: Author.

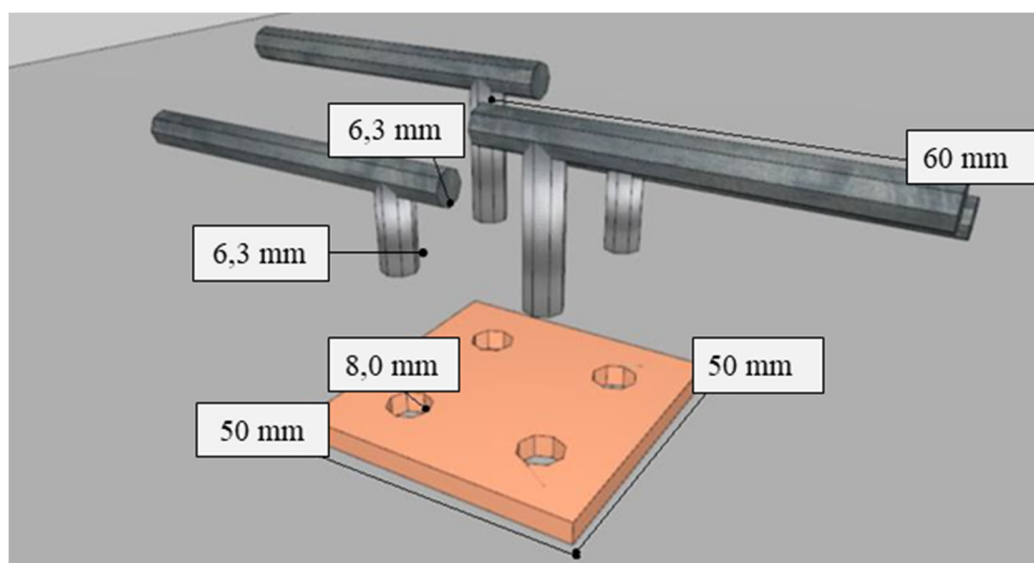
Figure 4. Sensor assembly diagram.

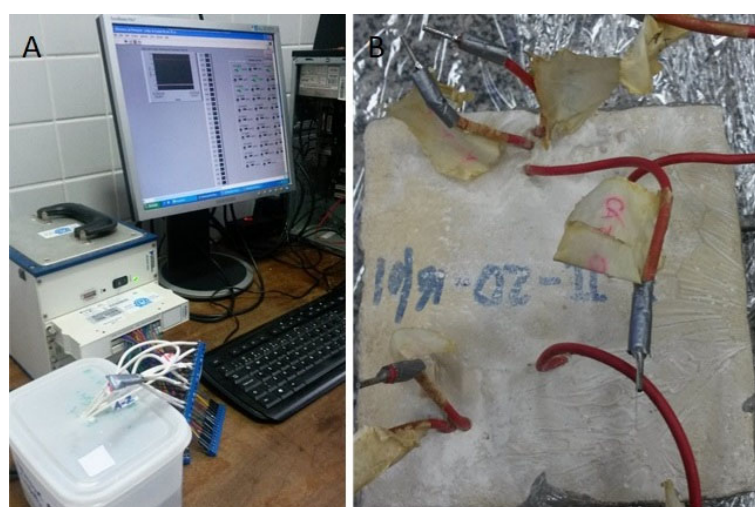
Figure 5. a) LabVIEW 8.5 data logger reading E_{pair} . b) Specimen with electrical pin connectors. Source: Calvo, (2018).

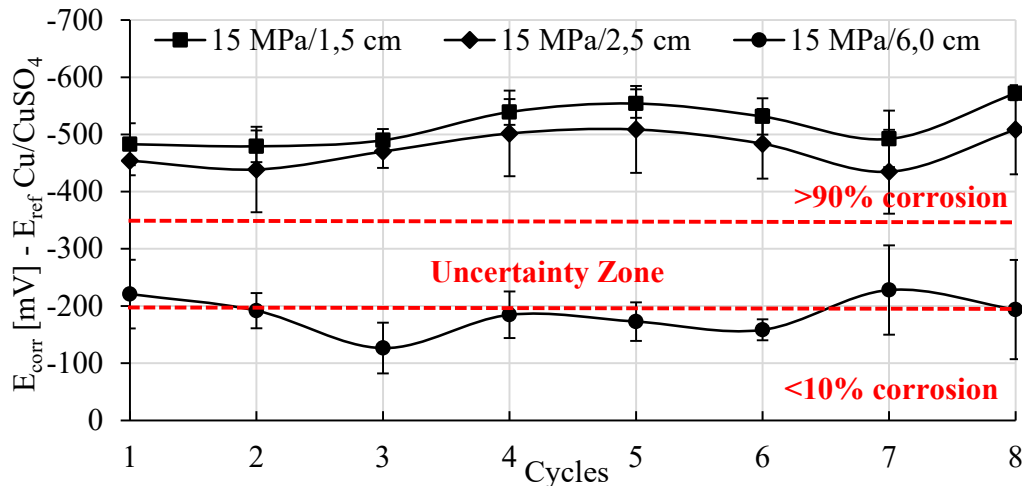
Figure 6. Corrosion potential for the 15 MPa mix. Source: Author.

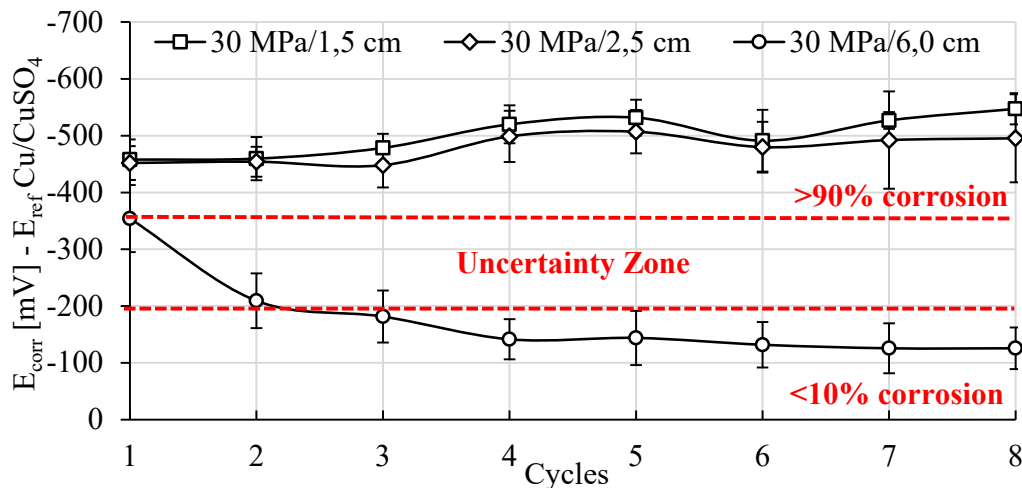
Figure 7. Corrosion potential for the 30 MPa mix. Source: Author.

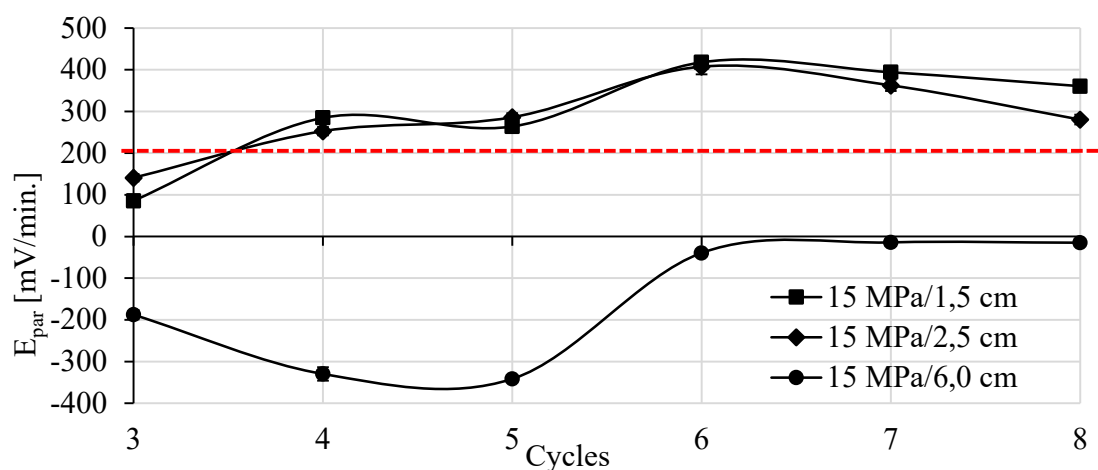
Figure 8. Pair potential for the 15 MPa mix. Source: Author.

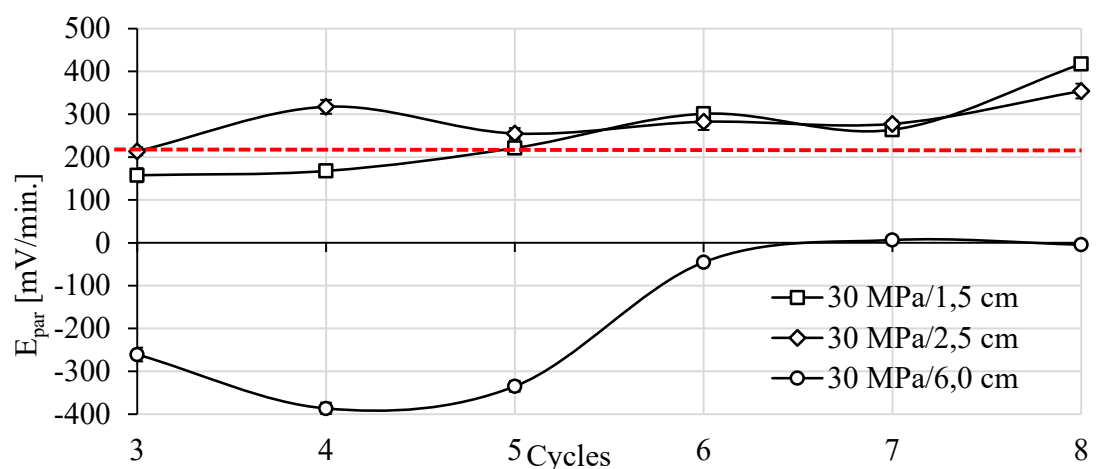
Figure 9. Pair potential for the 30 MPa mix. Source: Author.

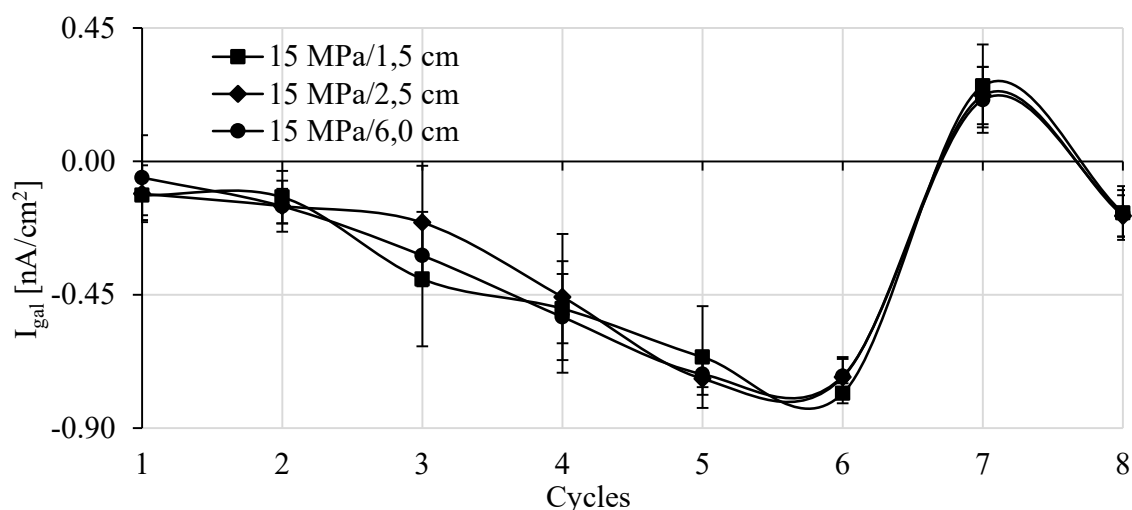
Figure 10. Galvanic current for the 15 MPa mix. Source: Author.

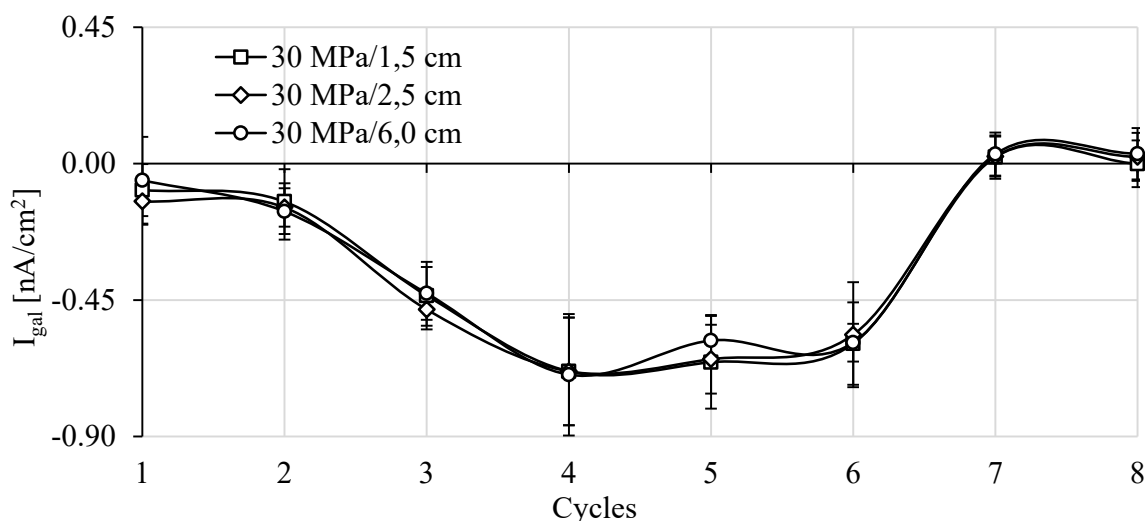
Figure 11. Galvanic current for the 30 MPa mix. Source: Author.

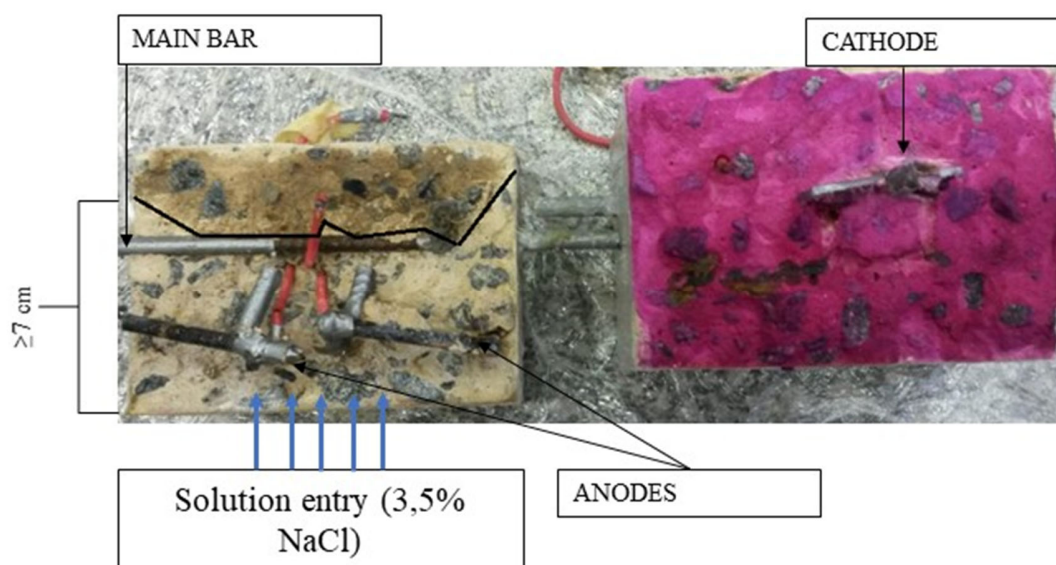
Figure 12. Colorimetric test (chloride penetration and carbonation) in the specimen after the end of monitoring.

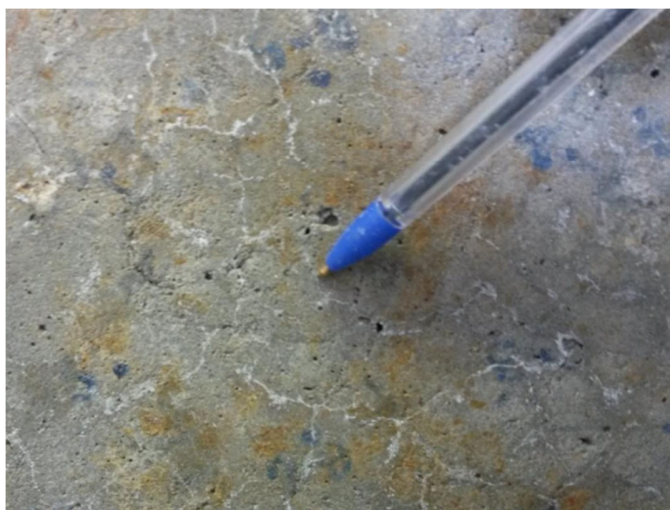
Figure 13. Microcracks in specimens.

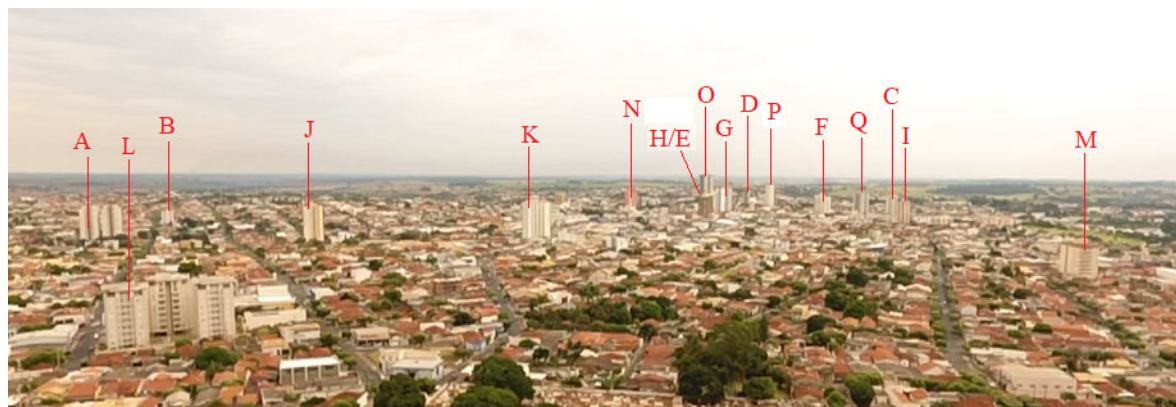
Figure 1. Multi-storey residential buildings studied (panoramic view)

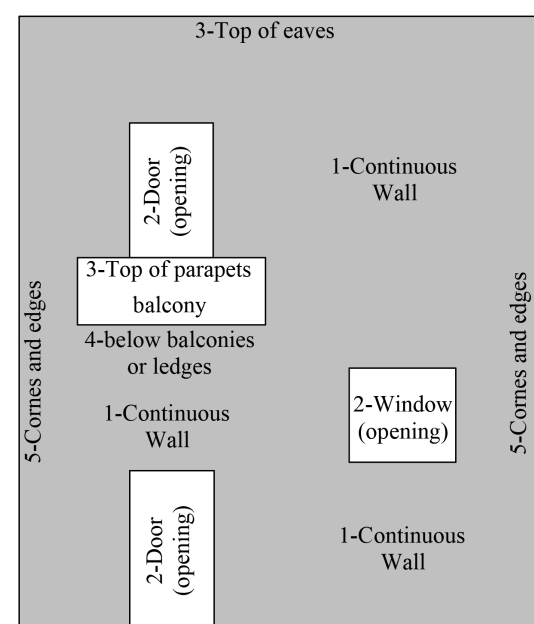
Figure 2. Typified regions of the facade
Source: Gaspar and Brito (2005) - modified by the Author

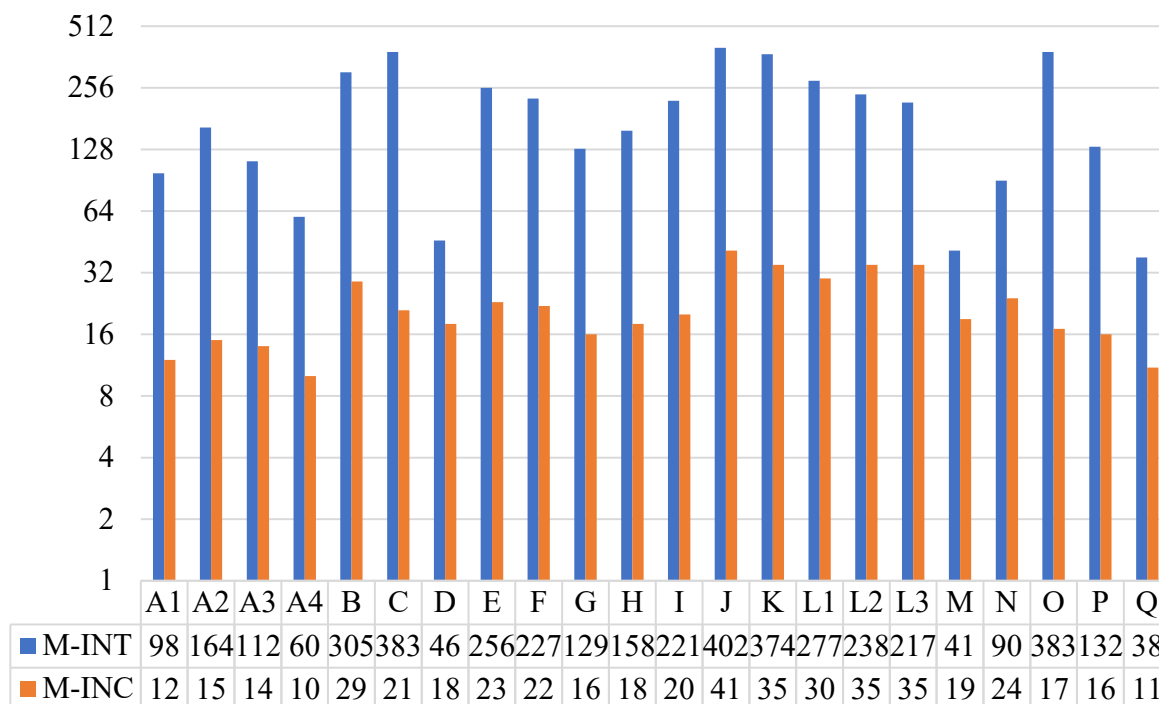
Figure 3. Number of BDs per building and quantification method

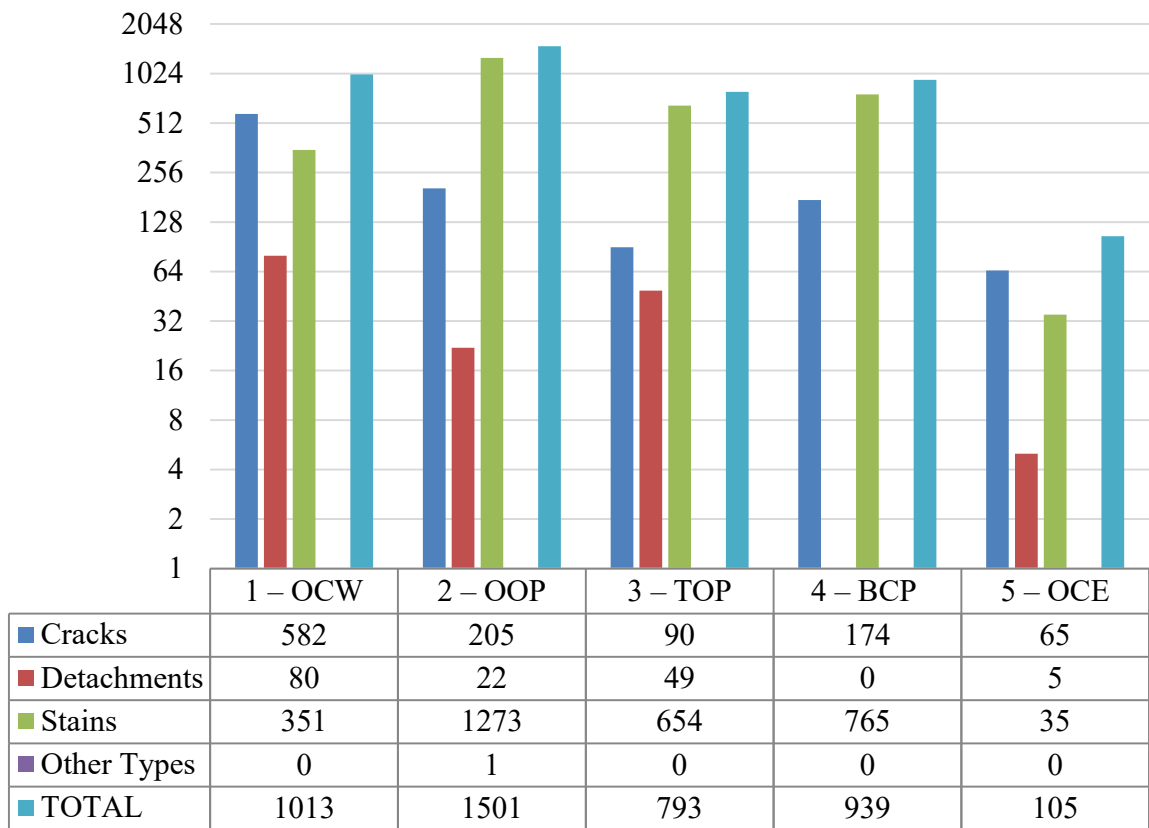
Figure 4. Location of BDs by group and location - Intensity Method

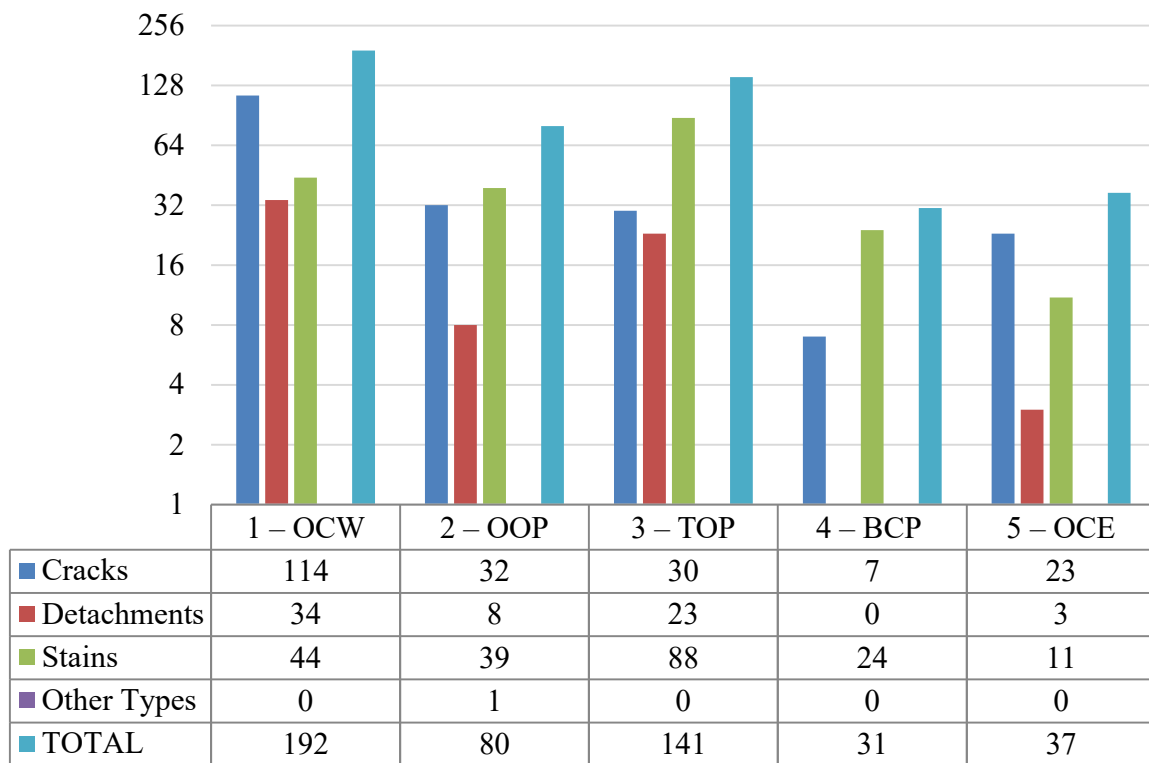
Figure 5. Location of BDs by group and location - Incidence Method

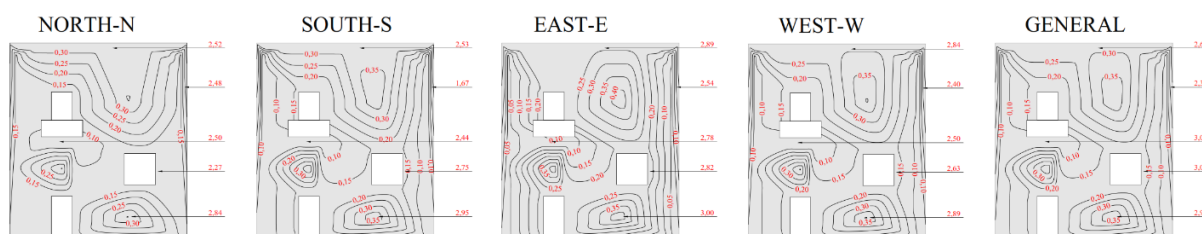
Figure 6. Map of Probability of occurrence of BDs - Incidence Method
 OBS: values on the right represent the average level of degradation of each typified region

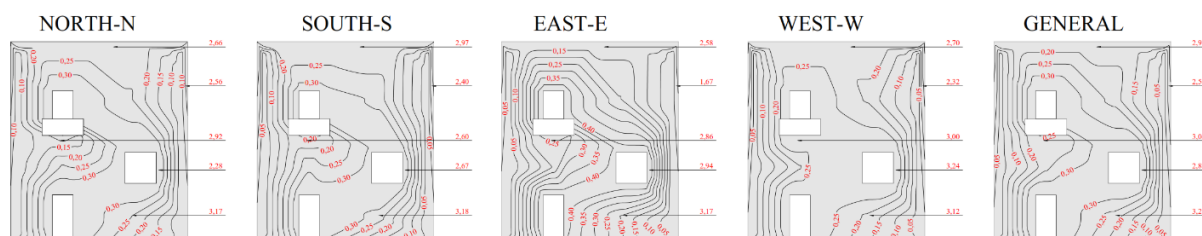
Figure 7. Map of Probability of occurrence of BDs - Intensity Method
 OBS: values on the right represent the average level of degradation of each typified region

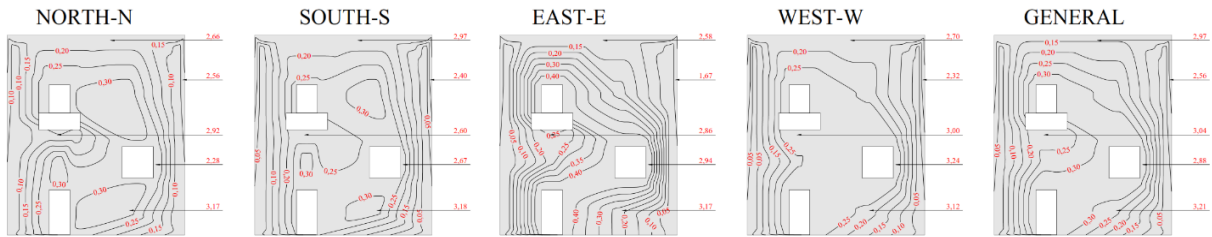
Figure 8. Potential Map of Degradation of the Region - Incidence Method
 OBS: values on the right represent the average level of degradation of each typified region

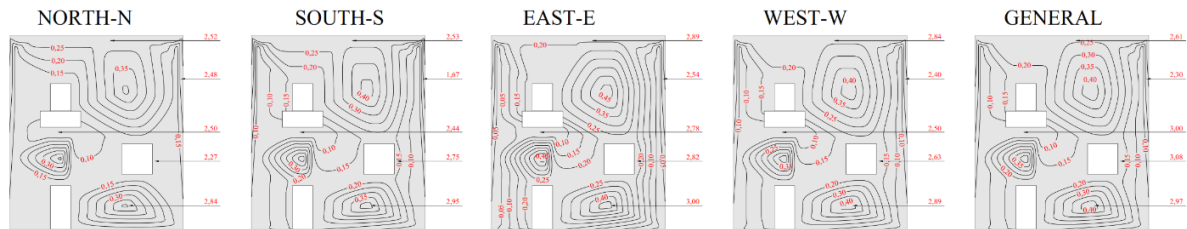
Figure 9. Potential Map of Degradation of the Region - Intensity Method
 OBS: values on the right represent the average level of degradation of each typified region

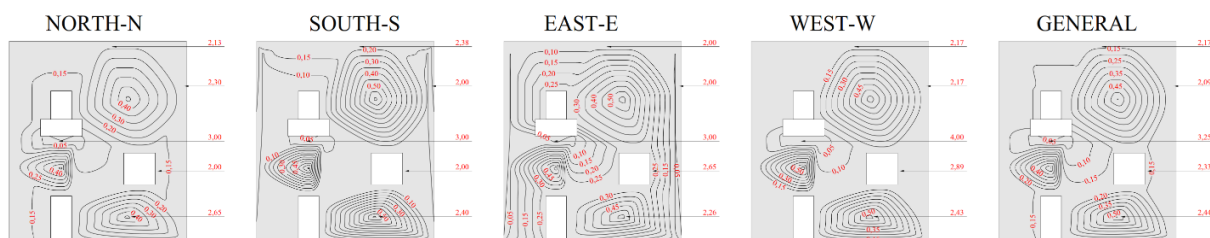
Figure 10. Sensitivity to crack formation - Incidence Method
 OBS: values on the right represent the average level of degradation of each typified region

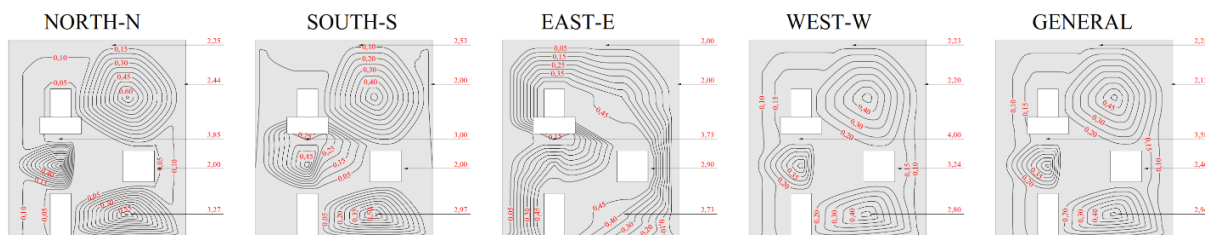
Figure 11. Sensitivity to crack formation - Intensity method
 OBS: values on the right represent the average level of degradation of each typified region

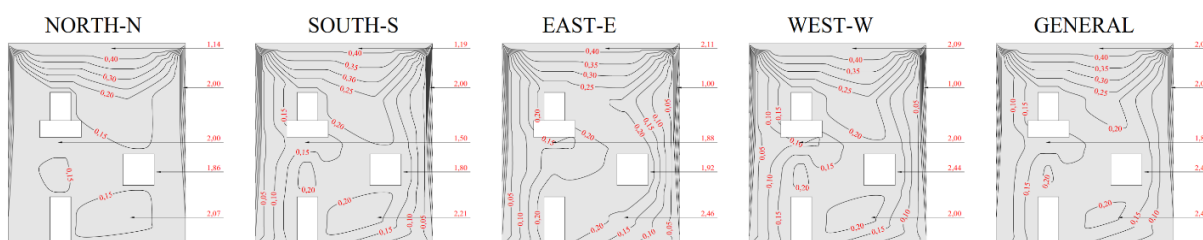
Figure 12. Sensitivity to staining - Incidence method
 OBS: values on the right represent the average level of degradation of each typified region

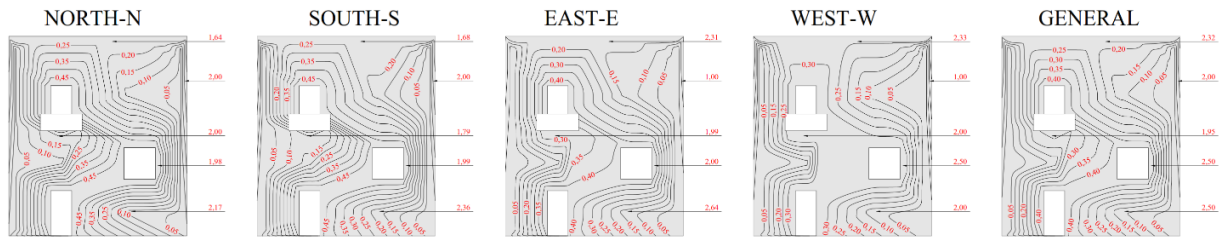
Figure 13. Sensitivity to staining - Intensity method
 OBS: values on the right represent the average level of degradation of each typified region

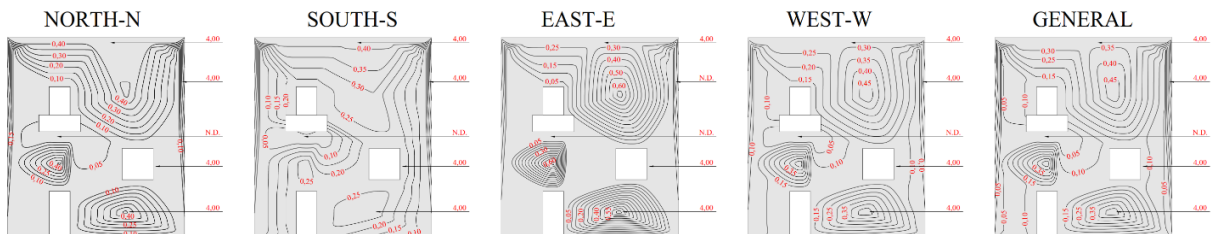
Figure 14. Sensitivity to the formation of detachments - Incidence Method
 OBS: values on the right represent the average level of degradation of each typified region

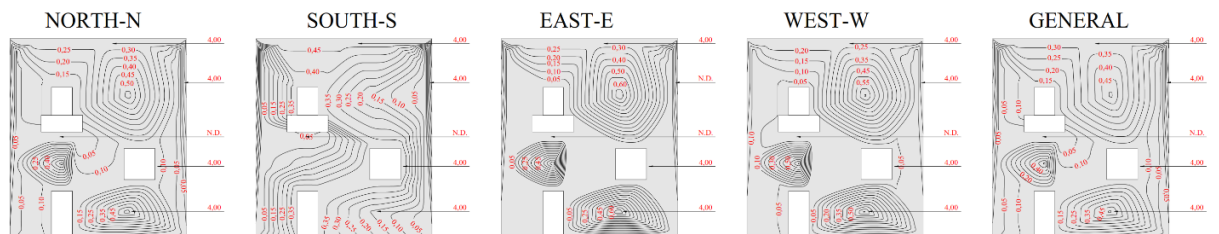
Figure 15. Sensitivity to the formation of detachments - Intensity method
 OBS: values on the right represent the average level of degradation of each typified region

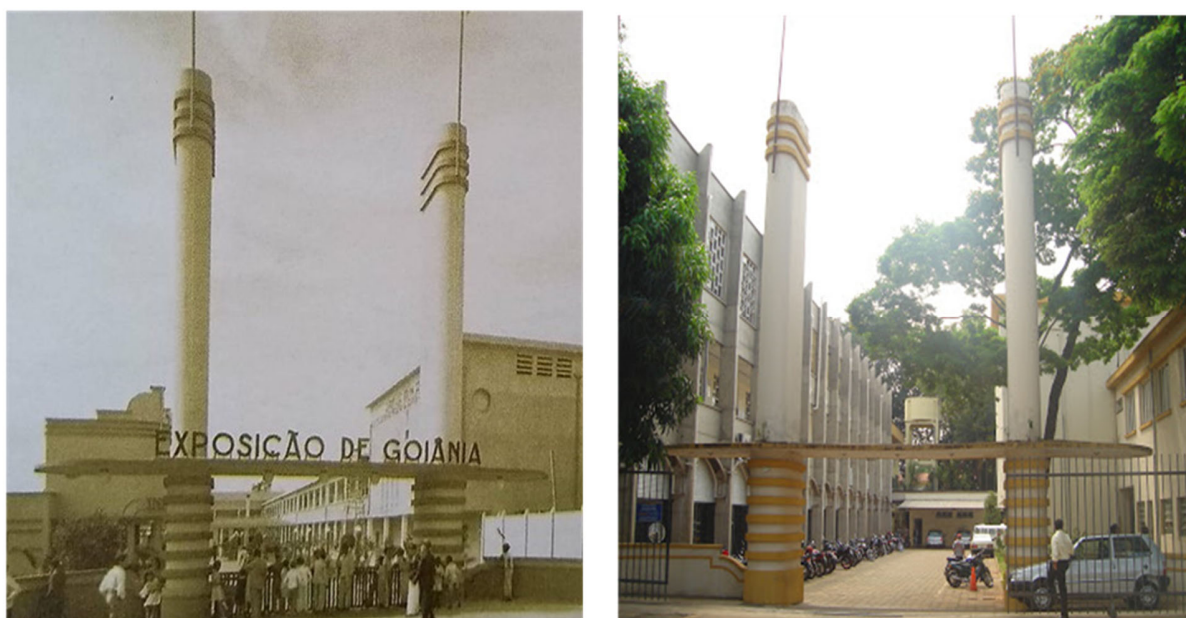
The Portico is a reinforced concrete structure coated with mortar. The structure is made of two pillars of approximately 12 meters high and a slender slab with an ellipsoidal shape with a thickness of around 8 centimeters. The pillars are similar, each pillar has at its top and its base, respectively, three and seven friezes equidistant from each other, as can be seen in Figure 4.

Figure 4. View of the Portico of the Cultural Baptism of Goiânia in 1942, on the left (Galli, 2007) and in 2002 (IFG Collection)

A typical feature of the Art Deco style observed in the Portico architecture is the use of aerodynamics and sinuosity. In the pillars of the Portico there are similarities with the geometry of the chimneys of the 20th century ocean liners, a typical characteristic of the Art Deco style. Another feature observed is the use of reinforced concrete as a prominent object, bringing volume to the structure, conveying a sensation of grandeur and modernity.

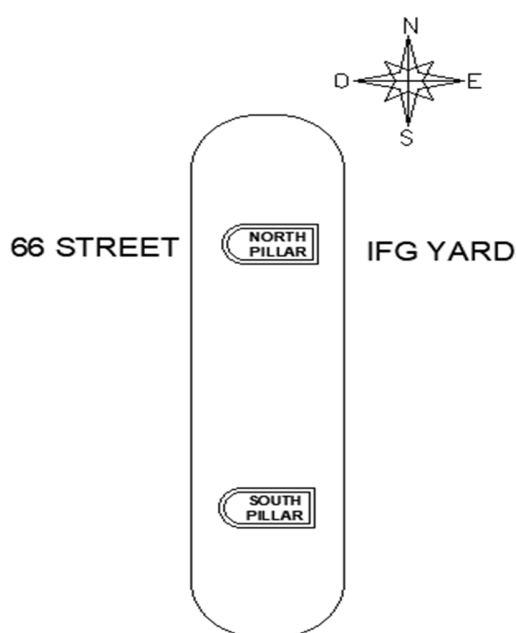
Figure 5. Portico floor plan

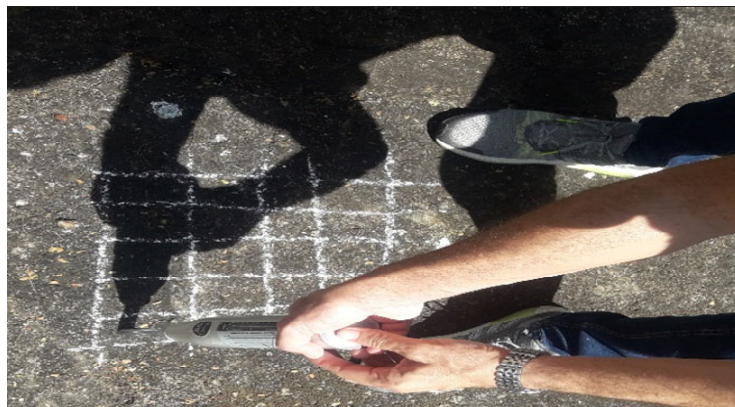
The sclerometer test was performed in four regions of the slab. Locations where there was no segregation of concrete and with homogeneous and regular surfaces were sought. Figure 7 shows the test execution and Figure 8 illustrates the location of the tested areas along with their dimensions.

Figure 7. Carrying out the sclerometer test

The test execution followed the guidelines of the NBR 7584 (ABNT, 2012).

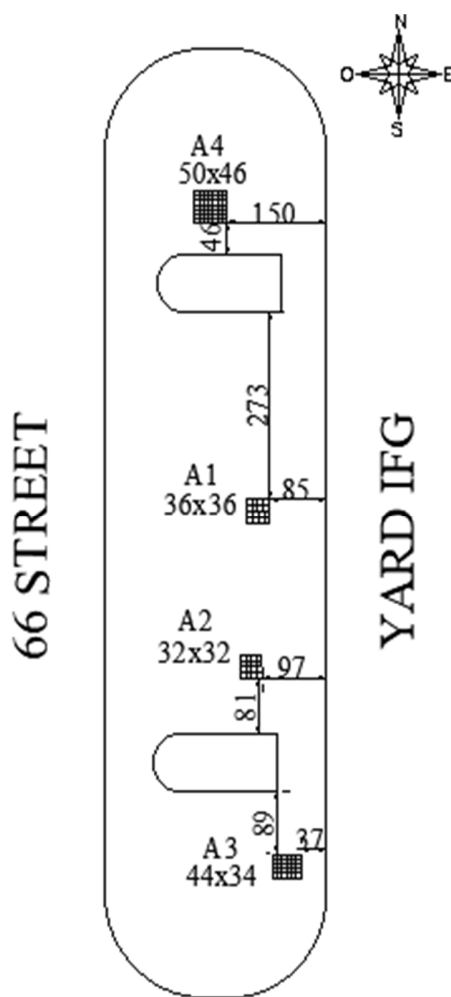
Figure 8. Location of the tested areas for the sclerometer test

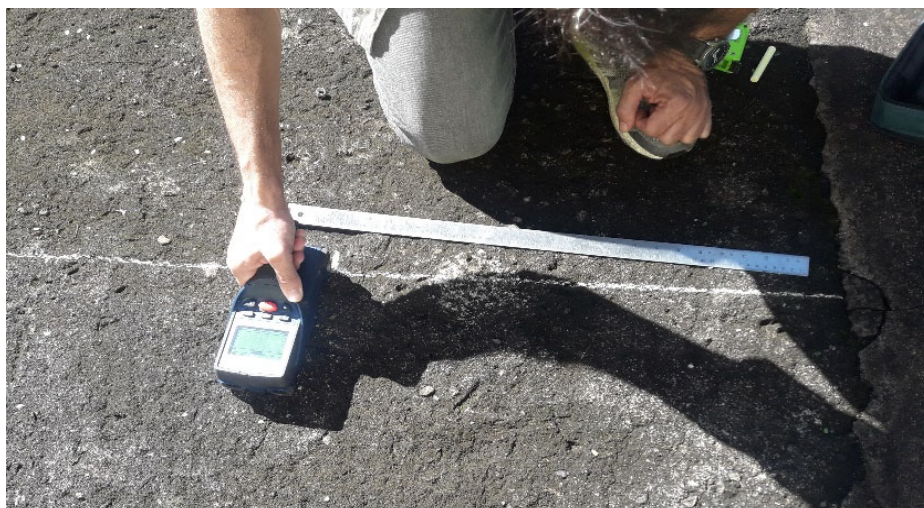
Figure 9. Carrying out the cover meter test

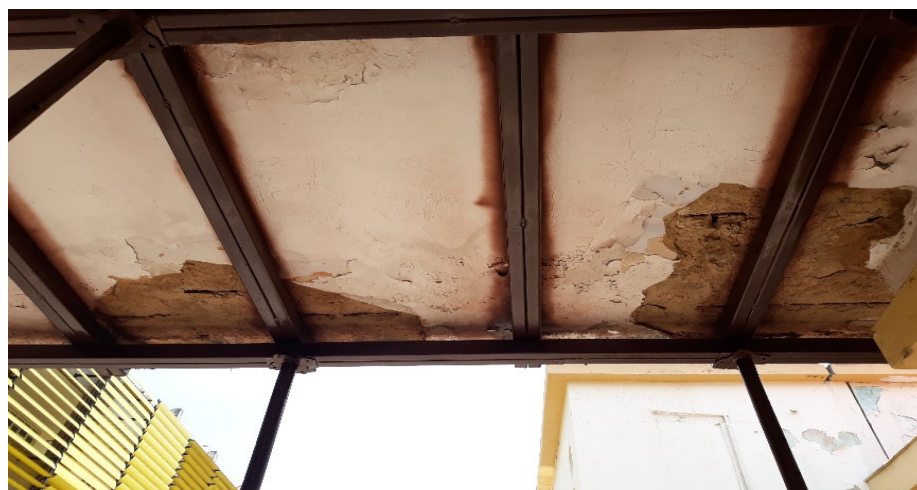
Figure 10. Detachment of concrete at the bottom of the slab

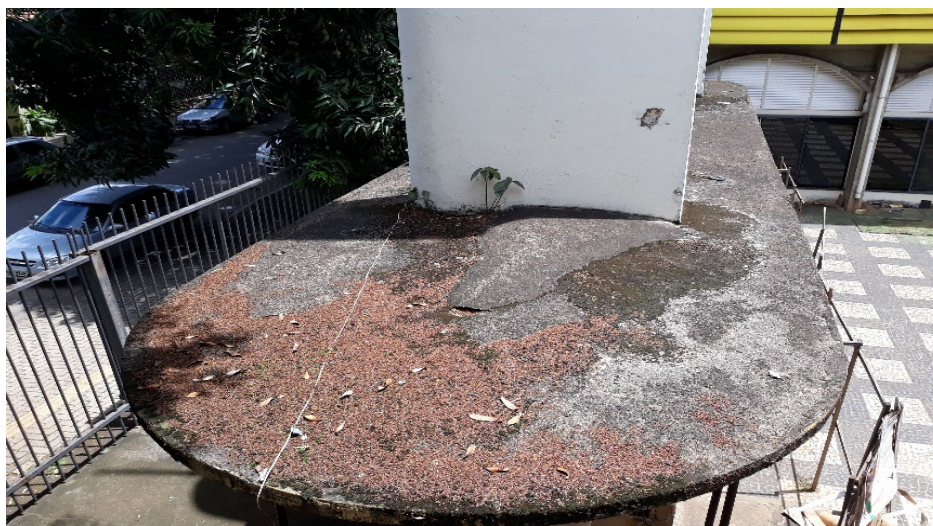
Figure 11. Mold and dirt on the slab

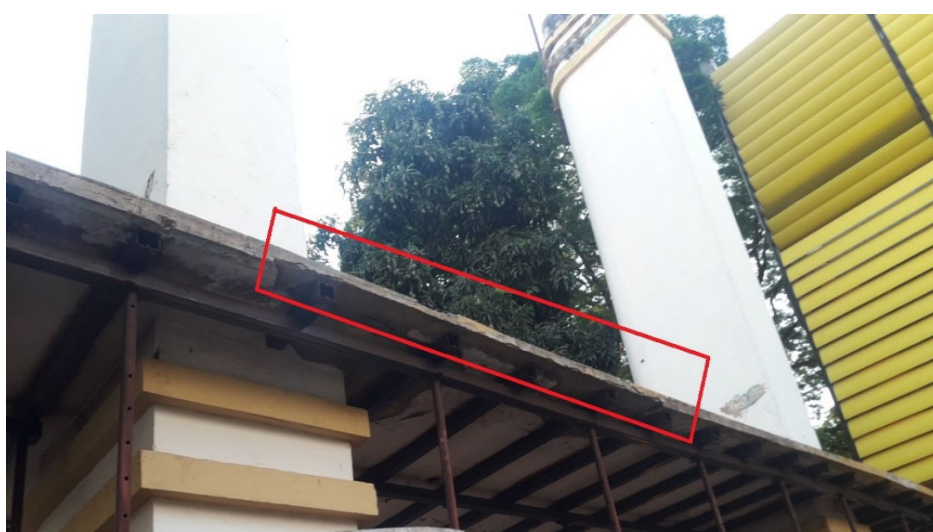
Figure 12. Detachment of the edge of the slab

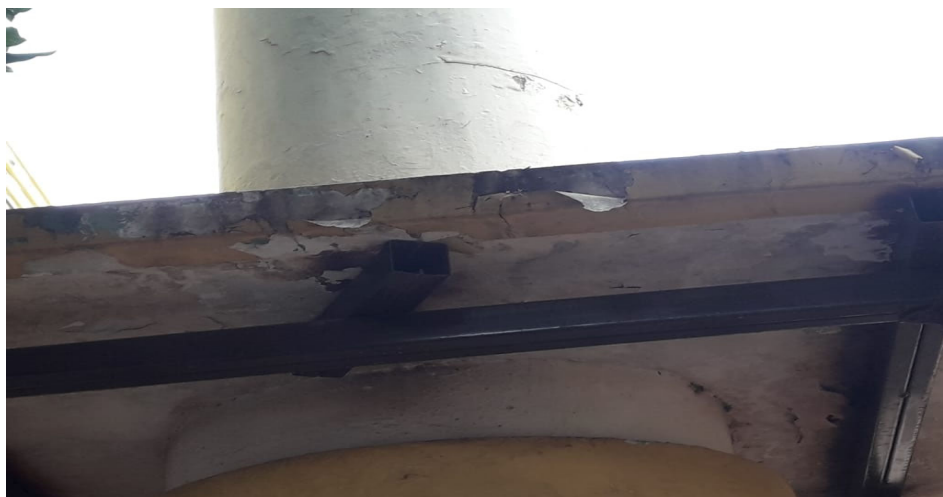
Figure 13. Detachment of the slab paint.

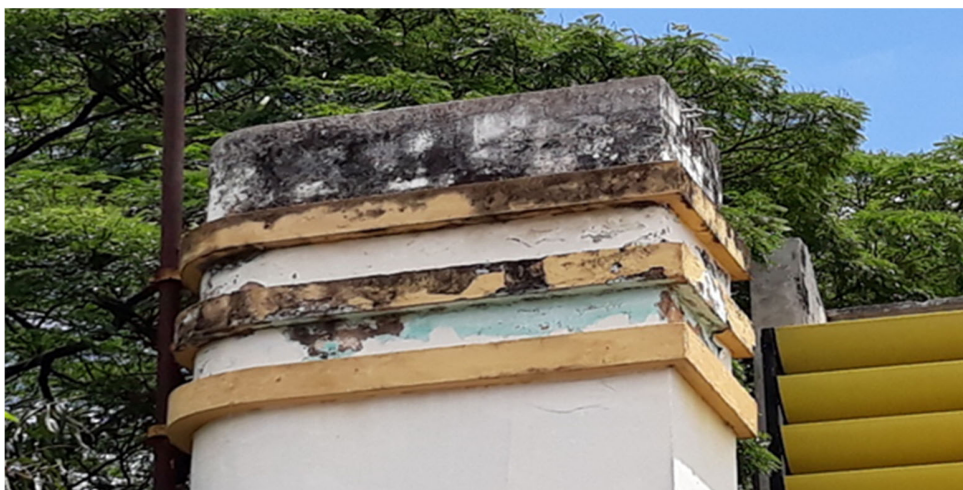
Figure 14. Dirt and detachment of the paint on top of the pillar

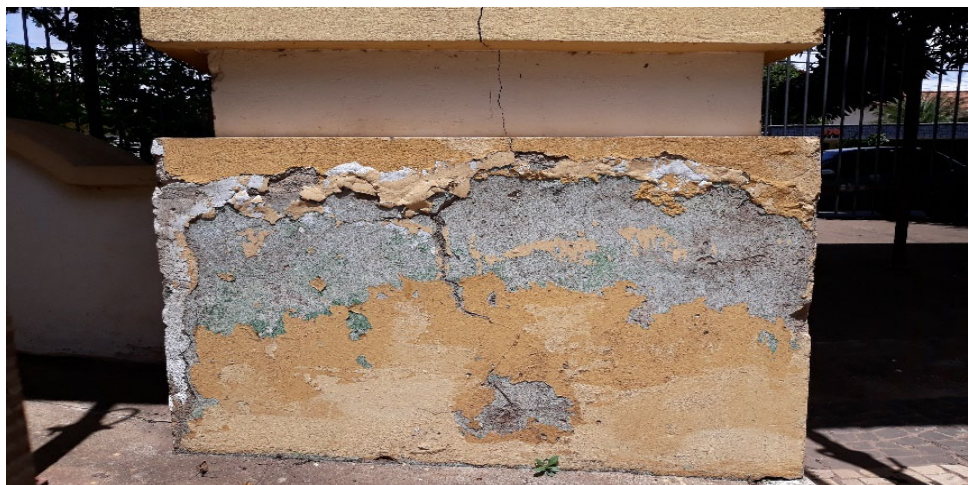
Figure 15: Incidence of cracks and paint discoloration

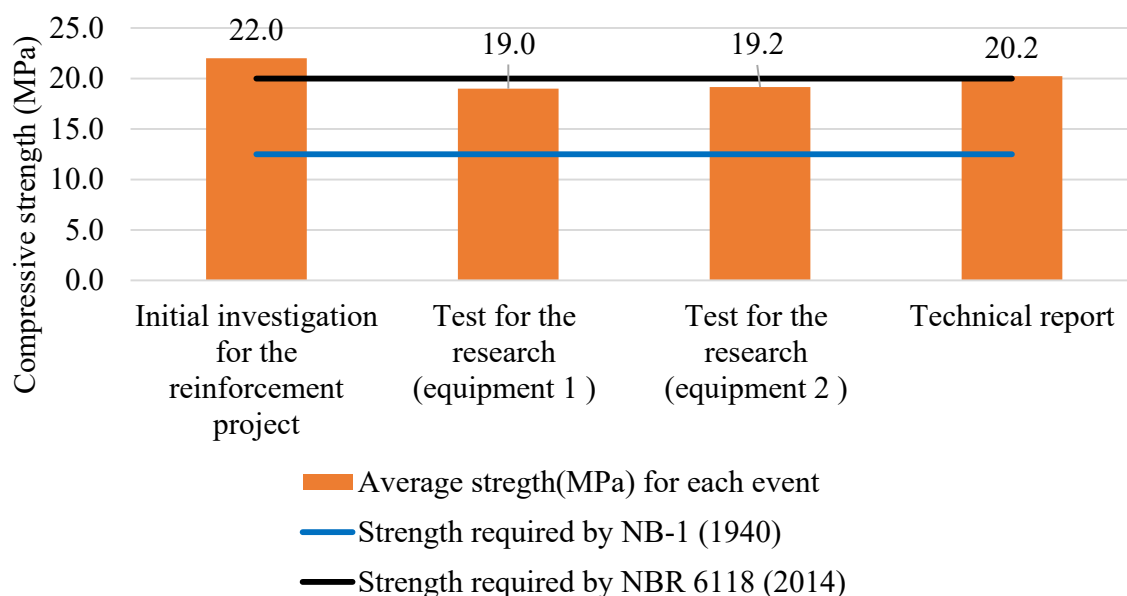
Figure 17. Comparative graph of strength obtained with normative requirements

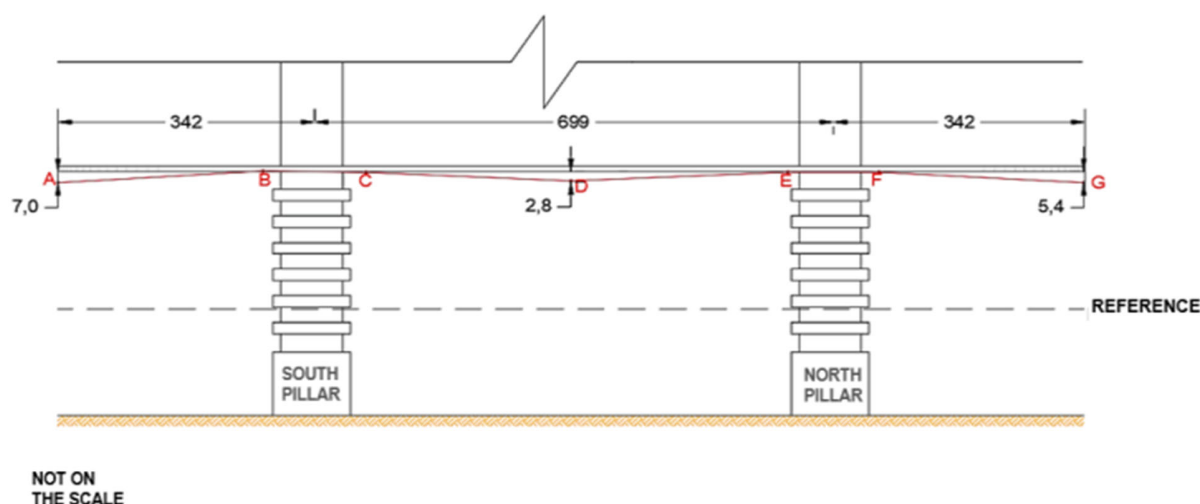
Figure 18. Representation of the biggest slab deflections verified
