# Revista **ALCONPAT**

Latin American Journal of Quality Control, Pathology and Construction Recovery

Volume 12

January - April 2022

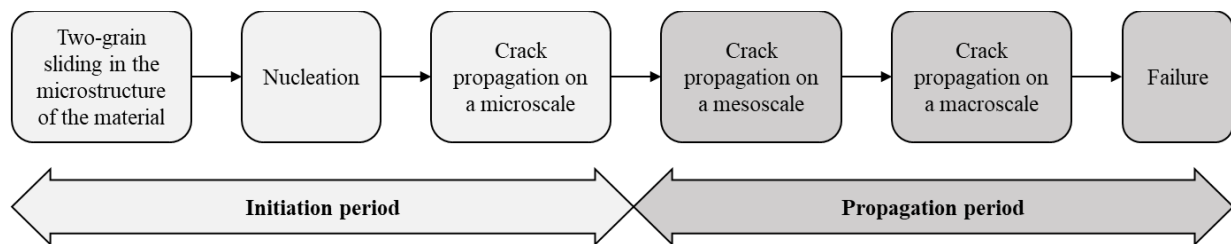
Fatigue life is usually classified into two stages: the nucleation of cracks, sometimes called initiation, and their propagation. In the nucleation period, the microstructural growth of cracks is observed but only with insignificant dimensions thus disregarded in the quantification of damage. On the other hand, the propagation period is characterized by the development of cracks at mesoscale. Figure 1 shows the phases that compose the fatigue life, considering aspects related to the material cracking.

Figure 1. Fatigue life stages associated with concrete cracking.

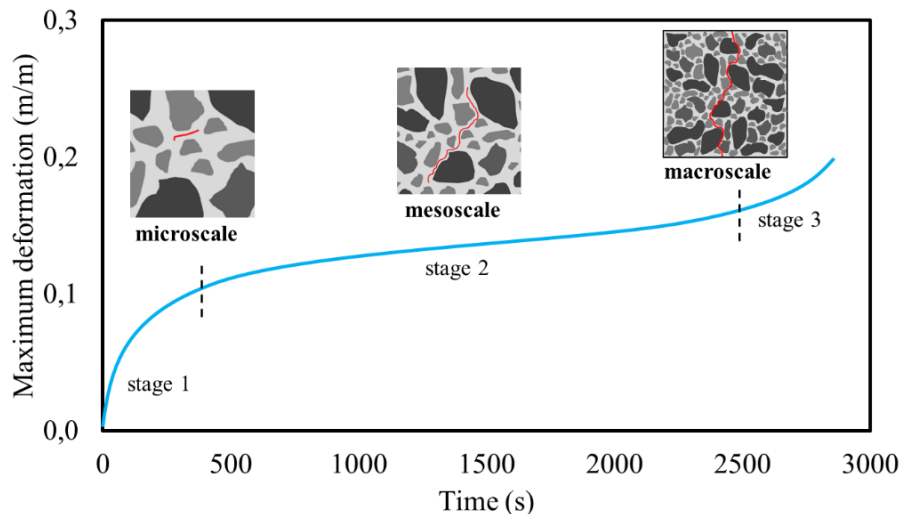
In this sense, three stages characterize the fatigue damage of concrete, from the nucleation of the first micro-crack till rupture (as seen in Figure 2): (i) crack initiation, in which microcracks arise in discontinuities of the crystal structure due to stress concentration or in pre-existing material discontinuities; (ii) crack propagation, due to the energy accumulation at the ends of existing cracks; and (iii) failure, an abrupt rupture due to its quasi-brittle nature.

Figure 2. Development of cracks in concrete due to cyclic loading as function of time and maximum strain.

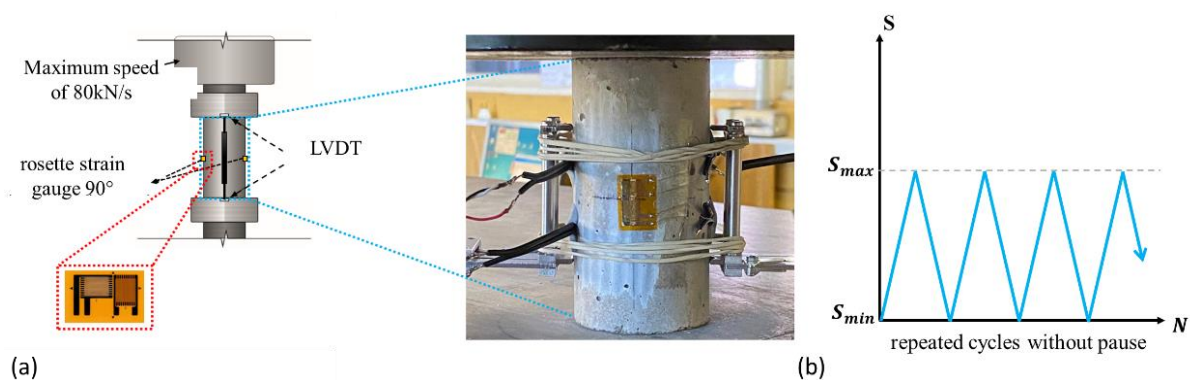
The servo-hydraulic system has an electronic control that receives analog signals from up to six different channels - load, displacement, or strain gauge. Figure 4a shows the adopted design for two rosette strain gauge and two LVDT, used in the specimens. Figure 4b shows the scheme used for the load controlled cyclic loading. Two configurations were defined for maximum load – 50% and 70% of the compressive strength ( $f_c$ ), and the minimum load was always 0 kN, thus the ratio between the minimum and maximum stress  $R$  is 0.00 for both cases.

Figure 4. Arrangement (a) of instrumentation and (b) of cyclic loading.

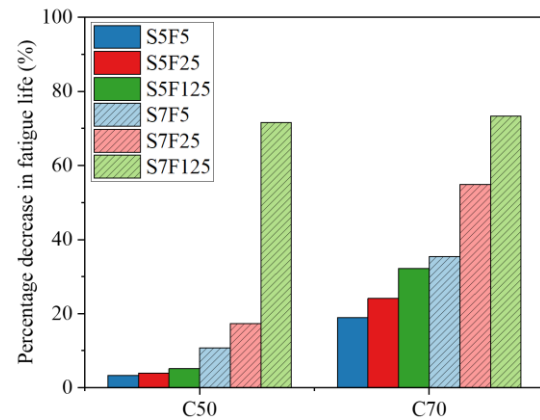
Figure 9 shows the decrease in fatigue life for concretes C50 and C70 when compared to C30, when the same loading frequency and maximum stress is applied. Thus, there is positive relationship between the compressive strength of concrete and its fatigue life, especially for high-strength concretes (C50 and C70). The influence of compressive strength on fatigue life was investigated by Al-Gadhib et al. (2000) and by Kessler-Kramer et al. (2003), where authors indicate that concrete is more prone to damage as strength is increased, and this can be linked to its fatigue behavior.

Figure 9. Variation of fatigue life of concrete C50 and C70 compared to C30.

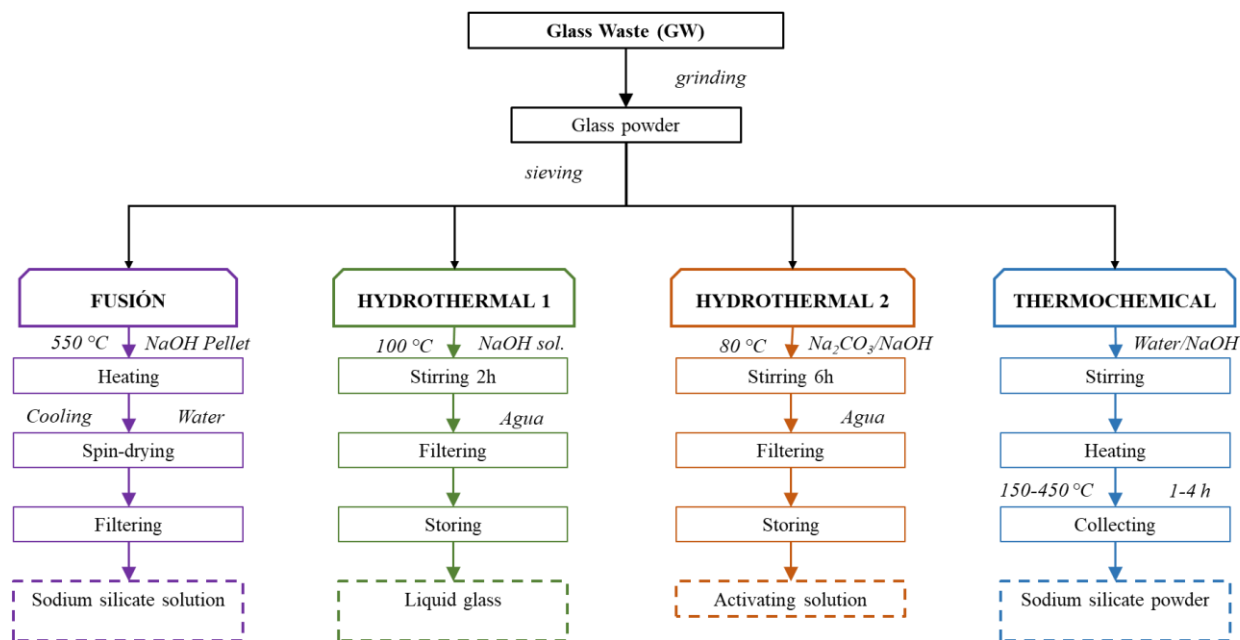
For GW, various chemical GW compositions can be found, although the most notable one is the amorphous state and a high percentage of silica. Since 2014, the potential of GW for manufacturing activators has been studied. The  $\text{SiO}_2$  percentages in GW fall within the 65-80% range with significant CaO and  $\text{Na}_2\text{O}$  contents (Liu et al., 2019). Several approaches have been performed to prepare the AA, as shown in Figure 3. They include melting, hydrotherma, and thermochemical methods. It has been shown that the nature and rate of formation of cementitious hydrates depend primarily on the precursor type.

Figure 3. Methods to obtain alternative activators from glass waste (GW) (adapted from Lie et al., 2019).

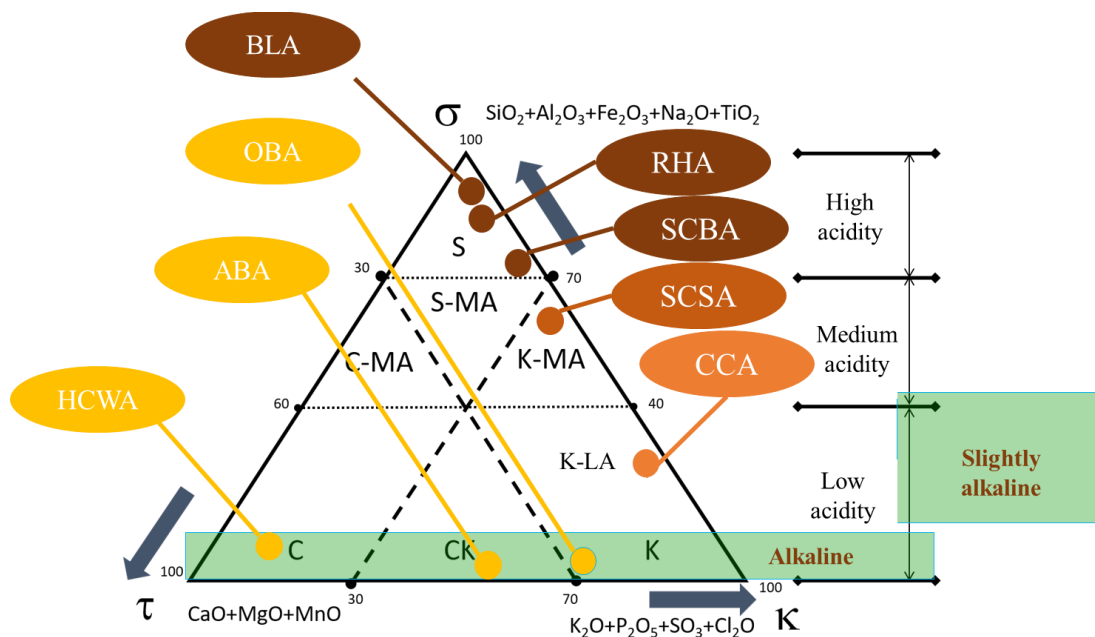
Employing biomass ashes is an interesting alternative for synthesizing sustainable activators. The ternary diagram in Figure 4 illustrates an extended version of the Vassilev diagram (Vassilev et al., 2010) of the biomass ashes classification. Reactivity zones have been modified, and different ashes have been represented. In zone S (top of the diagram) we see a set of ashes that are potentially very acidic and can supply a high percentage of silicates to alternative activators: RHA, BLA and sugar cane bagasse ash (SCBA). In an intermediate situation (Zone K-MA), we find sugar cane straw ash (SCSA) whose composition contains other elements that reduce its contribution to silicate formation. Finally in low-acid materials (Zone K-LA), we find CCA, with limited silicon contribution and a high proportion of potassium. At the bottom of the diagram, where more alkaline oxides are involved, basically CaO (far left) and K<sub>2</sub>O (far right), three zones stand out: the "C" zone, which is characteristic of ashes with high calcium content, such as HCWA; the "K" zone, with a high proportion of potassium oxide, as in ABA; finally, the intermediate "CK" zone, where OBA is found.

*Key: olive stone ash (OBA); almond shell ash (ABA); high calcium wood ash (HCWA); corn cob ash (CCA); sugar cane straw ash (SCSA); sugar cane bagasse ash (SCBA); rice husk ash (RHA); bamboo leaf ash (BLA).*

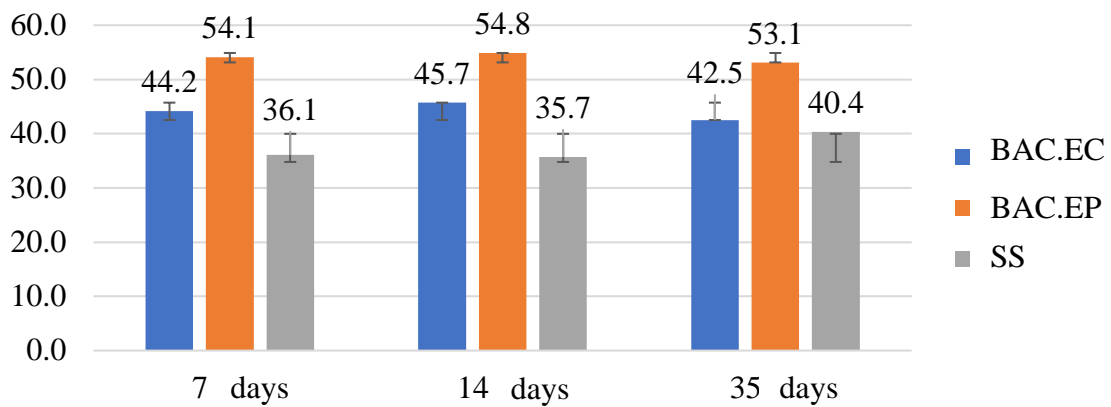
Compressive strength results are shown in Figure 4. Overall, compression strength levels were similar over time within each formulation, likely due to the type of cement having high strength at initial ages. The largest change in strength over time occurred for formulations SS, which varied 4.7 MPa (11.63%) between 13 days and 35 days. This was likely the result of C-S-H being produced within the matrix since its activation did not depend on fissuring (Giannaros *et al.*, 2016). However, there were significant differences in strength between formulations. Formulation BAC.EC presented the highest strength, 12.7 MPa more than the other formulations at 35 days. This was probably a result of perlite having lower density than clay but both materials being added with similar granulometries.

Figure 4. Average compression strength (MPa) of the formulations of this study.

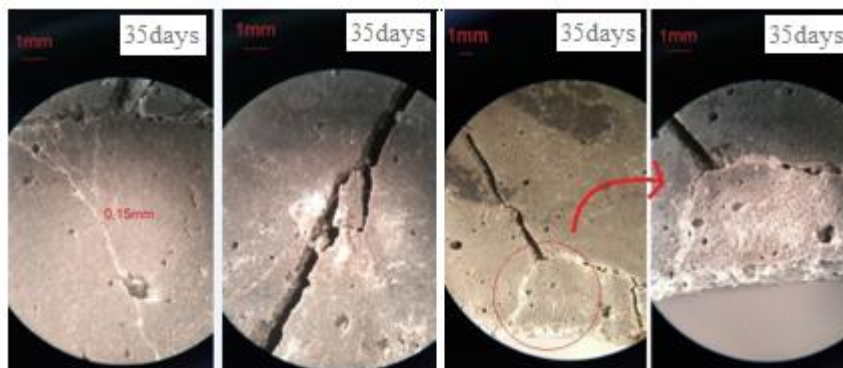
Selected surface visual analyses of formulation BAC.EP are shown in Figure 5. Healing products were observed in secondary fissures and in surface deposits. Visual analysis indicated that fissure opening limited healing as no healing products were observed in the main fissures of Figure 5. This was in agreement with other studies which observed healing only in narrower fissures (Zhang *et al.*, 2016; Jiang *et al.*, 2020). Visual analysis also noted that healing occurred in plaques, attributed to the presence of calcite produced from bacterial solutions (Schwantes-Cezario *et al.*, 2018; Alghamri *et al.*, 2016).

Figure 5. Sel-healing in formulation BAC.EP – Sample 1.

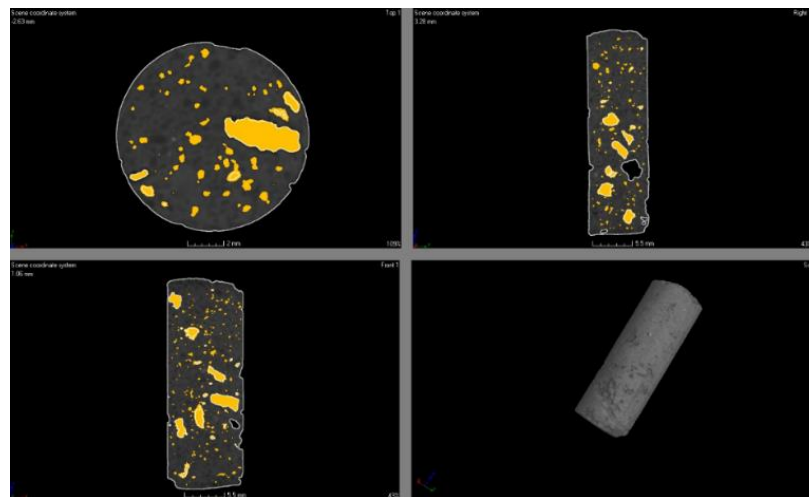
spaces were determined as 11.45% in volume of the test body, which reinforced the compression strength results as porous materials tend to have lower resistance (Yang; Jiang, 2003).

Figure 9. 3-D Microtomography results of formulation BAC.EP.

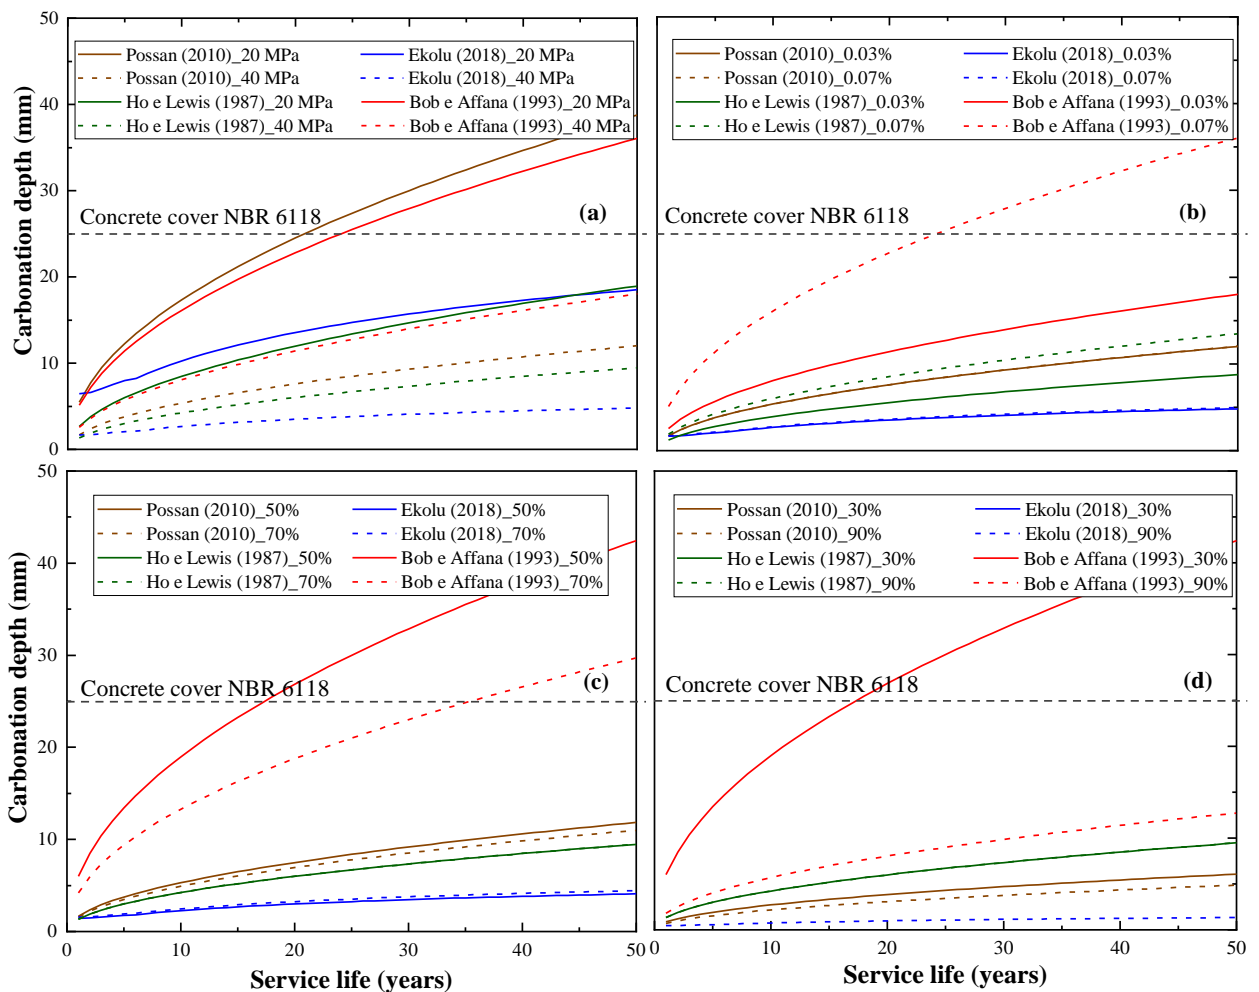
Figure 2. Service life and carbonation depth in relation to compressive strength - Scenario A - (a), carbon dioxide in the environment - Scenario B - (b), relative humidity of 50 and 70% - Scenario C - (c) and relative humidity of 30 and 90% - Scenario C - (d).

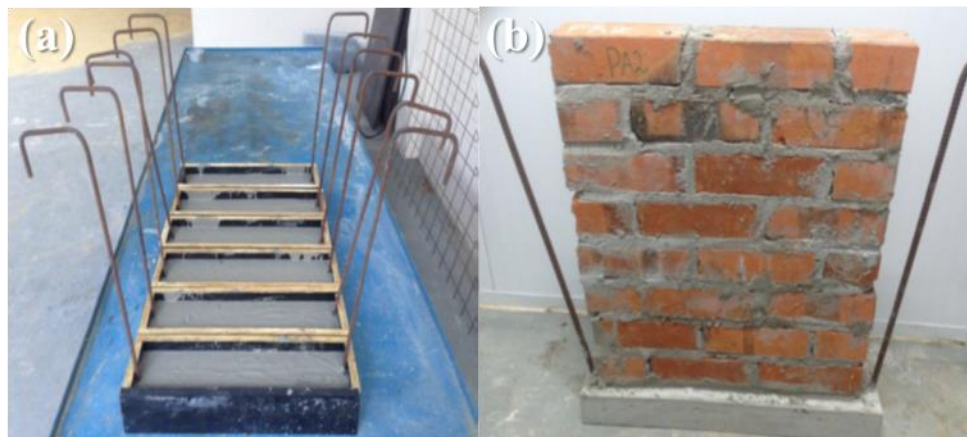
Figure 2. (a) Base of the wall and (b) Finished wall.

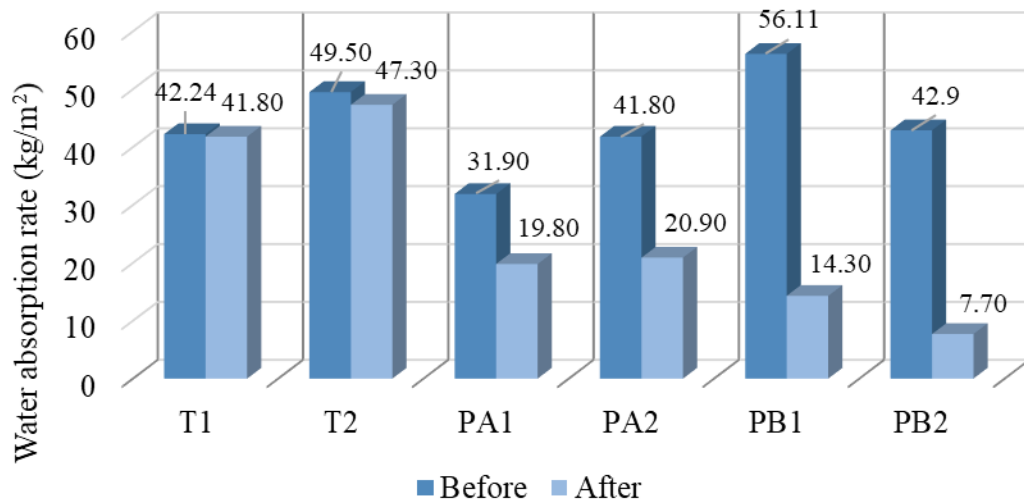
Figure 5. Mass measurement and water absorption rate before and after treatment.

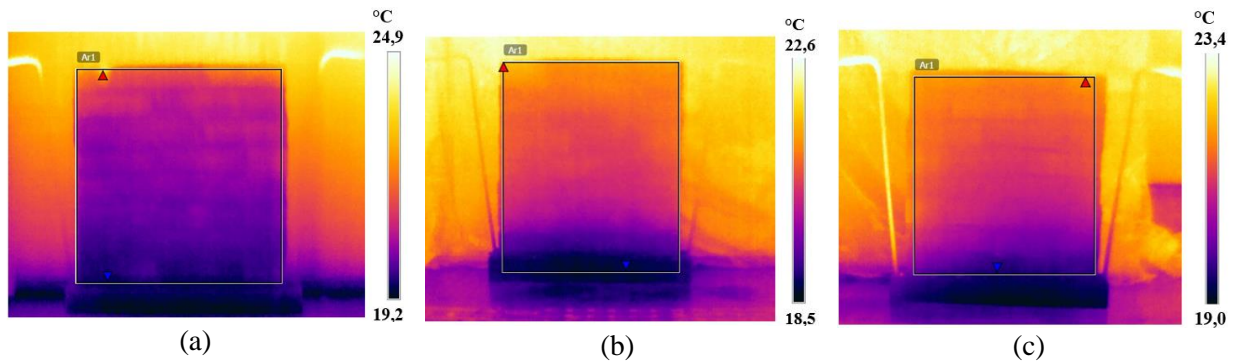
Figure 9. Sample PA1: a) dry wall; b) humid wall; and c) wall at 28 days

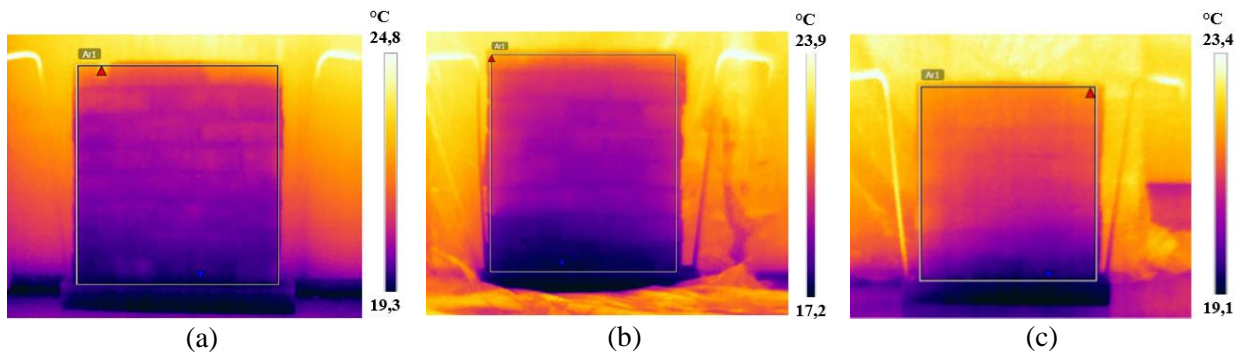
Figure 10. Sample PA2: a) dry wall; b) humid wall; and c) wall at 28 days

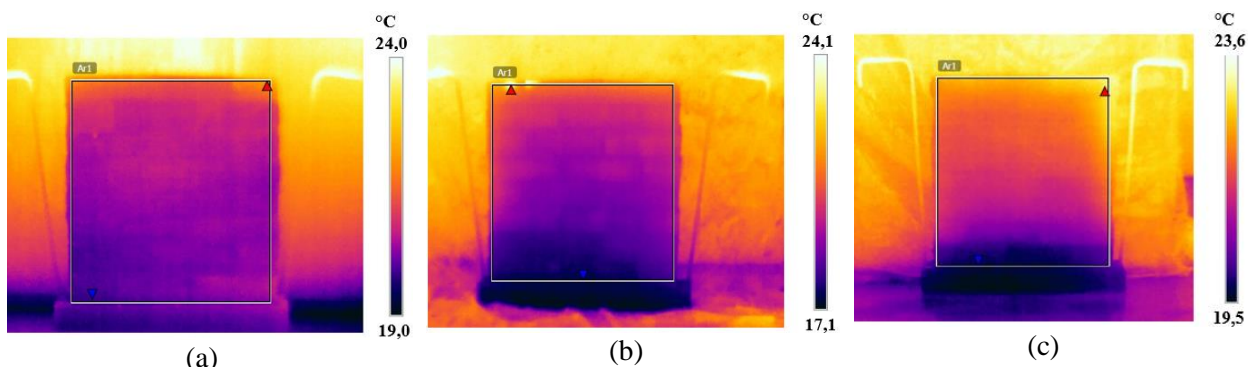
Figure 12. Sample PB2: a) dry wall; b) humid wall; and c) wall at 28 days

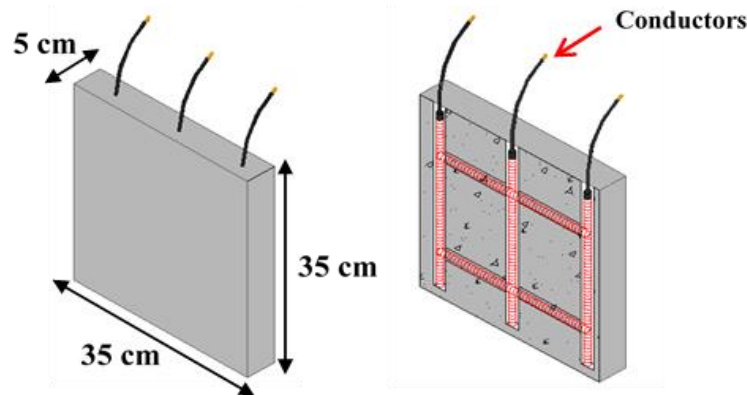
Figure 2. Schematic representation of the test specimen configuration.

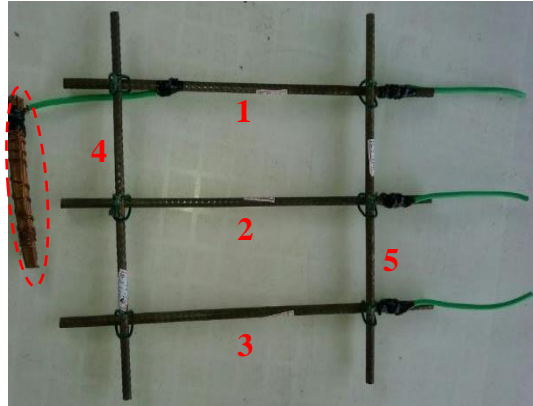
Figure 3. Organization and connection of the steel bars.

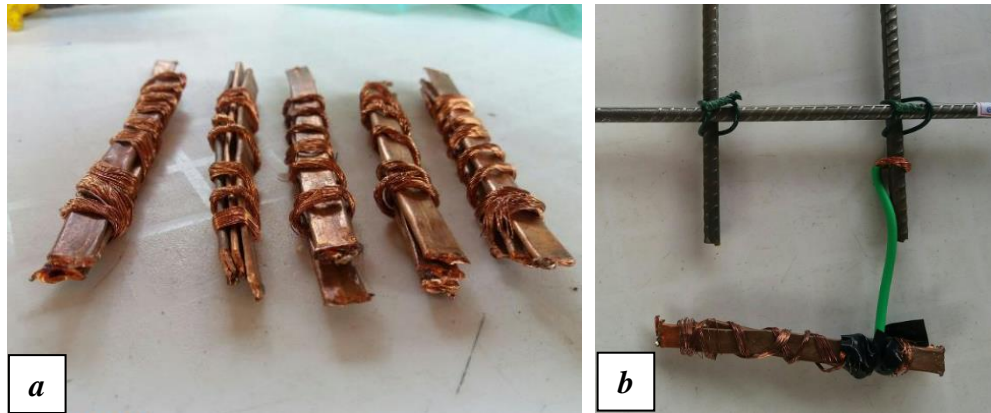
Figure 5. (a) Copper used to induce galvanic corrosion; (b) Material connected to the steel mesh.

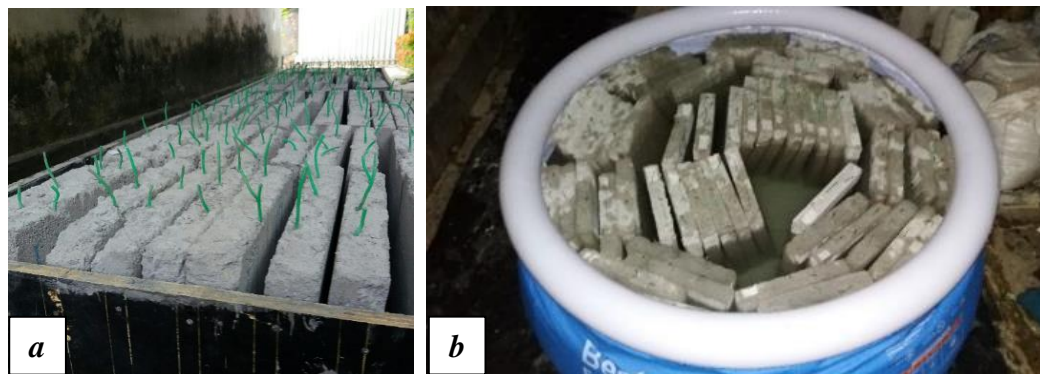
Figure 6. (a) Cast concrete specimens; (b) Concrete slabs in NaCl solution for induction of chloride ions.

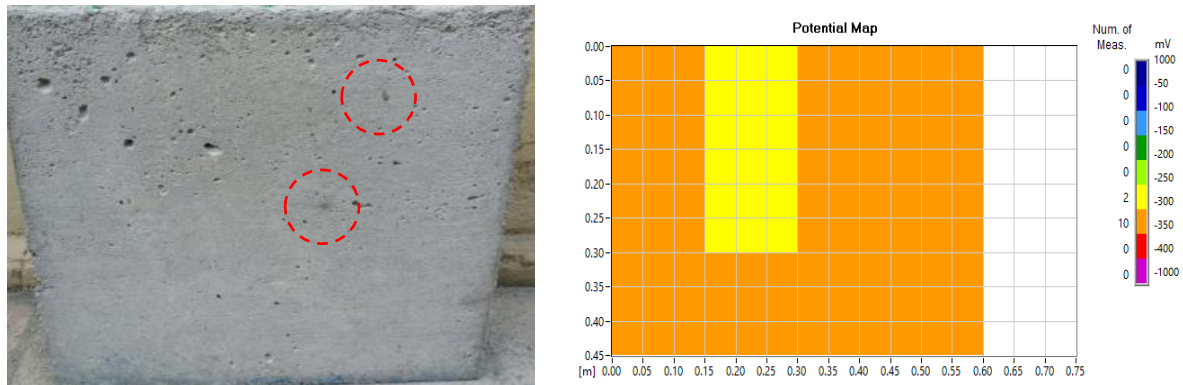
Figure 8. (a) "Absorption" of corrosion products through the pores; (b) Map of corrosion potential (no severe effects apparent).

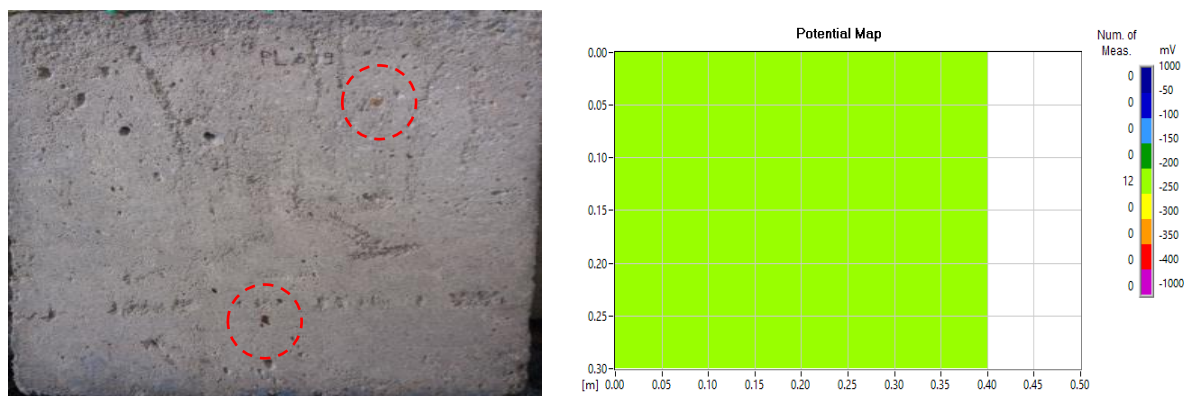
Figure 9. (a) "Absorption" of corrosion products through the pores; (b) Map of corrosion potential (no severe effects apparent).

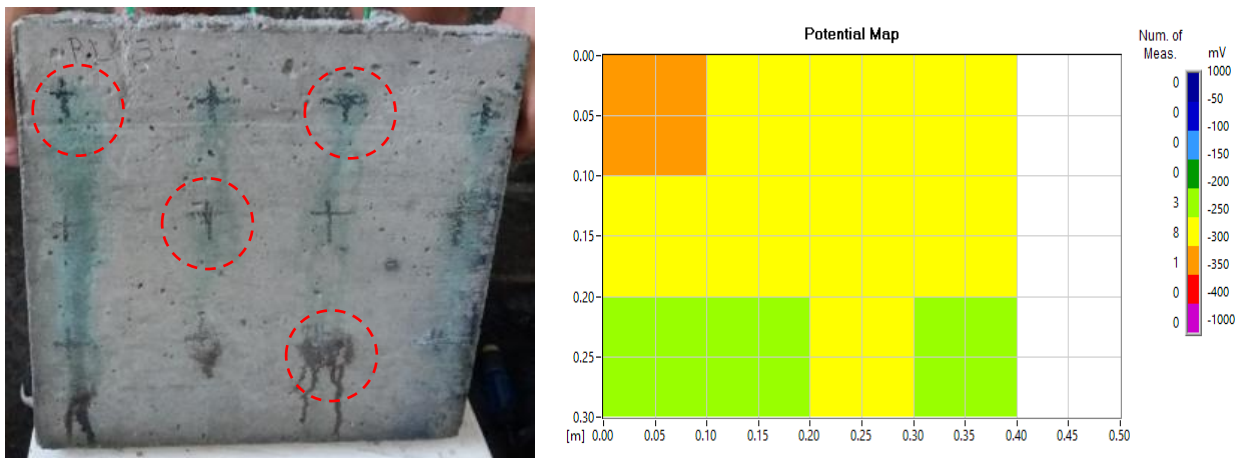
Figure 12. (a) Effects of surface degradation on the concrete slabs; (b) Map of corrosion potential (mild effects).

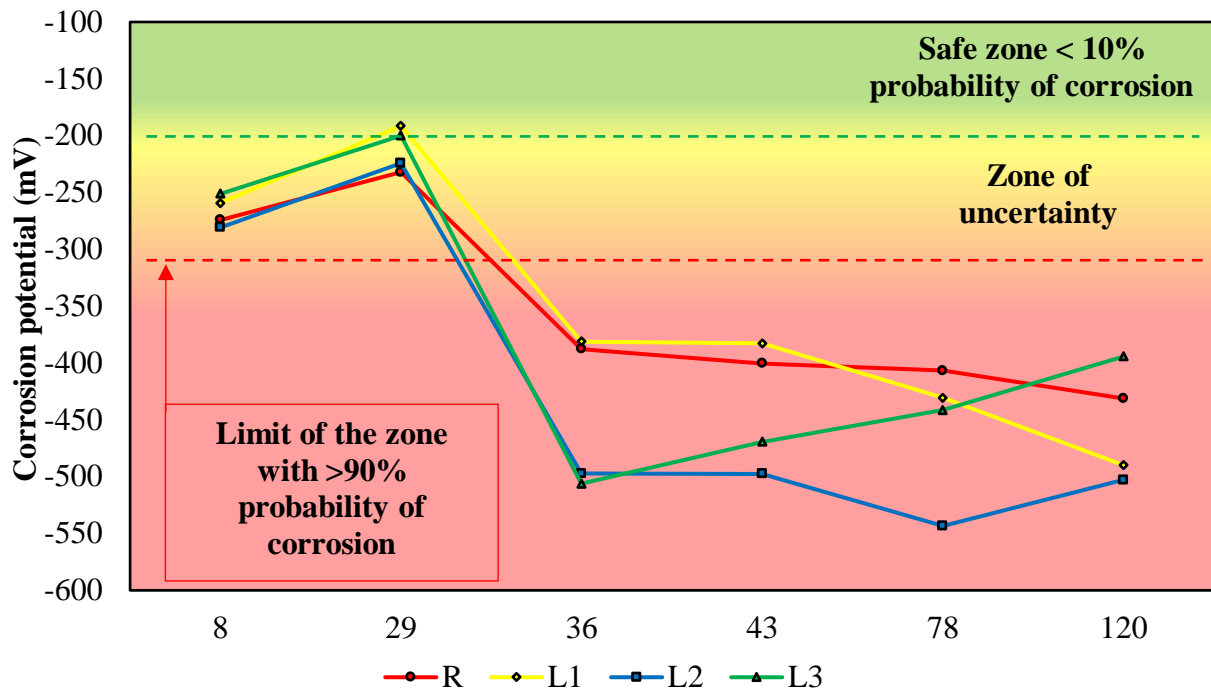
Figure 15. Behavior of the average corrosion potential of the families over time.

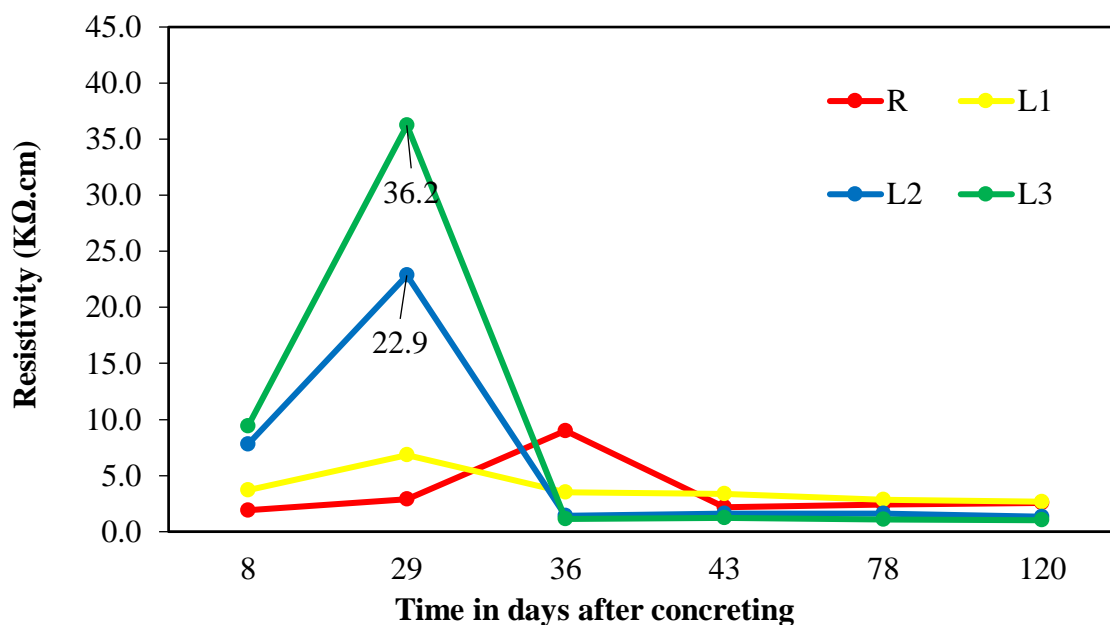
Figure 17. Behavior of concrete surface resistivity over time.

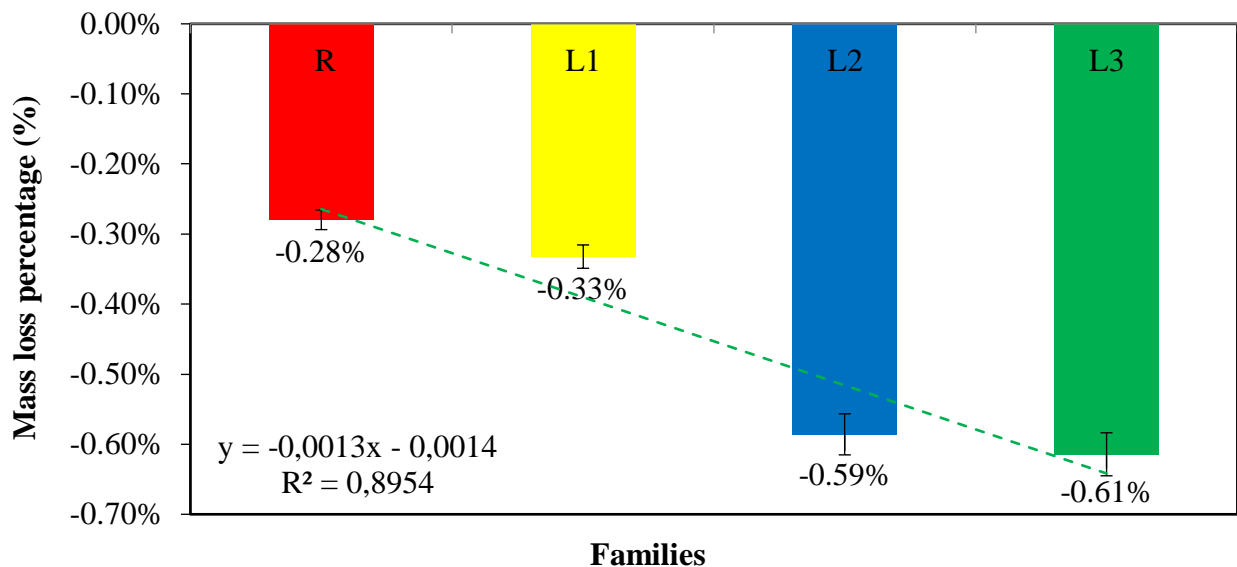
Figure 18. Percentage of total mass loss from steel bars by family.

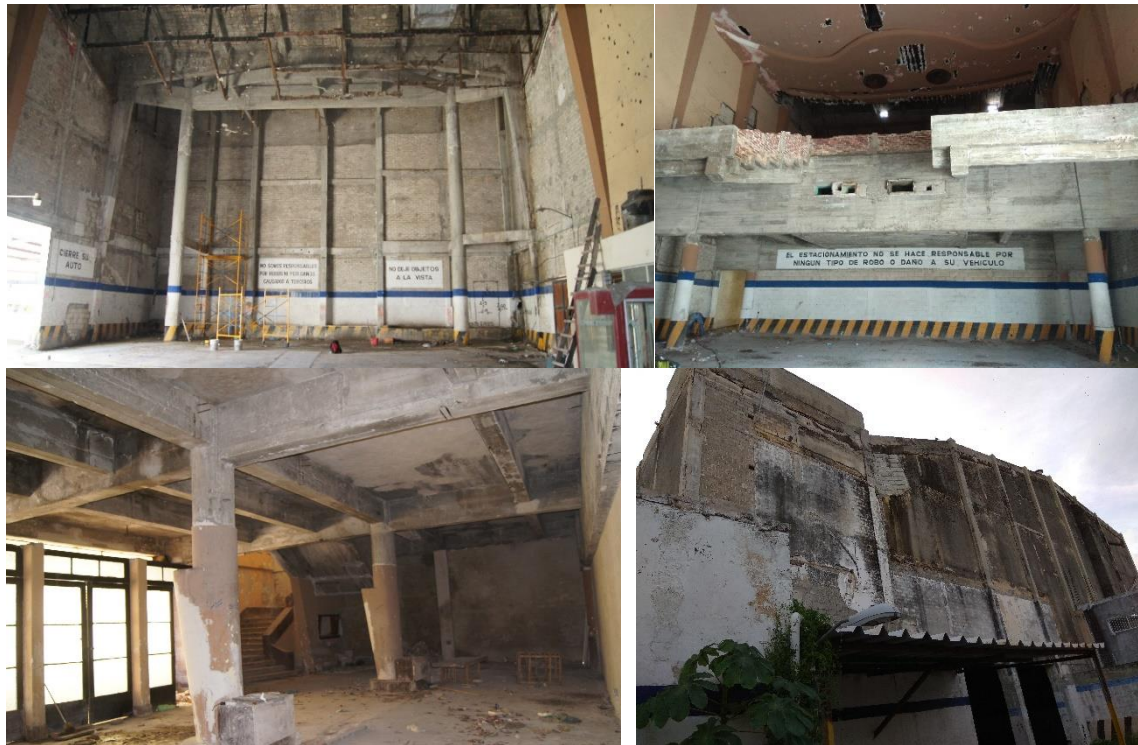
Figure 2. State of the structure before being repaired.

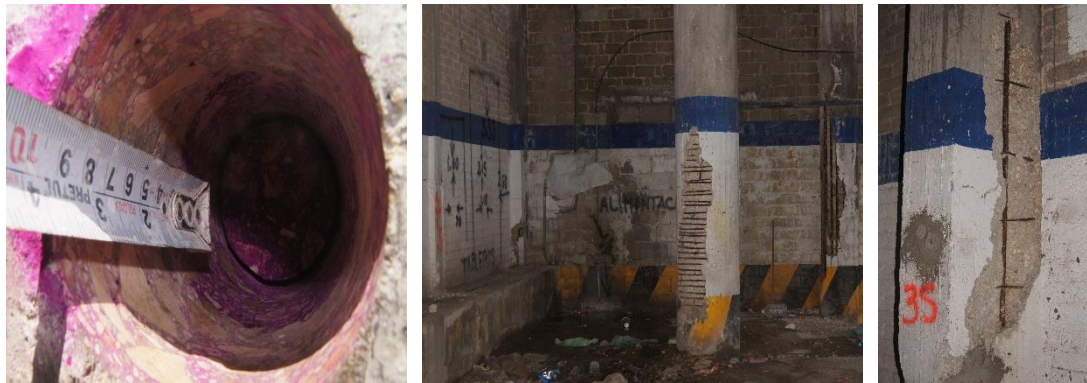
Figure. 3. Carbonation and detachment of concrete.

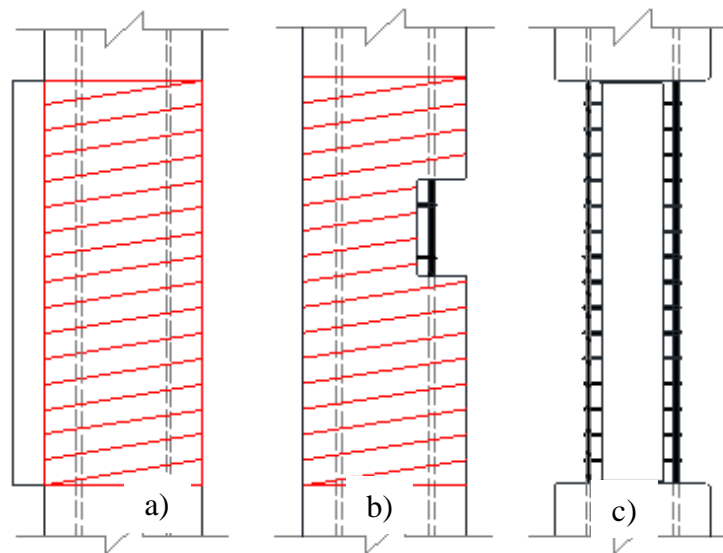
Figure 4. Uniform deep repair: a) Delimitation of the area to be demolished, b) scarification started, c) final section after scarification

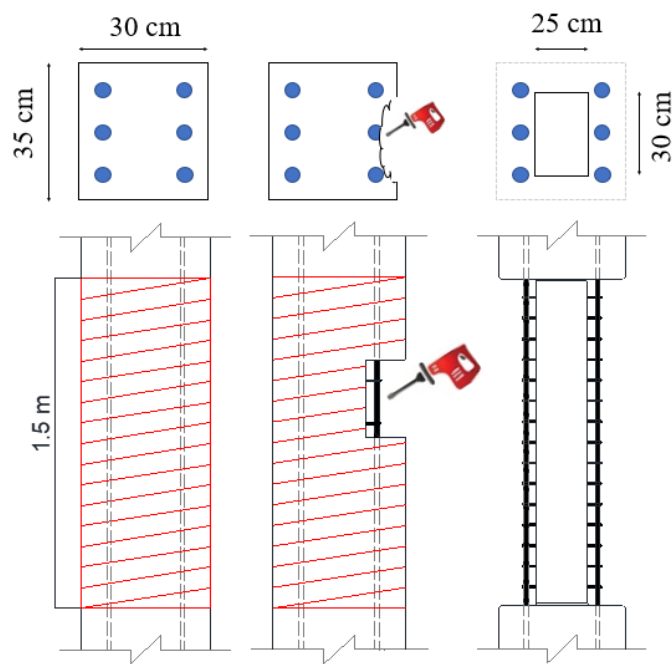
Figure 5. Criterion for delimitation and scarification of repairs

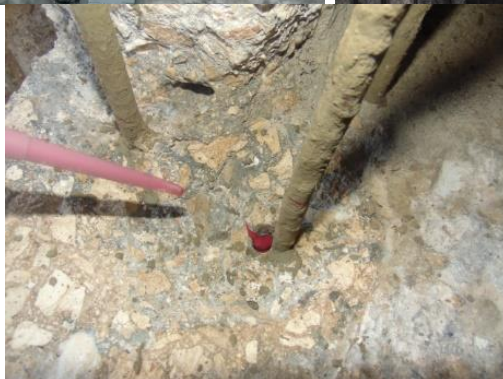
Holes were drilled for the placement of new steel to replace the corroded one. For its correct anchoring, a high-performance epoxy resin was injected for high loads.

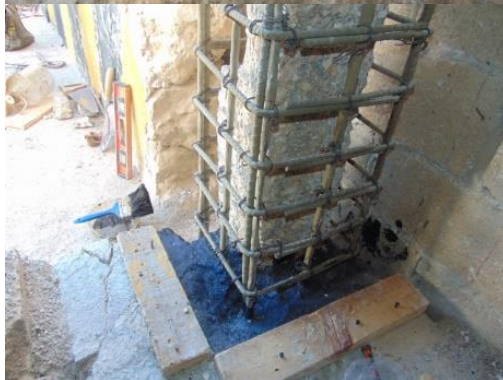
Before carrying out the installation, the base of all the elements was covered with an asphalt waterproofing around the floor to avoid any penetration of moisture or corrosive agents.

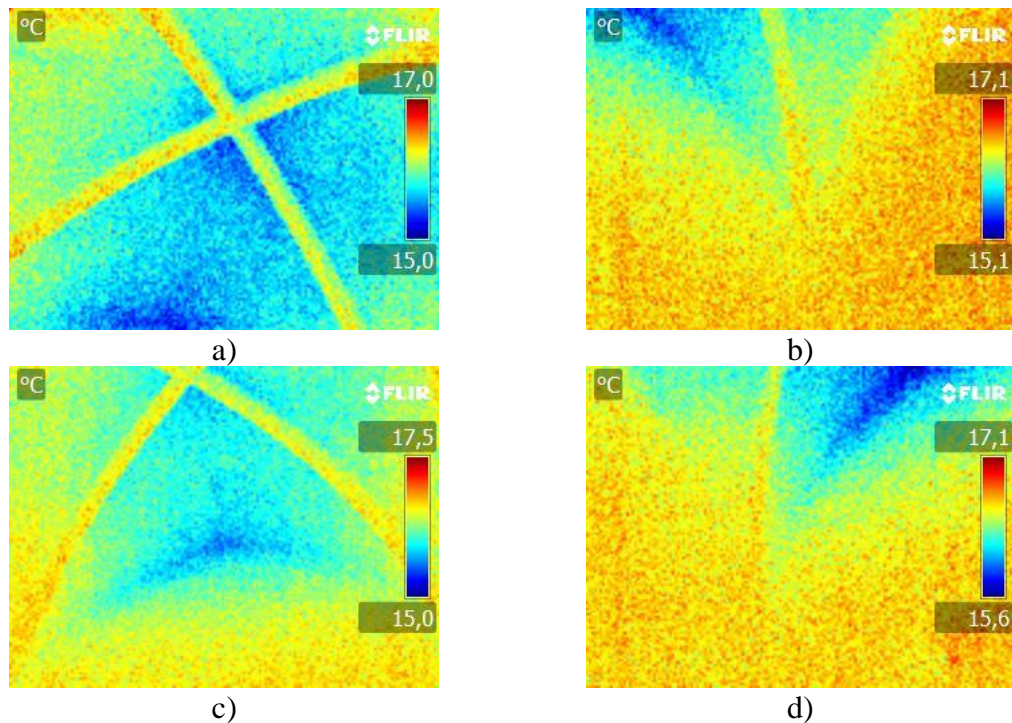
Figure 5. Thermography of rooms under roof 1, adjacent to the side building: a) General view of roof, b) Connection between facade and side corner, c) Connection between facade and roof, d) Connection between facade and opposite side corner.
