Revista **ALCONPAT**

Latin American Journal of Quality Control, Pathology and Construction Recovery

Volume 12

Issue 2

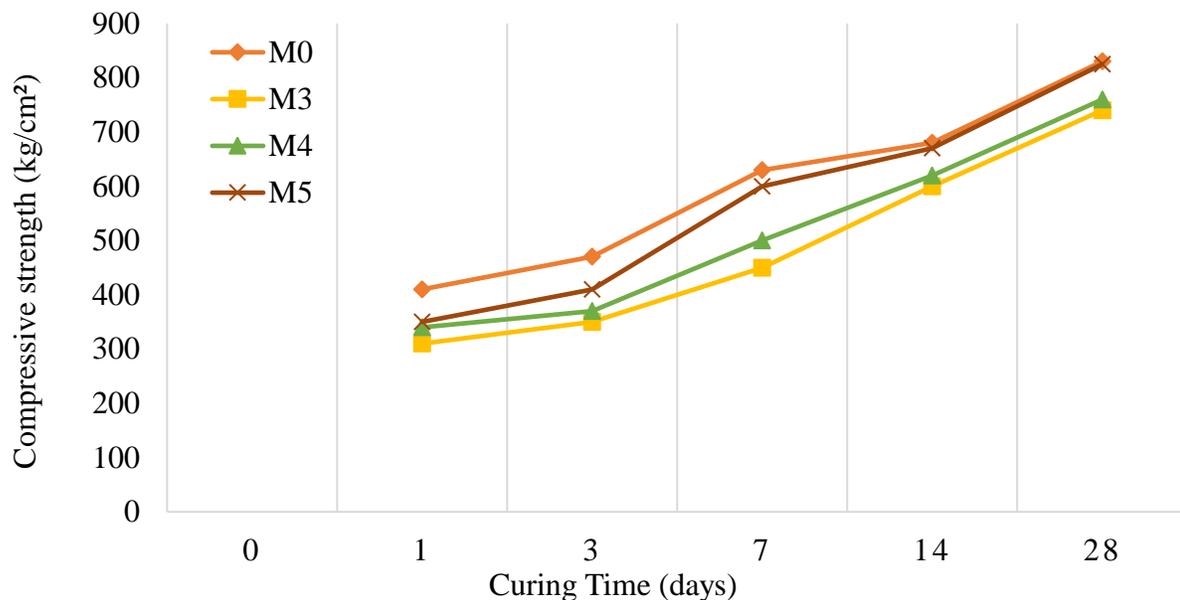
Figure 1. Compressive strength of hardened Portland cement pastes incorporating 3%(M3), 4% (M4), and 5%(M5) marble powder residues versus curing time. (El-Sayed, et al., 2016)

El-Sayed, Farag, Kandeel, Younes, and Yousef (2016) replaced 3, 4, and 5 wt% of the cement with marble powder, observing that, due to the high presence of calcium carbonate, it did not affect the properties of the cement. With the hardened cement pastes, compression tests were performed at ages of 1, 3, 7, 14, and 28 days; it was observed that the strengths increased proportionally to the age of curing from 1 to 28 days, as shown in Figure 1.

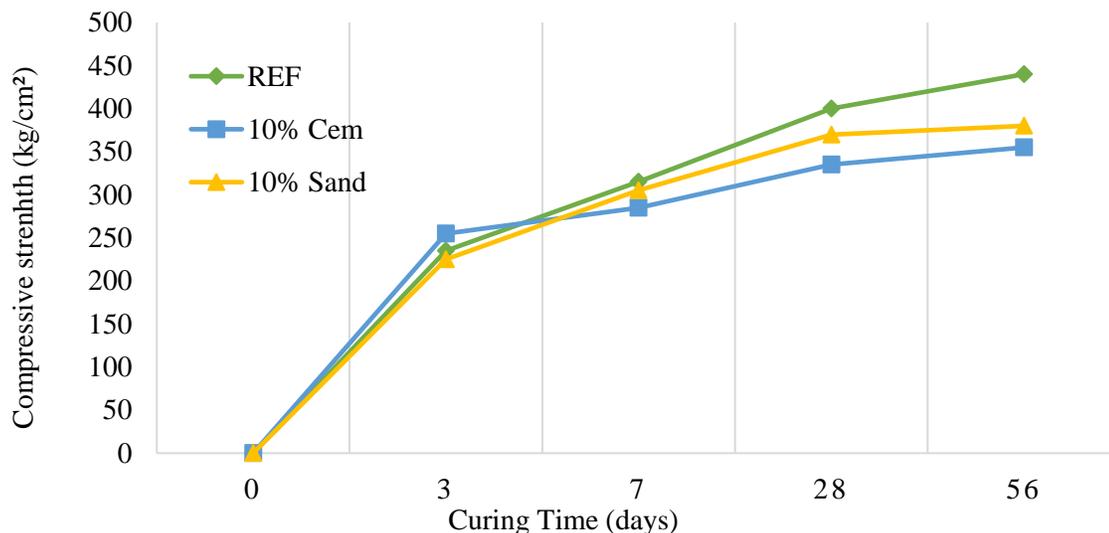
Figure 2. Compressive strength versus curing time for mortars with partial substitution of marble powder by cement and sand. (Corinaldesi, et al., 2010)

The results obtained are shown in Figure 2. It can be observed that the mixture with 10% cement replaced by marble powder showed a reduction in compressive strength. However, the marble powder used as a replacement for 10% sand obtained higher strength than the mixture with the replacement of marble powder by cement.

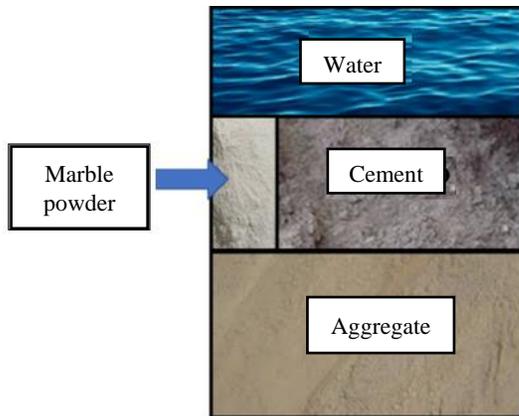
Figure 1. Cement replacement method (Li, et al., 2019)

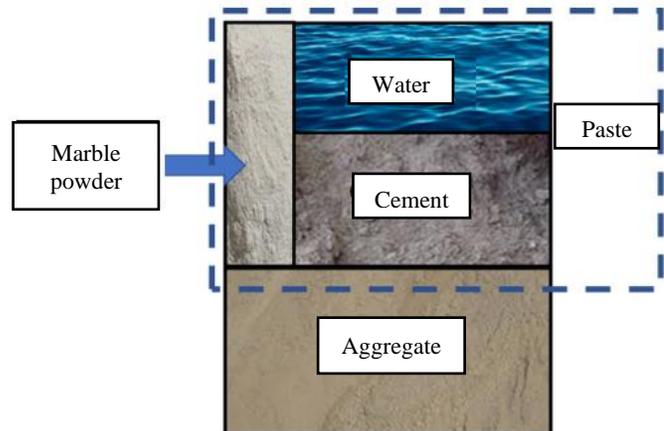
Figure 2. Paste replacement method (Li, et al., 2019)

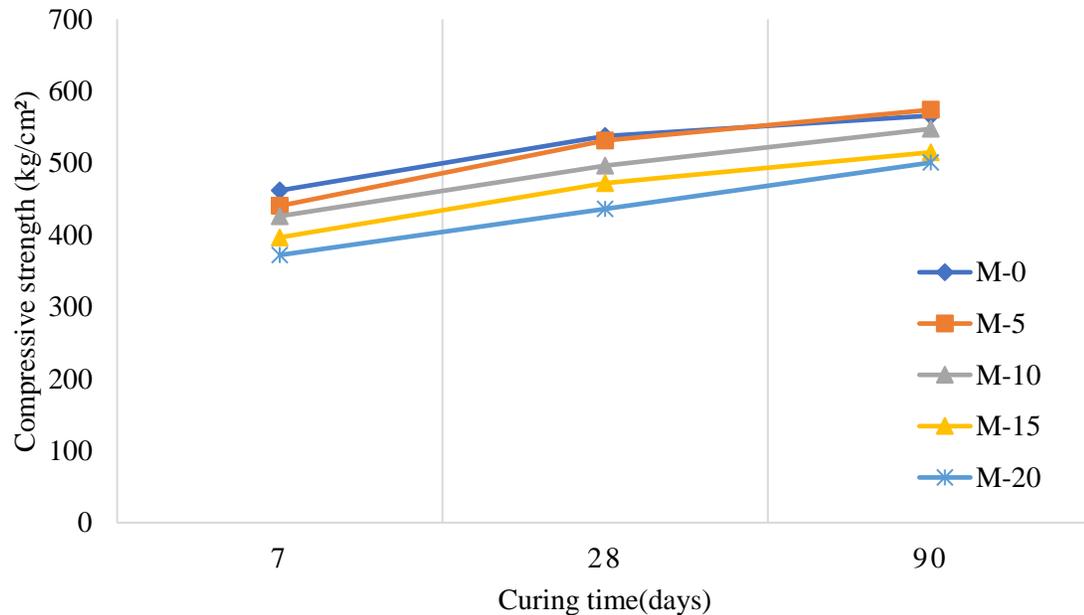
Figure 3. Compressive strength of mortars. (Yamanel, et al., 2019)

At 90 days of curing, the mix with a 5% replacement of marble powder to cement increased the compressive strength even more than the mix without marble powder (Figure 5).

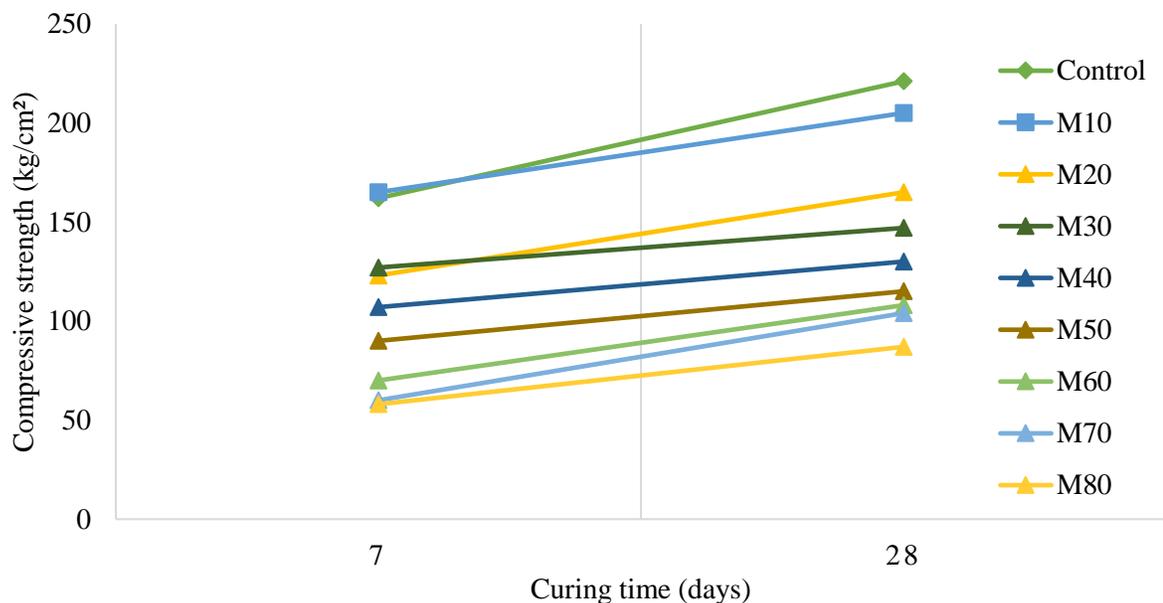
Figure 6. Compressive strength results from concretes with marble powder. (Santos, et al., 2012)

From the compressive strength tests applied to the above dosages at 7 and 28 days of curing, the following results were obtained and are shown in Figure 6.

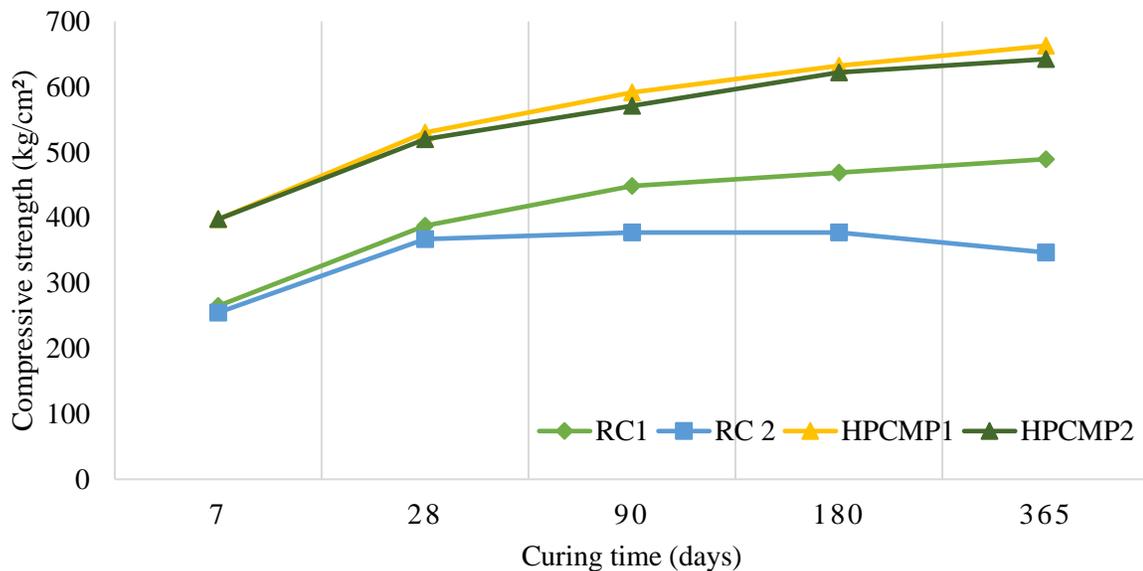
Figure 7. Evolution of compressive strength at different ages. (Talah, et al., 2015)

Figure 7 shows the compressive strength results of the mixes, according to the curing condition and age of the concrete.

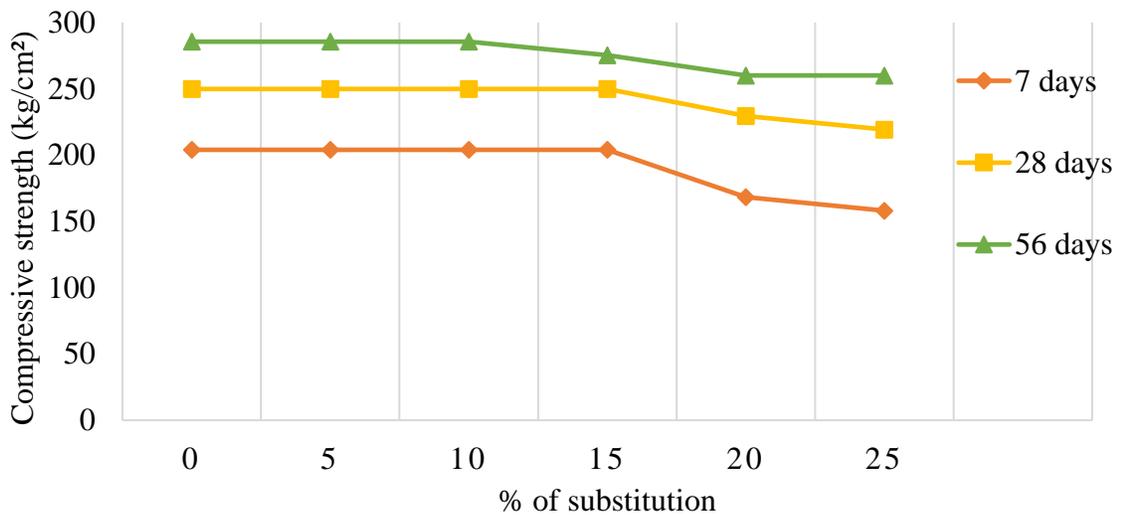
Figure 6. Compressive strength of concrete samples with w/c ratio 0.45.

For the w/c ratio of 0.45, the compressive strength decreased compared to w/c ratios of 0.35 and 0.40 (Figure 10).

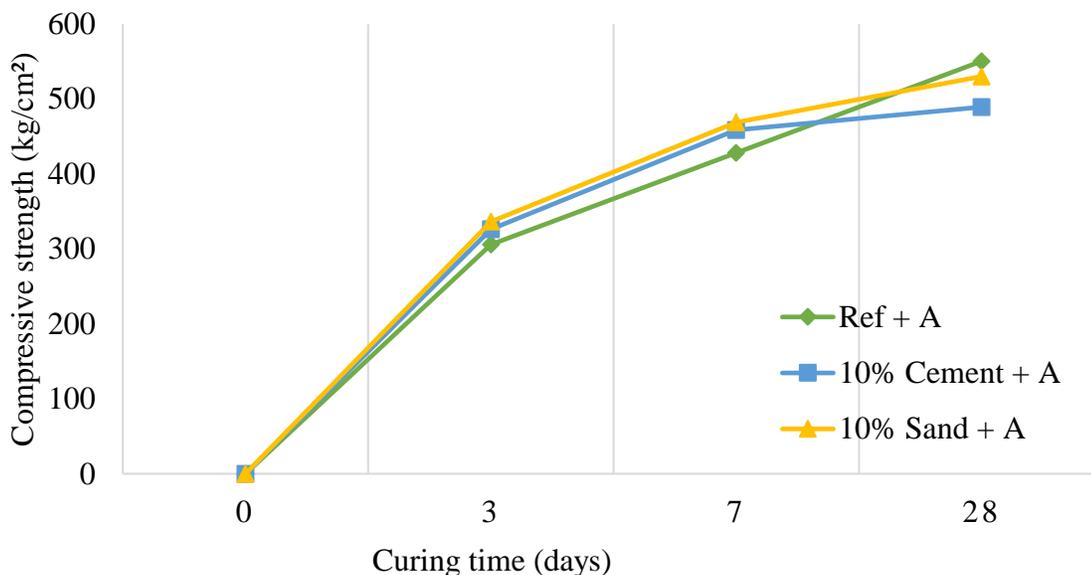
Figure 11. Compressive strength in relation to curing time in mortars with superplasticizer admixture.

Both samples reported higher compressive strength at early ages. At 28 days of age, the reference sample obtained higher strength; however, the use of the plasticizer provided an increase in compressive strength compared to the study carried out without the additive. (Figures 2 and 11).

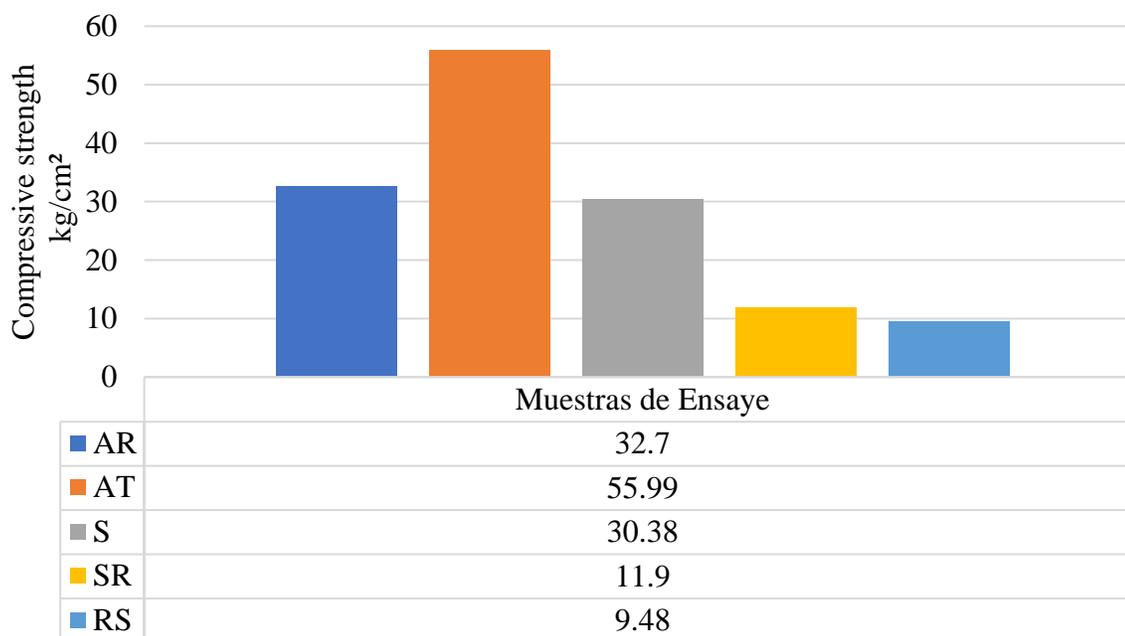
Figure 7. Compressive strength of test specimens. (Moreno Juárez, et al., 2020)

In the first mix, river sand was added; in the second mix, 100% of the river sand was replaced by crushed limestone sand (AT); in the third mix, 100% of the river sand was replaced by silica sand (S); in the next mix, 66% of the river sand was replaced by silica sand (SR); in the last mix, 66% of the river sand was replaced by silica sand (RS); and the rest of the aggregate was replaced by silica sand (RS). The compression results at 28 days of curing, according to each mix, are shown in Figure 12.

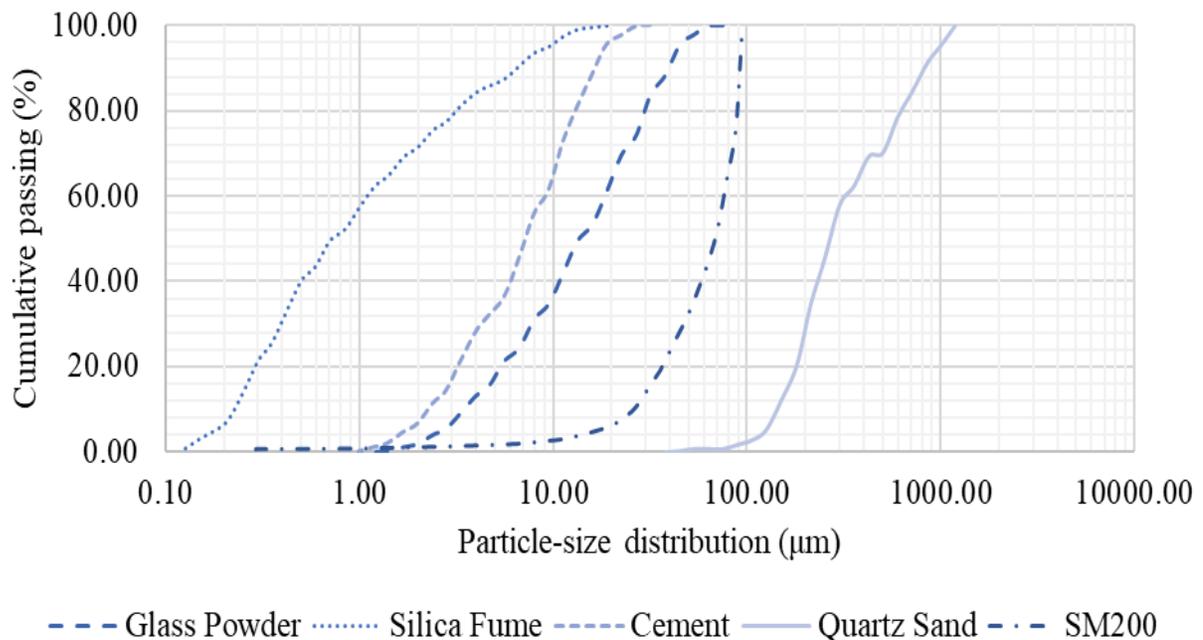
Figure 1. Particle size distribution of granular materials in the UHPCC.

Figure 1 shows the particle size distribution of cement, silica fume, glass powder, fine aggregate (quartz sand), and filler (SM200). The d50 values of 0.8, 7, 15, 32, and 270 µm were determined for silica fume, cement, glass powder, filler, and fine aggregate, respectively.

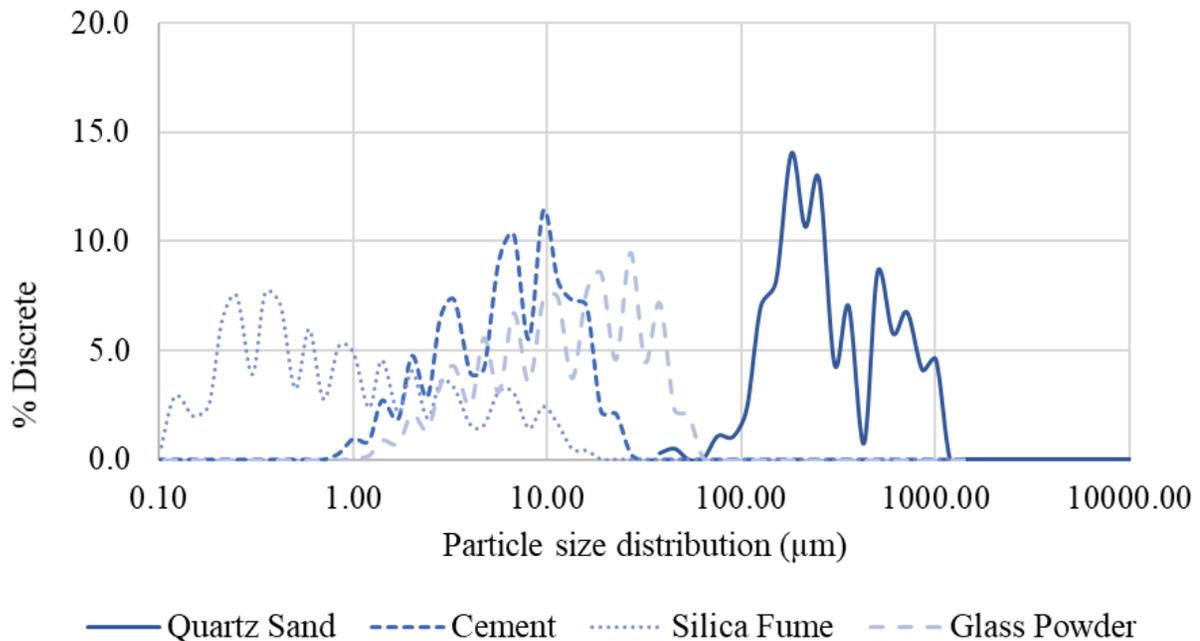
Figure 2. Discrete particle size distribution of materials without SM200.

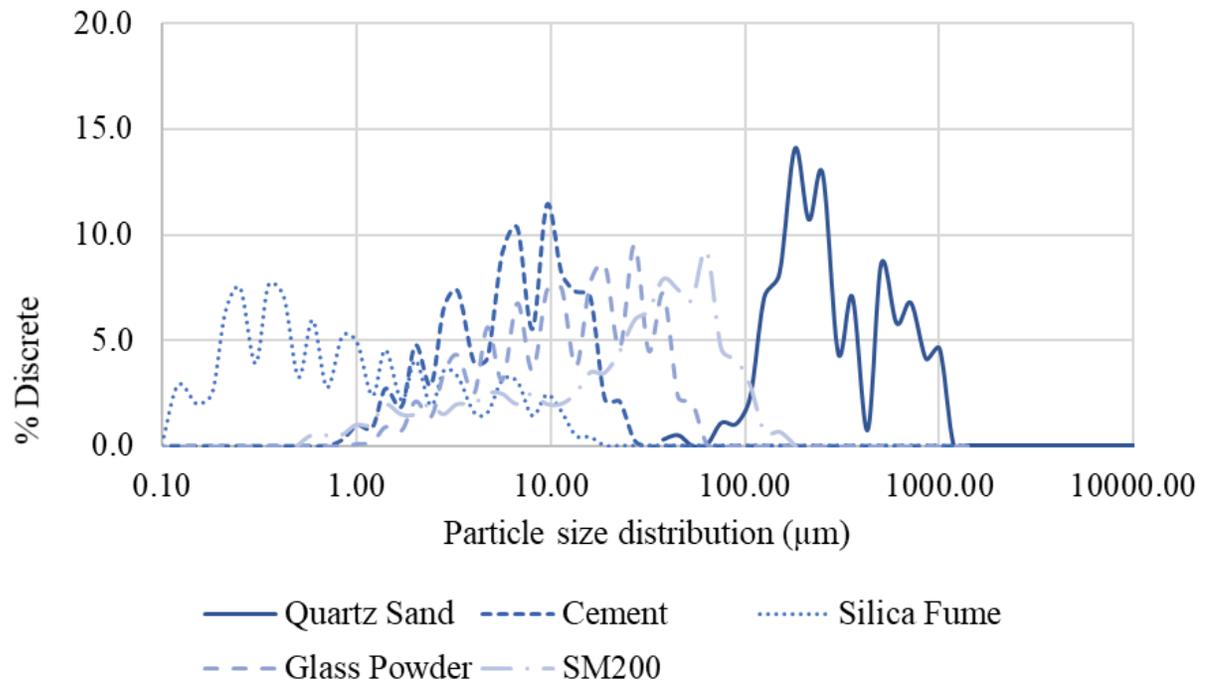
Figure 3. Discrete particle size distribution of materials with SM200.

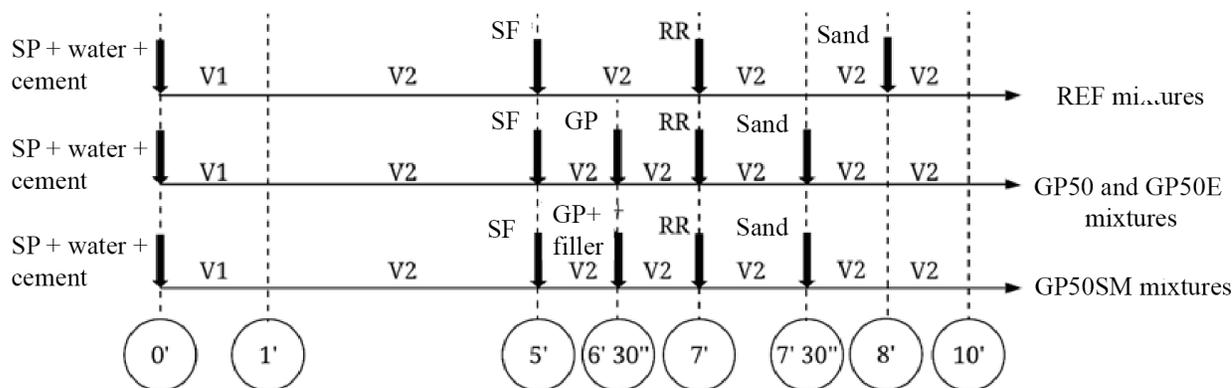
Figure 4. The mixing procedure, in which V1 and V2 represent, respectively, the low and high speeds of the mortar mixer/pump/machine.

Then, cylindrical specimens of 50 mm x 100 mm were manually molded, following a material mixing procedure developed during the research and suitable for each different mix (Figure 4). When producing the GP50SM mix, the glass powder and filler were weighed separately, packed in the same package, and homogenized for about 2 minutes before being added to the mixture.

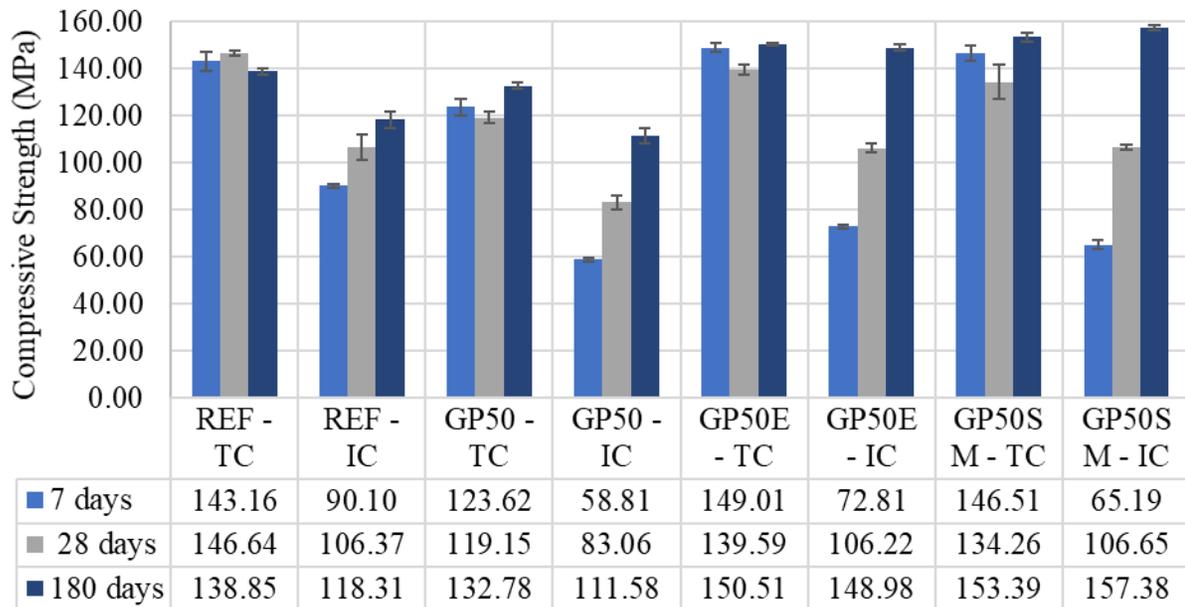
Figure 5. Compressive strength of the UHPCC mixtures.

Figure 5 shows graphically the compressive strength results for the studied mixtures. The values are the average of four individual values obtained from the specimens tested at the ages of 7, 28, and 180 days.

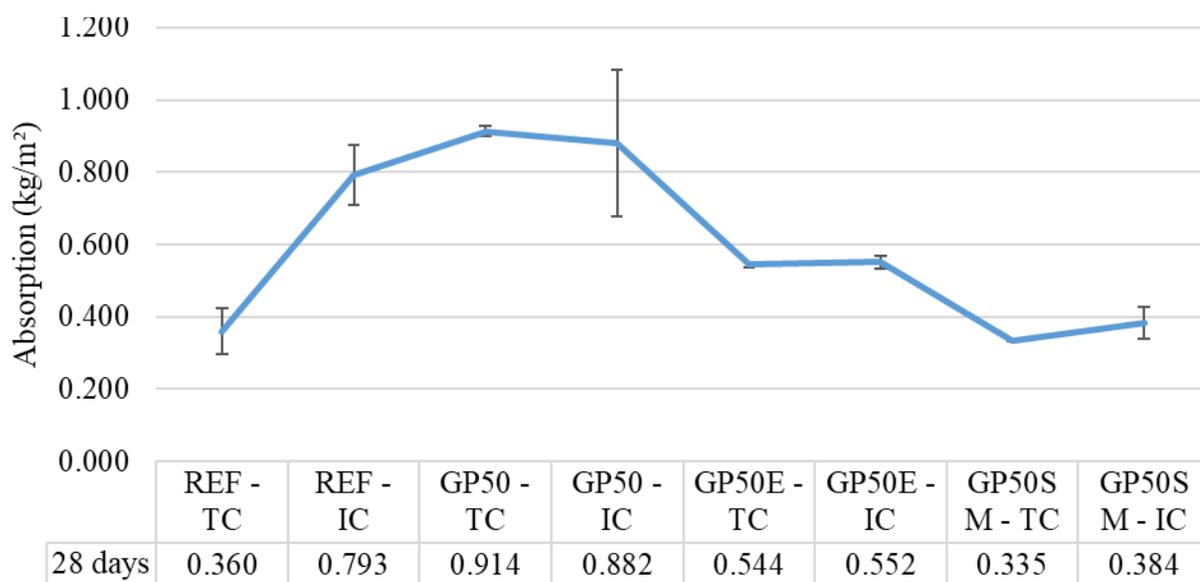
Figure 6. Capillary water absorption of the studied UHPCC mixtures.

Figure 6 shows graphically the results of the capillary water absorption test obtained for the studied mixtures. The values are the average of three individual measurements obtained from the specimens tested at 28 days.

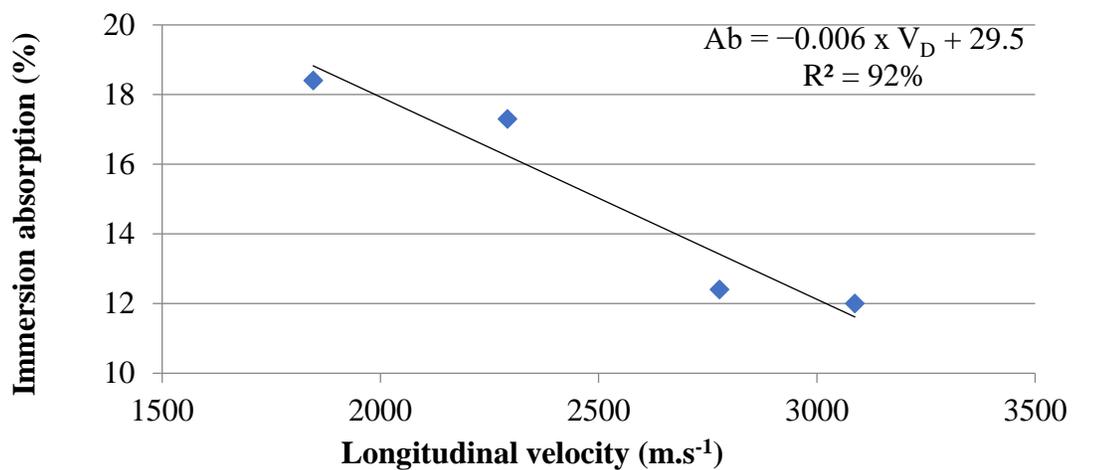
Figure 3. Regression model between immersion absorption and longitudinal velocity.
Source: Authors (2021).

The regression between ultrasound velocity and absorption showed a model with R² of 92% (Figure 3) and P-Value of $0.04 < 0.05$, demonstrating that there is a statistically significant relationship between the parameters, with a 95% confidence level, obtained through ANOVA. The outcomes suggest that the wave propagation method is sensitive to the increase of water content inside the samples, caused by increased porosity after drying the synthetic polymer within the cement, decreasing its ultrasound velocity. Thus, the concrete will present more voids (pores) and, therefore, absorbing more water and presenting lower density and mechanical properties. Water is the main erosive agent in concrete, therefore concrete performance as a barrier to reduce the transport of potentially corrosion-causing agents is related to its porosity (Dudhal, 2016; Liu et al., 2020; Matiko, 2000).

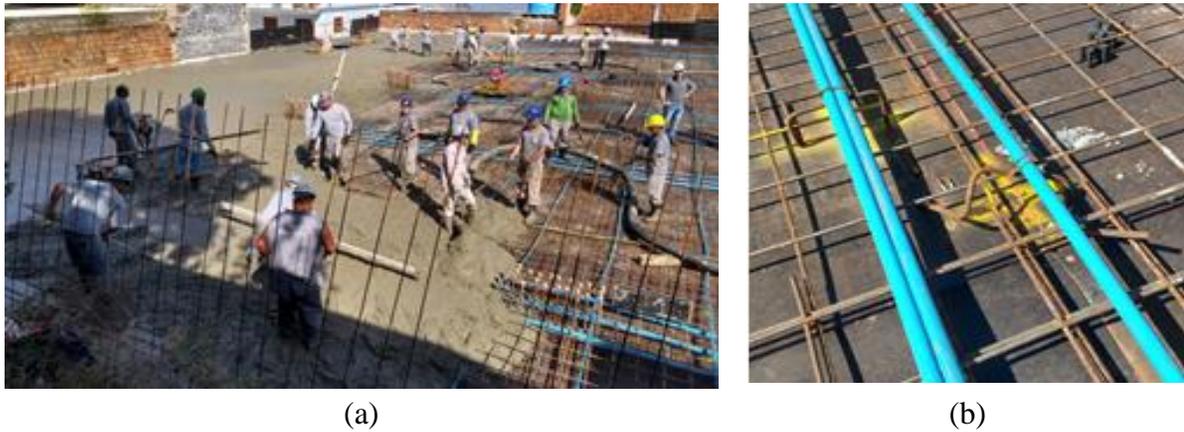
Figure 1. Concrete pouring example: (a) workers in direct contact with the reinforcement and (b) damaged and out of position spacer.

The incorrect placement of strands can lead to slab fissuring, excessive vertical displacements and loading stresses different from predicted to the point of exceeding projected limits of tension and compression in the structural element. Further effects can occur such as concrete flaking and acceleration of steel corrosion due to insufficient cover (Souza, 2018; Xin and Xianyan, 2012).

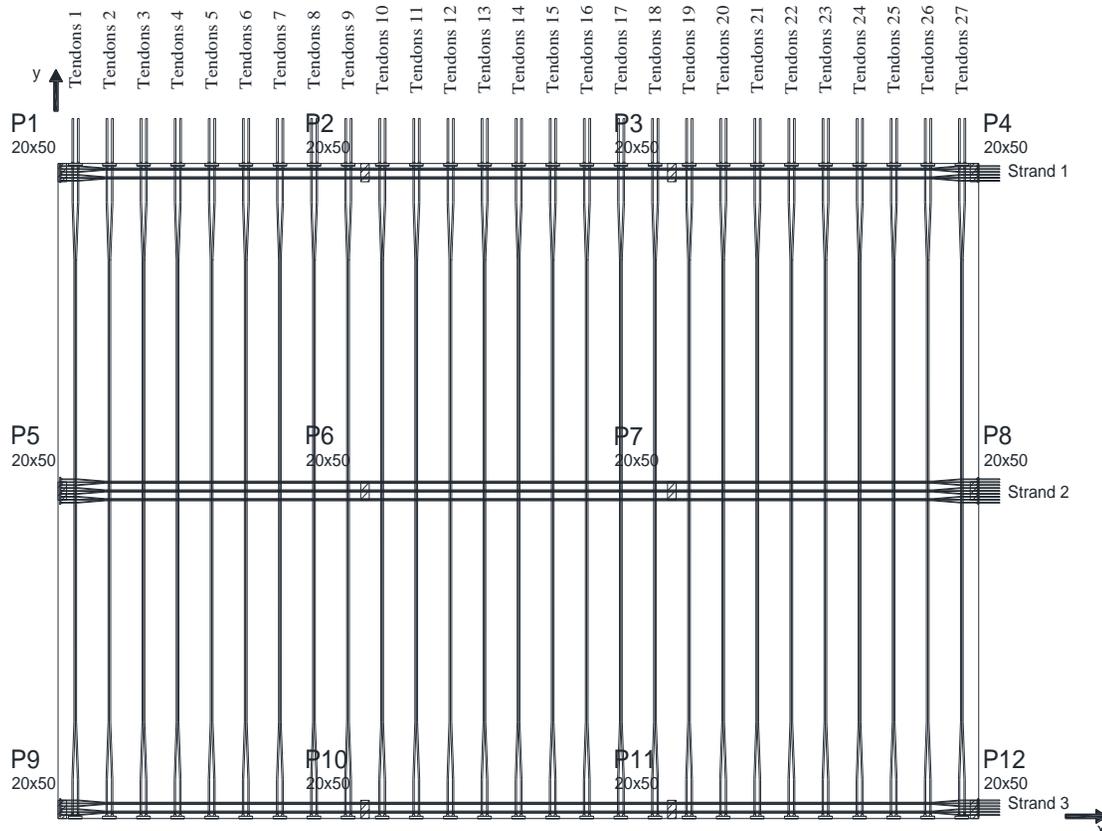
Figure 3. Layout of unbonded tendons and strands in a model post-tensioned slab.

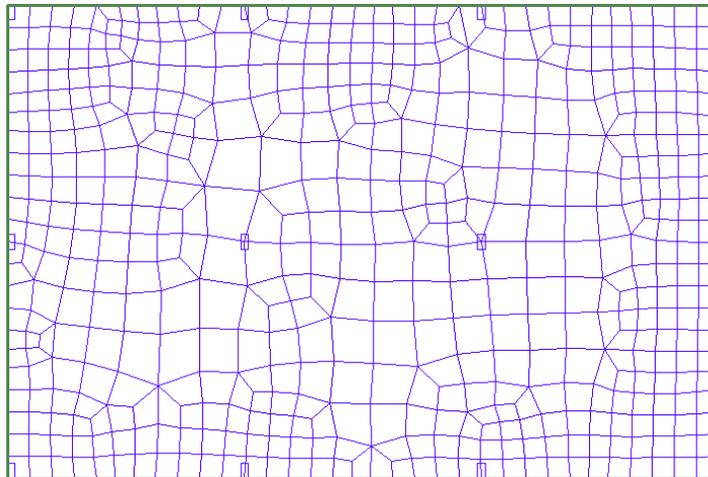
Figure 6. Finite element mesh for slab model M8.

Slab model analysis made use of support lines aligned with pillar positions. Each support line defined “design sections” with average stress values which compiled stresses from surrounding areas delimited by the support lines.

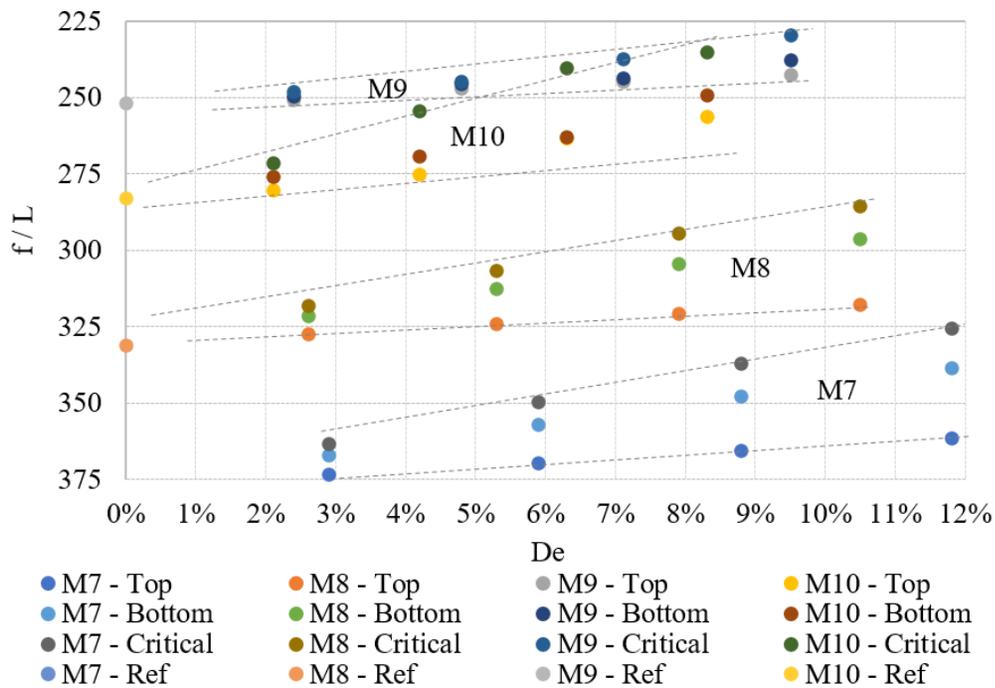
Figure 8. Relative displacement with respect to relative eccentricity for all slab models.

The effects of changes in eccentricity on displacement are better understood graphically from Figure 8. In the figure, the vertical axis contained the f/L ratio, which represented the equivalent center span displacement in denominator format: for example $L/430$ with $L/250$ being the limit. The horizontal axis contained the relative eccentricities, which were the variation in height of the strand (eccentricity) with respect to slab thickness. The dashed lines were placed in order to visually separate the slab models. The relative eccentricity (or its variation) could have more or less of an effect depending on the case study: examining the trends of Figure 8, it could be noted that, for all slab models, the “Critical” hypothesis produced the most variations in displacement.

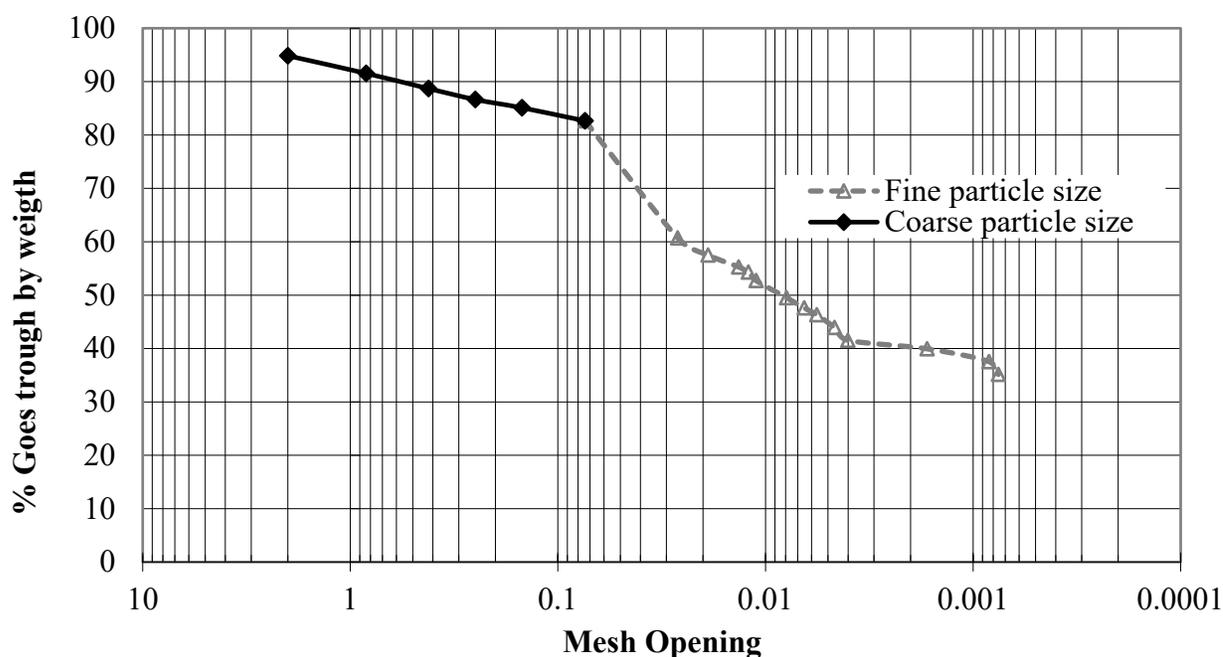
Figure 5. Particle size analysis combining coarse and fine soils of the original simple

The Figure 2 shows both the results obtained from the sieve analysis, performed with ASTM meshes; and the fine material particle size, which was performed with the hydrometer analysis. The A of the clay was obtained with the last test.

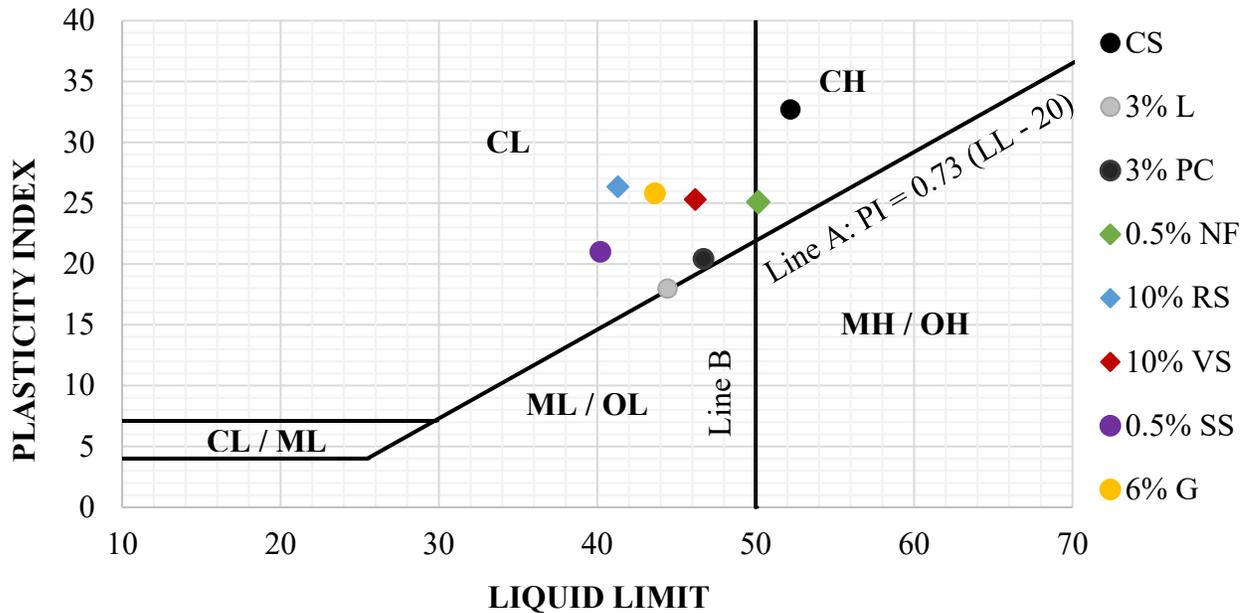
Figure 6. Plasticity chart with location of the original sample and the mixtures with stabilizers.

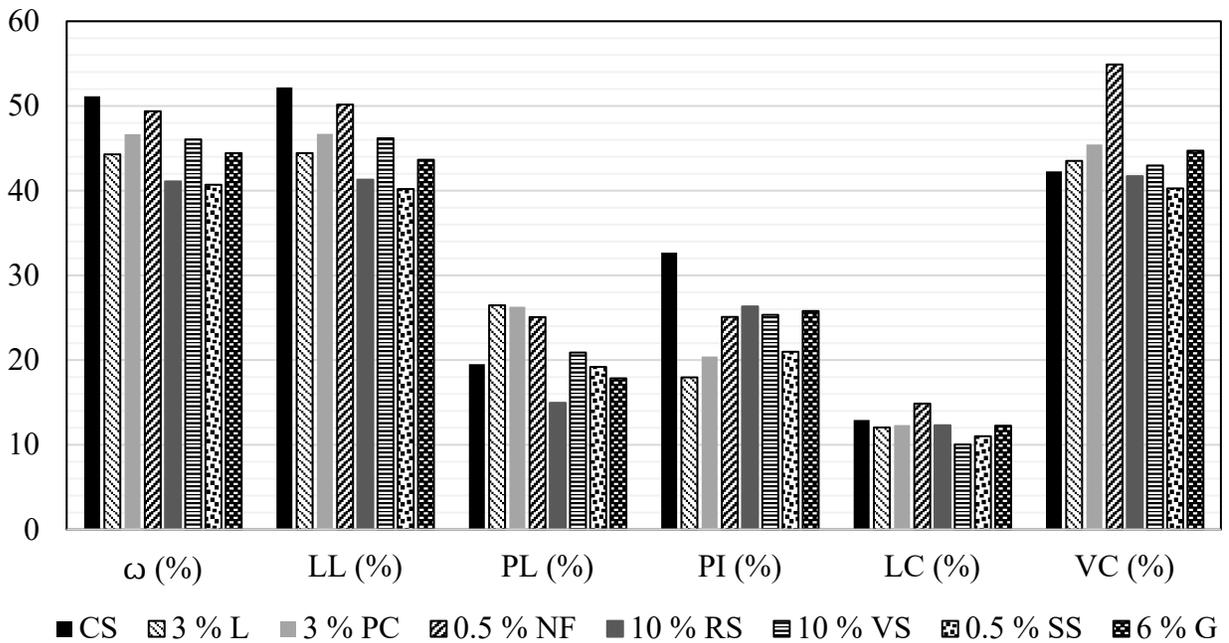
Figure 7. Index properties of the natural soil and the stabilized mixtures.

Figure 7 reveals the ensemble of index properties of each one of the stabilized mixtures and the natural soil. From the graph, it is noted that the stabilizers diminish the optimum water content (ω), the LL and the PI; on the other hand, the stabilizers also produce an irregular behaviour of the PL, LC and VC, which could be caused by the particular properties of each one of the stabilizers. For these three index properties (PL, LC and VC) the results obtained were both superior and inferior than the natural soil used as a control sample.

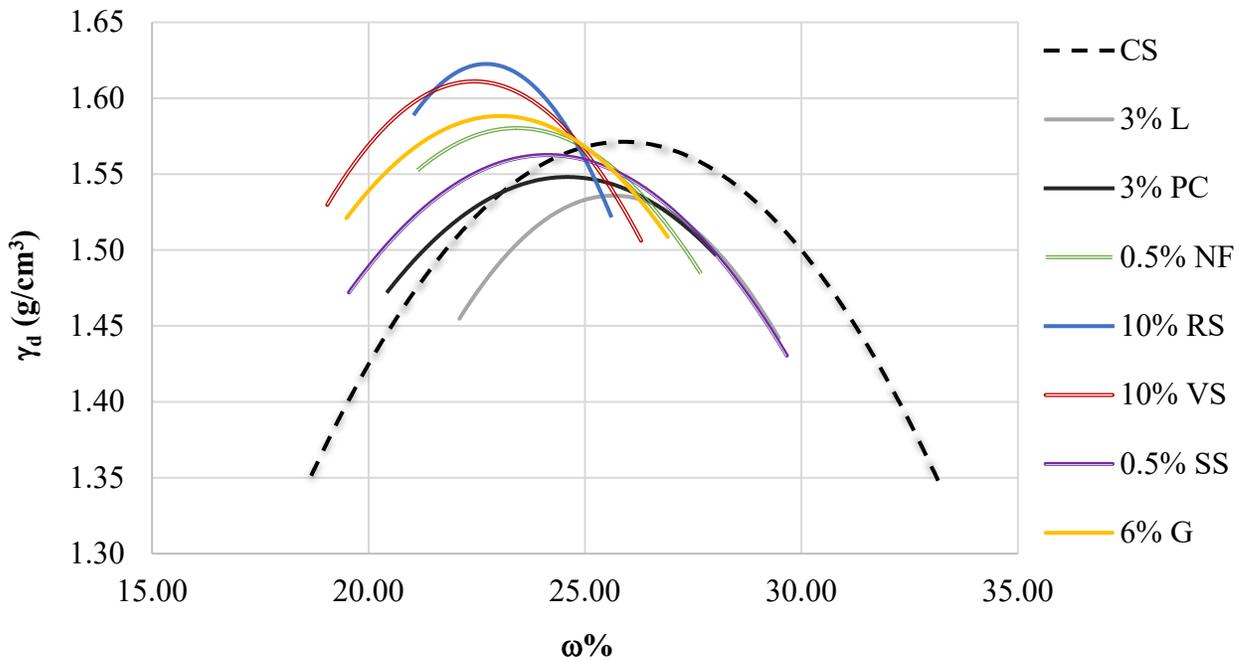
Figure 8. Results of the Standard Proctor test (variant A).

The Standard Proctor test determines the necessary content of water (ω_{opt}) to reach the maximum specific gravity ($\gamma_{dm\acute{a}x}$) through mechanical compaction (See Figure 8). In this case, it can be clearly noted the effect of the stabilizers on the necessary water content and the increase or decrease of the maximum specific gravity. The Figure 8 shows both, the behaviour of the CS and the stabilized mixtures with different colours, with the greater results corresponding to the RS and the lowers to L. The optimum water contents to achieve the maximum specific gravity are shown in Figure 9.

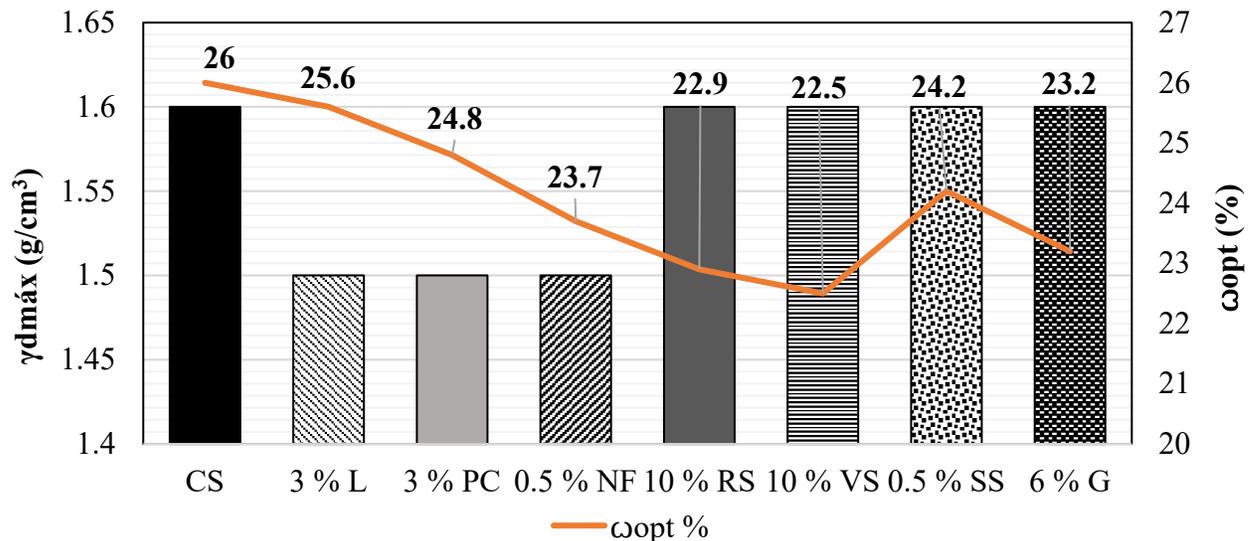
Figure 9. Results of the Standard Proctor test (Variant A) regarding the optimum water content.

Figure 9 displays the results of the Standard Proctor test (Variant A), allowing to perceive the effect of the different stabilizers regarding the maximum specific gravity ($\gamma_{dm\acute{a}x}$) and the optimum water content (ω_{opt}) through the compaction of the samples in the laboratory. Reading the graph, we can observe the clear reduction of the optimum water content with the addition of L, PC and NF; this decrease also involves a related reduction of the specific gravity, which could be caused by the workability and plasticity properties of these materials, keeping in mind that water acts as a lubricant for the accommodation of the clay particles. Both L and PC are known to maintain a fluidity degree for certain time to provide facility of application during construction works; also, this behaviour has been monitored for lime and cement mortars which incorporate NF (Díaz-Blanco, et al., 2019; Knapen y Van Gemert, 2009; Ramírez-Arellanes et al., 2012).

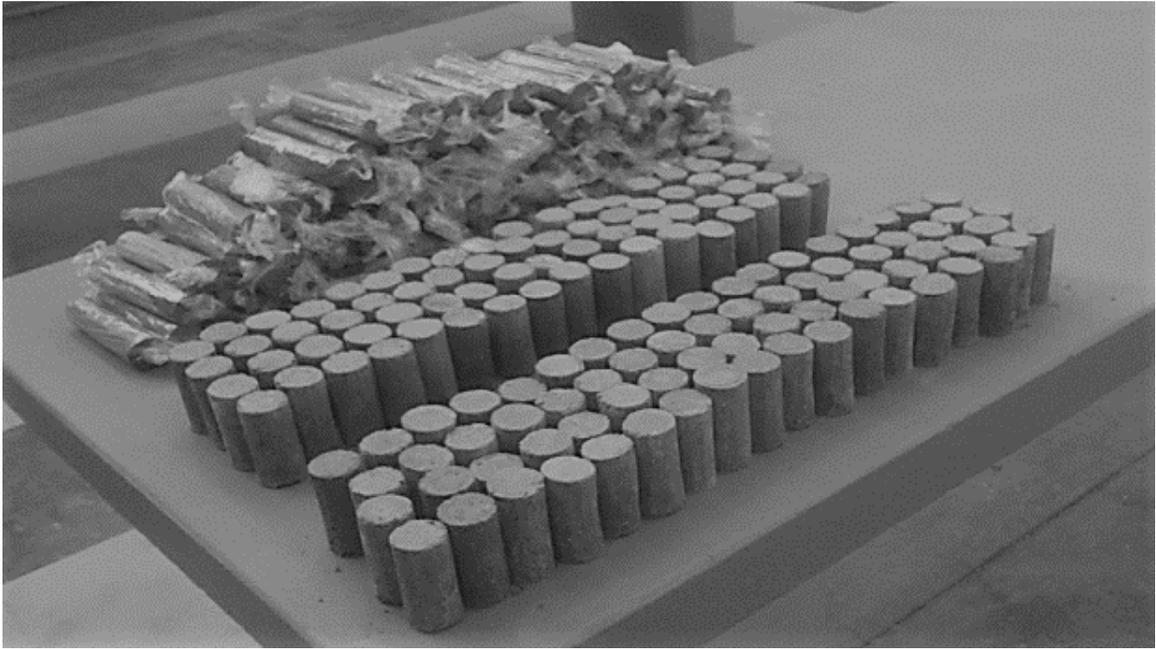
Figure 10. 144 specimens of clay mixtures with different stabilizers ready for the triaxial test UU (Miranda, 2017).

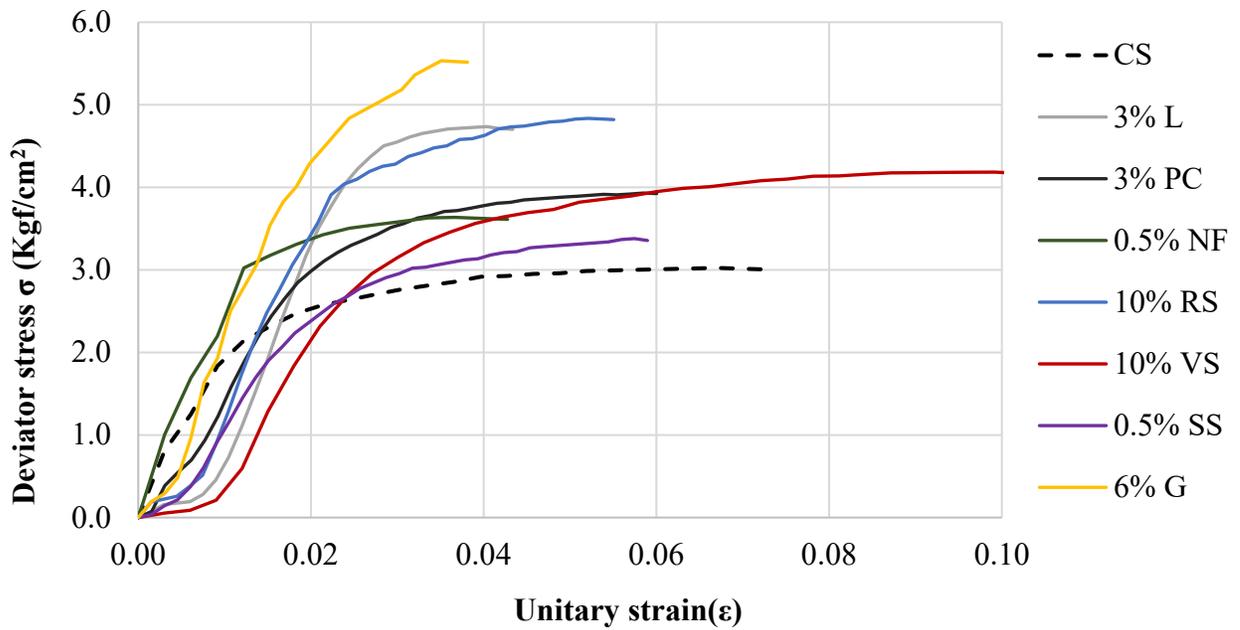
Figure 11. Stress-strain diagram curves.

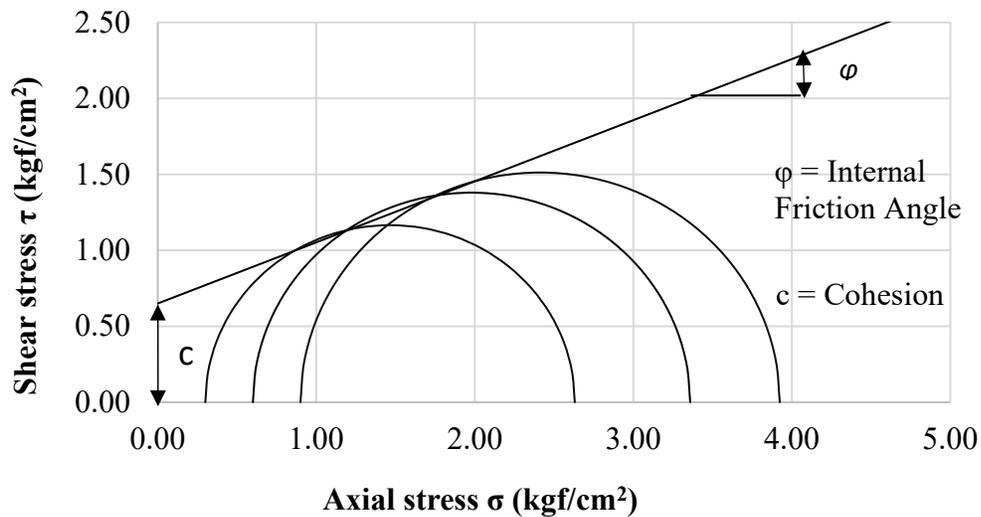
Figure 12. Rupture envelope obtained for the original soil (in situ), $c = 0.65 \text{ kgf/cm}^2$ y $\phi = 22^\circ$.

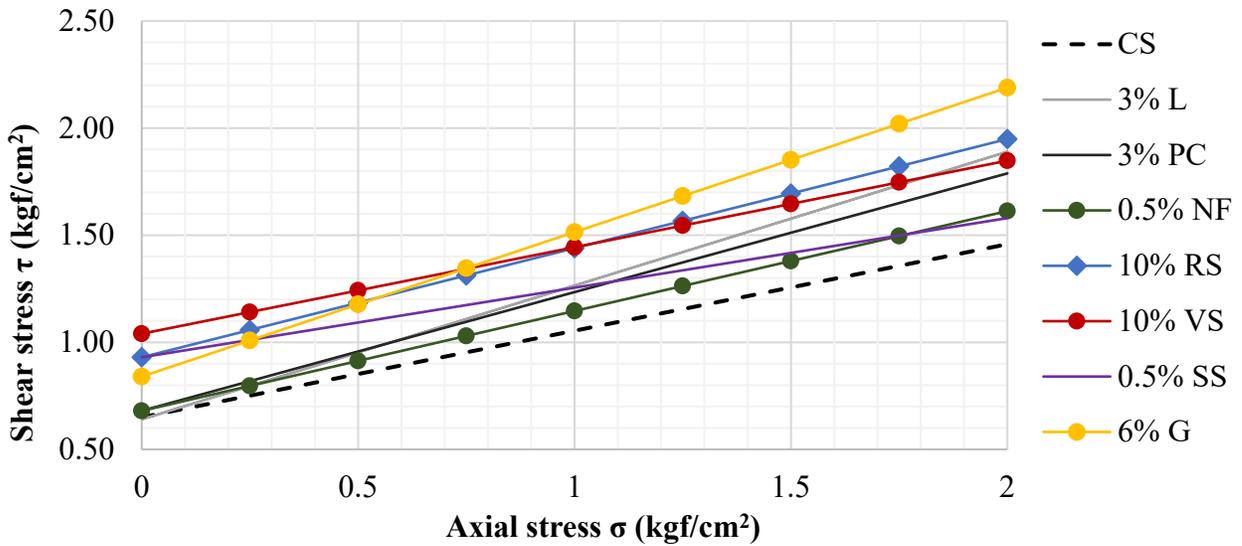
Figure 13. Correlative of the rupture envelopes of the control sample and the mixtures with stabilizers.
