Revista **ALCONPAT**

Latin American Journal of Quality Control, Pathology and Construction Recovery

Volume 12

Issue 2

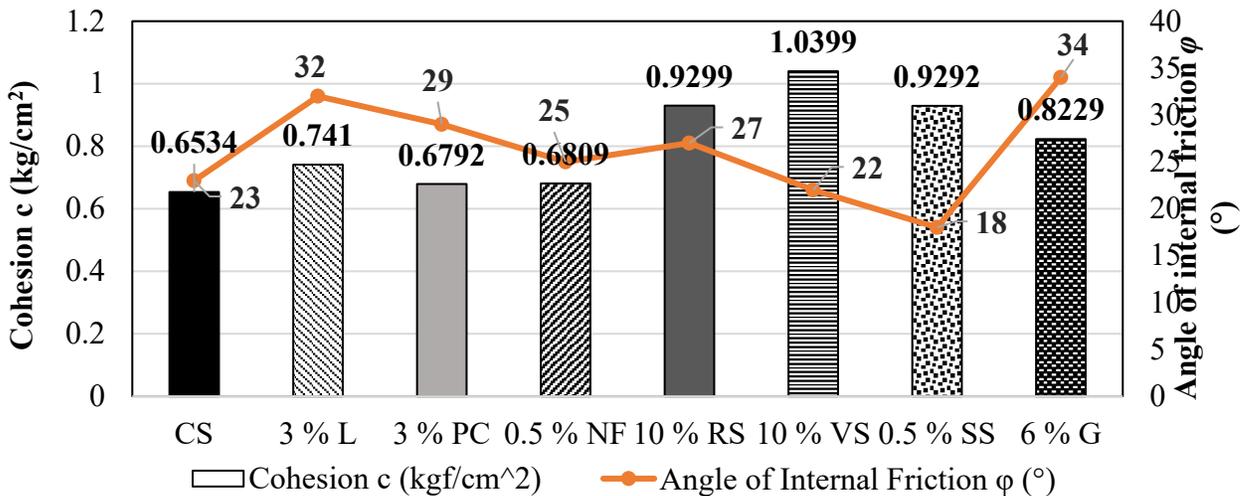
Figure 14. Cohesion (c) and internal friction angle (ϕ) values of the original sample and the mixtures with stabilizers.

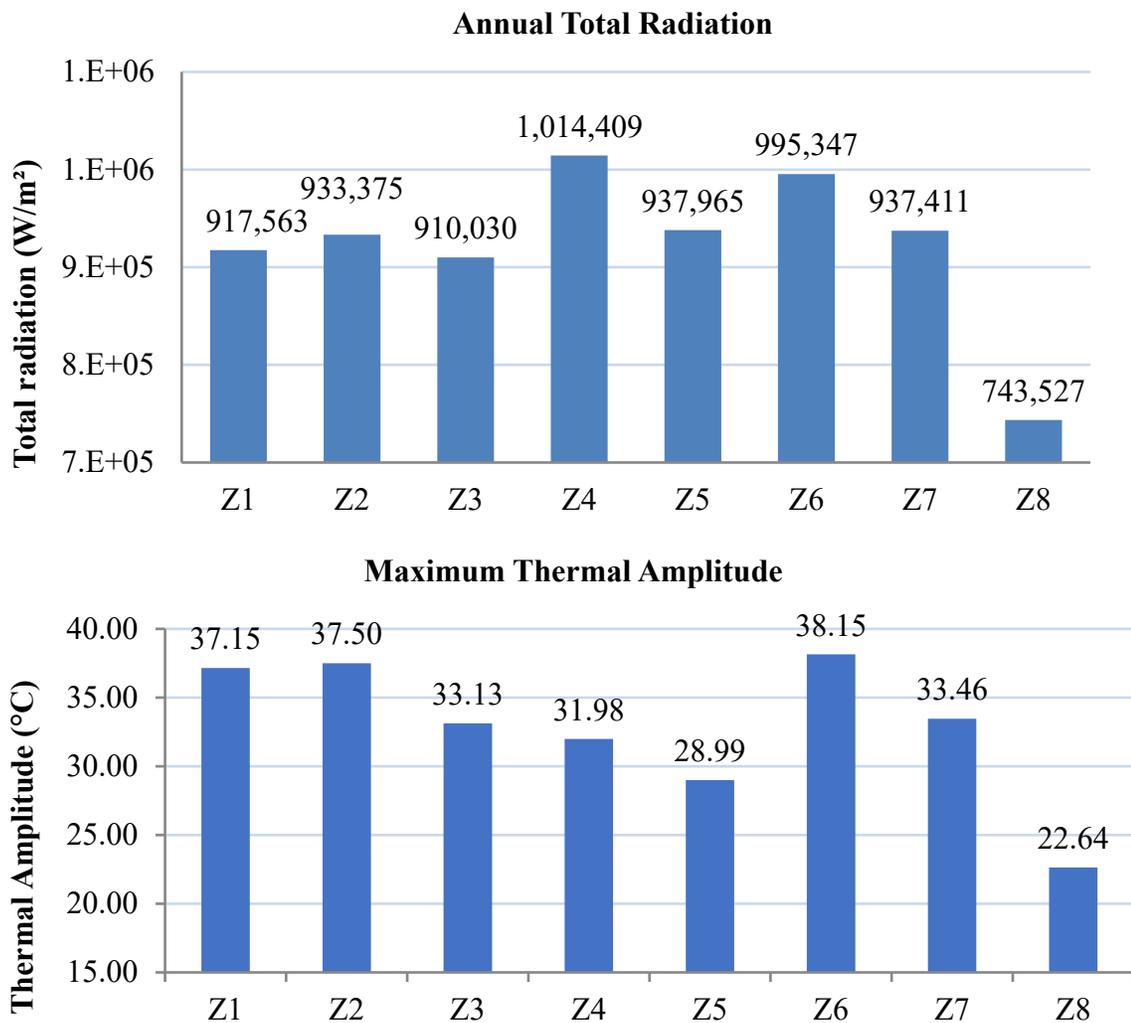
Figure 2. Total accumulated radiation and maximum thermal amplitude in the simulation year.

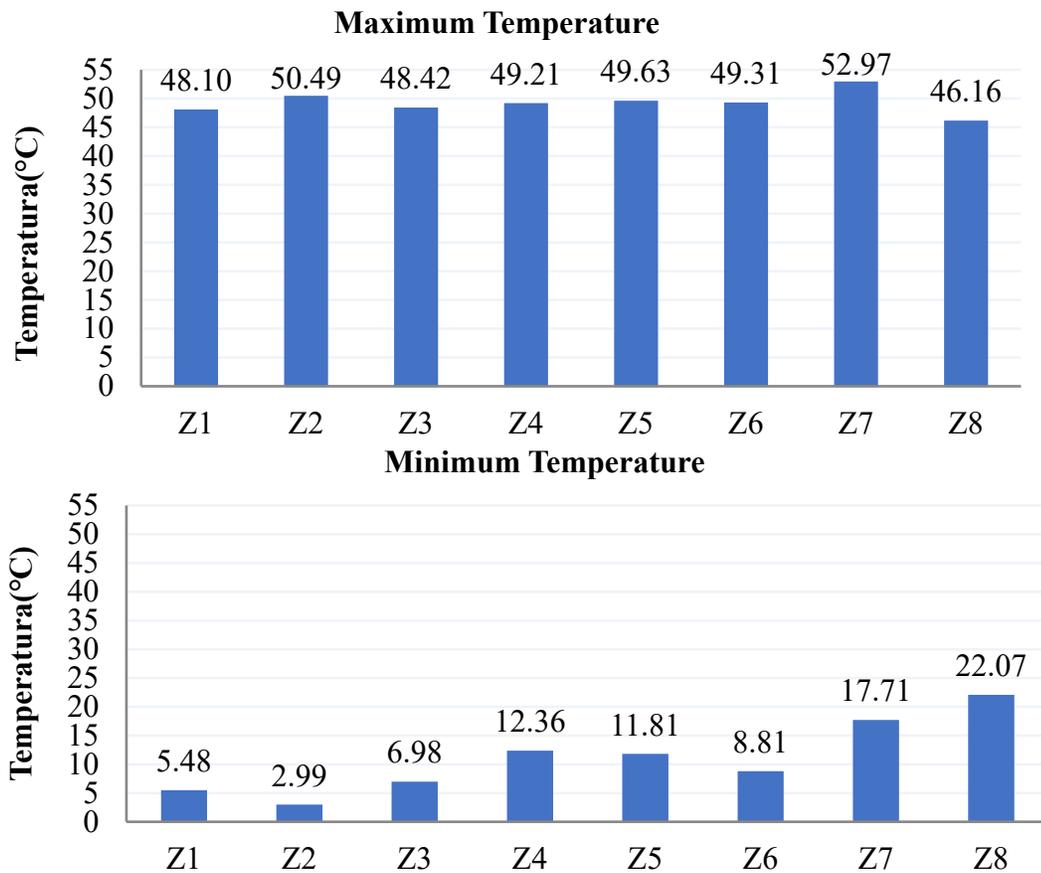
Figure 3. Absolute maximum and minimum surface temperatures for each bioclimatic zone in the studied year.

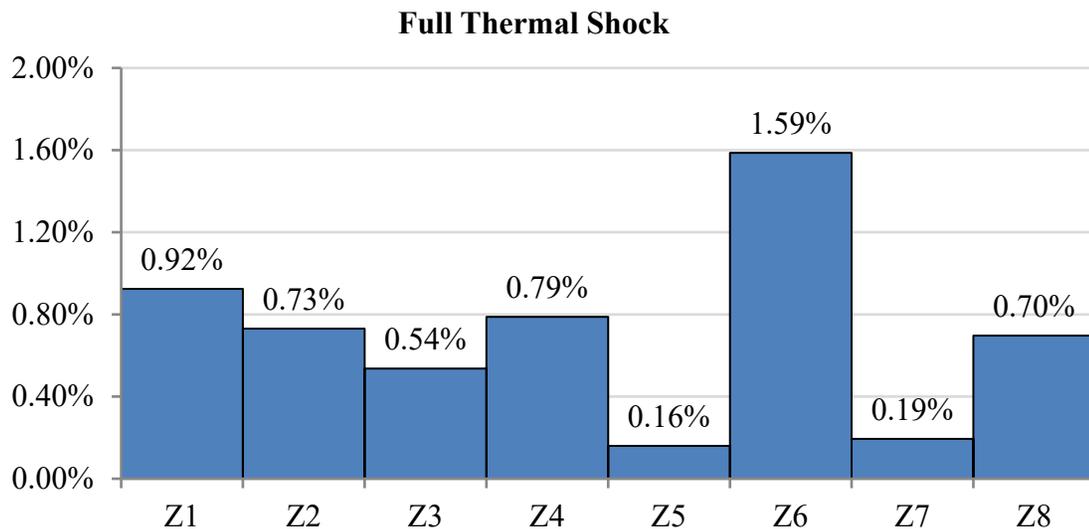
Figure 4. Frequency of occurrence of full thermal shock during one year.

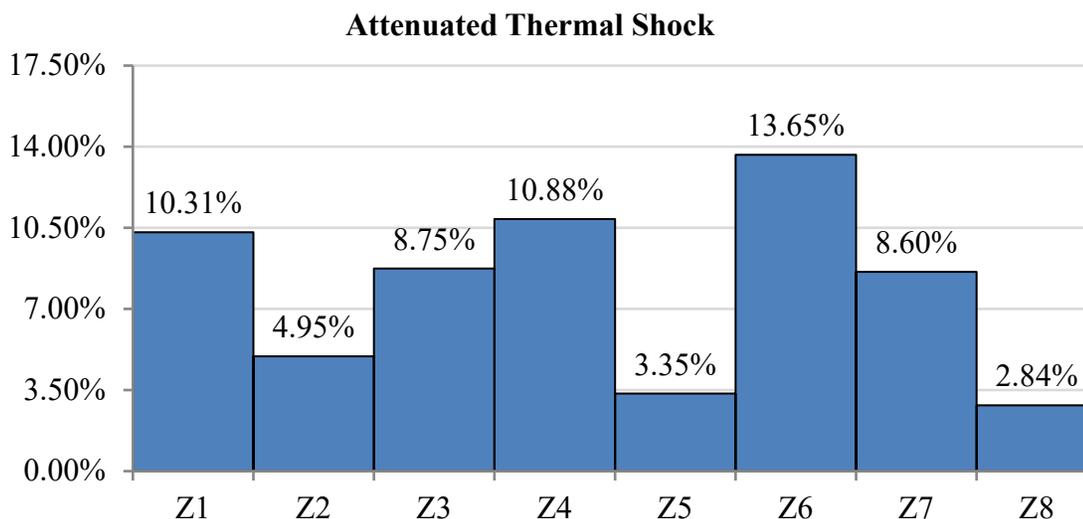
Figure 5. Frequency of attenuated thermal shock observed in one simulation year.

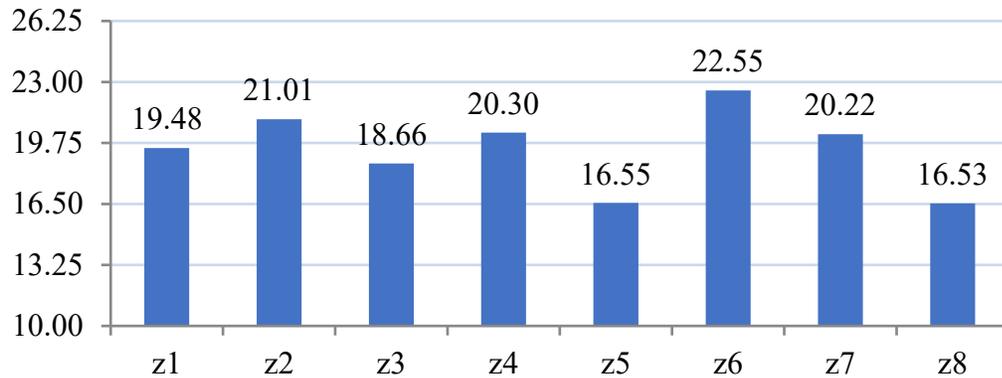
Figure 6. I_{IT} values for all bioclimatic zones.

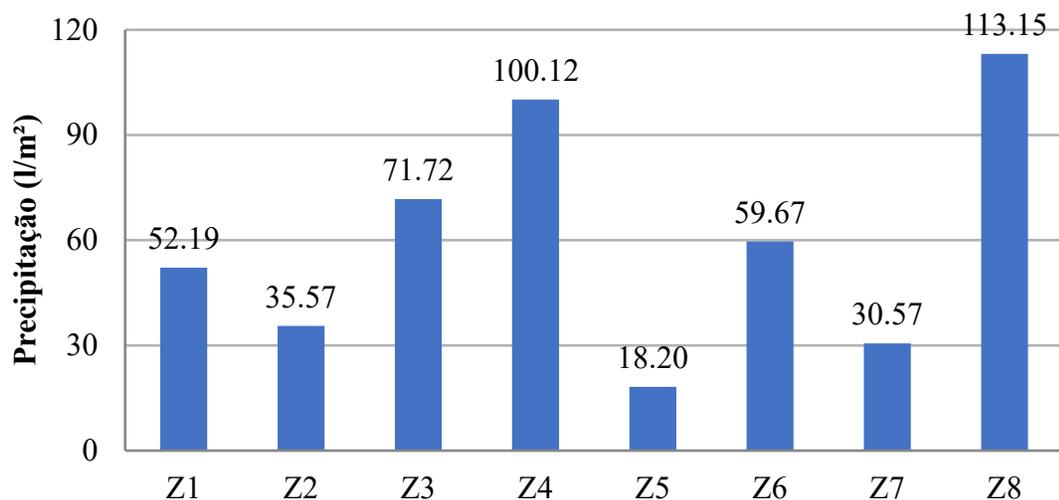
Figure 7. Accumulated driving rainfall in all bioclimatic zones during one year.

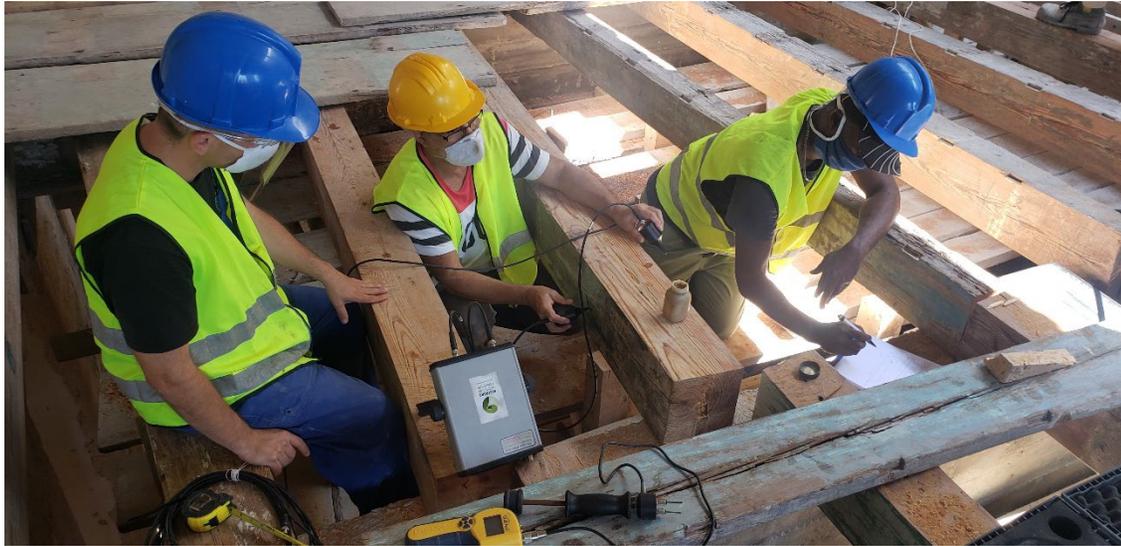
Figure 9. Application of UPV tests on wooden beams

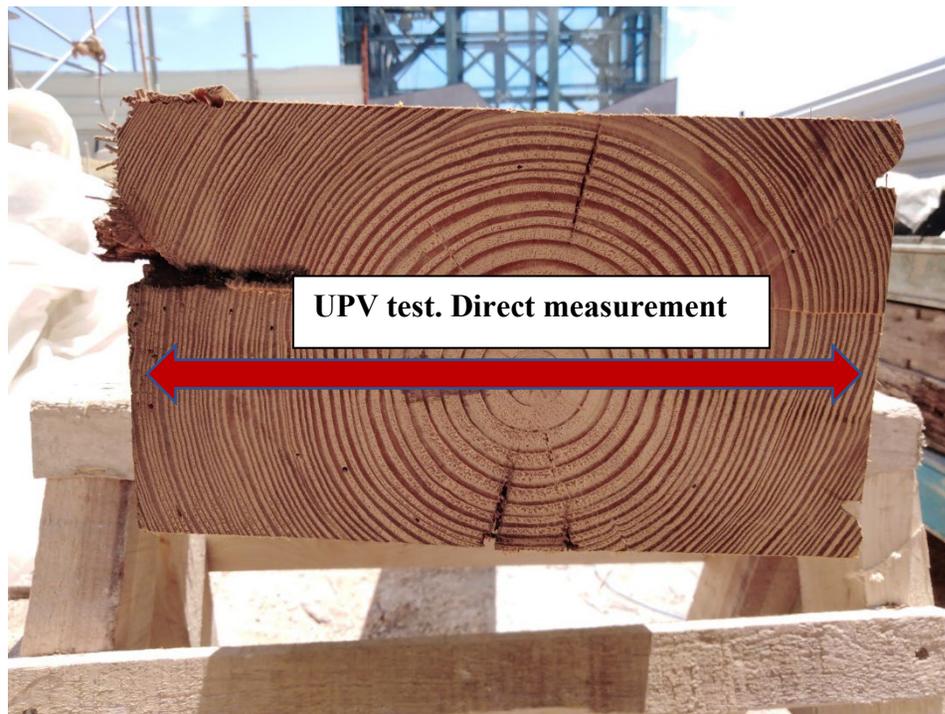
Figure 10. UPV application diagram perpendicular to the fiber

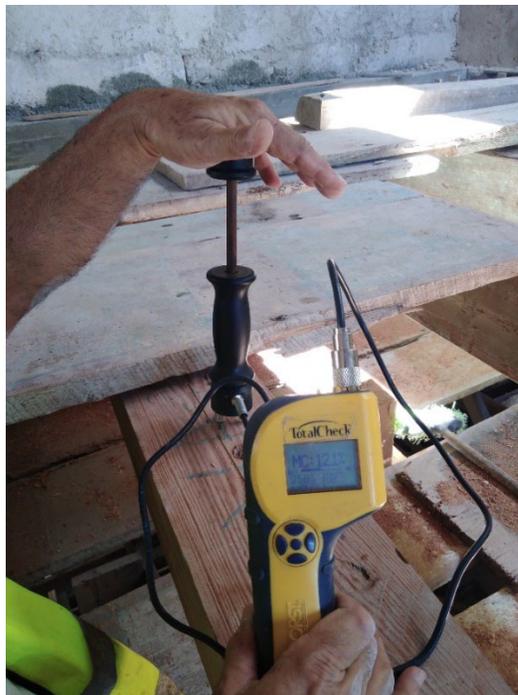
Figure 11. Surface moisture measurement with Delmhorst's TotalCheck thermo-hygrometer equipment

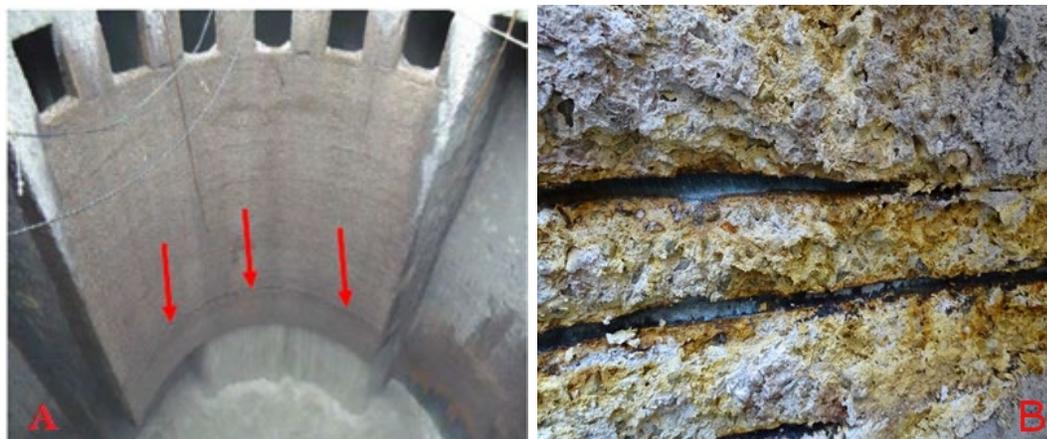
Figure 1. (a) wet-well (b) Degradation of concrete and steel bars observed by site inspection

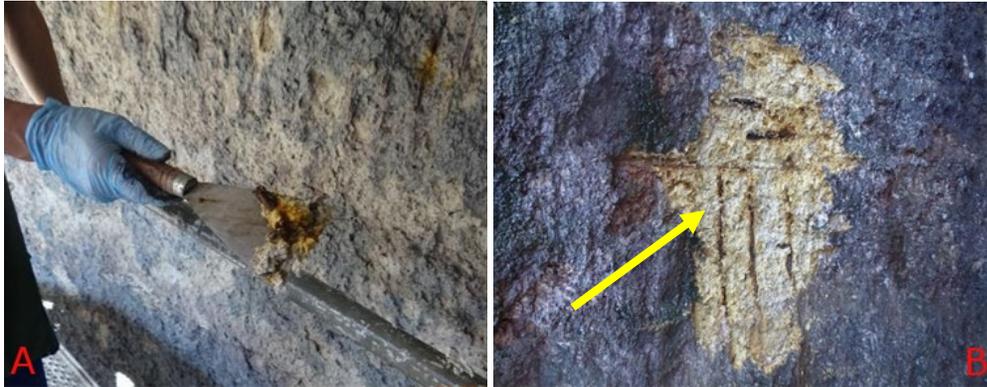
Figure 2. (a) removal of the degraded concrete layer using a spatula and (b) parts of completely reinforcement dissolution

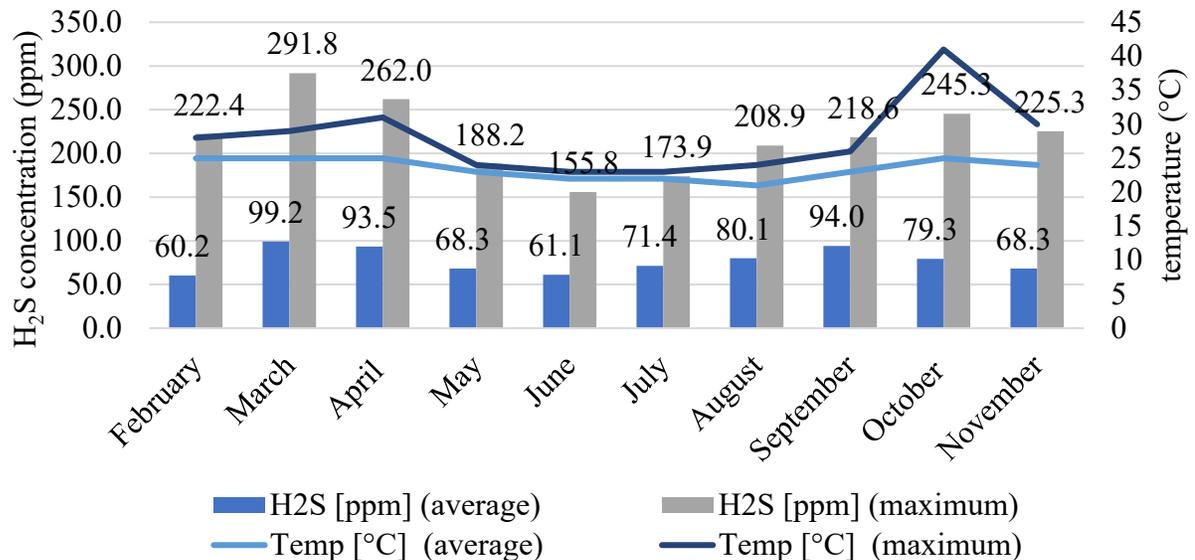
Figure 3. H₂S concentration and temperature over the months

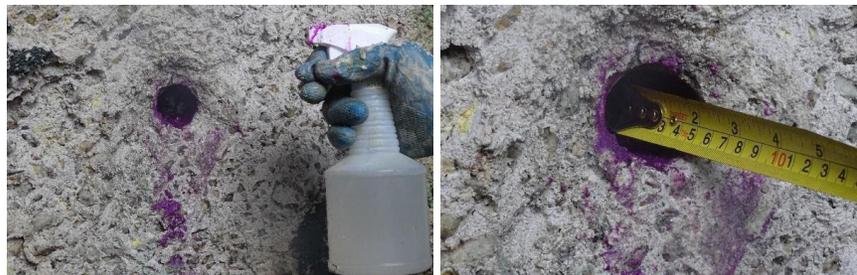
Figure 4: wet-well’s wall - alkaline concrete

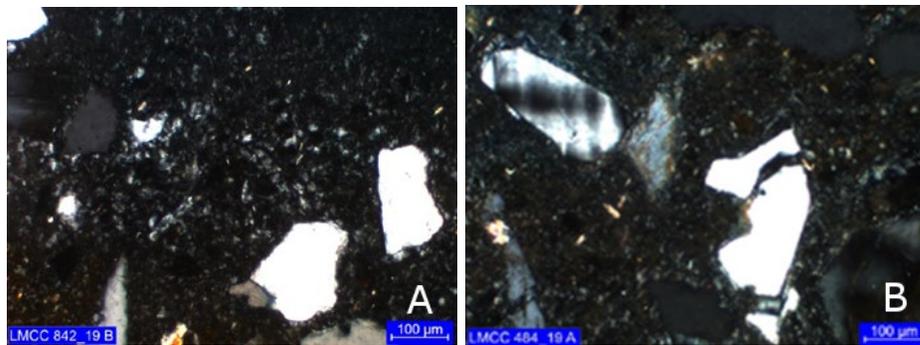
Figure 6. First alteration layer, possibly gypsum cores (a) 1 and (b) 2. Cross polarization, with capacitor.

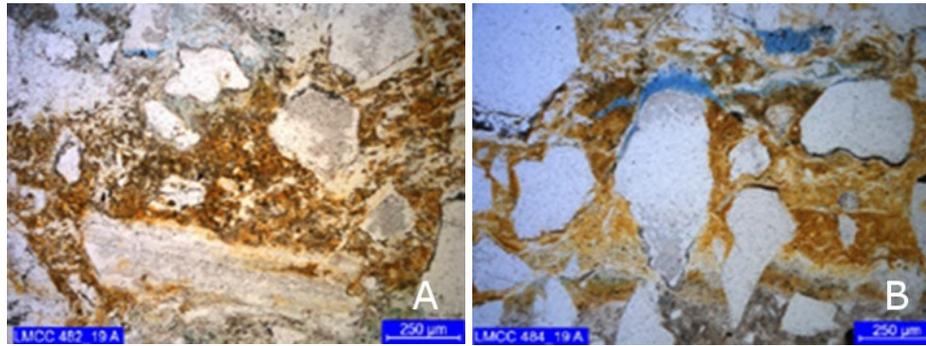
Figure 7. Impregnation of iron hydroxides (reddish tones) from cores (a) 1 and (b) 3. Simple polarization with capacitor.

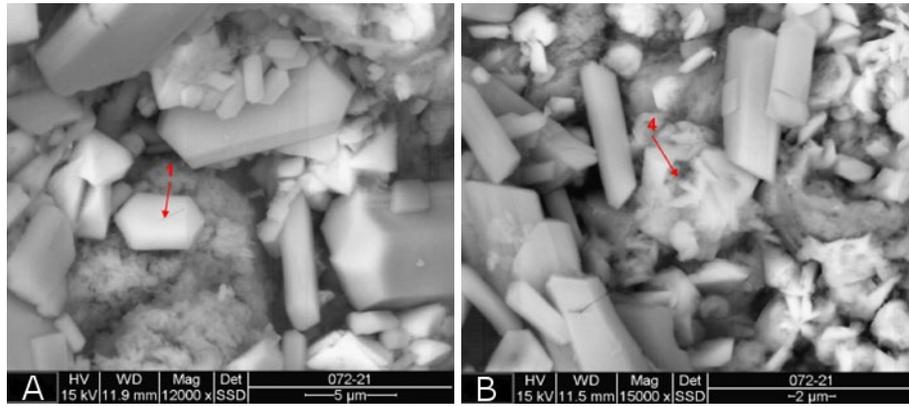
Figure 10. SEM scraped material - sulfoaluminosilicate crystalline phases, containing Ca, Fe and K.

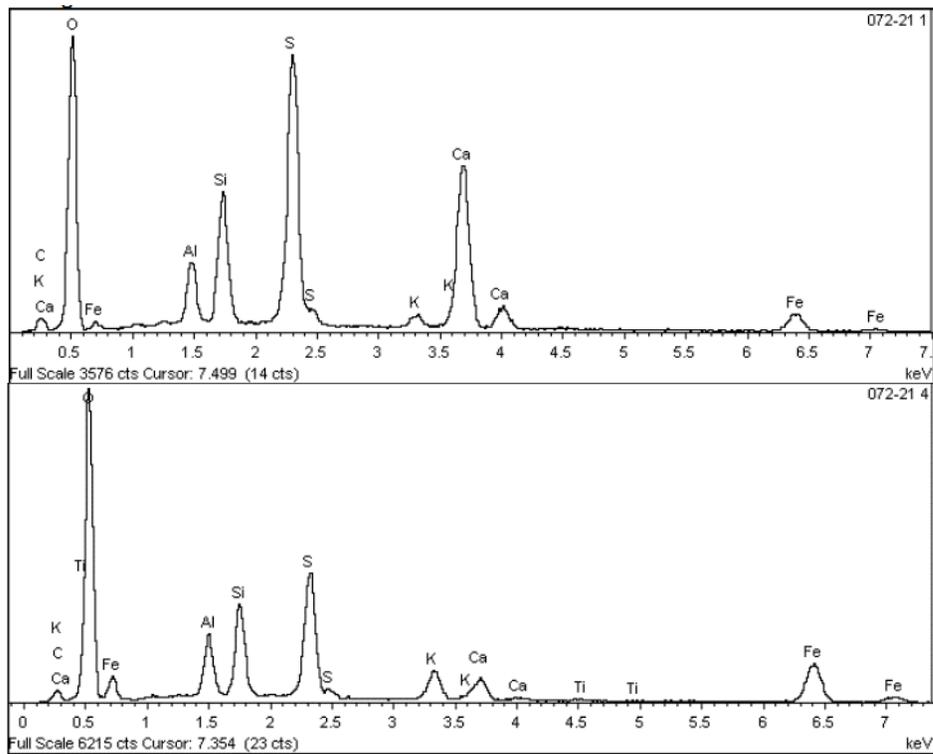
Figure 11. EDS spectra indicated in figure 10 (a) and (b)

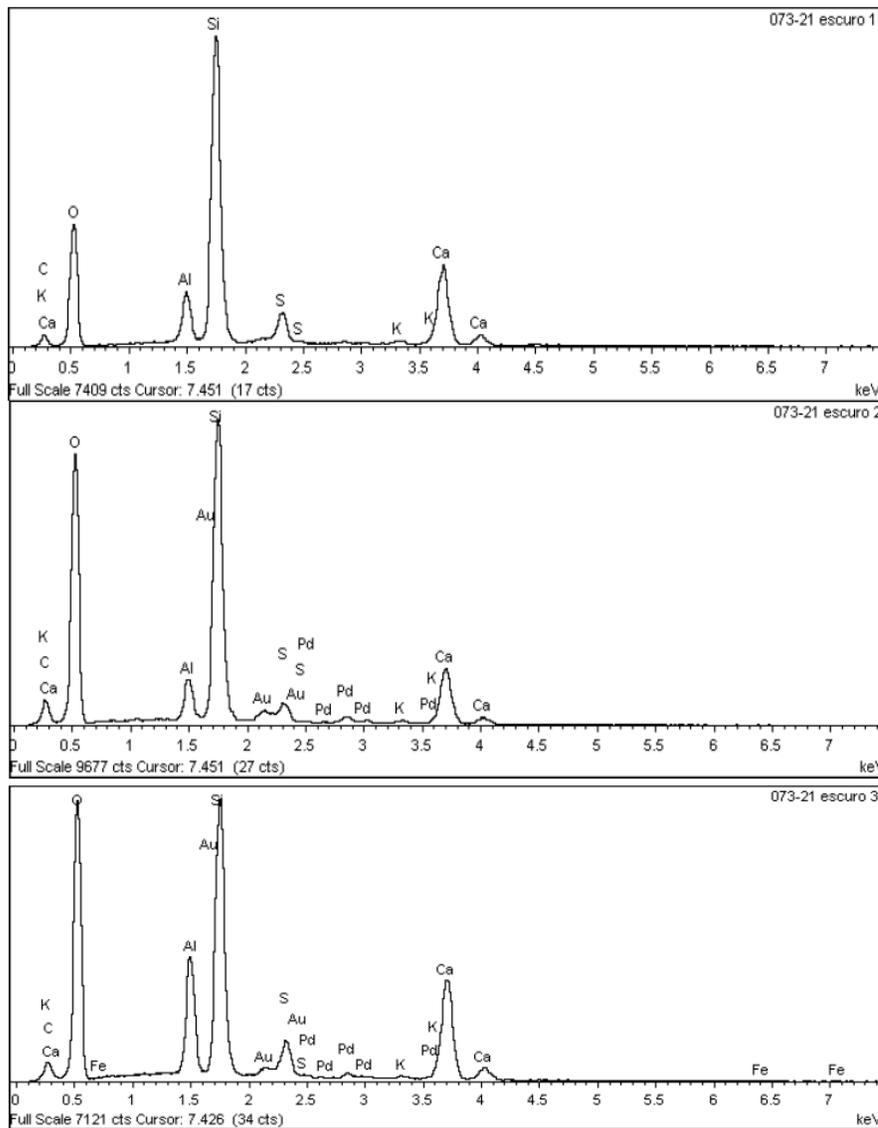
Figure 15. EDS spectra indicated in figure 14 and b.

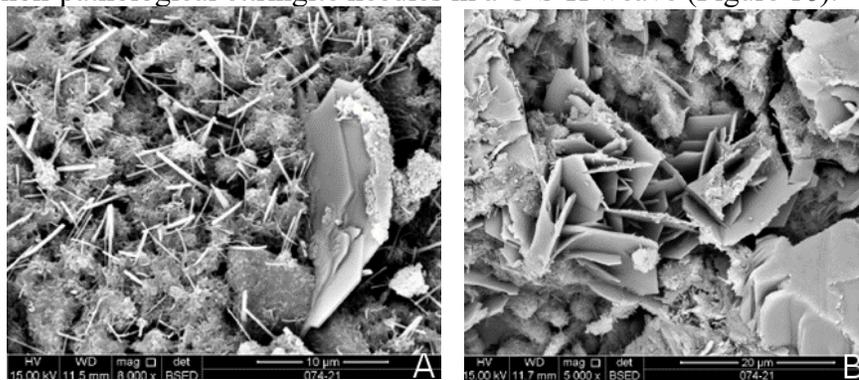
Figure 16. SEM innermost sample - magnification of (a) 10µm and (b) 20µm.

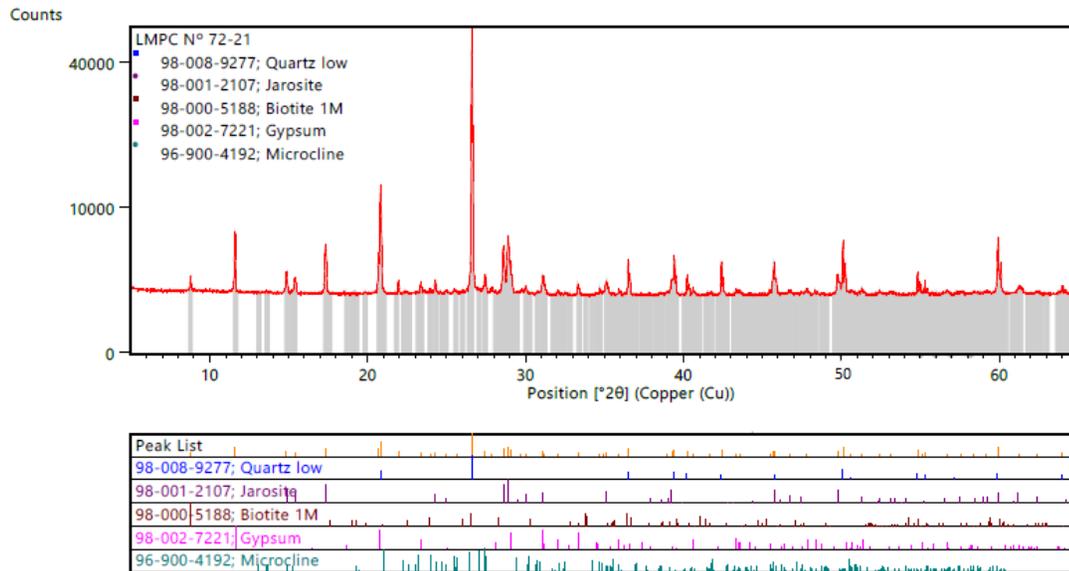
Figure 17. X-Ray diffractogram – scraped material.

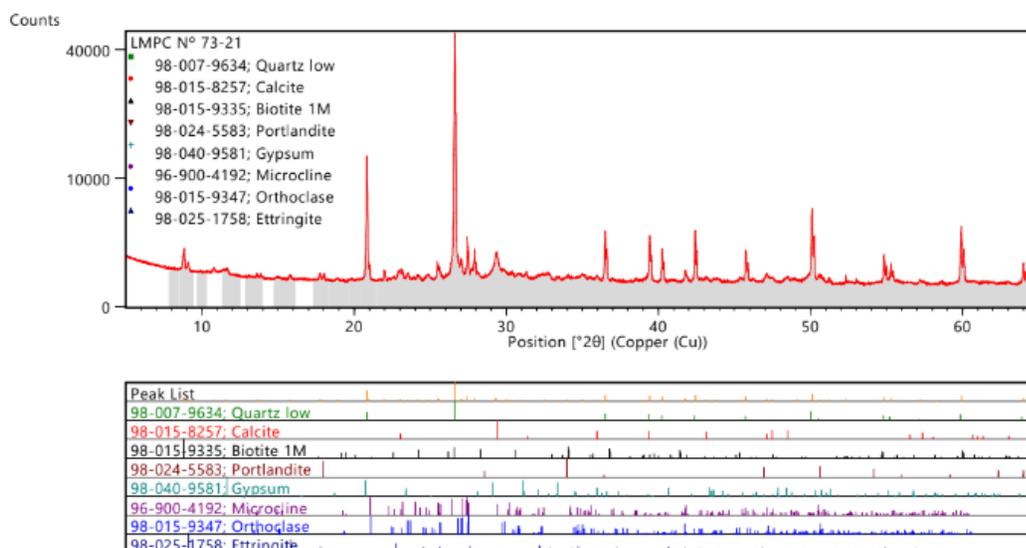
Figure 18. X-ray diffractogram – intermediate sample.

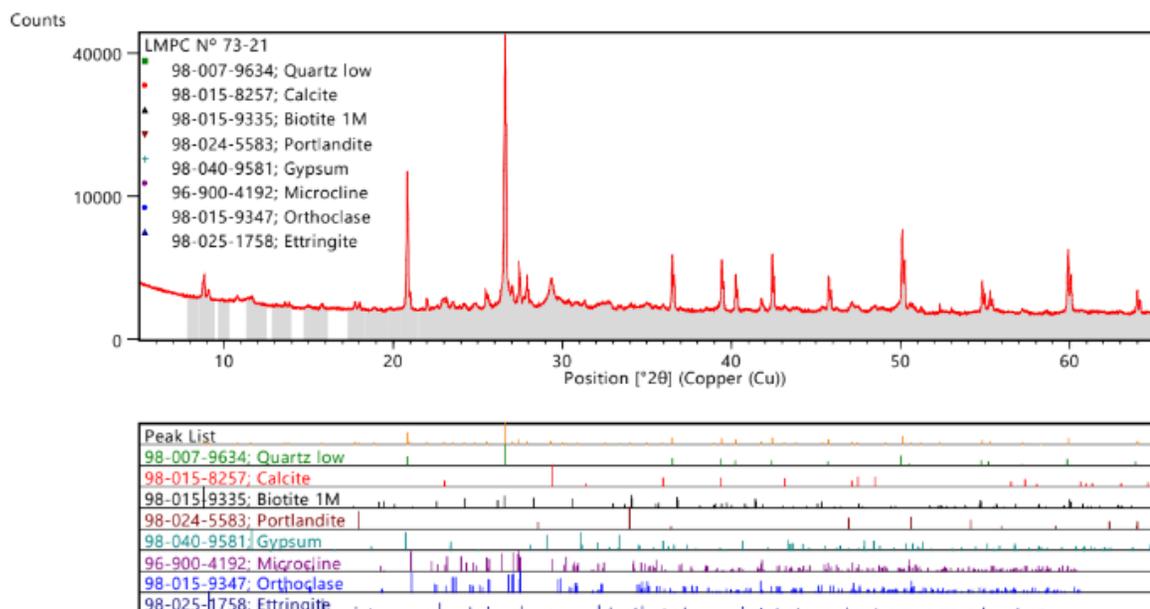
Figure 19. X-ray diffractogram – innermost sample.

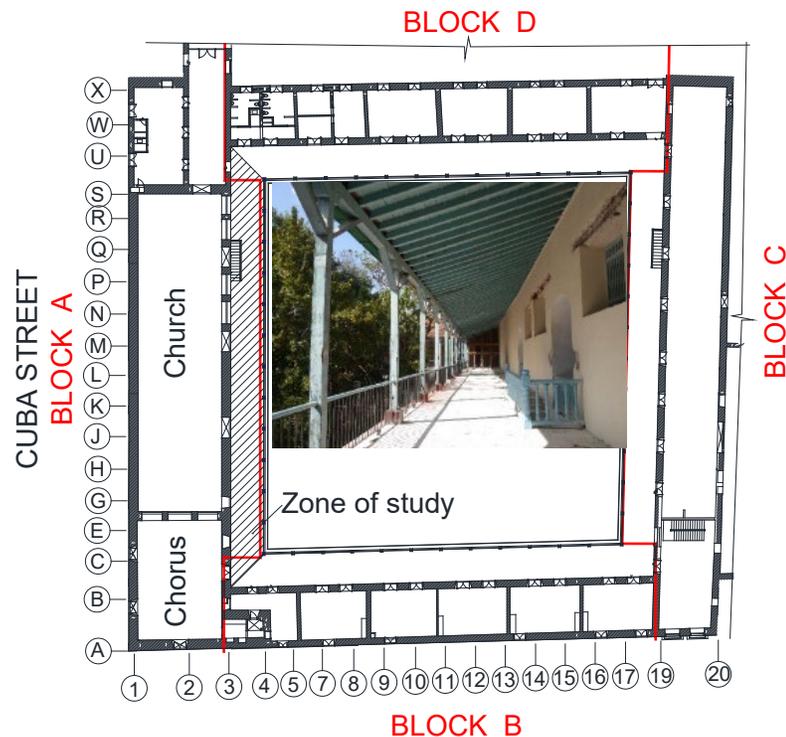
Figure 1. Floor plan sketch of the first cloister, signs and photograph of the gallery studied

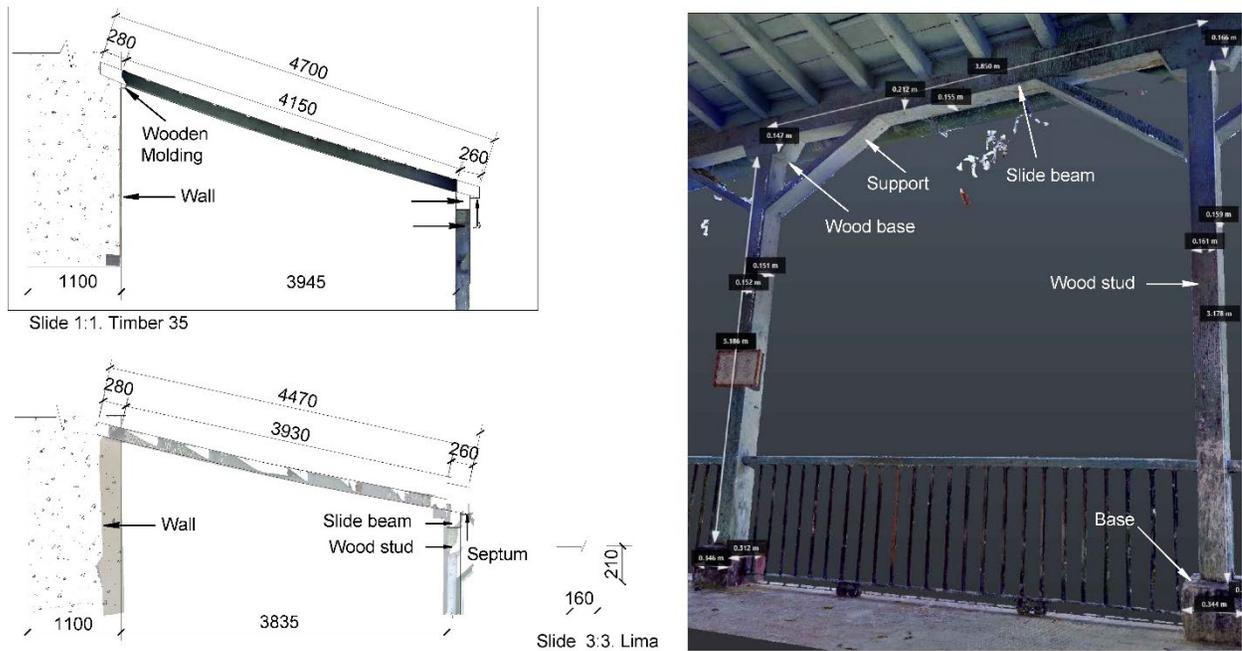
Figure 3. Dimensioning and deformation (in mm) of the wooden elements from the 3D models

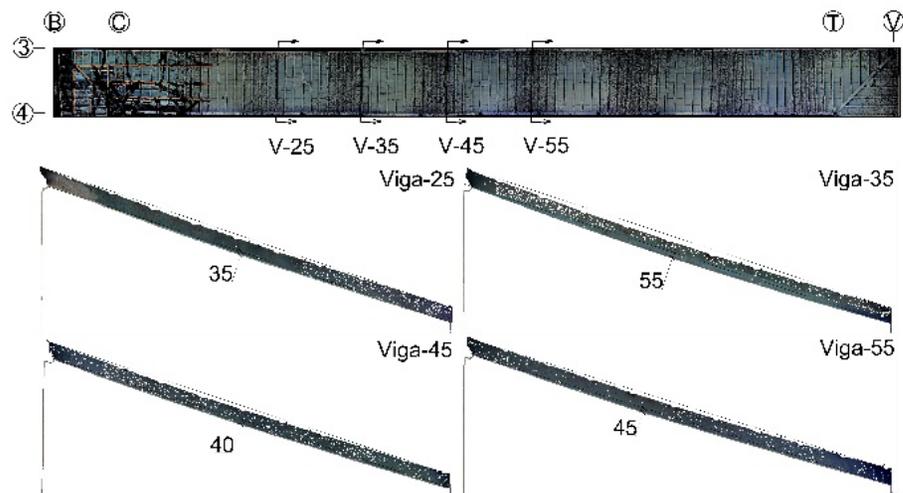
Figure 4. Deformations (in mm) of some wood beams

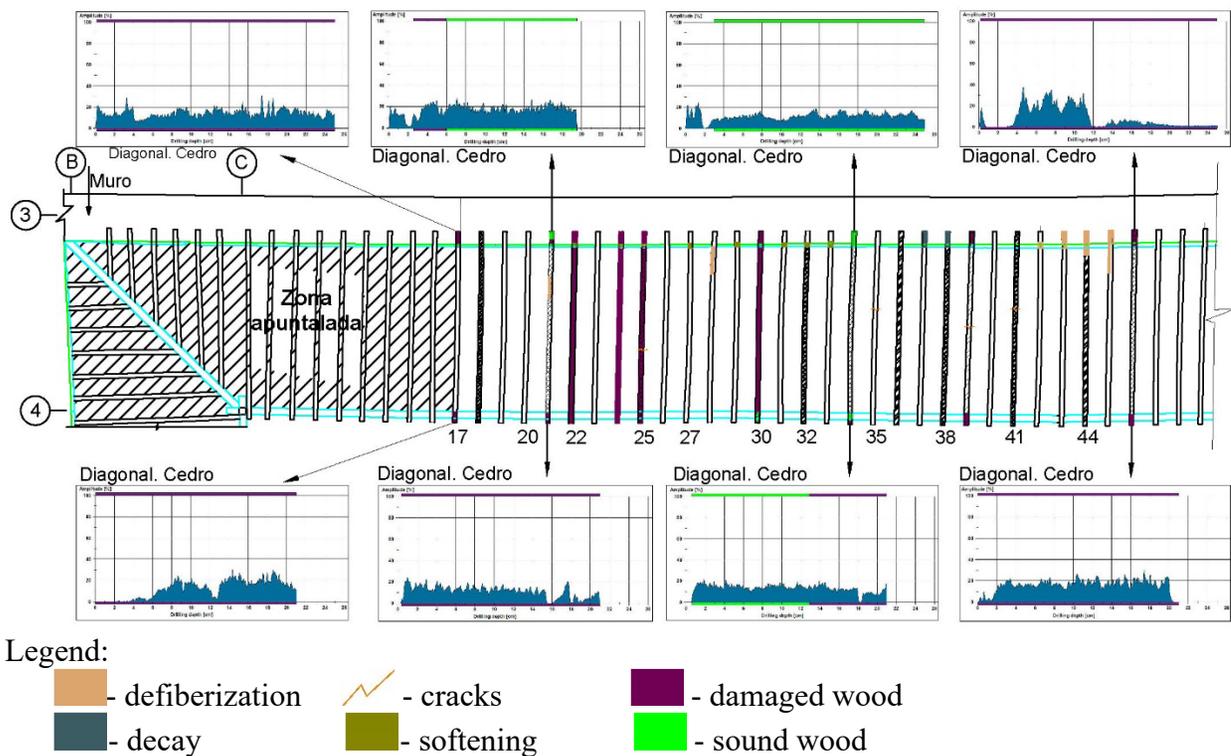
Figure 6. Results of resistography tests and damages in wooden elements between beams 1-49

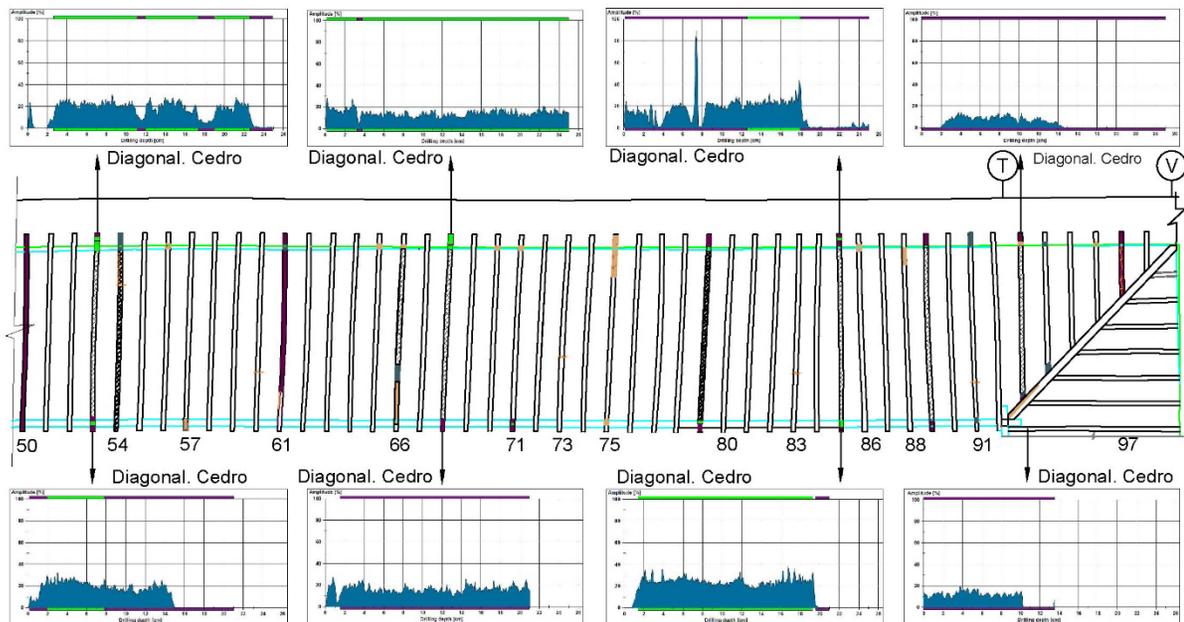
Figure 7. Results of resistography tests and damages in wooden elements between beams 50-98

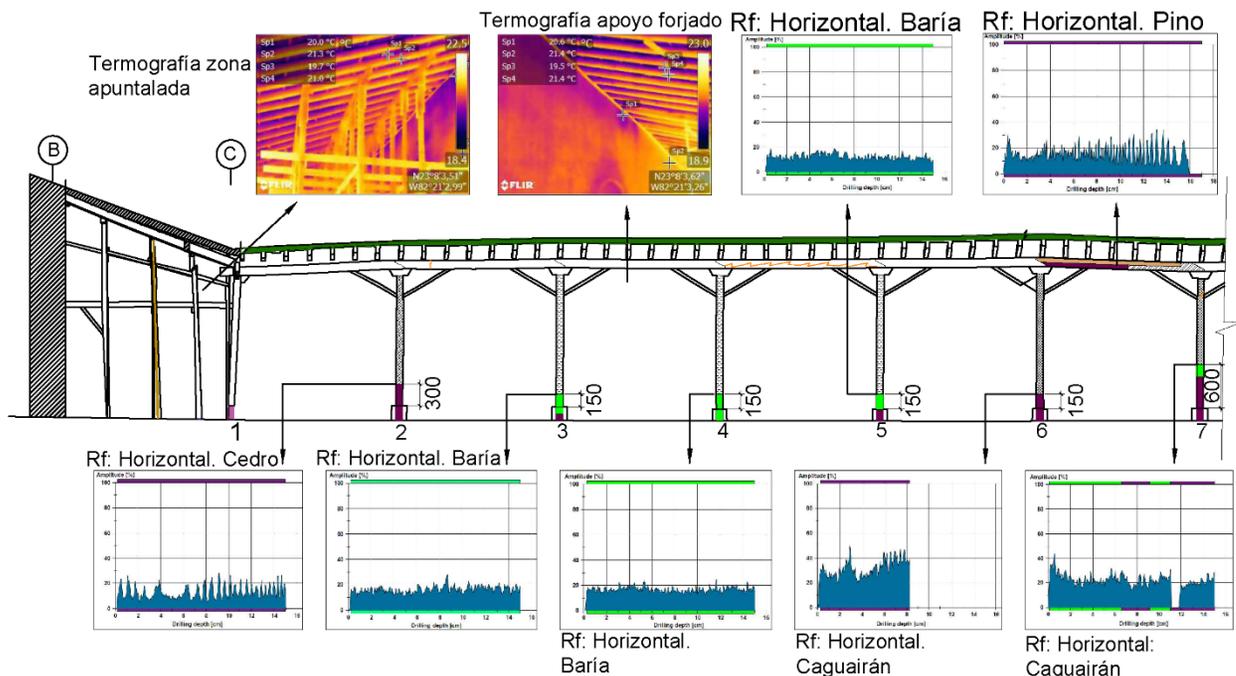
Figure 8. Results of tests on elements of the slab between wood studs 1-7, where the thermography reflects the humidity present in the wall of axis 3 in the support area of the beams, and the resistography in the wood stud and sliding beam of the axis 4

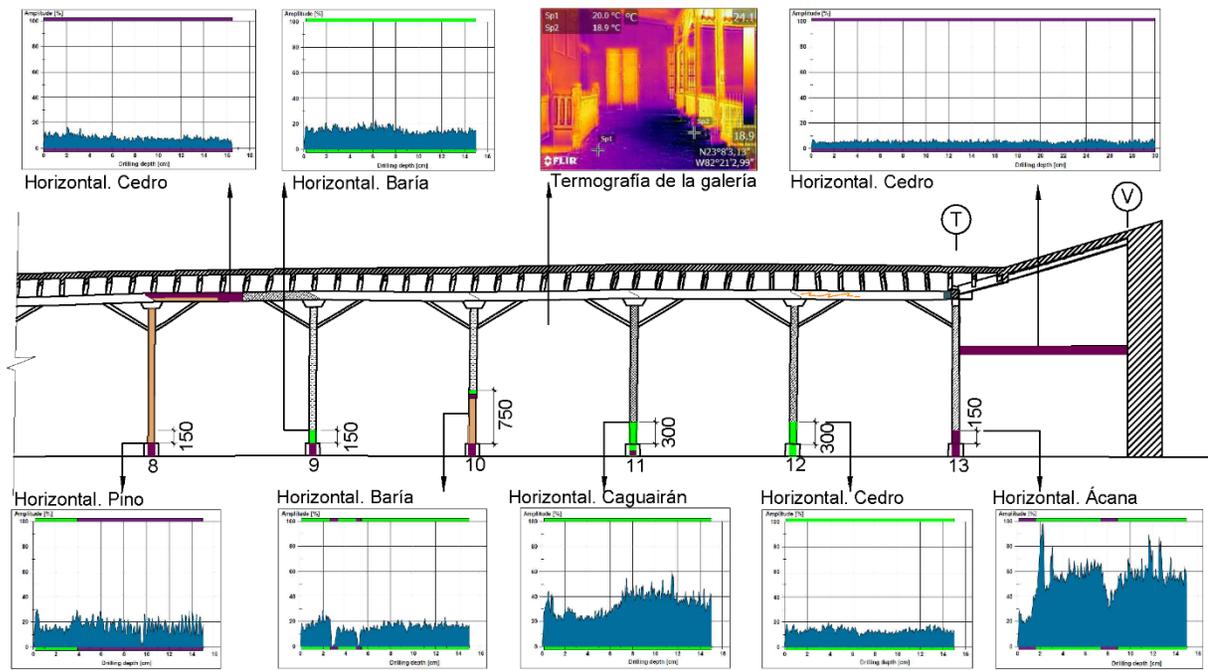
Figure 9. Results of tests on elements of the slab between wood stud 8-13, showing the thermography of the gallery with a high level of humidity in the supports of the wood stud, and the resistography in the wood stud and slide beam at axis 4.
