Diagnosis and structural underpinning project of the Tampieri Palace

The diagnosis and structural underpinning of the Tampieri Palace is detailed, within a comprehensive restoration project. The building has a high patrimonial value, constituting one of the two existing palaces in the Province of Córdoba, Argentina. It presents fractures in load-bearing masonry, caused by differential settlements, as it is founded on collapsible silts affected by cyclical variations in the water table. The methodology consisted of relieving the existing injuries, conducting searches and technical and historical investigation of its construction to diagnose its structural and constructive state. The intervention was divided into two stages: A) stabilize and seal the building, and B) rehabilitate and restore facades and interiors. It is concluded that the driven micropiles constitute a valid alternative to refund buildings in saturated soils, with minimally destructive interventions.

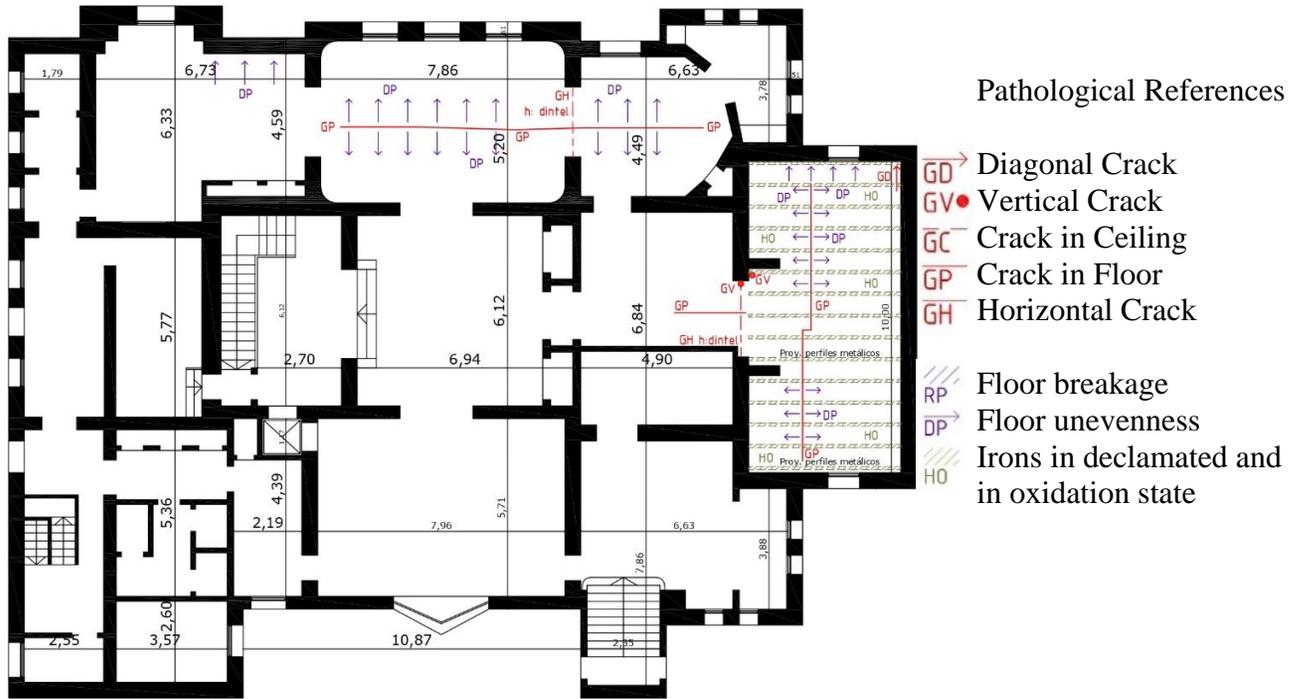
Figure 2. Pathology survey at subsoil level.

Figures 2 to 4 present diagrams, in plan and façade, of the pathological surveys carried out.

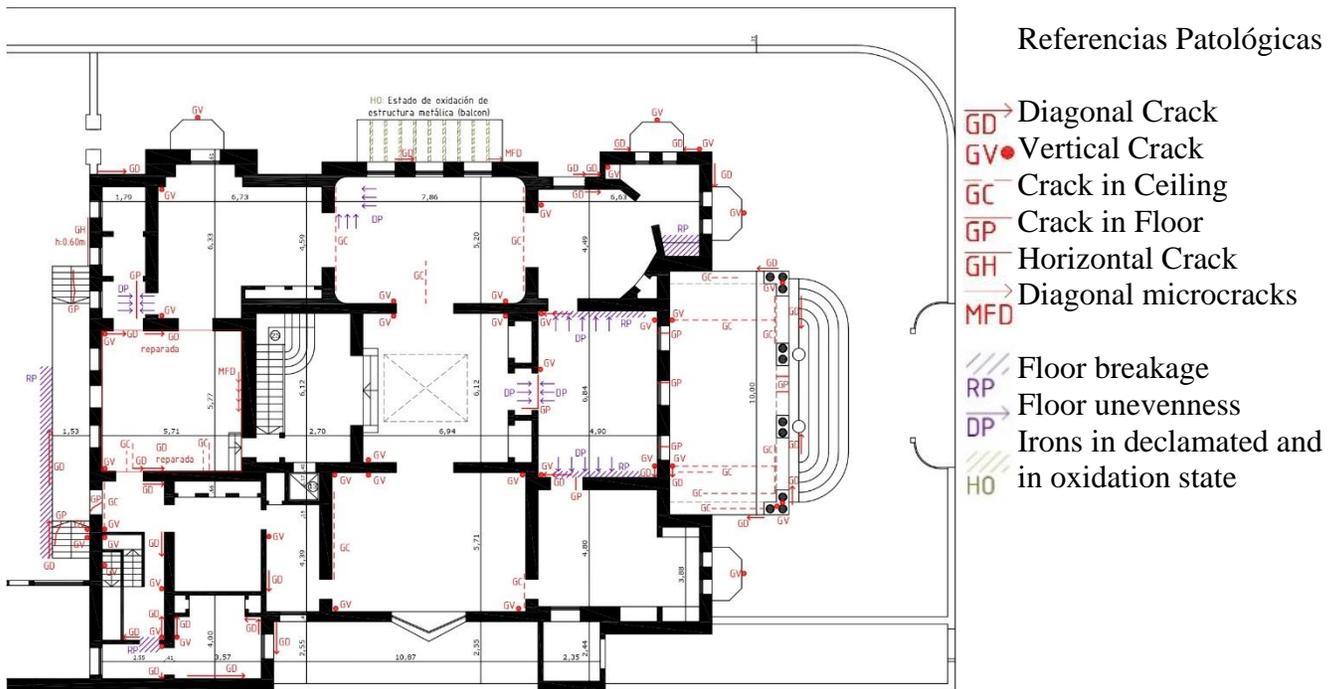
Figure 3. Pathology survey at ground floor level.

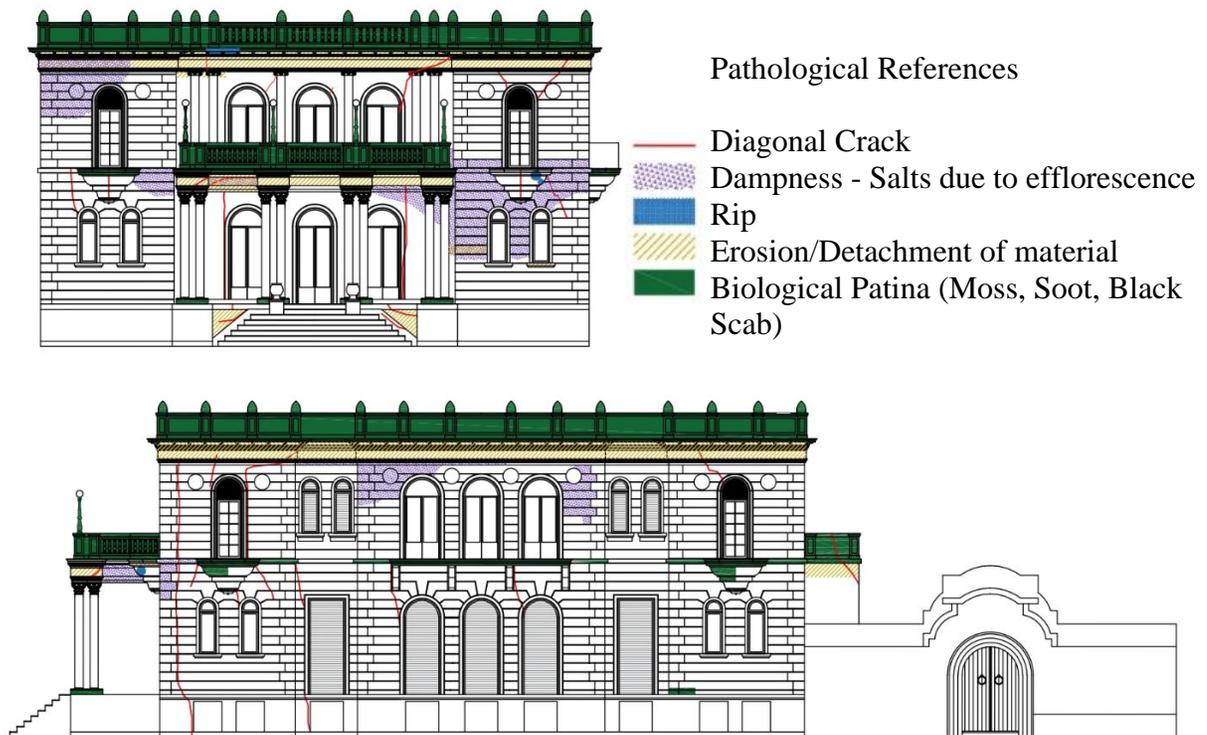
Figure 4. Survey of pathologies on North and West façades.

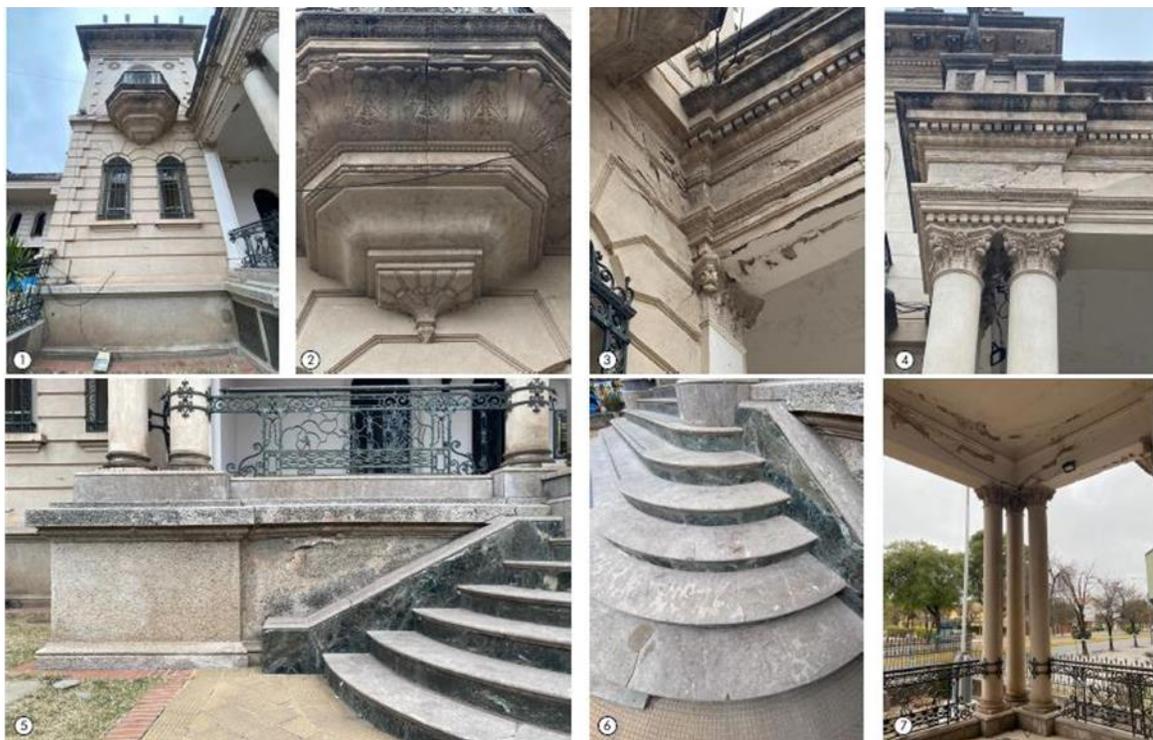
Figure 5. Photographic survey of gradients. 5.1) and 5.2): cracks in the lower coating of the balcony, caused by corrosion of the interior reinforcement structure. 5.3), 5.4) and 5.7): The displacement of the lintelled metal structure of the entrance porch, due to differential seats, caused pulling and tensile cracks in the joints with load-bearing walls, giving rise to the entry of water seepage and the consequent degradation of stone-like plaster. 5.5) and 5.6): differential descents of terrace columns over entrance porch, with warping of molding lines and breakage of cladding plates, even in stairways.

The study and analysis allows us to infer the causes that probably originated them. Figure 5 shows a photographic survey of the palace's degradations.

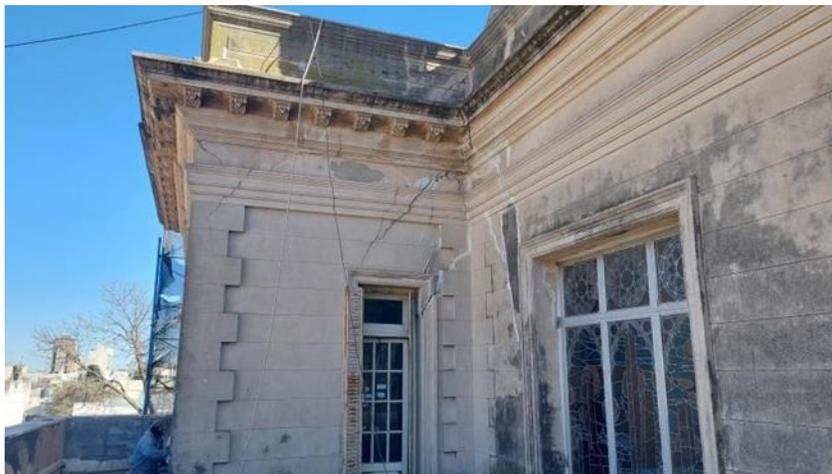
Based on the survey and analysis of the existing fractures, their causes were diagnosed, reaching the conclusion that they are due to differential settlements of the structure, due to deformation of the supporting soil, originated by its saturation. The loessic silts of the central part of Argentina have particular granulometric characteristics, being formed by a fraction of the size of sands and a significant fraction of the size of silts, clays and calcium carbonates. In general, these soils have low plasticity and stratum strengths or thicknesses that vary regionally. In the sector under study, it is very common for silt strata to appear at depths varying between 8 and 12 meters with presence of isolated nodules, with lower hydraulic conductivity than the upper silts, so that the water that infiltrates tends to accumulate above this layer. Regionally, there is a slight slope in the terrain, characteristic of wind deposits, which gives rise to the presence of depressions and wetlands. The latter is in addition to the increasing values of water surpluses in the balances, increasing from the 1970's onwards the frequency of years with excesses. Hydrological balances show that the storage of these surpluses in these lowland systems results in a significant increase in water tables (Gómez et al., 2006).

Figure 6. The differential seats caused diagonal tensile forces on the walls, resulting in the appearance of parabolic cracks perpendicular to the tensile diagonal.

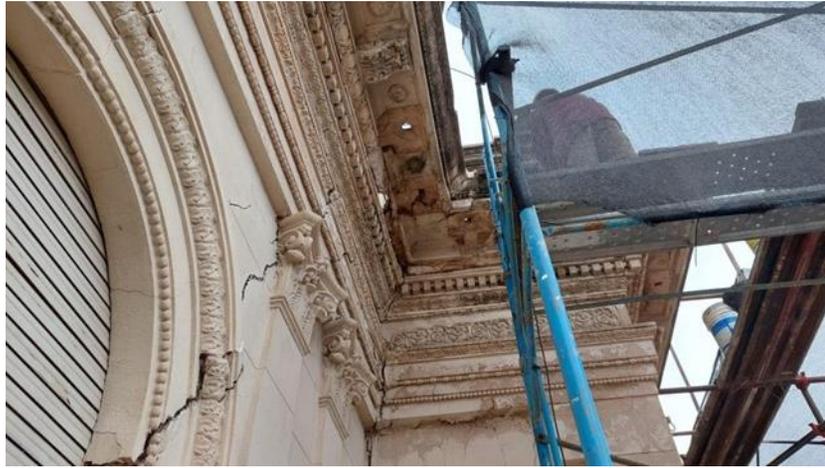
Figure 7. Detail of cracks with displacement between wall fragments.

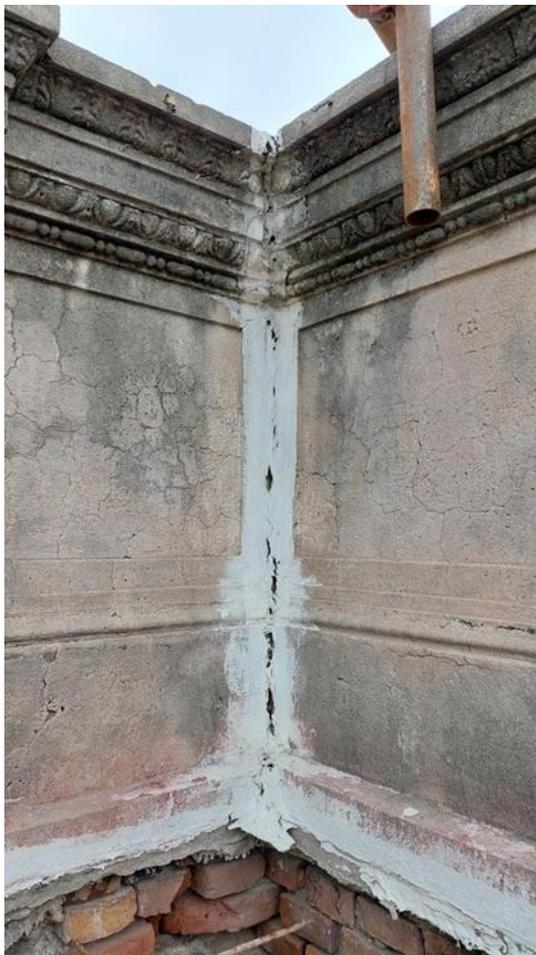
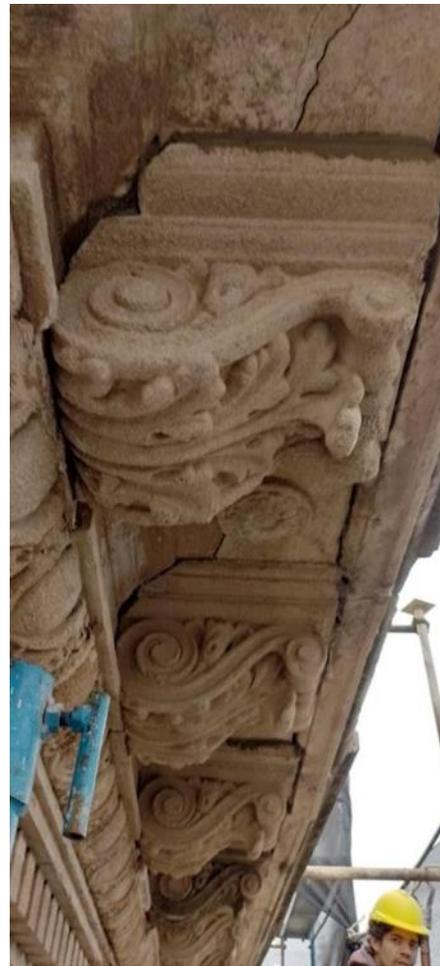
Figure 8. a) Disconnection of walls at corner encounters, due to differential displacements and collapses between them. b) Detail of detachment of ornaments and volutes due to deformation of the cornices, as a result of the settlements. Such loose elements pose a risk of falling into the void.

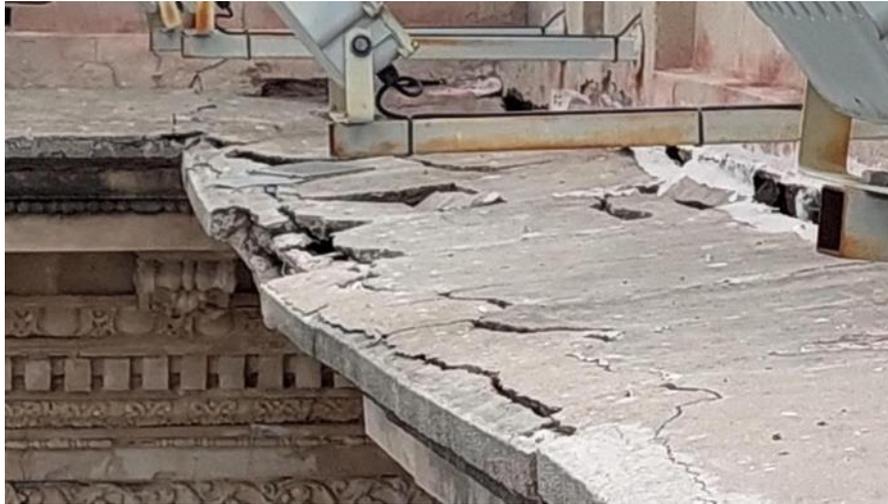
Figure 9. Deformation and breakage of the metal structure of the cornice frame.

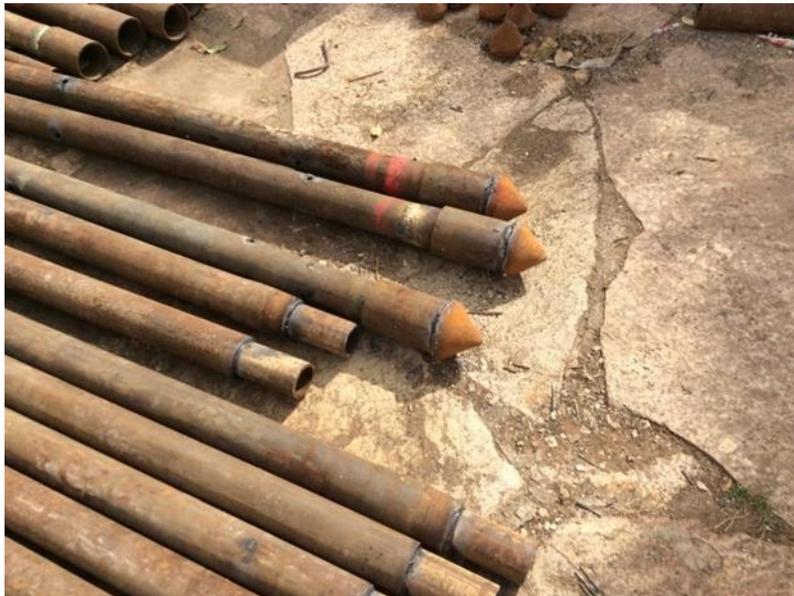
Figure 10. Focus on the Manessmann tubes with a diameter of 73 mm. Injection drilling and driving azuches are observed without vibration transmission to the surrounding soil.

These micropiles consist of seamless, special alloy steel pipes with tensile stress that duplicate traditional structural steels, called Manesmann (Figure 10). They have an external diameter of 73 mm, and are welded every 3 meters, driven by percussion until the rejection resistance of the ground is reached, which must be compatible with the foundation horizon foreseen in the previous geotechnical studies.

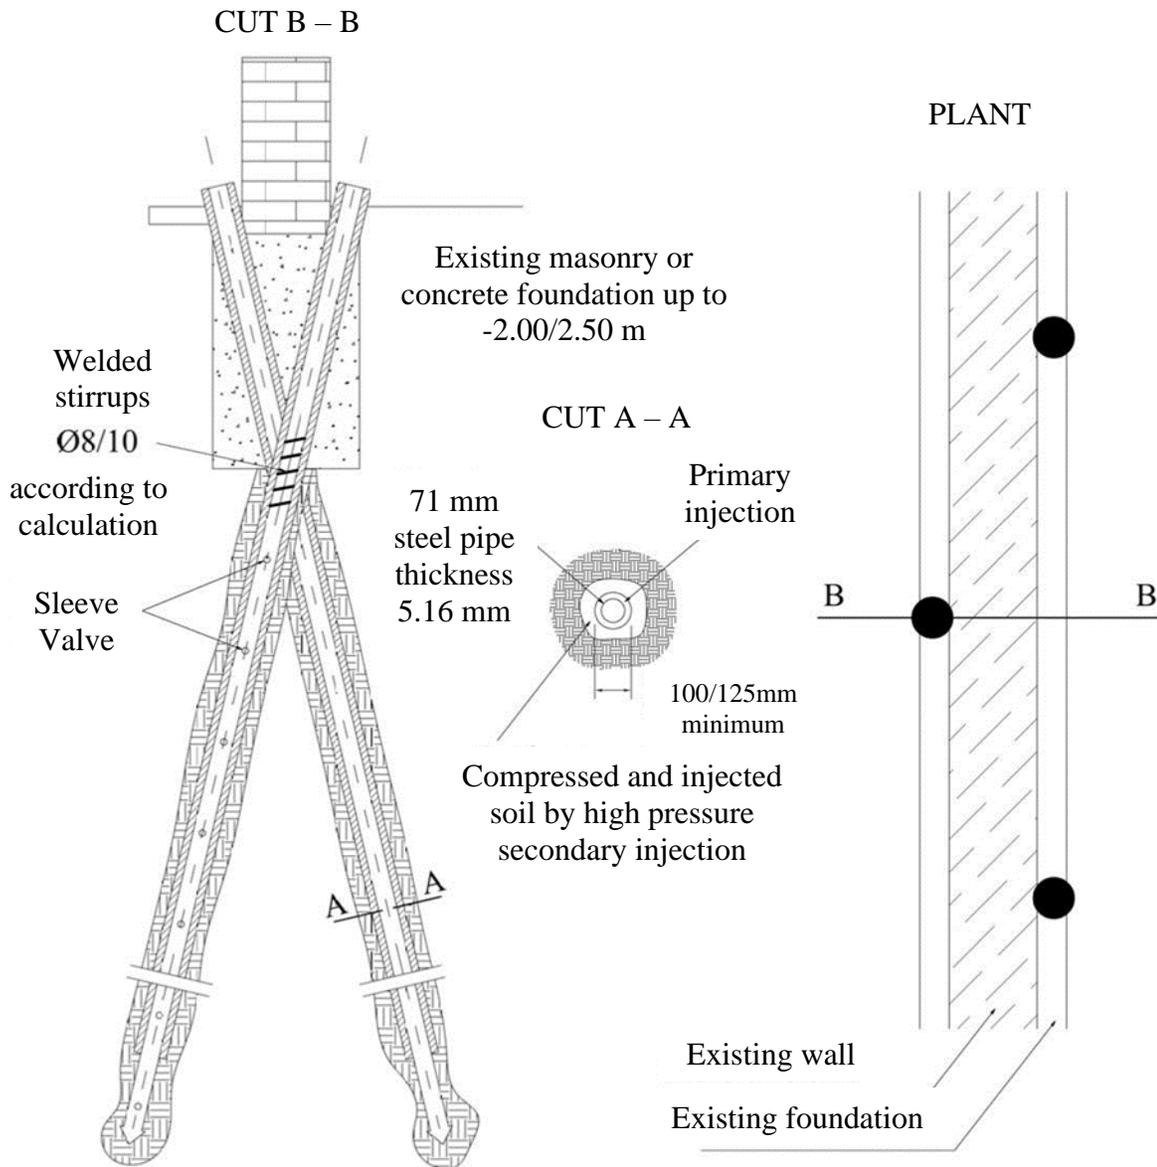
Figure 11. Diagram of support of interior walls in sub-vertical micropiles.

The arrangement of the micropiles to materialize the underpinning of the walls is carried out in three-bolillos (Figure 11). The number of micropiles to be used is determined by the load the wall receives and the load capacity of the micropile. Table 1 shows the calculation parameters of the micropiles that then allowed us to determine the amount needed for the underpinning of each wall.

During the execution, and in order to cross the wall avoiding vibrations due to driving, a hole of 120 mm in diameter was first drilled with a diamond crown, until it crossed the support base. At that moment, the crown was removed and the micropile was introduced until it made contact with the underlying soil, to just begin the driving process. In the case of the interior BA walls, the piles alternate on either side of each wall, with a "cot leg" scheme, as shown in Figure 11.

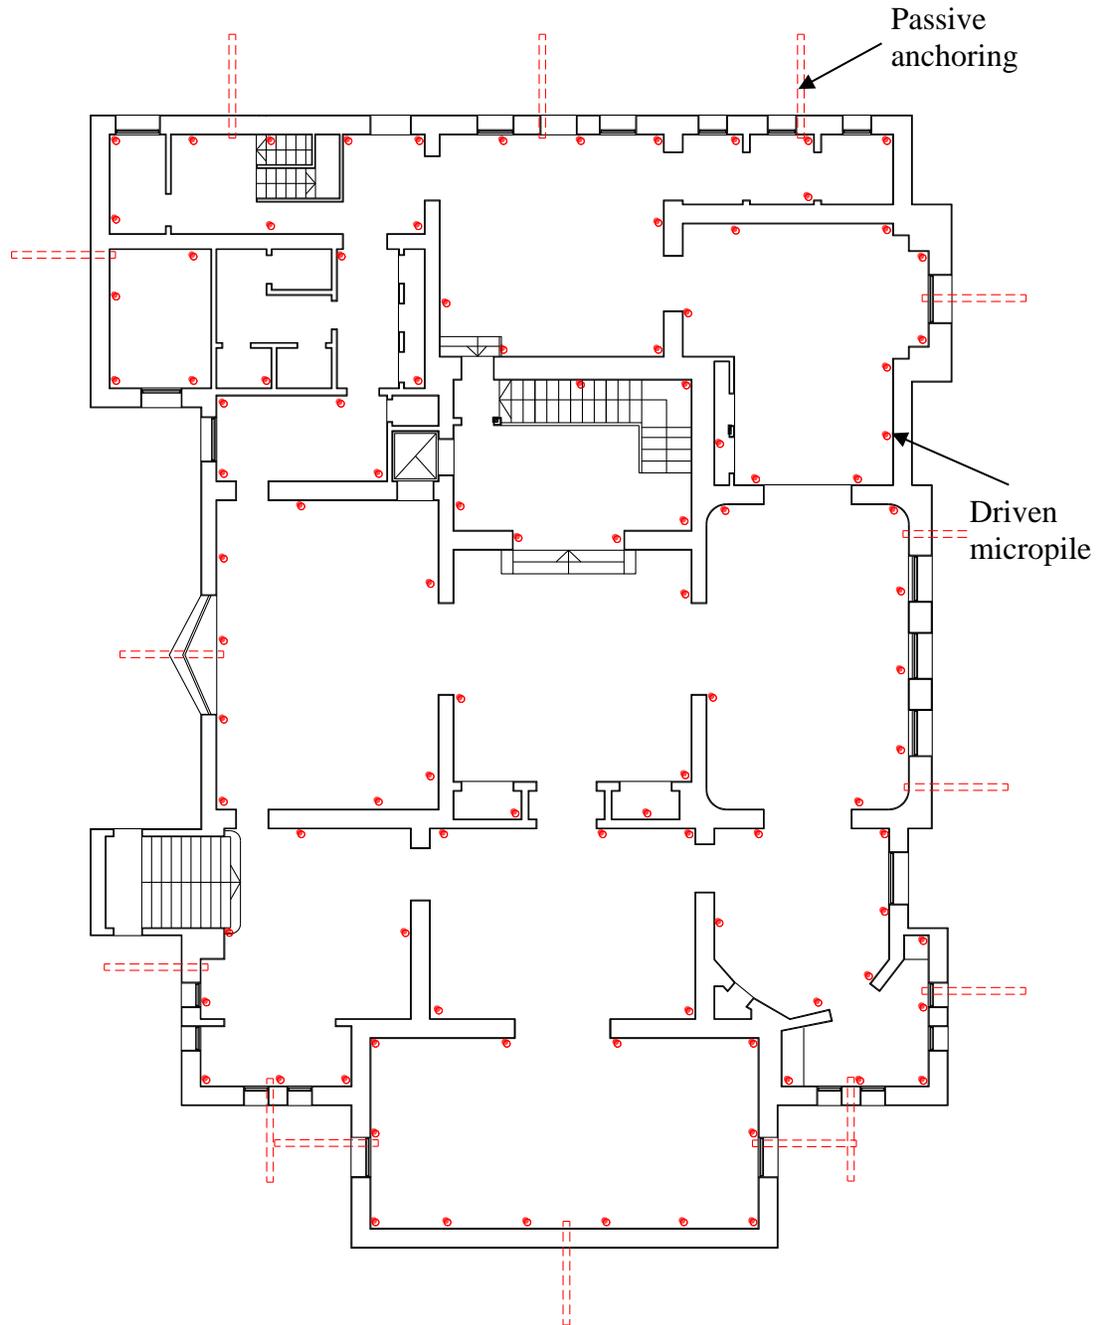
Figure 12. Diagram of the subsoil with the proposed location of the driven micropiles.

The location of the elements is detailed in the Basement Plan (Figure 12).

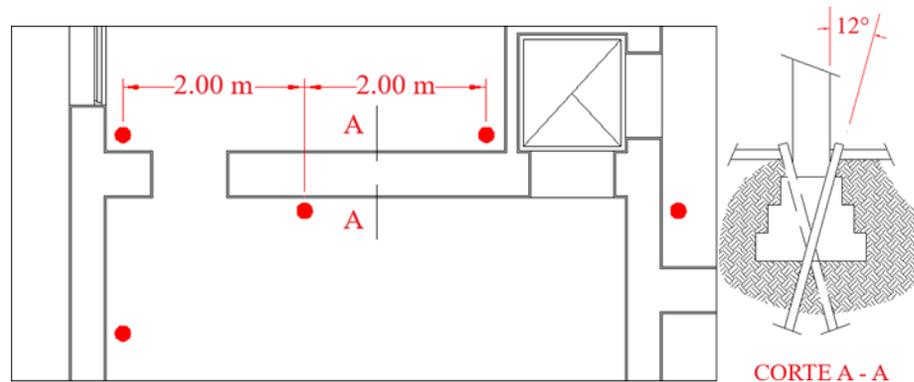
Figure 13. Detail of the arrangement and separation of micropiles in interior walls, along with a cut showing the link with the foundation masonry.

Figure 13 shows a detail with the approximate separation between micropiles, arranged on both sides of the interior walls, and a section with the detail of their location in relation to the existing

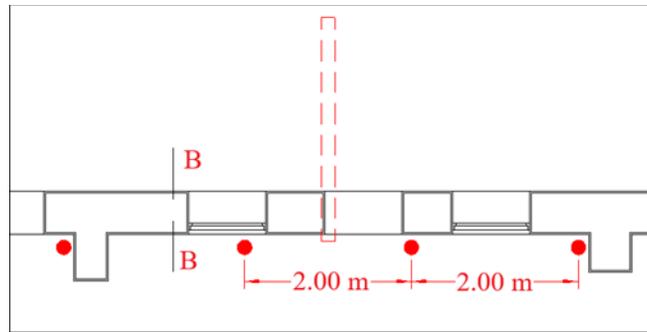
Figure 14. Detail of the arrangement and separation of micropiles in exterior walls, with the tentative location of the passive balance anchors.

Based on the analysis of the load of the outer wall and the bearing capacity of each micropile, the underpinning project was developed, the details of which are presented in Figure 14. The sub-vertical arrangement of the driven micropiles, crossing the alignment of the exterior walls only from the inside of the subsoil, generates a horizontal thrust on the underpinning structure that must be balanced in part, by means of the frictional resistance developed in the wall-floor interface, and the surplus, from the incorporation of a passive sub-horizontal anchor arranged towards the perimeter retreat of the palace. The diagram of loads involved in the wall is shown in Figure 15, from which it is feasible to determine the value of the load to be balanced by means of the proposed passive anchorage.

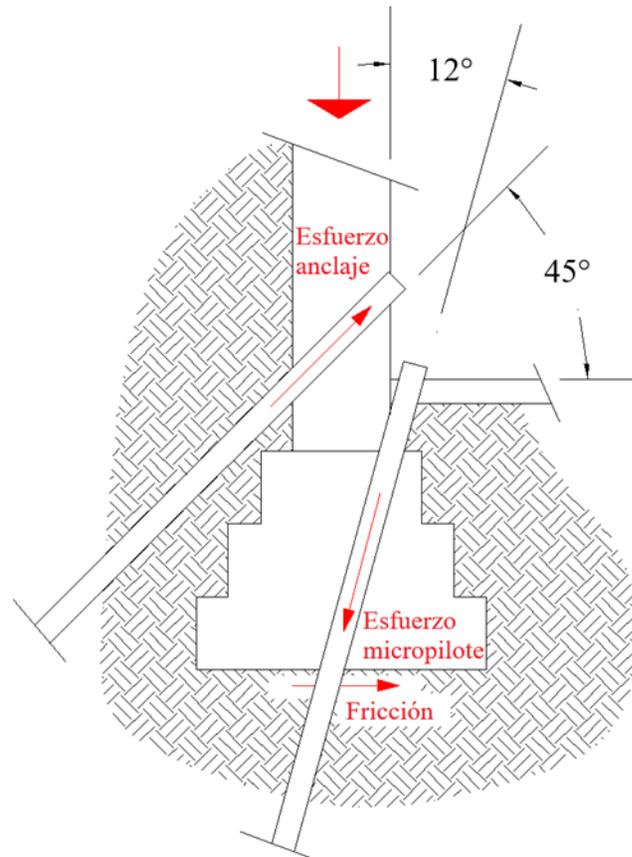
Figure 15. Section B-B, shown in Figure 14, showing the connection with the foundation masonry and the arrangement of the passive anchorage.

From the loads detailed in Figure 15, the horizontal force balance equation (1) is proposed, from which the value of the anchor stress is delineated, by micropile.

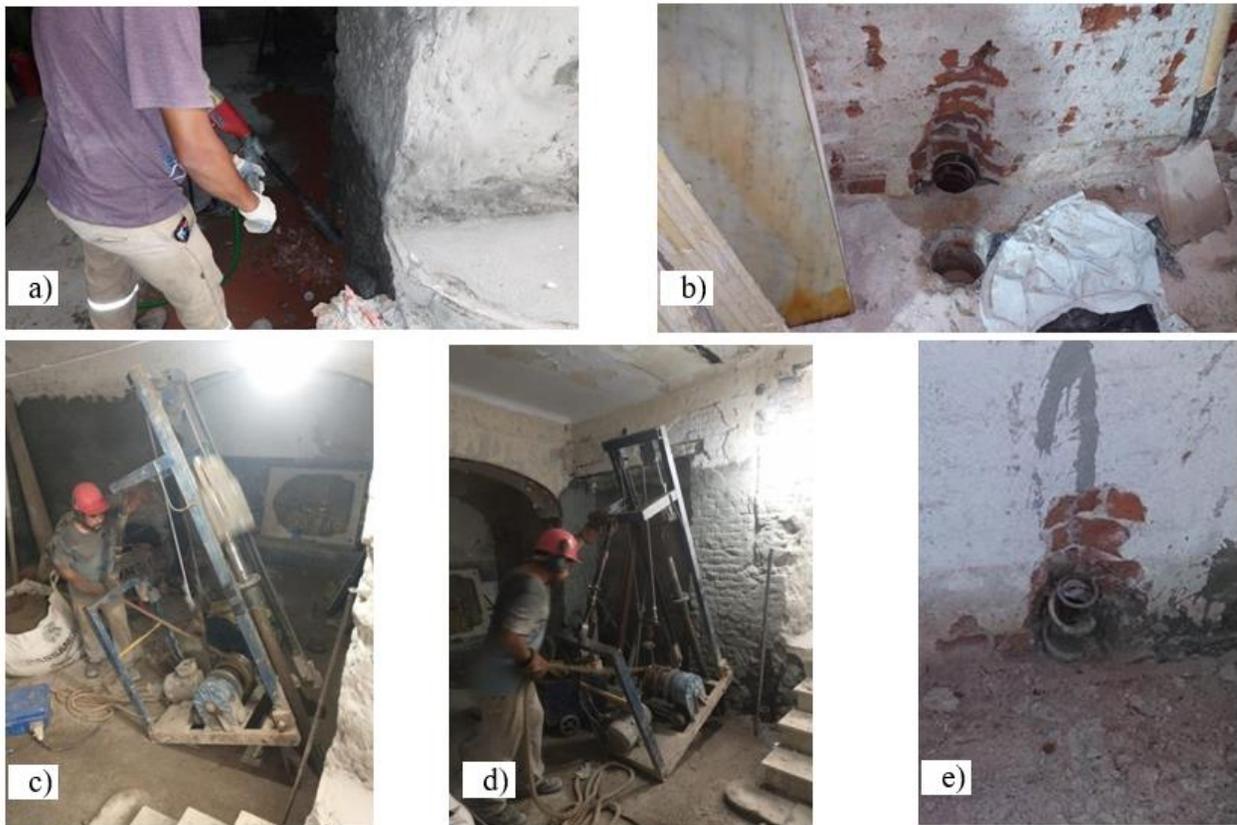
Figure 16. Detail of the intervention procedure. a) Image of diamond crown drilling. b) Photograph of the holes drilled in the masonry up to the pre-existing floor horizon. c) Photograph taken during the mechanical driving process of the micropile. (d) Photograph taken during the driving of a micropile. e) Image of the upper end of the Manessmann tube, driven, with welded abutments to increase the frictional surface against the sub-pressure slab to be executed.

The thrust to balance by means of passive anchors is the equivalent of 4 micropiles. Consequently, the passive anchor will have to be designed to absorb 10 tonnes. The proposed separation of 2.00m between micropiles is reasonable and allows us to infer that the load transferred to each micropile is approximately 40 tons. Because each pile has a load capacity of around 20 tons, the load not absorbed by the micropiles will continue to be resisted by the supporting soil. In this sense, it is considered to be low and compatible with the carrying capacity of the same, so that it is sufficient for the cessation of settlements. Figure 16 shows, by means of a photographic sequence, the driving procedure of a metal micropile.

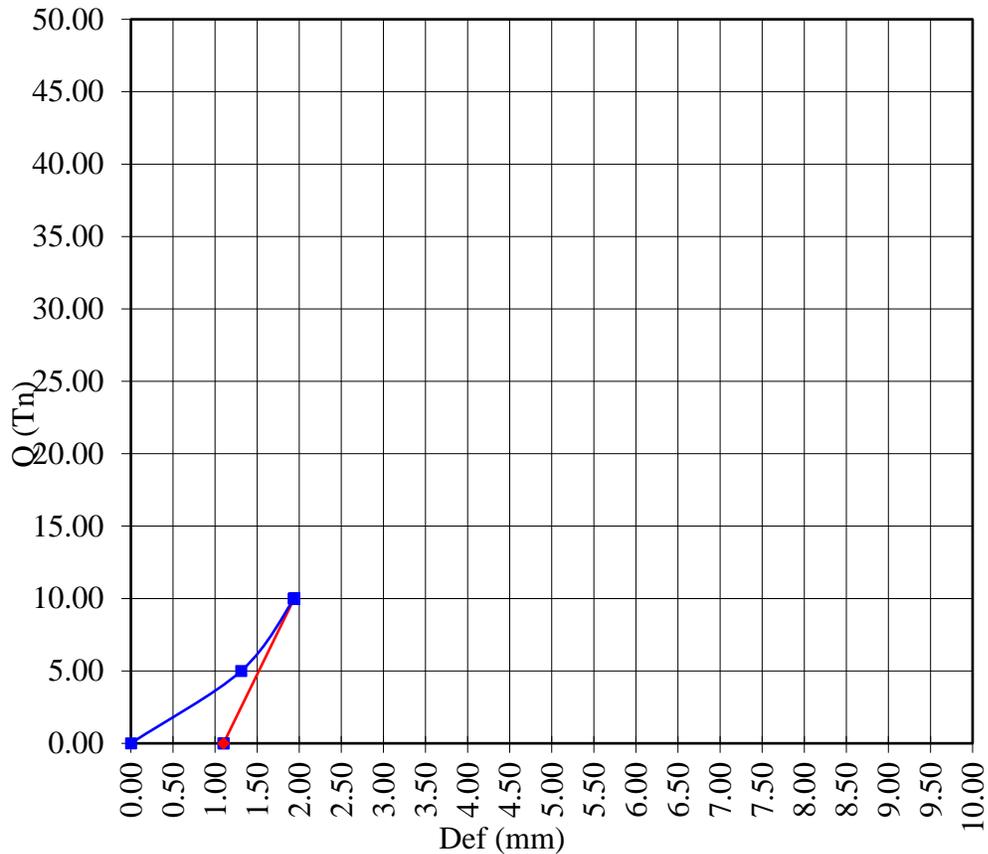
Figure 17. Load-strain graph of the 1st loading cycle (10 tn).

Figures 17 and 18 show a quasi-linear behavior of the soil requested by the micropile, both in load and discharge, warning that, due to the level of deformations reached, there is a modification of the

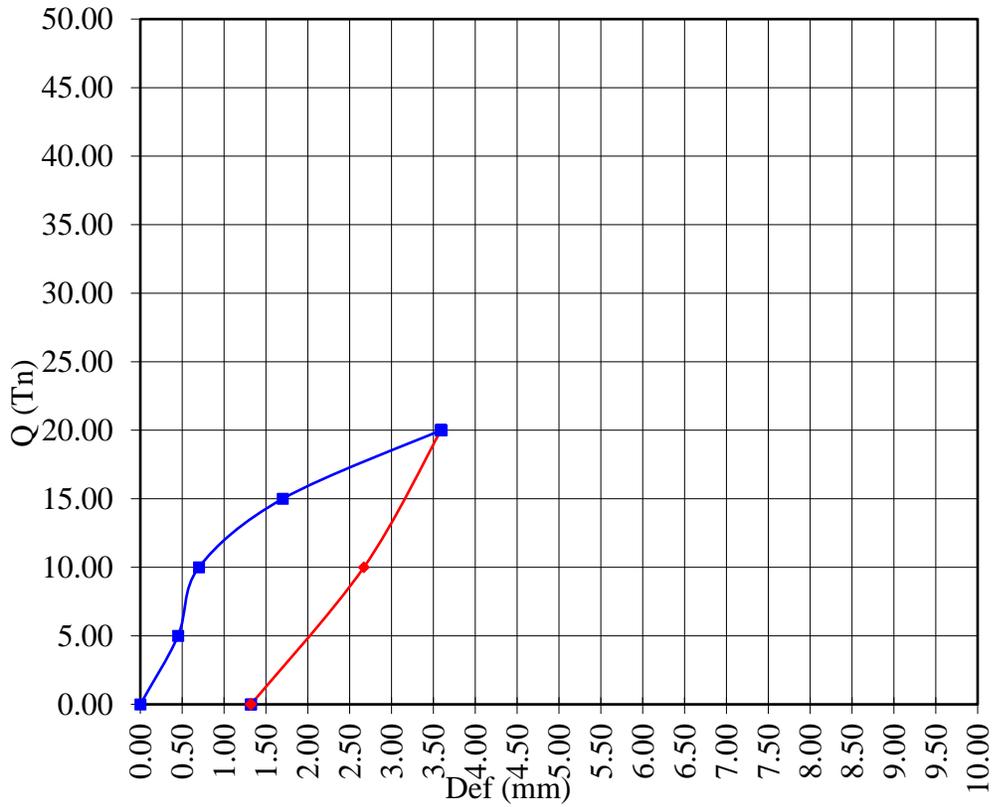
Figure 18. Load-strain graph of the 2nd loading cycle (25 tn).

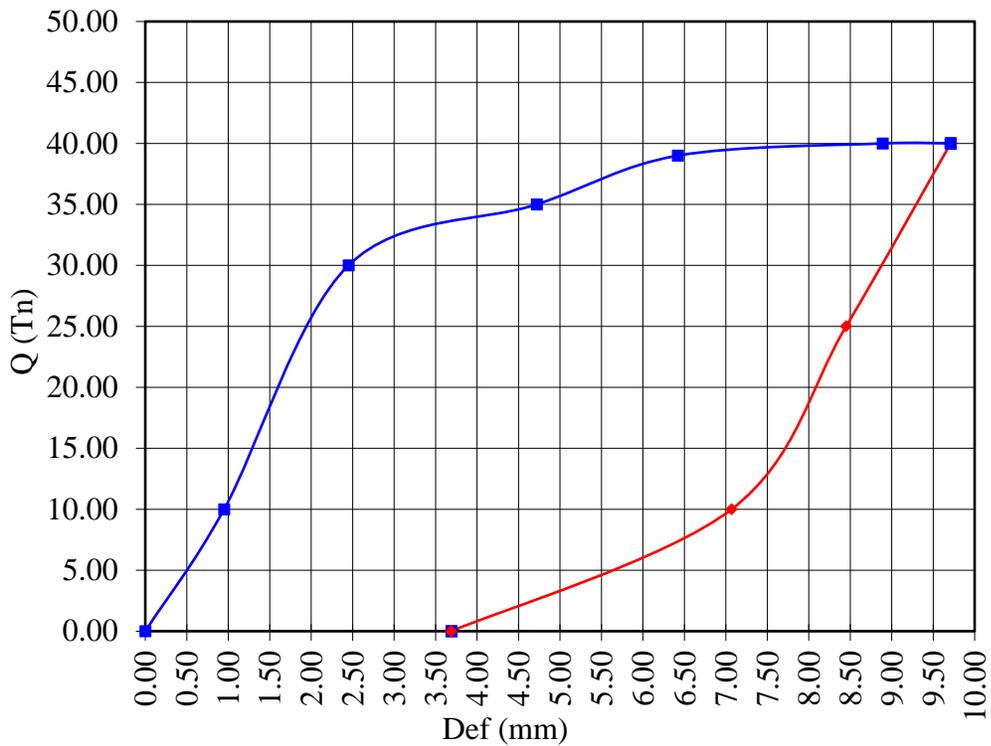
Figure 19. Load-deformation graph of the 3rd loading cycle (45 tn).

cemented microstructure of the silt, causing plastic deformations (permanent) but compatible with the limit established for the residual values of settlements. Figure 19 shows a clear bilinear behavior, typical of cemented silt, in which the slope of the load-settlement curve changes from the applied load of 30 tons (Capdevila, 2008). After the tensioner breaks, the discharge is carried out, reaching an internal residual settlement at the limit value.
