YOLOv8-based model for automatic detection of residential roof damage.

Cite as: Silva, A. S., Azevedo, A. R., Neto, F. H. A. M., Ferreira, P. H. (2025), “YOLOv8-based model for automatic detection of residential roof damage.”, Revista ALCONPAT, 15 (1), pp. 50 – 63, DOI: <https://doi.org/10.21041/ra.v15i1.783>

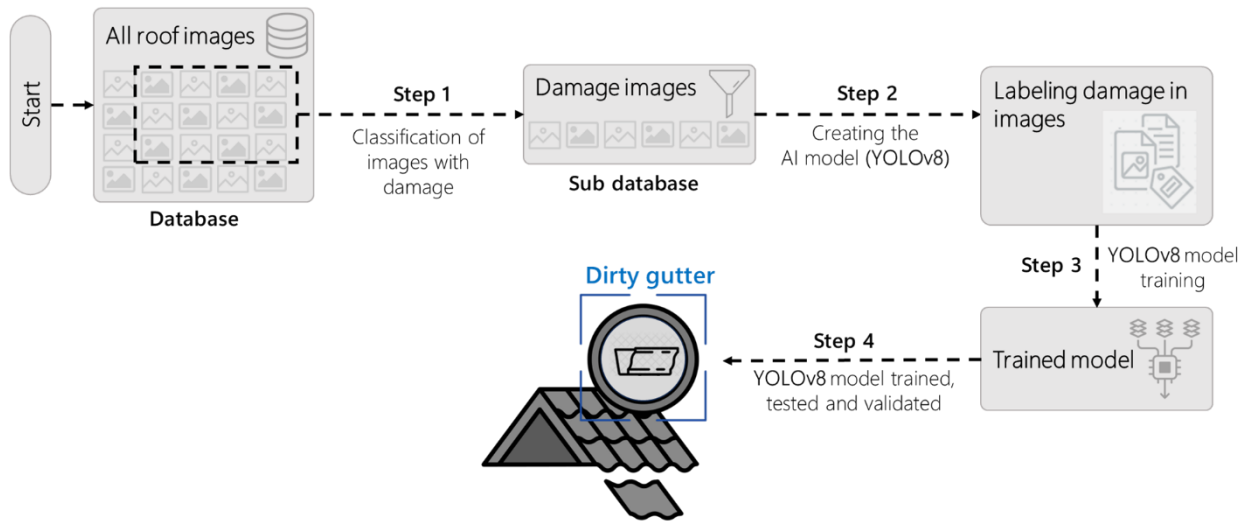
This study adopted an experimental simulation research strategy, developed in four stages (Figure 1): (1) refining the database of residential roof images with surface damage; (2) creating the automated damage recognition model using the YOLOv8 architecture; (3) training the model using 70% of the database; and (4) testing and validating the trained model with new images (30%). Precision, Recall, and mAP indicators evaluated the model's performance.

Figure 1. Research design.

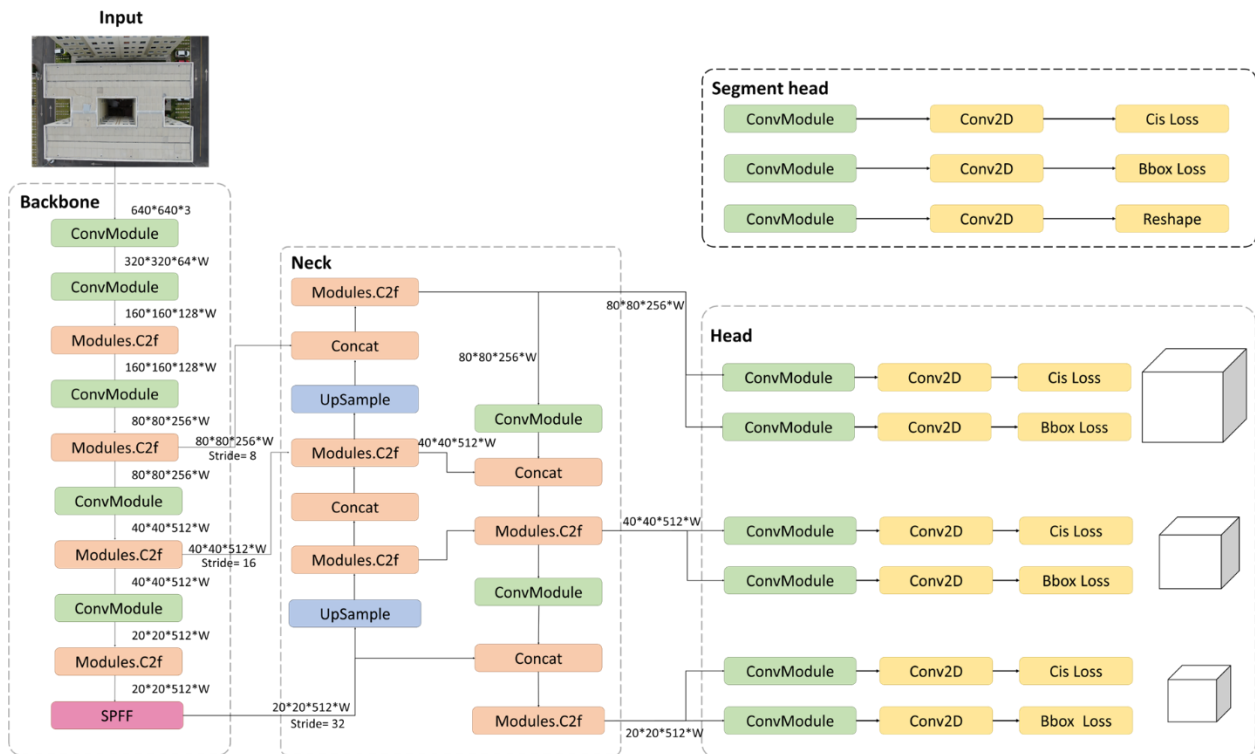
Figure 2. YOLOv8 architecture used.

Figure 2 shows that the architecture is organized into three main components: Backbone, Neck, and Head, each playing a specific role in image processing and prediction generation.

The input image is the starting point of the process, where the network begins to extract relevant features to identify potential defects. The Backbone extracts basic features from the image through several convolutional layers that detect initial patterns, such as edges and textures. As the image progresses through these layers, more complex modules, known as Modules.C2f, refine the extracted features, allowing for a more detailed image analysis. The Backbone also includes the Spatial Pyramid Pooling Fast (SPPF) module, aggregating information at different scales and enhancing detection robustness.

The Neck is an intermediary between the Backbone and the Head, refining and combining the extracted features through Concatenation (Concat), Upsampling, and additional convolutional layers. The Neck's goal is to prepare these features for more precise multi-scale detection, ensuring that both fine details and larger structures in the image are considered in the final prediction.

Finally, the Head is responsible for generating the final predictions. The features refined by the Neck are used to identify and classify objects or defects in the image. The Head consists of two main types: the Segment Head, which handles segmentation tasks by identifying exact areas where defects are present, and the Detection Head, which focuses on object detection and classification by generating bounding boxes and object classes. Additionally, losses (Cis Loss and Bbox Loss) associated with these predictions are calculated to optimize the model's performance.

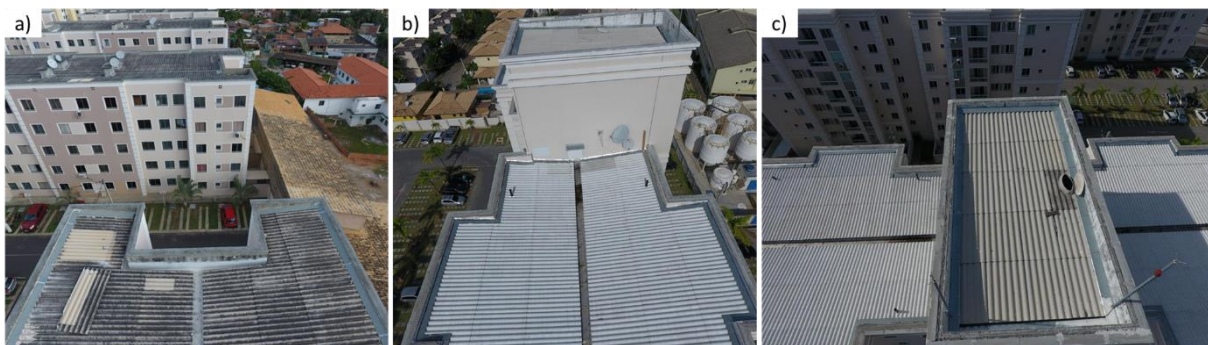
Figure 3. Examples of roof damage addressed in this research: a) Presence of extra tile in the transverse direction of the roof; b) Gutter integrity (oxidation); c) Open trapdoor.

GETEC-UFBA ("Grupo de Pesquisa e Extensão em Gestão e Tecnologia das Construções da Escola Politécnica da Universidade Federal da Bahia", in Portuguese) provided the dataset used in this research. These images were collected from residential buildings aged between one and five years. Over 167 residential roofs were inspected from manual drone flights, with an approximate altitude of 5 meters above the building being analyzed. The data acquisition followed inspection protocols proposed by Silveira et al. (2021). After analyzing the images in this dataset, 394 images were selected, distributed among 425 annotations for the class "Presence of extra tile in the transverse direction of the roof", 473 annotations for the class "Gutter integrity (oxidation)", and 29 annotations for the class "Open trapdoor". The dataset was split into approximately 70% for training, 20% for validation, and 10% for testing. After data augmentation in the training set, 498 images were obtained from the training set, with examples of these classes shown in Figure 3.

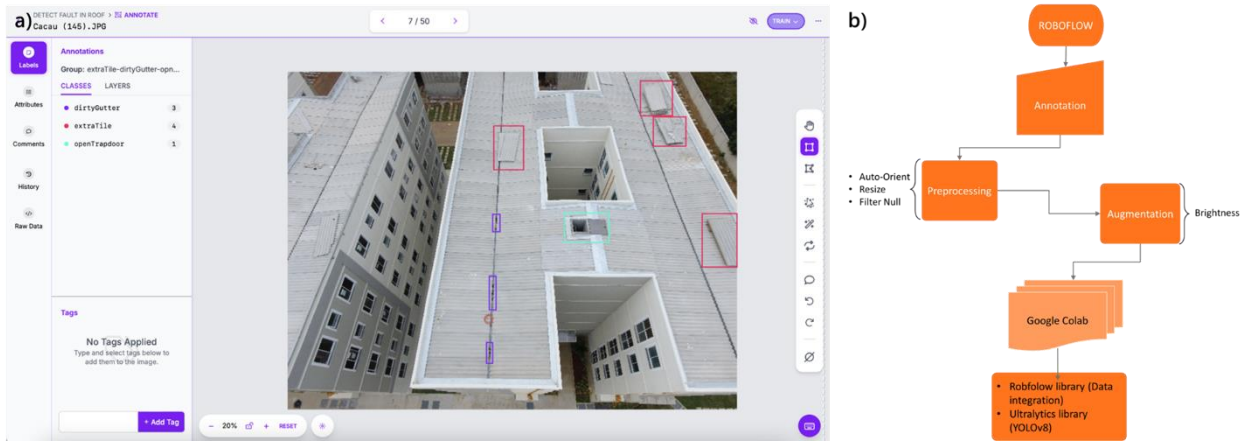
After defining the anomalies, the training images were labeled using Roboflow. An example of this labeling is shown in Figure 4a, where some extra tiles on the roof, oxidation, and an open skylight are labeled. Figure 4b illustrates the complete workflow from data entry to model training and

subsequent inference process, where annotations are made; then preprocessing, data augmentation, and finally, the data is exported in YOLOv8 format for analysis in Google Colab.

Figure 4. a) Damage notes; b) Workflow.

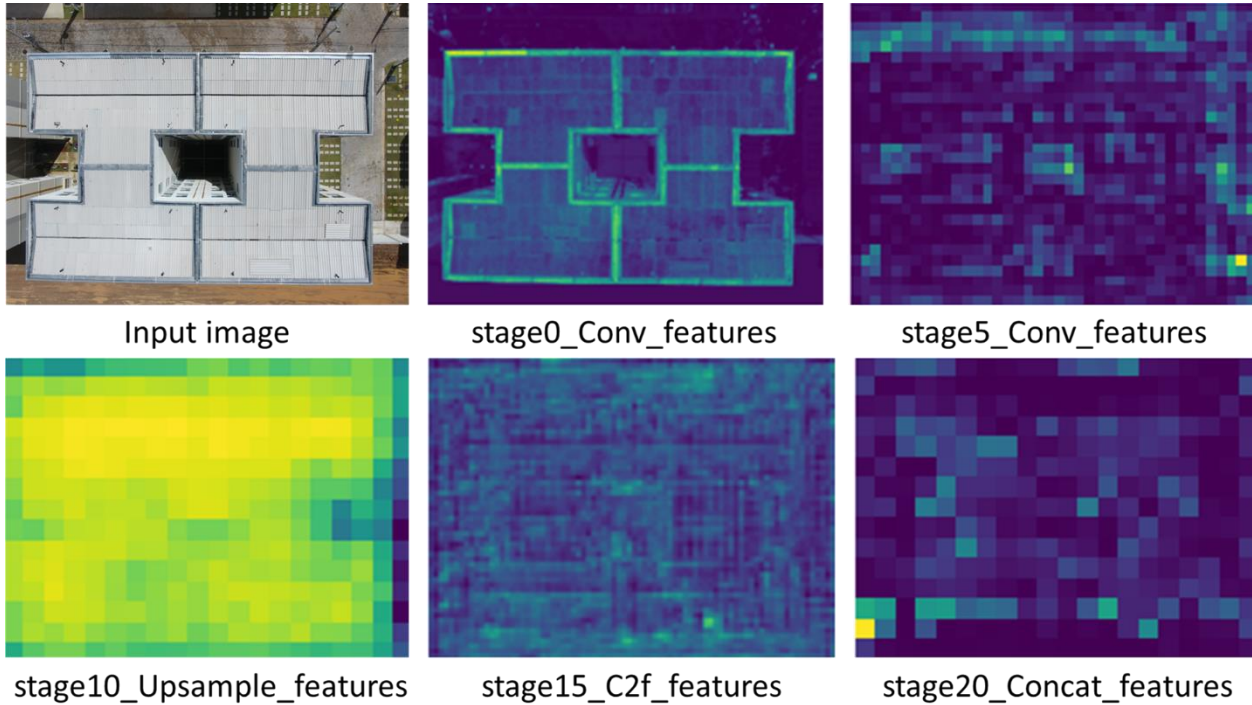
During the model training, the YOLOv8 architecture performs feature activations at different neural network stages. These activations demonstrate how the network processes visual information to detect patterns and important features in the input images (Figure 5). These visualizations illustrate how YOLOv8 performs object detection, from basic feature extraction to combining information across different scales and resolutions, enabling precise identification of roof defects.

Figure 5: Structure of the trained YOLOv8 layers.

The "Conv_features" are the outputs of the convolutional layers, responsible for identifying local patterns such as edges and textures. As we progress through the different stages, from "stage0_Conv_features" to "stage20_Concat_features," the activations reflect increasingly complex and abstract representations of the image features. The "Upsample_features" are related to the upsampling process, where the spatial resolution of the activations is increased, allowing the network to detect objects at different scales. This process is crucial for detecting smaller details on roofs.

The "C2f_features" refer to combinations of convolutions followed by activation functions designed to capture more complex interactions between features extracted in previous layers, enhancing the network's ability to identify patterns. Finally, the "Concat_features" result from concatenation operations, which combine activations from different layers or stages of the network. This technique allows the network to integrate information from other levels of abstraction, merging features extracted at various stages to produce the final prediction.

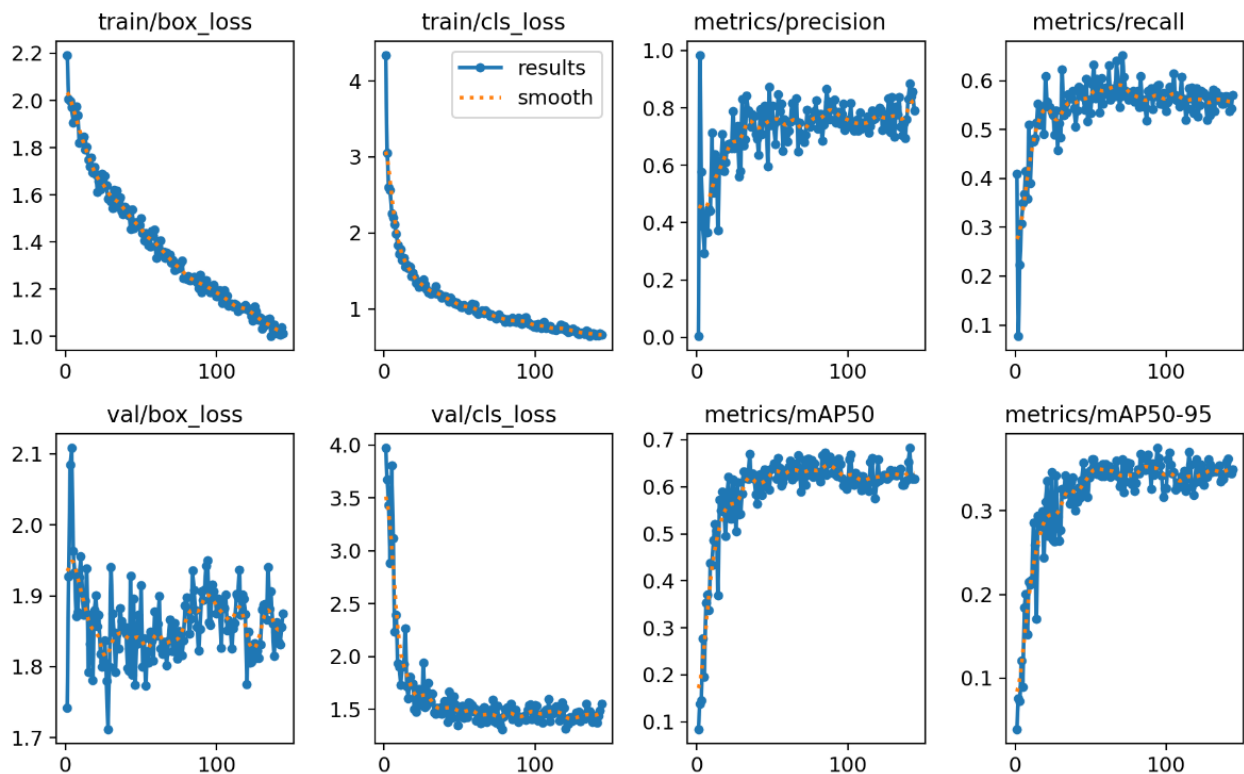
Figure 6. Training and validation losses, Precision and Recall metrics of YOLOv8.

For extra tiles across the roof, the model achieved a Precision of 78%, Recall of 66%, and mAP50 of 68%. The model effectively identifies extra tiles, although it is slightly less accurate than detecting open skylights. Finally, for the integrity of the gutters, the model performed the worst, with a Precision of 69%, Recall of 44%, and mAP50 of 51%, indicating greater difficulty in detecting and accurately classifying this issue. Figure 6 shows the training and validation loss graphs, along with the Precision and Recall metrics; these indicate that the model is learning robustly and steadily (with decreasing losses and increasing metrics).

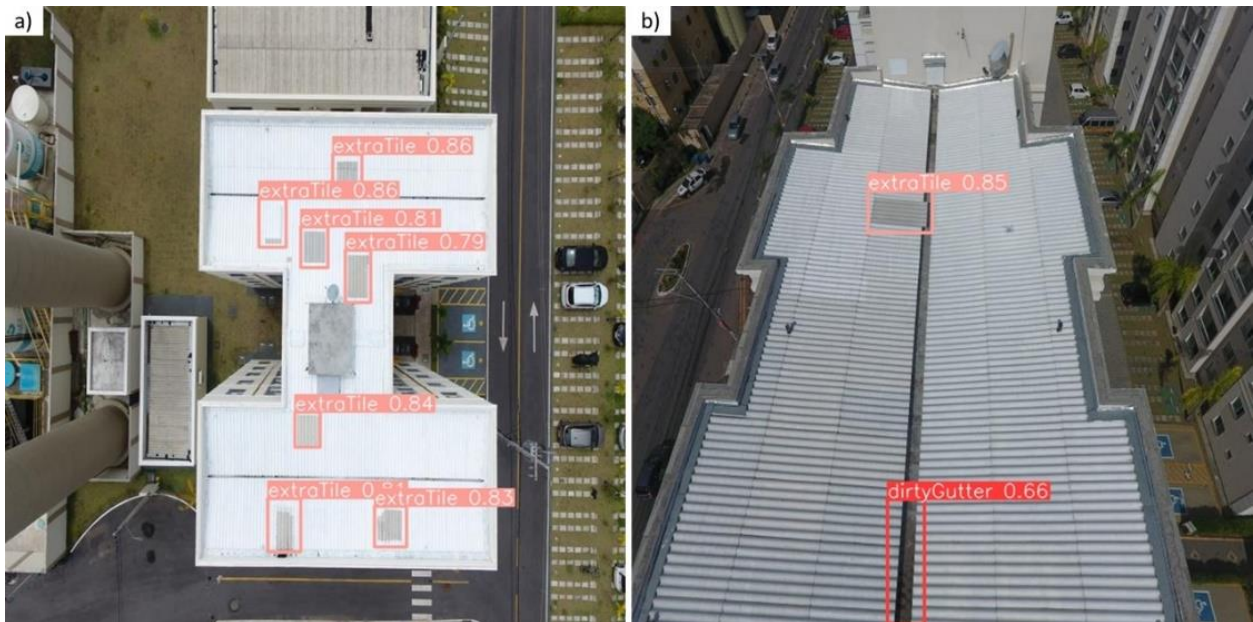
Figure 7: Test set classification for extra tiles and oxidation.

Figures 7 and 8 display the classification results from the test set. From these images, it is clear that the model can identify extra tiles arranged in different orientations (Figure 7a shows extra tiles; Figure 7b shows an extra tile and oxidation on the gutter) and open skylights in various positions (Figures 8a and 8b show an open skylight and some extra tiles). These classifications are vital for preventive maintenance, ensuring the roofs' structural integrity and proper functionality. Despite the model's successes, some elements were not identified in Figures 7 and 8.

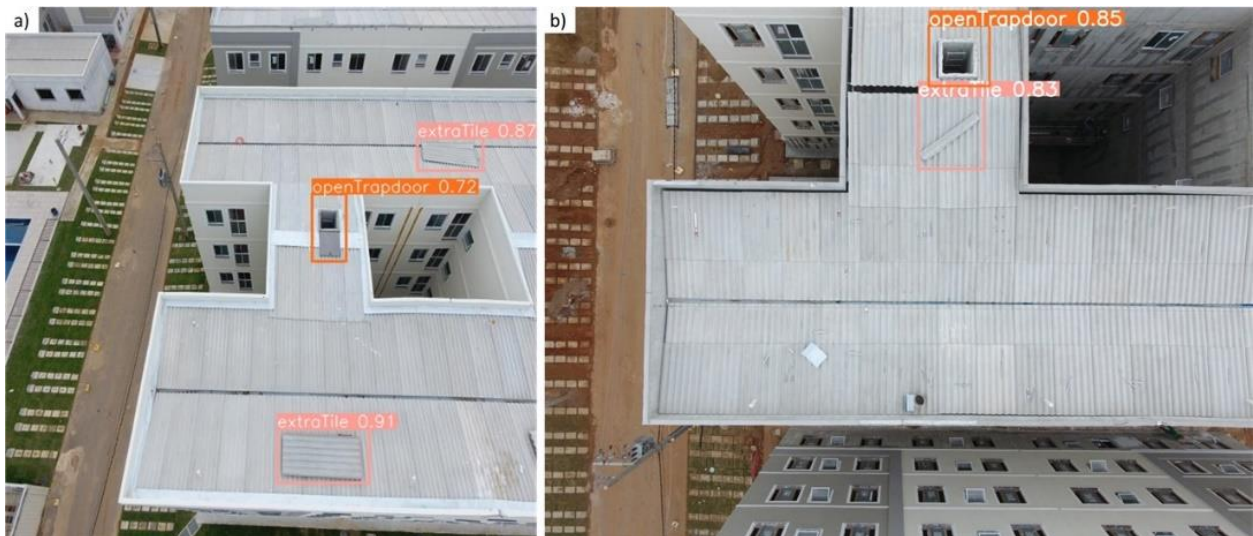
Figure 8: Test set classification for open trapdoor and extra tile.
